# Environmental Impact Study and Tree Conservation Report for 3555 Borrisokane Road, Ottawa

2024-10-07

Final Report  
(Revised Figure 3 and Appendices)

Project Number: PAI 1461.4

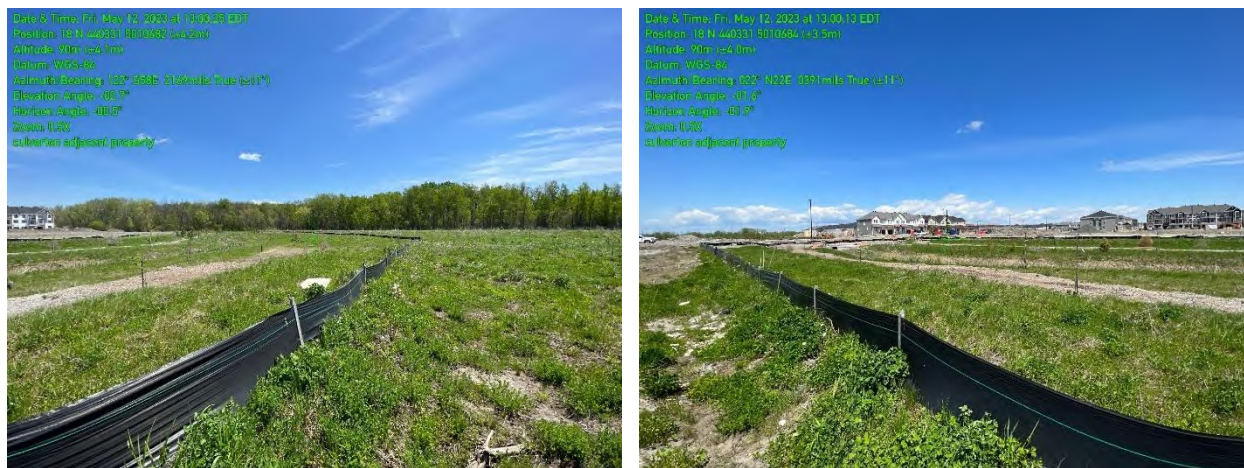
**Figure 2 Sediment fencing separating Tipperary Creek (the realigned watercourse) and the Site**

The setback requirements for Tipperary Creek were identified and confirmed within the KAL (2022) EIS supporting Phase 3 of Mattamy's Half Moon Bay West residential development on the opposite side of the watercourse, in accordance with the stipulations of *Jock River Reach One Subwatershed Study* (Stantec, 2007). Setbacks for this reach are not defined by distances from the channel per se, but rather provide that the channel be located (and approximately centered within) a 30 m wide corridor with an additional 5 m on either side, which may be used for potential pathways. Directly south of Flagstaff Road the property lines on either side of the creek fully accommodate the 40 m corridor requirement. At the eastward creek bend ~90 m south of Flagstaff Road, the gap between the associated property lines narrows such that they correspond with 30 m base corridor width. An additional 5 m of setback thus extends onto the Site adjacent to the realigned channel (and similarly on the Half Moon Bay West

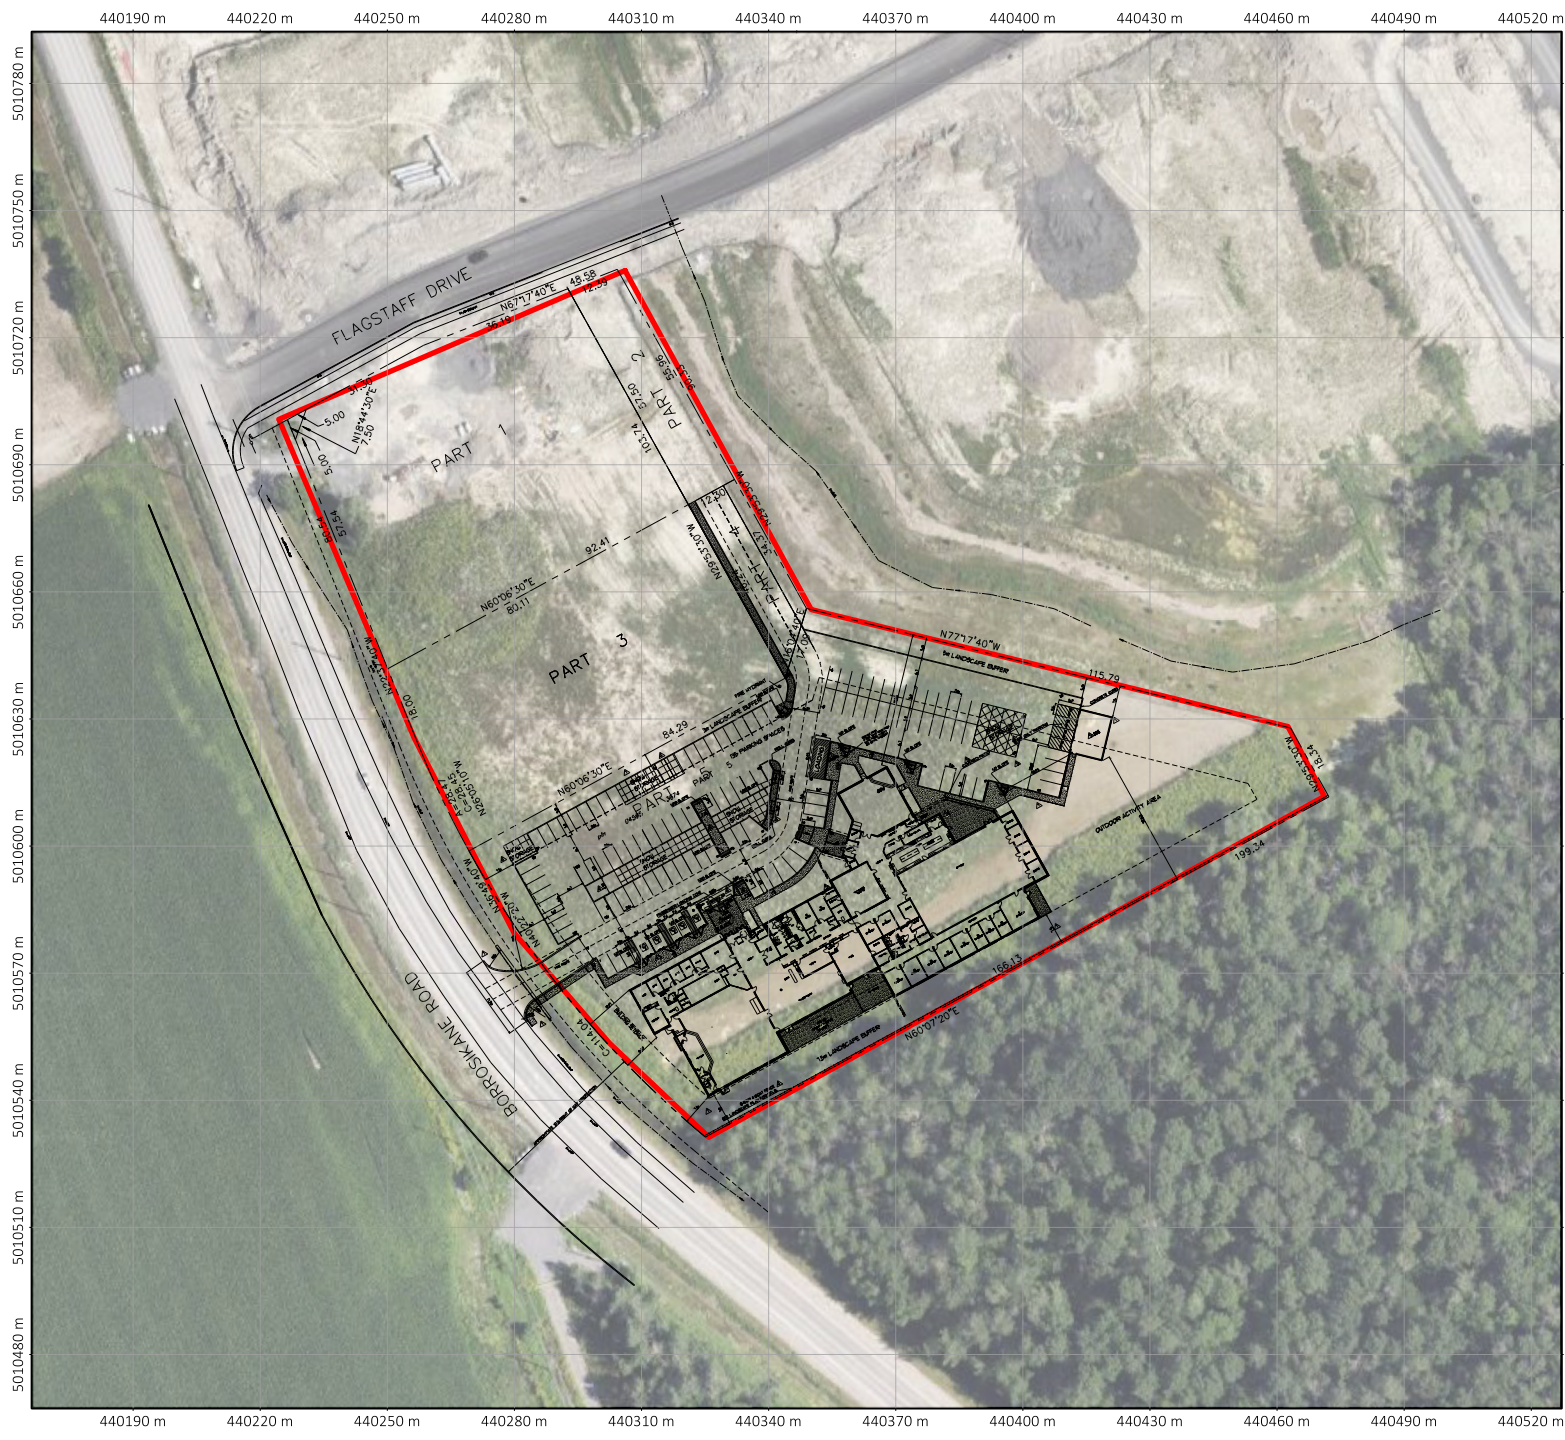
**Figure 3** Site Development Plan

In consideration of the Ottawa Bird- Safe Design Guidelines, Walker/Vitro Architectural Glass “AviProtek E” bird friendly vertical etched glass will be utilized for the large windows along the southern church facade, the main lobby area and adjacent Ainos room. Windows are a double glazed Solarban 60(2) Solargray + Clear Glass Insulating Glass Unit. This is a tinted glass specification with Visible Light Transmittance (VLT) of 35% and an exterior reflectance of 6%. Windows have also been divided into smaller panes using a contrasting clear anodized aluminum framing system to avoid a large monolithic glass facade.

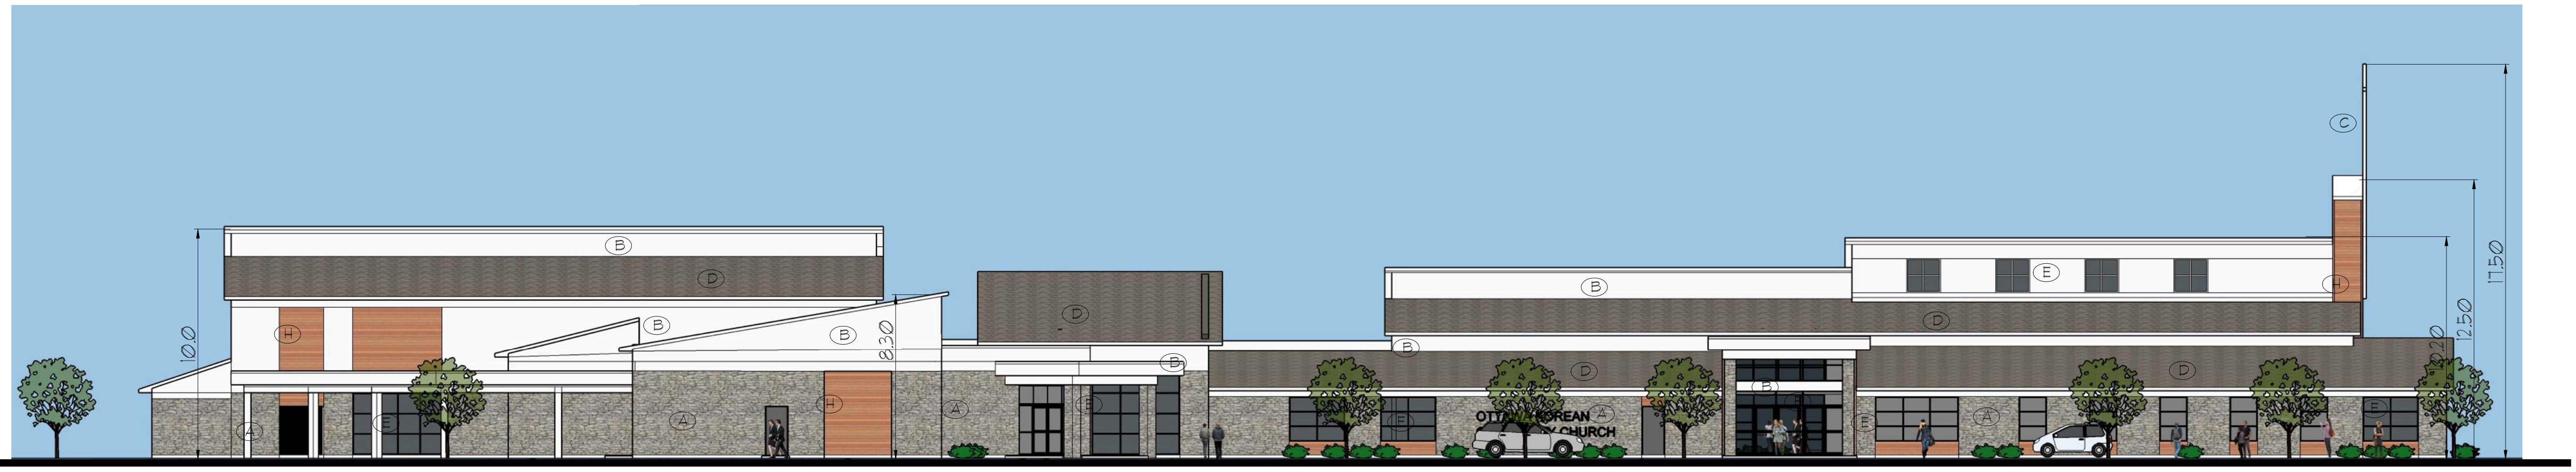
# FRONT (NORTHWEST) ELEVATION

- (A) STONE
- (B) STUCCO FINISH (EIFS)
- (C) METAL CROSS
- (D) ASPHALT SHINGLES
- (E) DOOR & WINDOW (TINTED GLASS)
- (F) GARAGE DOOR & MAN DOOR
- (G) AVI PROTEK E ETCHED (BIRD SAFE GLASS) PATTERN 211 VERTICAL
- (H) WOOD LOOK METAL SIDING

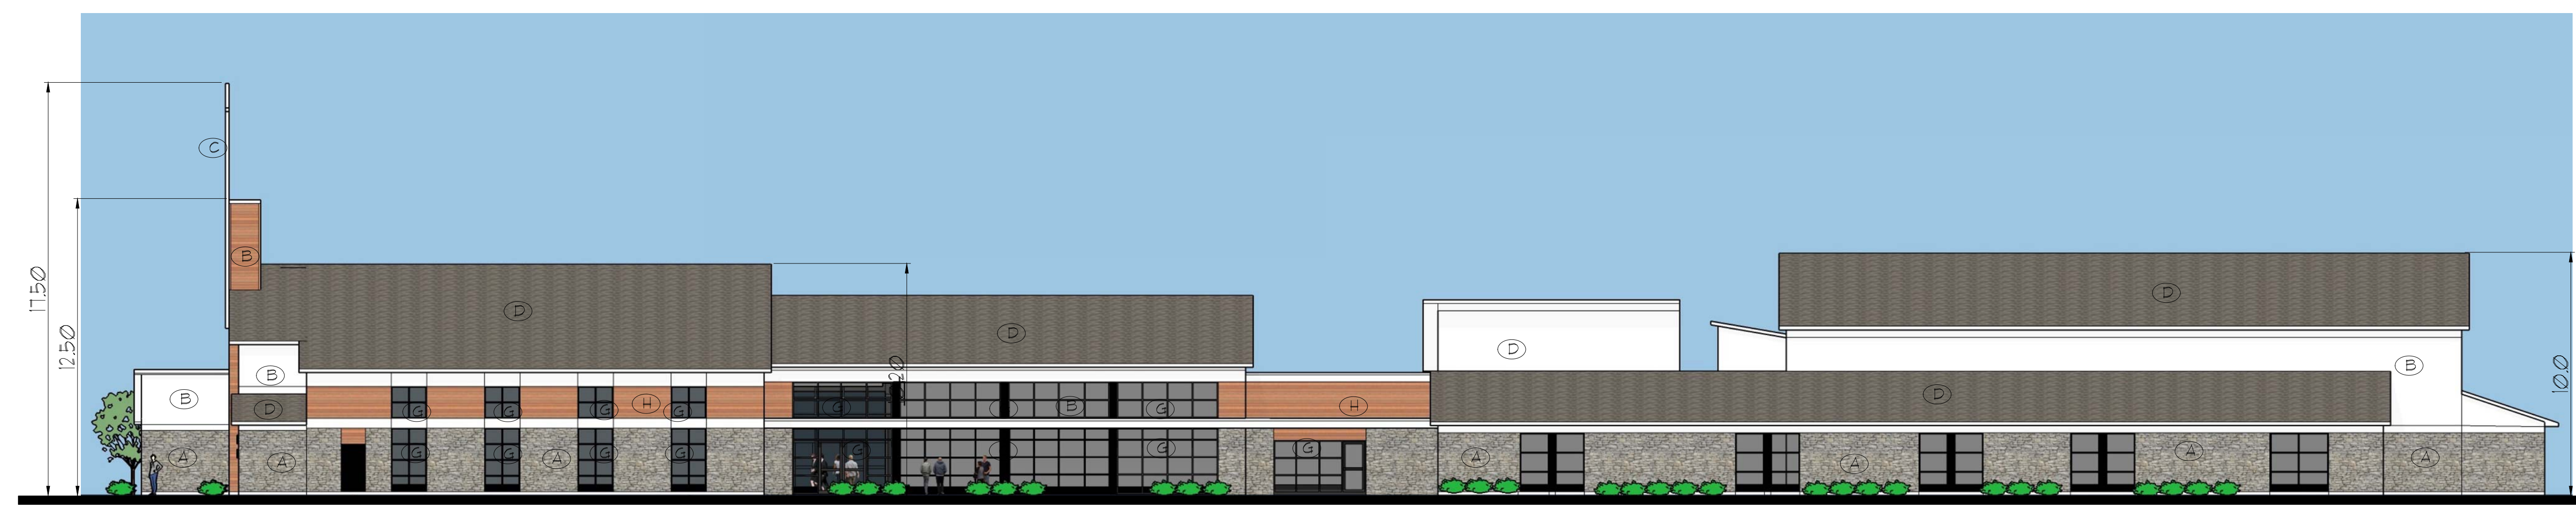
REAR (SOUTHEAST) ELEVATION  
SCALE 1:150

- (A) STONE
- (B) STUCCO FINISH (EIFS)
- (C) METAL CROSS
- (D) ASPHALT SHINGLES
- (E) DOOR & WINDOW (TINTED GLASS)
- (F) GARAGE DOOR & MAN DOOR
- (G) AVI PROTEK E ETCHED (BIRD SAFE GLASS) PATTERN 211 VERTICAL
- (H) WOOD LOOK METAL SIDING

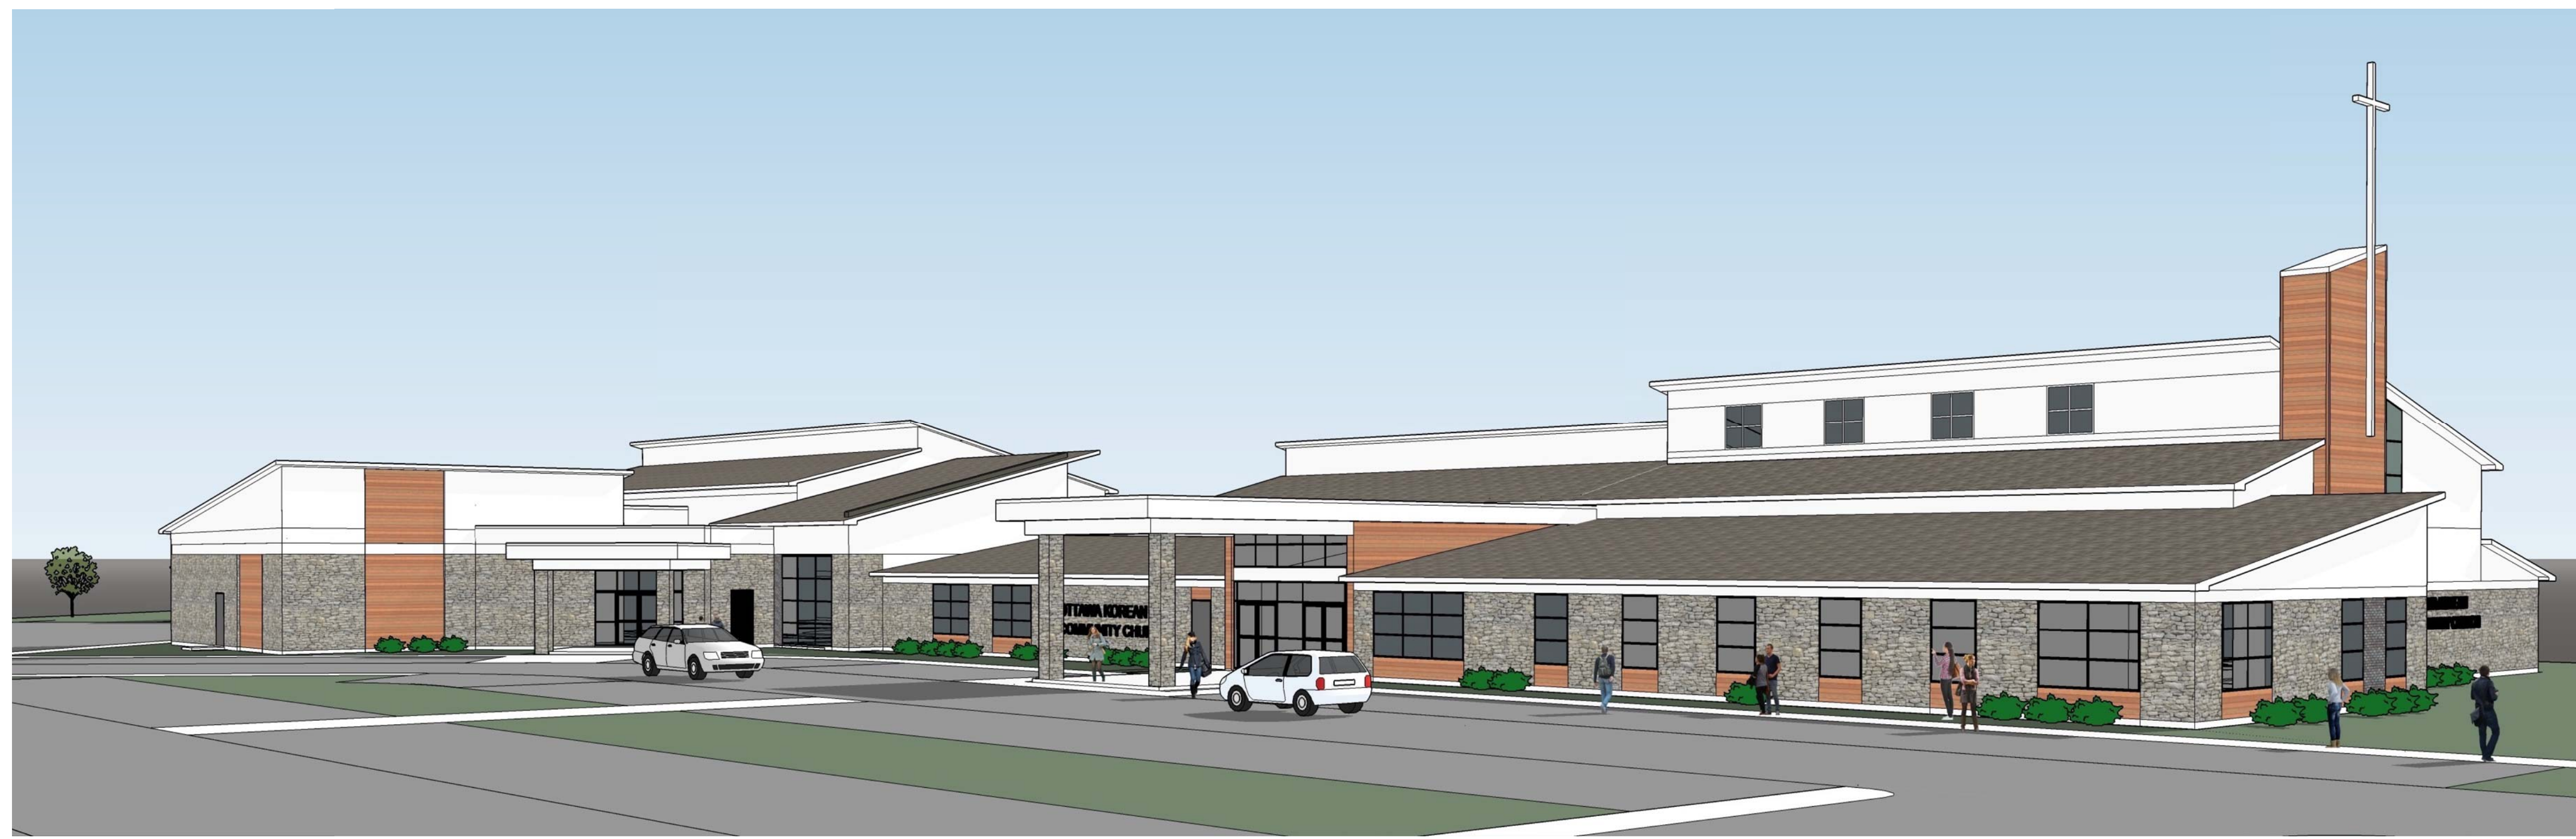
VIEW OF SOUTHWEST FACADE FROM BORRISOKANE ROAD

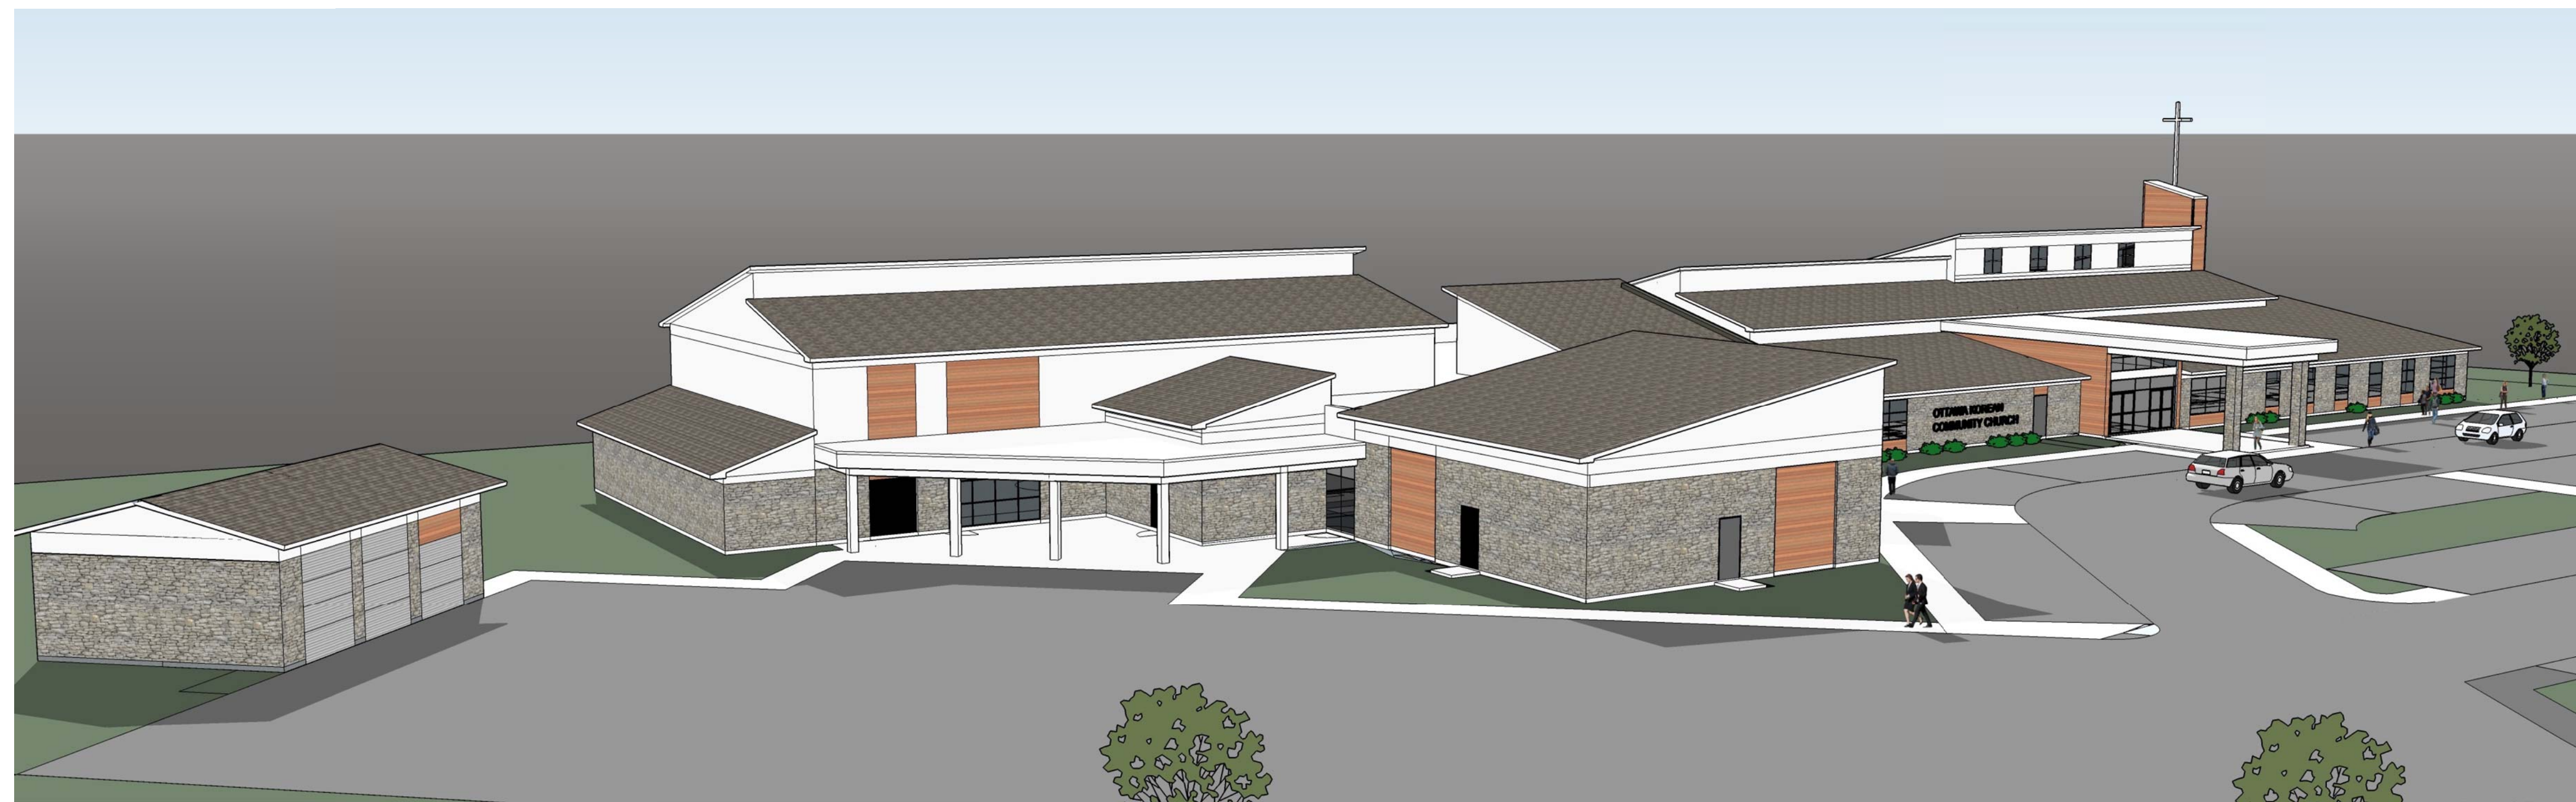
VIEW OF NORTHEAST FACADE

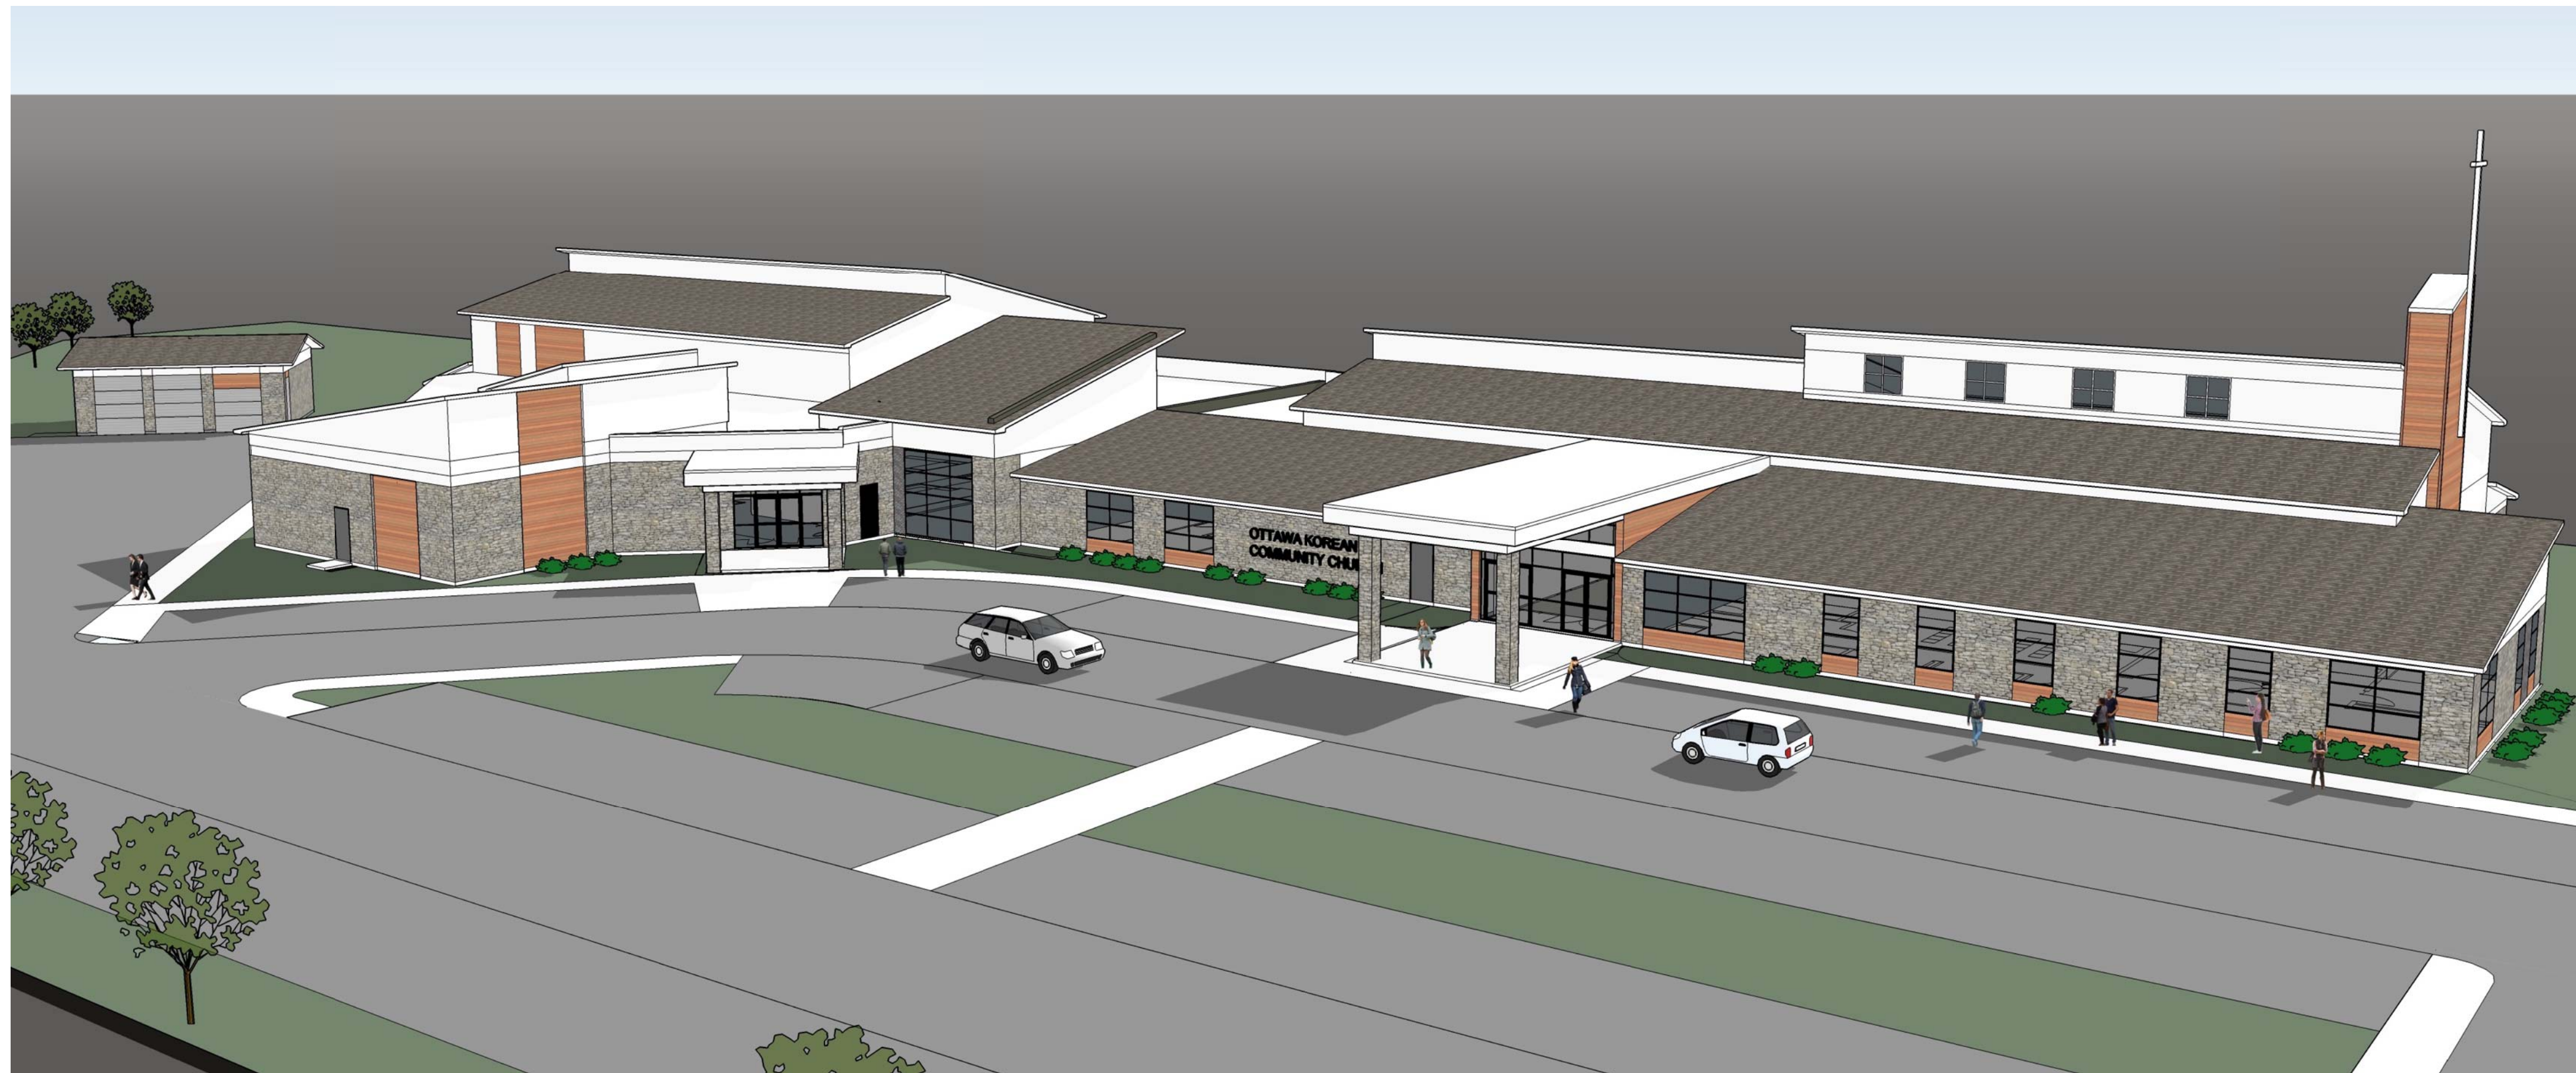
AERIAL VIEW OF NORTHEAST FACADE

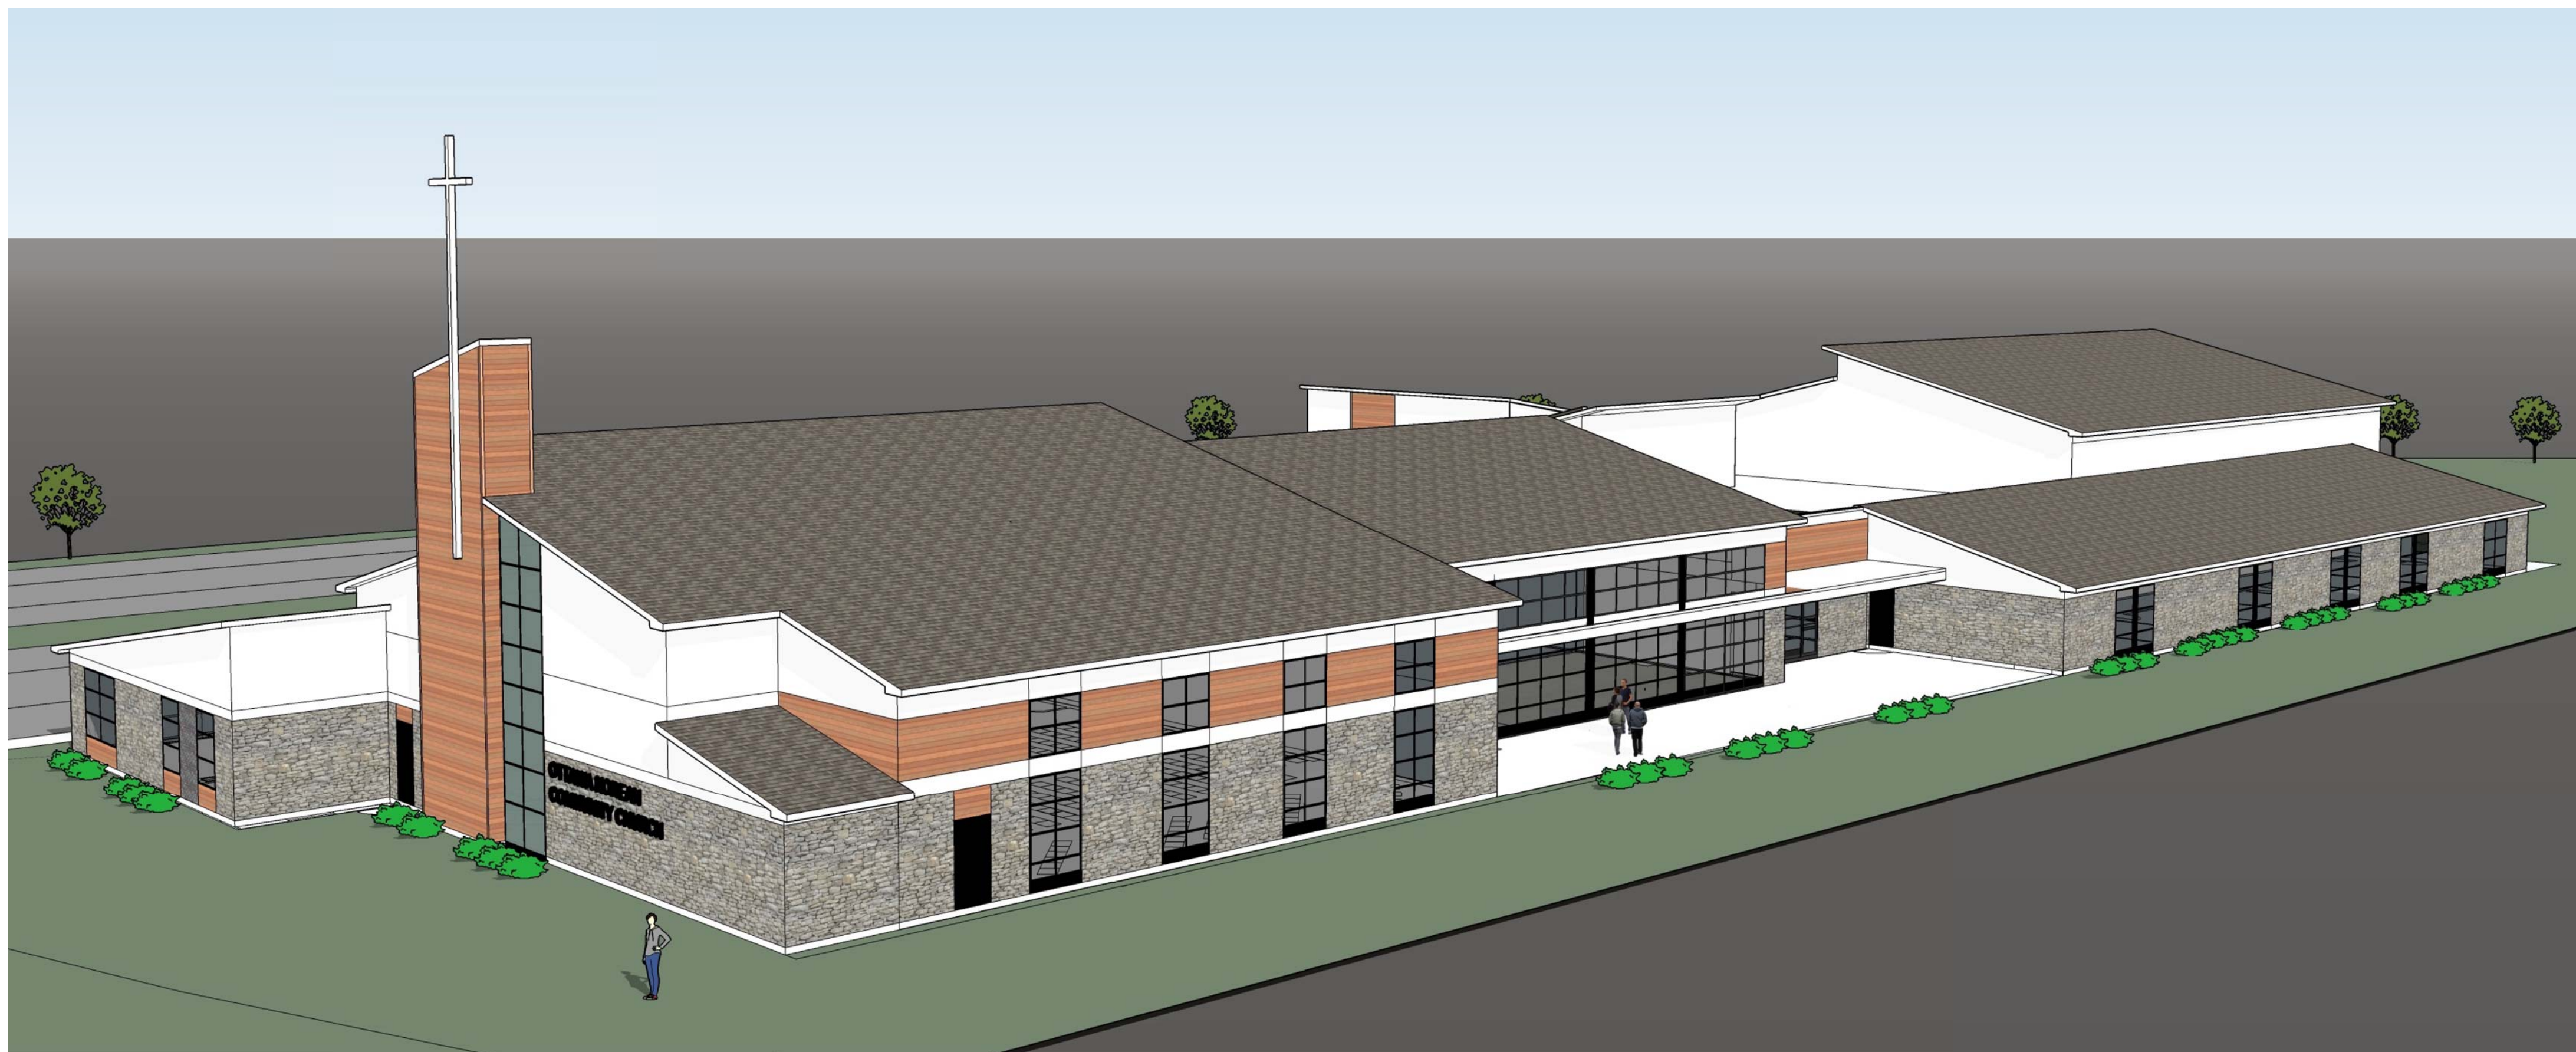
AERIAL VIEW OF SOUTHWEST FACADE

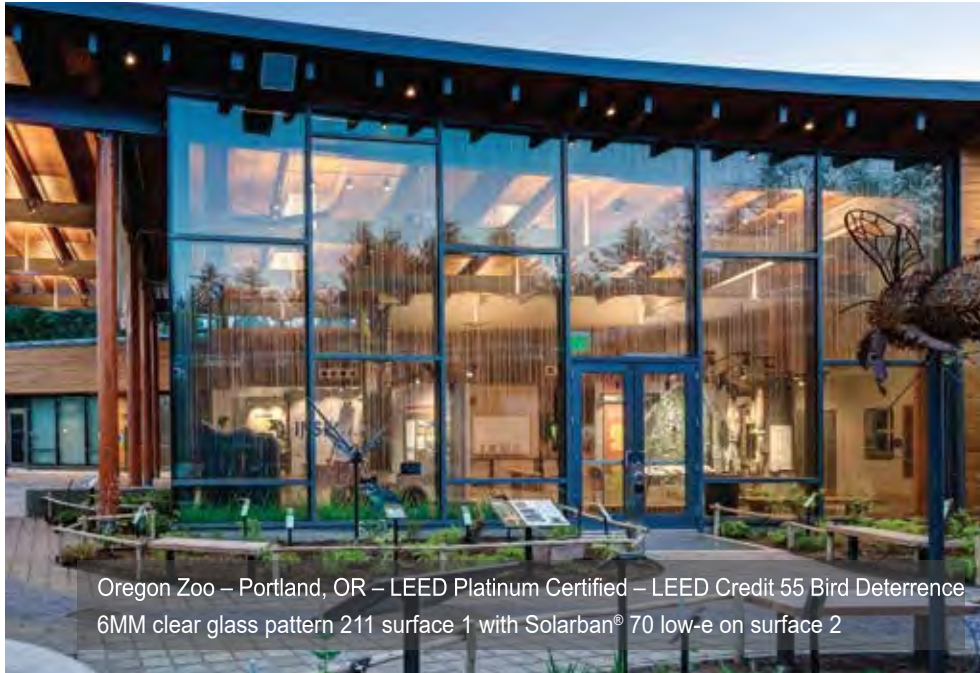
Oregon Zoo – Portland, OR – LEED Platinum Certified – LEED Credit 55 Bird Deterrence  
6MM clear glass pattern 211 surface 1 with Solarban® 70 low-e on surface 2

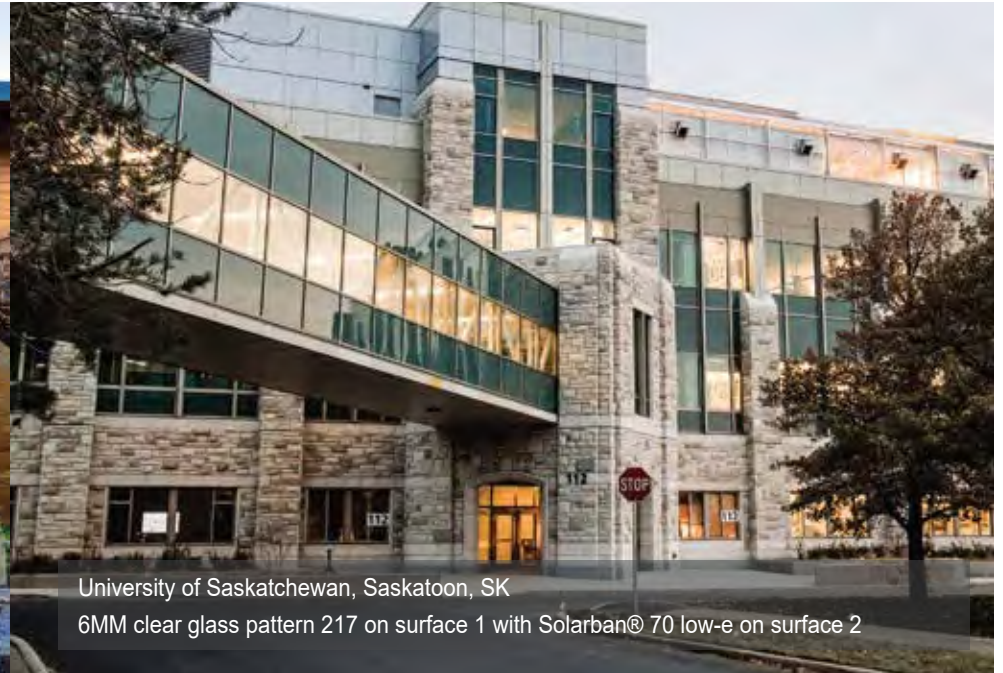
University of Saskatchewan, Saskatoon, SK  
6MM clear glass pattern 217 on surface 1 with Solarban® 70 low-e on surface 2

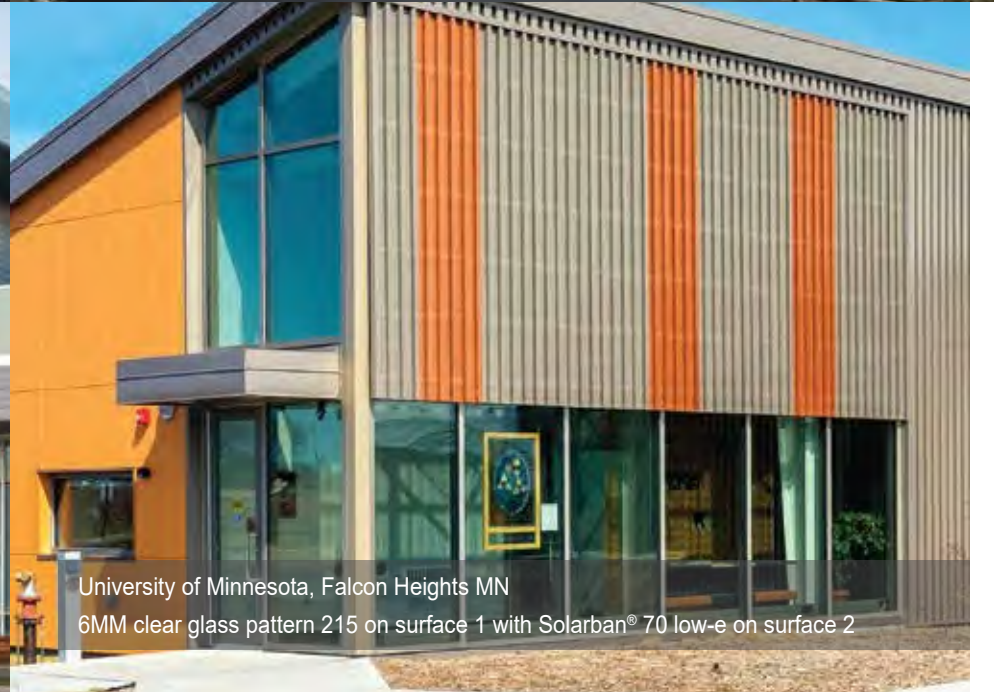
University of Minnesota, Falcon Heights MN  
6MM clear glass pattern 215 on surface 1 with Solarban® 70 low-e on surface 2
