**HENRY INVESTMENTS  
14072375 Canada Inc.**

**Phase II Environmental Site Assessment  
73-79, 83 Ste-Cecile,  
Vanier, Ontario**

**CM3 Project SDC1009**

**December 20, 2022**

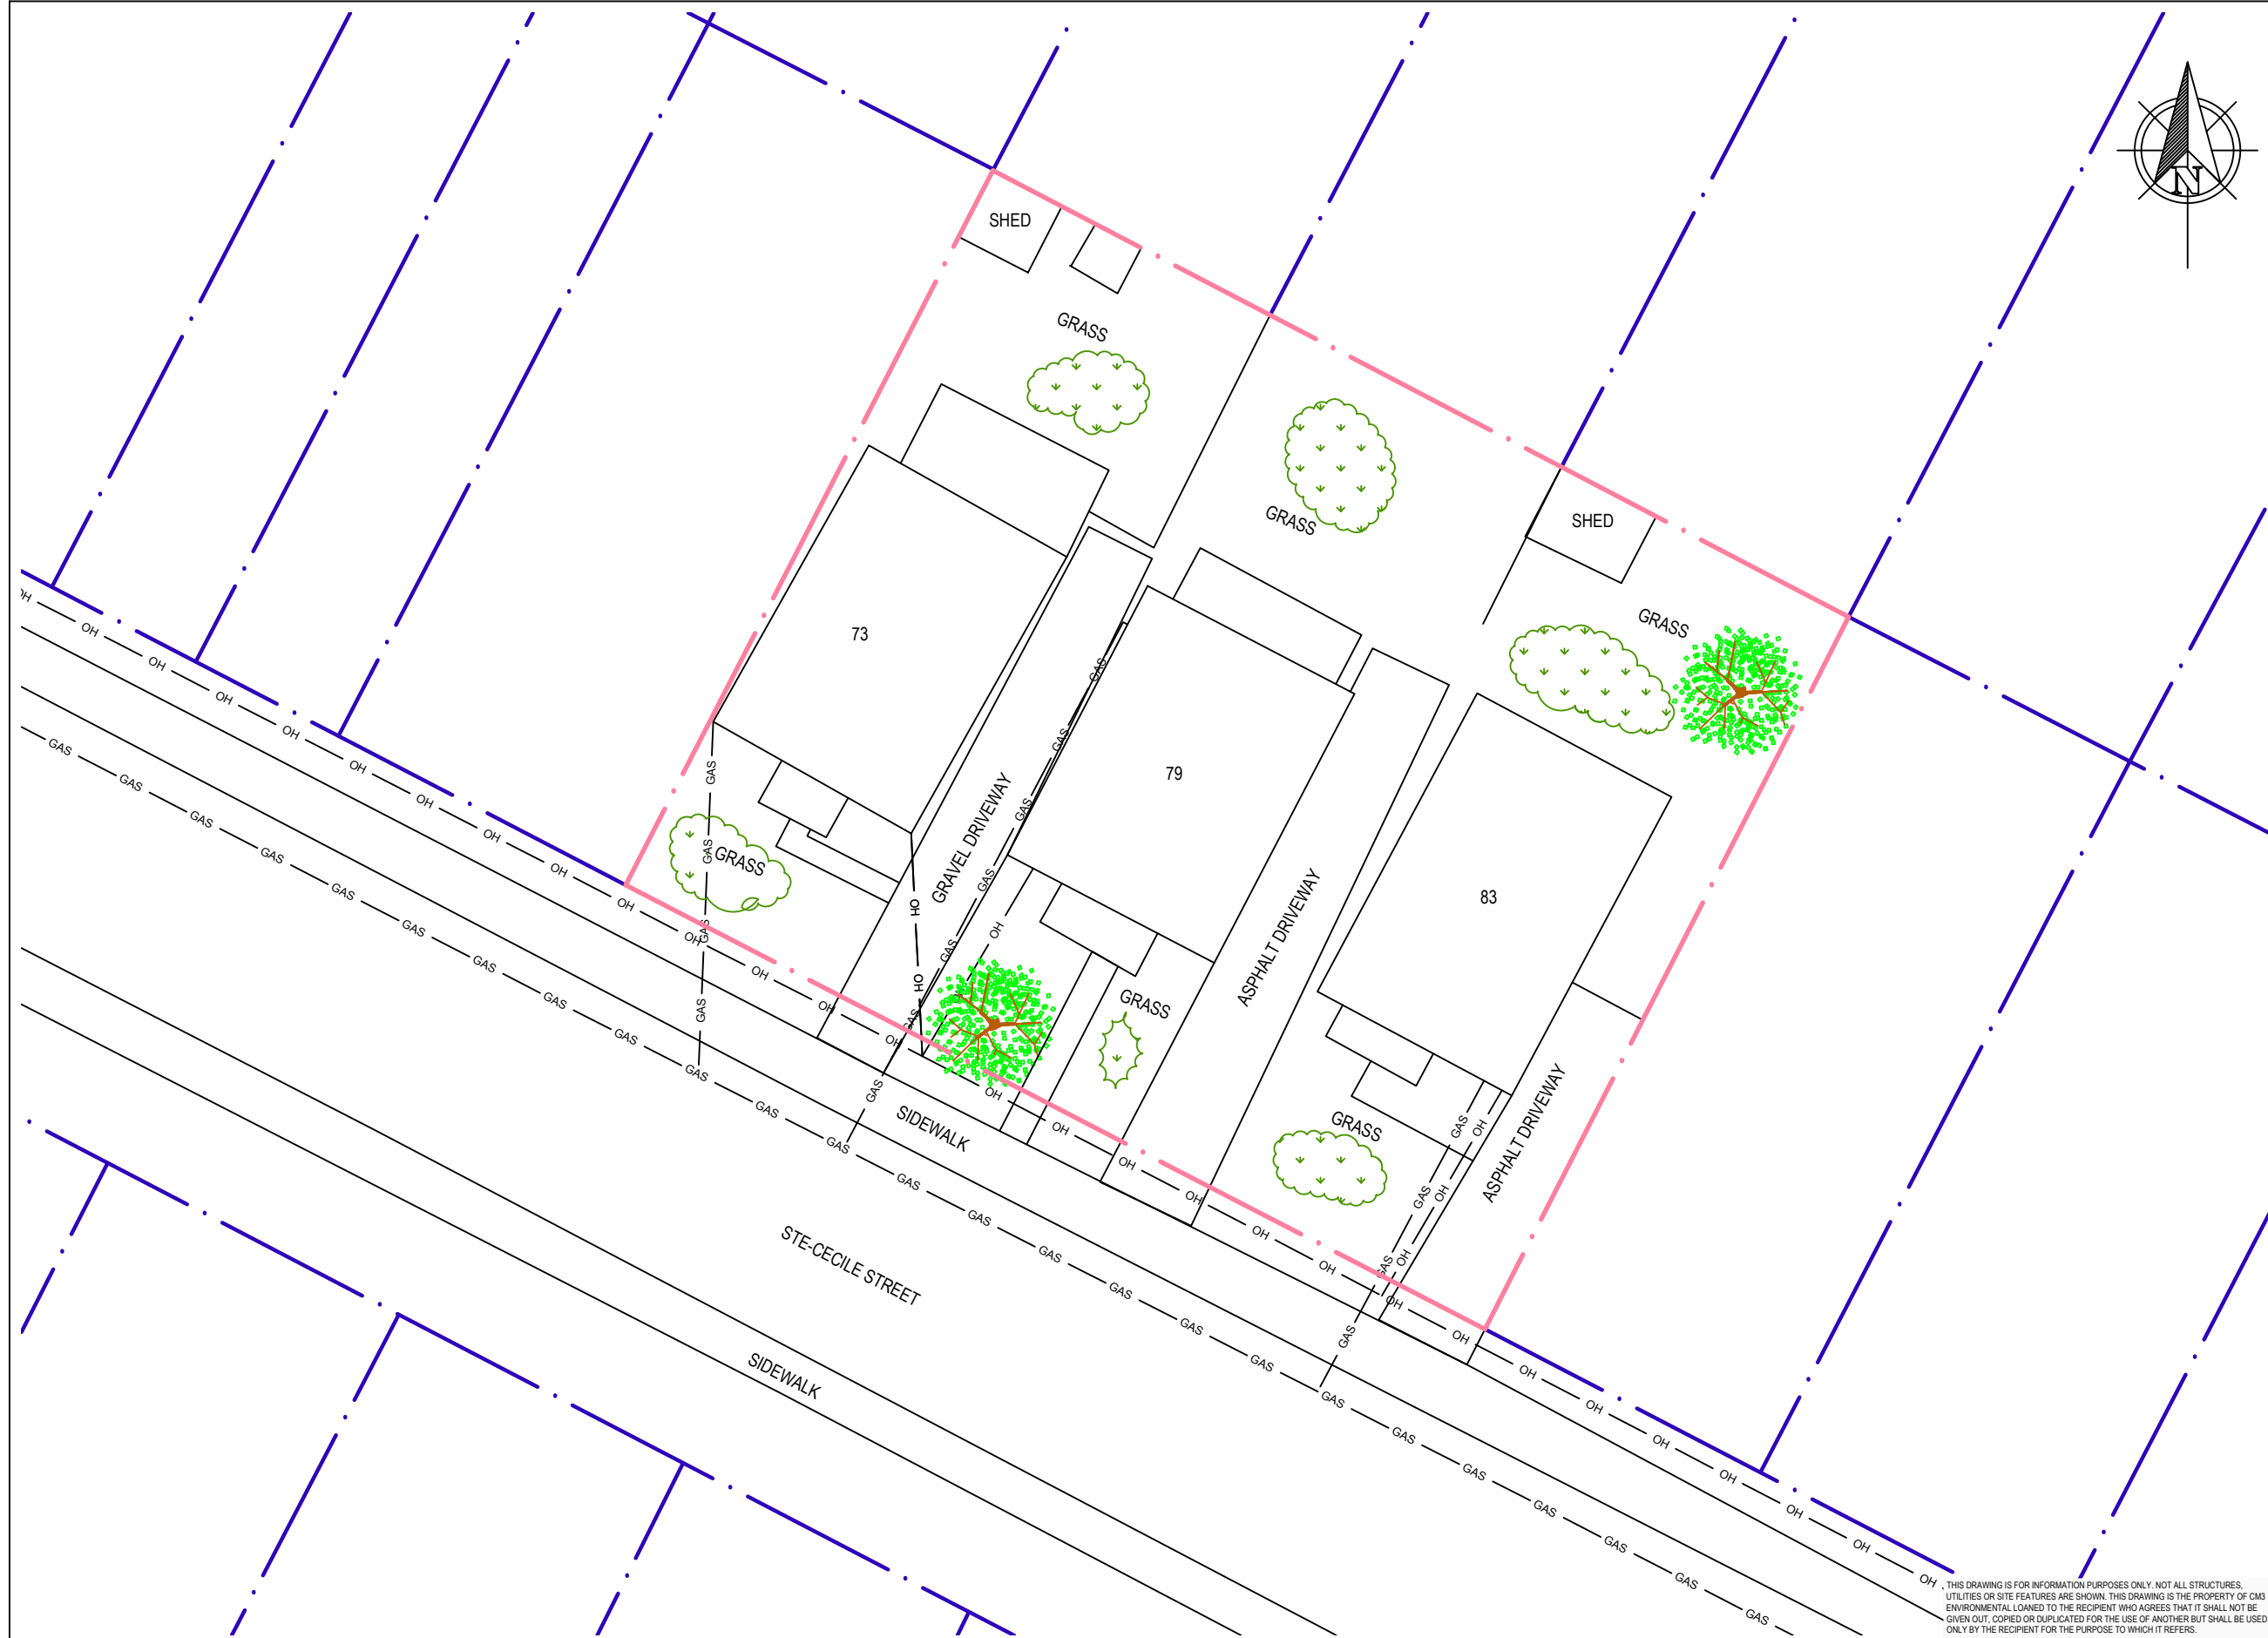
SITE PLAN

The subject properties comprised the three civic addresses 73, 79 and 83 Ste-Cecile Street, Ottawa, Ontario. The subject properties are rectangular in shape and bounded by the Ste-Cecile Street to the south, residential properties on Marquette Avenue to the north, and residential properties to the east and west. The total area of the subject properties is approximately 1,112 square metres (0.1 hectares). Buildings at the properties included a south-facing residential building on each lot. 73 and 83 Ste-Cecile were bungalow style single residence buildings. 79 Ste-Cecile was a two-storey multi unit-residential building. There were small sheds in the back yards of 73 and 83 Ste-Cecile.

The area between Ste-Cecile and the residential building was a concrete sidewalk with grass up to the buildings. Some landscaping and flower gardens were present next to the south wall of the building. A gravel laneway was present on the east side of 73 Ste-Cecile. An asphalt laneway was present on the east of both 79 Ste-Cecile and 83 Ste-Cecile. The 73 property was enclosed by a chain link fence to the north, west and shared the fence with the 79 property to the east. The 79 property was fenced into the north and shared a vinyl fence with the 83 property to the east. Most of the yards to the north were grass covered. All other ground coverings on the remainder of the properties consisted of grass or various types of vegetation.

A site plan is provided as **Figure 2**.

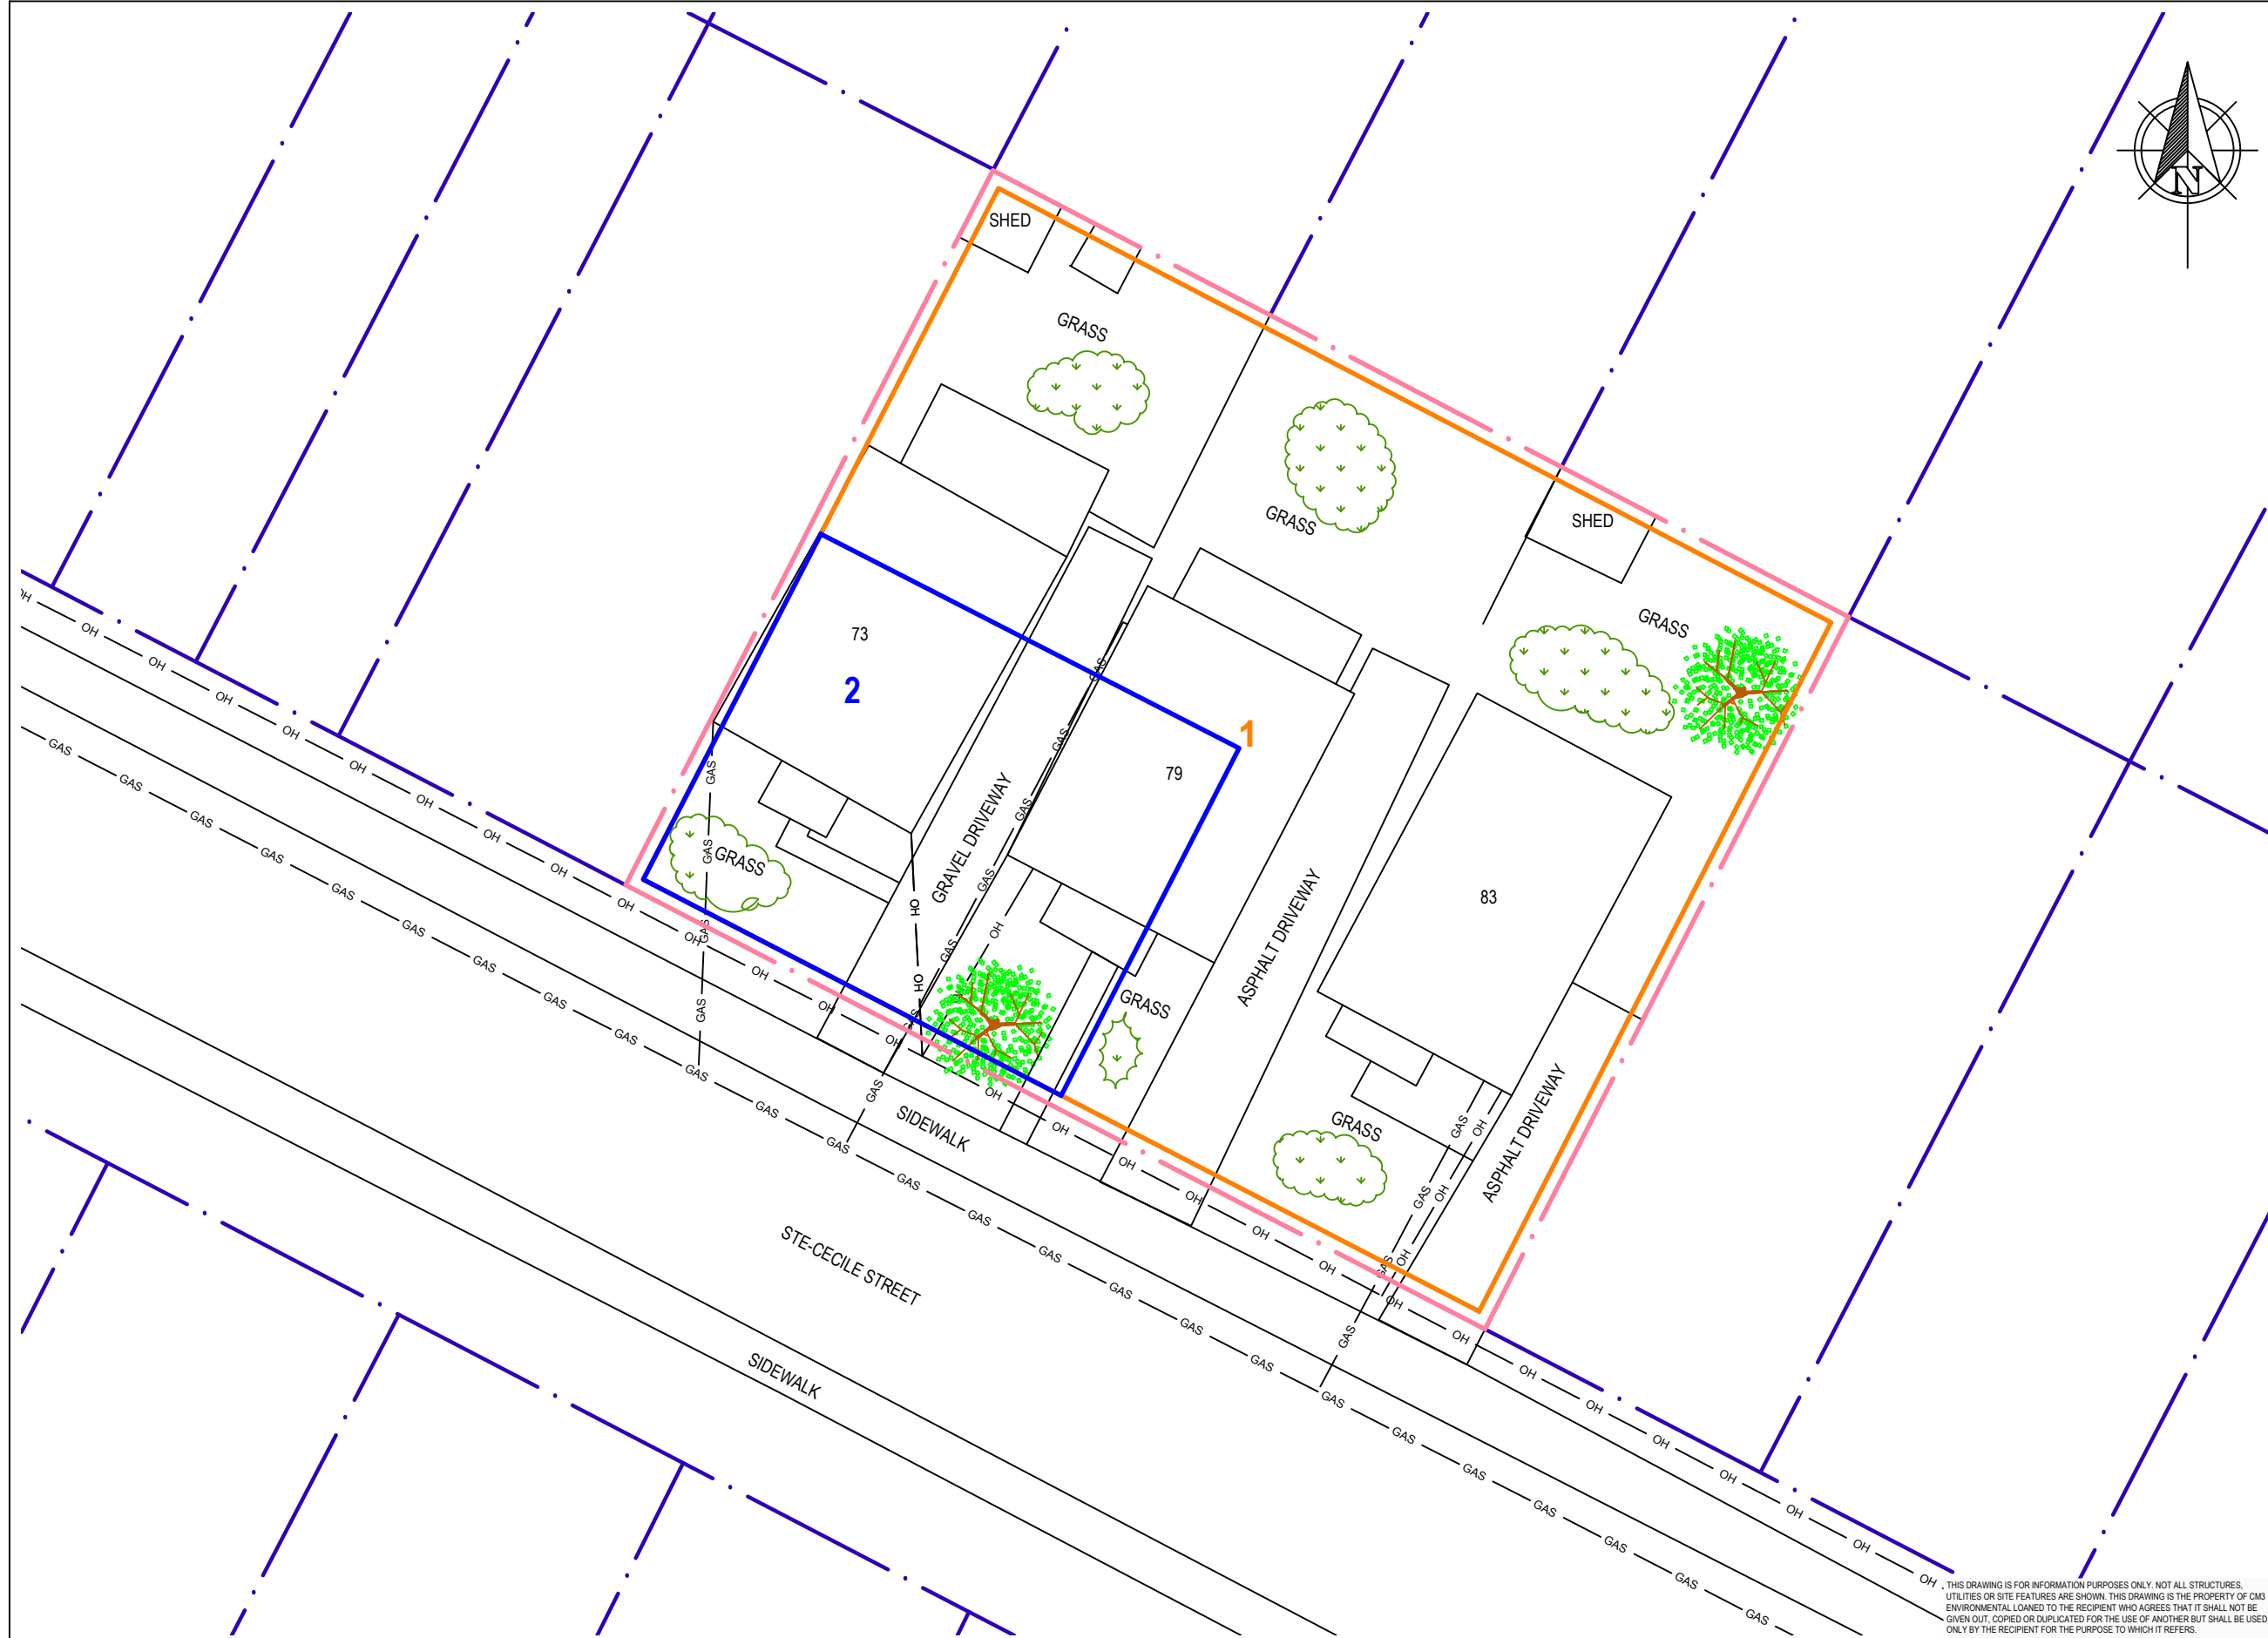
AREAS OF POTENTIAL ENVIRONMENTAL  
CONCERN

| Areas of Potential Environmental Concern | | | |
|---|---|---|---|
| 1 | Subject property. | PCA 1 – Importation of fill material of unknown quality. | VOCs, PHCs F1-F4 fractions, metals, PAHs |
| 2 | South-west of the subject site at 72 Ste-Cecile St. | PCA 2 – Former metal fabrication. | VOCs, metals |

The findings of the Phase I ESA identified two areas of potential environmental concern on the subject properties due to historic and current land use at the site. APECs are shown on **Figure 3**. The contaminants of concern were identified as VOCs, PHCs F1-F4 fractions, PAHs and metals, and potentially contaminated media included soil and groundwater. CM3 concluded that the PCAs and APECs could result in adverse environmental conditions at the subject property and a Phase II ESA was required to characterize soil and groundwater conditions and assess the presence of contamination at the APECs.

Soil samples from all borehole and all groundwater samples at all locations were used to evaluate the fill quality at the site. The results identified the presence of metals, PHCs and PAHs in at concentrations that were not detectable or well below the Table 5 SCS. VOCs were not detected in soil or groundwater. In general, the concentrations in subsurface soil samples met the MECP Table 5 SCS, suggesting that the fill material is not contaminated or contaminating groundwater.

Borehole soil sample MW1 SA7 and groundwater sample MW1 were collected to identify any possible impacts due to the historic presence of a metal fabrication shop located across the street from the subject property. The results identified the presence of metals and PHCs in soil and metal impacts in groundwater that comply with the SCS. Groundwater flow analysis also confirmed that the former metal fabrication facility is downgradient of the subject sites, making the possibility of contamination unlikely.

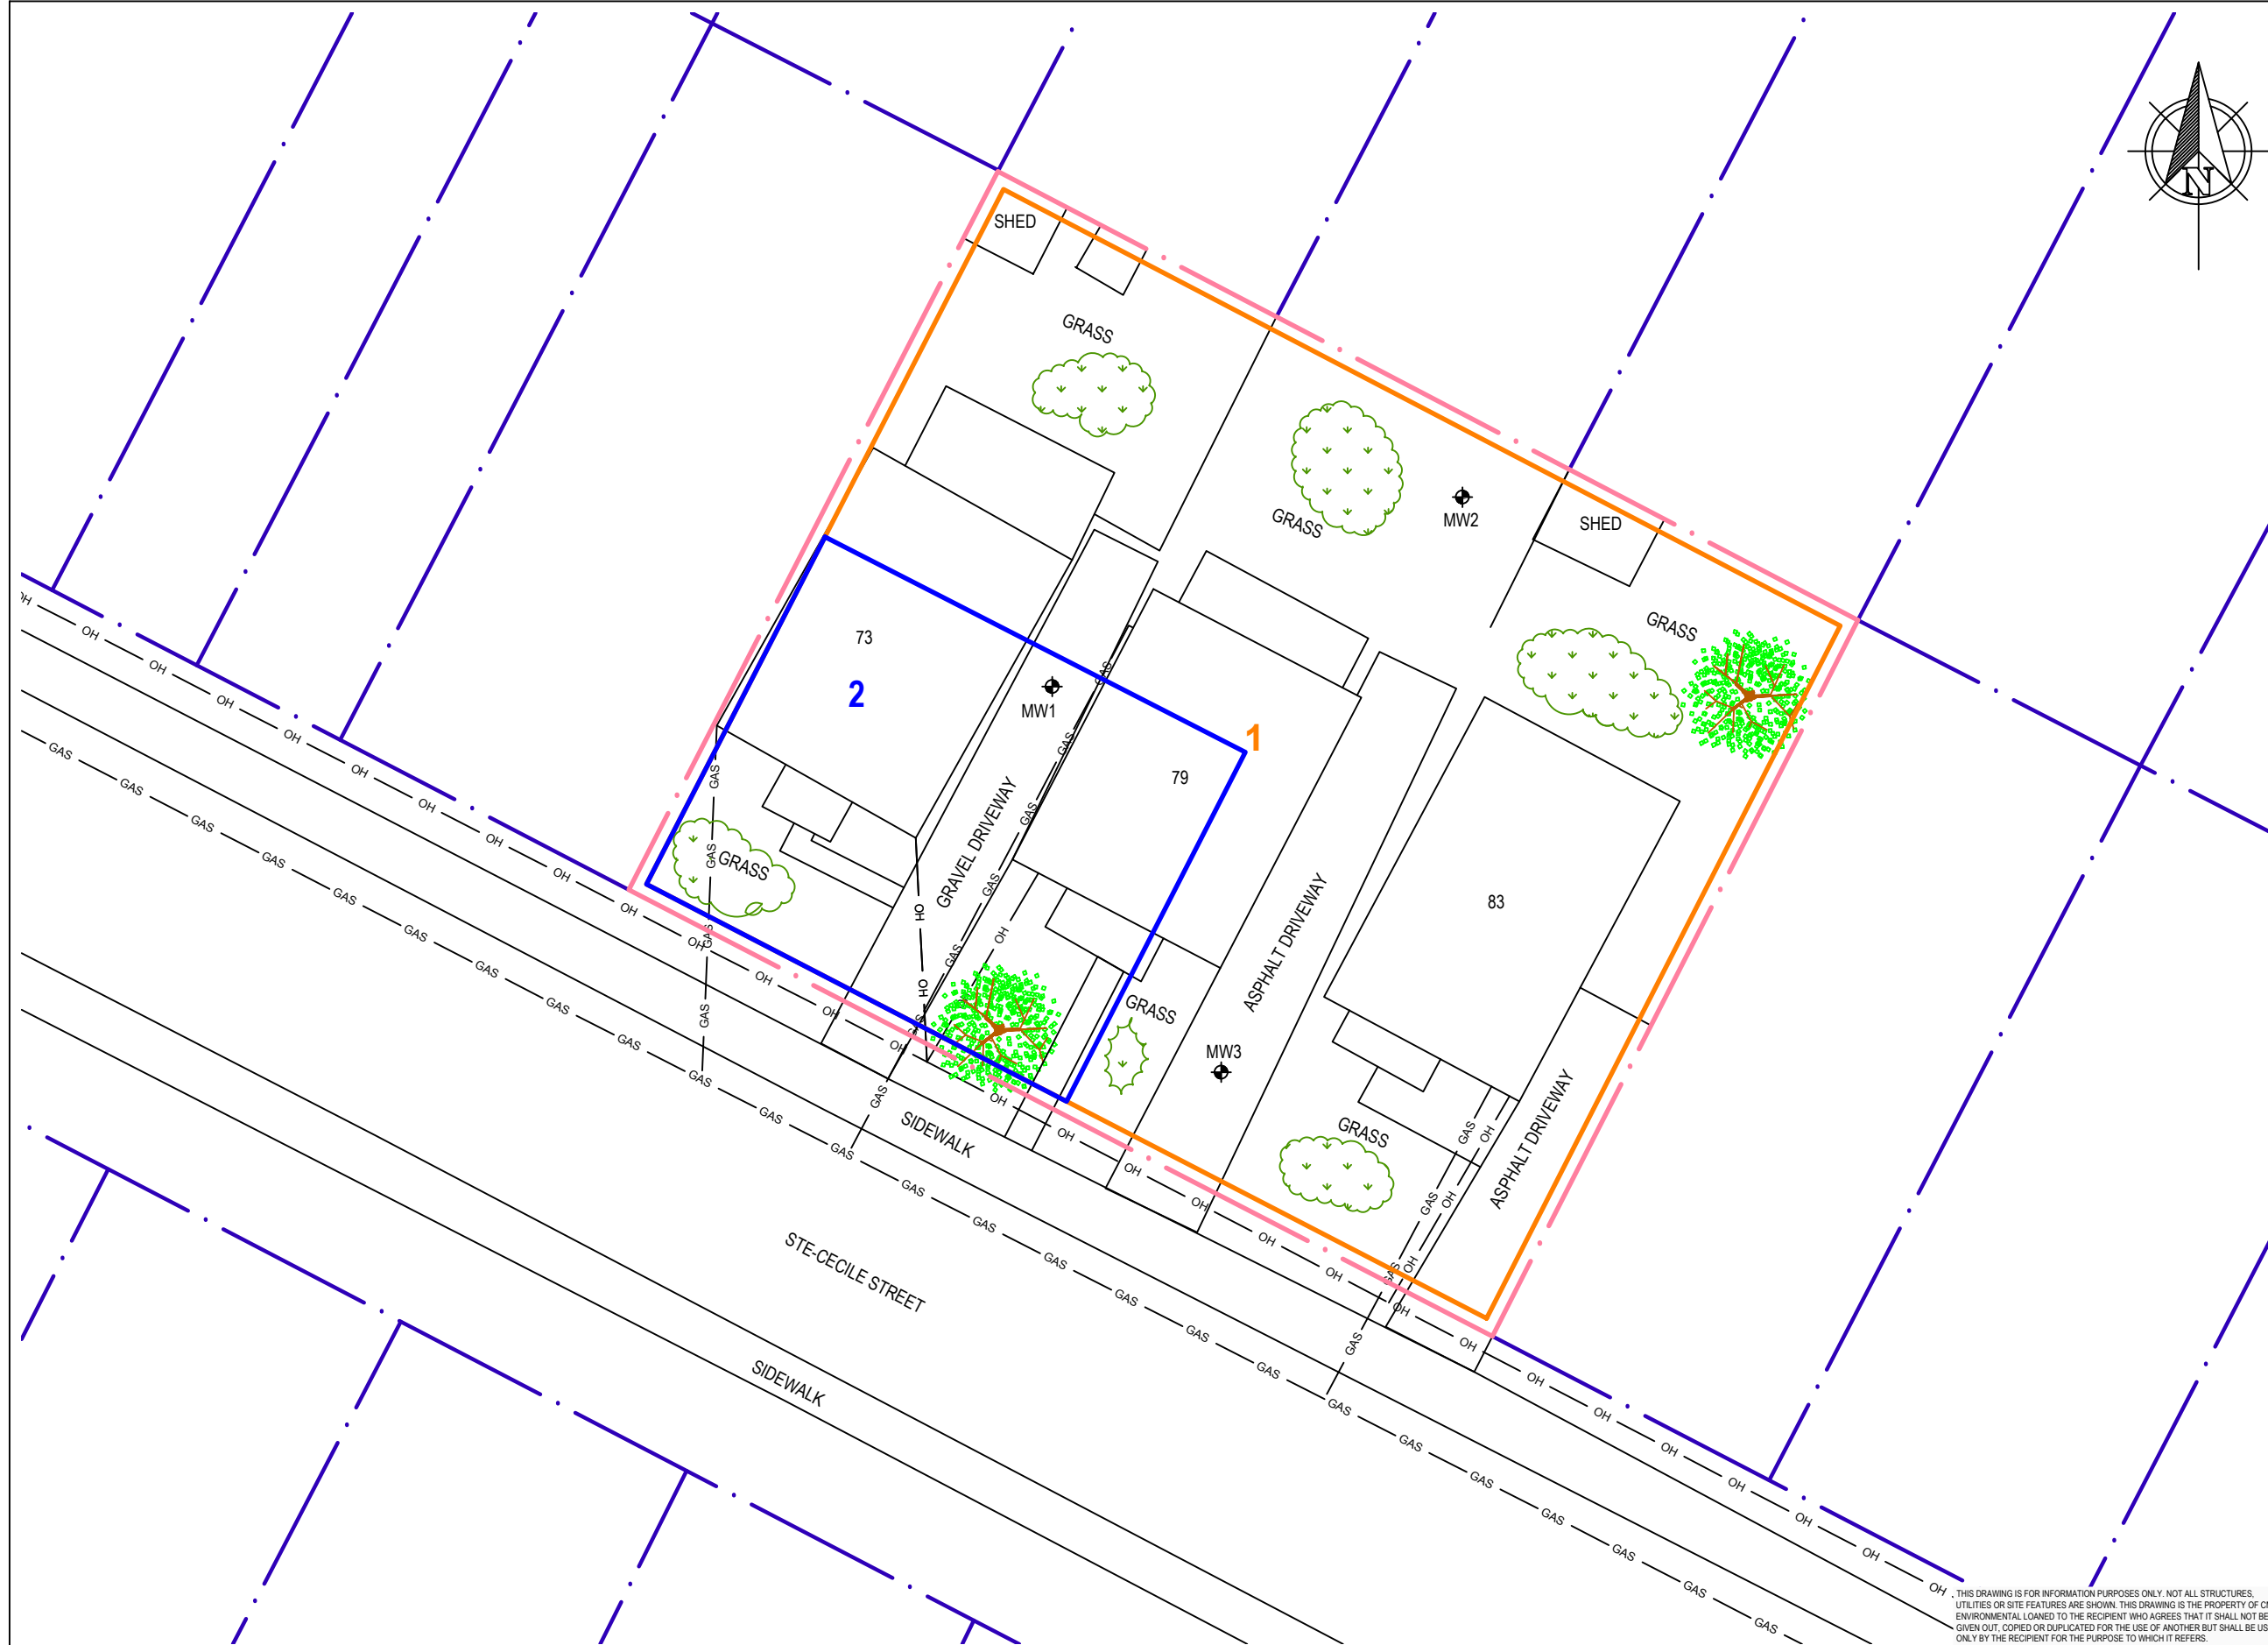
MONITORING WELL LOCATIONS

- The advancement of three overburden boreholes at APECs 1 and 2, completed as monitoring wells in areas cleared of utilities;
- The collection of soil samples during the borehole drilling for logging of the soil conditions, field screening and possible laboratory analysis of contaminants of concern;
- The submission of one soil sample from each borehole location for laboratory analysis of VOCs, PHCs F1-F4 fractions, PAHs and metals;
- The measurement of the depth to liquid phase hydrocarbons (LPH) and groundwater in all monitoring wells;
- The collection of groundwater samples from all monitoring wells for laboratory analysis of VOCs, PHCs F1-F4 fractions, PAHs and metals; and
- A survey of all new borehole/monitoring well locations, including ground surface and well top of pipe elevations.

Boreholes MW1, MW2 and MW3 were completed as monitoring wells. Monitoring well construction consisted of 32 mm or 50 mm outside diameter, flush-threaded schedule 40 PVC well screens and risers. At each borehole, a 10-slot well screen was placed to intercept the water table to allow for the detection of LPH. A silica sand pack was placed around the outside of the well screen in the annular space of the borehole, to a minimum of 0.3 m above the screened interval. A bentonite seal was placed above the sand pack to approximately 0.3 m bg. All monitoring wells were capped with lockable j-plugs and finished at below grade in flush-mounted manhole protective casings set in gravel, asphalt or grass.

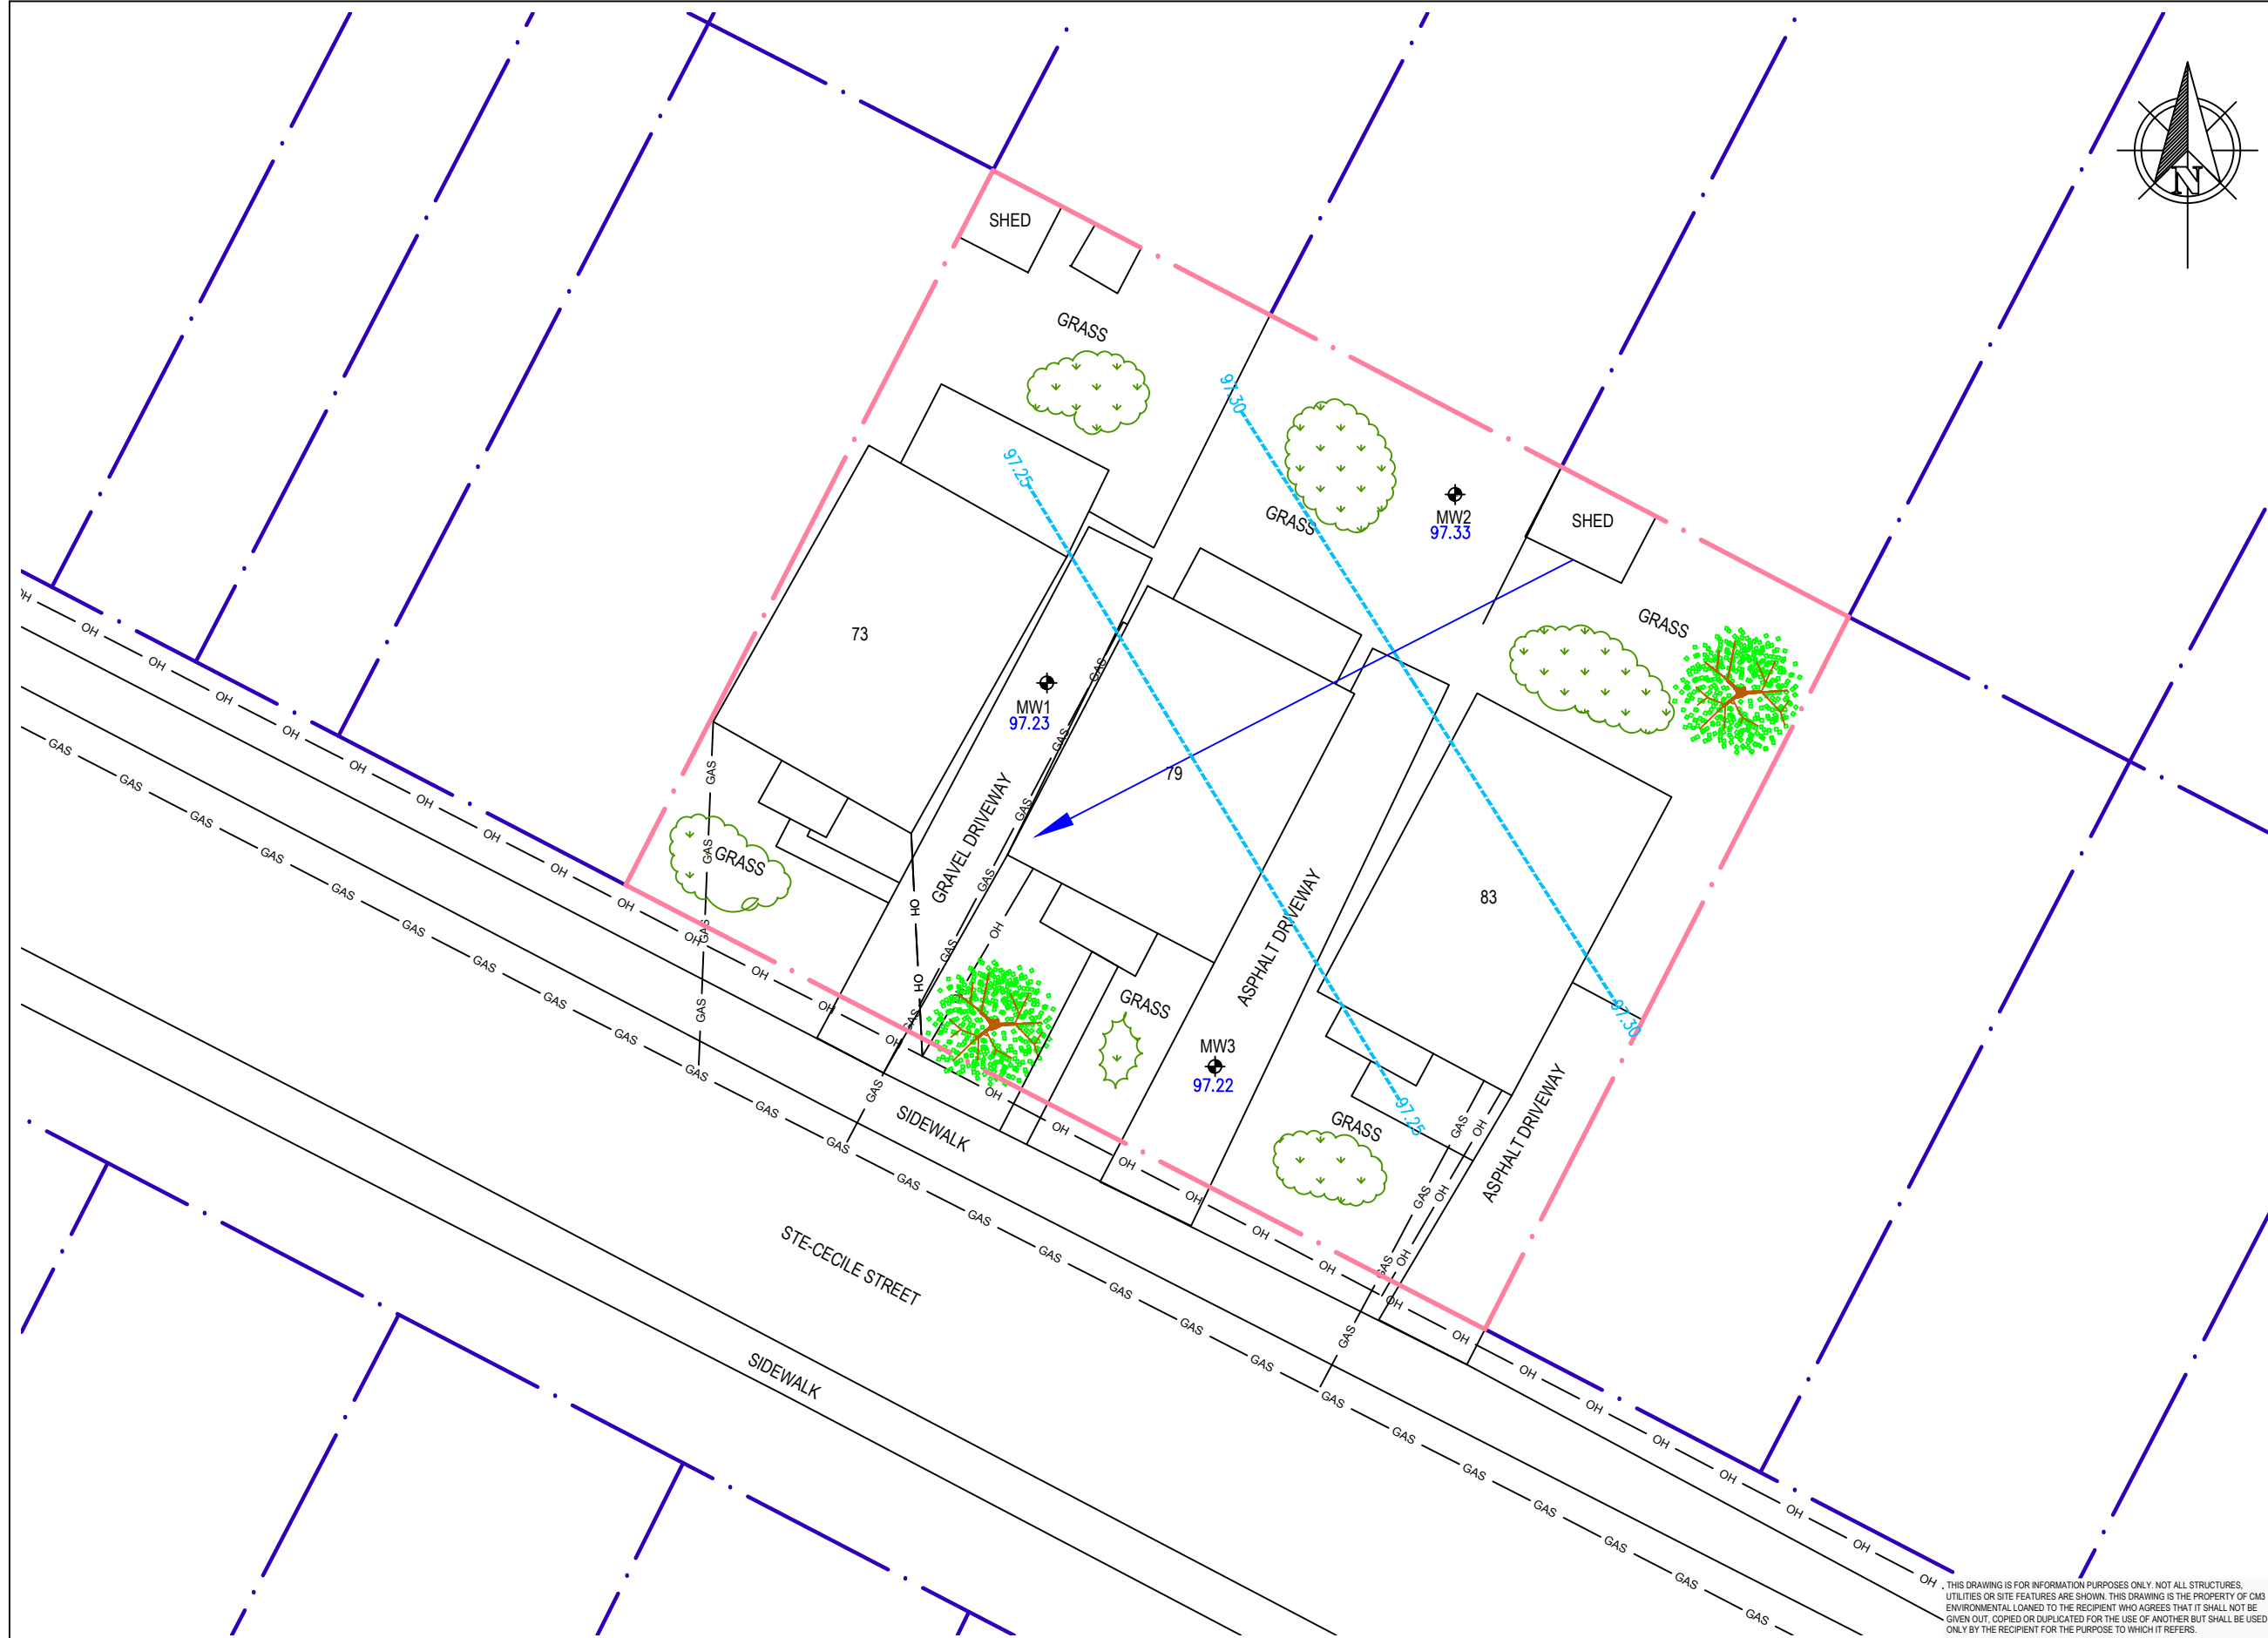
The depth to LPH (if present) and groundwater was measured in all monitoring wells on December 5, 2022. The December 5, 2022 water levels were at a relative elevation of 97.22 m arl to 97.33 m arl, and the average groundwater elevation was 97.26 m arl (2.74 m bg). The depth to LPH and water level measurements are provided in **Table 1**.

The groundwater flow direction was determined to be south-west based on the groundwater data. The groundwater elevations, contours and flow direction are provided on **Figure 5**.

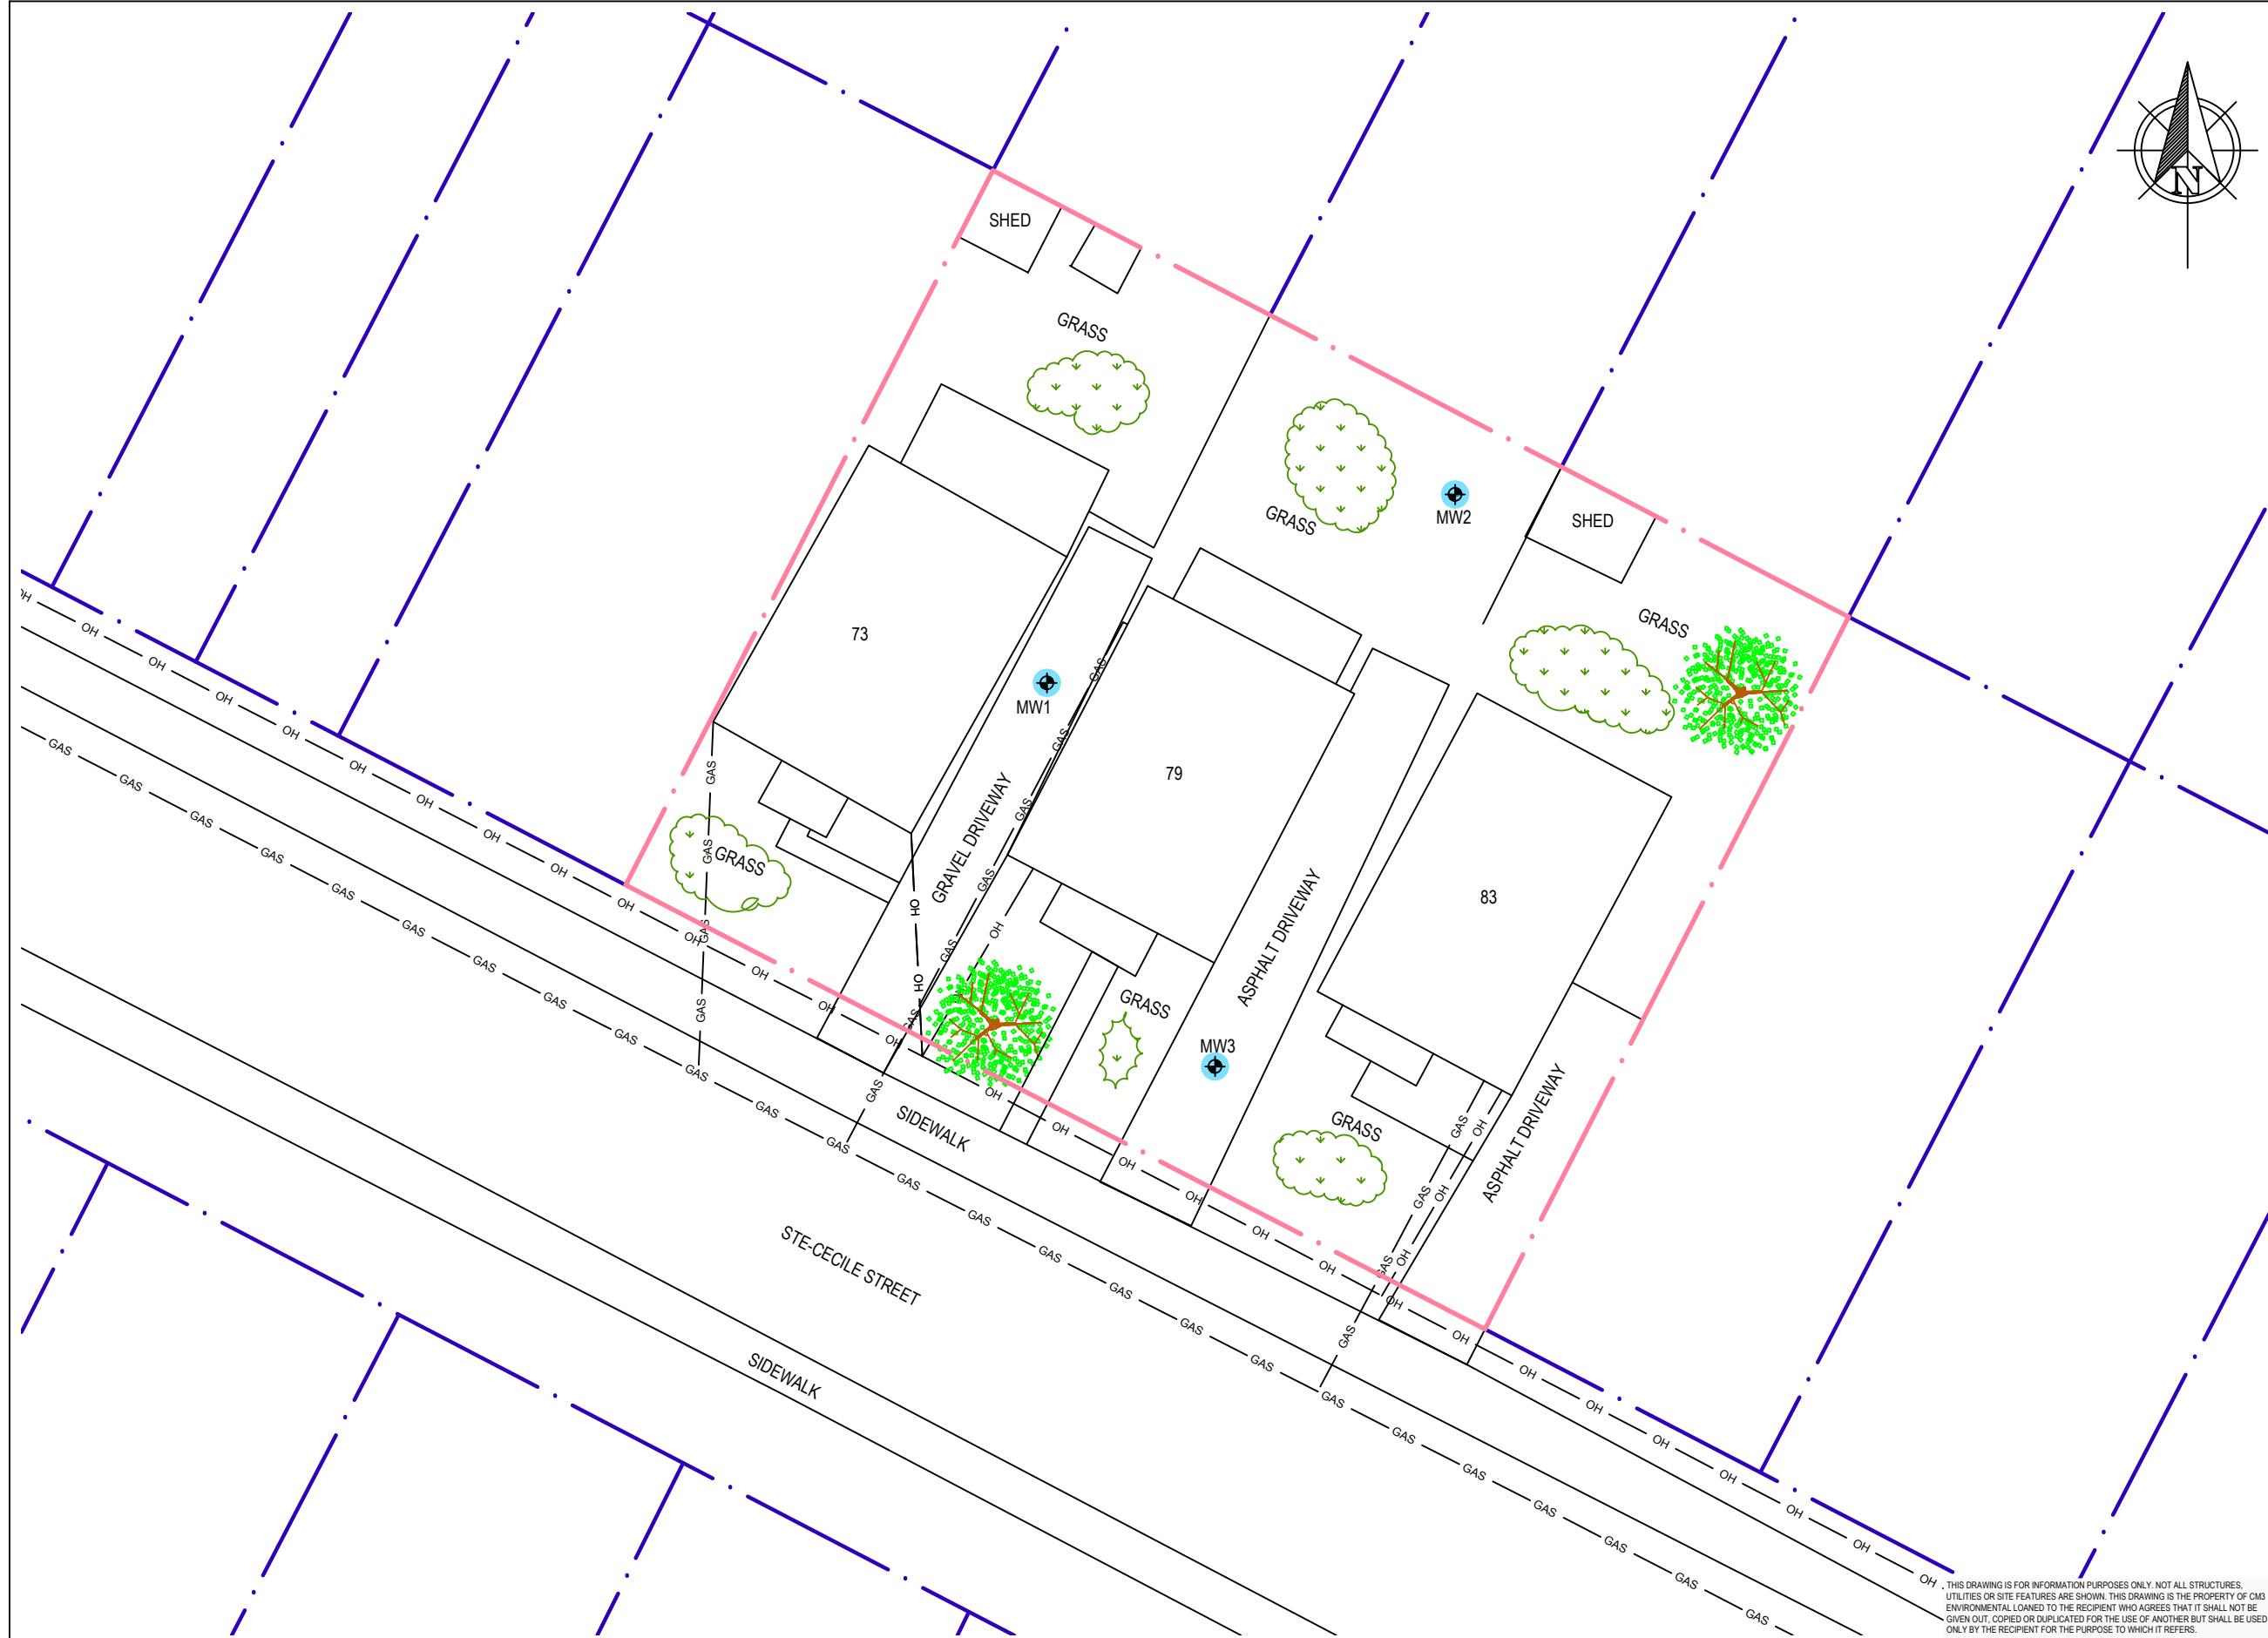
A total of 18 soil samples were collected from boreholes MW1, MW2 and MW3 for field screening and combustible vapour analysis. The vapour concentrations in borehole MW1 varied at depth and were between 40 ppm to 100 ppm. Vapour concentrations in borehole MW2 were between 35 to 110 ppm and vapour concentrations in MW3 were between 30 to 60 ppm. The borehole locations are provided on **Figure 4** and the vapour concentrations and field observations are included on the borehole logs, **Appendix A**.

The analytical results showed the presence of one or more PHCs F1-F4 fraction in MW1 SA7 and MW3 SA2. PHCs F1-F4 fractions were not detected in sample MW2 SA4. The concentration of

PHCs F1-F4 fractions detected in samples MW1 SA7 and MW3 SA2 met the Table 5 SCS. VOCs were not detected in any of the analysed samples, meeting the Table 5 SCS.

The PAHs fluoranthene, phenanthrene, and pyrene were detected in the soil sample MW2 SA4 at concentrations that comply with the Table 5 SCS. PAHs were not detected in any of the other analysed samples, meeting the MECP Table 5 SCS.

Metals were detected in all three borehole soil samples MW1 SA7, MW2 SA4 and MW3 SA2 at concentrations that comply with the Table 5 SCS.

The results of the Phase II ESA did not identify impacts at any of the investigated APECs. No further environmental assessment is recommended, and the existing groundwater monitoring wells should be decommissioned prior to site development, as per Ontario regulation 903.
