**LANSDOWNE 2.0 EVENT CENTRE, NORTH SIDE STANDS AND PUBLIC REALM ENHANCEMENTS**

DWG. TITLE  
**TREE CONSERVATION REPORT PROPOSED DEVELOPMENT HAUL ROAD ACCESS**

DWG. TITLE: **PROPOSED HAUL ROAD PLAN**

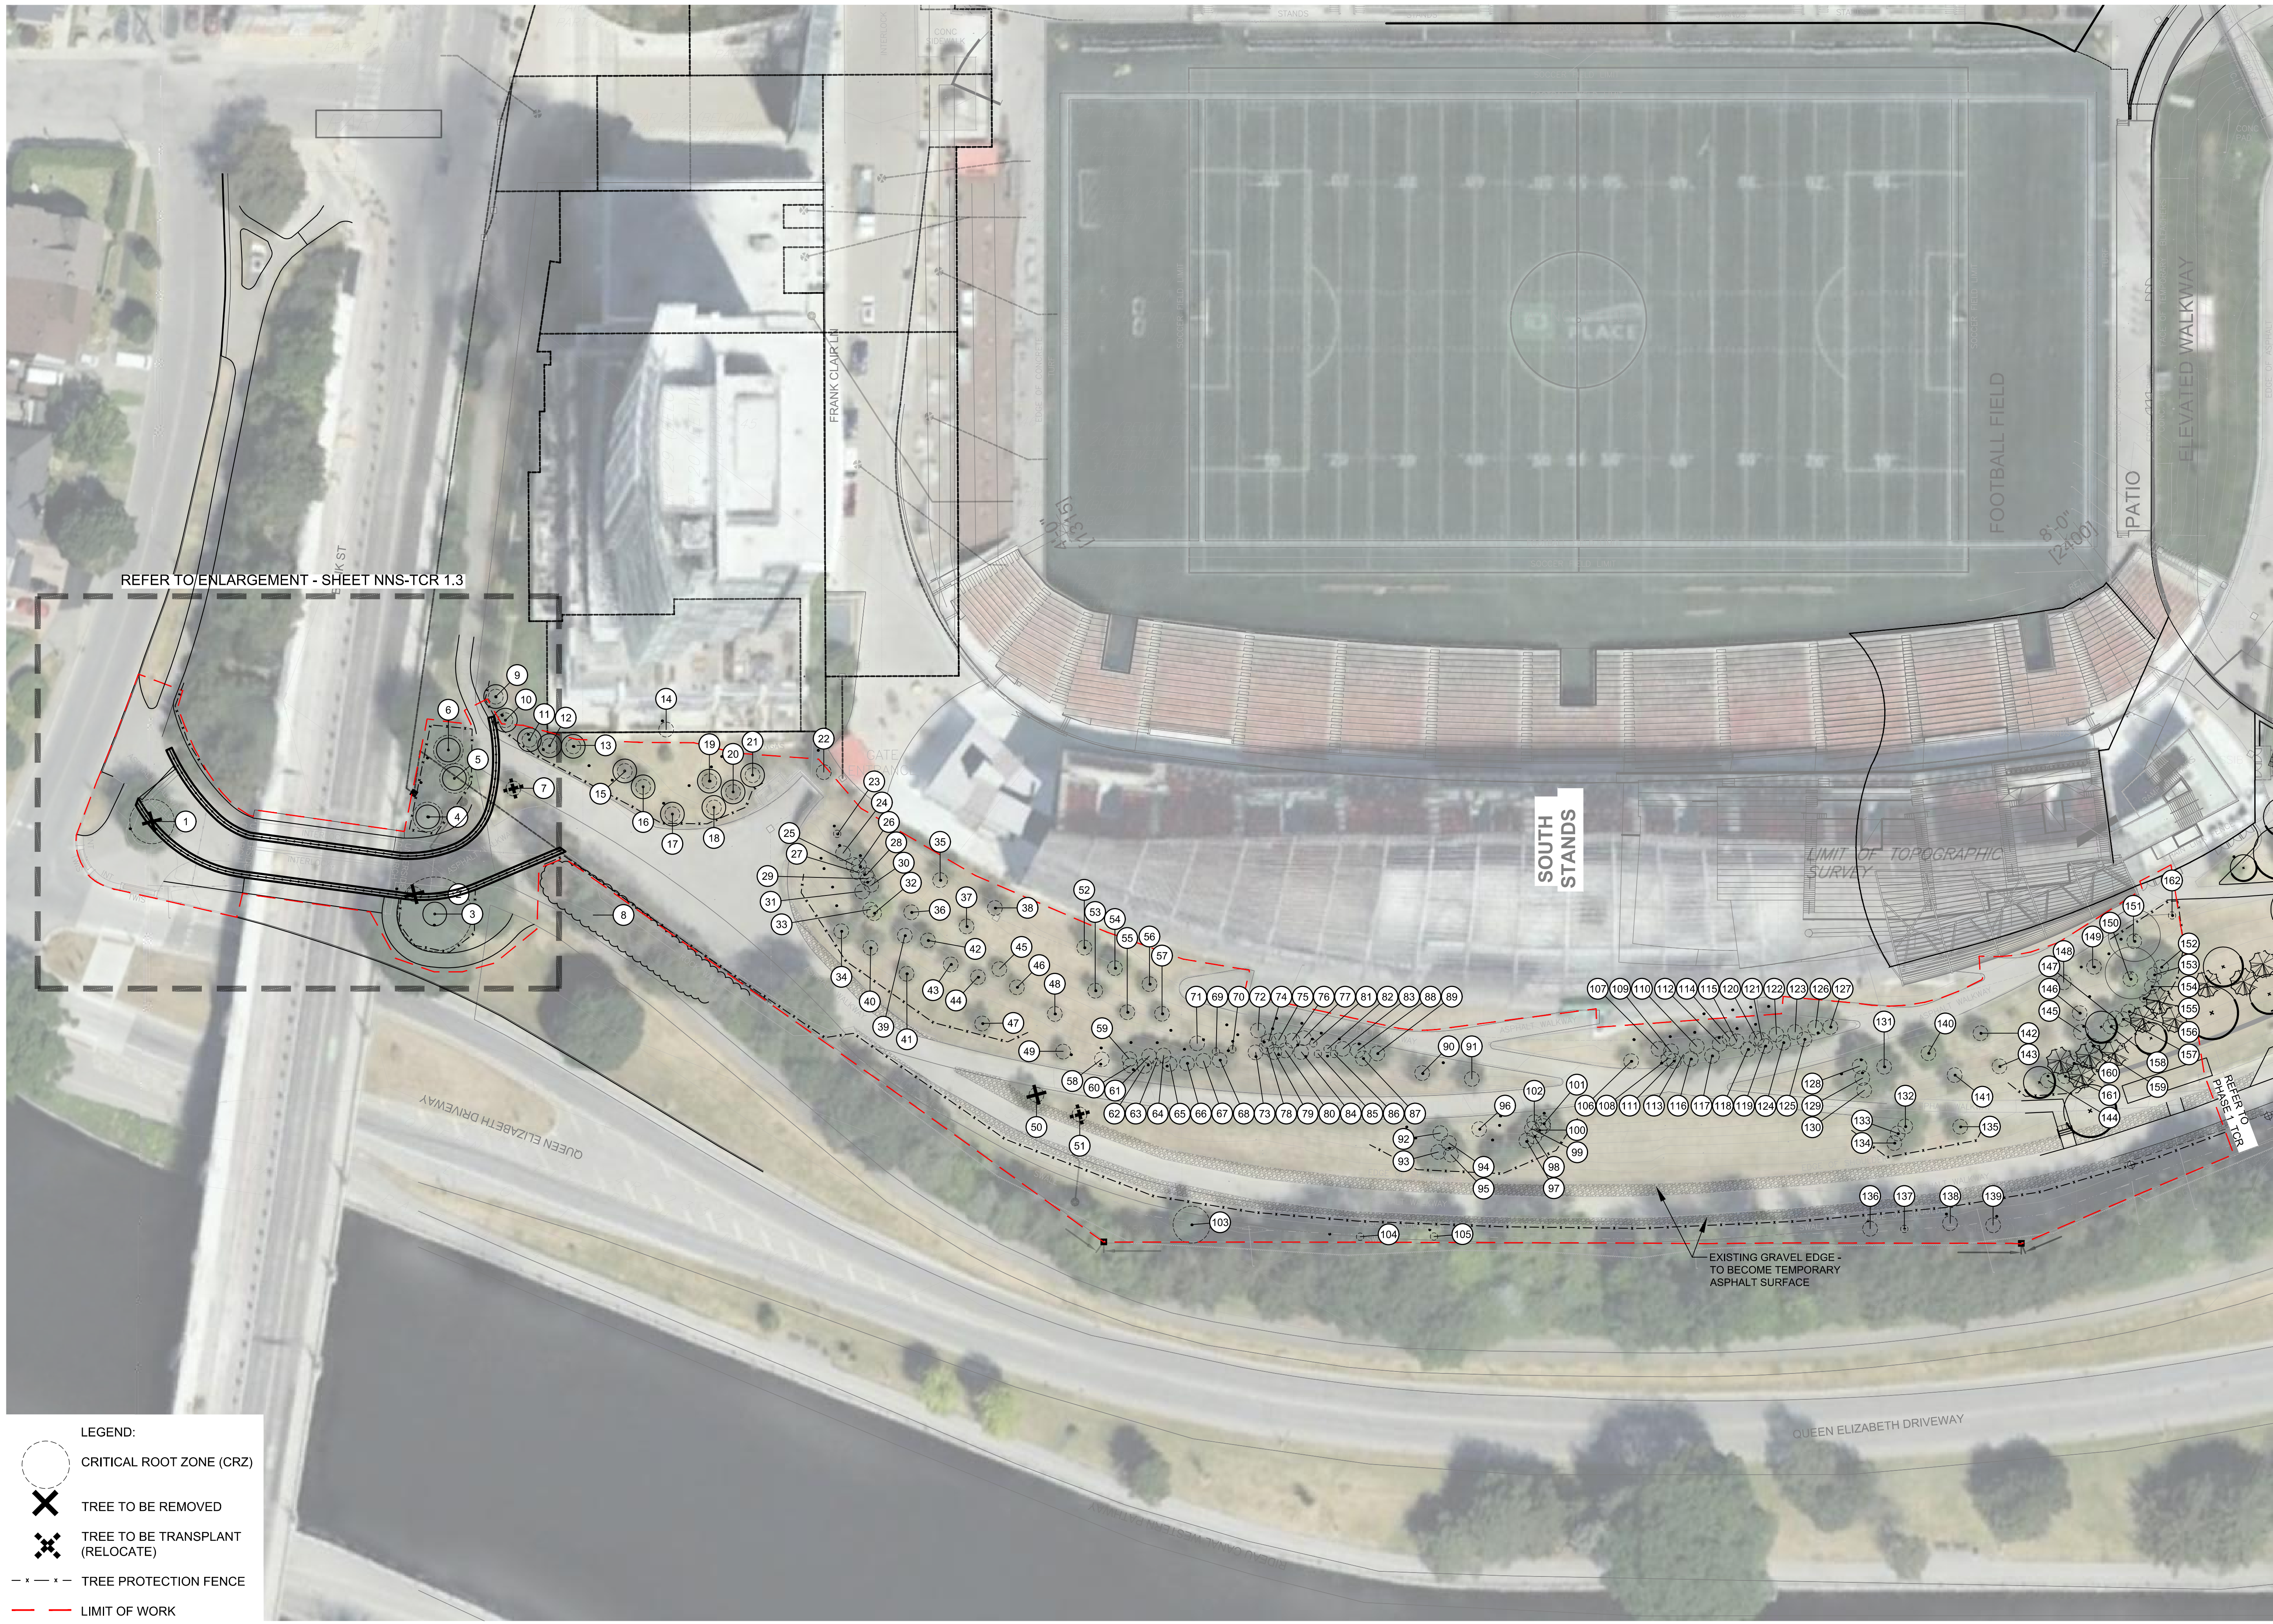
SCALE	1 : 250	DWG. NO.	NNS-TCR.1
PROJ. NO.	CSW #1766-15

EXISTING GRAVEL EDGE - TO BECOME TEMPORARY ASPHALT SURFACE

- LEGEND:**
- CRITICAL ROOT ZONE (CRZ)
  - TREE TO BE REMOVED
  - TREE TO BE TRANSPLANT (RELOCATE)
  - TREE PROTECTION FENCE
  - LIMIT OF WORK

NOTE: SOME TREES MAY BE SUITABLE FOR TRANSPLANTING. (TO BE REVIEWED THROUGH DETAILED DESIGN DEVELOPMENT)
