Geotechnical Investigation Report

**1386 & 1394 Greely
Lane, Ottawa, Ontario**

April 13, 2023

Cambium Reference: 17281-001

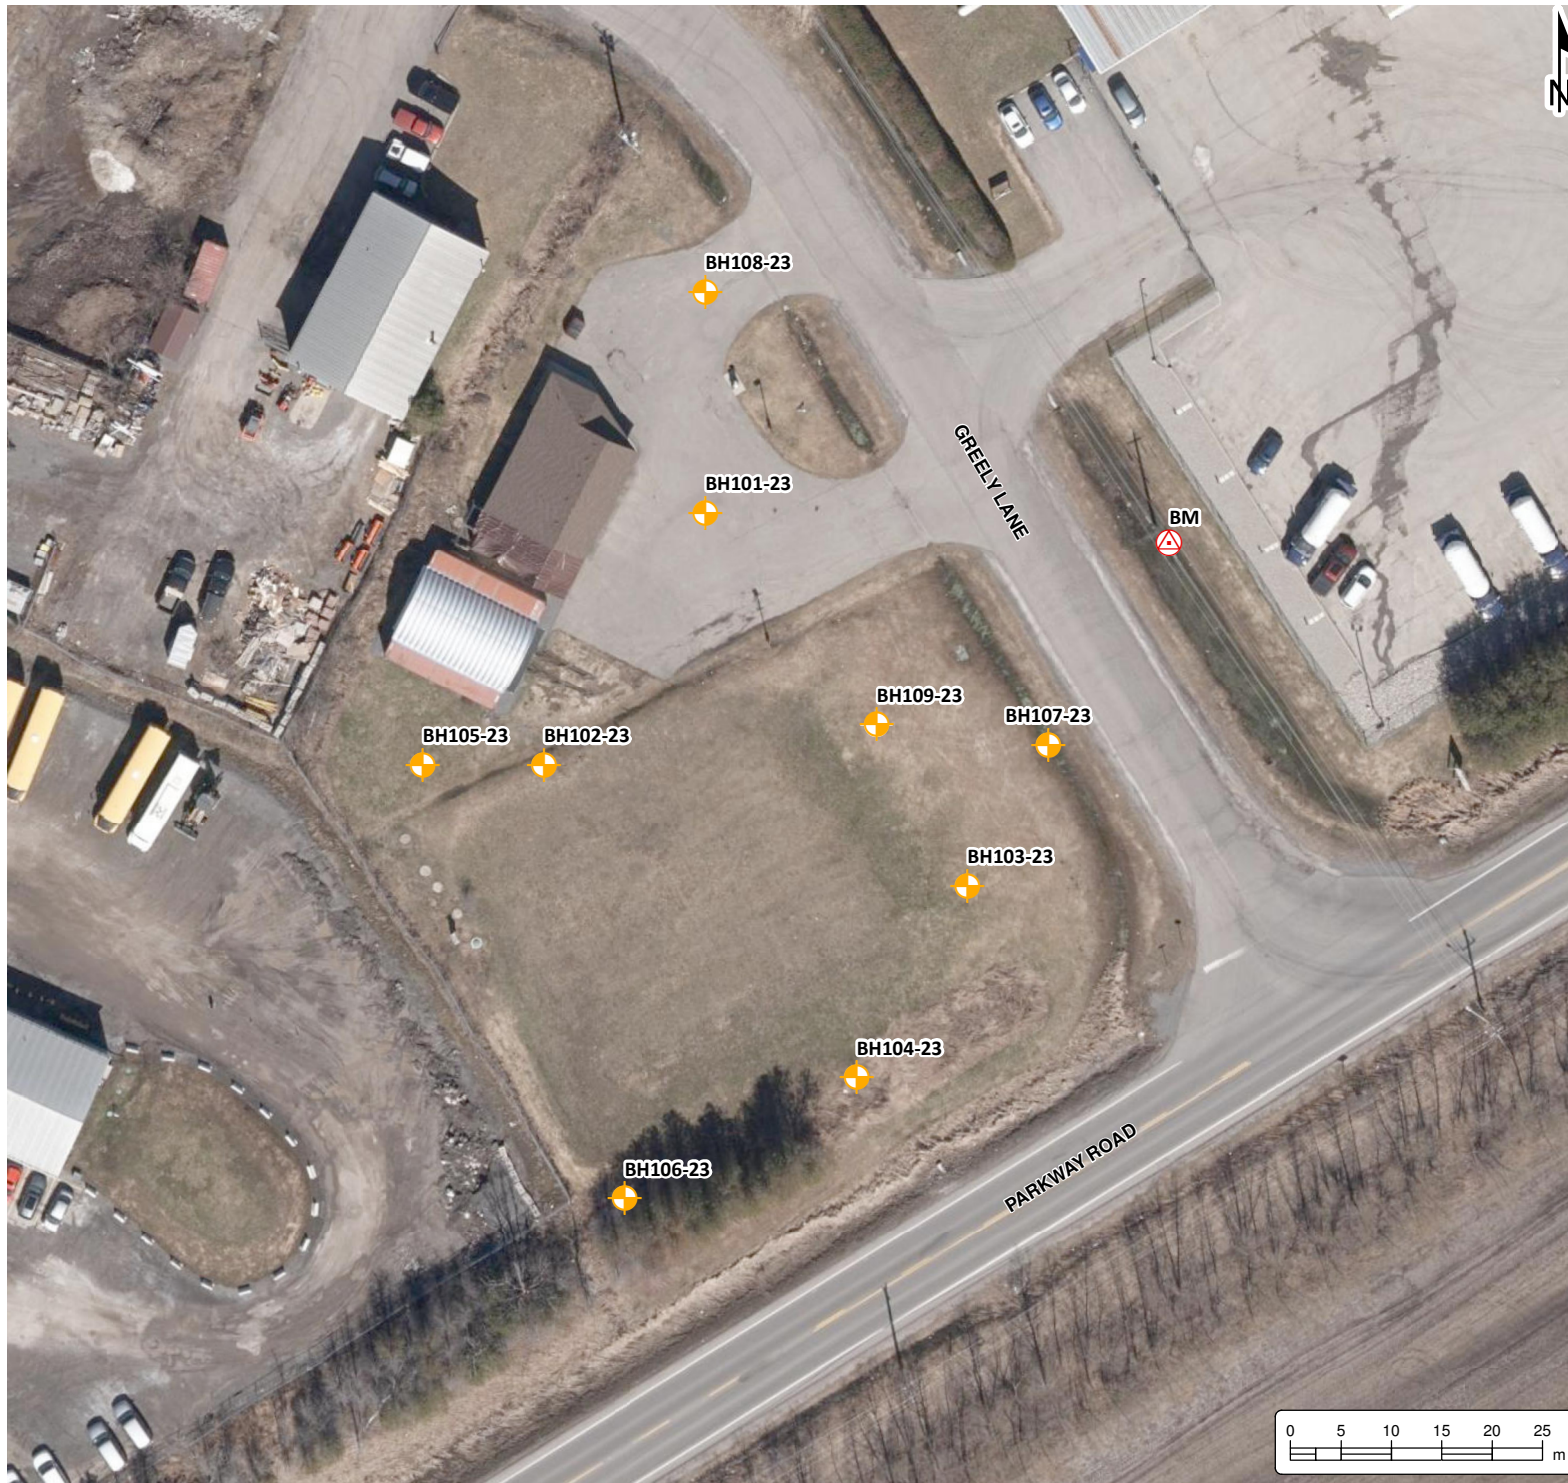
O:\GIS\MXDs\17200-17299\17281-001 Cassidy E.W. - Phil IESA & GEO - 1388 & 1394 Greely Ln, Ottawa\2023-03-23 FIG 2 - Borehole Location Plan.mxd

The locations of the boreholes relative to the existing site conditions are provided as Figure 2.
