Phase One Environmental Site Assessment

1412 Stittsville Main Street
Ottawa, Ontario

Prepared for:

Elite Living Developments
10 Brad's Court
Stittsville (Ottawa), Ontario
K2S 1V2

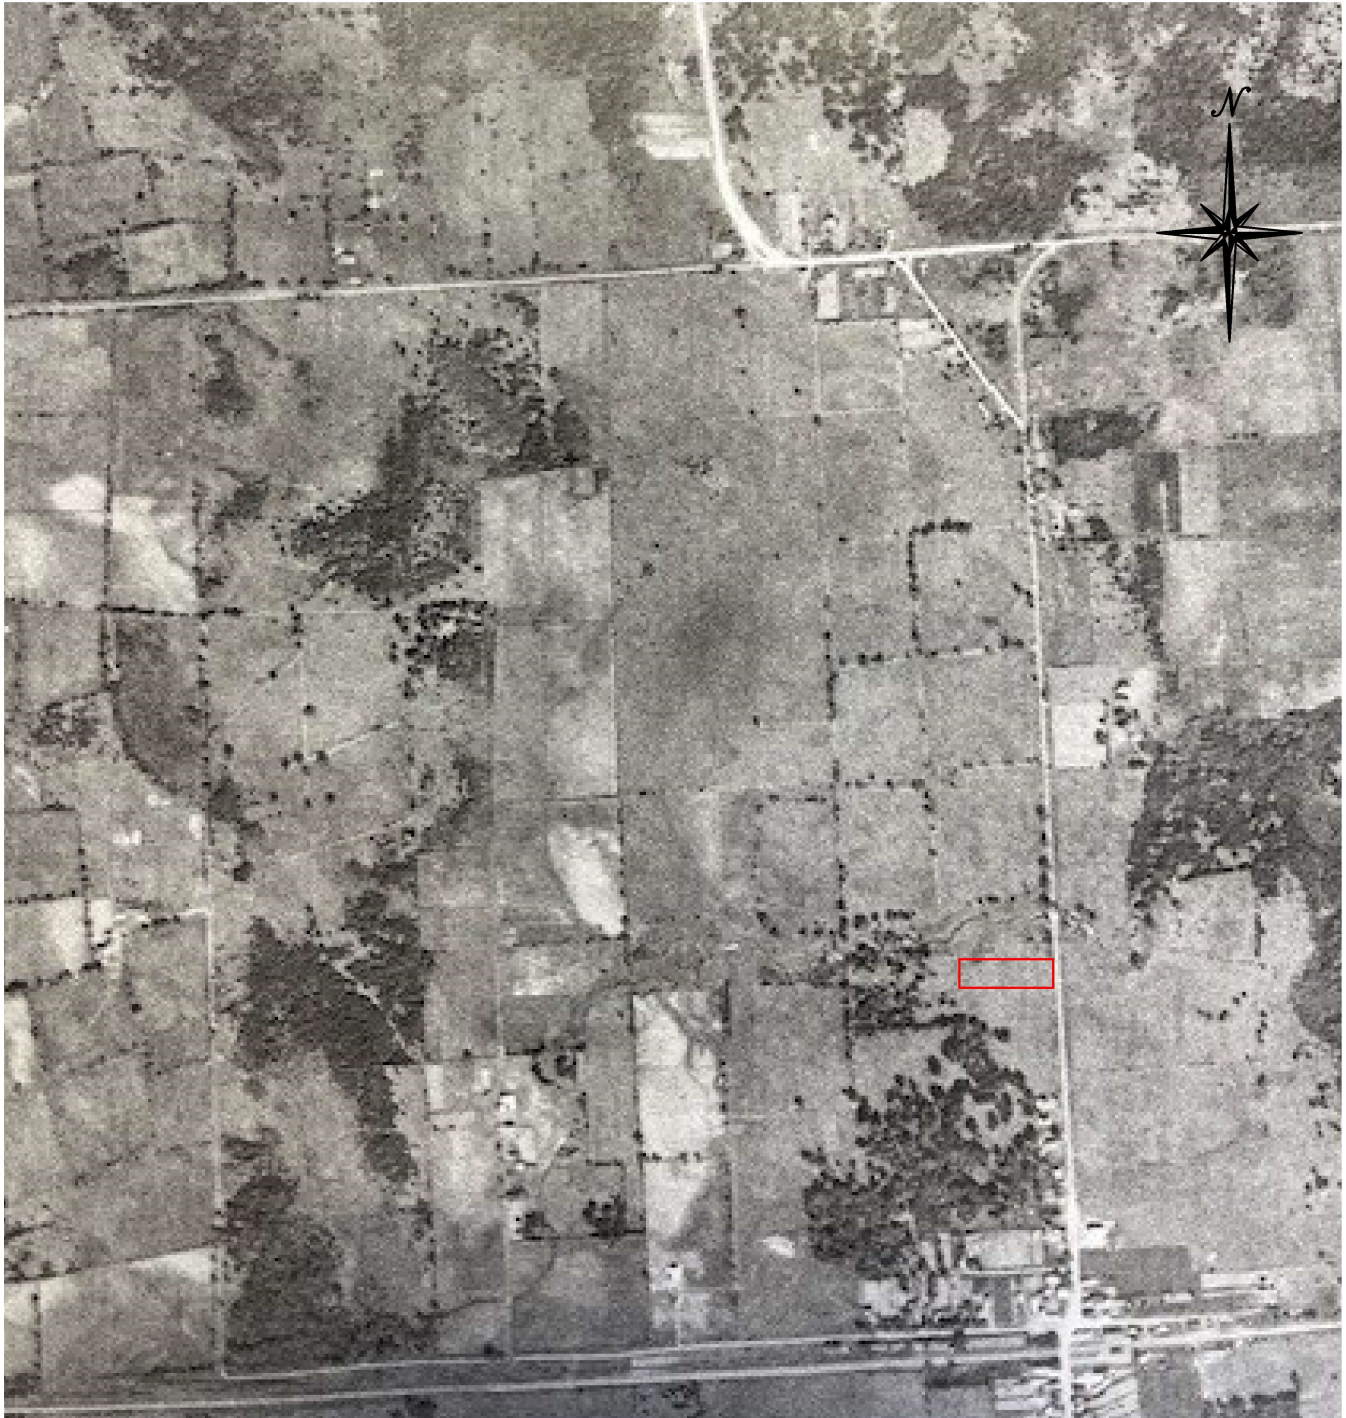
AP1

Year	Phase One Property (Site)	Phase One Study Area (Surrounding Area)
1932 (AP1)	The aerial photograph number is A4432-35. The Site appears to be agricultural land.	Stittsville Main Street is present to the east of the Site. The surrounding lands to the north, south, east and west appear to include agricultural lands, with areas of tree cover. Development is observed further south of the Site along Stittsville Main Street.
1945 (AP2)	The aerial photograph number is A9610-112. The Site appears to be developed. Although the scale of the image makes it difficult for detailed observations, there does appear to be two (2) small structures, and an access road from Stittsville Main Street, at the eastern portion of the Site. The remainder of the Site appears to be agricultural land.	The properties to the north, east, south and west appear to include agricultural land, with areas of tree cover. The adjacent property to the south of the Site is developed.

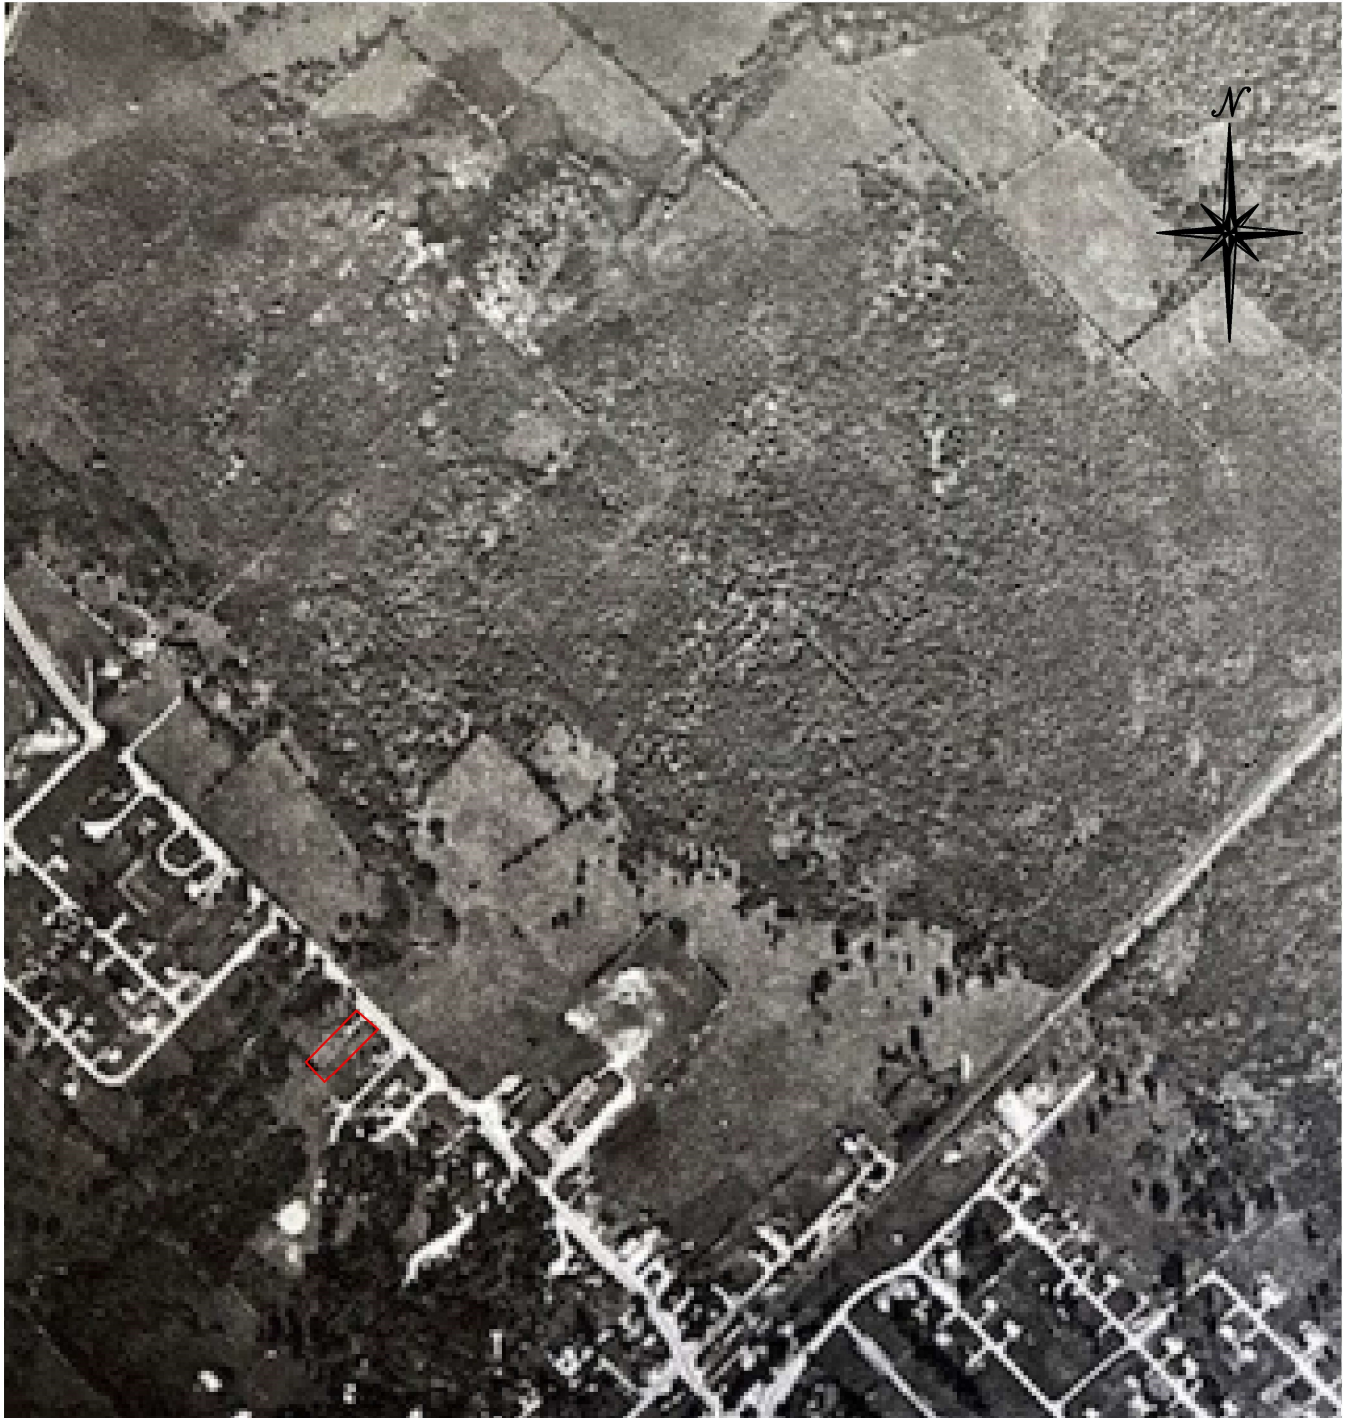
AP3

1963 (AP3)	The aerial photograph number is A18155-74. The previous development on the Site appears to have been replaced with a larger structure which is visible across the majority of the Site and extending on to the adjacent property to the north. There appears to be an access lane from Stittsville Main Street, extending west towards the structure.	The adjacent property to the north is forested followed by a residential development. The property to the west appears vacant, and possible occupied with agricultural fields. West of the Site is forested, and a baseball diamond is visible to the southwest. South and southeast of the Site is developed with residential, and the current school structure is visible.
1976 (AP4)	The Site appeared undeveloped. The previously identified structure is no longer visible.	Warner Colpitts Lane is present to the north of the Site. Other than additional development in the general area, no significant changes were observed in the general area of the Site.

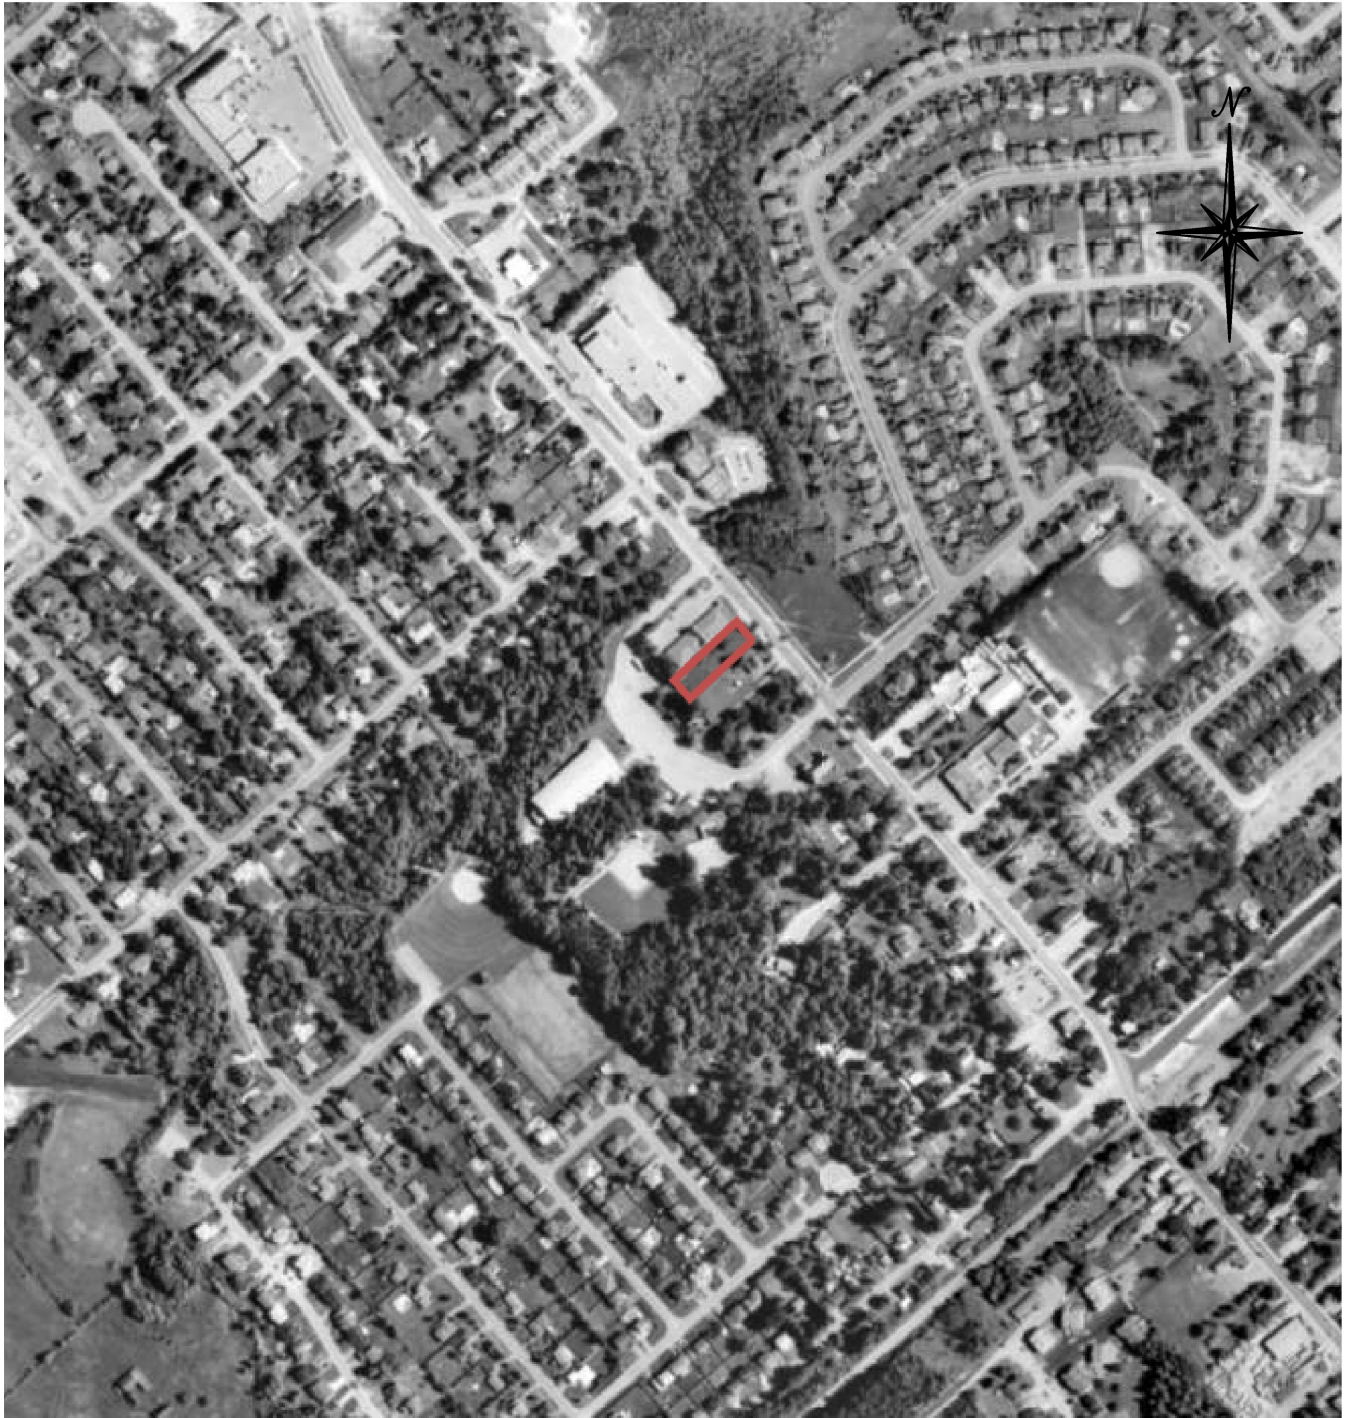
AP5

1999 (AP5)	The Site appeared similar to 1976.	No significant changes were observed to the Phase One study area with the exception of additional residential developments in the general area of the Site.
2002 (AP6)	The Site appeared similar to 1999.	No significant changes were observed to the Phase One study area from the observations made in 1999.
2011 (AP7)	The Site appeared similar to 2002.	No significant changes were observed to the Phase One study area from the observation made in 2002.
2022 (AP8)	The Site appeared similar to 2011.	No significant changes were observed to the Phase One study area from the observation made in 2011.

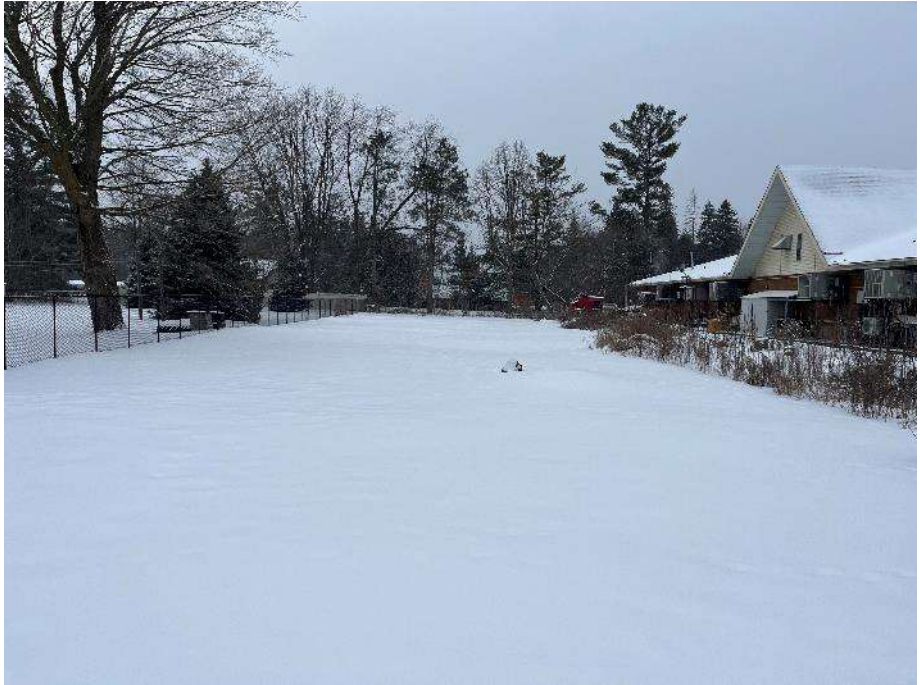
Photograph No. 1

Date: 1/27/2025	
Description From east facing west across entirety of the Site.	
Photograph No. 2

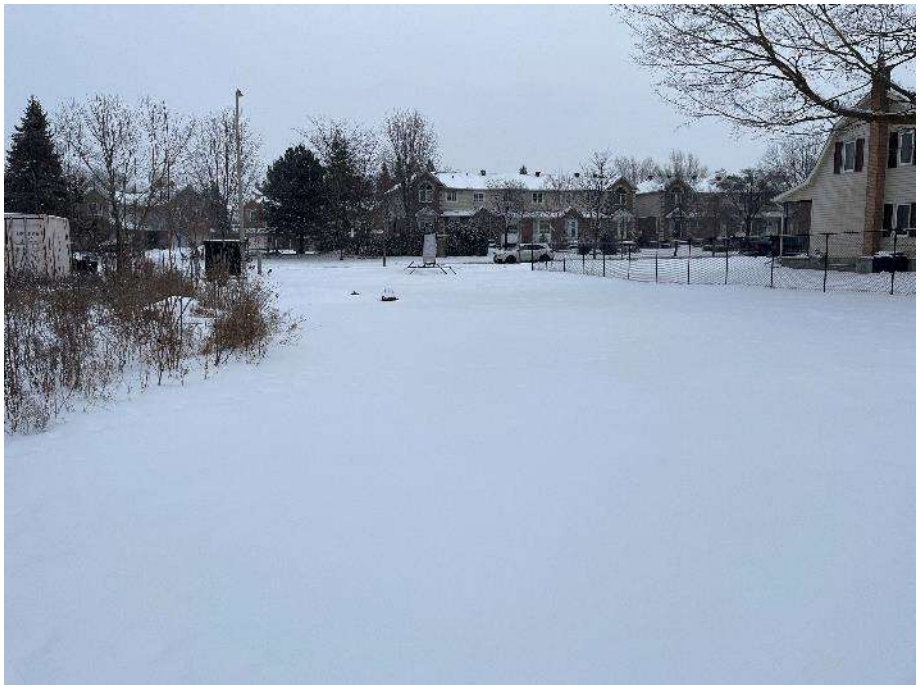
Date: 1/27/2025	
Description From west facing east across entirety of the Site.
