# **Geotechnical Investigation**

## **Proposed Industrial Redevelopment**

135 Cardevco Road  
Carp, Ontario

Report PG6018 -1 Revision 6 dated February 18, 2025

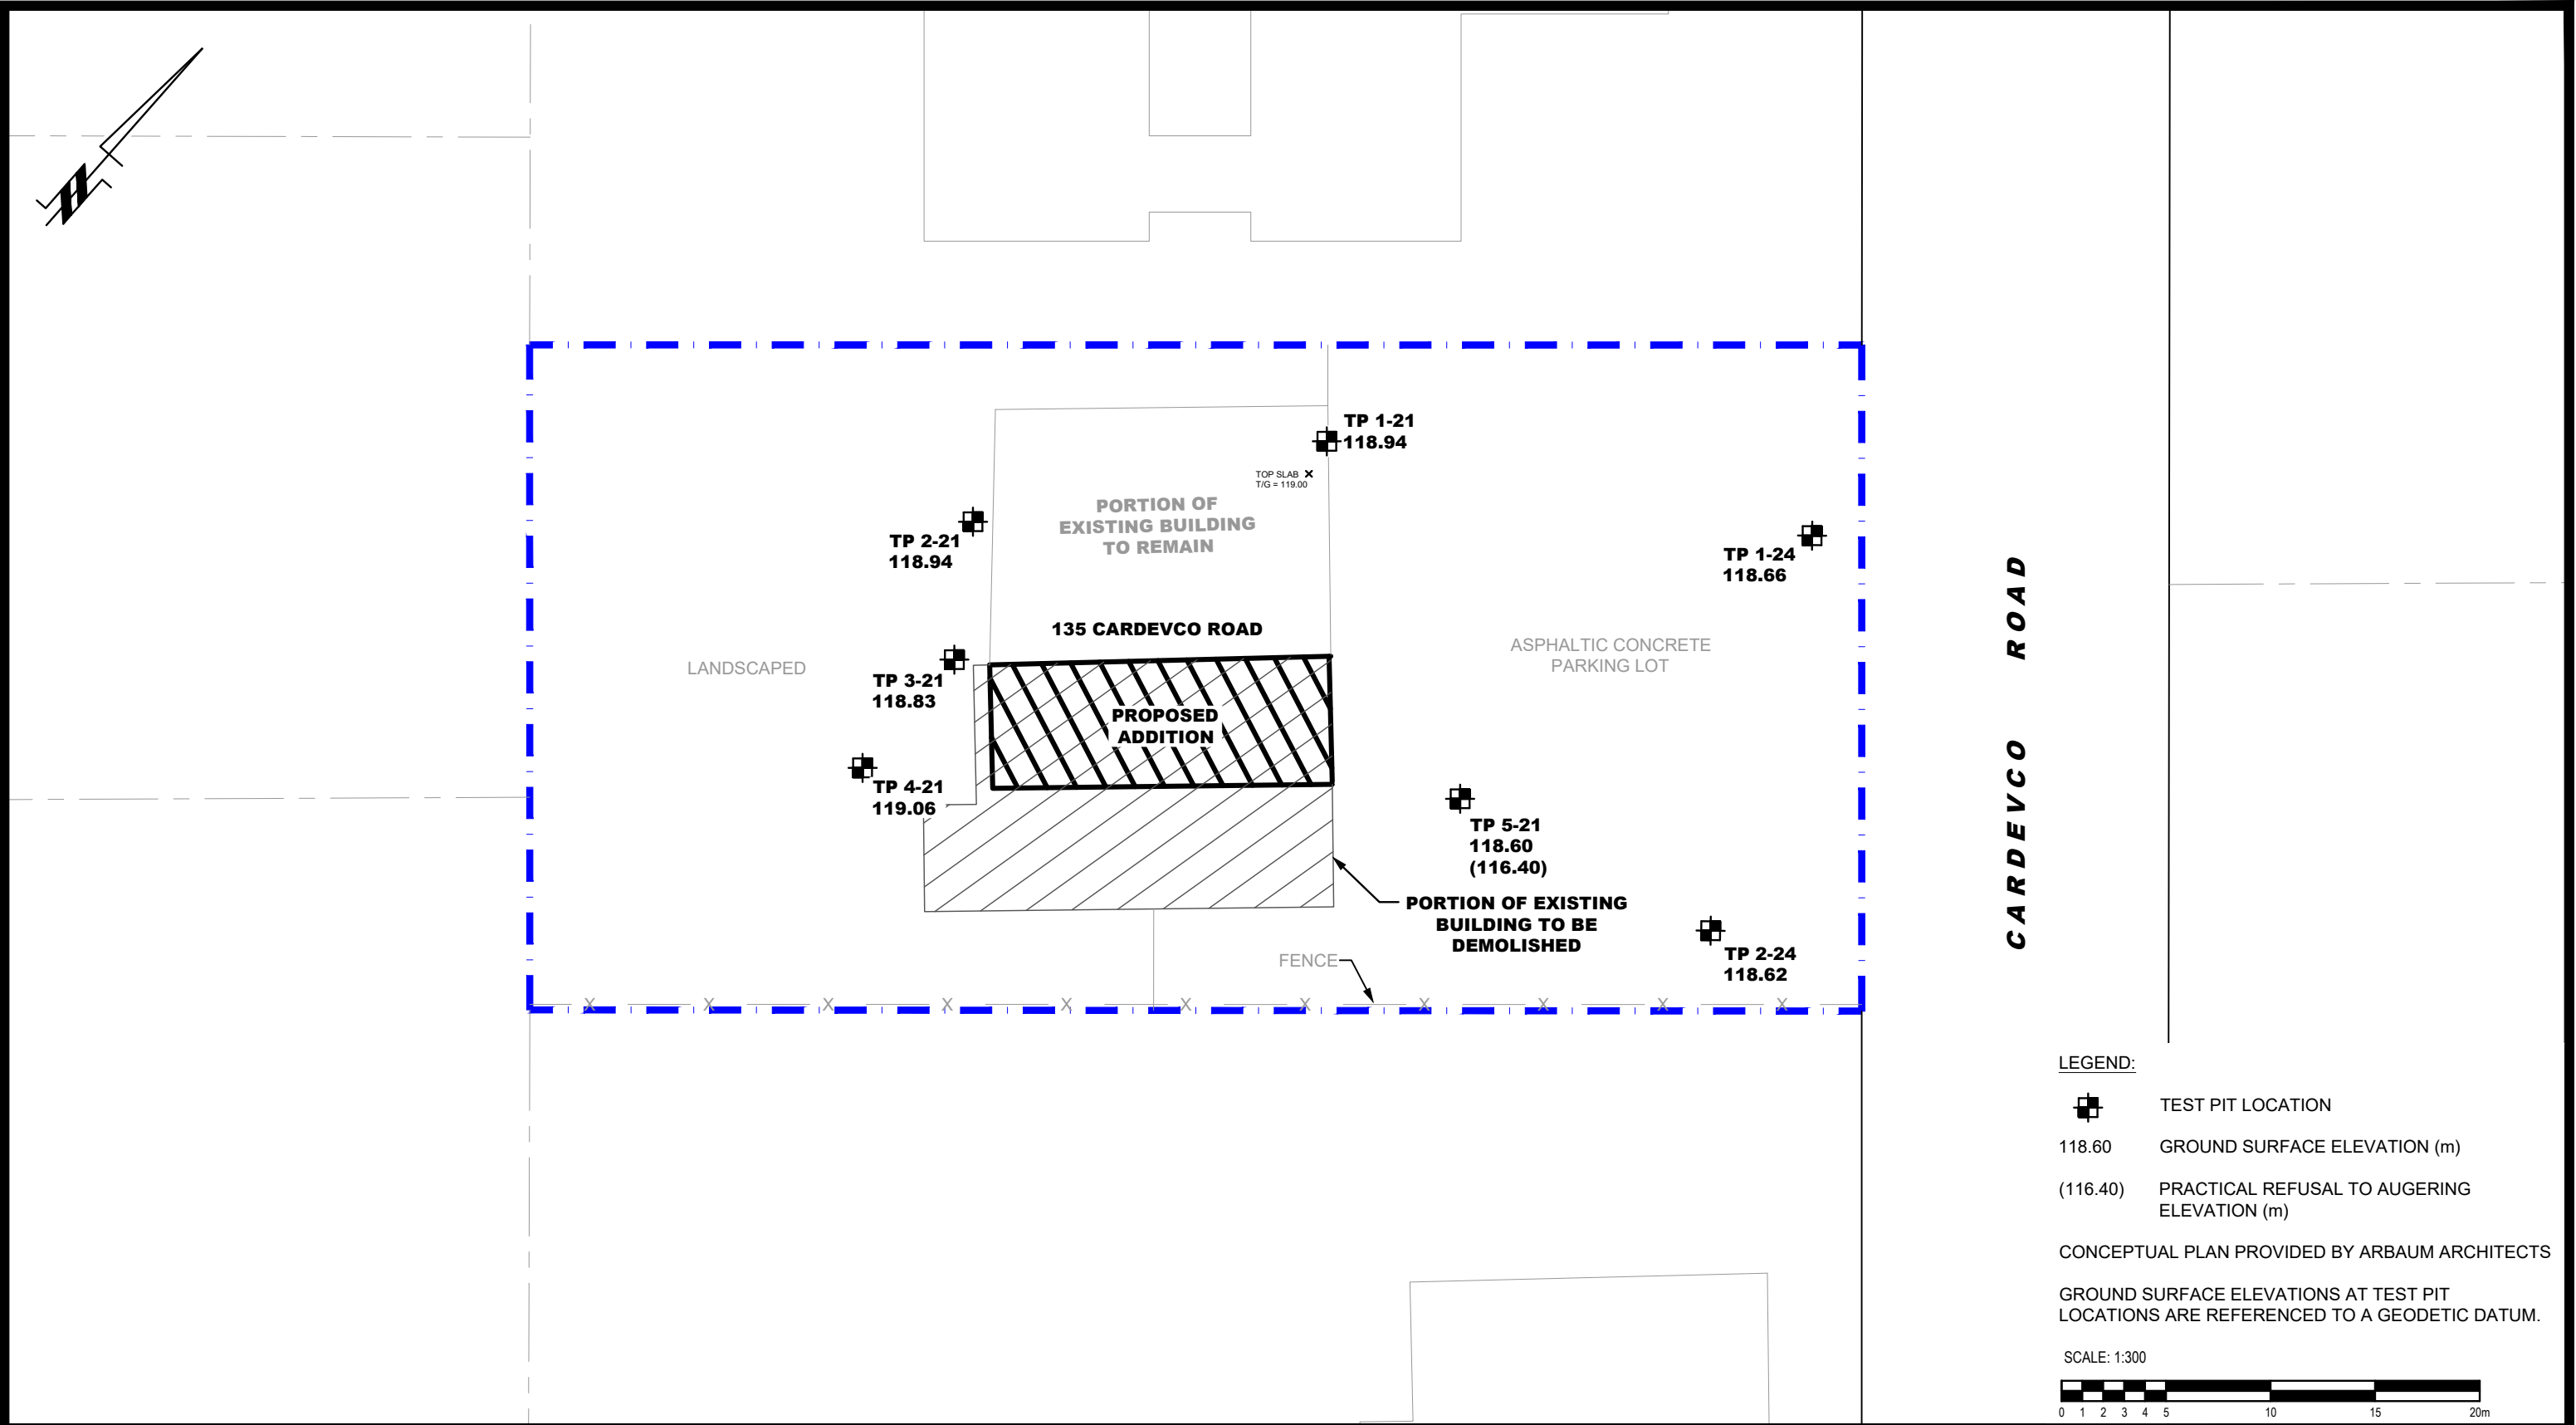
**FIGURE 5**

FIGURE 5 – UNDERPINNING PROGRAM SECTION A-A

The lateral support zone of 1.5H:1V for footings should be protected. Upon our review of the grading plans for the proposed building addition, it was noted that the proposed USF will be at geodetic elevation 117.4m. Therefore, underpinning of the eastern footings along the existing building will be required to complete the proposed excavation. Details regarding the underpinning program are discussed further under subsection 6.3 – Excavation Side Slopes.

Based on our review of the grading plans, and on information collected from our geotechnical investigation, it is understood that the USF for the proposed building addition and the eastern foundation wall are at approximate geodetic elevation 117.4 and 118.4 m, respectively. Furthermore, there will be no horizontal setback between the proposed building addition and the eastern foundation wall of the existing warehouse. Therefore, the underpinning of the eastern foundation wall of the existing warehouse should be underpinned.
