PM15625-LET.01-Rev.02

Subject: **Hydrogeological Assessment and Terrain Analysis
Zoning Bylaw Amendment and Site Plan Control
Application
1811 Richardson Side Road
Ottawa (Carp), Ontario**

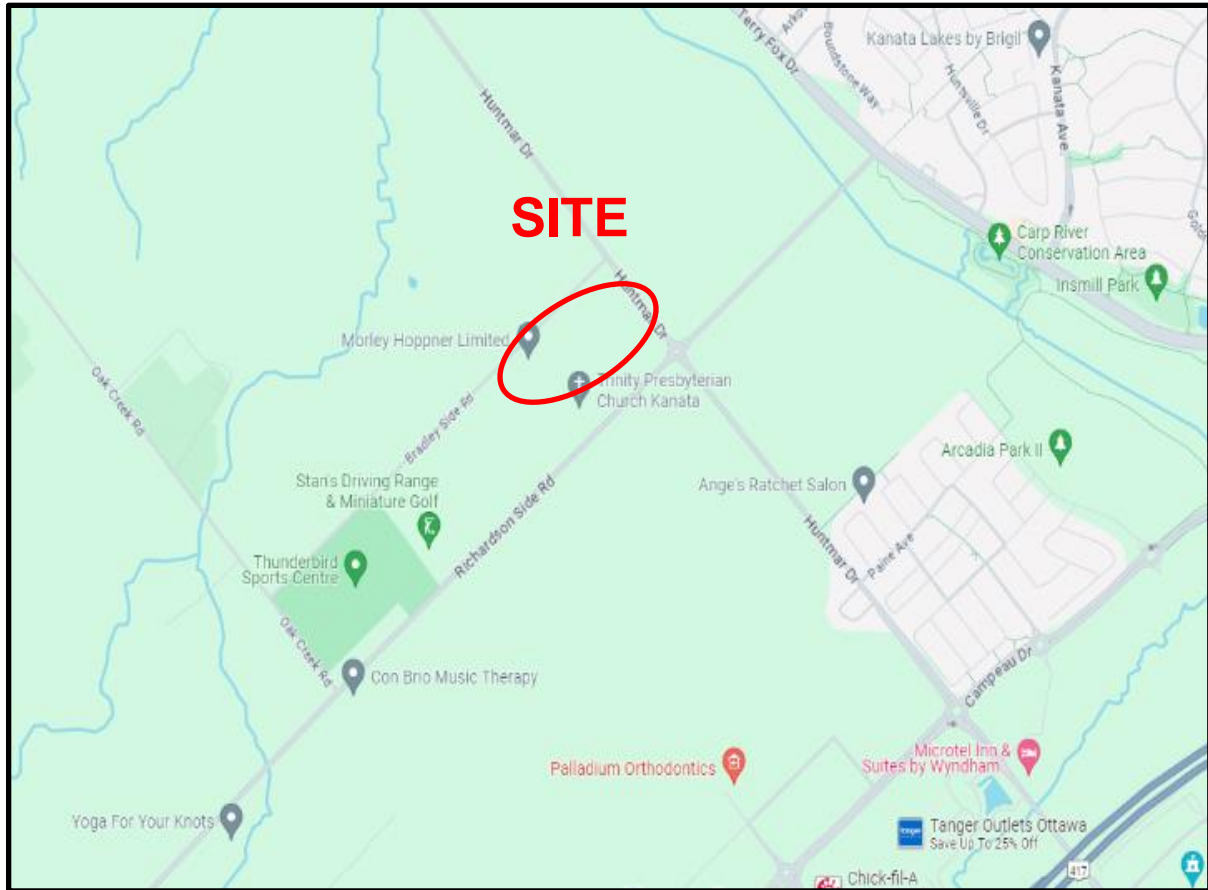
FIGURE 1

KEY PLAN

The subject site is an approximately 11.68 ha lot and is currently occupied by a two-storey residential dwelling, a commercial building to the south with associated parking and storage, a commercial building (Cidery), and agricultural lands to the east, with an associated temporary tent-based greenhouse. The Re-zoning Application is for a zoning by-law amendment to increase the number of guests allowed at the OFDU and/or restaurant. Please refer to Figure-1 Key Plan, attached, for the proposed site location.
