# **Geotechnical Investigation**

## **Proposed Self-Storage Facility**

1015 & 1045 Dairy Drive  
Ottawa, Ontario

Report PG6498-1 Revision 6 dated July 2, 2025

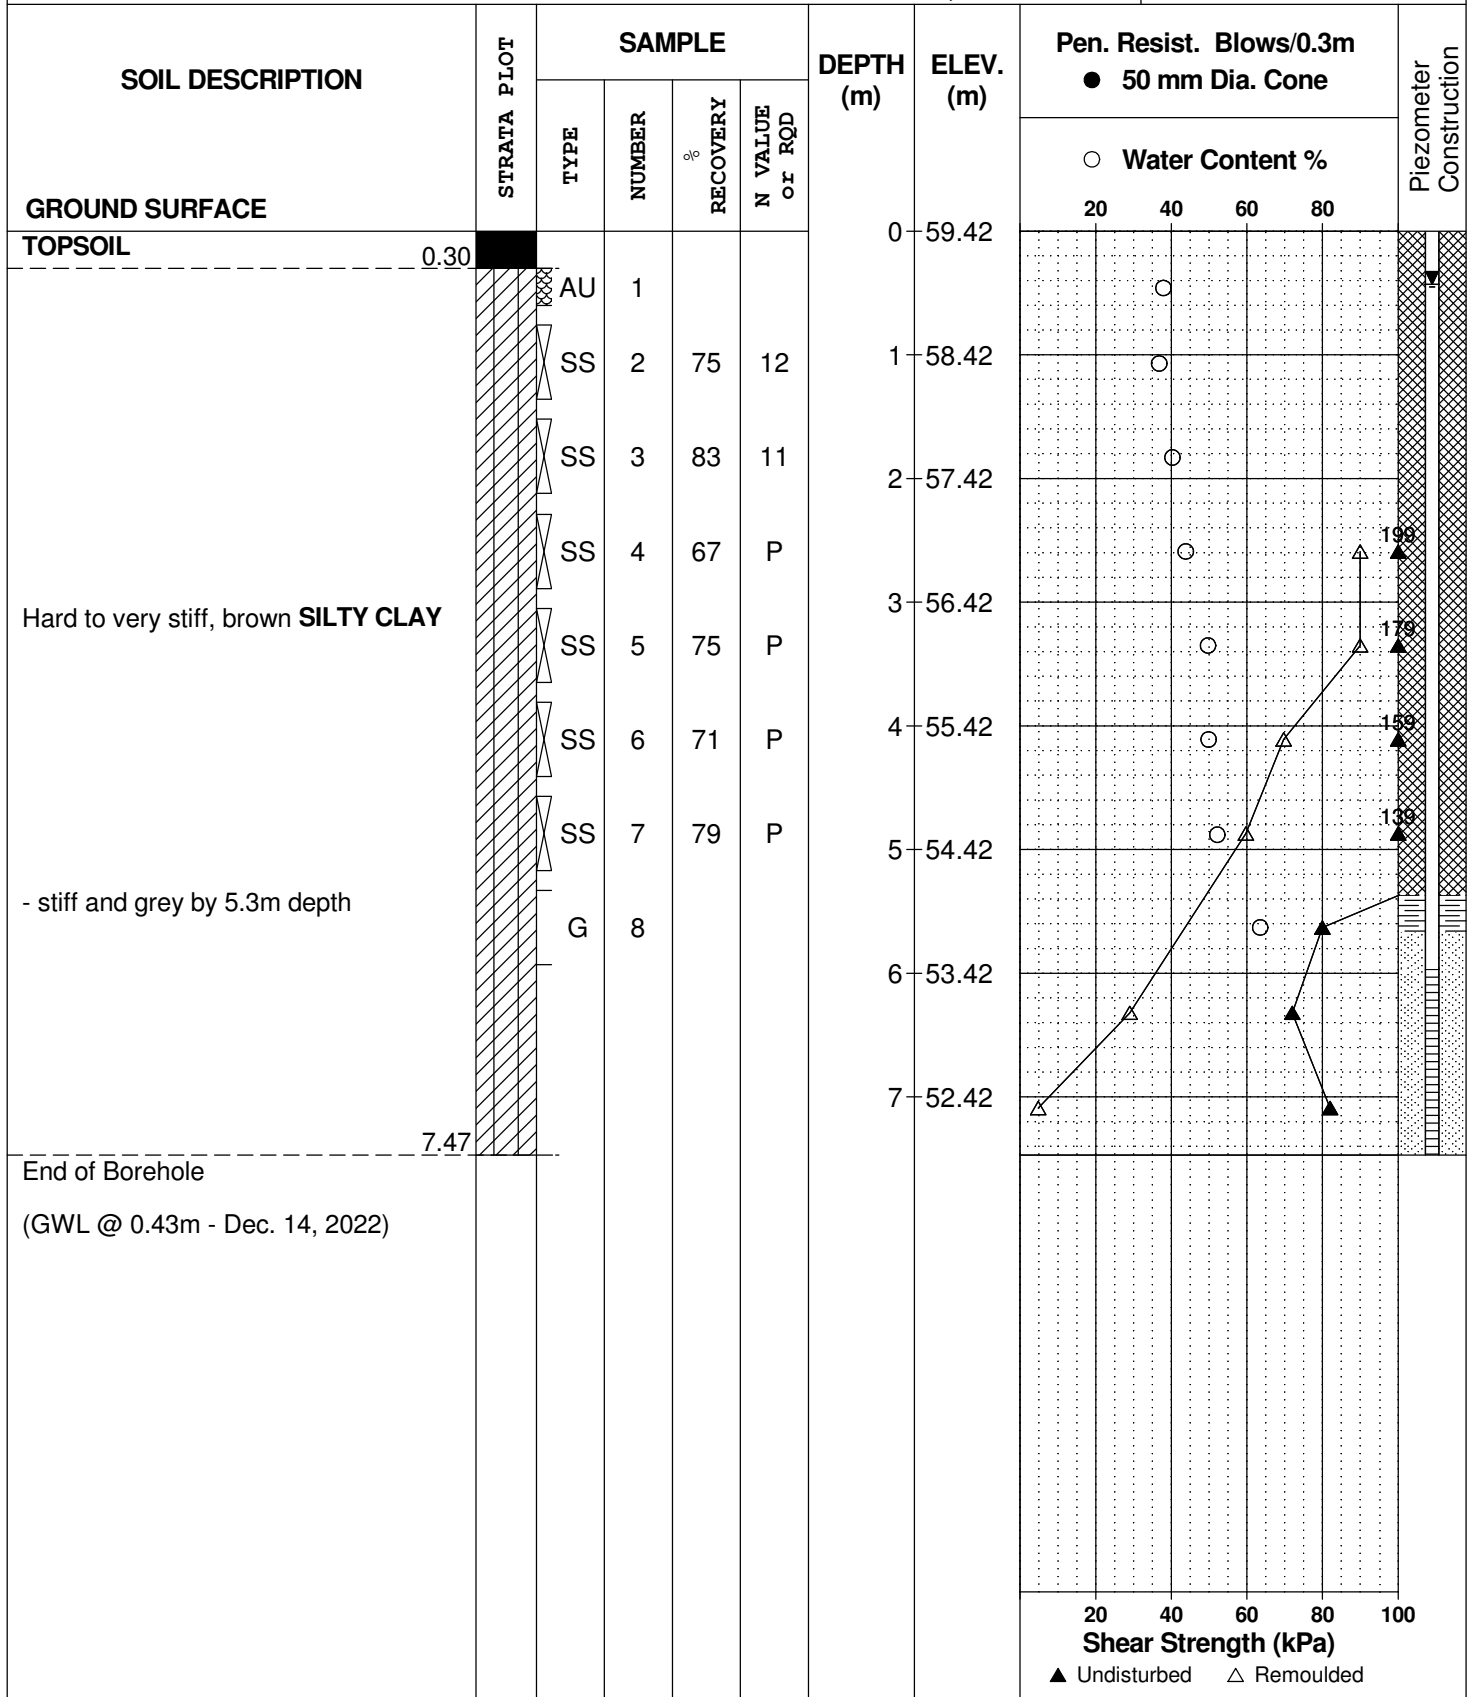
HOLE NO.  
**BH 2-22**

Specimen Identification		Classification				MC%	LL	PL	PI	Cc	Cu
●	BH 2-22 SS3										
☒											
▲											
★											
Specimen Identification		D100	D60	D30	D10	%Gravel	%Sand	%Silt	%Clay		
●	BH 2-22 SS3	0.25	0.00			0.0	0.2	99.8			
☒											
▲											
★

The subsurface conditions observed in the test holes were recorded in detail in the field. The soil profiles are logged on the Soil Profile and Test Data sheets in Appendix 1 of this report.

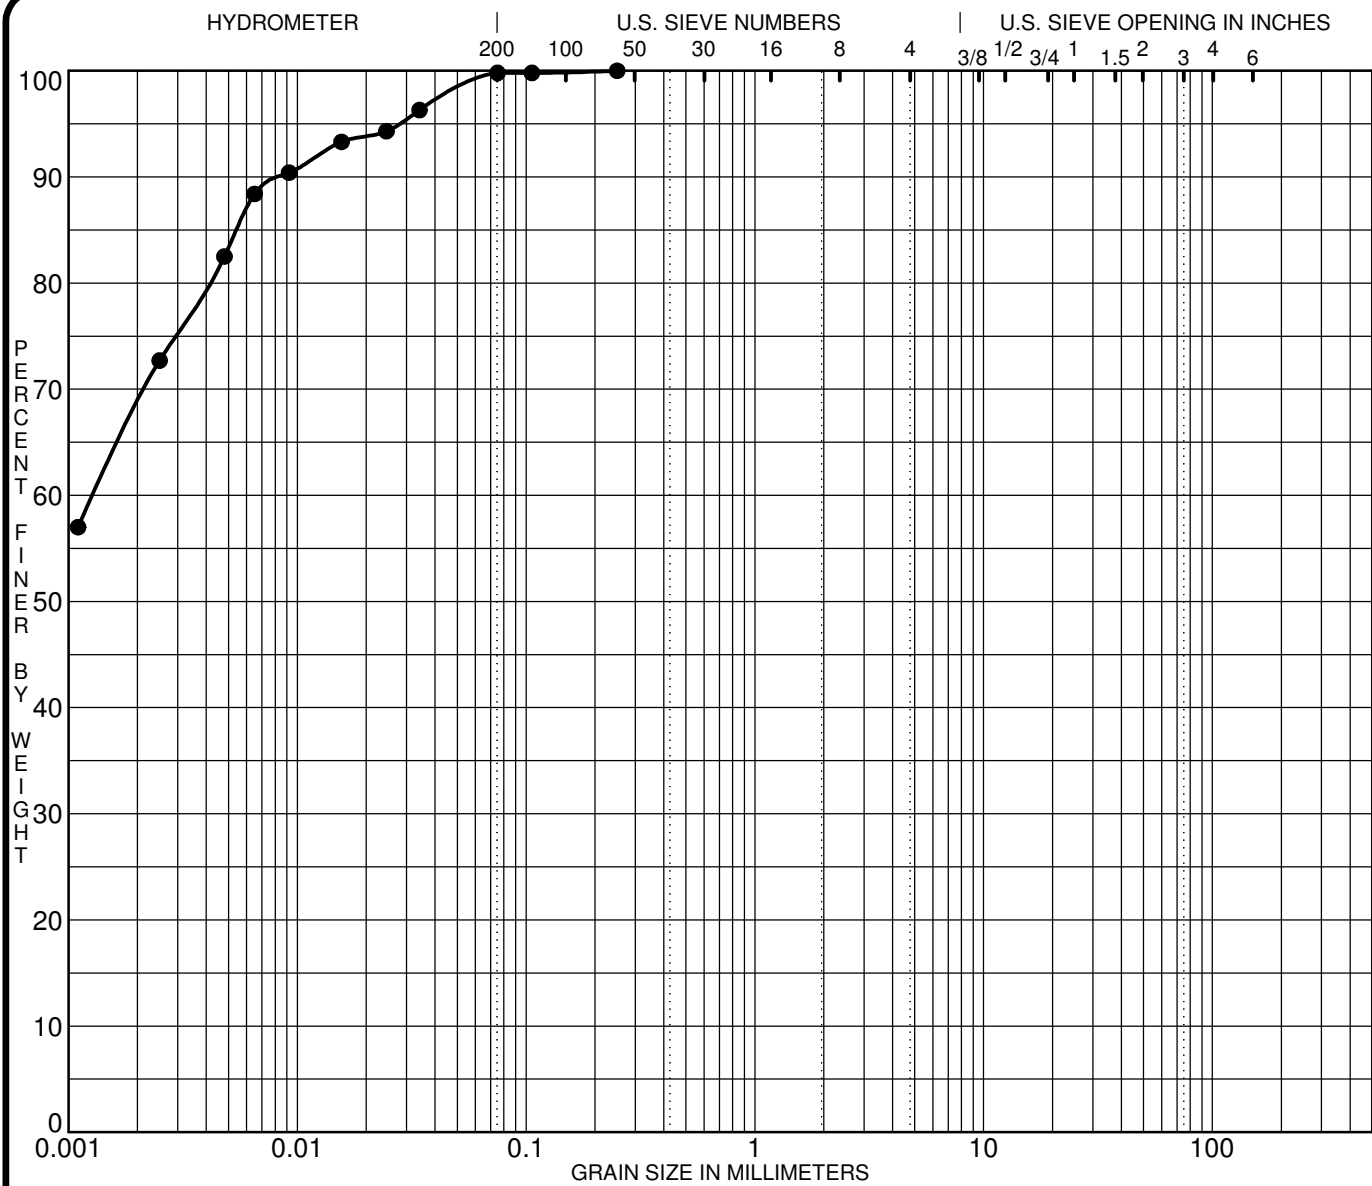
SILT OR CLAY	SAND			GRAVEL		COBBLES
	fine	medium	coarse	fine	coarse

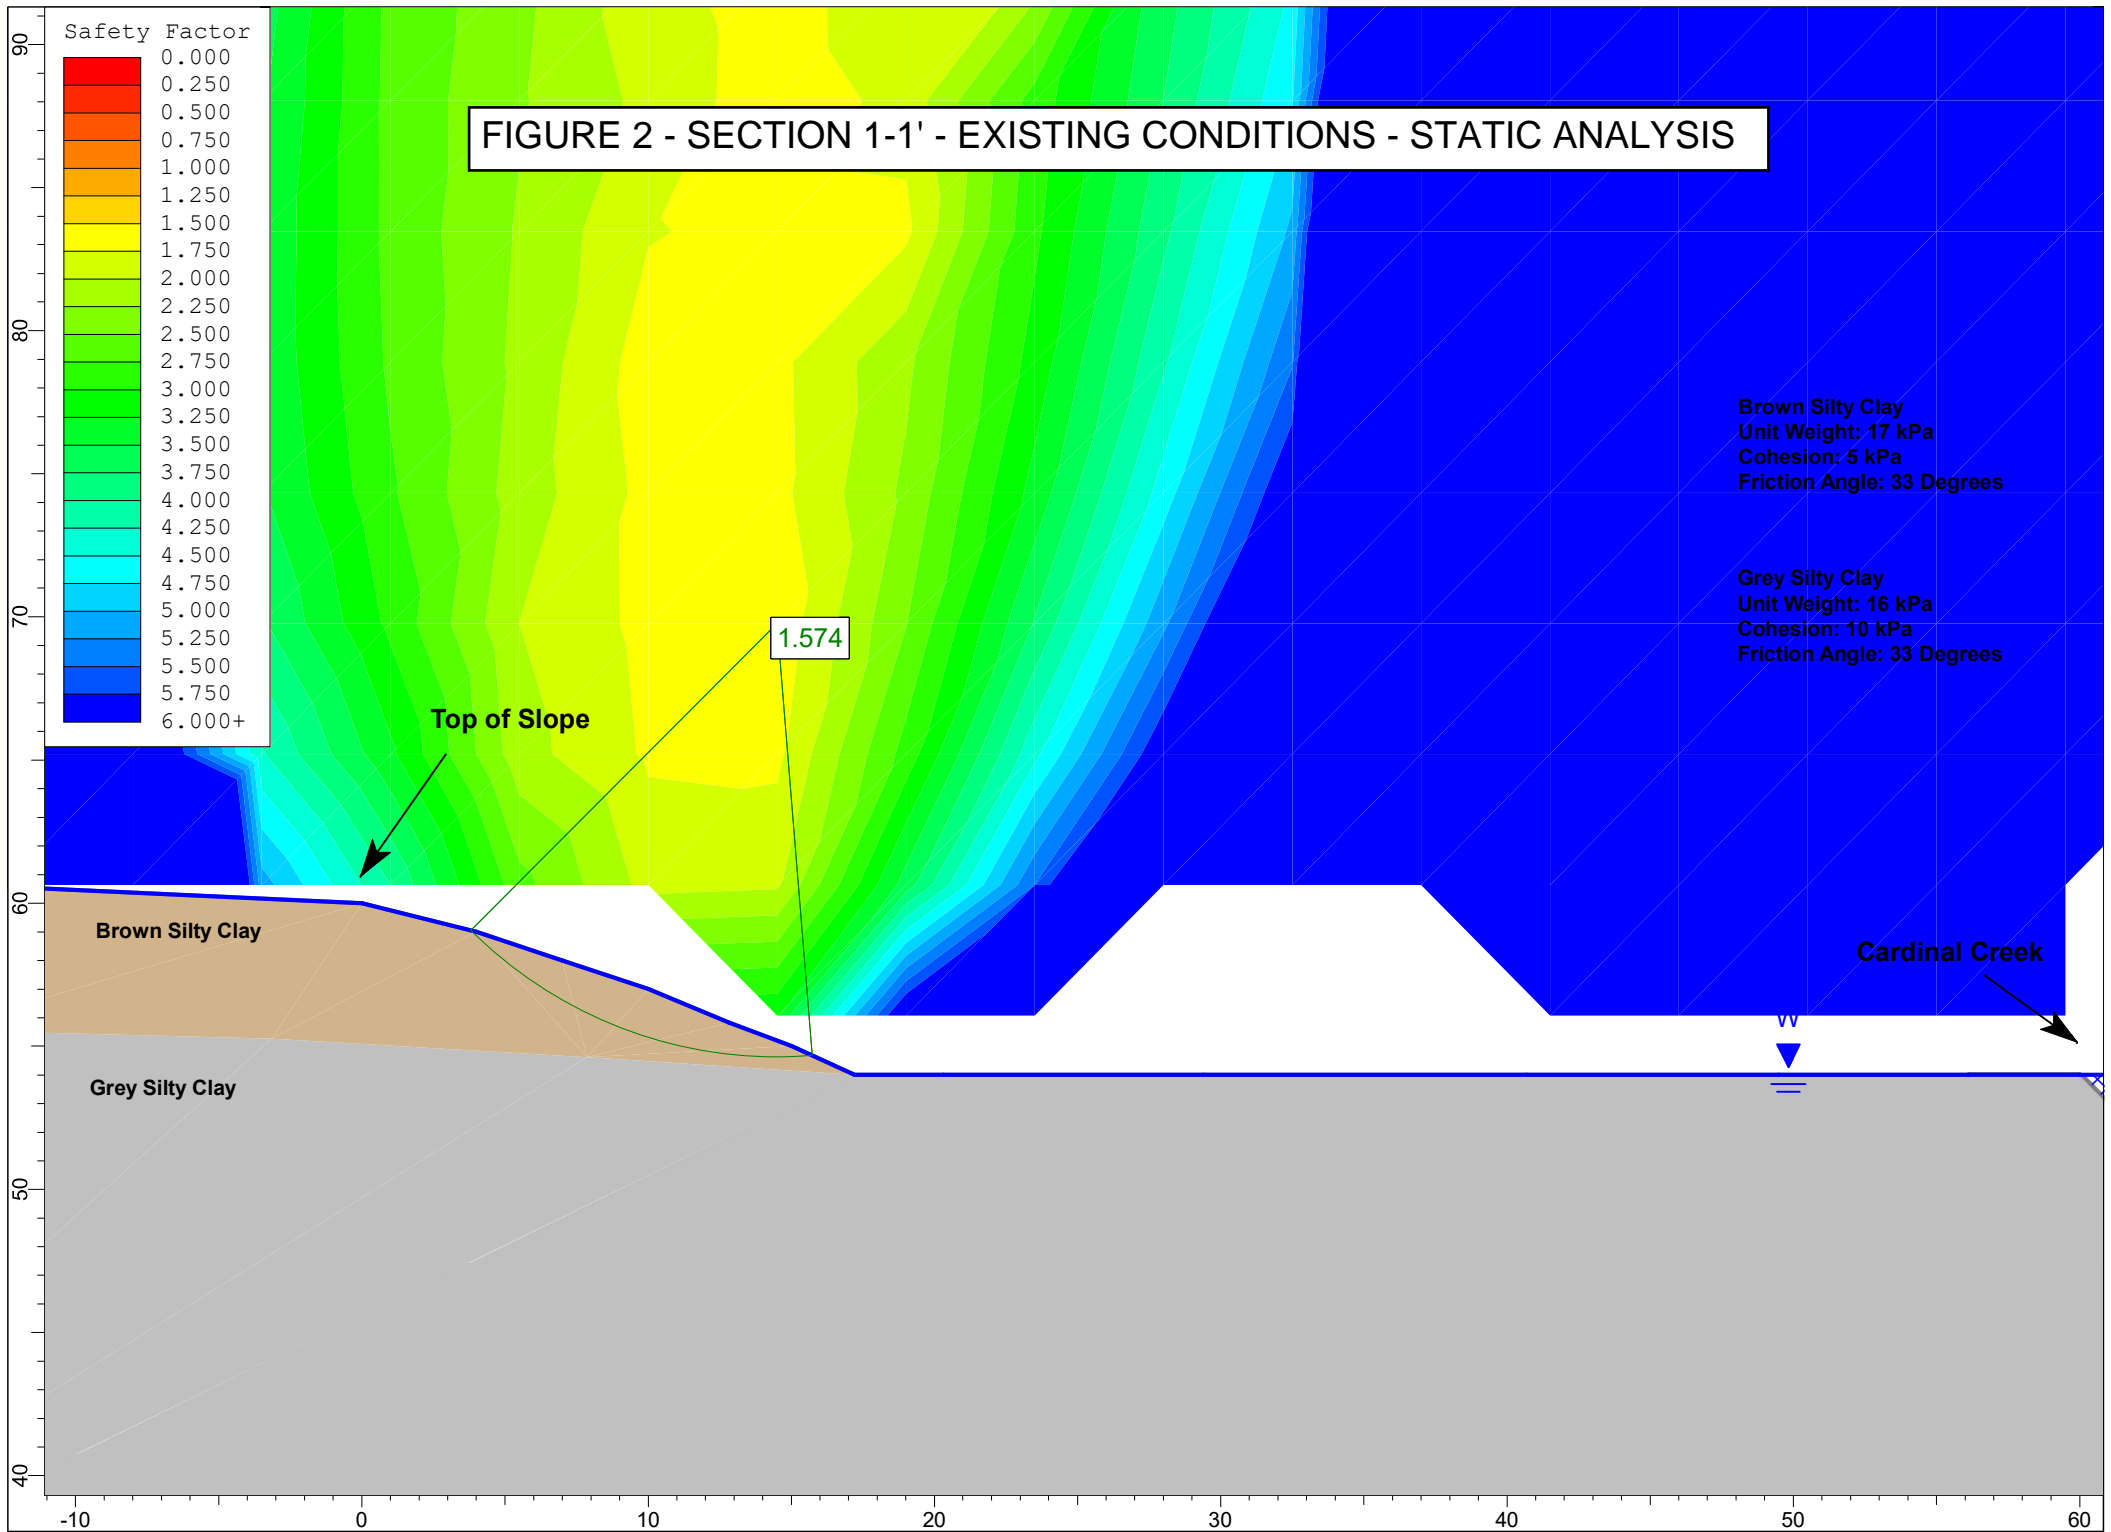
FIGURE 2 - SECTION 1-1' - EXISTING CONDITIONS - STATIC ANALYSIS

The slope stability analysis of the proposed site conditions was conducted using SLIDE, a computer program which permits a two-dimensional stability analysis using several methods, including the Bishop's method, which is a widely used and accepted analysis method. A horizontal acceleration of 0.16 g was utilized for the seismic analysis.

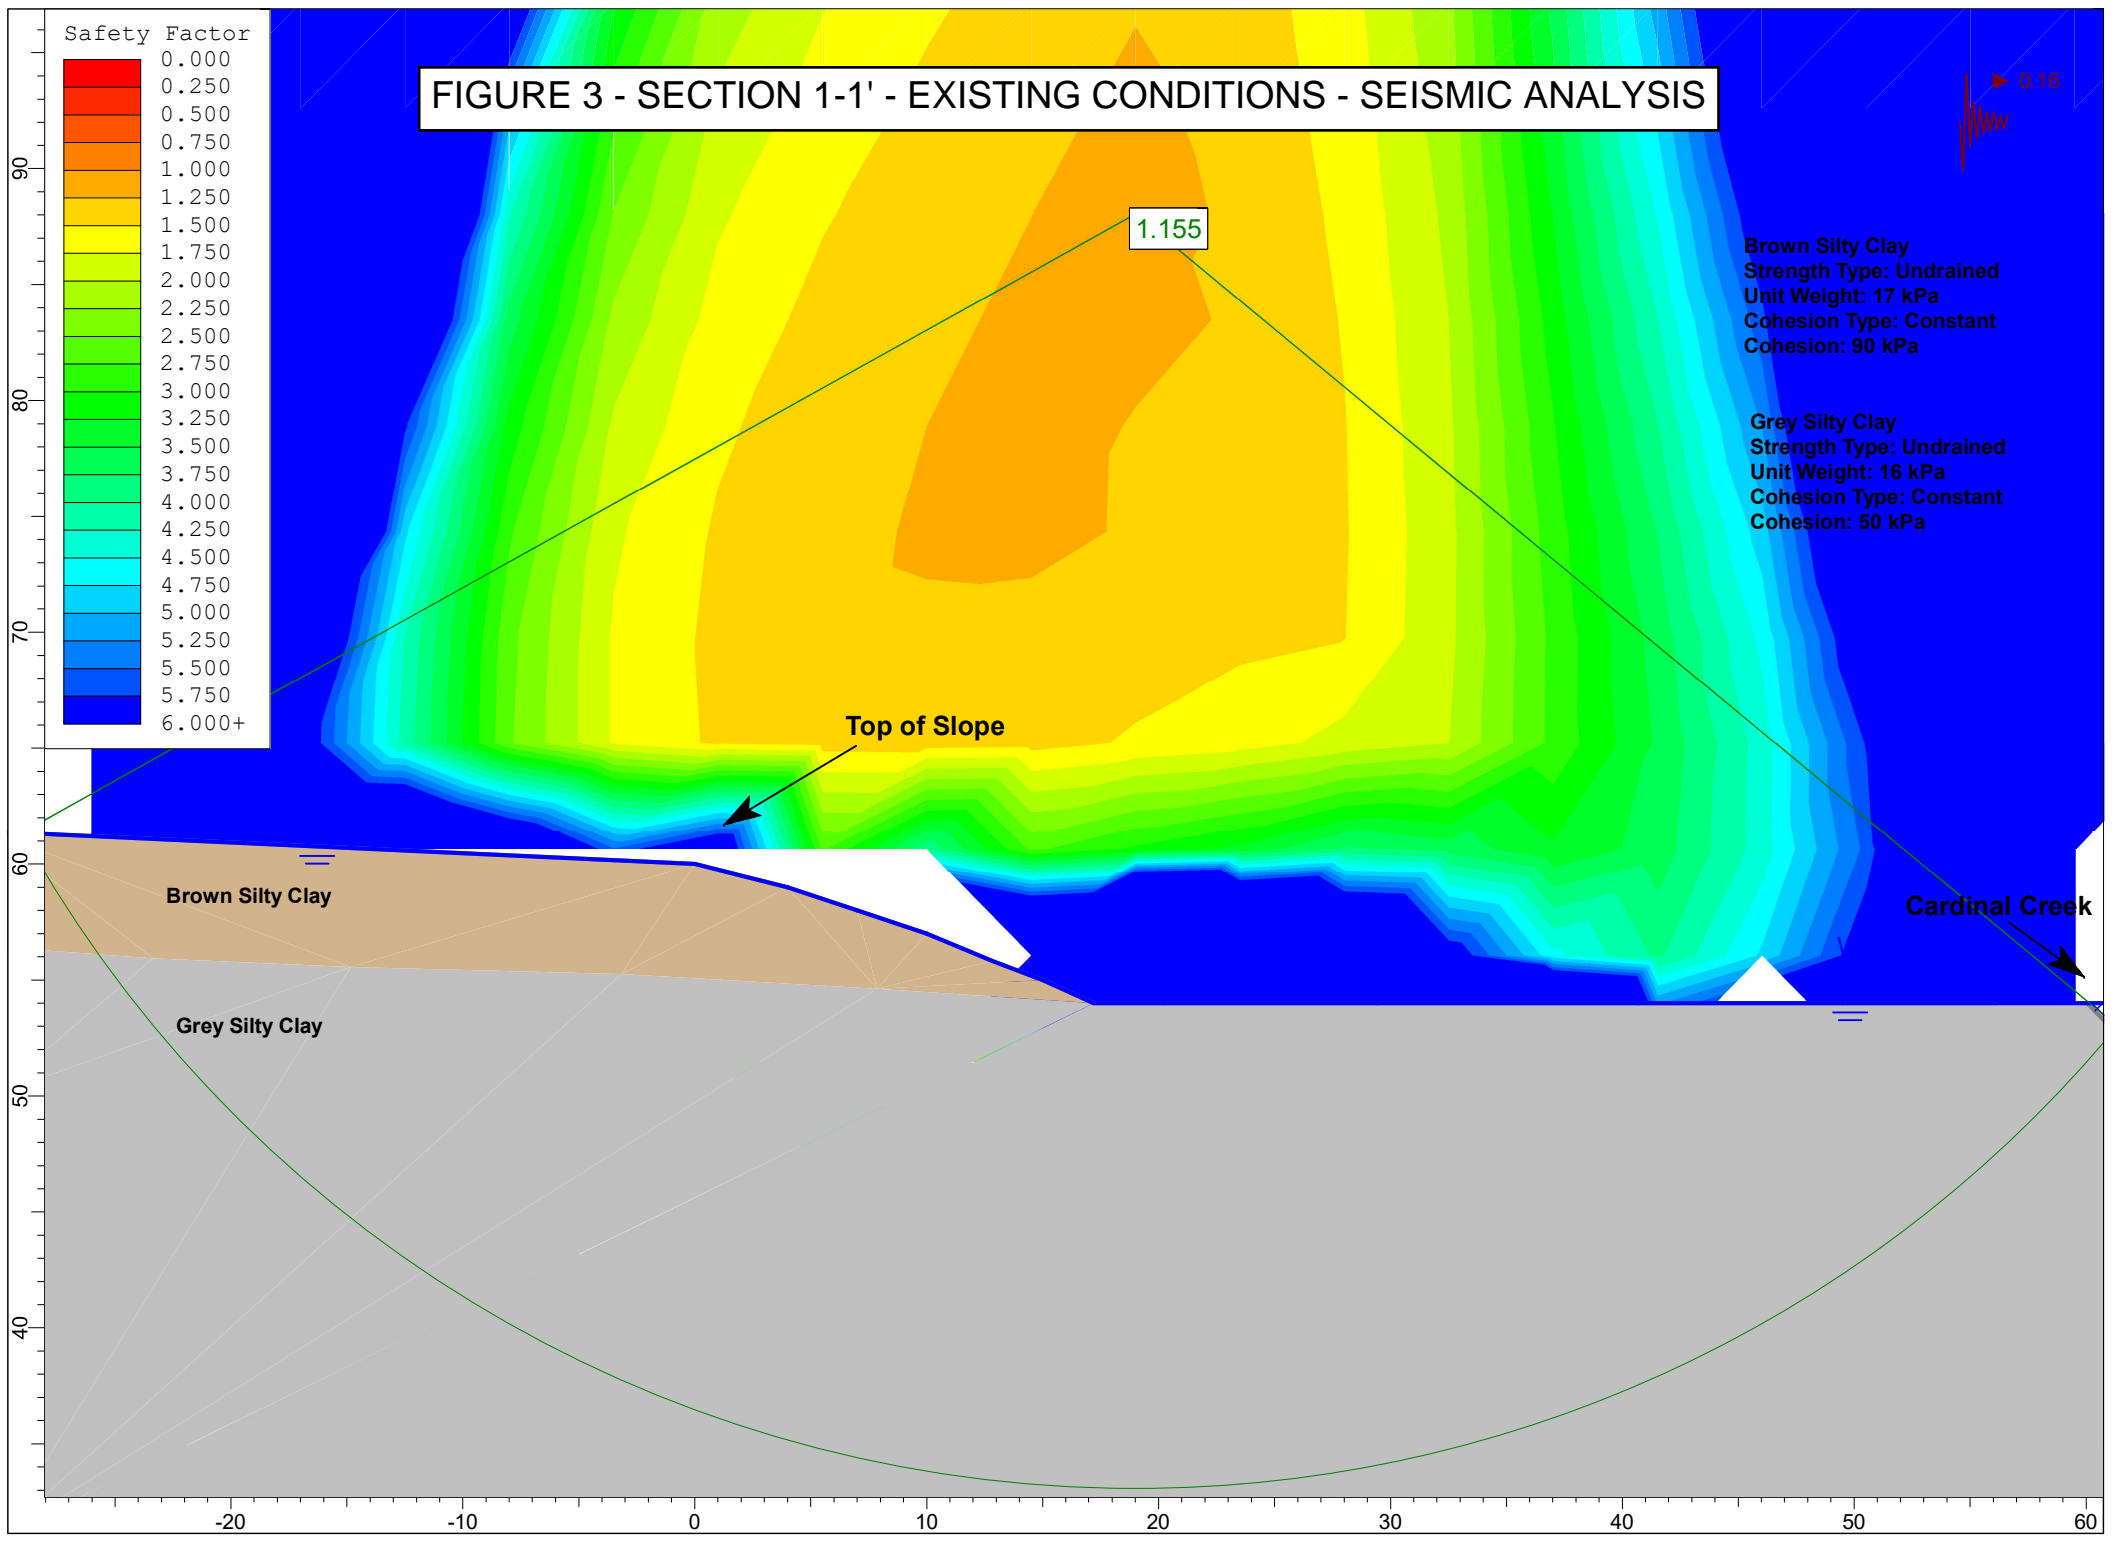
FIGURE 3 - SECTION 1-1' - EXISTING CONDITIONS - SEISMIC ANALYSIS

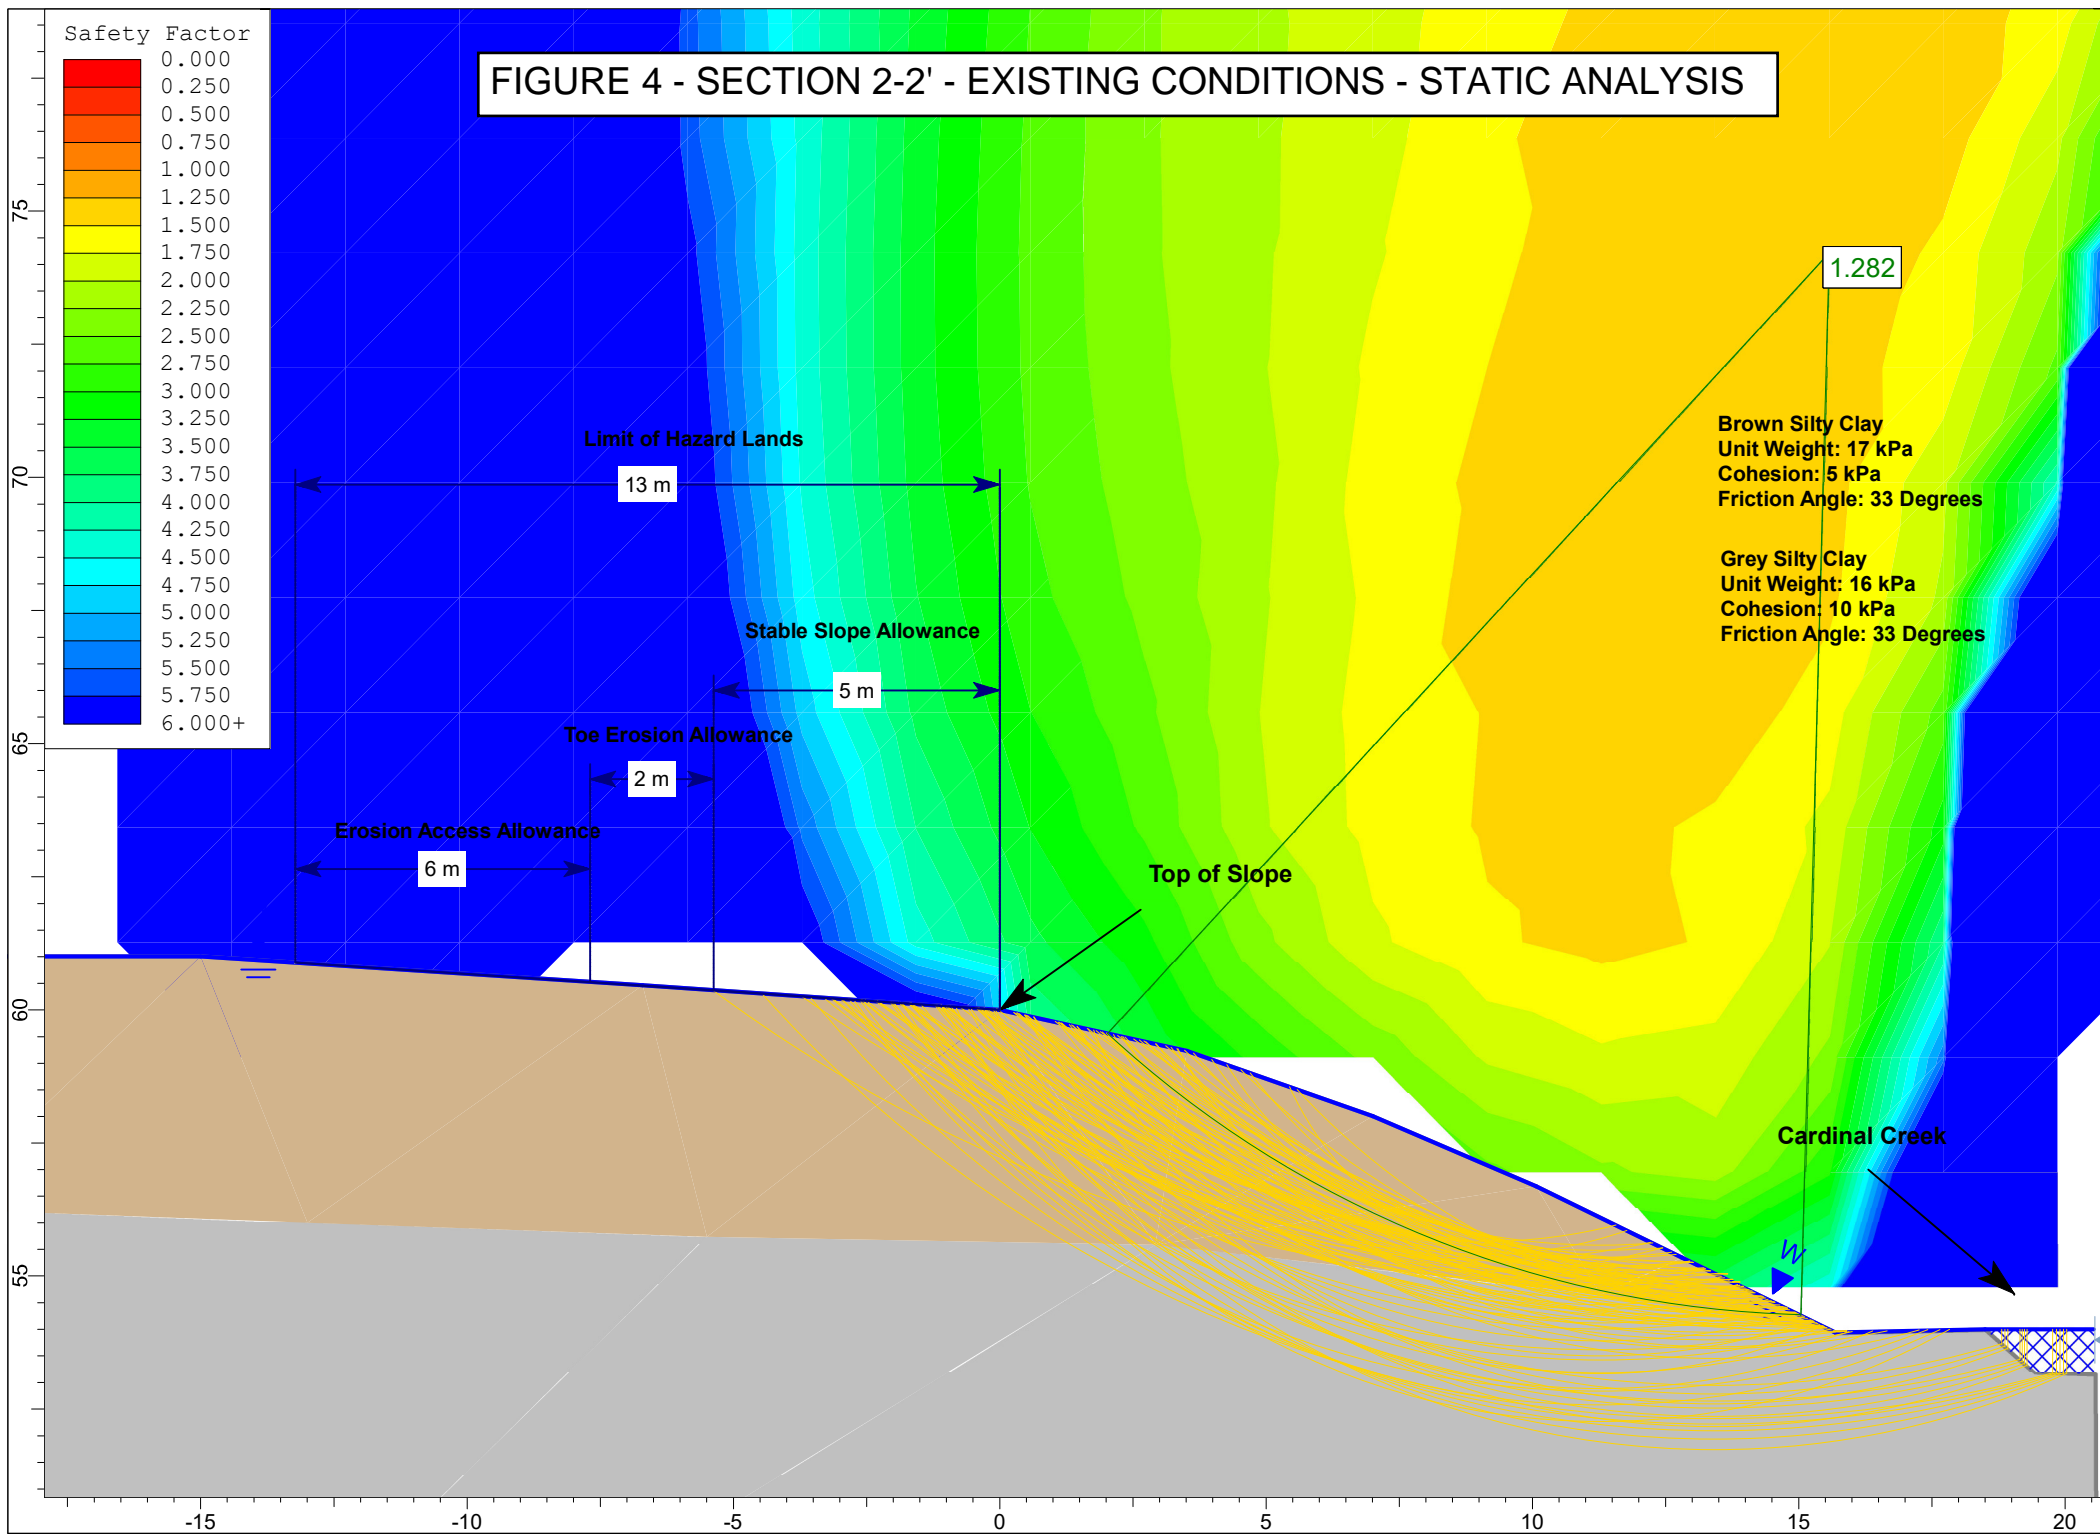
FIGURE 4 - SECTION 2-2' - EXISTING CONDITIONS - STATIC ANALYSIS

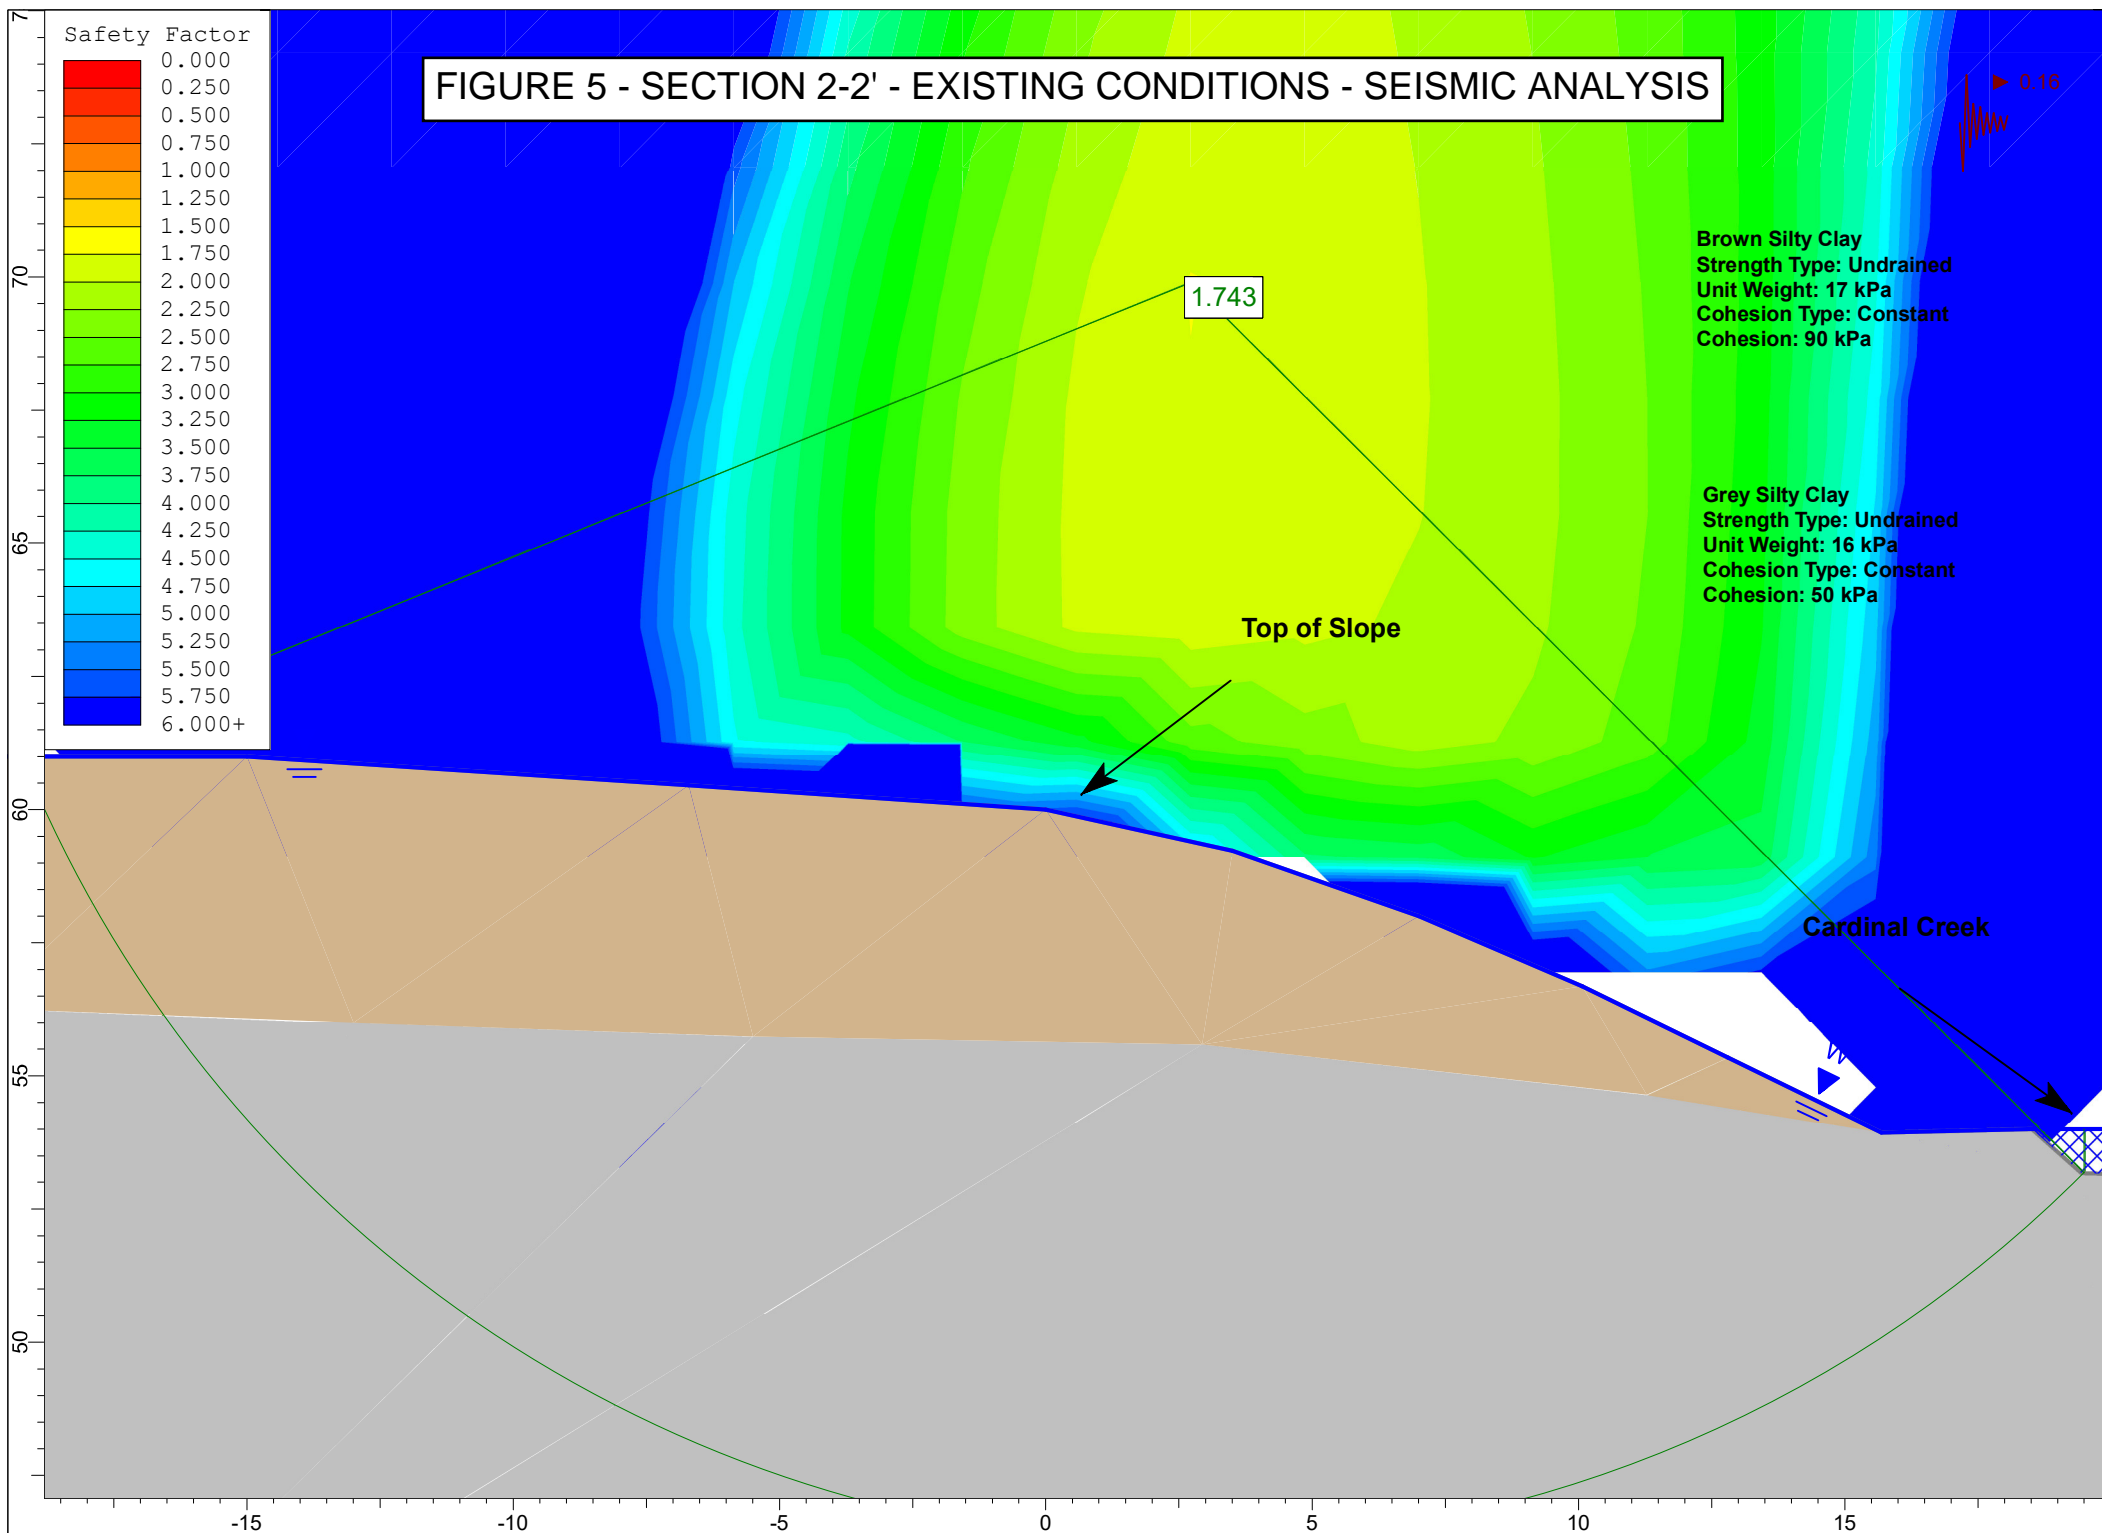
FIGURE 5 - SECTION 2-2' - EXISTING CONDITIONS - SEISMIC ANALYSIS

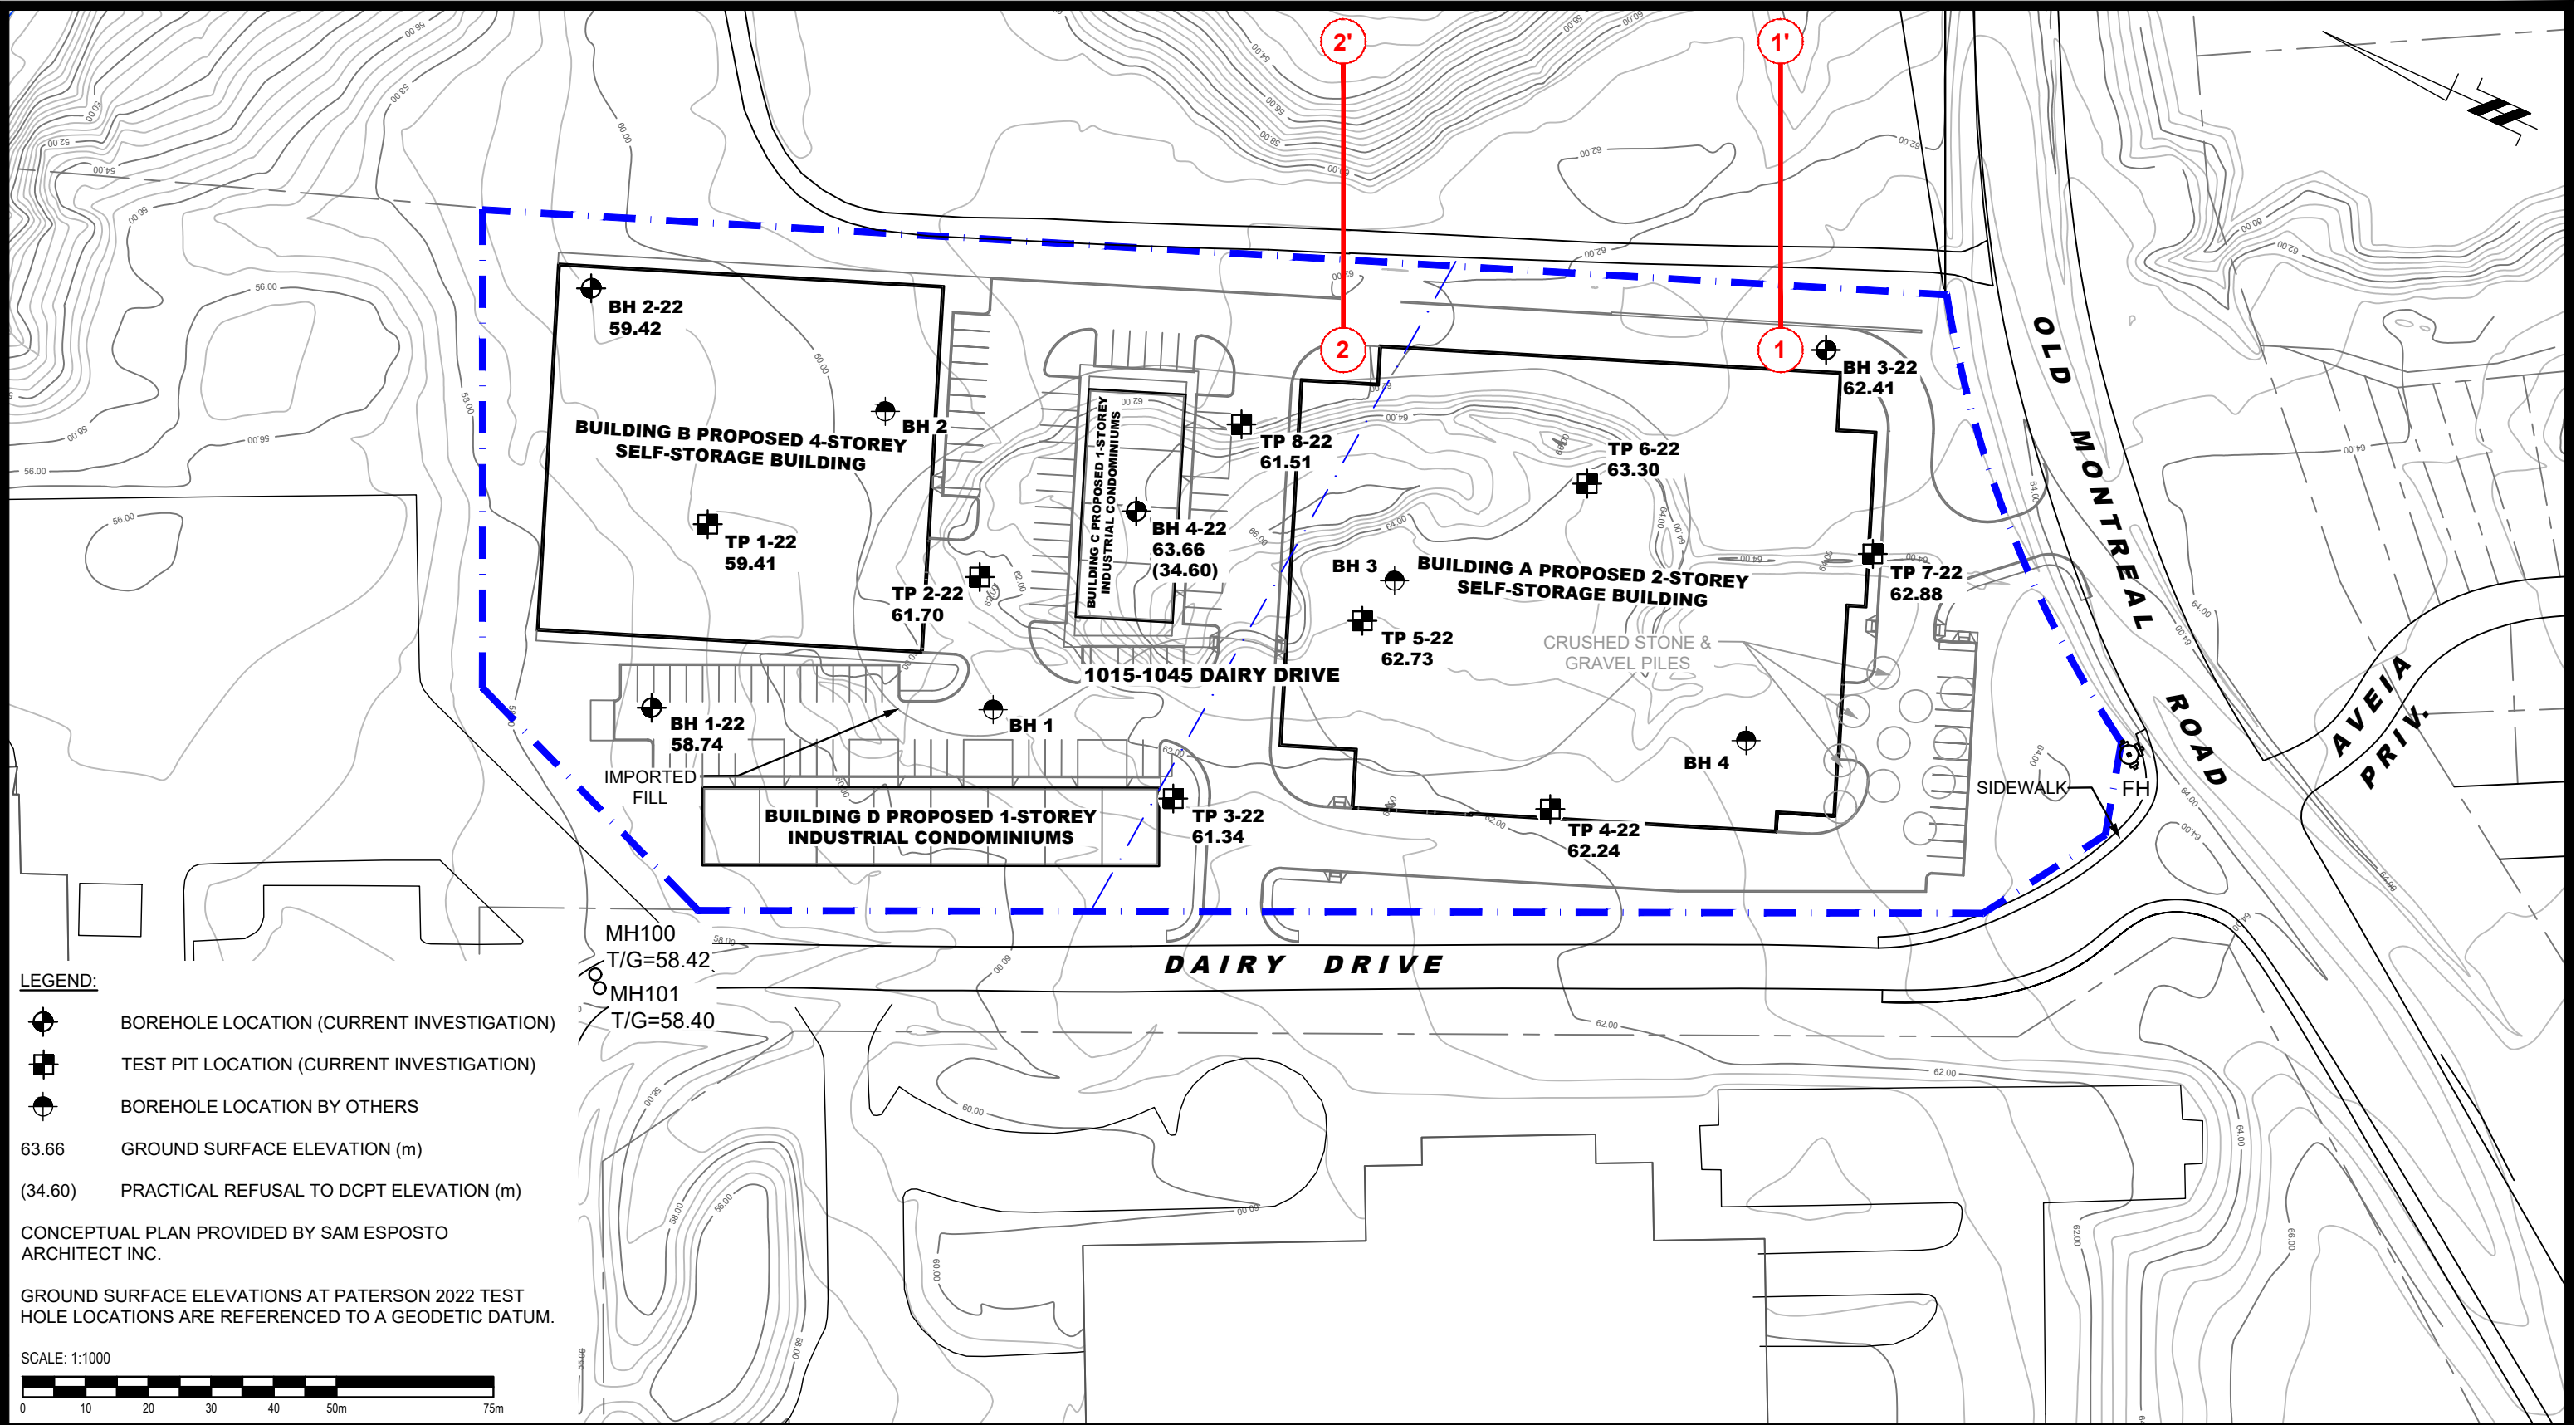
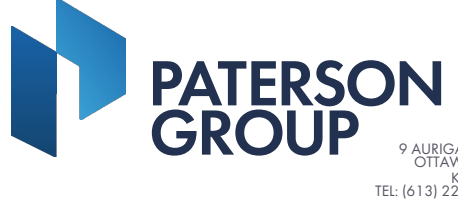
**PERMISSIBLE GRADE RAISE ELEVATIONS (m) WHICH ARE REFERENCED TO A GEODETIC DATUM**

<p>9 AURIGA DRIVE OTTAWA, ON K2E 7T9 TEL: (613) 226-7381</p>				TSL-DAIRY INC. GEOTECHNICAL INVESTIGATION PROPOSED SELF STORAGE FACILITY 1015 - 1045 DAIRY DRIVE ONTARIO				Scale: 1:1000	Date: 01/2023
3	UPDATED TO NEW CONCEPTUAL PLAN	06/06/2024	SD	OTTAWA, Title: <b>PERMISSIBLE GRADE RAISE PLAN</b>				Drawn by: YA	Report No.: PG6498-1
2	UPDATED TO NEW CONCEPTUAL PLAN	11/01/2024	SD					Checked by: FA	Dwg. No.: <b>PG6498-2</b>
1	UPDATED TO NEW CONCEPTUAL PLAN	15/09/2023	SD					Approved by: SD	Revision No.: 3
NO.	REVISIONS	DATE	INITIAL
