# **Geotechnical Investigation**

## **Proposed Self-Storage Facility**

1015 & 1045 Dairy Drive  
Ottawa, Ontario

Report PG6498-1 Revision 6 dated July 2, 2025

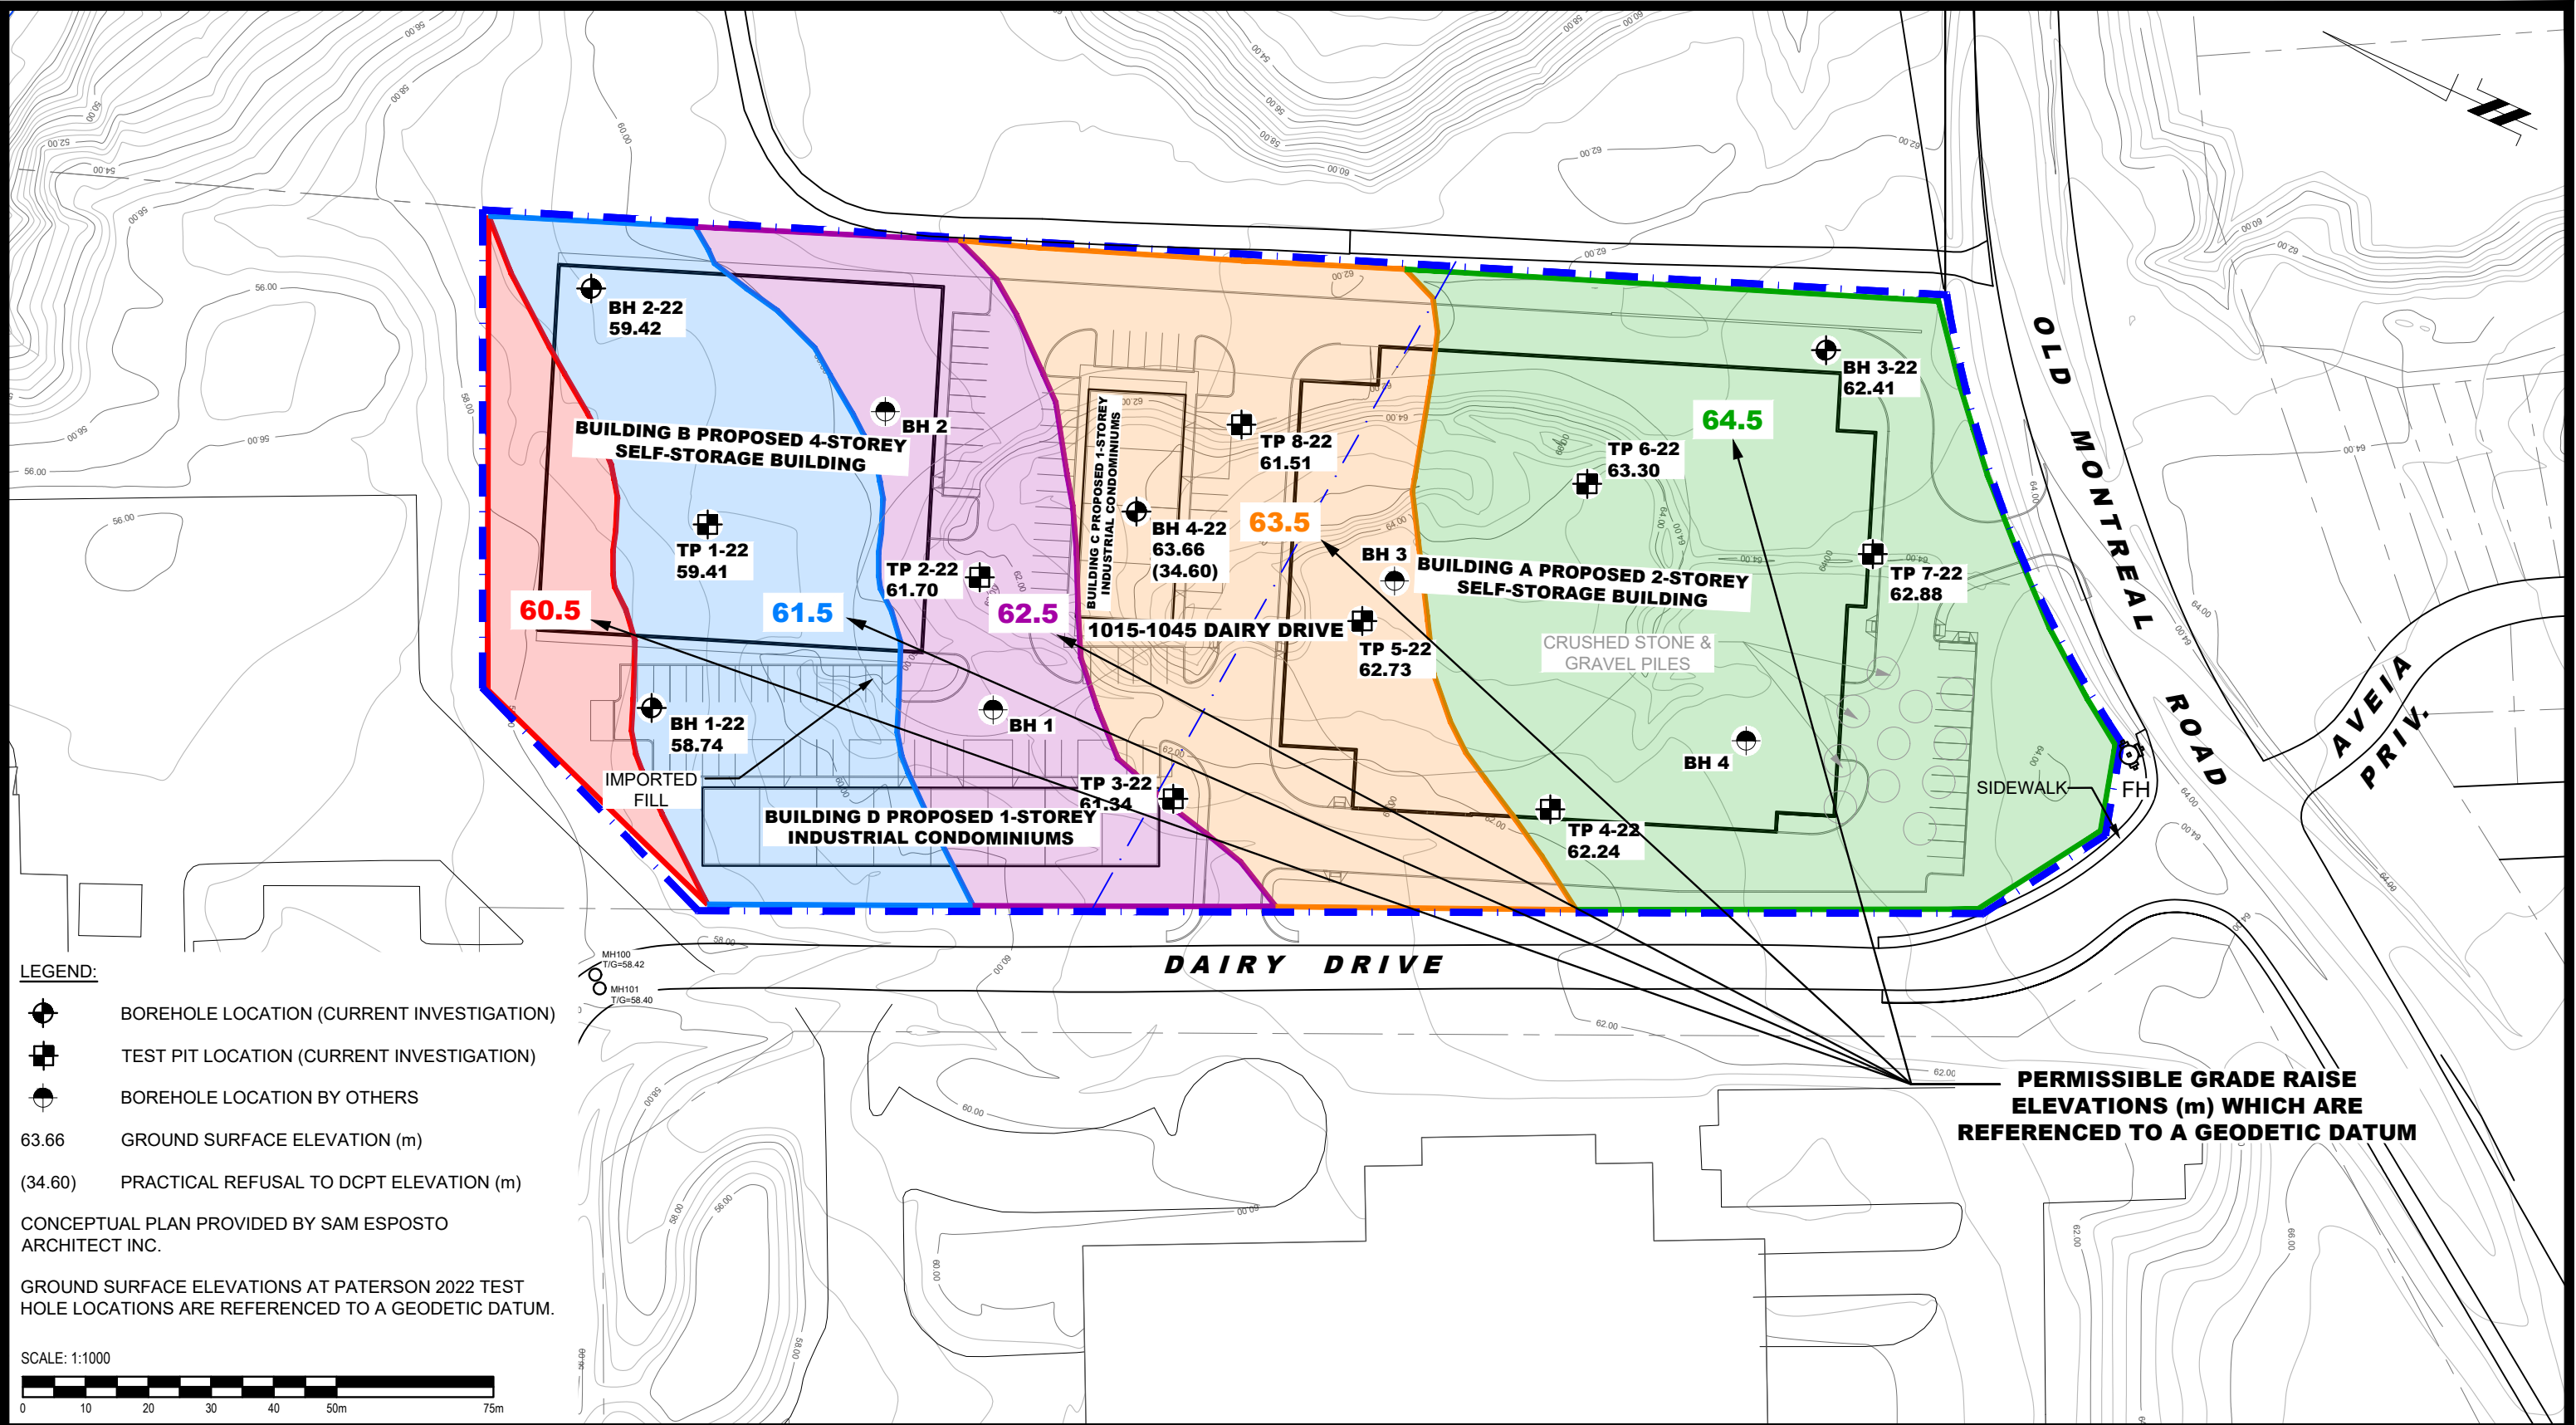
**PERMISSIBLE GRADE RAISE ELEVATIONS (m) WHICH ARE REFERENCED TO A GEODETIC DATUM**

Based on the undrained shear strength values of the silty clay deposit encountered throughout the subject site, the recommended permissible grade raise elevations for the proposed development are provided in Drawing PG6498-2 - Permissible Grade Raise Plan included in Appendix 2.

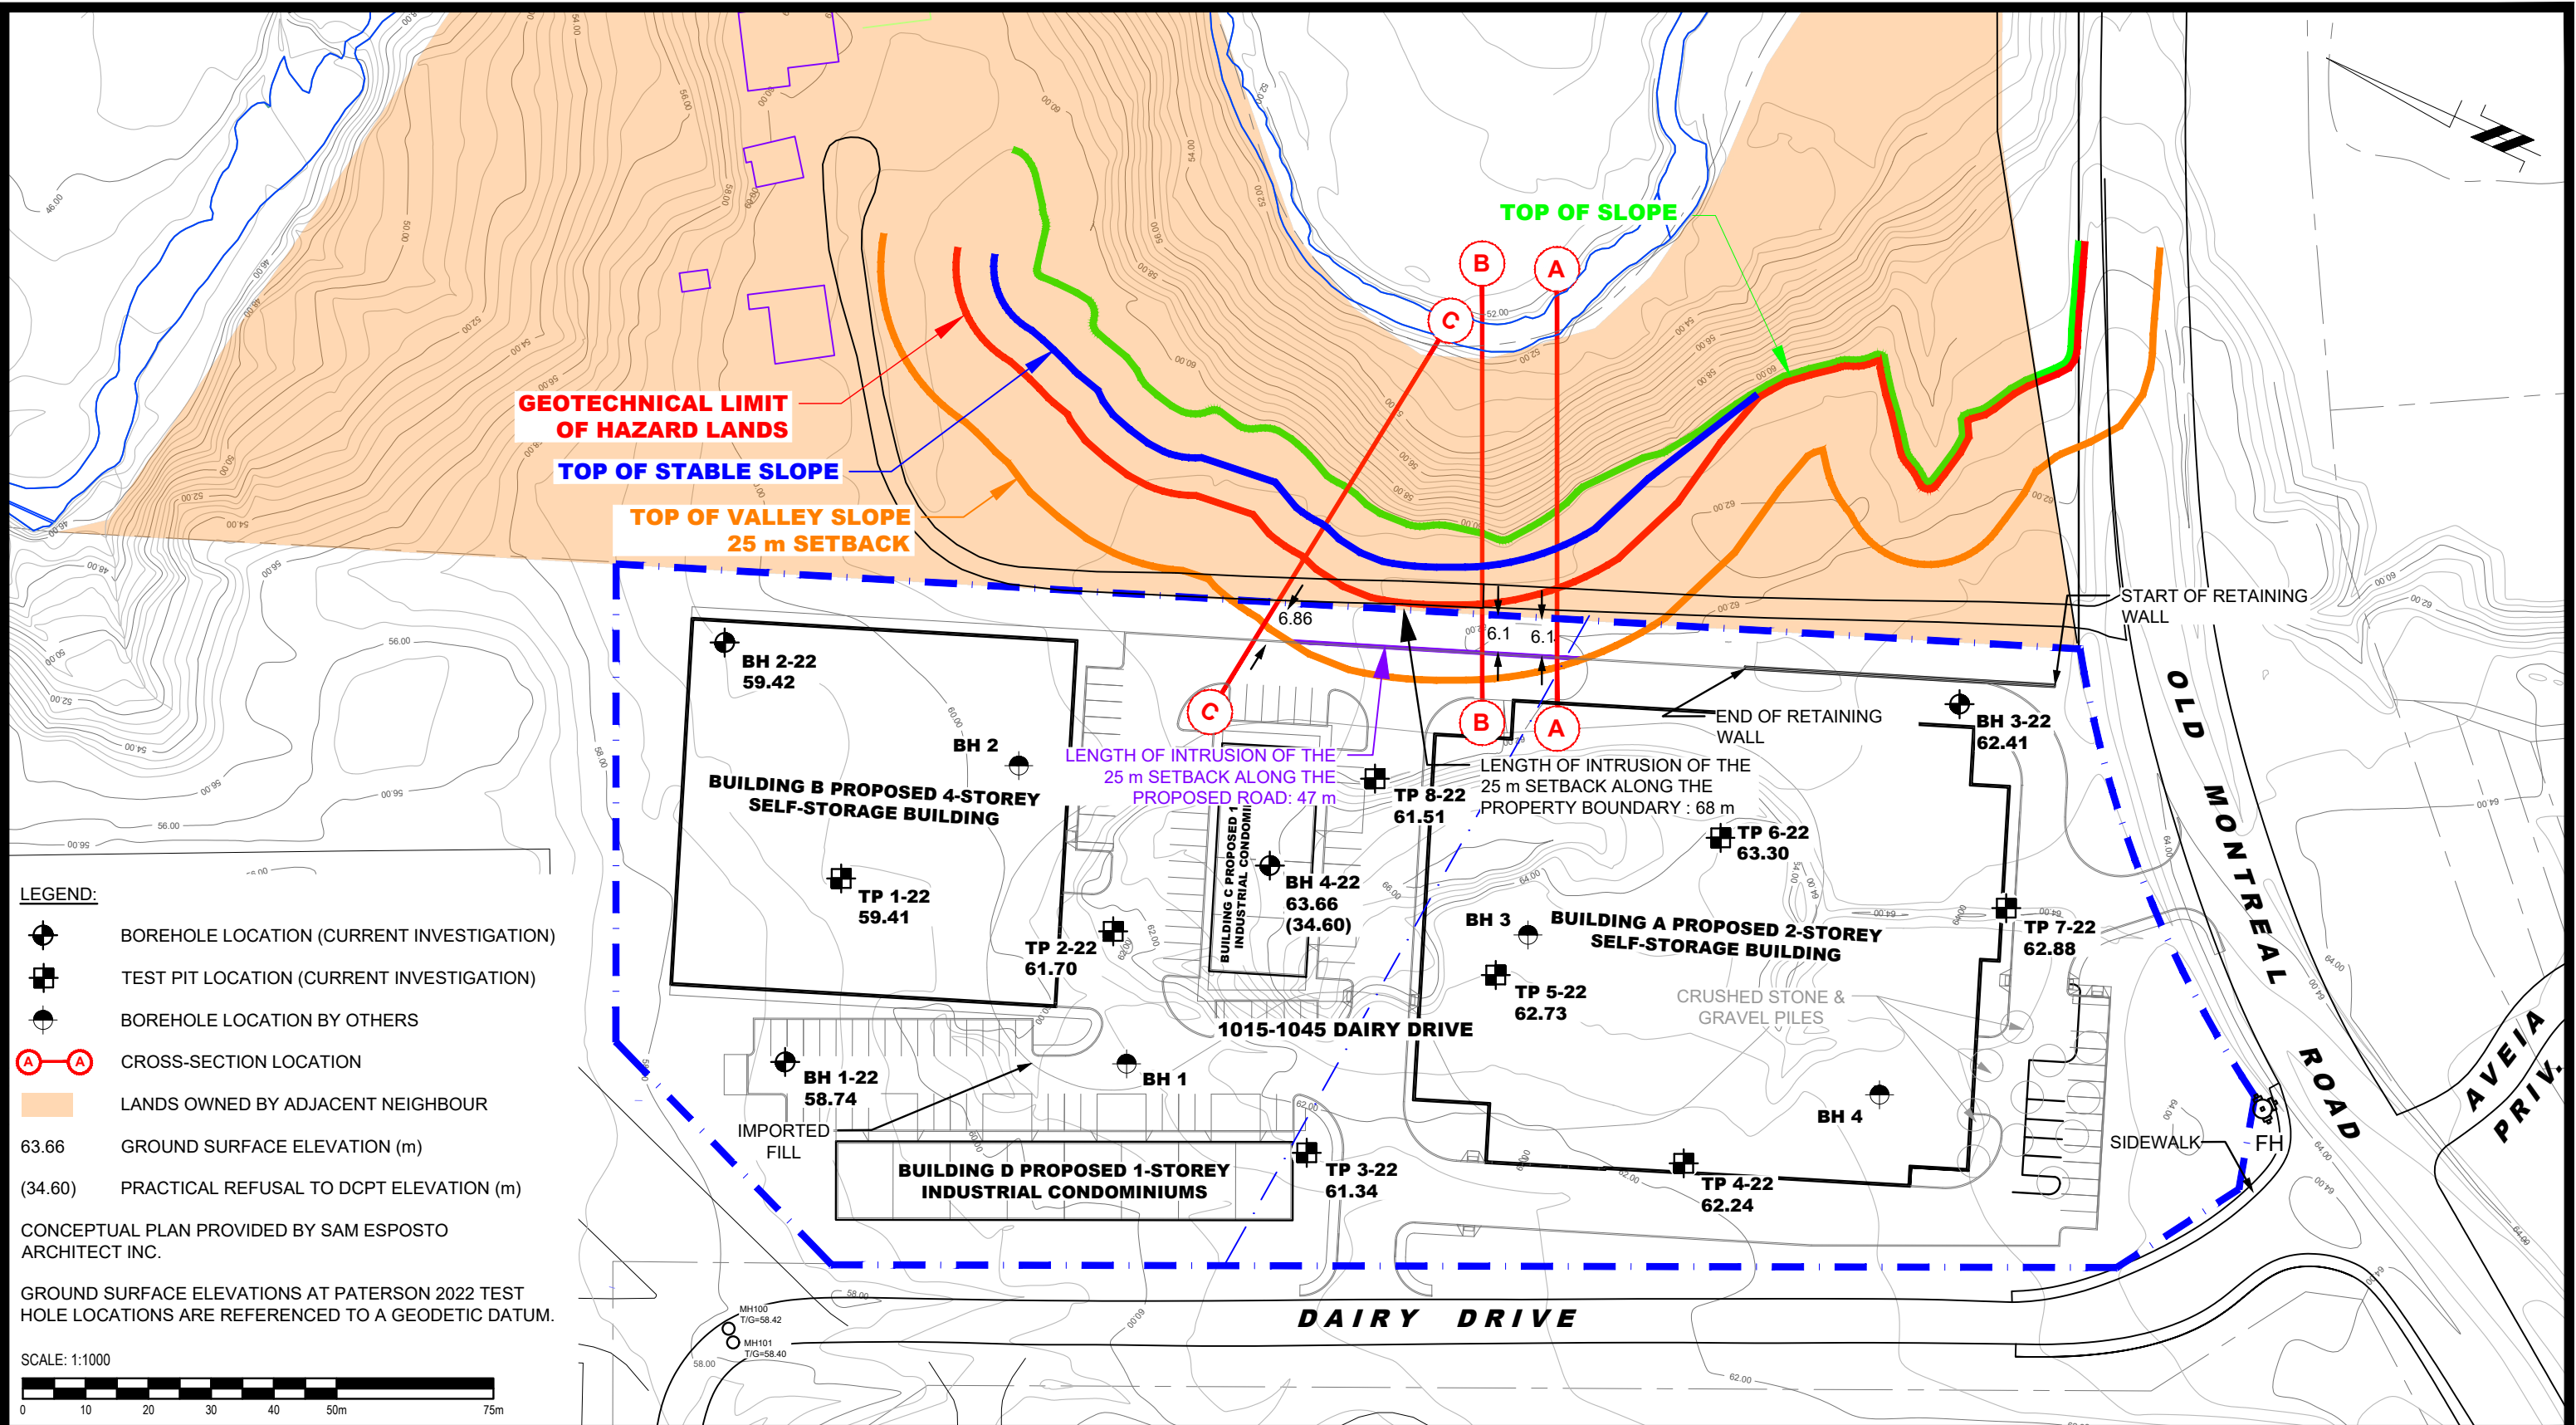
<div><div><div></div><div></div></div><div><div>PATERSON GROUP</div><div>9 AURIGA DRIVE OTTAWA, ON K2E 7T9 TEL: (613) 226-7381</div></div></div>					TSL-DAIRY INC.  PROPOSED SELF STORAGE FACILITY 1015 - 1045 DAIRY DRIVE  OTTAWA, ONTARIO  Title: SLOPE SETBACK PLAN	Scale: 1:1000	Date: 12/2023
						Drawn by: ZS	Report No.: PG6498-1
						Checked by: FA	Dwg. No.: PG6498-3
	1	UPDATED TO NEW CONCEPTUAL PLAN	06/06/2024	SD		Approved by: SD	Revision No.: 1
	NO.	REVISIONS	DATE	INITIAL
