# **Phase I Environmental Site Assessment**

240 Bank Street  
Ottawa, Ontario

**Report: PE6874-1**

**Date: February 4, 2025**

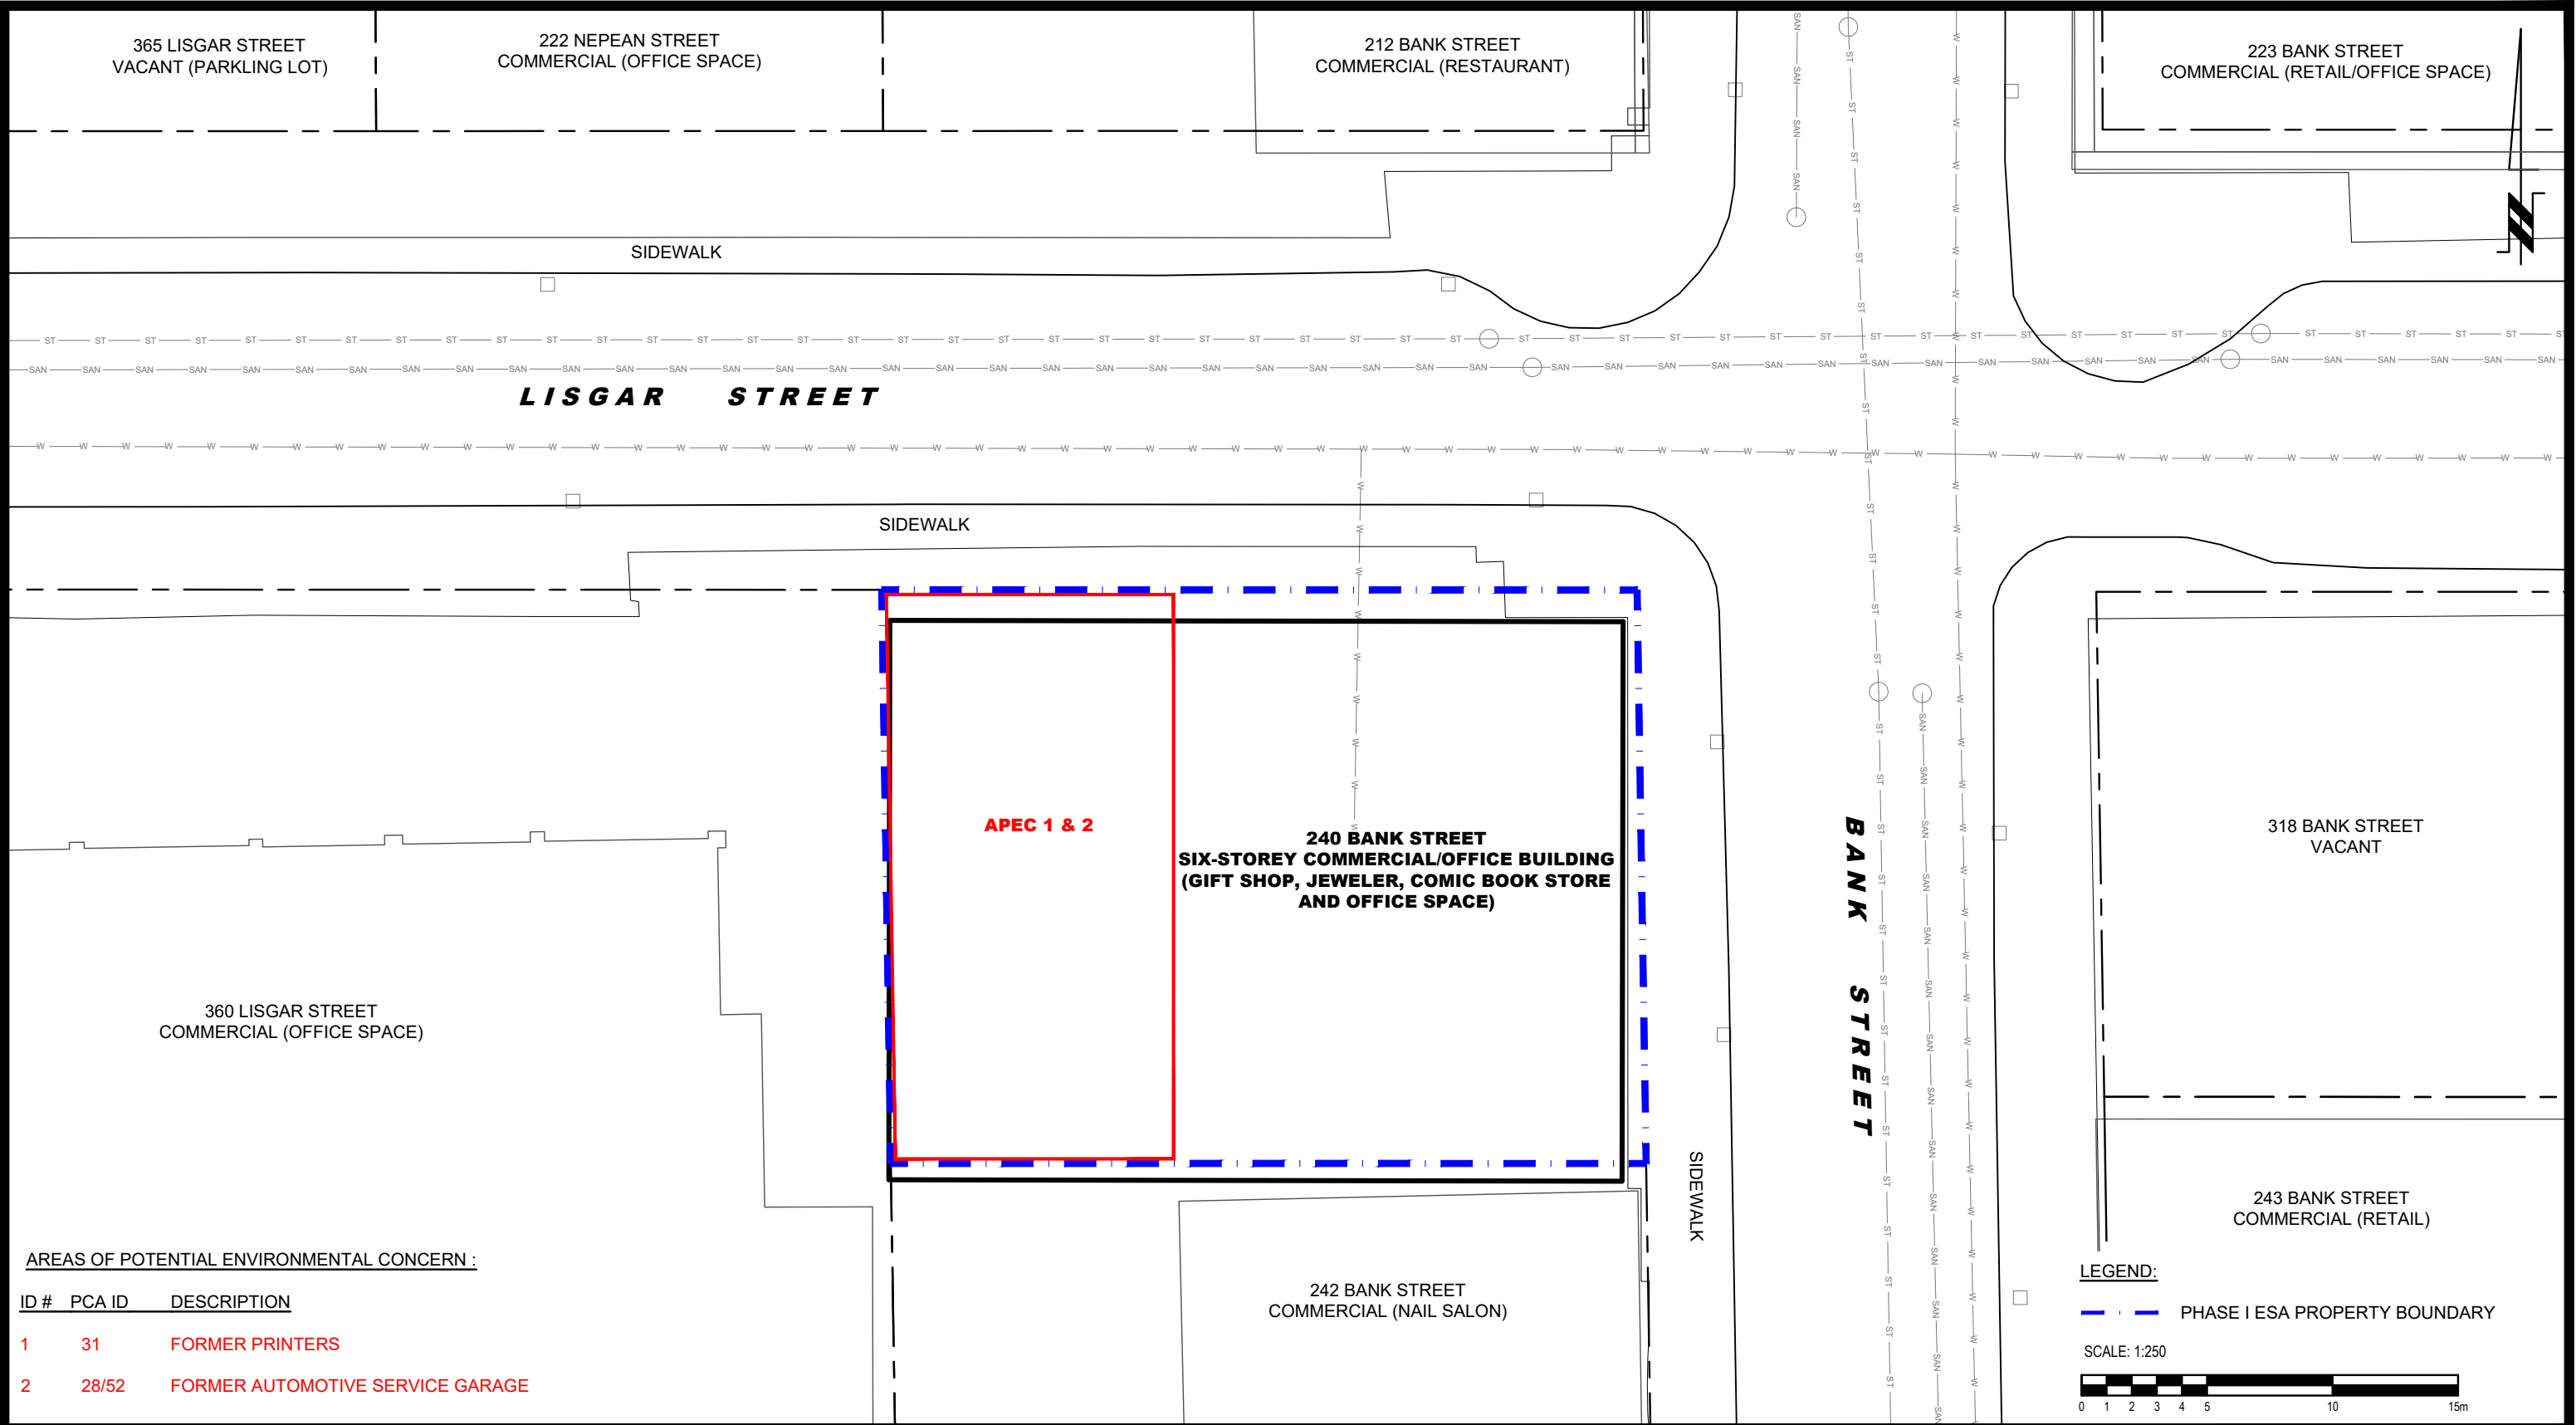
**DRAWING PE6874-1 – SITE PLAN**

AREAS OF POTENTIAL ENVIRONMENTAL CONCERN :

| ID # | PCA ID | DESCRIPTION |
|---|---|---|
| 1 | 31 | FORMER PRINTERS |
| 2 | 28/52 | FORMER AUTOMOTIVE SERVICE GARAGE |

- ☐ PCA 31 – Ink Manufacturing, Processing and Bulk Storage – this PCA is associated with the historical off-site printers addressed 346 Lisgar street, adjacent to the west of the Phase I Property (APEC 1)
- ☐ PCA 28/52 – Gasoline and Associated Products in Storage in Fixed Tanks, and Storage, maintenance, fuelling and repair of equipment, vehicles, and material used to maintain transportation systems – this PCA is associated with the historical off-site automotive service garage addressed 346 and 348 Lisgar Street, adjacent to the west of the Phase I Property (APEC 2)

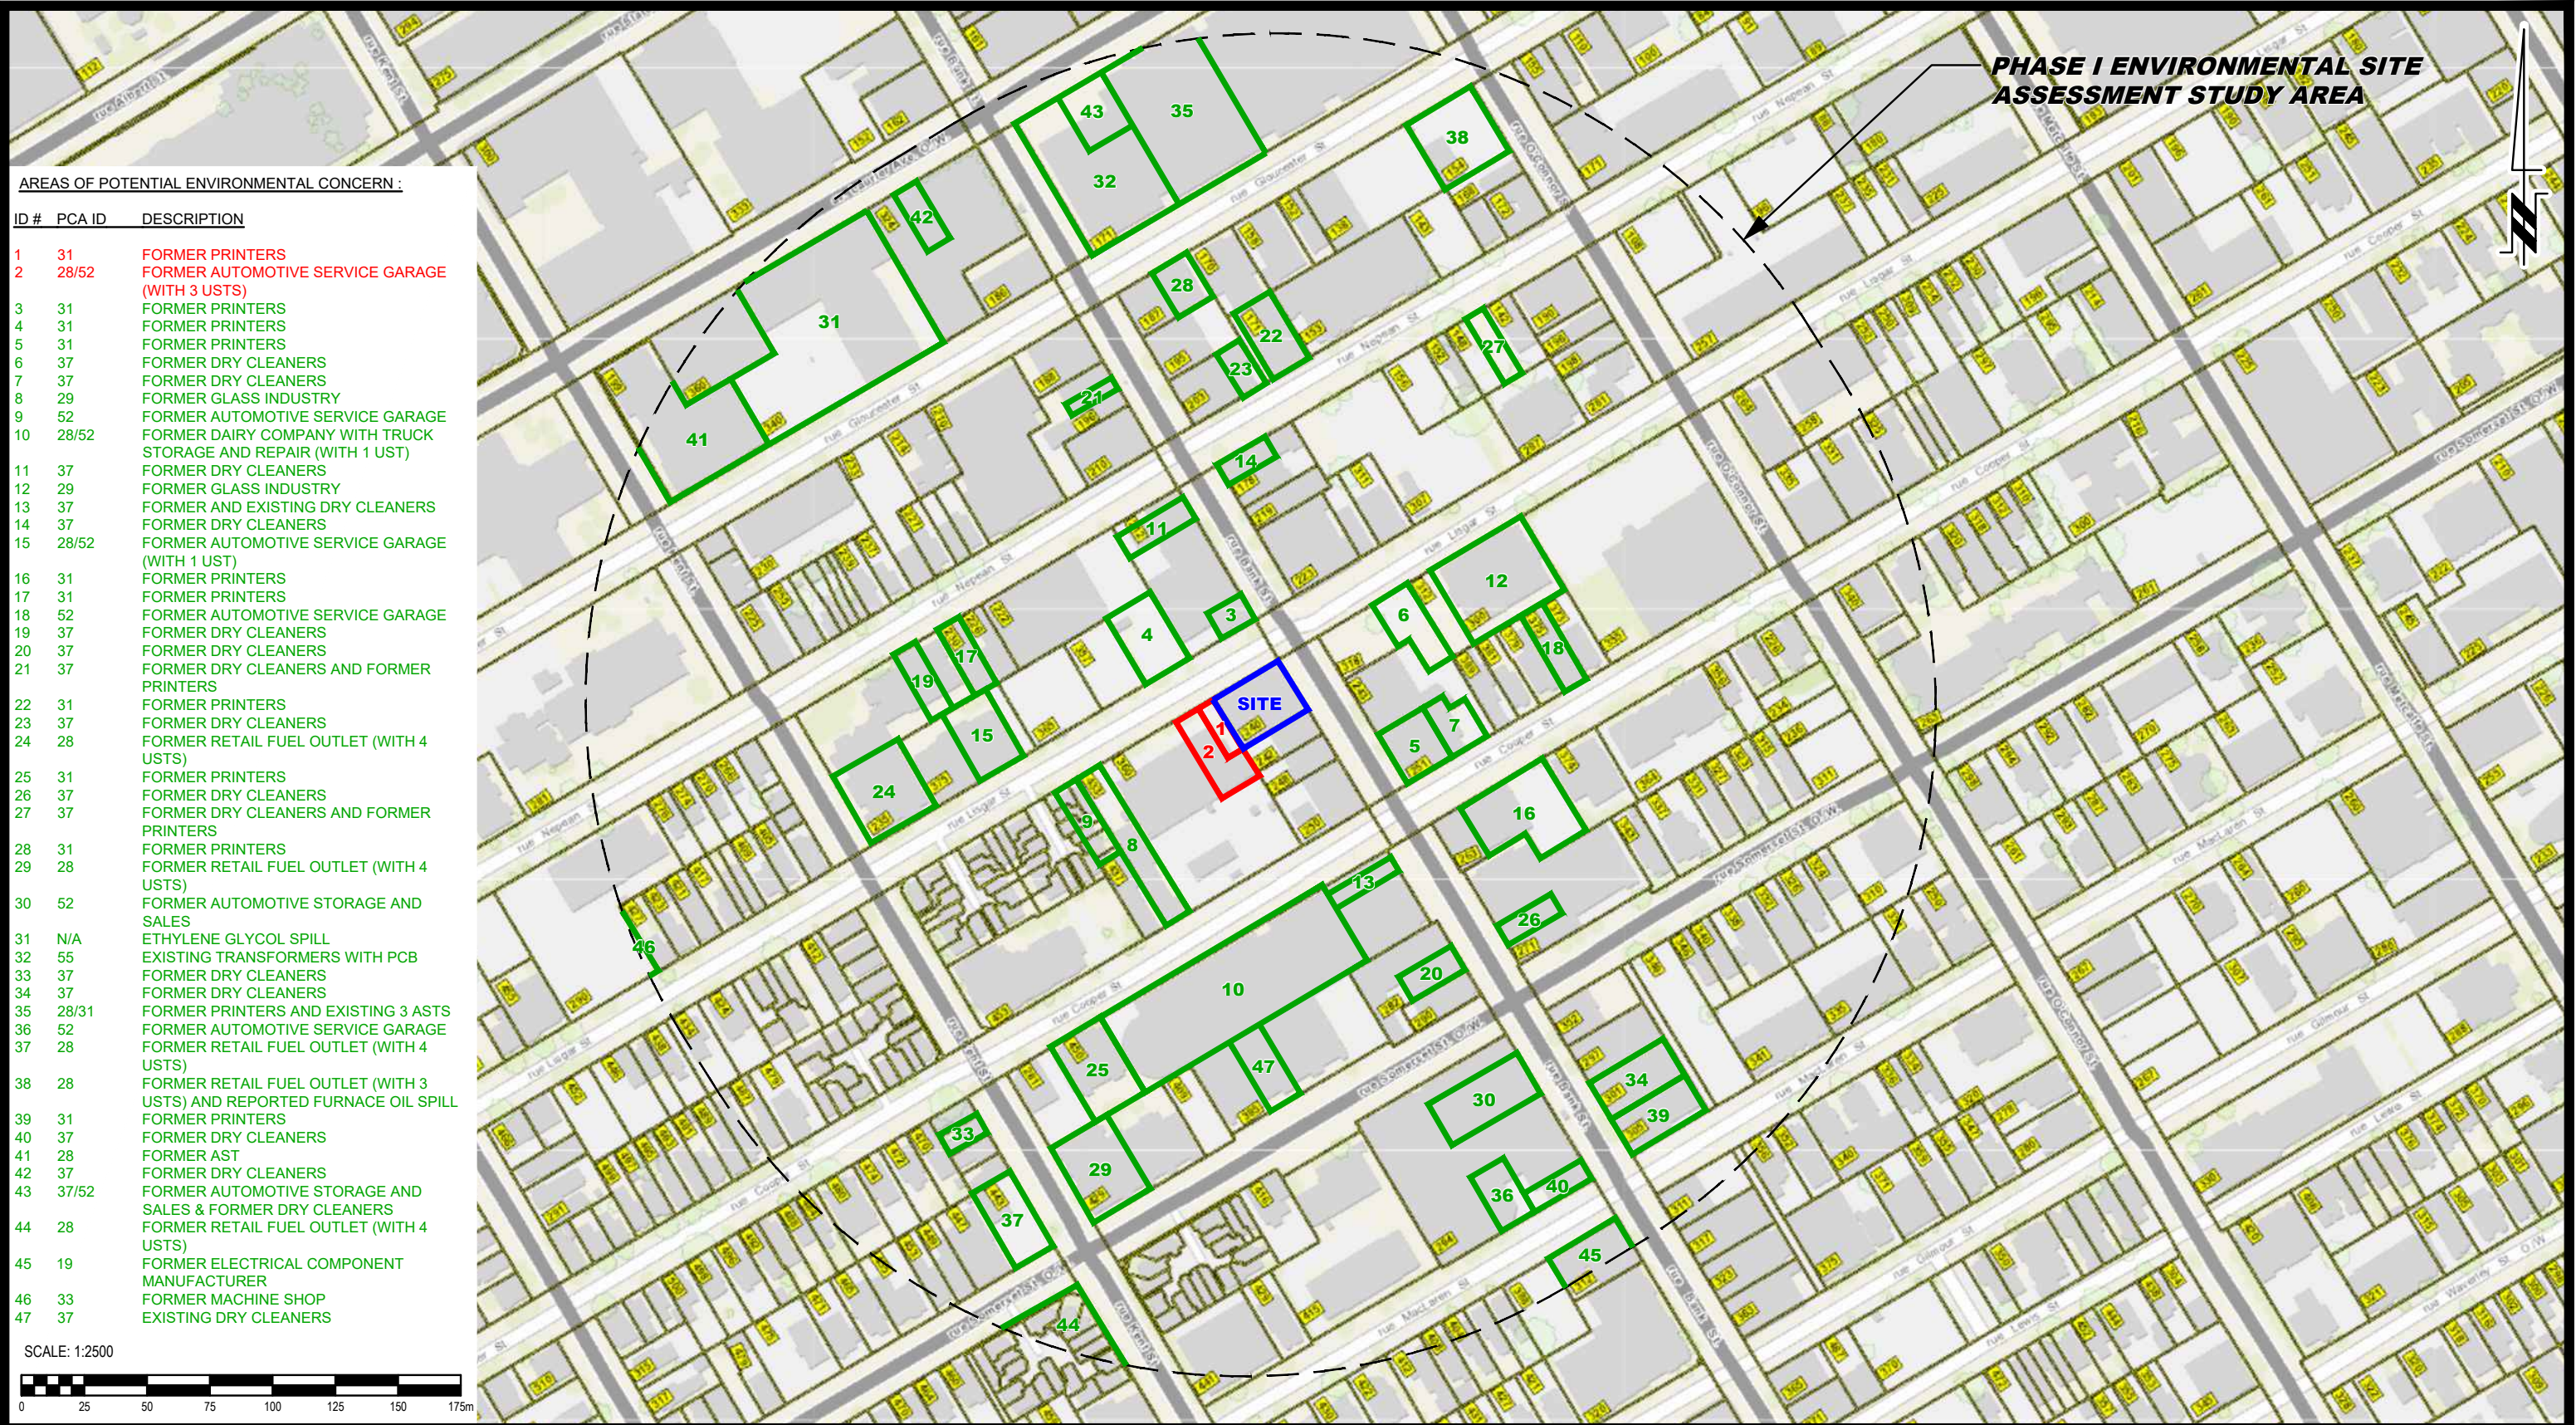
**DRAWING PE6874-2 – SURROUNDING LAND USE PLAN**

AREAS OF POTENTIAL ENVIRONMENTAL CONCERN :

| ID # | PCA ID | DESCRIPTION |
|---|---|---|
| 10 | 28/52 | FORMER DAIRY COMPANY WITH TRUCK STORAGE AND REPAIR (WITH 1 UST) |

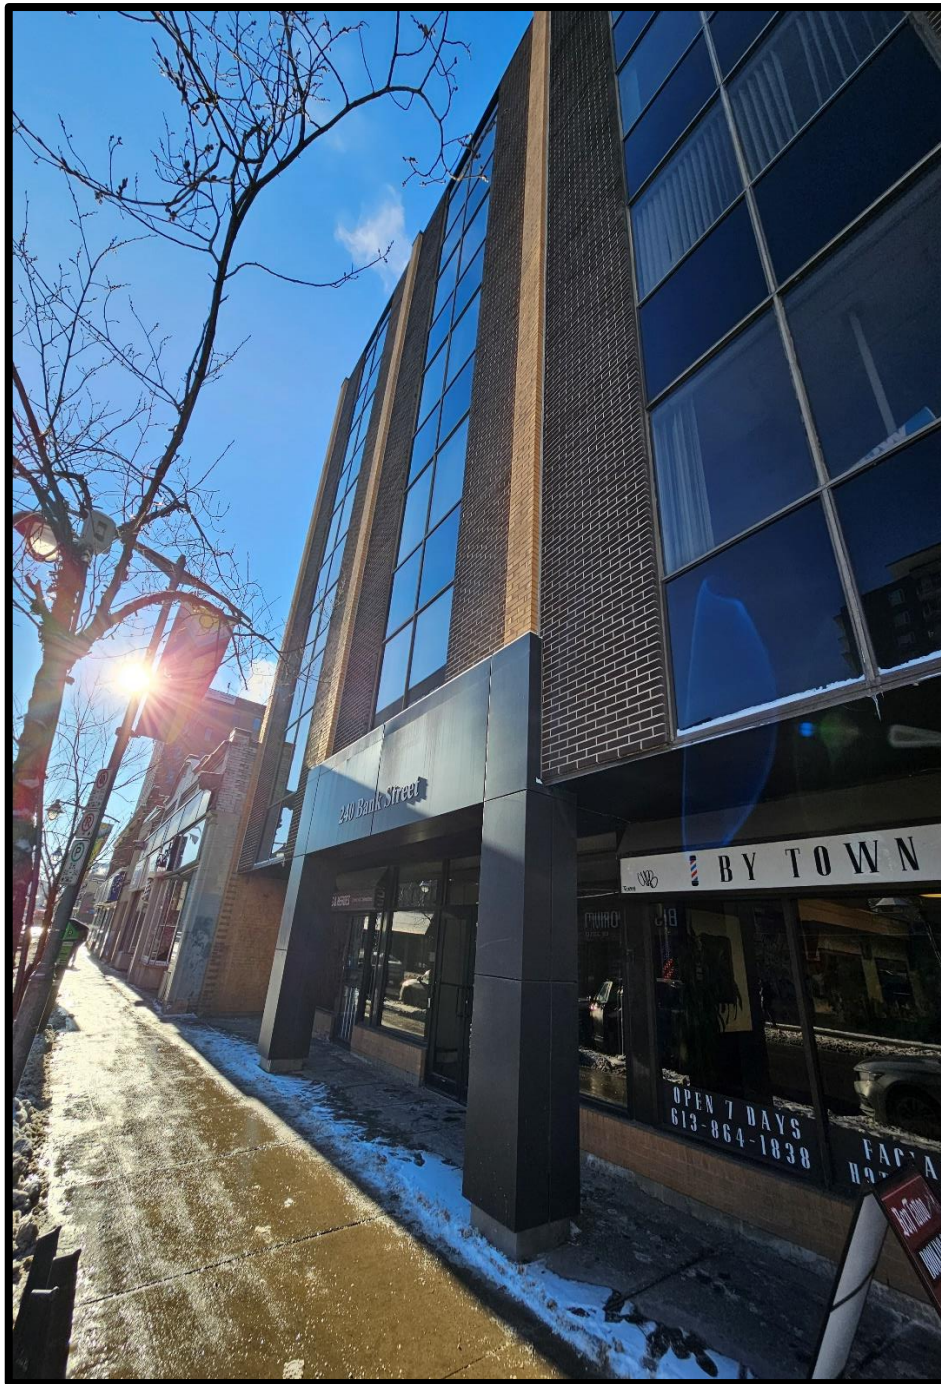
Photograph 1: View of the Phase I Property from Bank Street, facing south.

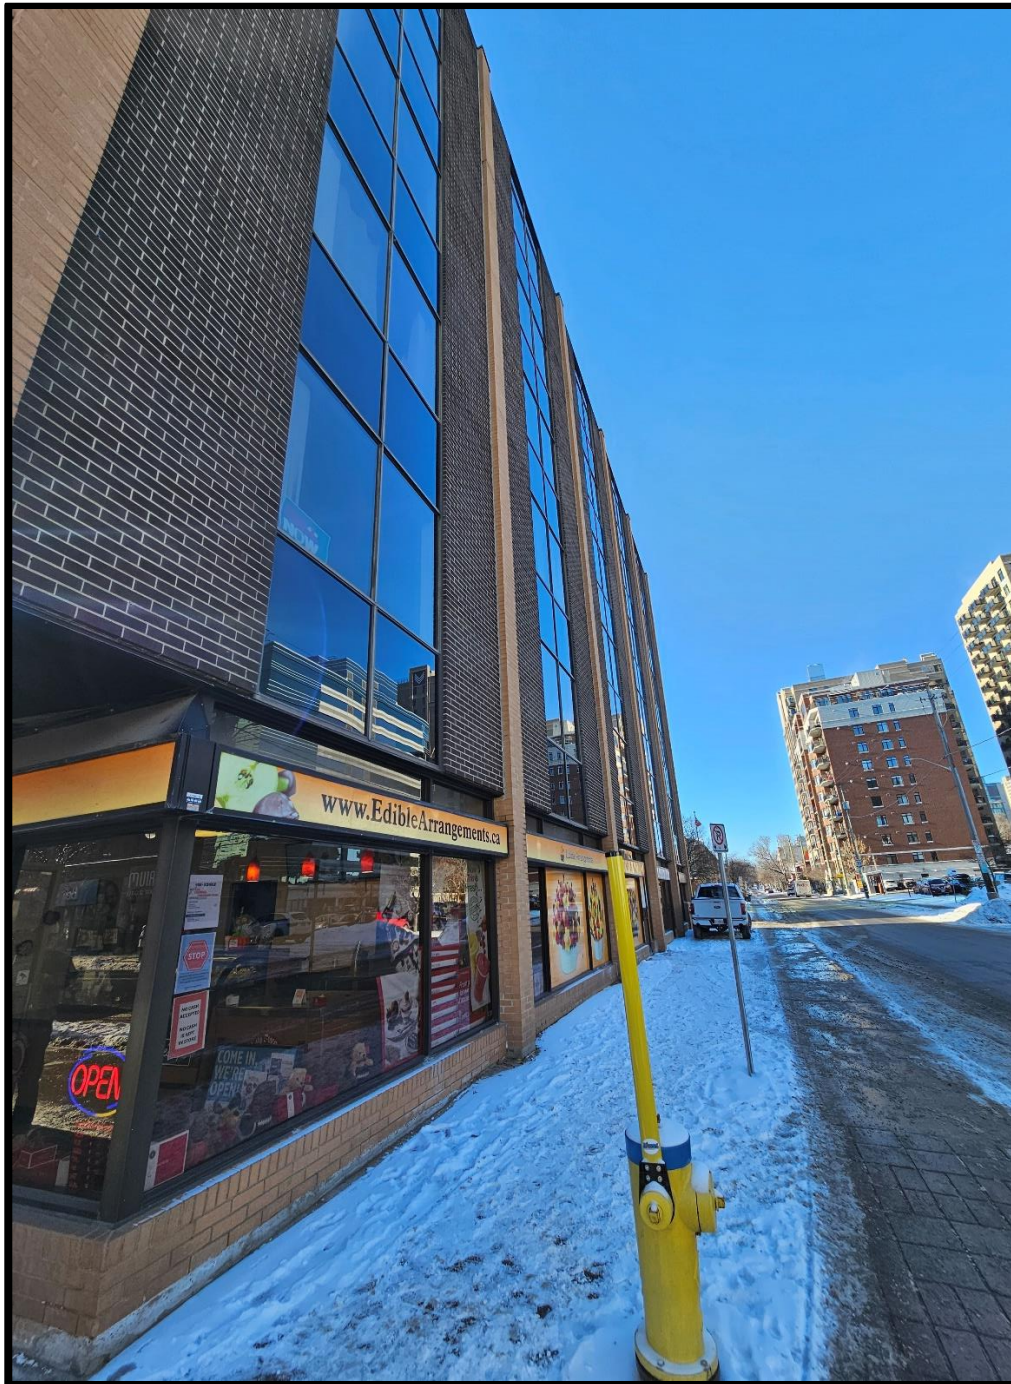
Photograph 2: View of the Phase I Property from Lisgar Street, facing west.
