Geotechnical Investigation

Proposed Commercial Development

301 Somme Street
Ottawa, Ontario

Report PG7567 -1 dated August 14, 2025

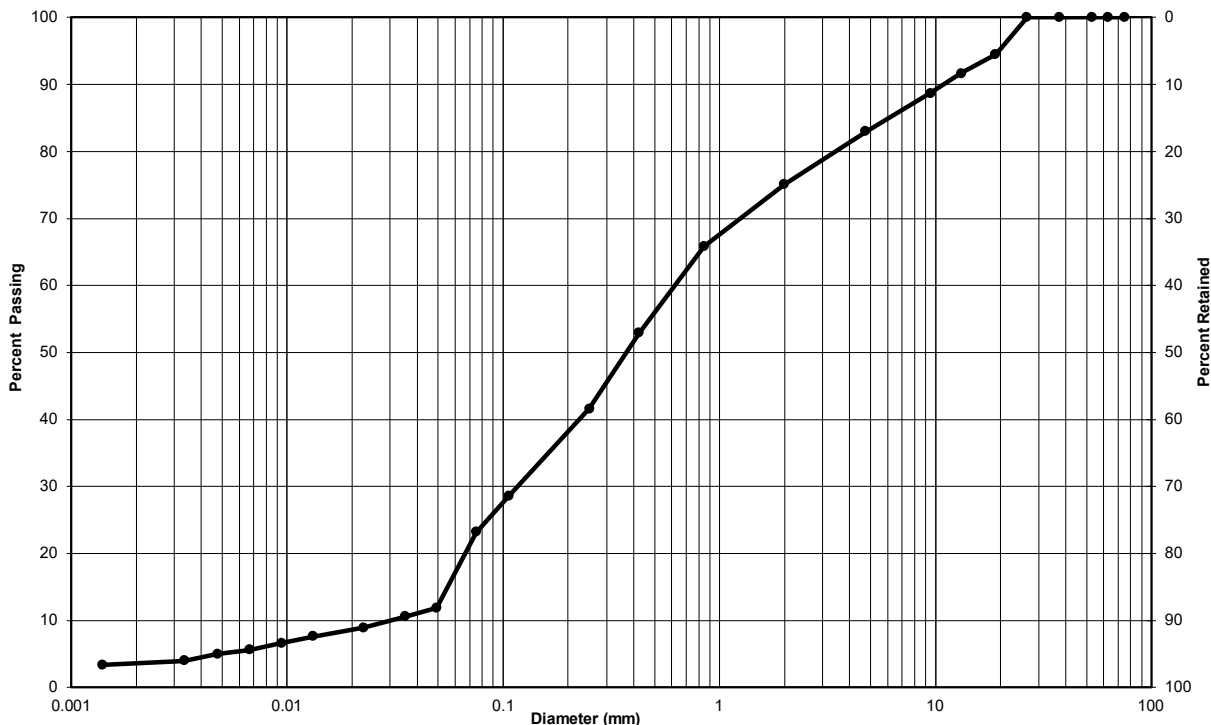
Borehole no.: BH1-21 **Sample no.:** SS2B

Soil Description	Gravel (%)	Sand (%)	Clay & Silt (%)
Silty sand with gravel (SM)	17	60	23
Silt-size particles (%):	19		
Clay-size particles (%) (<0.002mm):	4

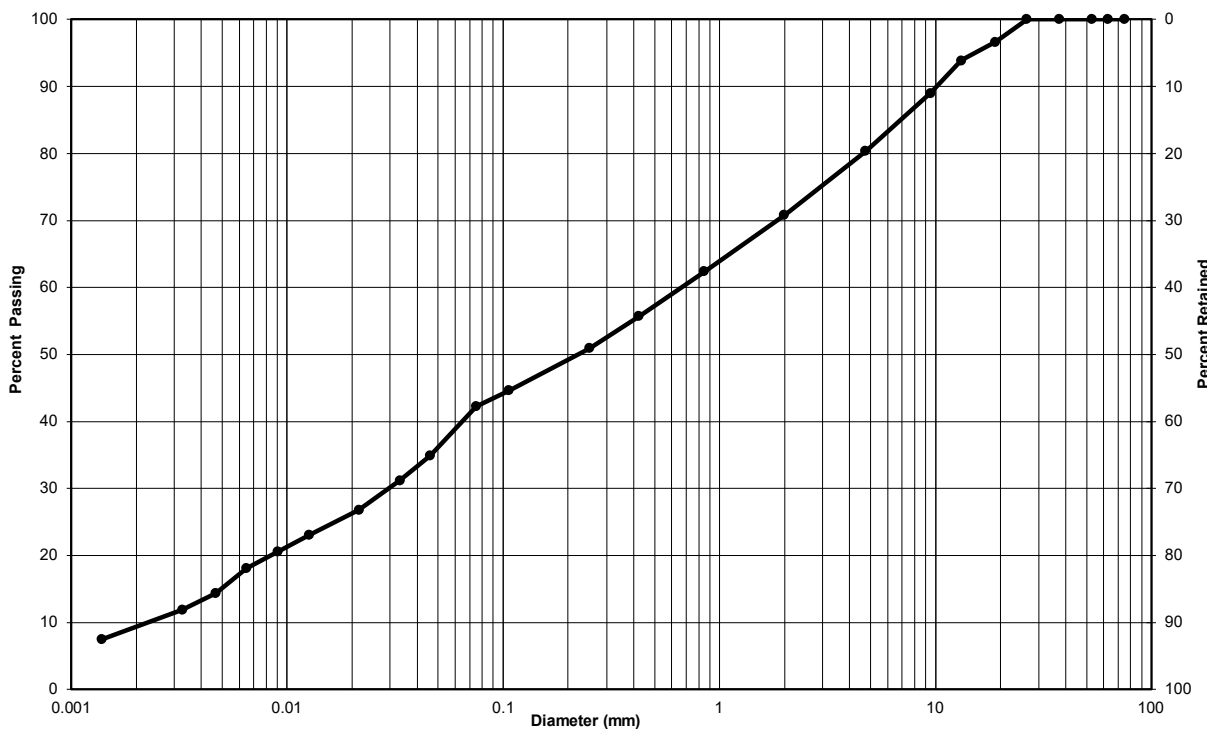
Borehole no.: BH2-21 **Sample no.:** SS12
Depth: 8.4 to 9.0m **Enclosure:** -

Soil Description	Gravel (%)	Sand (%)	Clay & Silt (%)
Sandy lean clay with gravel (CL)	20	38	42
Silt-size particles (%):	33		
Clay-size particles (%) (<0.002mm):	9

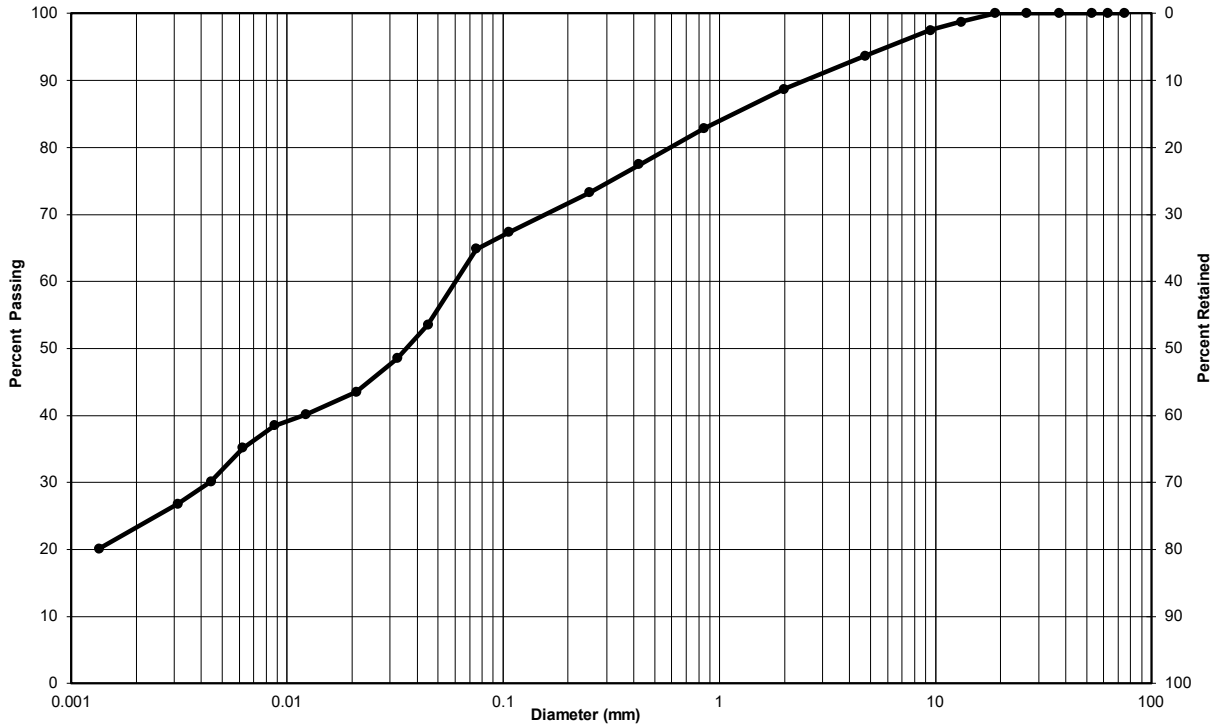
Borehole no.: BH2-21 **Sample no.:** SS18

Soil Description	Gravel (%)	Sand (%)	Clay & Silt (%)
Sandy lean clay (CL)	6	29	65
Silt-size particles (%):	42		
Clay-size particles (%) (<0.002mm):	23

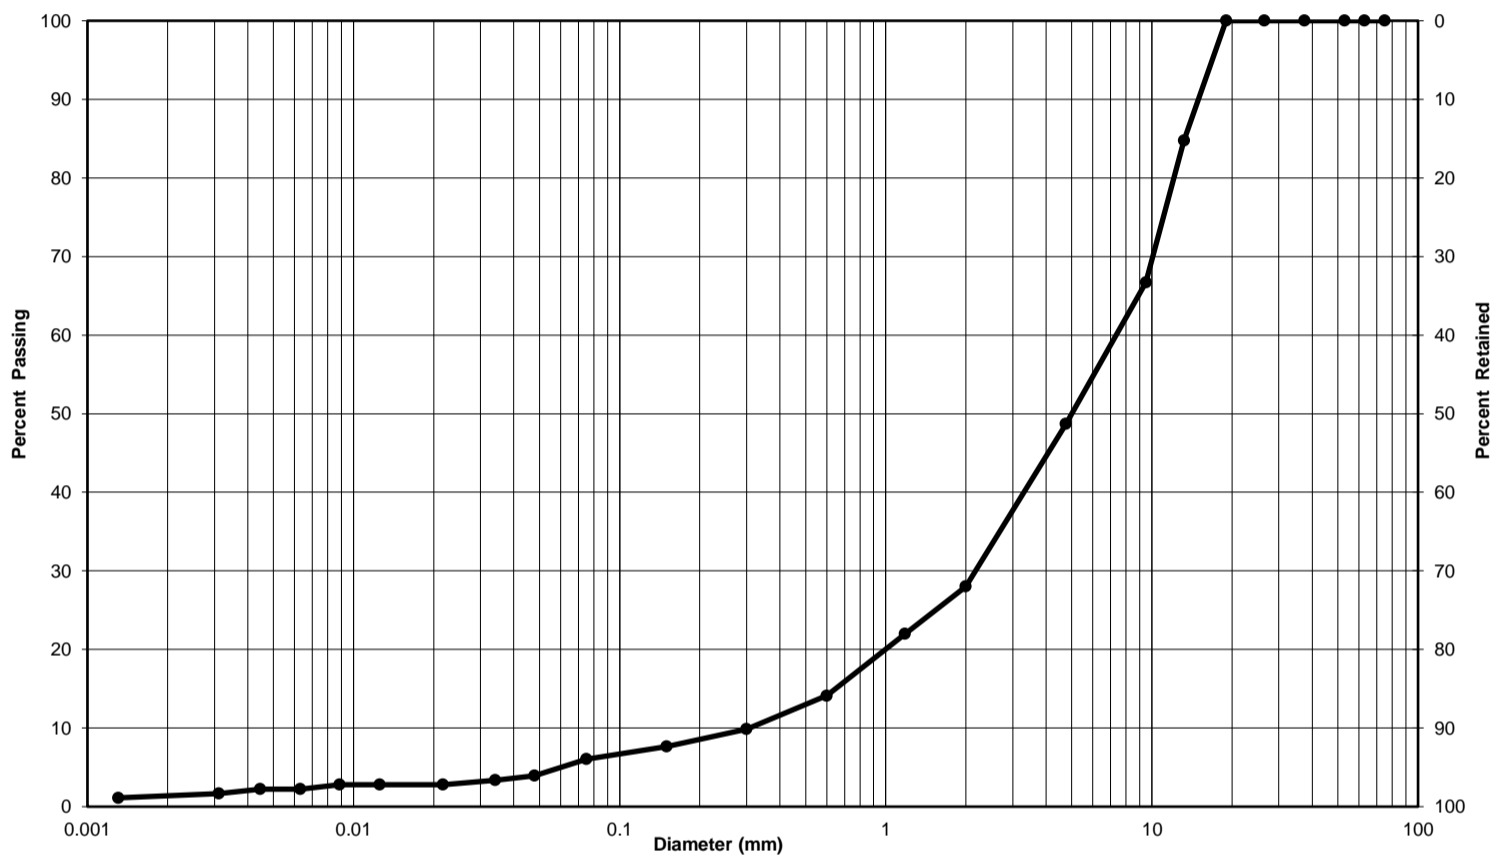
Client: Consolidated Fastrate (Ottawa) Holdings Ltd. **Lab No.:** G-20-13
Project, Site: New Warehouse, Somme Street, Ottawa, ON **Project No.:** 11215612
Borehole No.: 1 **Sample No.:** 3
Depth: 1.5 - 2.1m **Enclosure:** -

Soil Description	Gravel (%)	Sand (%)	Clay & Silt (%)
Gravel and Sand, trace Silt, trace Clay	51	43	6
			1 %

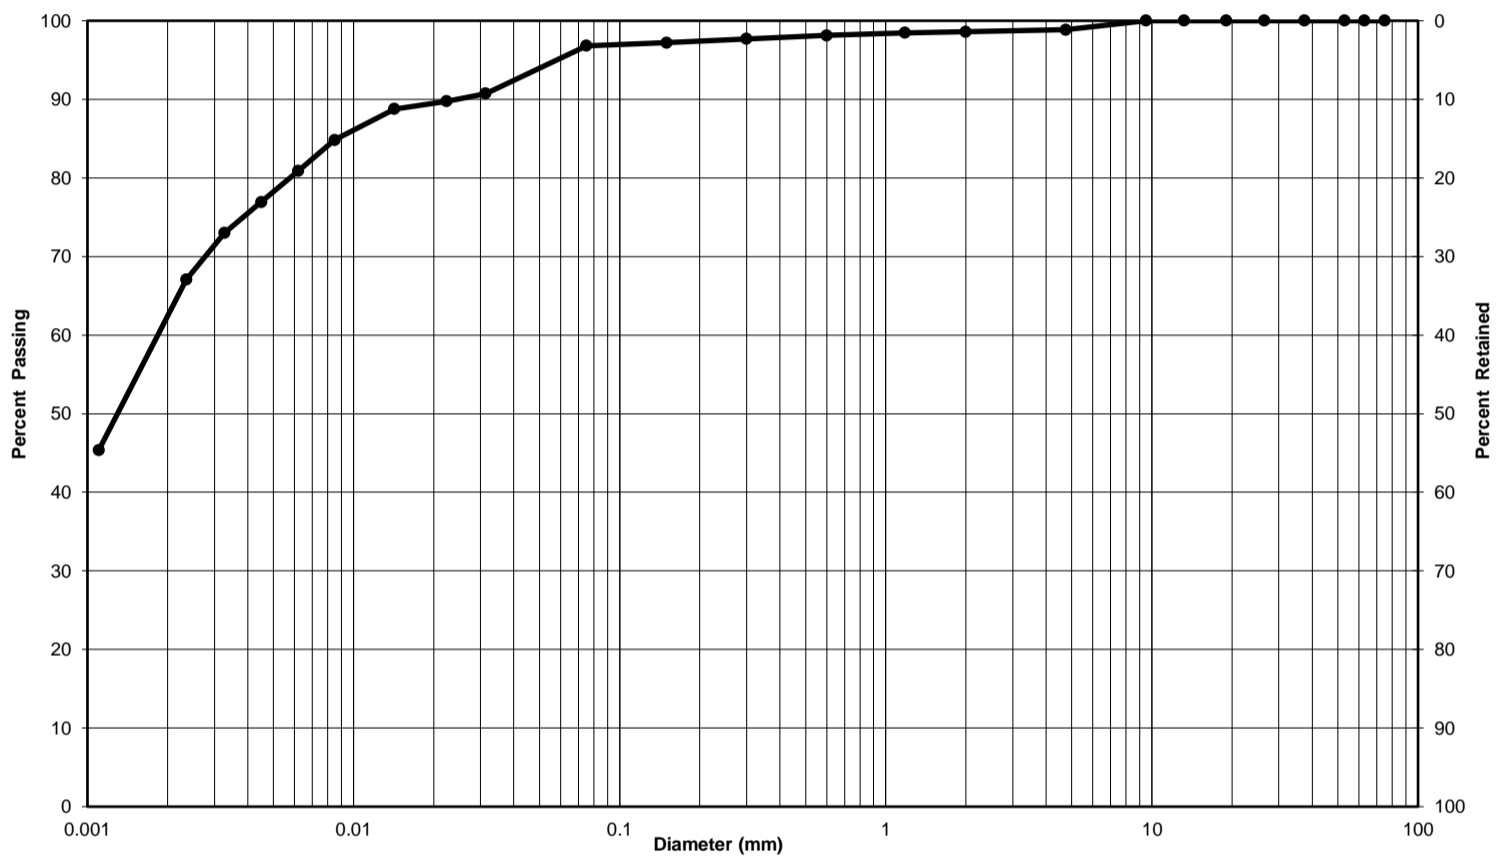
Client:	<u>Consolidated Fastrate (Ottawa) Holdings Ltd.</u>	Lab No.:	<u>G-20-13</u>
Project, Site:	<u>New Warehouse, Somme Street, Ottawa, ON</u>	Project No.:	<u>11215612</u>
Borehole No.:	<u>2</u>	Sample No.:	<u>4</u>
Depth:	<u>2.3 - 3.0m</u>	Enclosure:	<u>-</u>

Soil Description	Gravel (%)	Sand (%)	Clay & Silt (%)
Clay and Silt, trace Sand, trace Gravel	1	2	97
Clay-size particles (<0.002 mm):			61 %

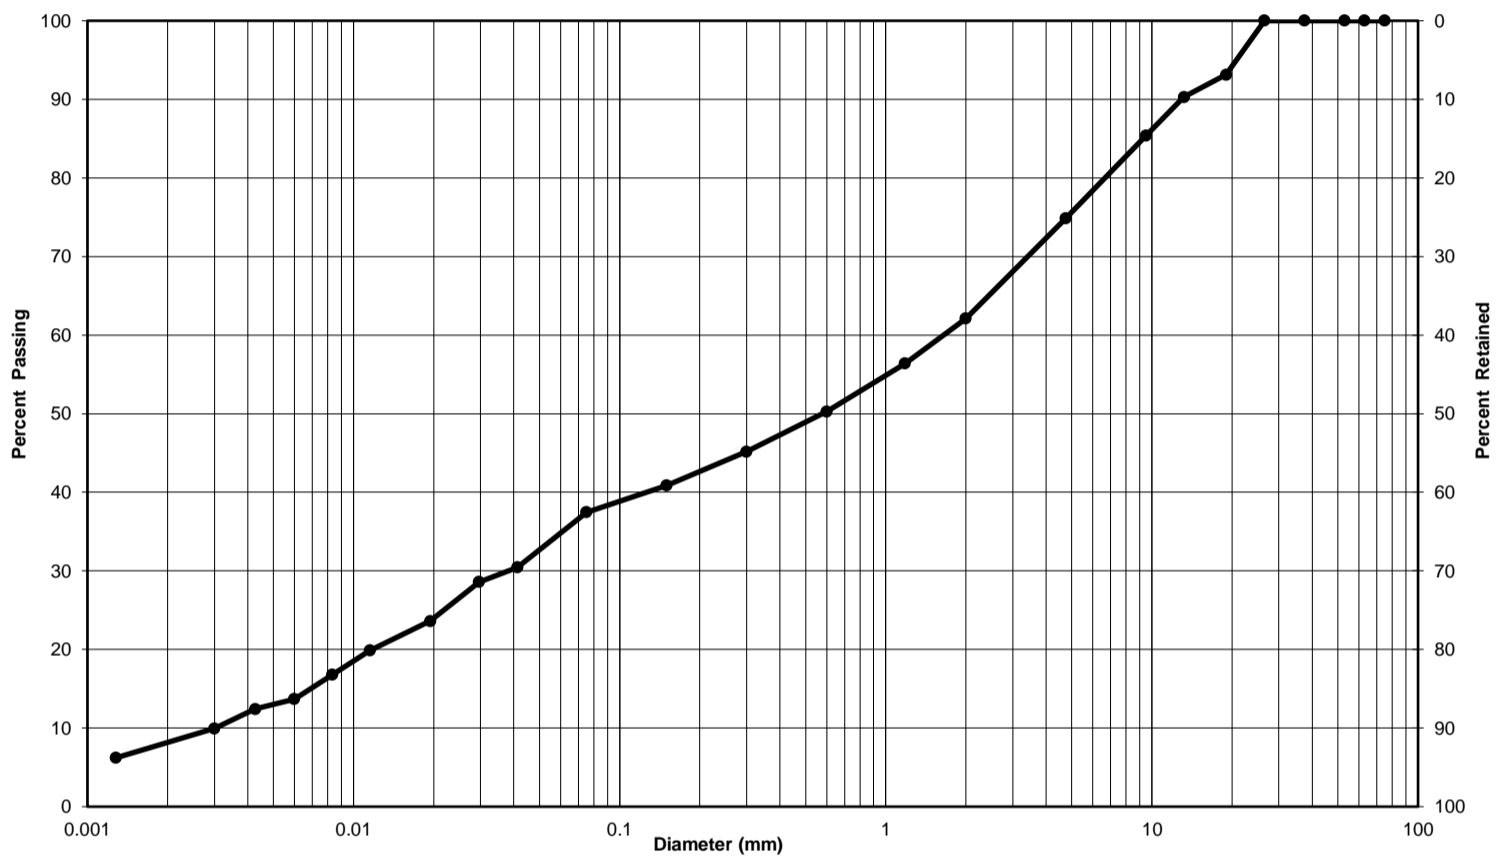
Client:	Consolidated Fastrate (Ottawa) Holdings Ltd.	Lab No.:	G-20-13
Project, Site:	New Warehouse, Somme Street, Ottawa, ON	Project No.:	11215612
Borehole No.:	2	Sample No.:	7
Depth:	4.5 - 6.1m	Enclosure:	-

Soil Description	Gravel (%)	Sand (%)	Clay & Silt (%)
Gravelly, Silty, Sand, trace Clay	25	38	37
Clay-size particles (<0.002 mm):	8 %

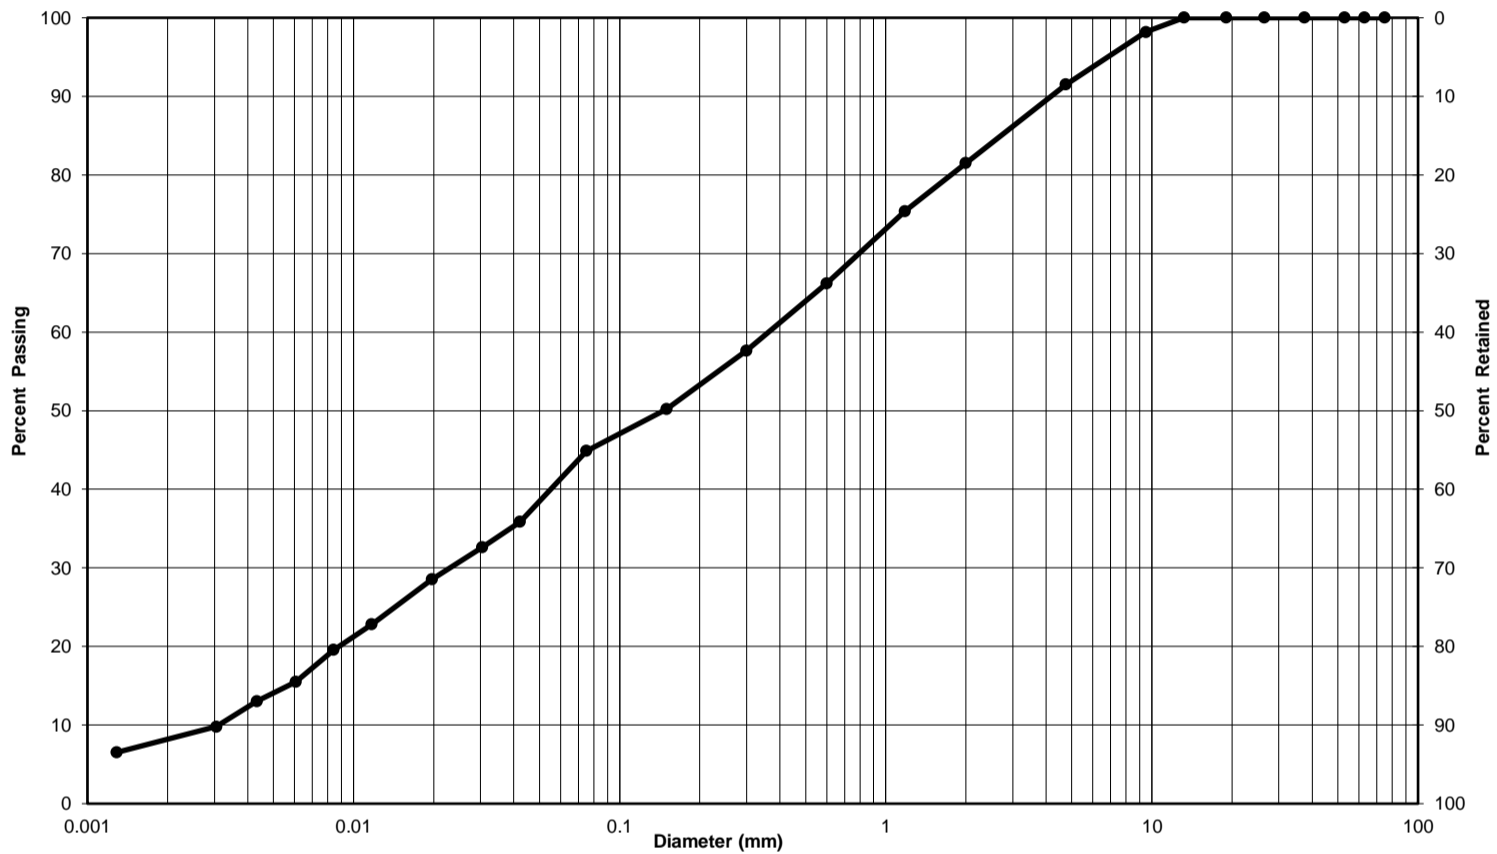
Client:	Consolidated Fastrate (Ottawa) Holdings Ltd.	Lab No.:	G-20-13
Project, Site:	New Warehouse, Somme Street, Ottawa, ON	Project No.:	11215612
Borehole No.:	3	Sample No.:	10
Depth:	6.9 - 7.5m	Enclosure:	-

Soil Description	Gravel (%)	Sand (%)	Clay & Silt (%)
Sand and Silt, trace Gravel, trace Clay	8	47	45
Clay-size particles (<0.002 mm):	8 %

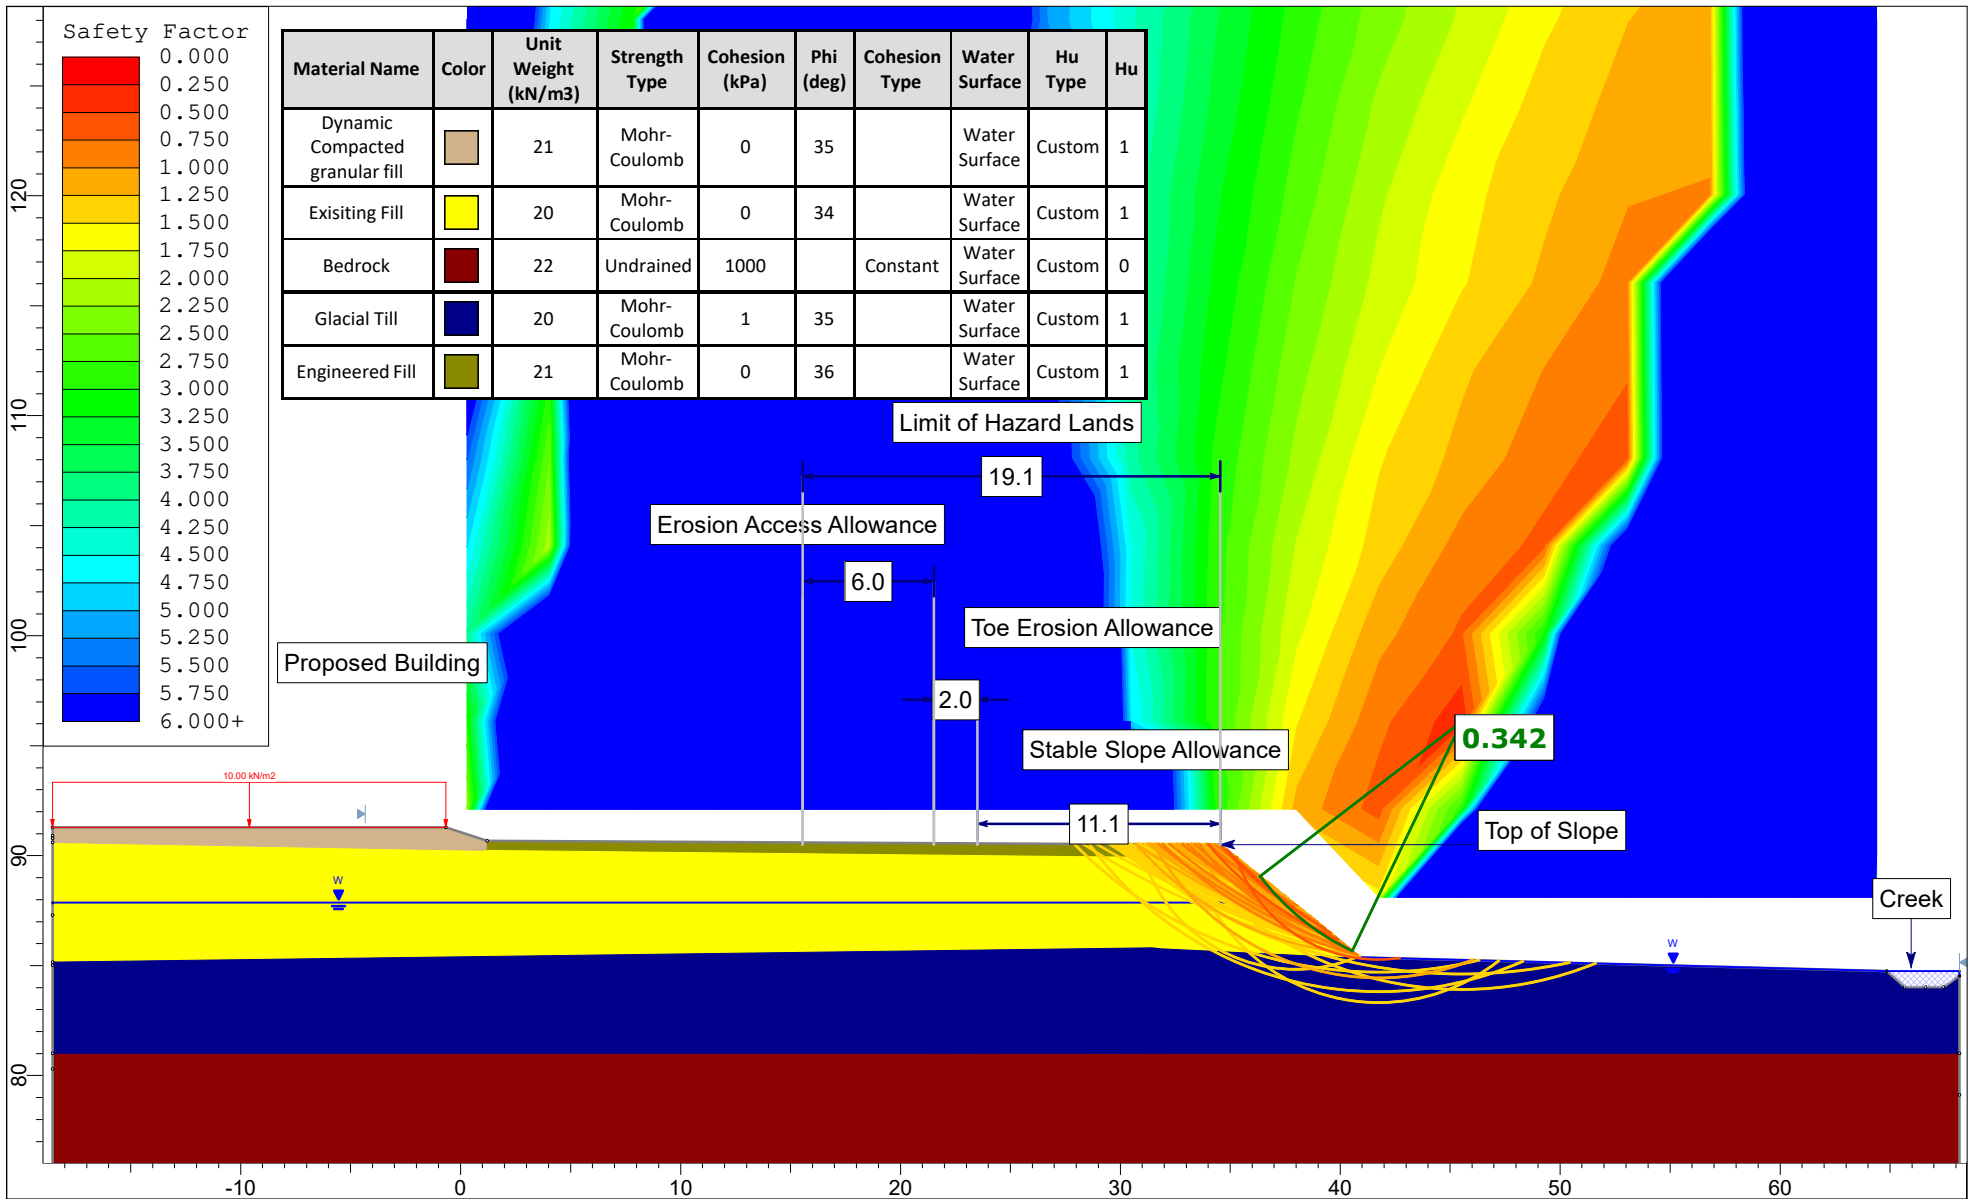
Project		PG7567 - 301 Somme Street	
	Slope Section		A	Scenario
	Drawn By		DR	Company
	Date		2025-06-27	File Name
			Existing Static Condition	
			W.O. Stinson & Son Ltd	
			Figure 2A

An analysis considering seismic loading for proposed conditions was also completed.

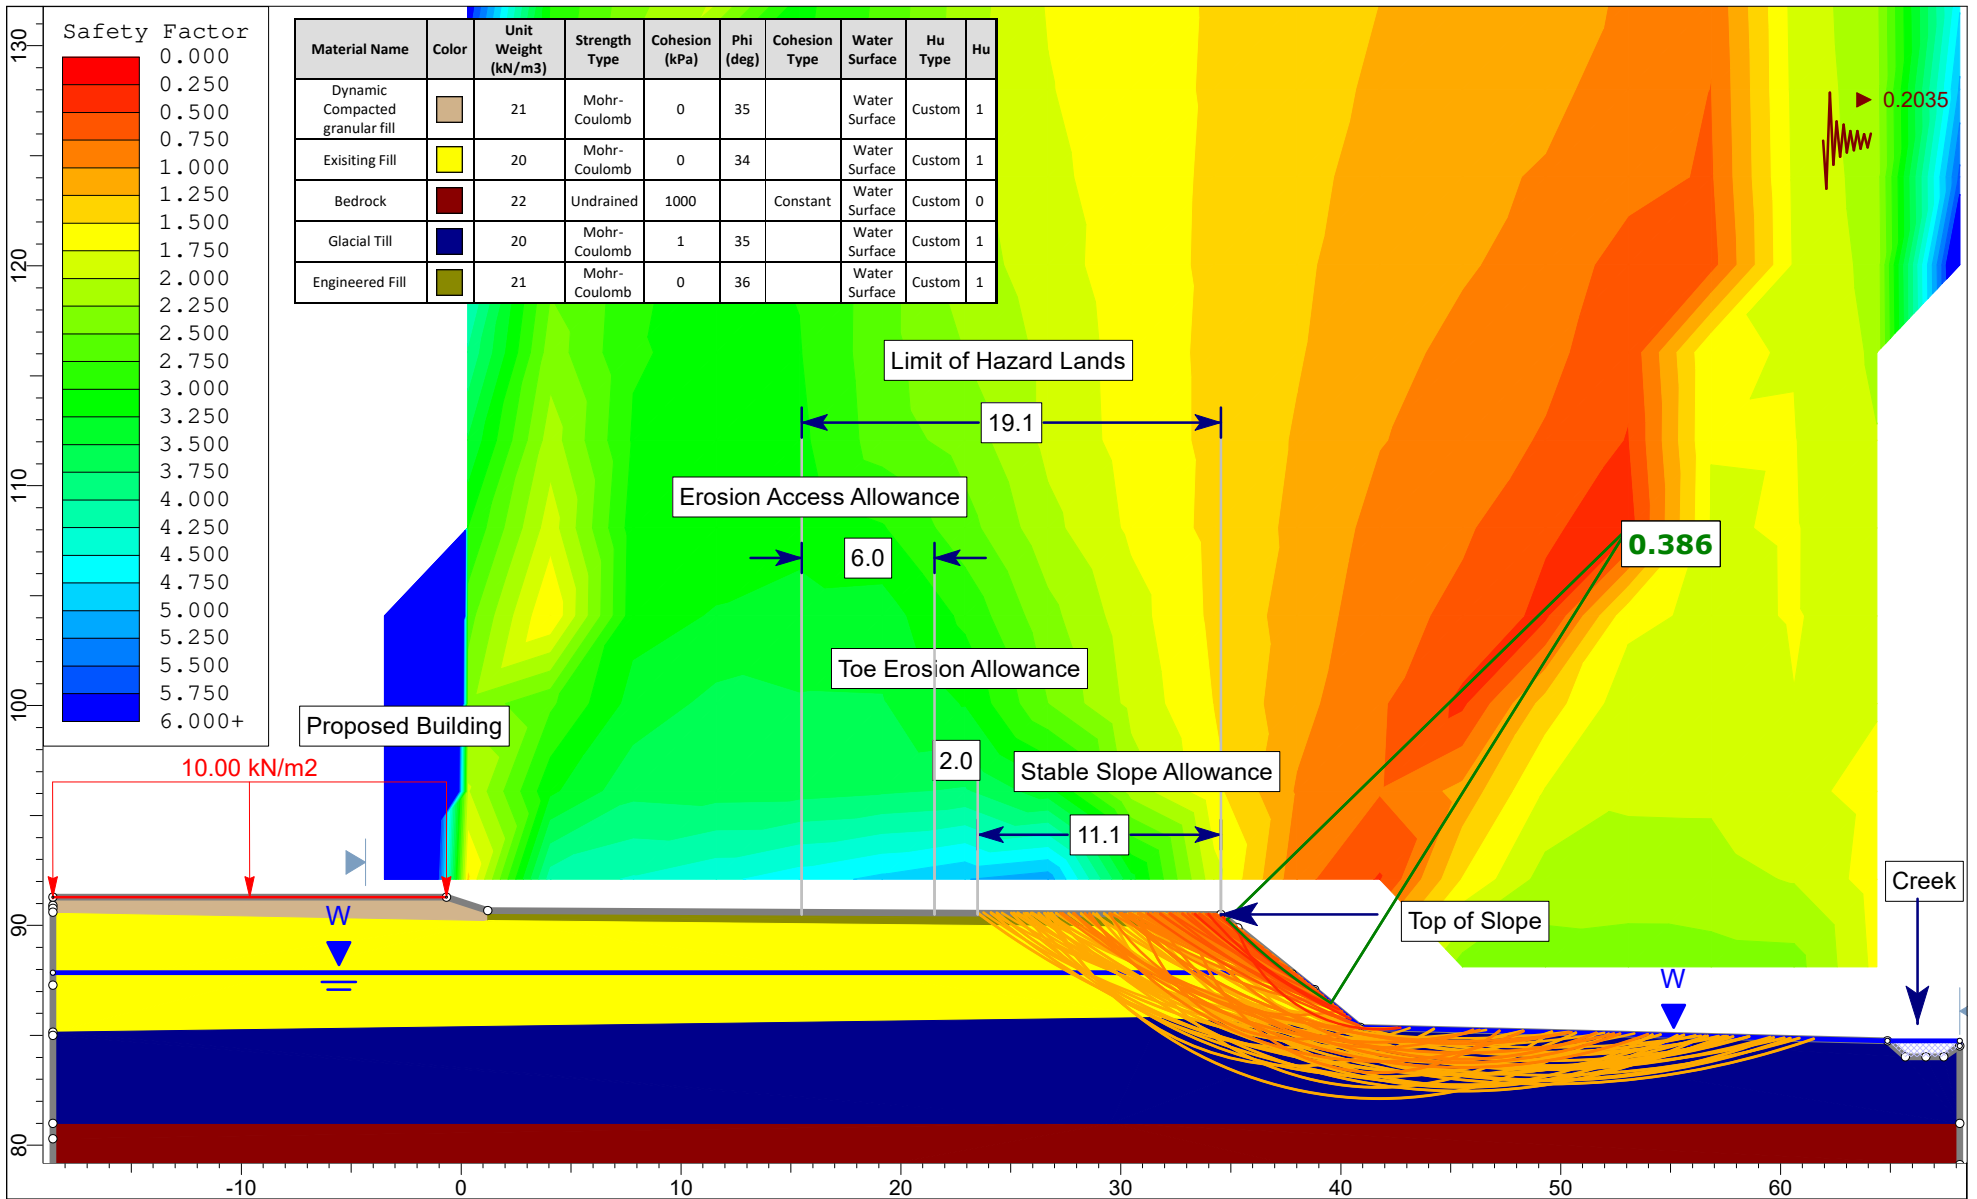
Project		PG7567 - 301 Somme Street		
	Slope Section		A	Scenario	Existing Seismic Condition
	Drawn By		DR	Company	W.O. Stinson & Son Ltd
	Date		2025-06-27	File Name	Figure 2B

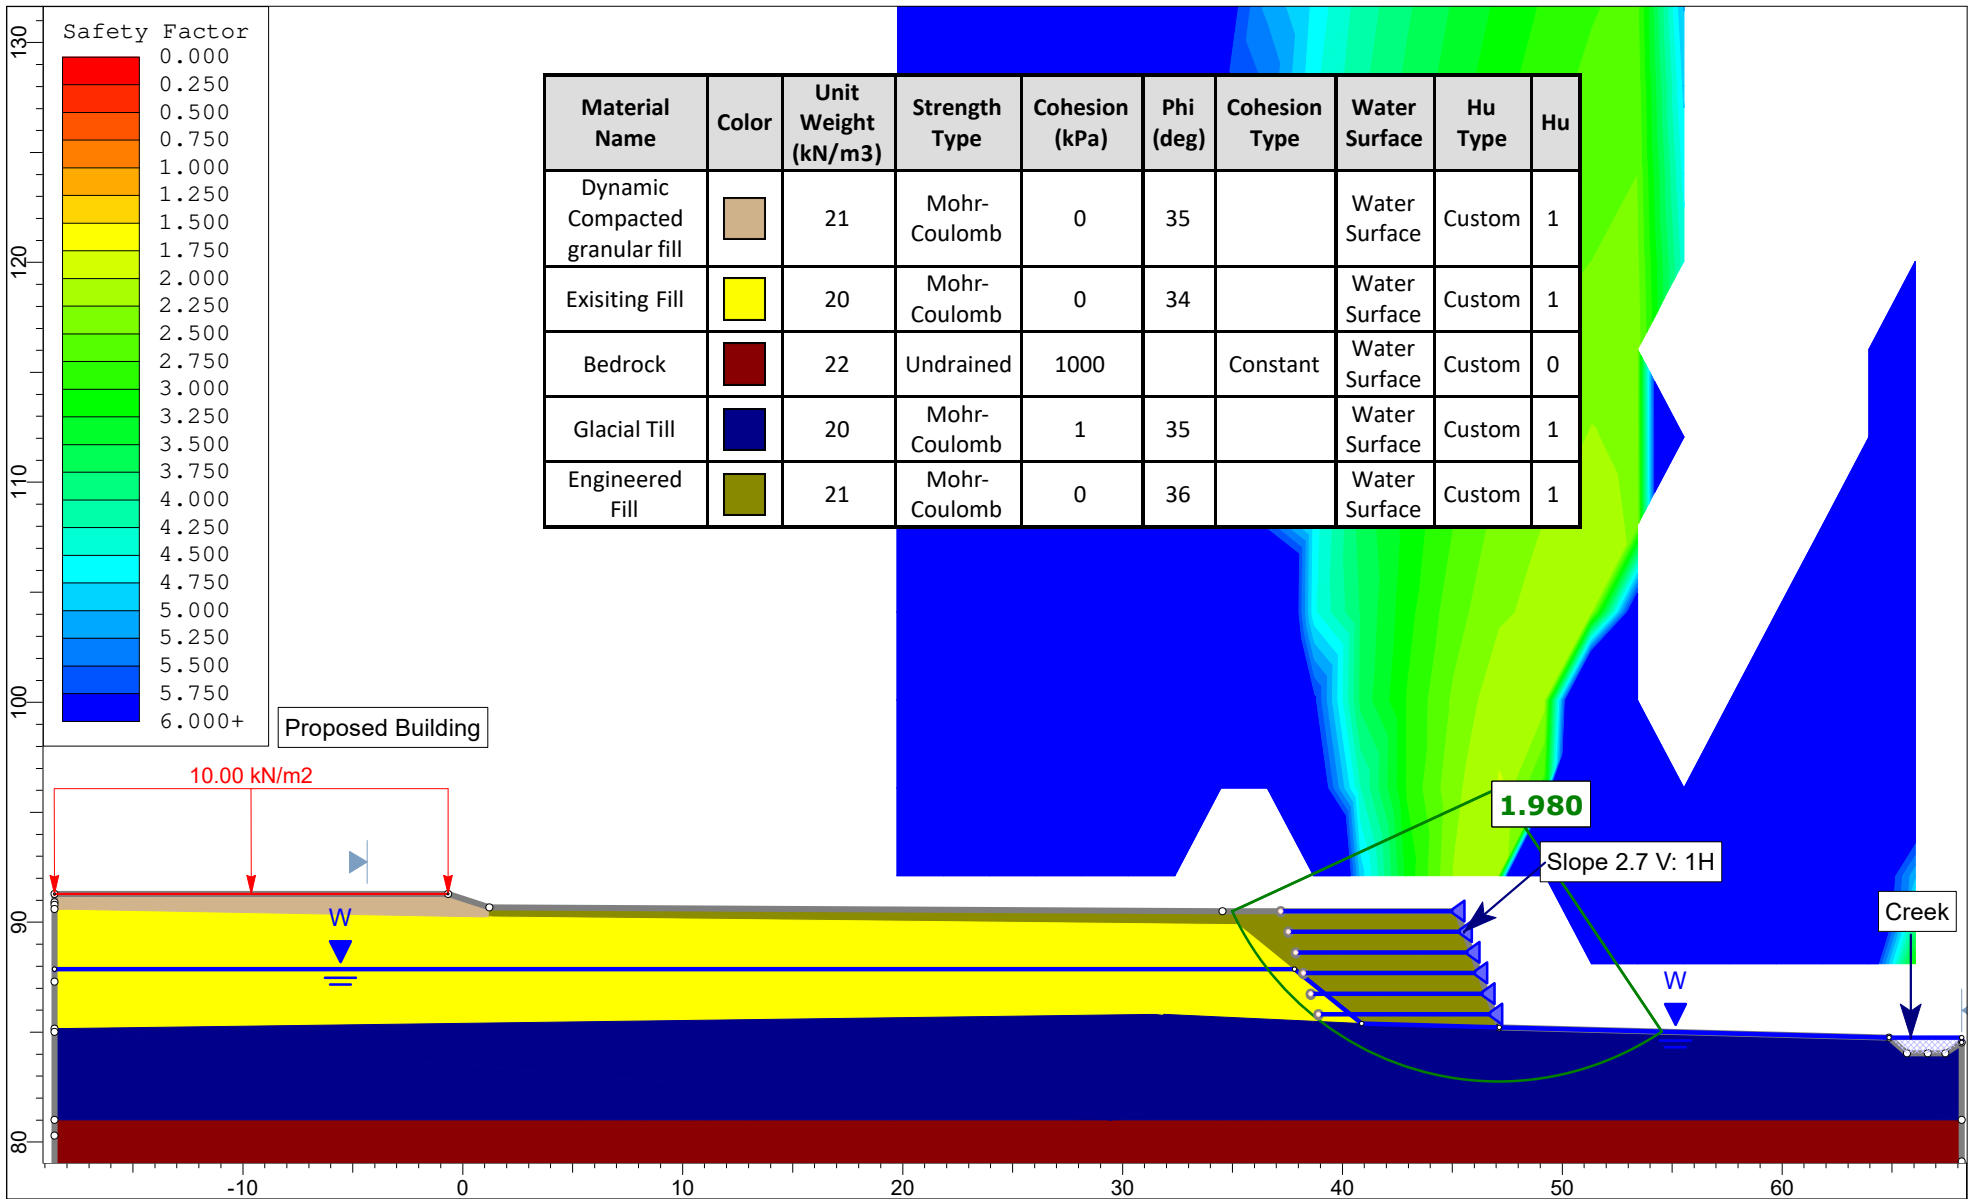
Project		PG7567 - 301 Somme Street			
	Slope Section		A	Scenario	Proposed Reinforced Static Condition	
	Drawn By		DR	Company		W.O. Stinson & Son Ltd
	Date		2025-06-27	File Name		Figure 2C

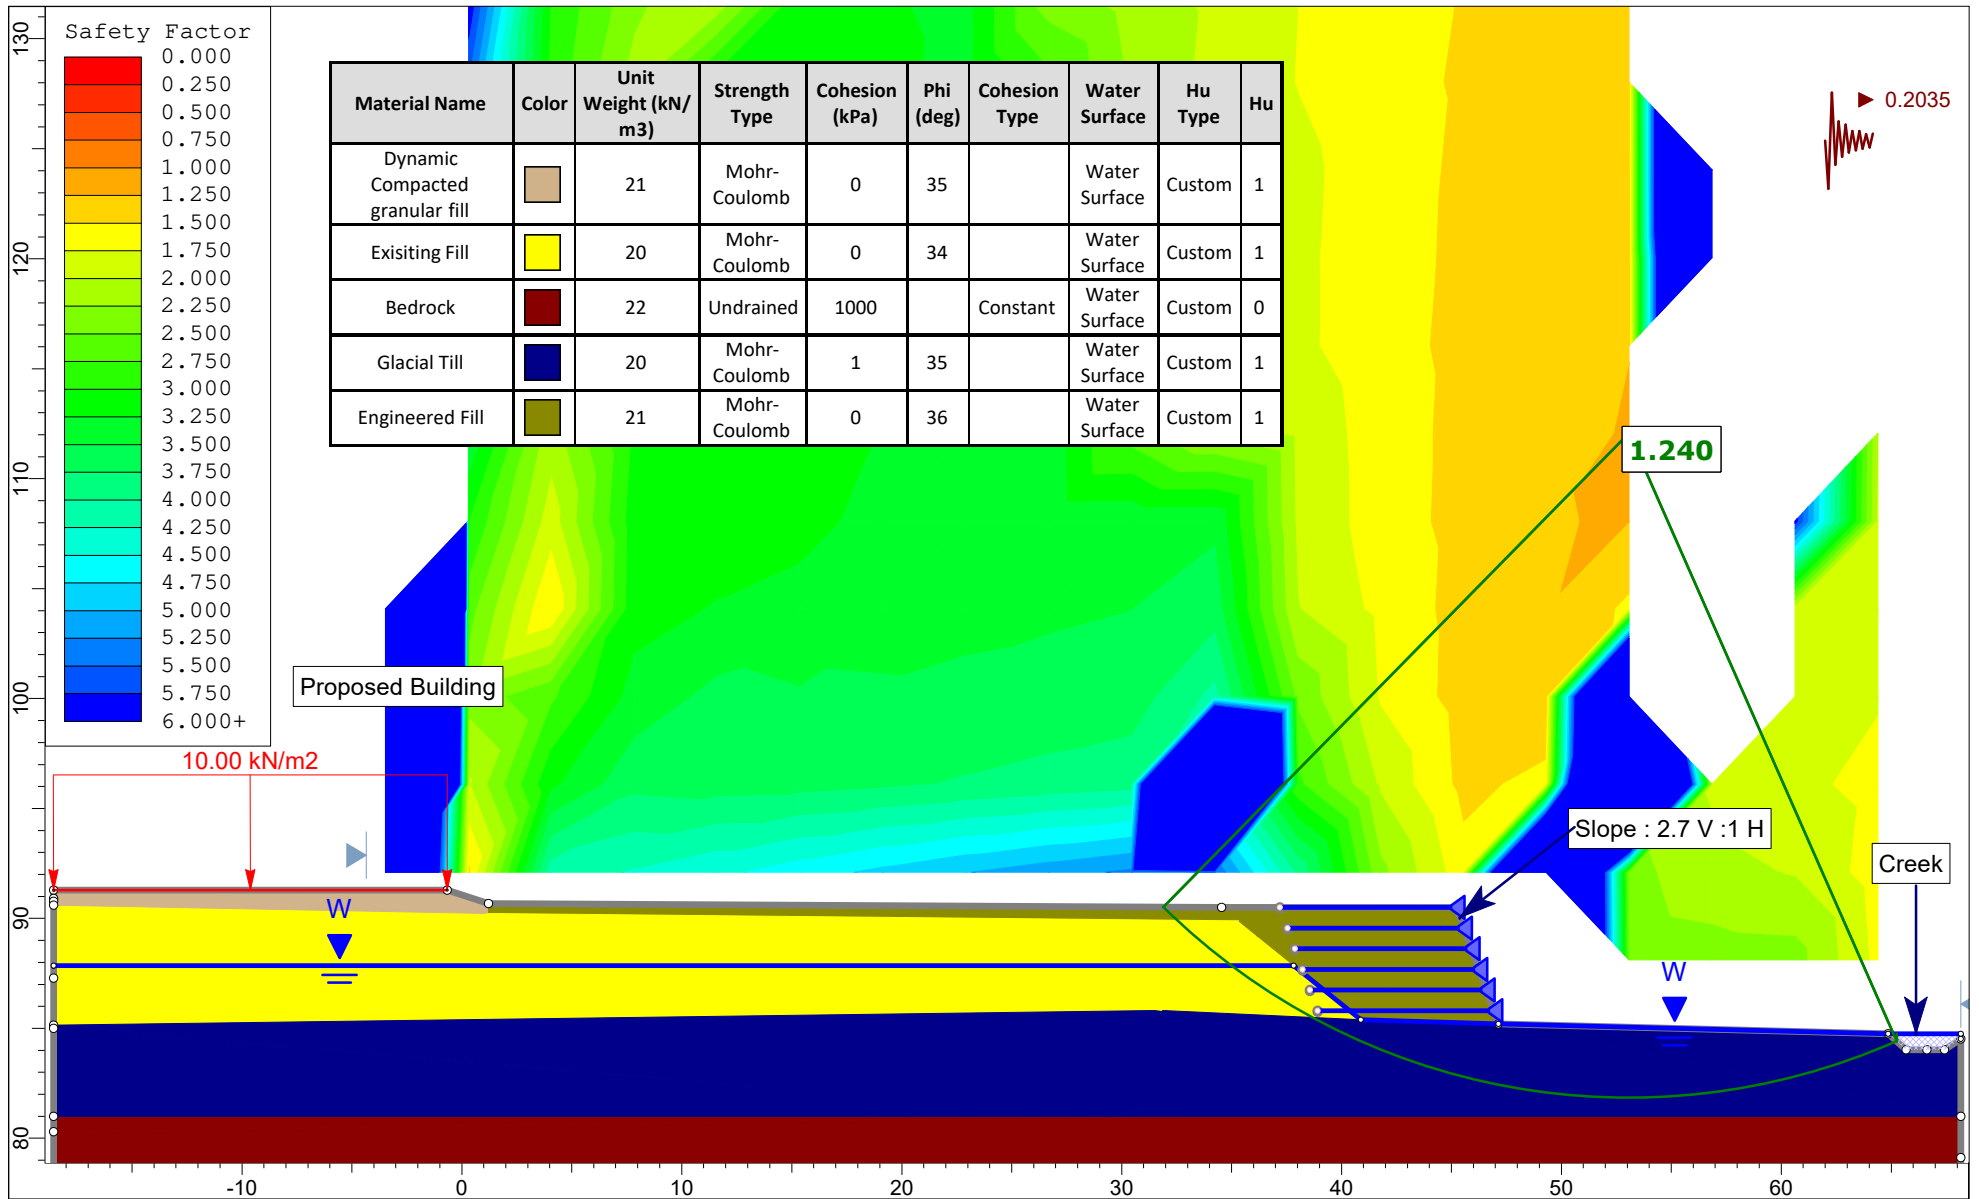
Project		PG7567 - 301 Somme Street		
	Slope Section		A	Scenario	Proposed Reinforced Seismic Condition
	Drawn By		DR	Company	W.O. Stinson & Son Ltd
	Date		2025-06-27	File Name	Figure 2D

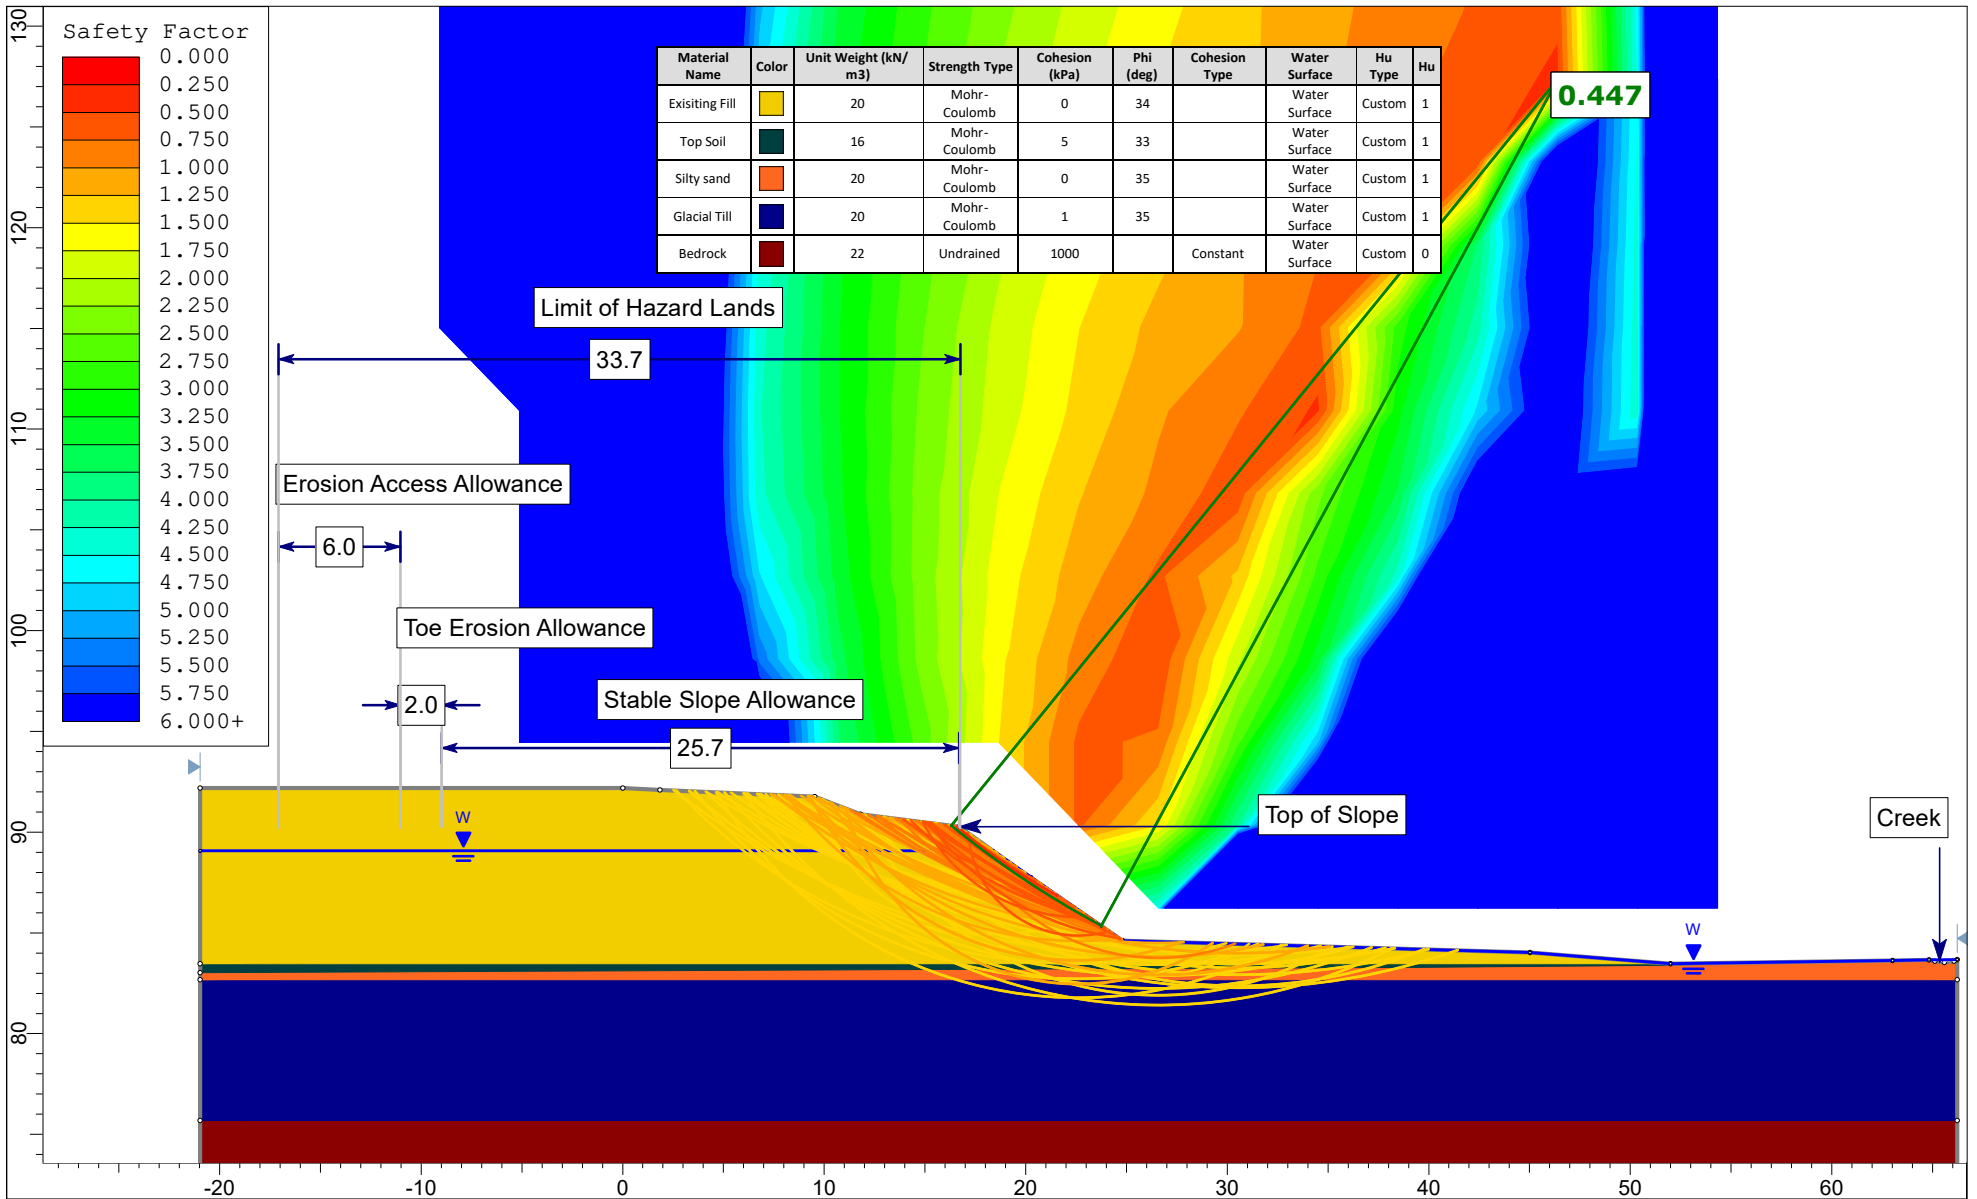
Project		PG7567- 301 Somme Street	
	Slope Section		B	Scenario
	Drawn By		DR	Company
	Date		2025-06-20	File Name
				Existing Static Condition
				W.O. Stinson & Son Ltd
				Figure 3A

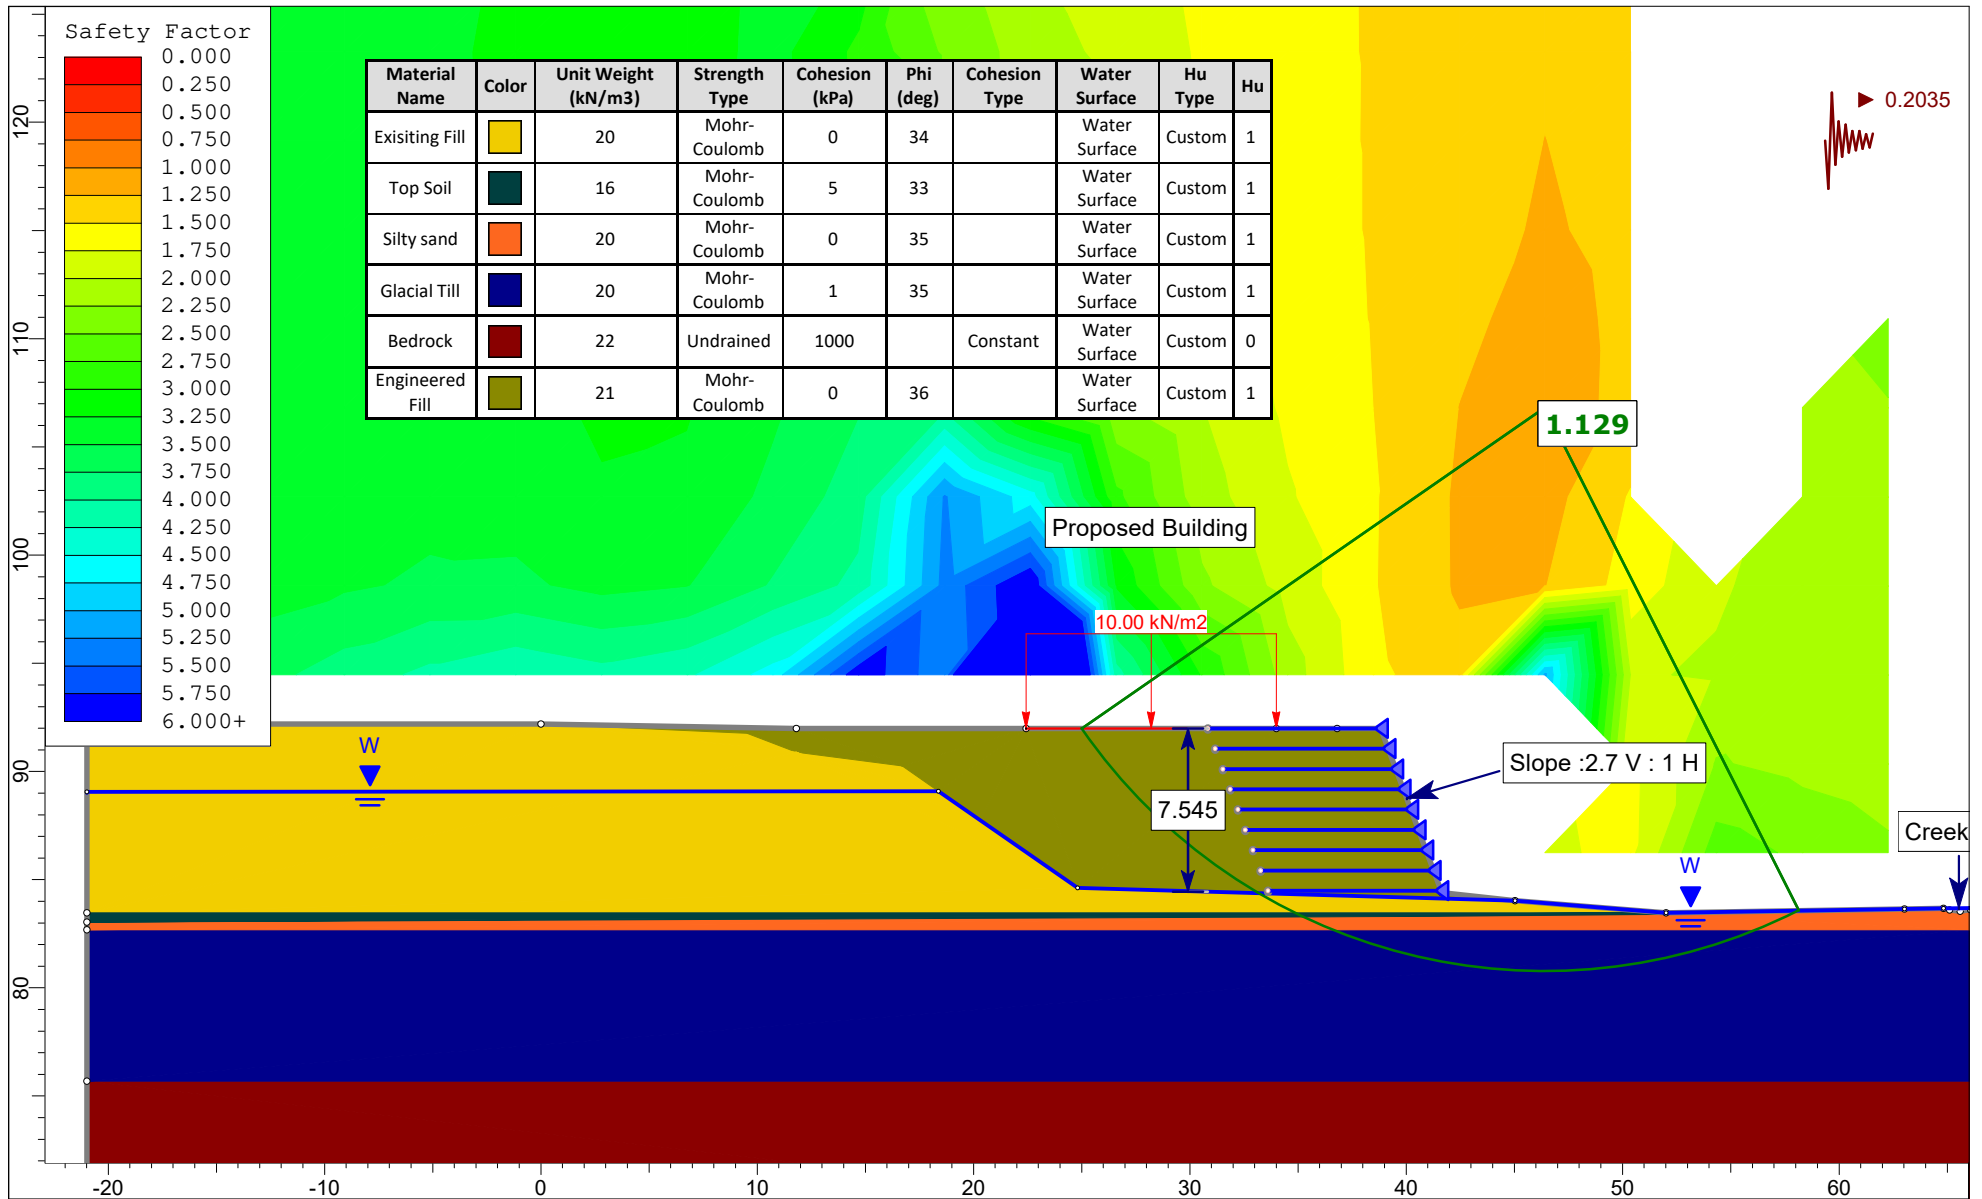
Project		PG7567 - 301 Somme Street	
	Slope Section		B	Scenario
	Drawn By		DR	Company
	Date		2025-06-27	File Name
			Proposed Reinforced Seismic Condition	W.O. Stinson & Son Ltd
				Figure 3D
