Geotechnical Investigation

Proposed Commercial Development

301 Somme Street
Ottawa, Ontario

Report PG7567 -1 dated August 14, 2025

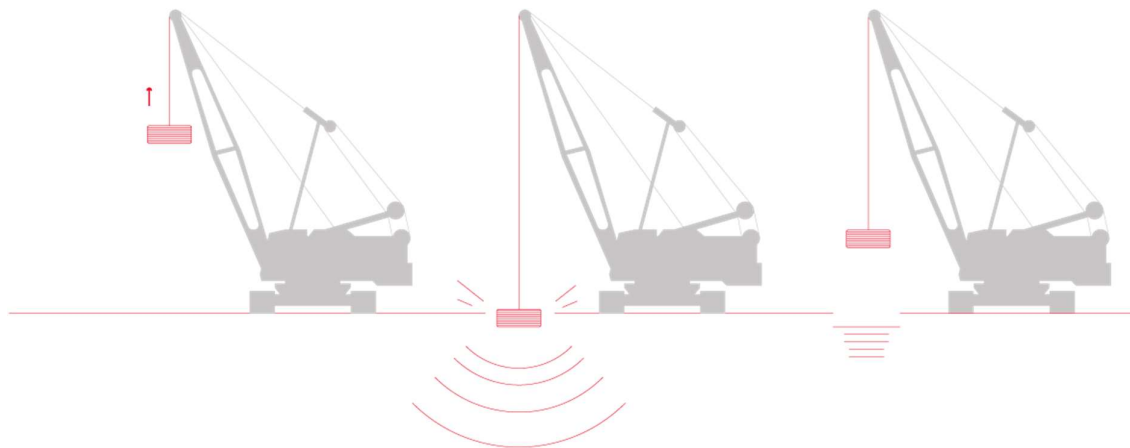
Figure 1 – Dynamic Compaction process

The existing ground improvement at the site was completed by deep dynamic compaction, which uses a heavy weight dropped from a crane, and which is effective for compacting loose soils to significant depths.

Dynamic Compaction (DC) is used to transmit high impacts to loose and soft soils that have an initial low bearing capacity, high compressibility and/or liquefaction potential in order to significantly improve their mechanical properties.

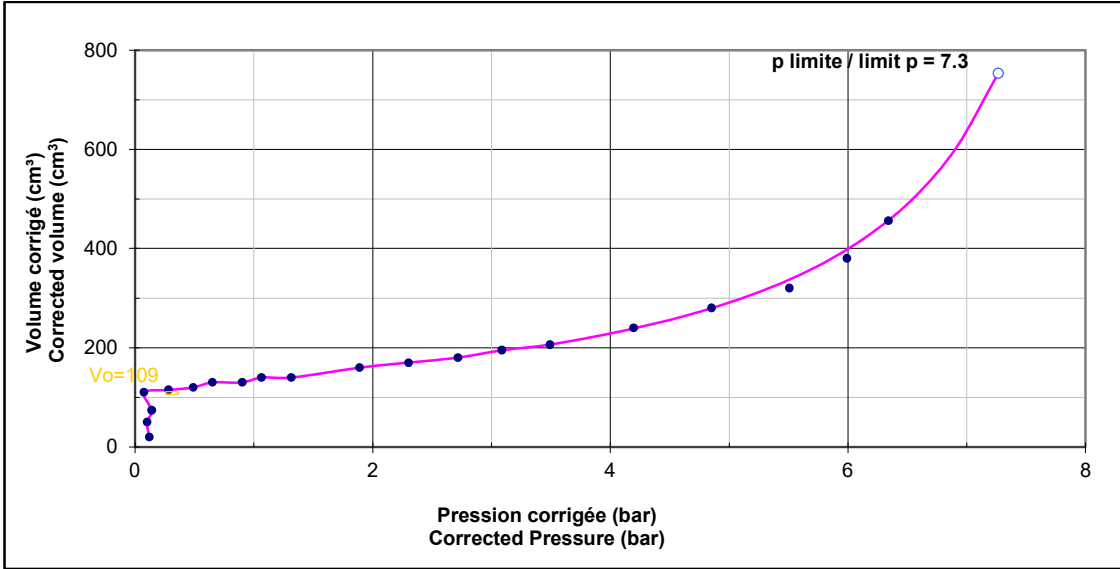
Figure 1: PMT01 curve at 1.5 m depth

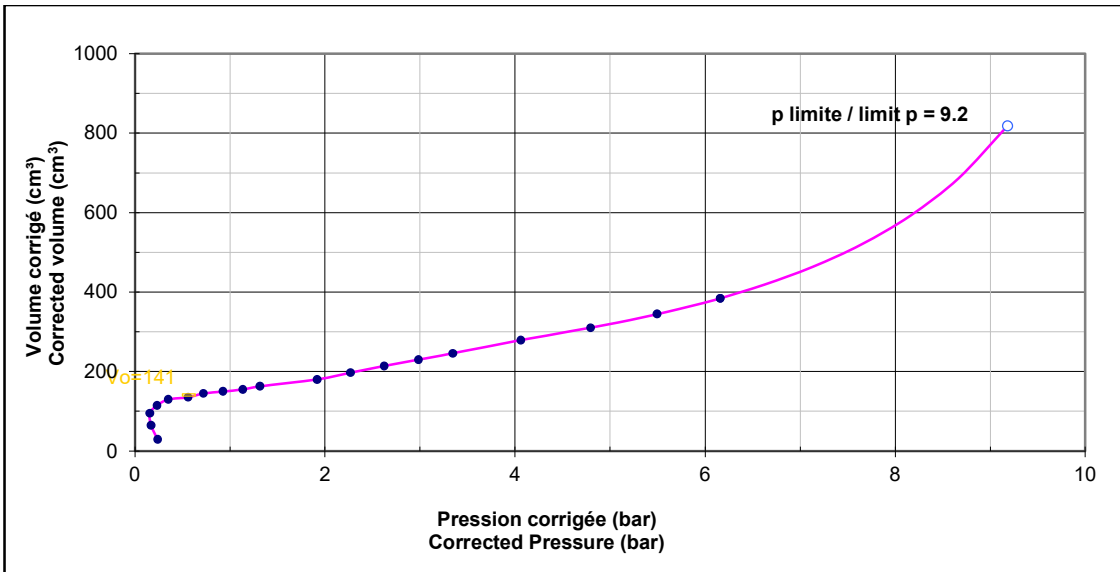
Figure 2: PMT01 curve at 3.5 m depth

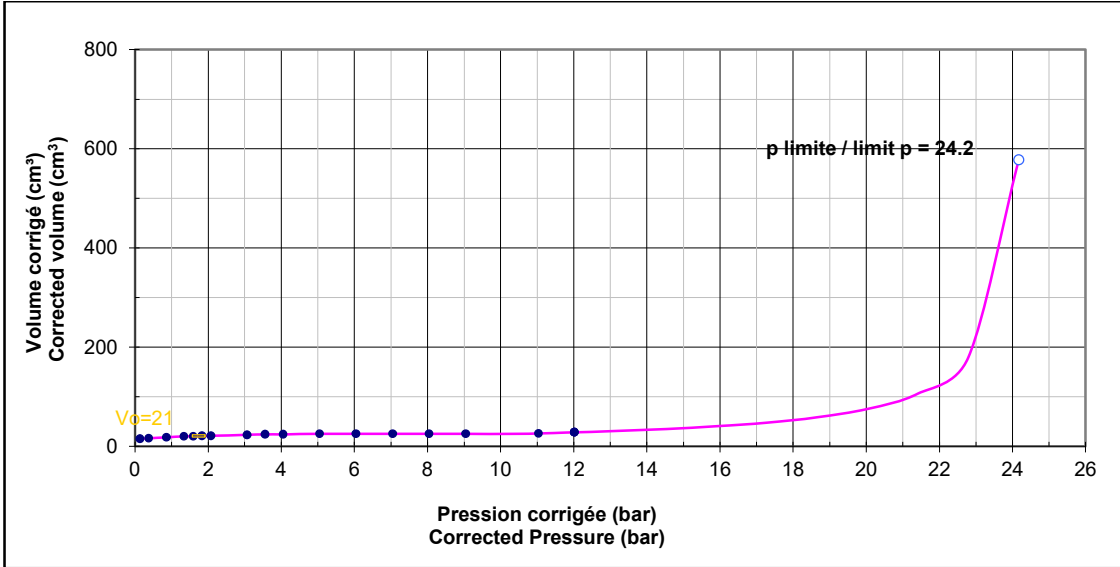
Figure 3: PMT02 curve at 1.2 m depth

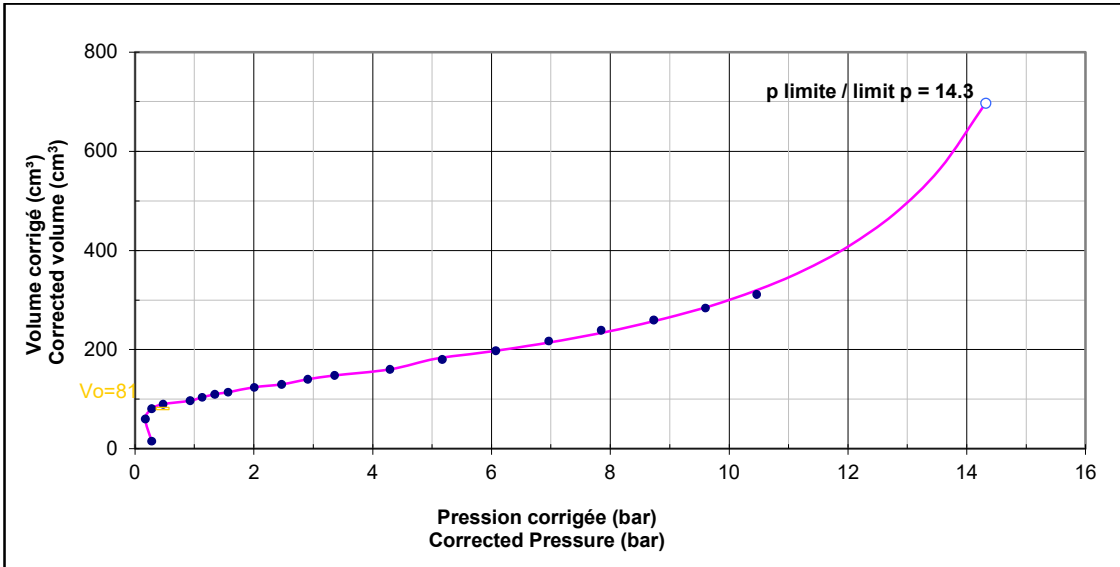
Figure 4: PMT03 curve at 3.0 m depth

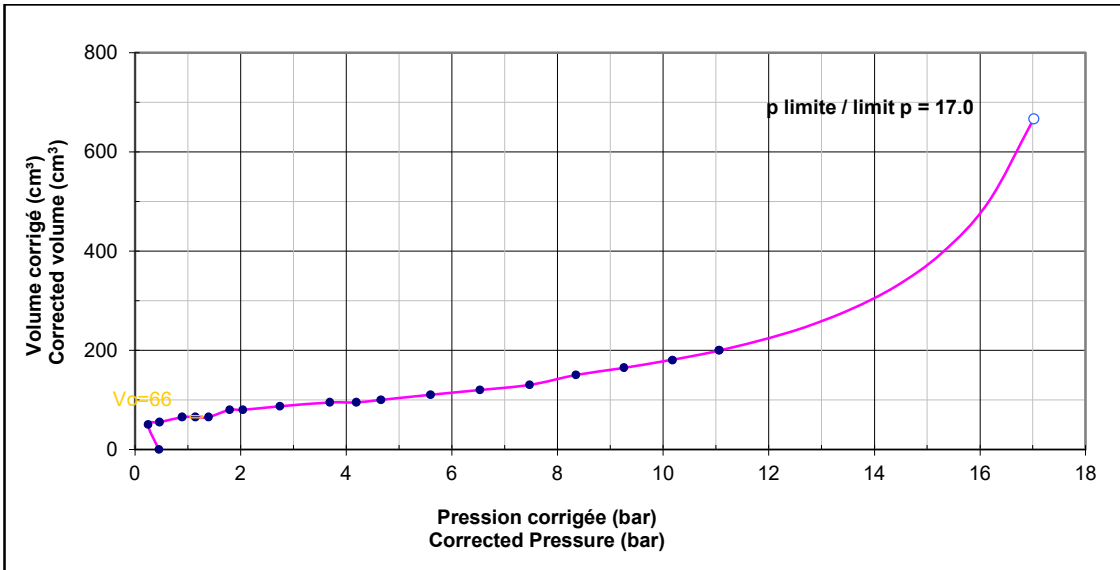
Figure 5: PMT04 curve at 3.0 m depth

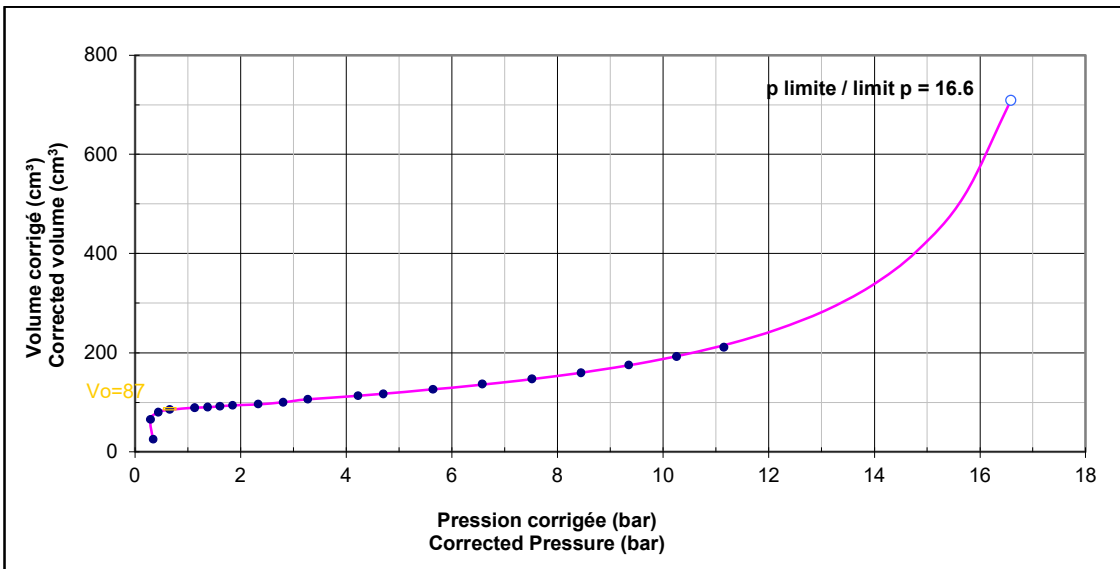
Figure 6: PMT03 curve at 4.5 m depth
