# VUZE Construction

1015 Tweddle Road

## TREE CONSERVATION REPORT

CIMA+ file number: Z0018492  
22 August 2025 - Review 000

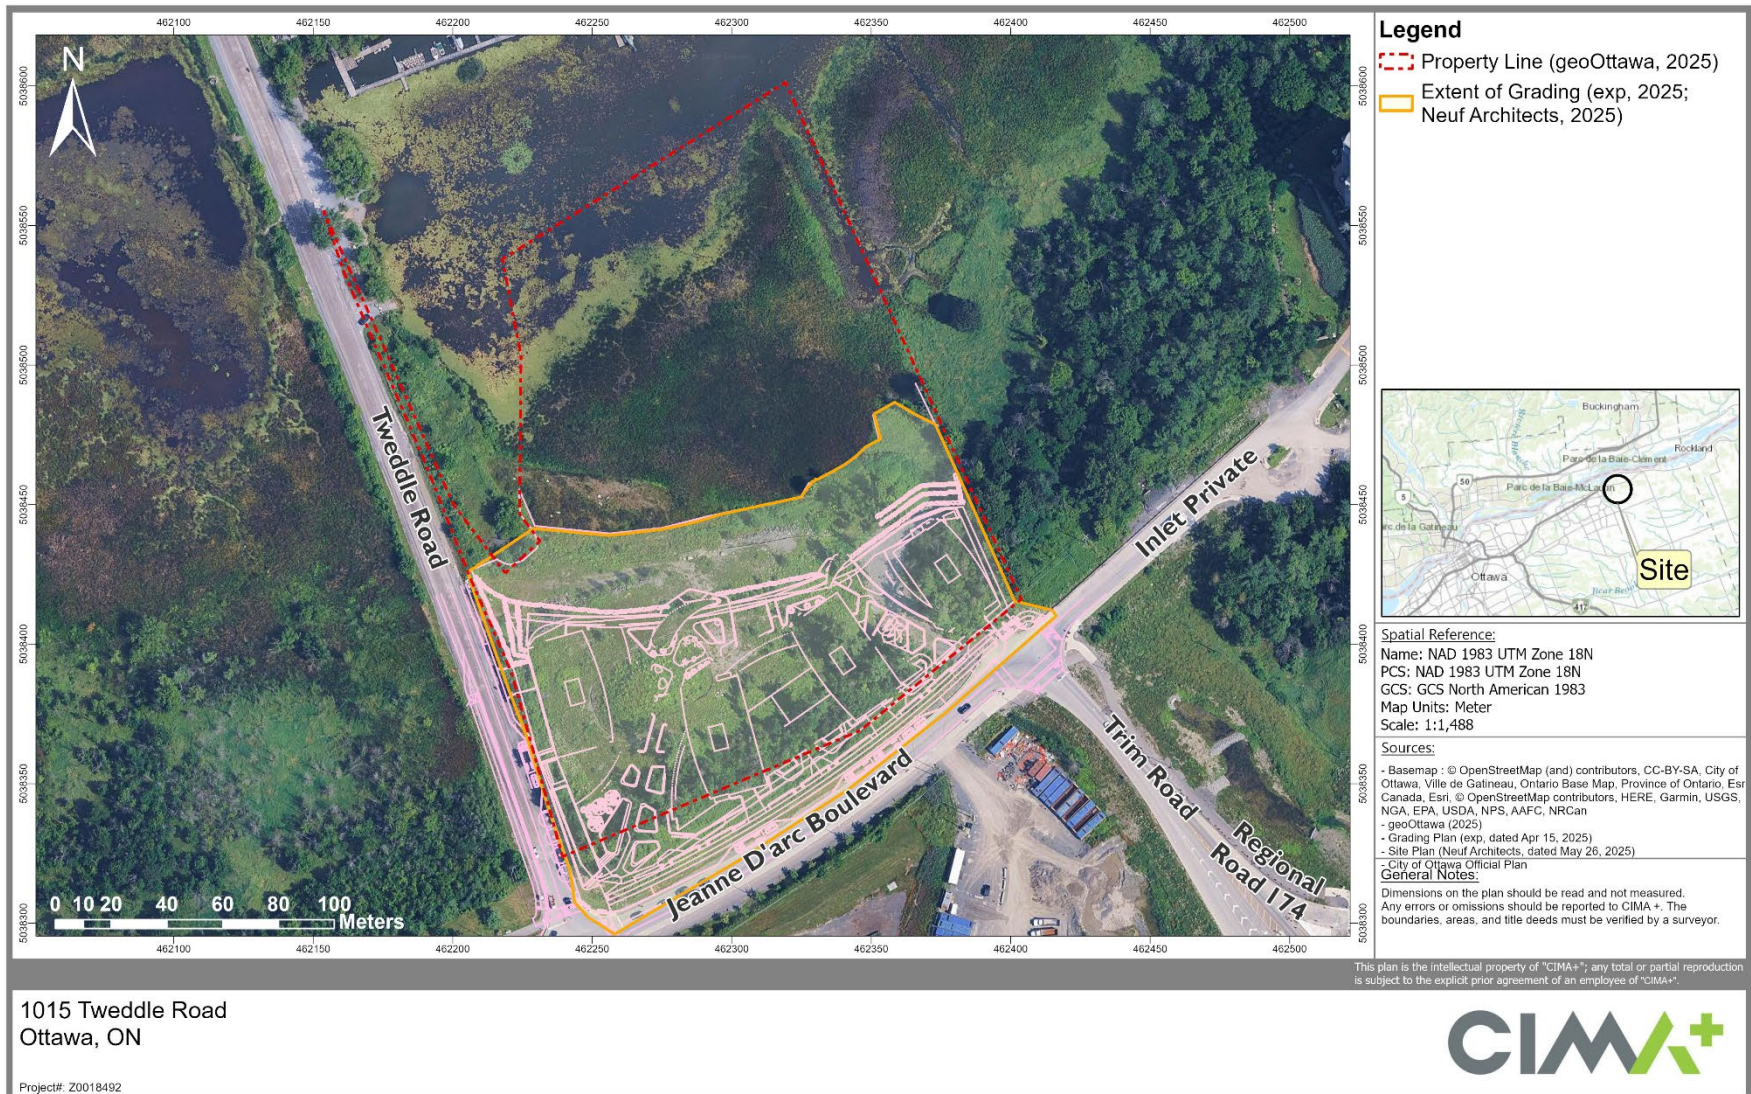
Figure 1: Property Location and Proposed Works

VUZE Construction, hereafter referred to as the proponent, intends to develop the property at 1015 Tweddle Road (the “Property”), situated at the northeast corner of the intersection at Tweddle Road and Jeanne d’Arc Boulevard North. As of 2022, Bowfin merged its services with CIMA+ who has taken over the mandate of updating this Tree Conservation Report (TCR) as per the City of Ottawa’s Tree Conservation Report Guidelines (2021).

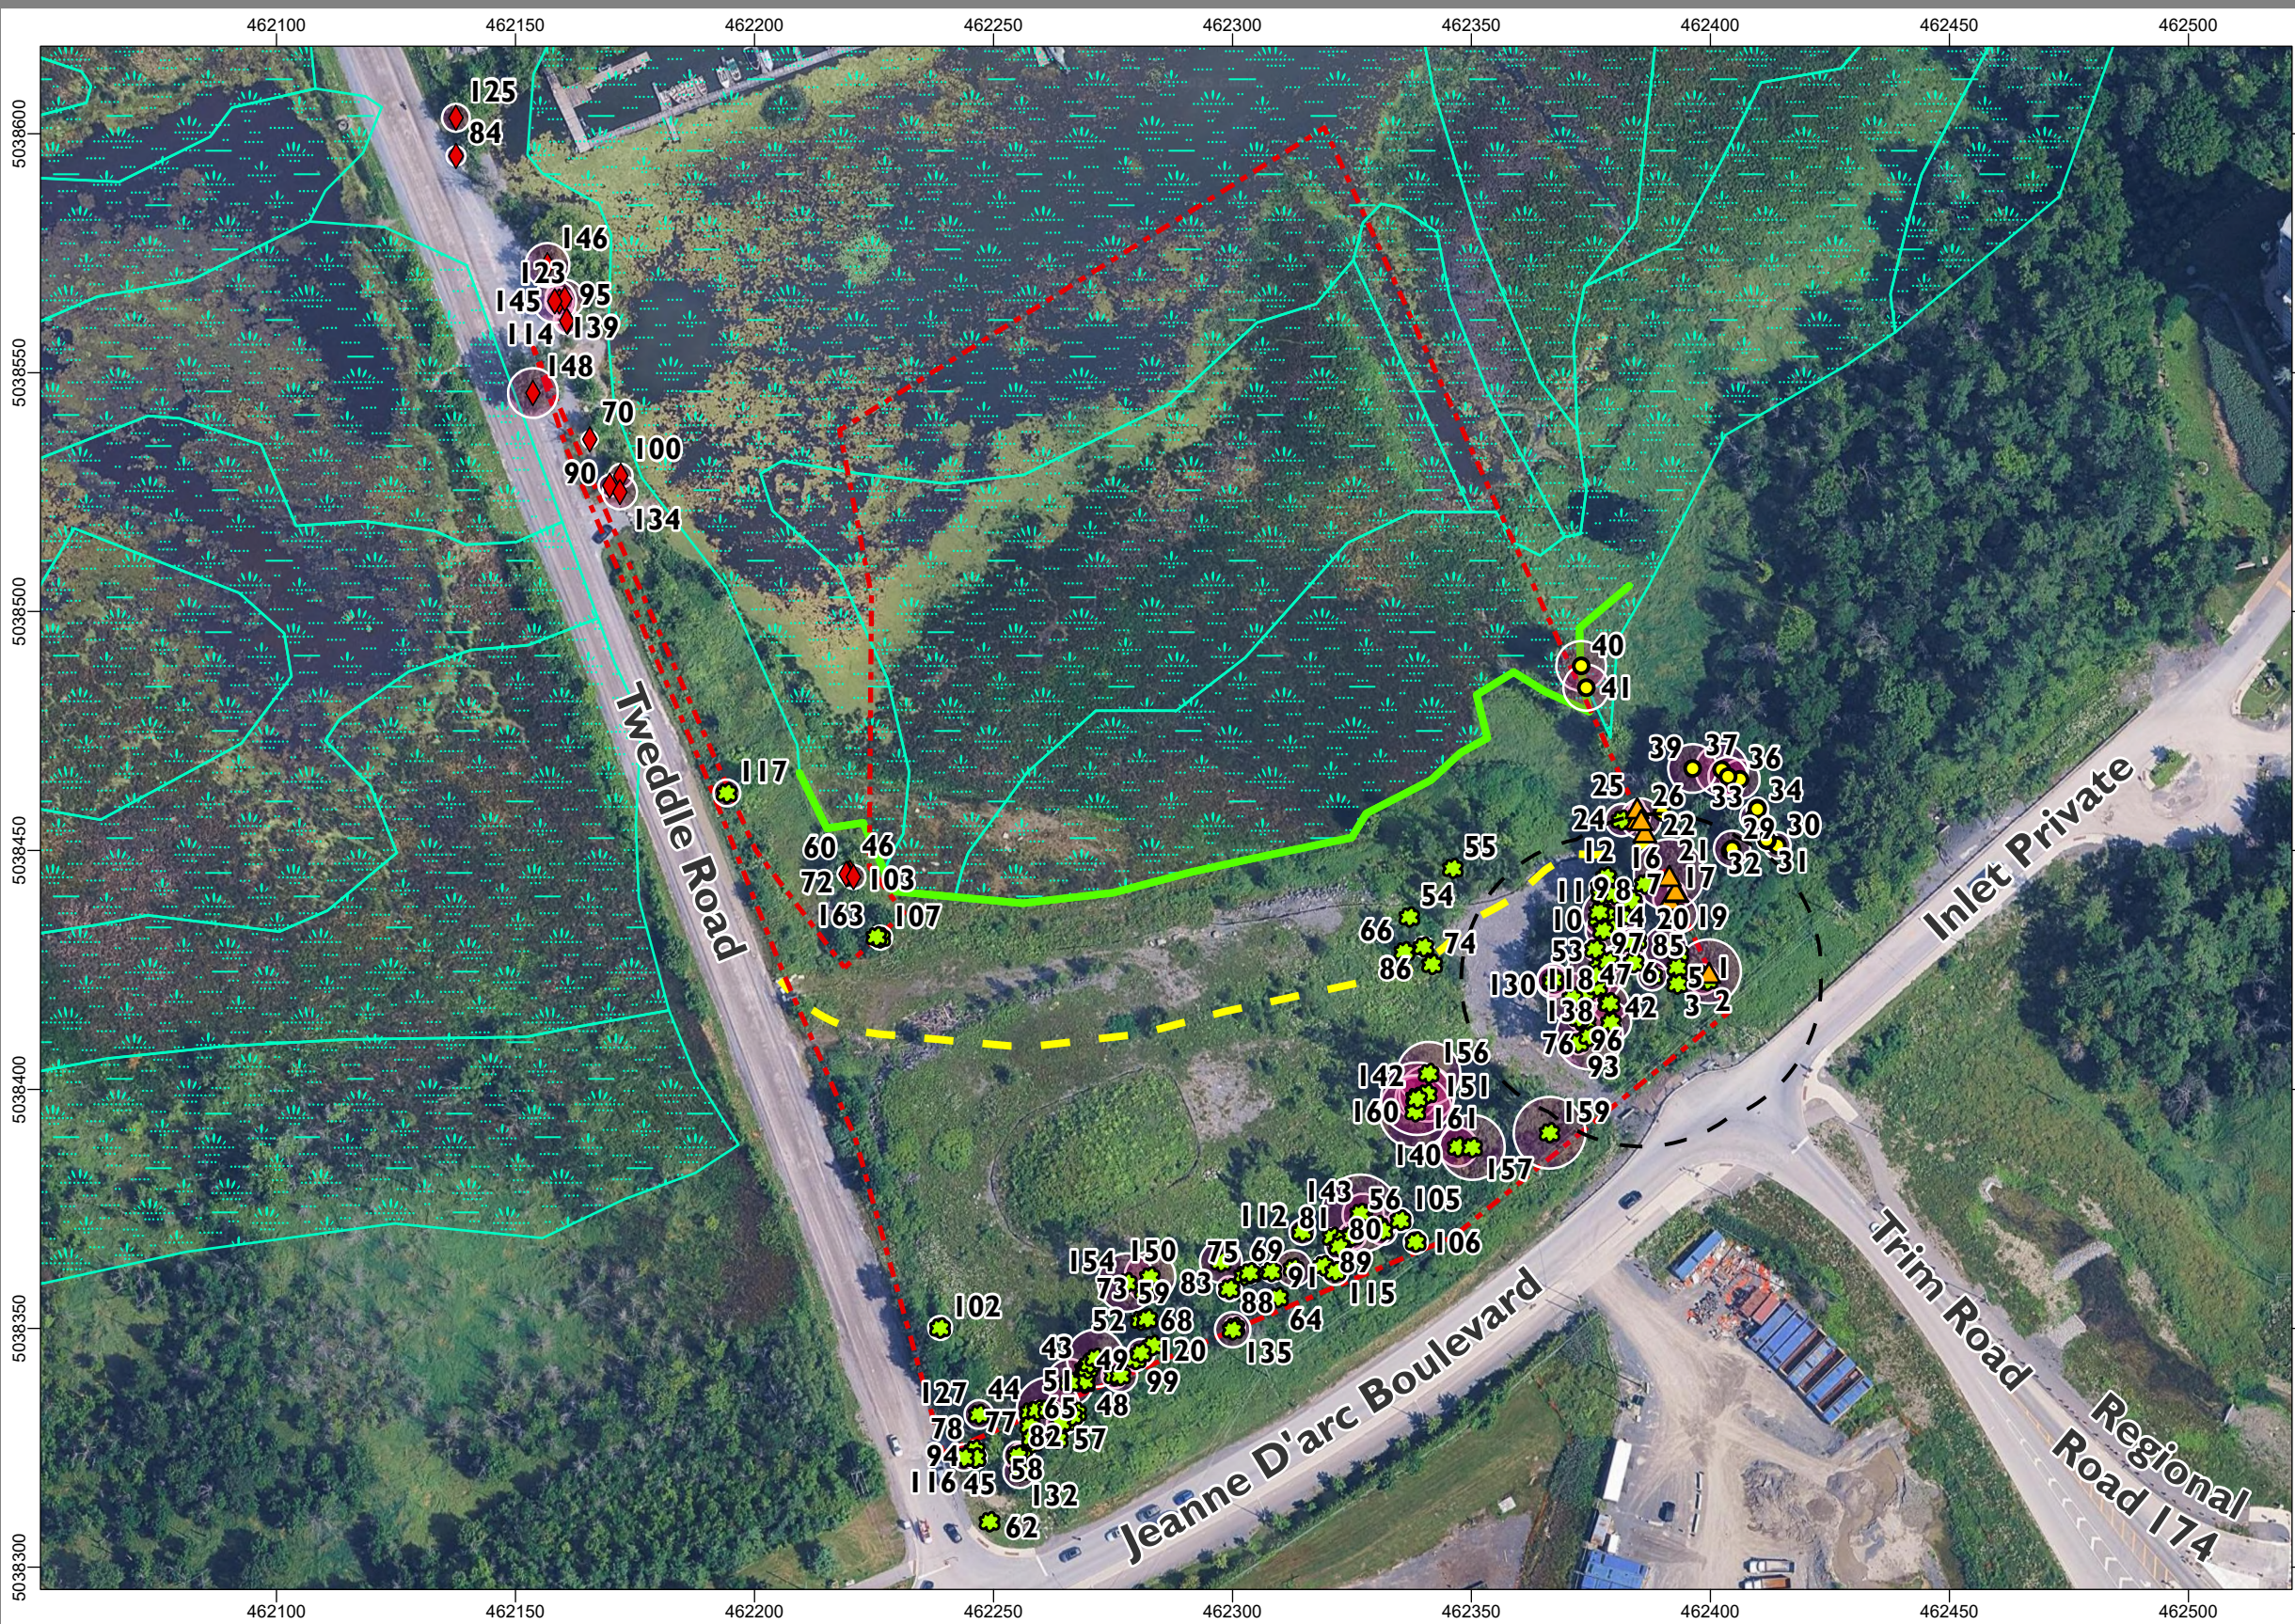
## Appendix A Map 1

The location of individual trees are depicted on Map 1 and Map 2 (Appendix A, Appendix B).

- Provincially significant wetland on the north side of the Property
- Habitat of endangered and threatened species
  - Two (2) SAR Black Ash trees were found (Trees 164, 165) with dbh of 10 and 14 cm. These were located on the southeast corner of the Property.

This development area consists primarily of fill area, some of which is revegetated with cultural meadow communities with inclusions of windrows, cultural thickets, mixed forests, along Tweddle Road and Inlet Private. The vegetation was dominated by bird's foot trefoil, common sow thistle, white sweet clover, wild carrot, cow vetch, burdock, viper's bugloss, field bindweed, smooth brome, coltsfoot, and common mullein, as well as young, scattered Eastern Cottonwood individuals. A patch of regenerating woody vegetation was present on the east side. The upper layer was 1-6 m tall (50% cover) and included Eastern Cottonwood, Staghorn Sumac, Manitoba Maple and Green Ash. The ground layer (90% cover) contained reed canary grass, Canada goldenrod, cow vetch, wild carrot, bird's-foot trefoil, common ragweed, and grasses. Several natural heritage features were identified on the Property or adjacent lands on provincial databases and further verified in-field (Appendix A):

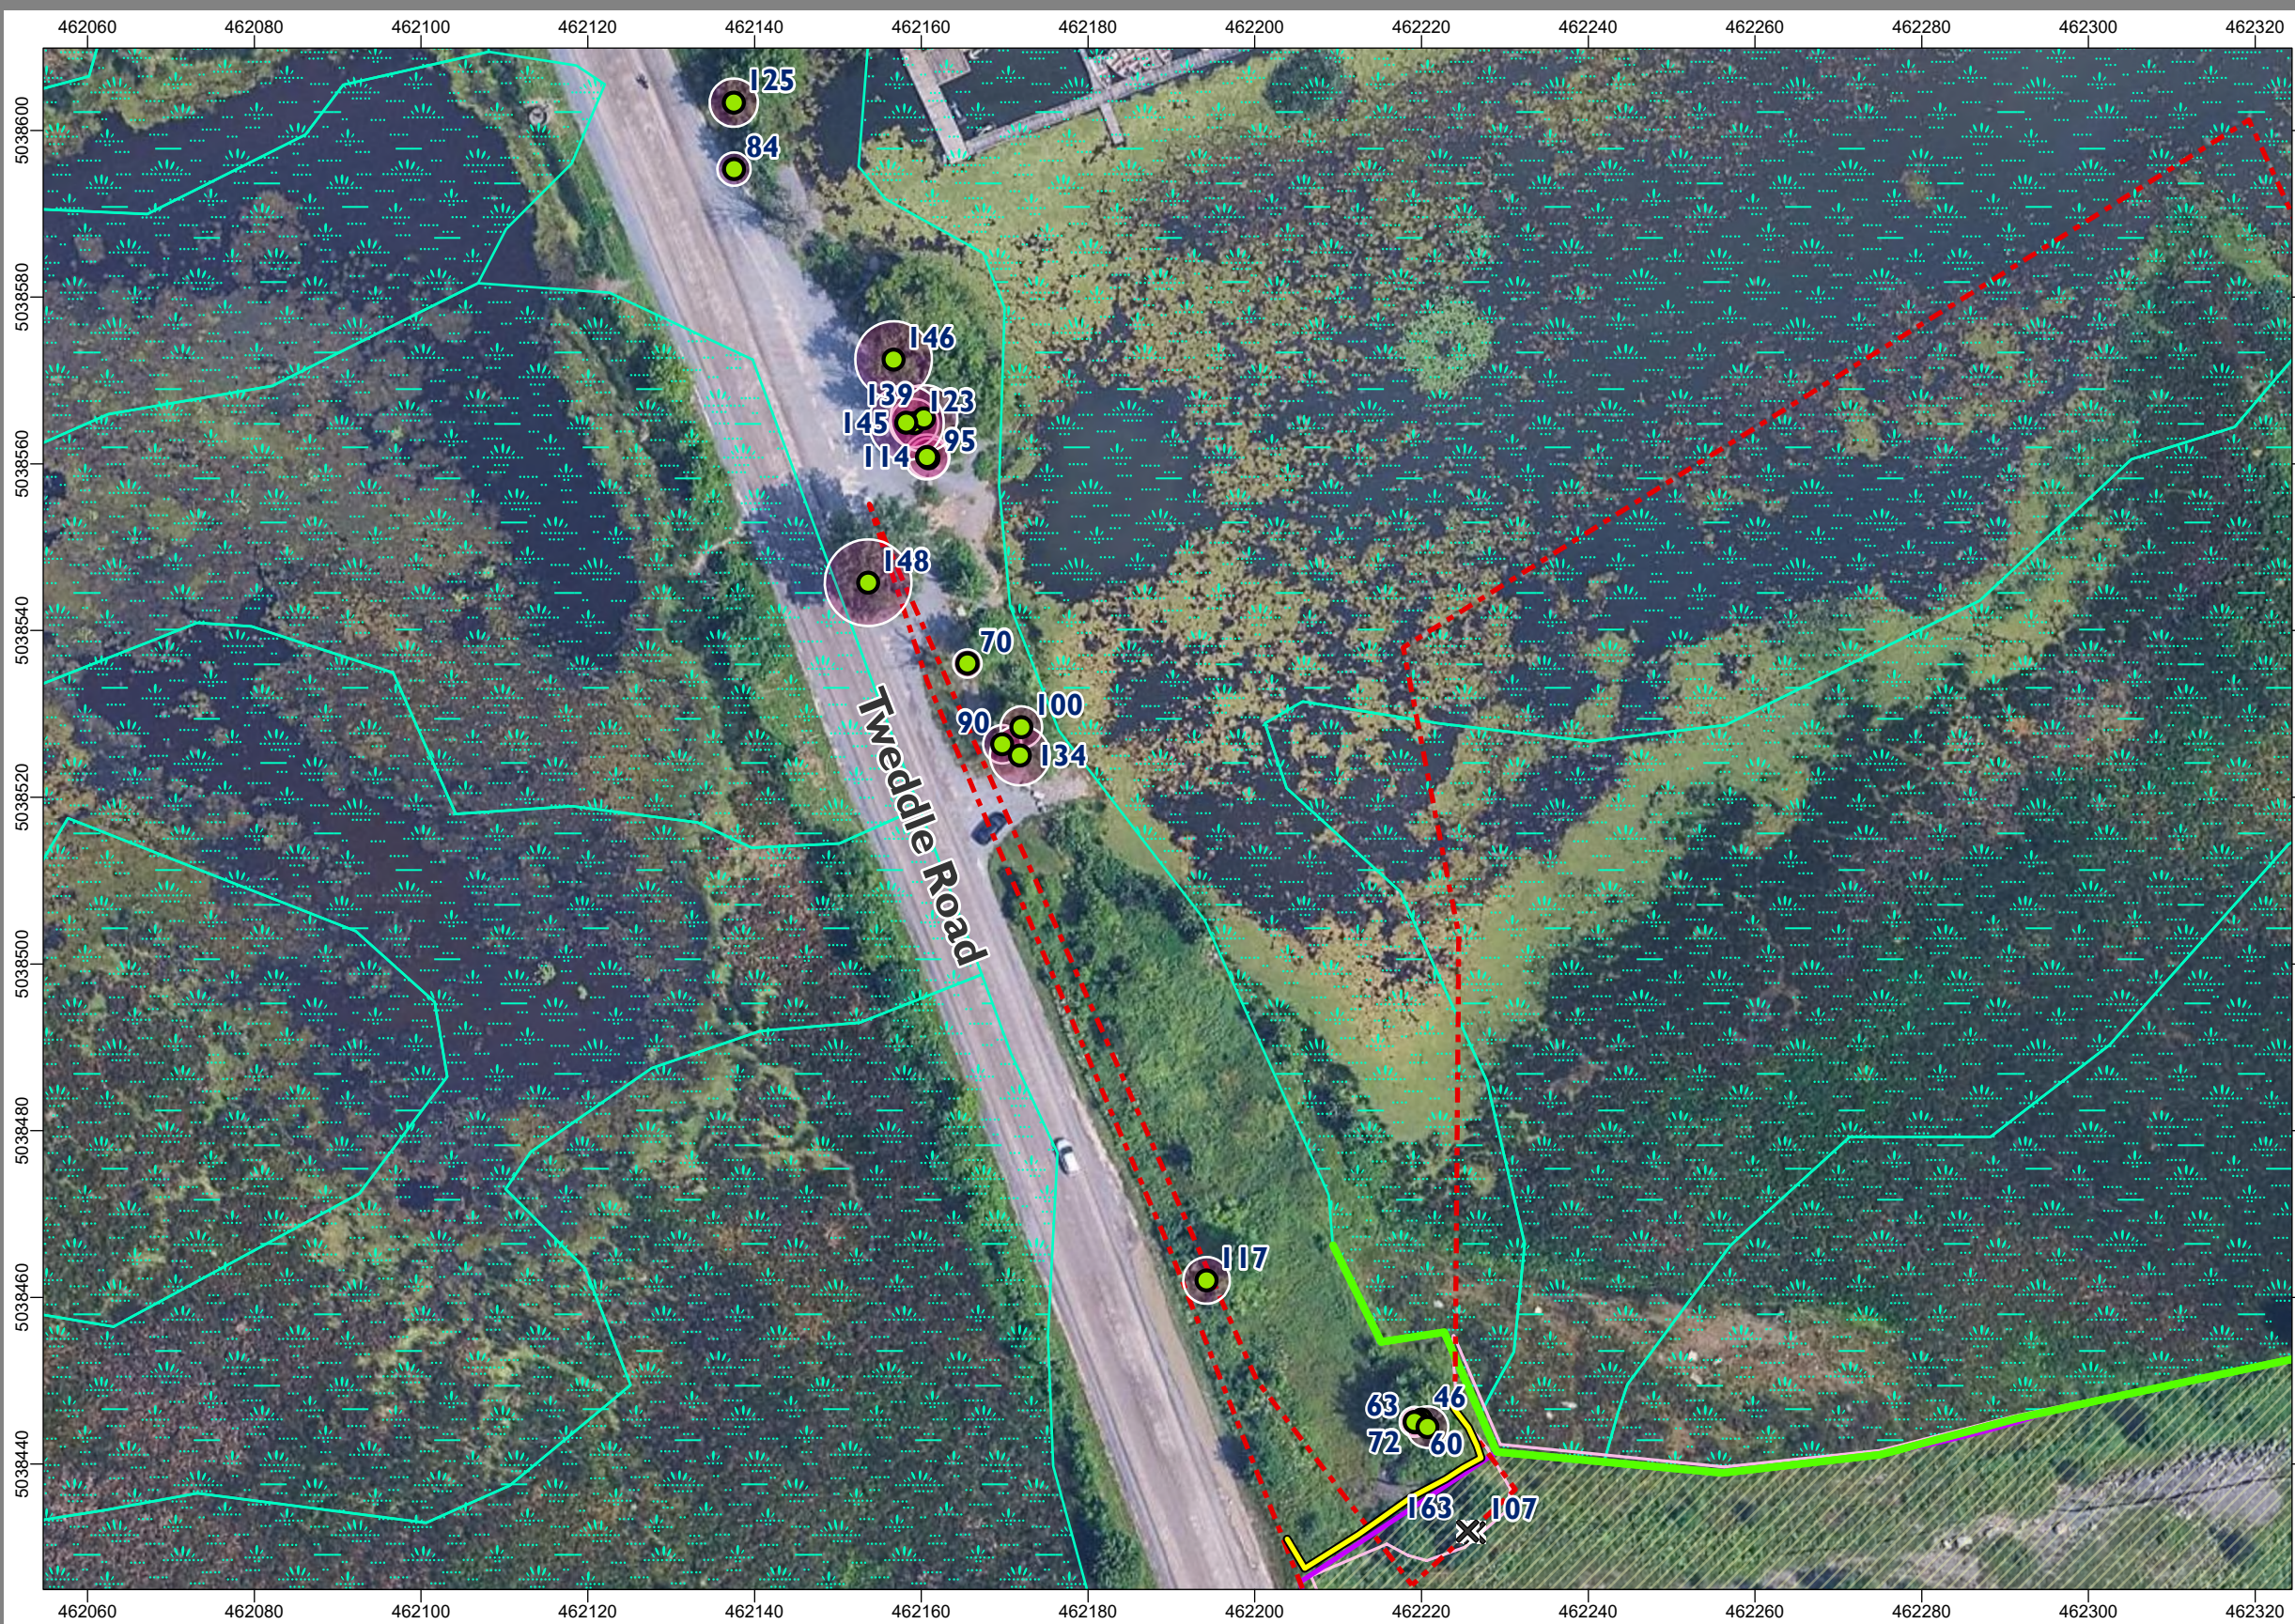
## Appendix B Map 2

Of the 165 individuals inventoried, **122 trees** are anticipated to be removed (Appendix B).

Of the 165 individual trees identified, **43 trees** are proposed for retention (Appendix B).

An impact assessment was undertaken to determine impacts to trees on the Property as a result of the project’s activities. Trees within the extent of grading are all recommended for removal.

- Trees 21, 23 and 26 are recommended for retention and pruning, as grading will occur within their CRZs.
  - Tree 21 is a Bur Oak with dbh 74 cm
  - Tree 23 is an American Elm with dbh 23 cm.
  - Tree 26 is a Bur Oak with dbh 42 cm.
  - Both trees fall near the property line and are of shared ownership.
