Phase One Environmental Site Assessment

Proposed Fernbank High School
5431 Fernbank Road, Ottawa, Ontario

OTT-23004319-B0

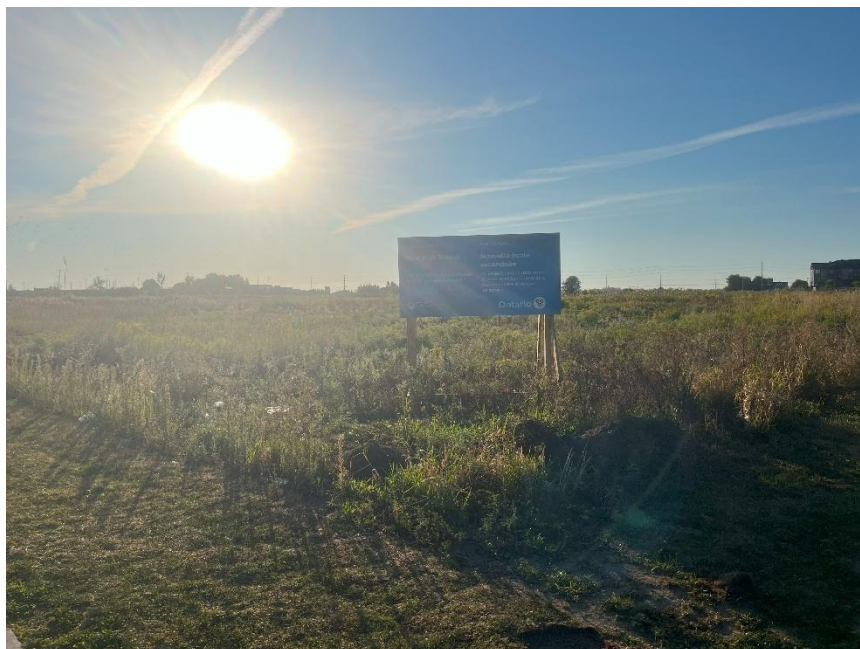
Photograph No. 1

View of the Phase One property looking southeast.

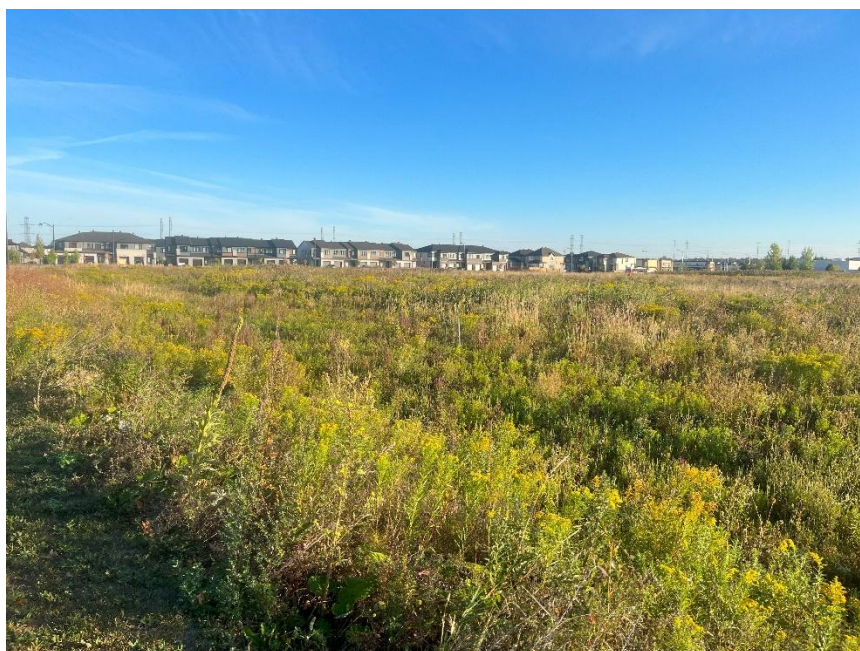
Photograph No. 2

View of the Phase One property looking northeast.

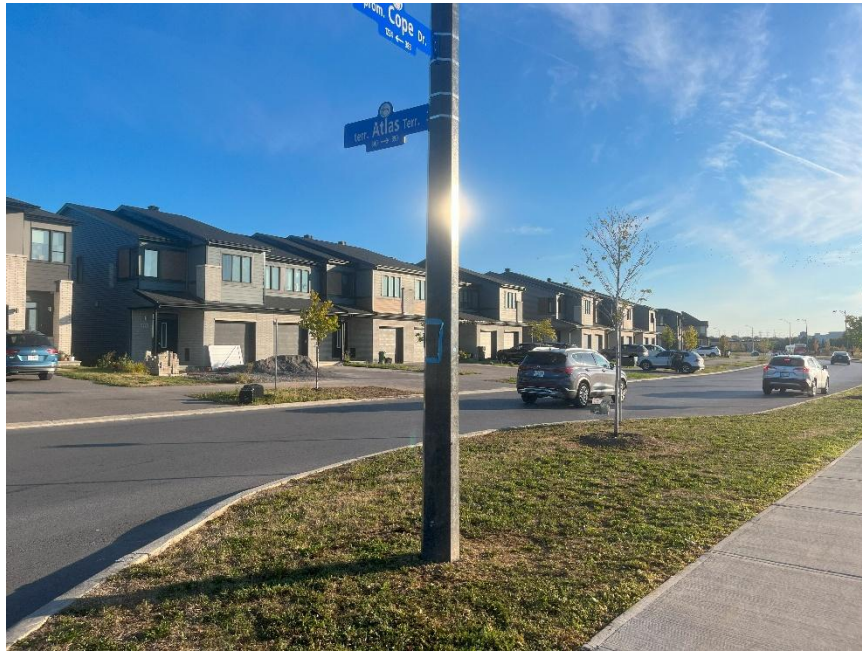
Photograph No. 3

View of the adjacent properties to the north.

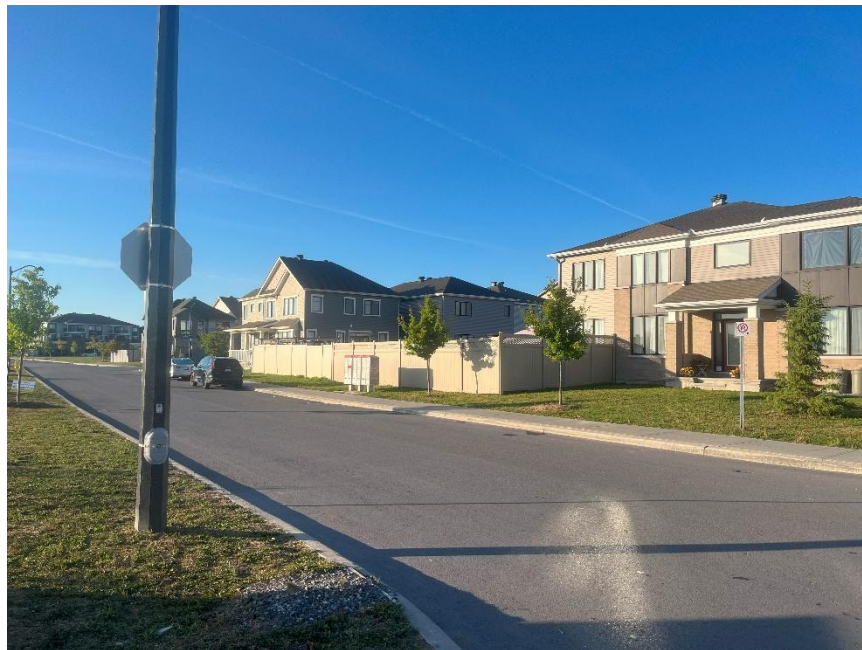
Photograph No. 4

View of the adjacent properties to the west.
