Geotechnical Investigation

Proposed Residential Development
5331 Fernbank Road
Ottawa, Ontario

Prepared for Claridge Homes

Report PG5683-1 Revision 1 dated November 18, 2025

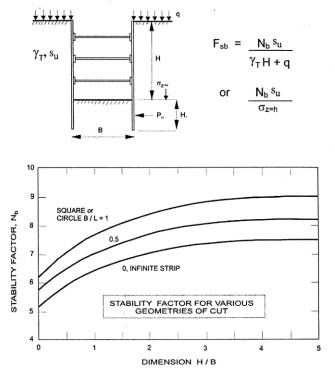
Figure 1 - Stability Factor for Various Geometries of Cut

σ_{z} - total overburden and surcharge pressures at the bottom of the excavation

In the case of soft to firm clays, a factor of safety of 2 is recommended for base stability.

The base of supported excavations can fail by three (3) general modes:

Shear failure within the ground caused by inadequate resistance to loads
imposed by grade difference inside and outside of the excavation,
Piping from water seepage through granular soils, and
Heave of layered soils due to water pressures confined by intervening low
permeability soils.

Shear failure of excavation bases is typically rare in granular soils if adequate lateral support is provided. Inadequate dewatering can cause instability in excavations made through granular or layered soils. The potential for base heave in cohesive soils should be determined for stability of flexible retaining systems.

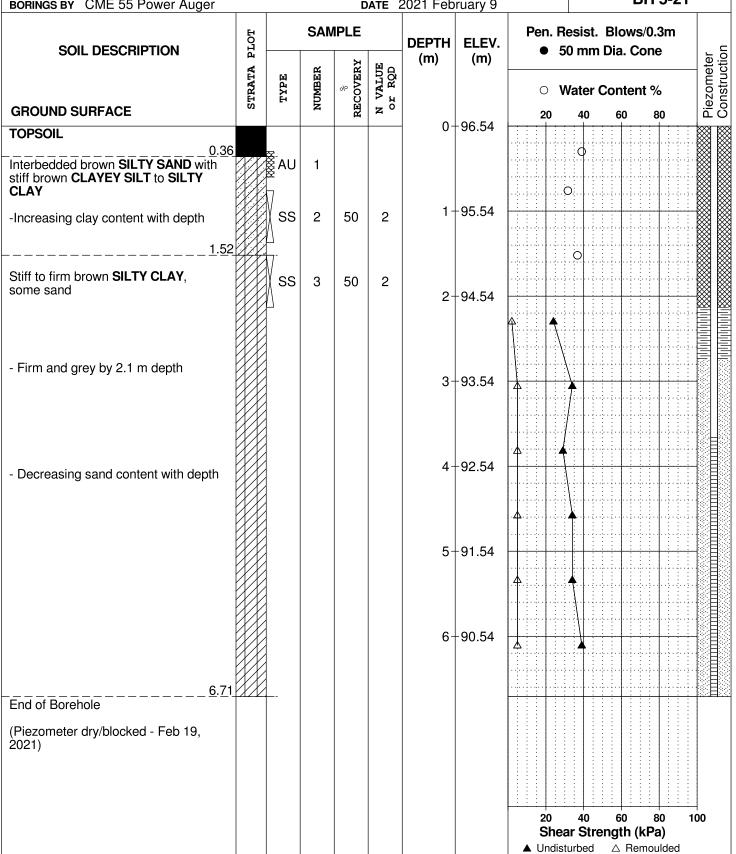
HOLE NO.
BH 5-21

SOIL PROFILE AND TEST DATA

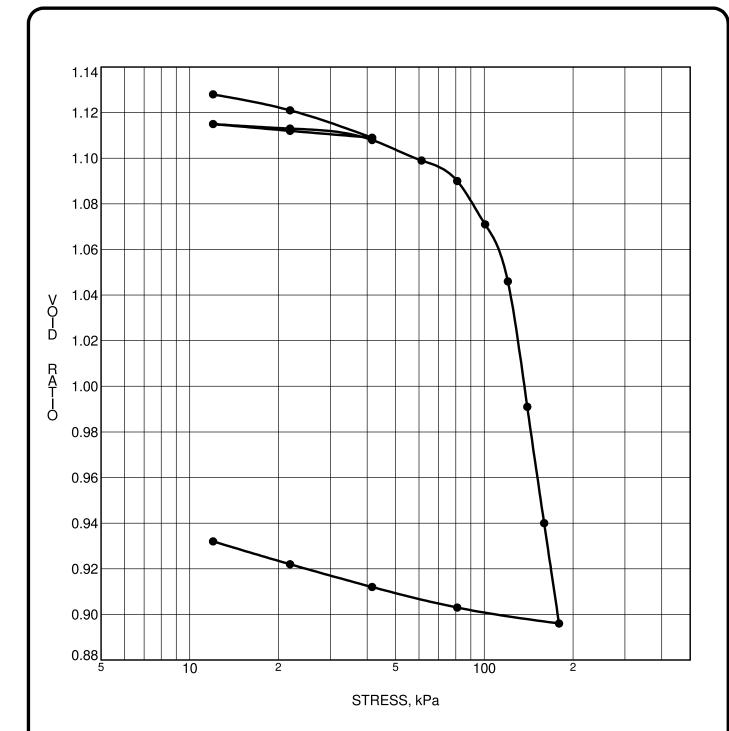
CONSOLIDATION TEST DATA SUMMARY								
Borehole No.	BH 3-18	p' ₀ 41.54 kPa	Ccr	0.013				
Sample No.	TW 3	p'c 110.66 kPa	Cc	0.898				
Sample Depth	4.04 m	OC Ratio 2.7	Wo	41.4 %				
Sample Elev.	92.64 m	Void Ratio 1.139	Unit Wt.	17.8 kN/m ³

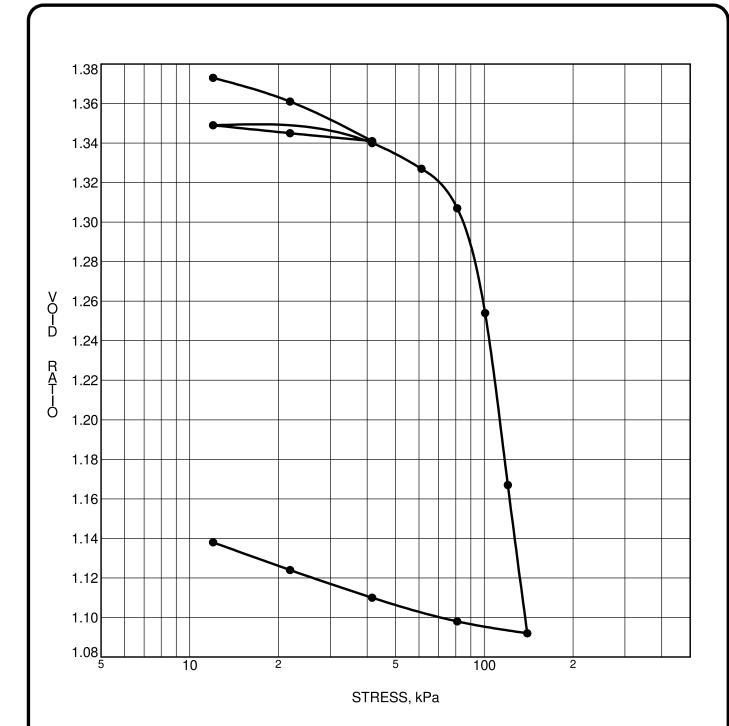
CONSOLIDATION TEST DATA SUMMARY								
Borehole No.	BH 7-18	p'o	40.6 kPa	Ccr	0.021			
Sample No.	TW 3	p'c	90 kPa	Сс	1.190			
Sample Depth	3.89 m	OC Ratio	2.2	Wo	50.5 %			
Sample Elev.	93.24 m	Void Ratio	1.389	Unit Wt.	17.0 kN/m ³

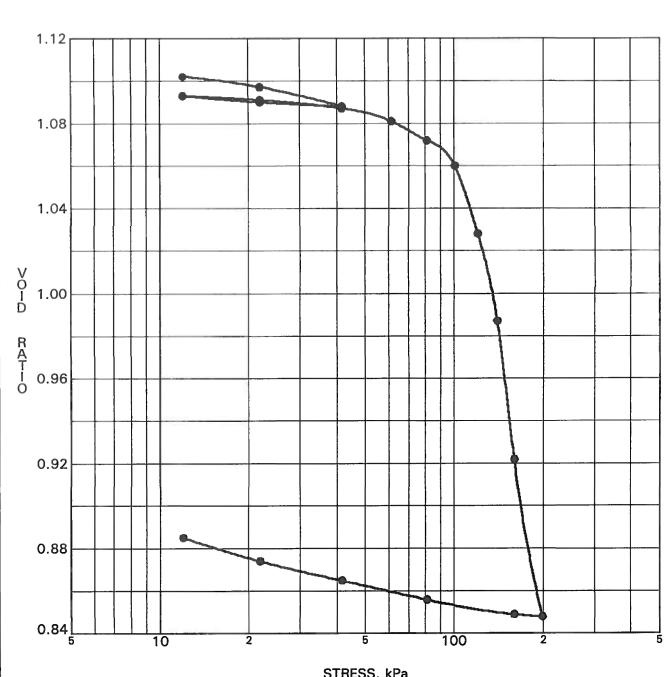
CONSOLIDATION TEST DATA SUMMARY							
Borehole No.	BH 2	p′o	52	kPa	Ccr	0.011	
Sample No.	TW 5	p'c	115	kPa	Сс	0.984	
Sample Depth	5.00 m	OC Ratio	2.2		Wo	40.3 %	
Sample Elev.	m	Void Ratio	1.10	07	Unit Wt.	18.0 kN/m ³

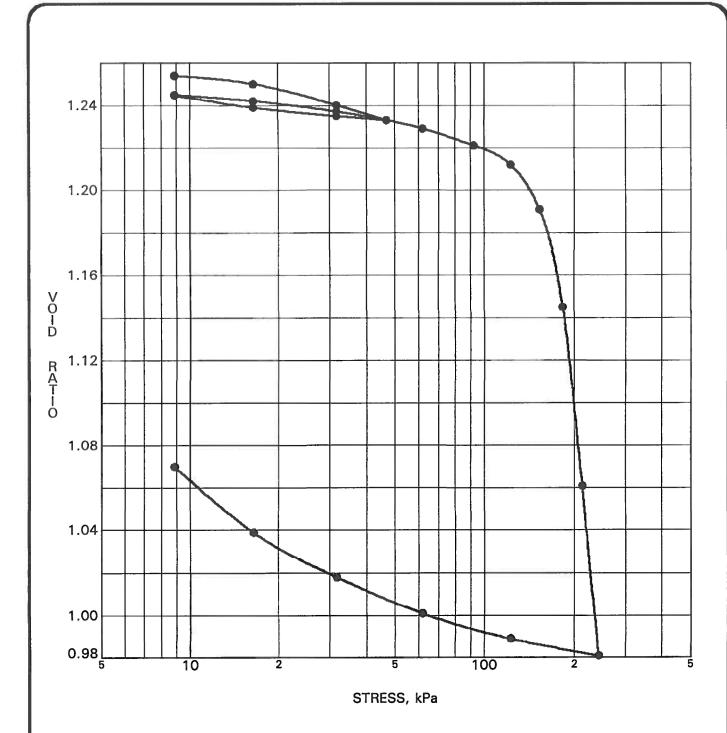
CONSOLIDATION TEST DATA SUMMARY							
Borehole No.	BH 2	p'o	114 kPa	Ccr	0.017		
Sample No.	TW 9	p'c	163 kPa	Cc	1.319		
Sample Depth	12.60 m	OC Ratio	1.4	Wo	45.7 %		
Sample Elev.	m	Void Ratio	1.256	Unit Wt.	17.4 kN/m ³

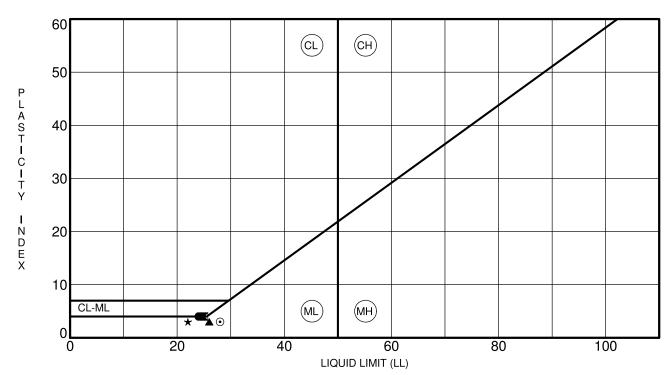
ATTERBERG LIMITS'
RESULTS

3	Specimen Identification	LL	PL	PI	Fines	Classification
•	BH 1-21 SS2	24	20	4		ML = Inorganic Silts of Low Plasticity
	BH 2-21 SS3	25	21	4		ML = Inorganic Silts of Low Plasticity
	BH 3-21 SS3	26	23	3		ML = Inorganic Silts of Low Plasticity
*	BH 4-21 SS3	22	19	3		ML = Inorganic Silts of Low Plasticity
•	BH 5-21 SS3	28	25	3		ML = Inorganic Silts of Low Plasticity

Based on the results of the Atterberg limit testing mentioned above, the plasticity index was found to be less than 40% in all the tested clay samples. In addition, based on the clay content found in the clay samples from the grain size distribution test results, moisture levels and consistency, the silty clay across the subject site is considered low to medium sensitivity clay and should not be designated as sensitive marine clays.
