# Geotechnical Investigation

*Proposed Building Expansion*

*Holiday Inn Express and Suites Hotel, Ottawa, Ontario*

CA0057064.0145-Rev0

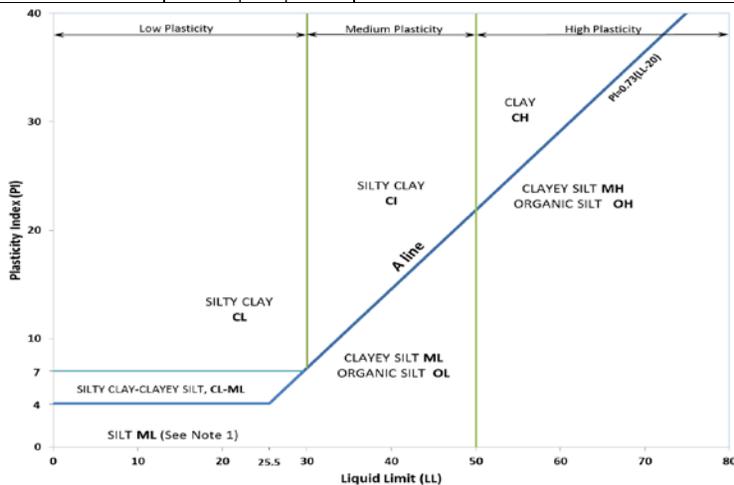
**Note 1** – Fine grained materials with PI and LL that plot in this area are named (ML) SILT with slight plasticity. Fine-grained materials which are non-plastic (i.e. a PL cannot be measured) are named SILT.  
**Note 2** – For soils with <5% organic content, include the descriptor “trace organics” for soils with between 5% and 30% organic content include the prefix “organic” before the Primary name.

**Dual Symbol** — A dual symbol is two symbols separated by a hyphen, for example, GP-GM, SW-SC and CL-ML. For non-cohesive soils, the dual symbols must be used when the soil has between 5% and 12% fines (i.e. to identify transitional material between “clean” and “dirty” sand or gravel. For cohesive soils, the dual symbol must be used when the liquid limit and plasticity index values plot in the CL-ML area of the plasticity chart (see Plasticity Chart at left).

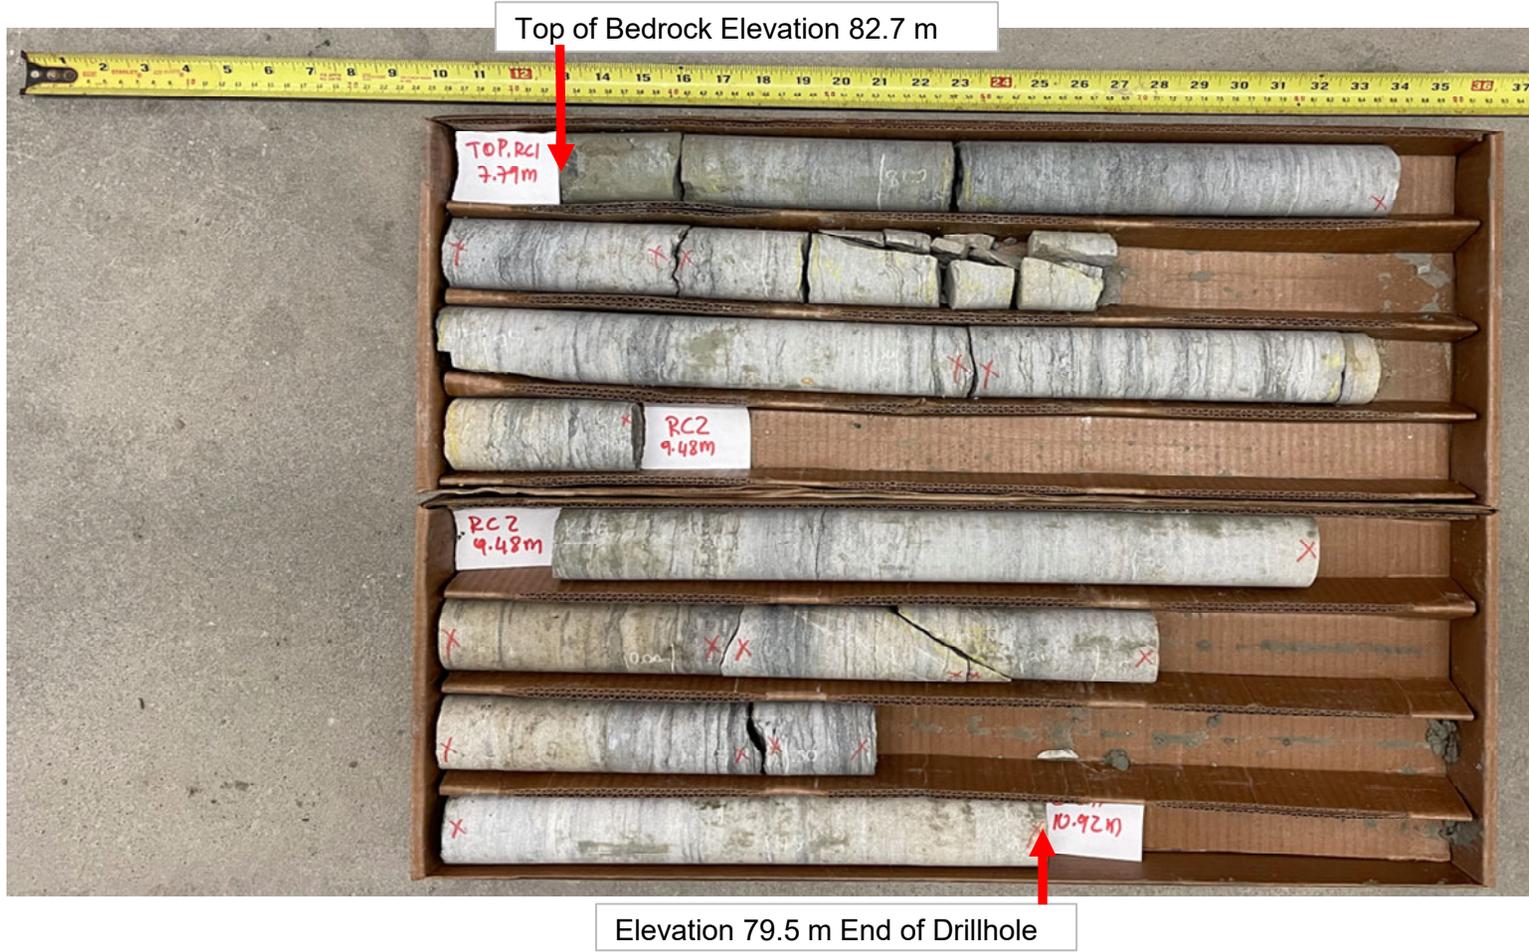
Figure B1

BH 25-01 (Dry)  
Core Box 2 of 2

The result of a UCS test carried out on a single core specimen of the bedrock was 201 MPa, which indicates a very strong rock. The result of the UCS test is provided in Figure D6 in Appendix D. Photographs of the recovered bedrock cores are presented in Appendix B. It is advised that a single UCS test and limited core sampling in one borehole may provide a preliminary indication of bedrock properties for routine foundation design but may not be sufficient to fully assess requirements for construction procedures; contractors should not rely on the limited testing presented above for construction tendering or subsequent claims.

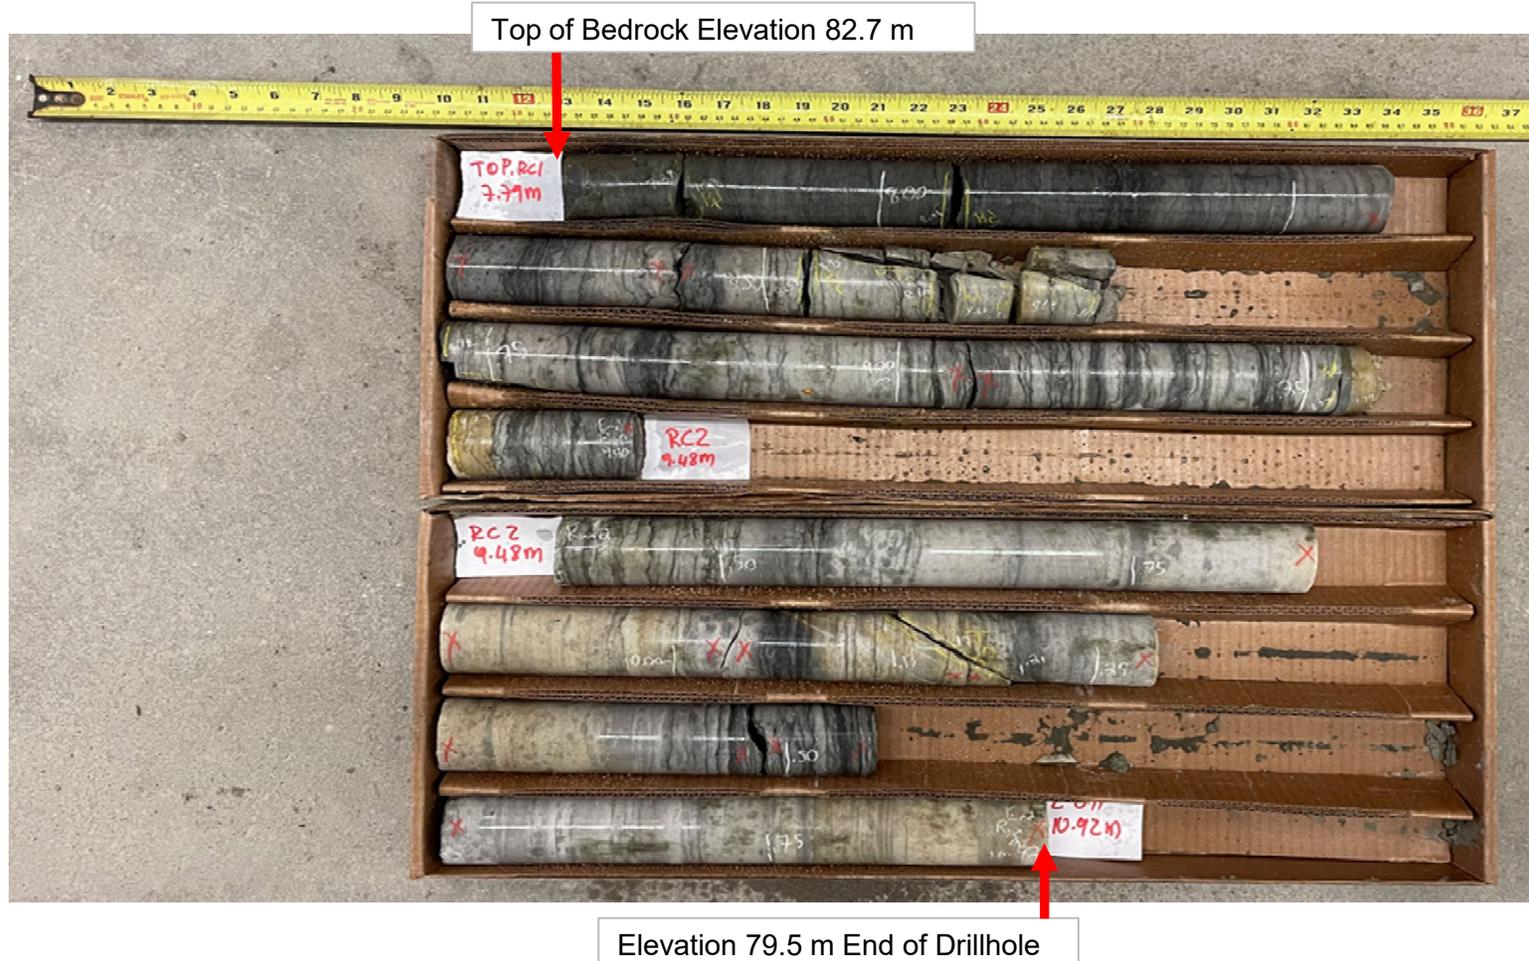
BH 25-01 (Wet)  
Core Box 2 of 2

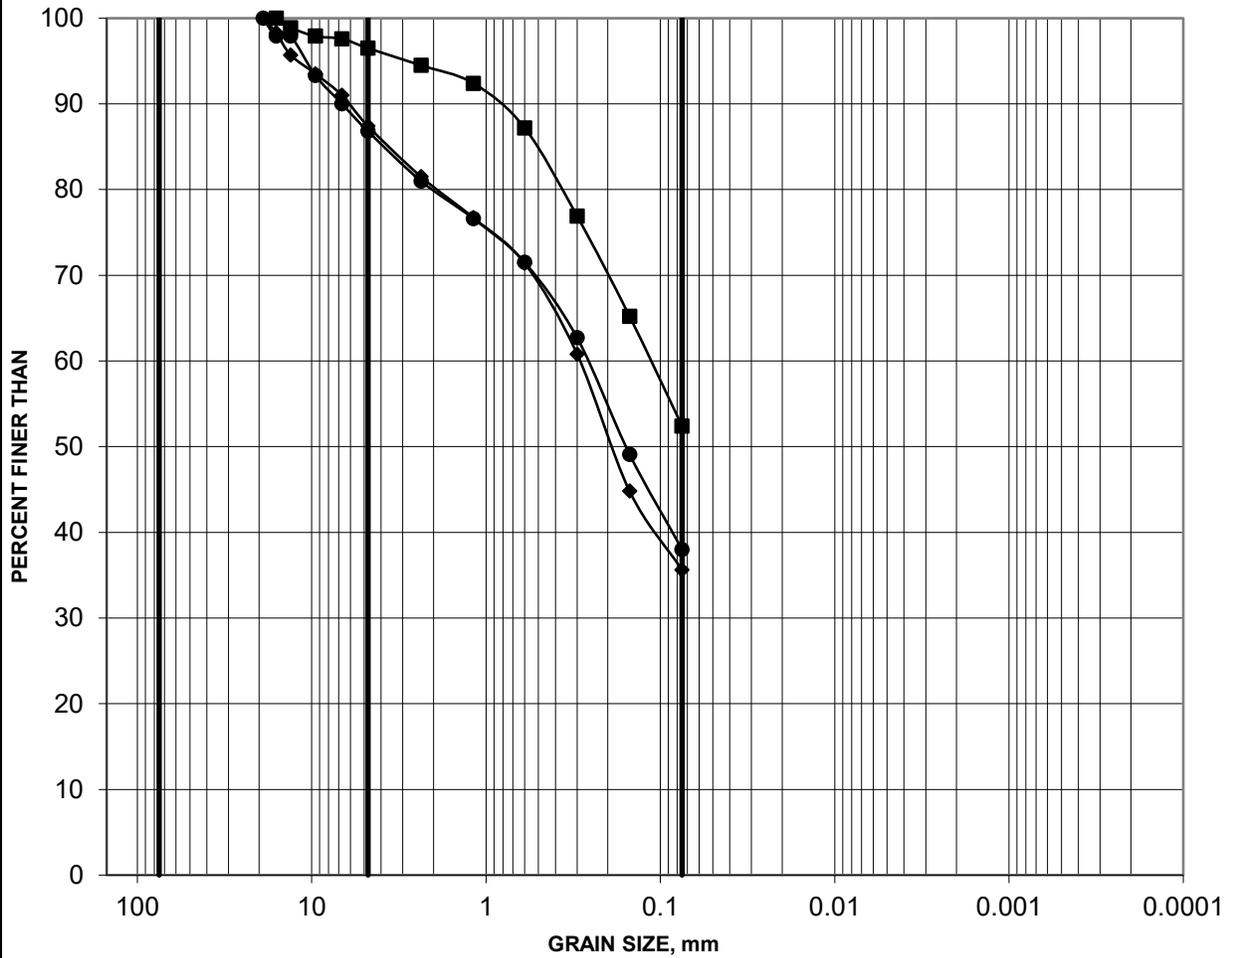
FIGURE D1

## FILL

Borehole	Sample	Depth (m)	Constituents (%)			
			Gravel	Sand	Silt	Clay
●	25-01	2	0.76-1.37	13	49	38
■	25-03	2	0.76-1.37	4	44	52
◆	25-06	2	1.12-1.52	13	51	36

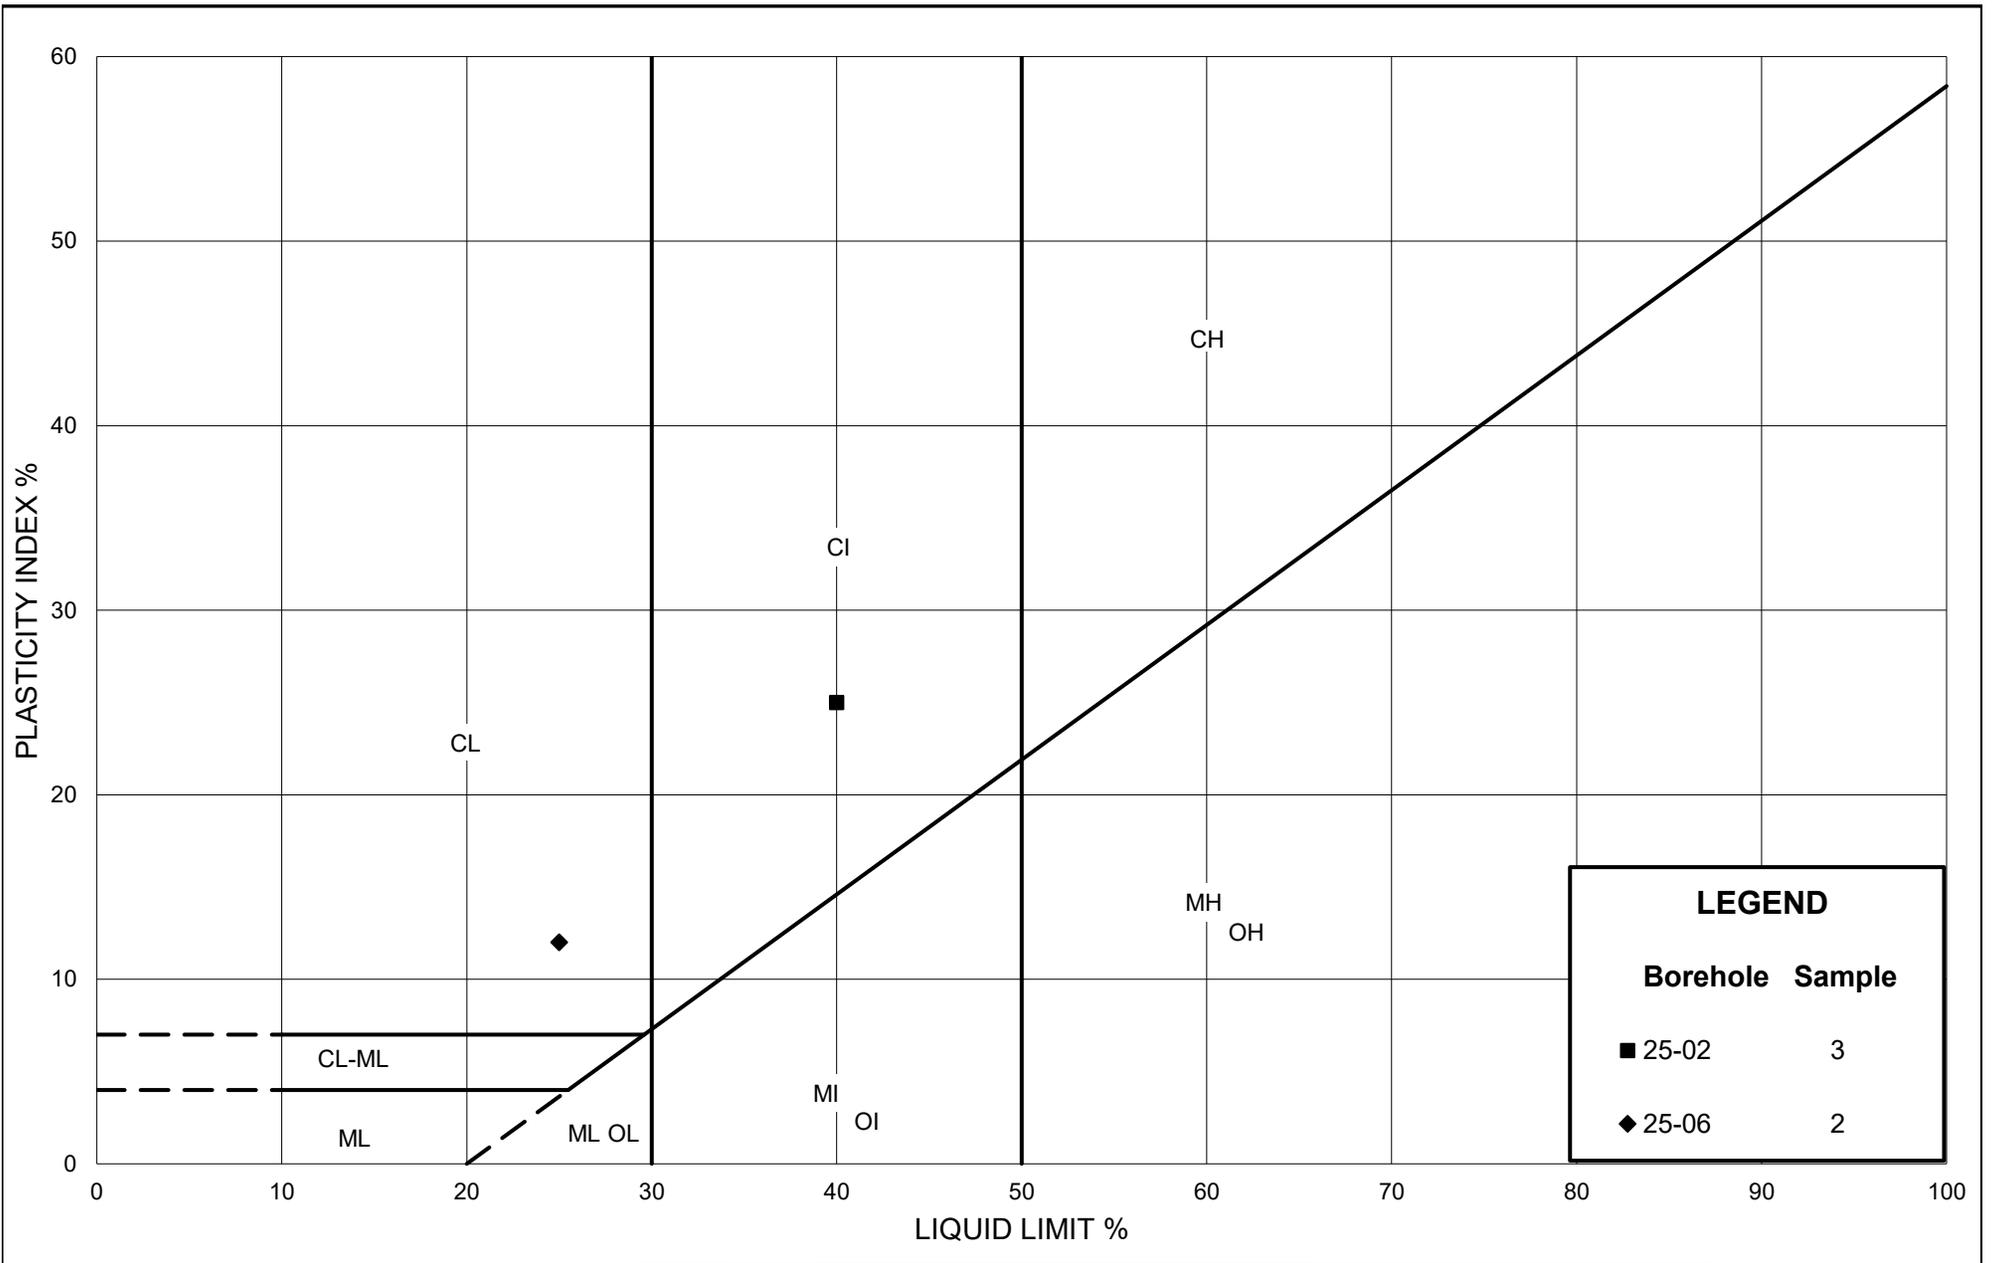
Figure:	D2
Project:	CA0057064.0145
Created By:	IK
Checked By:	KG

# PLASTICITY CHART FILL

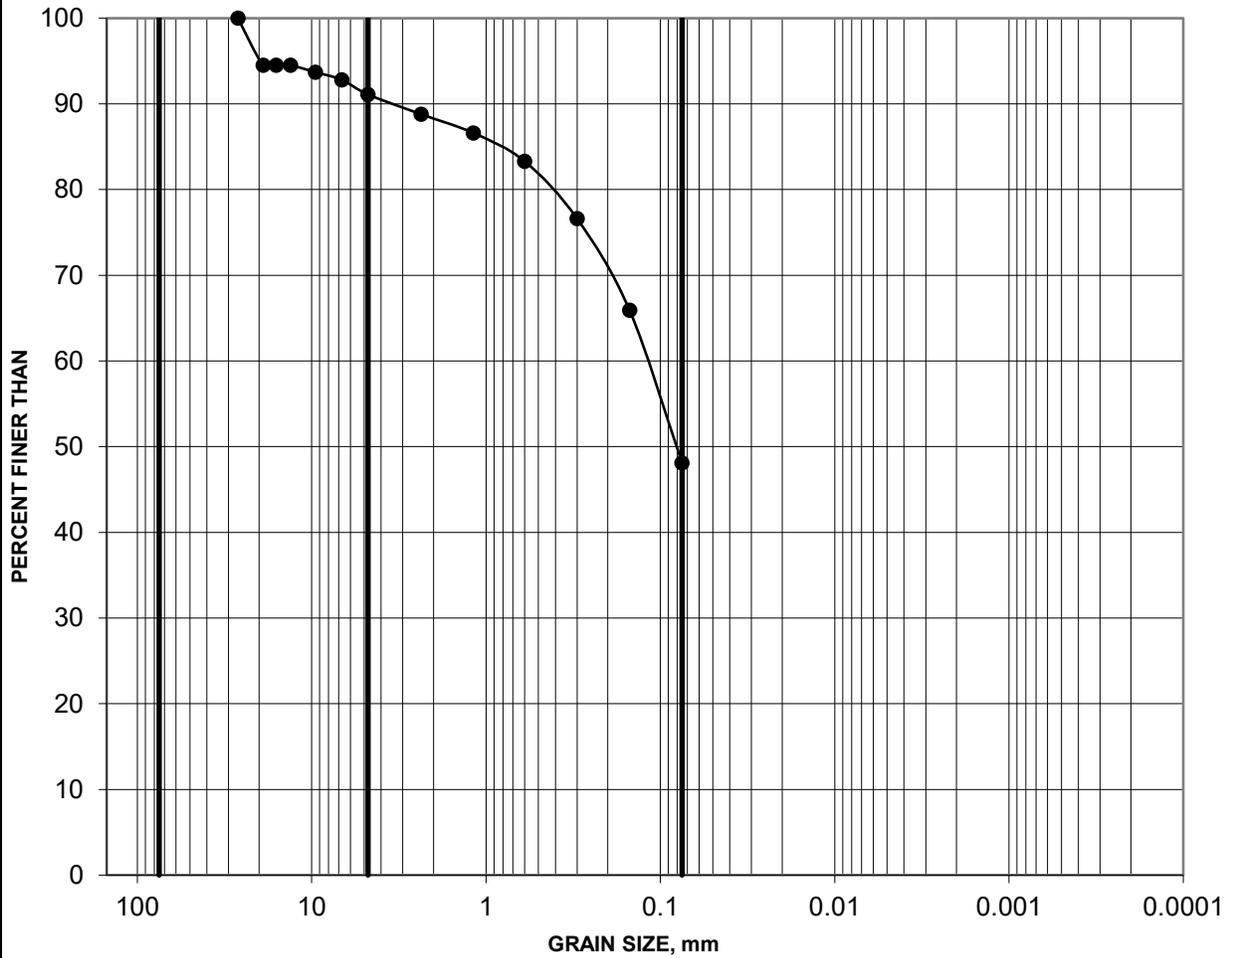
FIGURE D3

## (SC) CLAYEY SAND

Borehole	Sample	Depth (m)	Constituents (%)			
			Gravel	Sand	Silt	Clay
● 25-01	5	2.29-2.90	9	43	48

A clayey sand deposit with varying amounts of gravel was encountered below the silty clay fill layer at borehole BH25-01. Based on examination of soil samples retrieved from the borehole, there is a possibility that this material was used for valley infill on the site. The clayey sand layer extended to a depth of about 4.6 m (~El. 85.7 m) and had a thickness of about 2.3 m. SPT 'N' values ranged from 2 to 10 (blows per 0.3 m of penetration), indicating a very loose to loose state of packing.

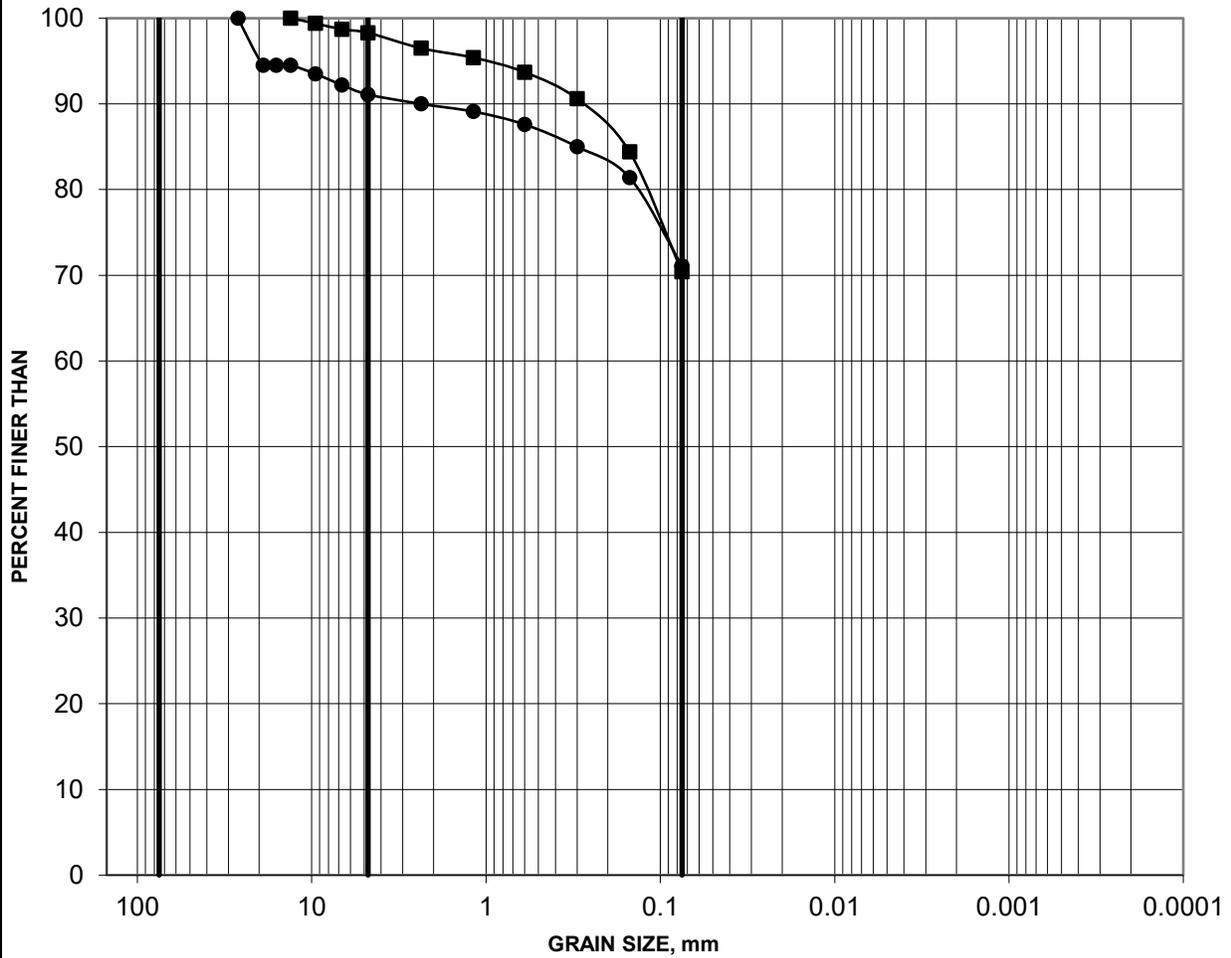
FIGURE D4

(CI) SANDY SILTY CLAY

Borehole	Sample	Depth (m)	Constituents (%)			
				Gravel	Sand	Silt	Clay
●	25-02	6	4.57-5.18	9	20	71	
■	25-02	7	6.10-6.71	2	28	70

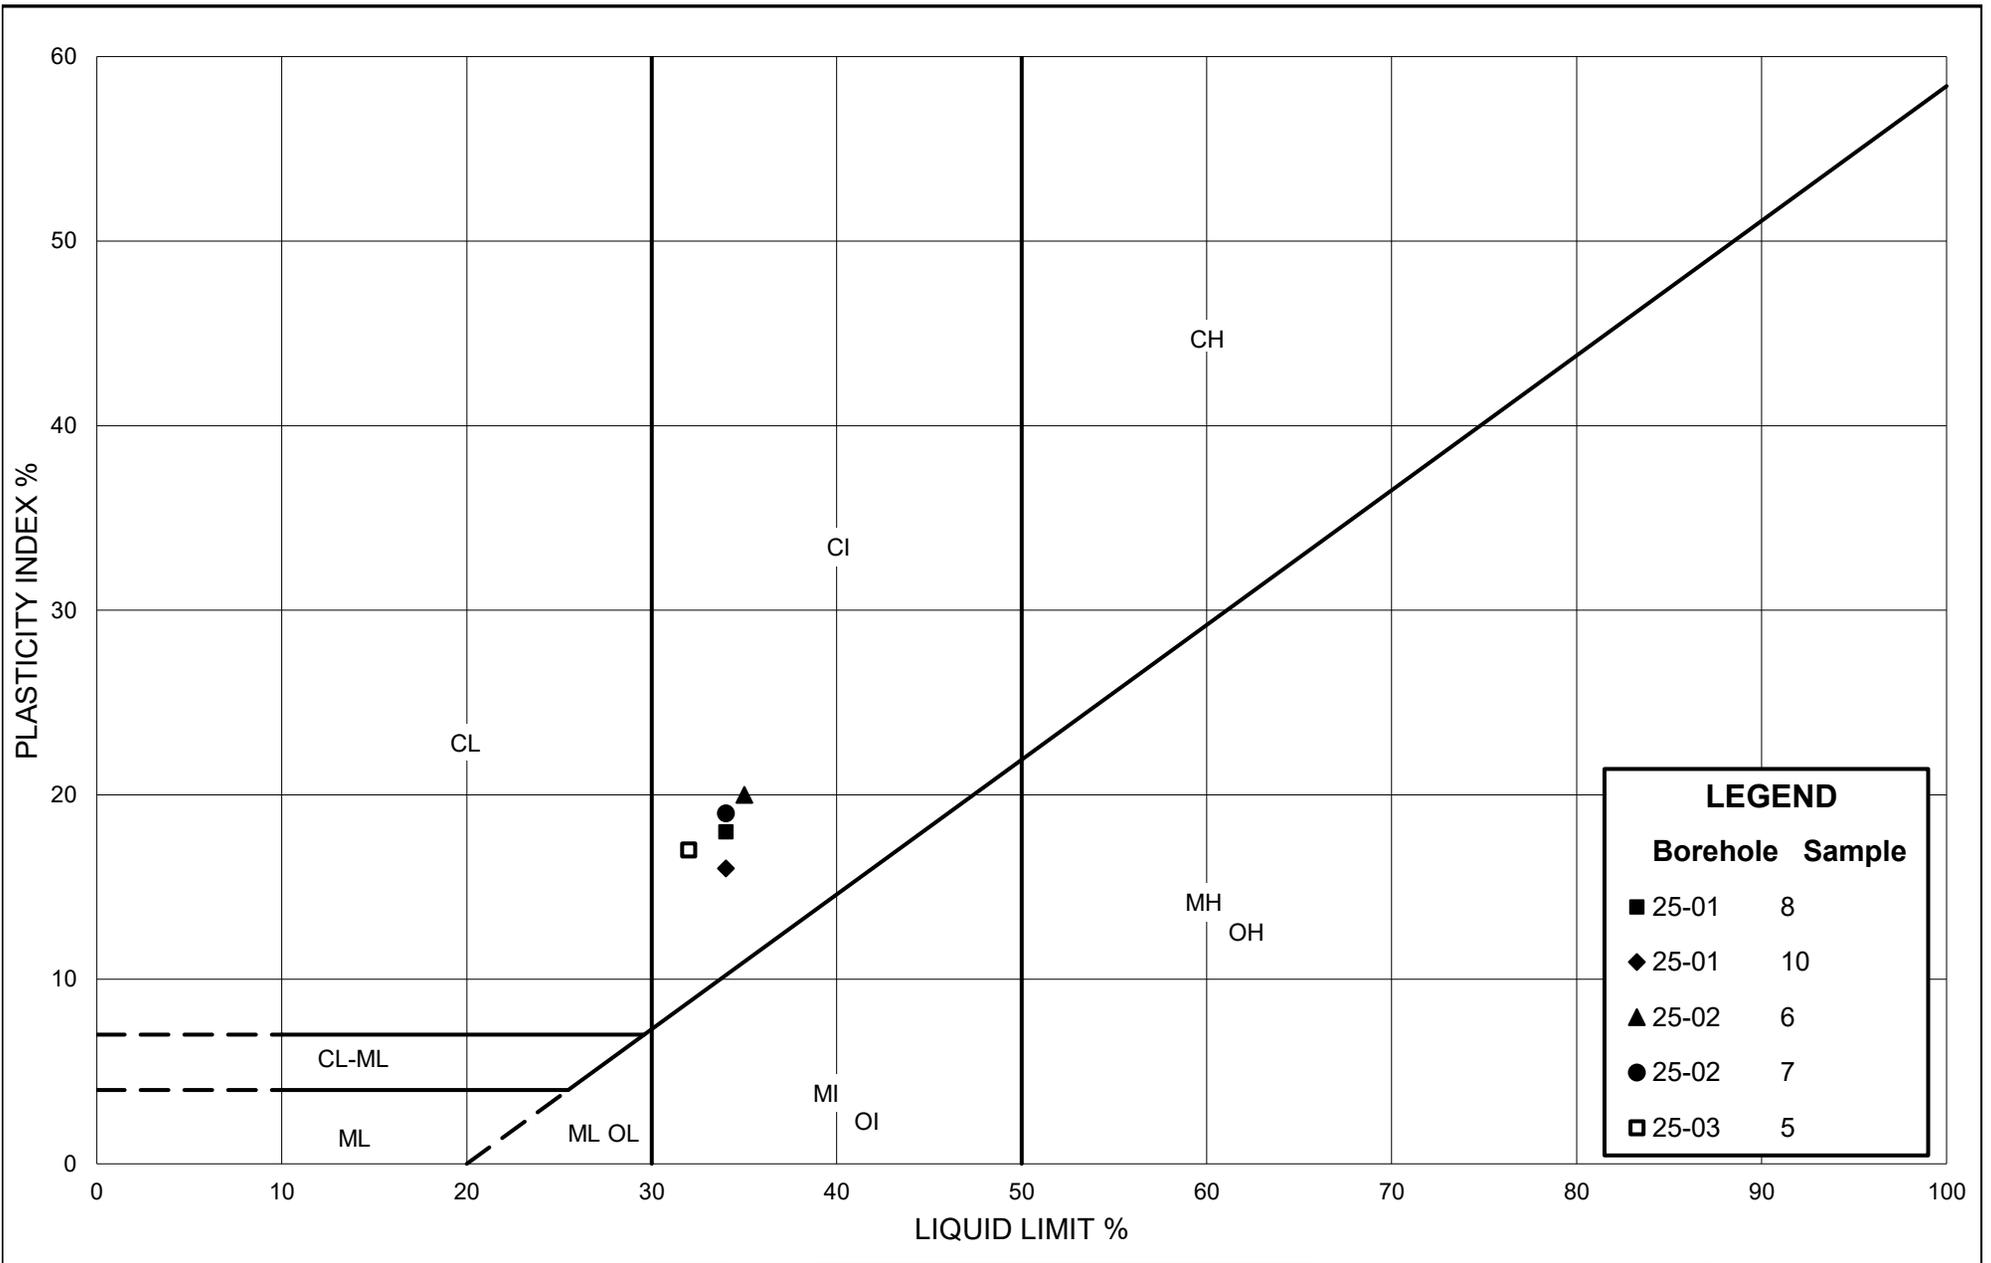
Figure:	D5
Project:	CA0057064.0145
Created By:	IK
Checked By:	KG

**PLASTICITY CHART**  
 SANDY SILTY CLAY (CI) to SILTY CLAY (CI)

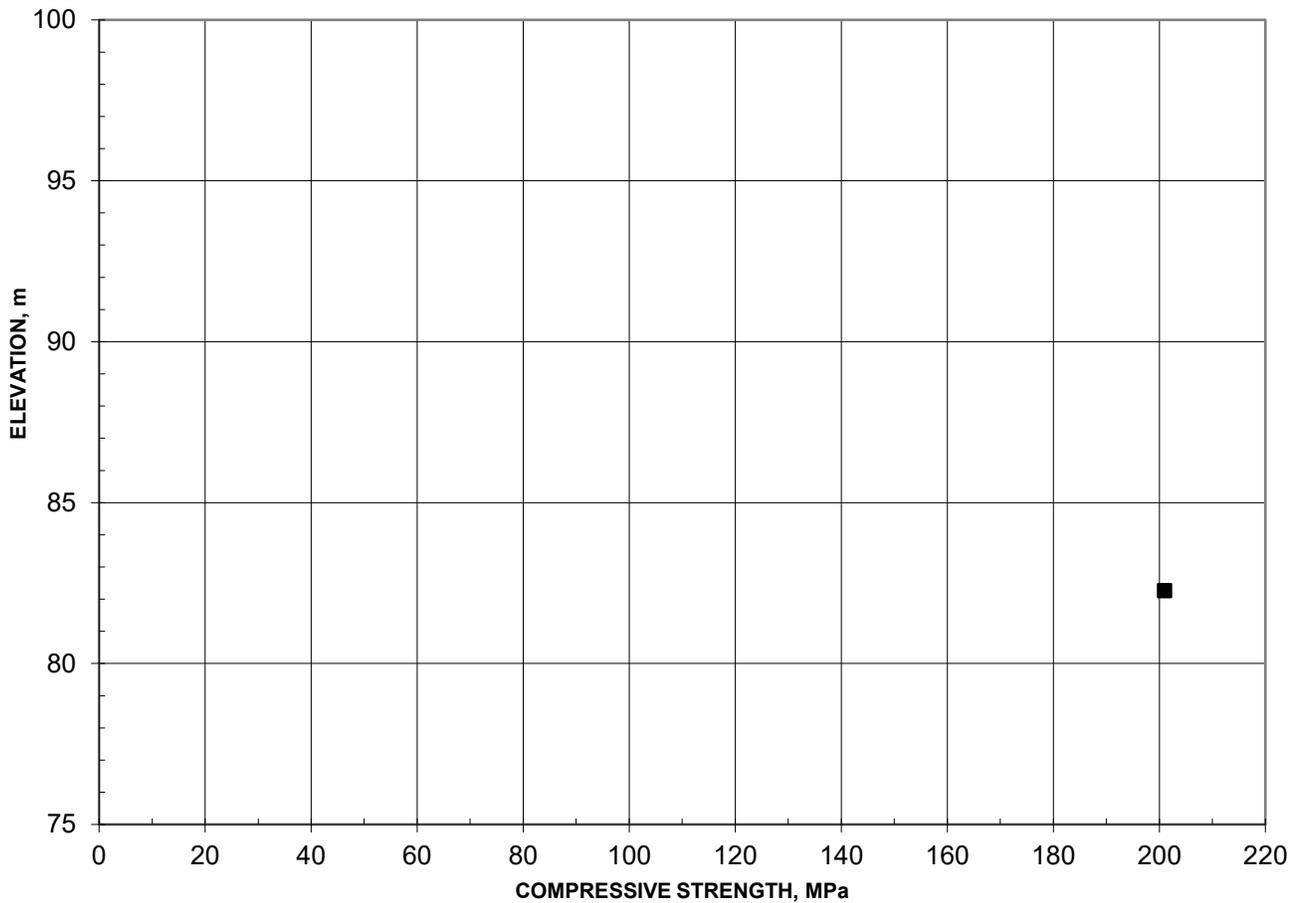
**FIGURE D6**

**ASTM D7012 - Method C**  
**UNCONFINED COMPRESSIVE STRENGTH OF ROCK CORE**  
**SUMMARY OF LABORATORY TEST RESULTS**

Borehole	Depth (m)	L/D	Bulk Density (kg/m <sup>3</sup> )	Lithology	UCS (MPa)	Failure Type
■ 25-01 RC1	8.0	2.3	2677	Sandstone	201	1

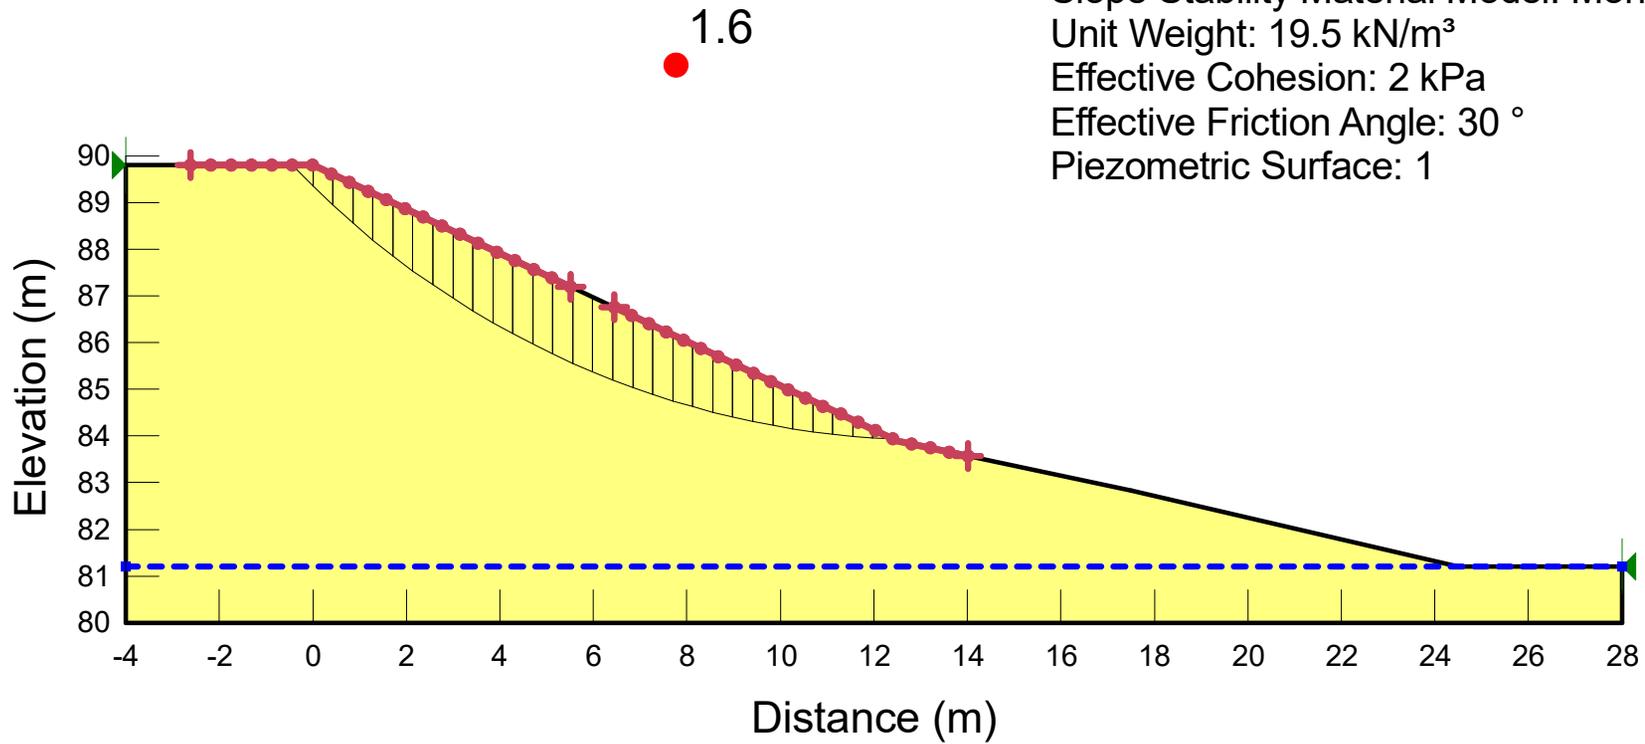
Figure F1 - Static Analysis

Name: Static Drained  
Analysis Type: Morgenstern-Price

Name: Silty Clay Fill  
Slope Stability Material Model: Mohr-Coulomb  
Unit Weight: 19.5 kN/m<sup>3</sup>  
Effective Cohesion: 2 kPa  
Effective Friction Angle: 30 °  
Piezometric Surface: 1

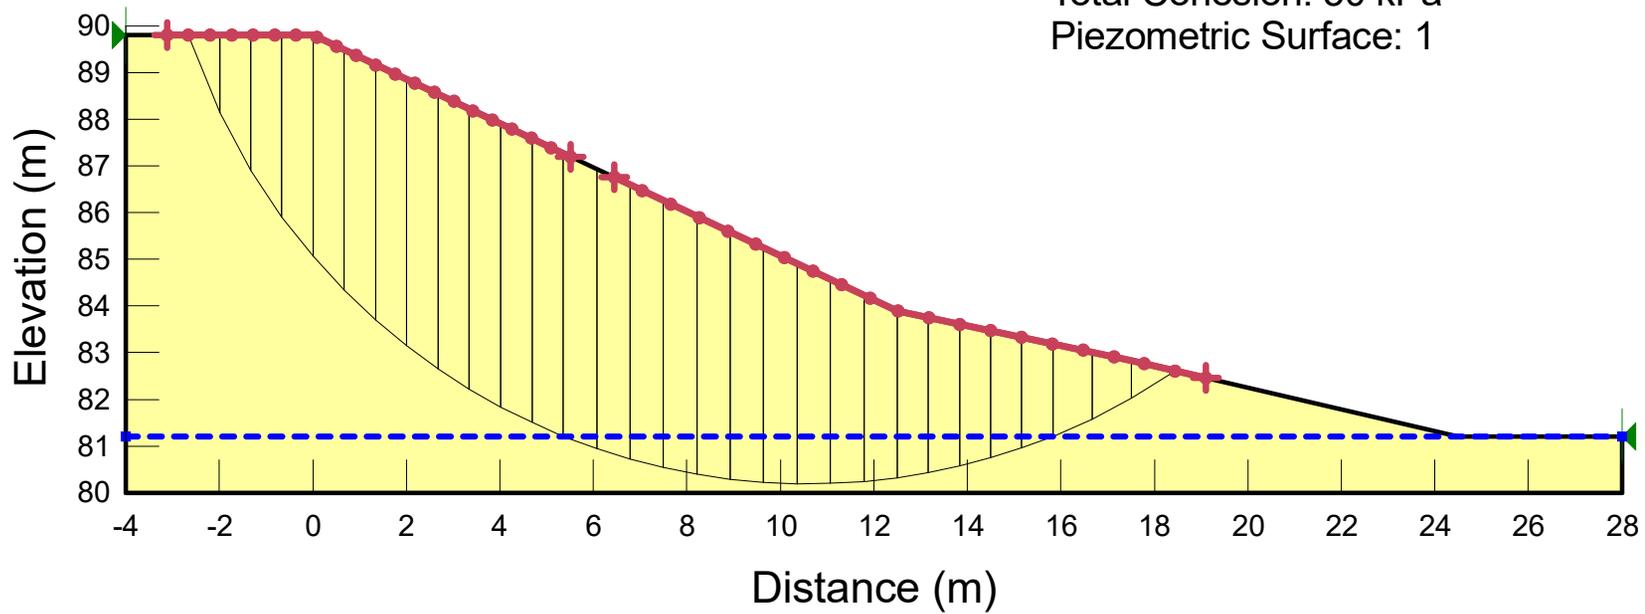
Figure F2 - Seismic Analysis

Name: Seismic Undrained  
Analysis Type: Morgenstern-Price  
Horz Seismic Coef.: 0.17

Name: Silty Clay Fill - Undrained  
Slope Stability Material Model: Undrained (Phi=0)  
Unit Weight: 19.5 kN/m<sup>3</sup>  
Total Cohesion: 50 kPa  
Piezometric Surface: 1
