Hydrogeological Assessment Report 1386 & 1394 Greely Lane, Ottawa, Ontario

Prepared for:
Cassidy EW Construction Consultant Ltd.

Cambium Reference: 17281-002

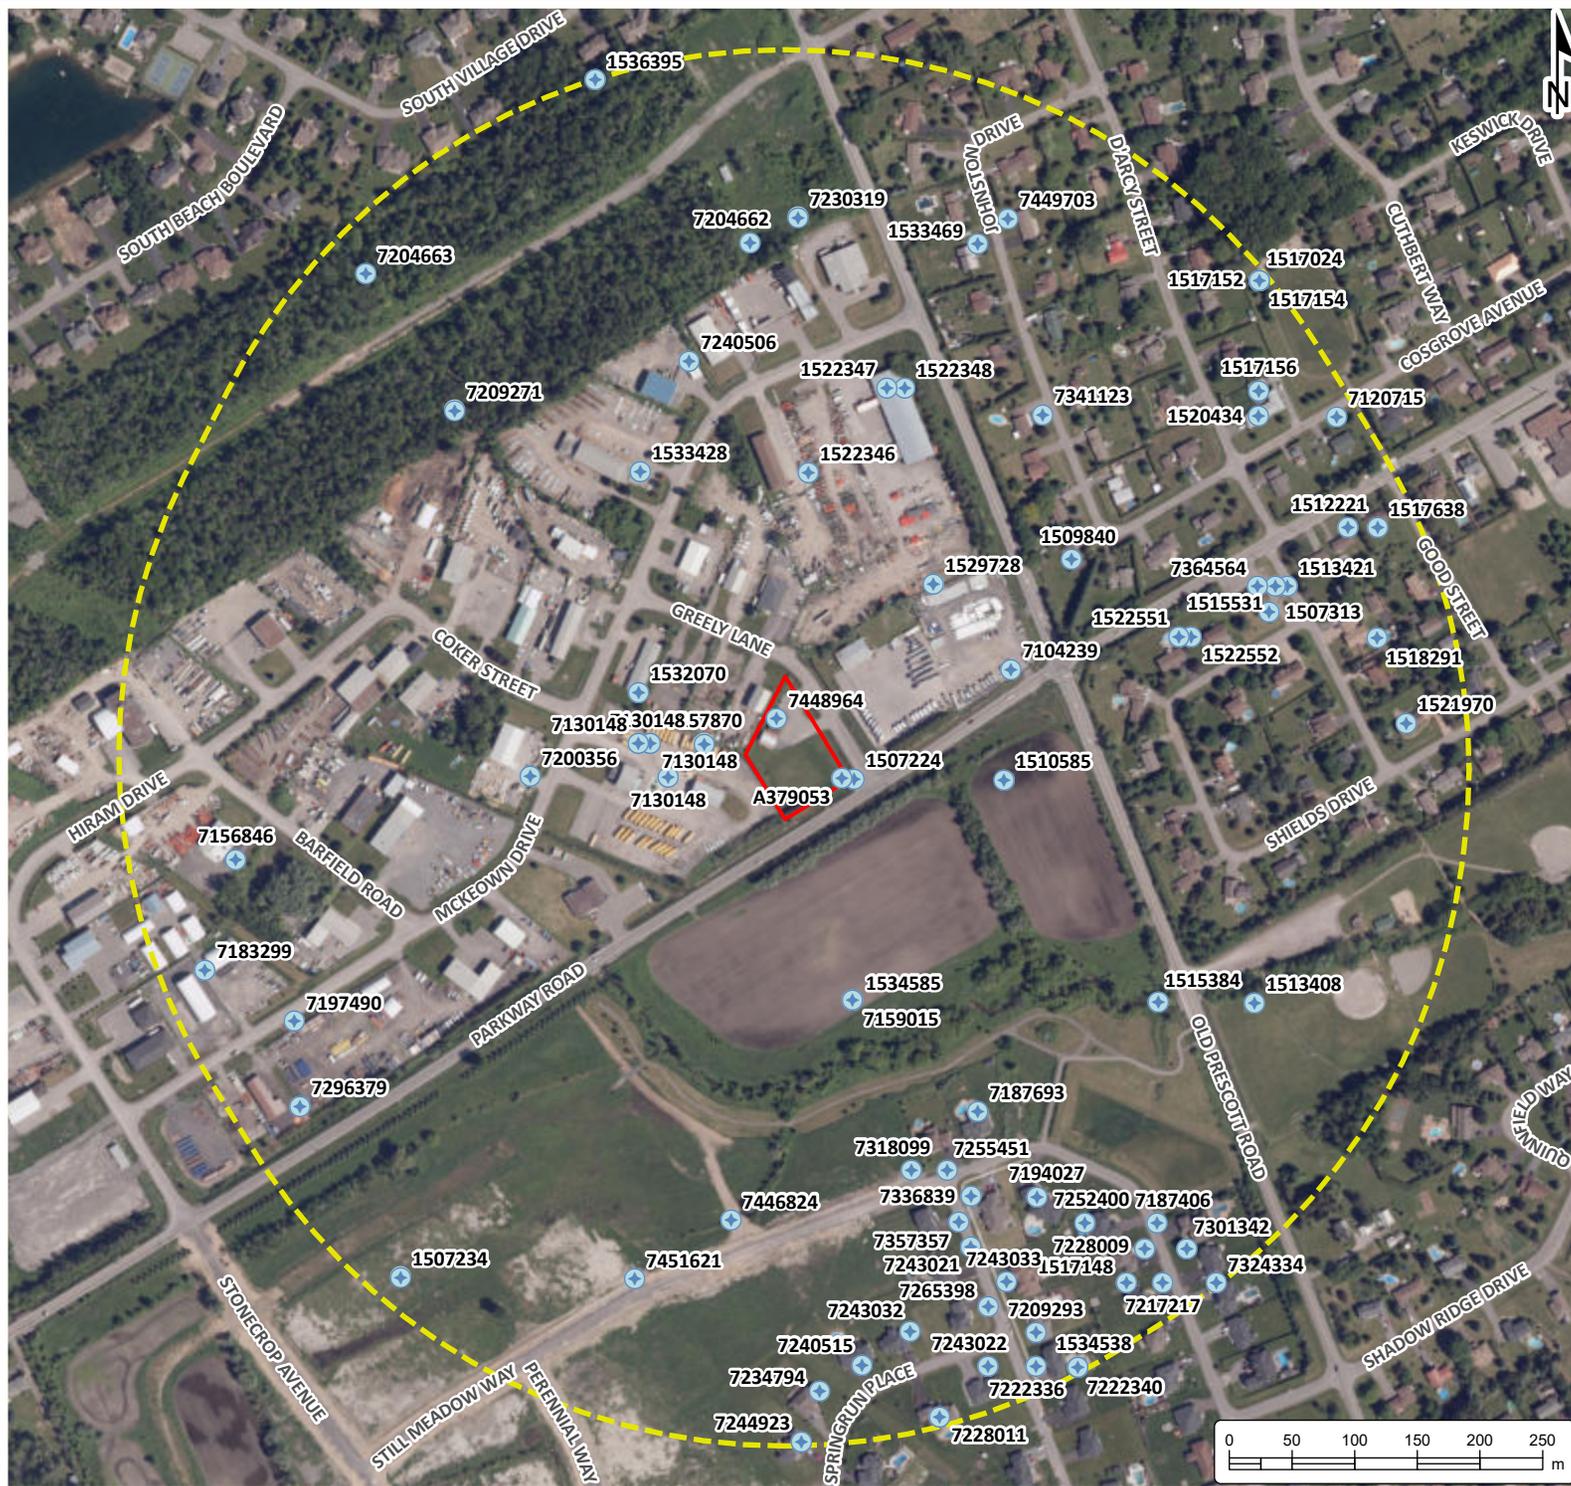
Project No.: 17281-002	Date: January 2026
Scale: 1:600	Rev.: Rev.:
Created by: LD	Checked by: JT
Projection: NAD 1983 UTM Zone 18N	Figure: 3

Groundwater was observed at all borehole locations during drilling. Unstabilized groundwater level measurements were recorded upon completion of drilling and monitoring wells were installed in three locations (BH105-23, BH106-23, and BH107-23) to enable further characterization. A subsequent monitoring event was completed as part of Phase II ESA work, as well as during hydraulic testing detailed later in this report (Section 4.3). As demonstrated in Table 1, there is significant variability in groundwater levels, which is expected within shallow unconfined aquifers. A figure illustrating the approximate groundwater flow direction based on water levels measured April 19, 2024 is provided in Figure 3.

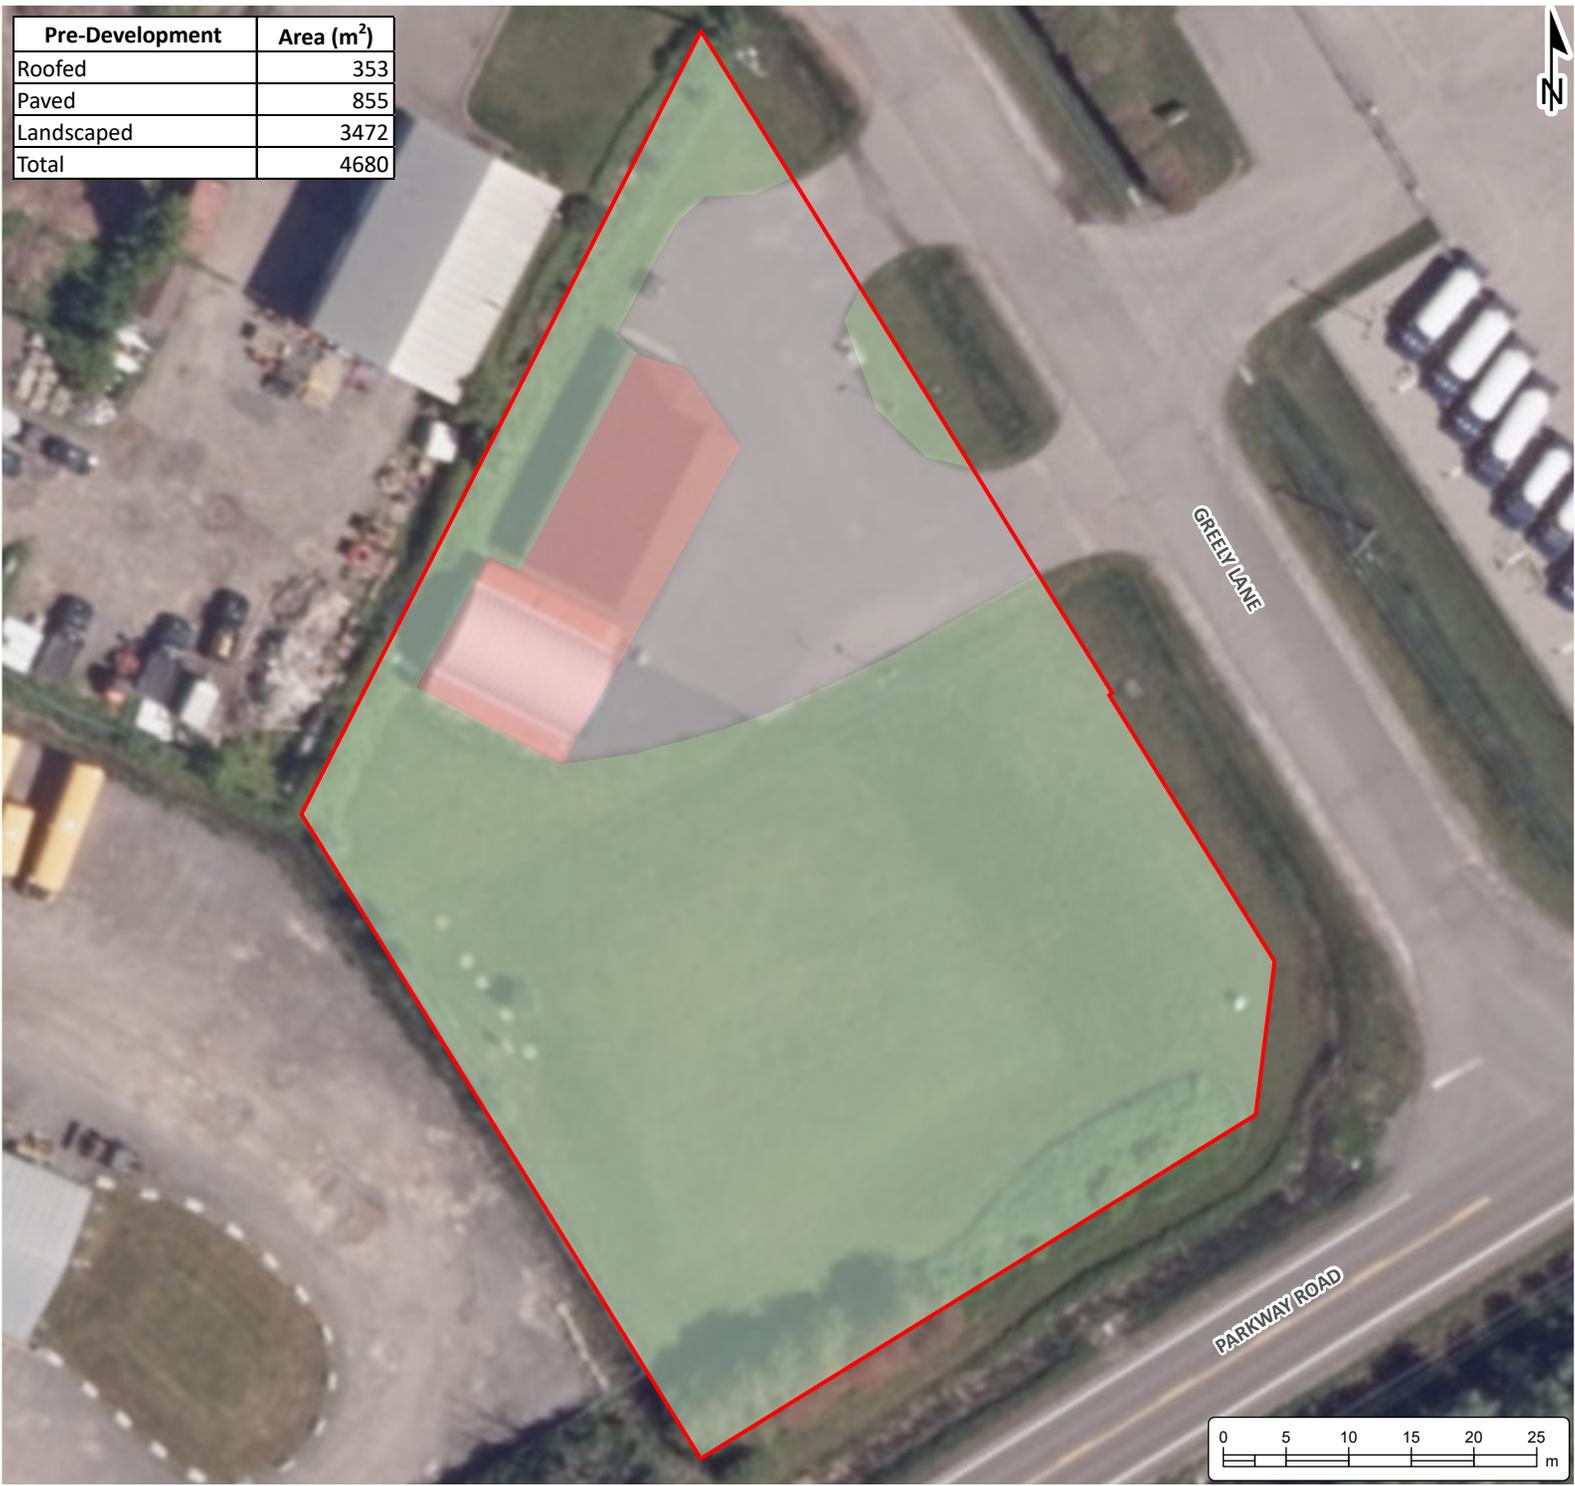
The water balance for existing conditions at the Site is summarized in Table 15. The pre-development infiltration rate and runoff rate was calculated to be 620 m³/year and 1,784 m³/year, respectively.

Pre-Development	Area (m ²)
Roofed	353
Paved	855
Landscaped	3472
Total	4680

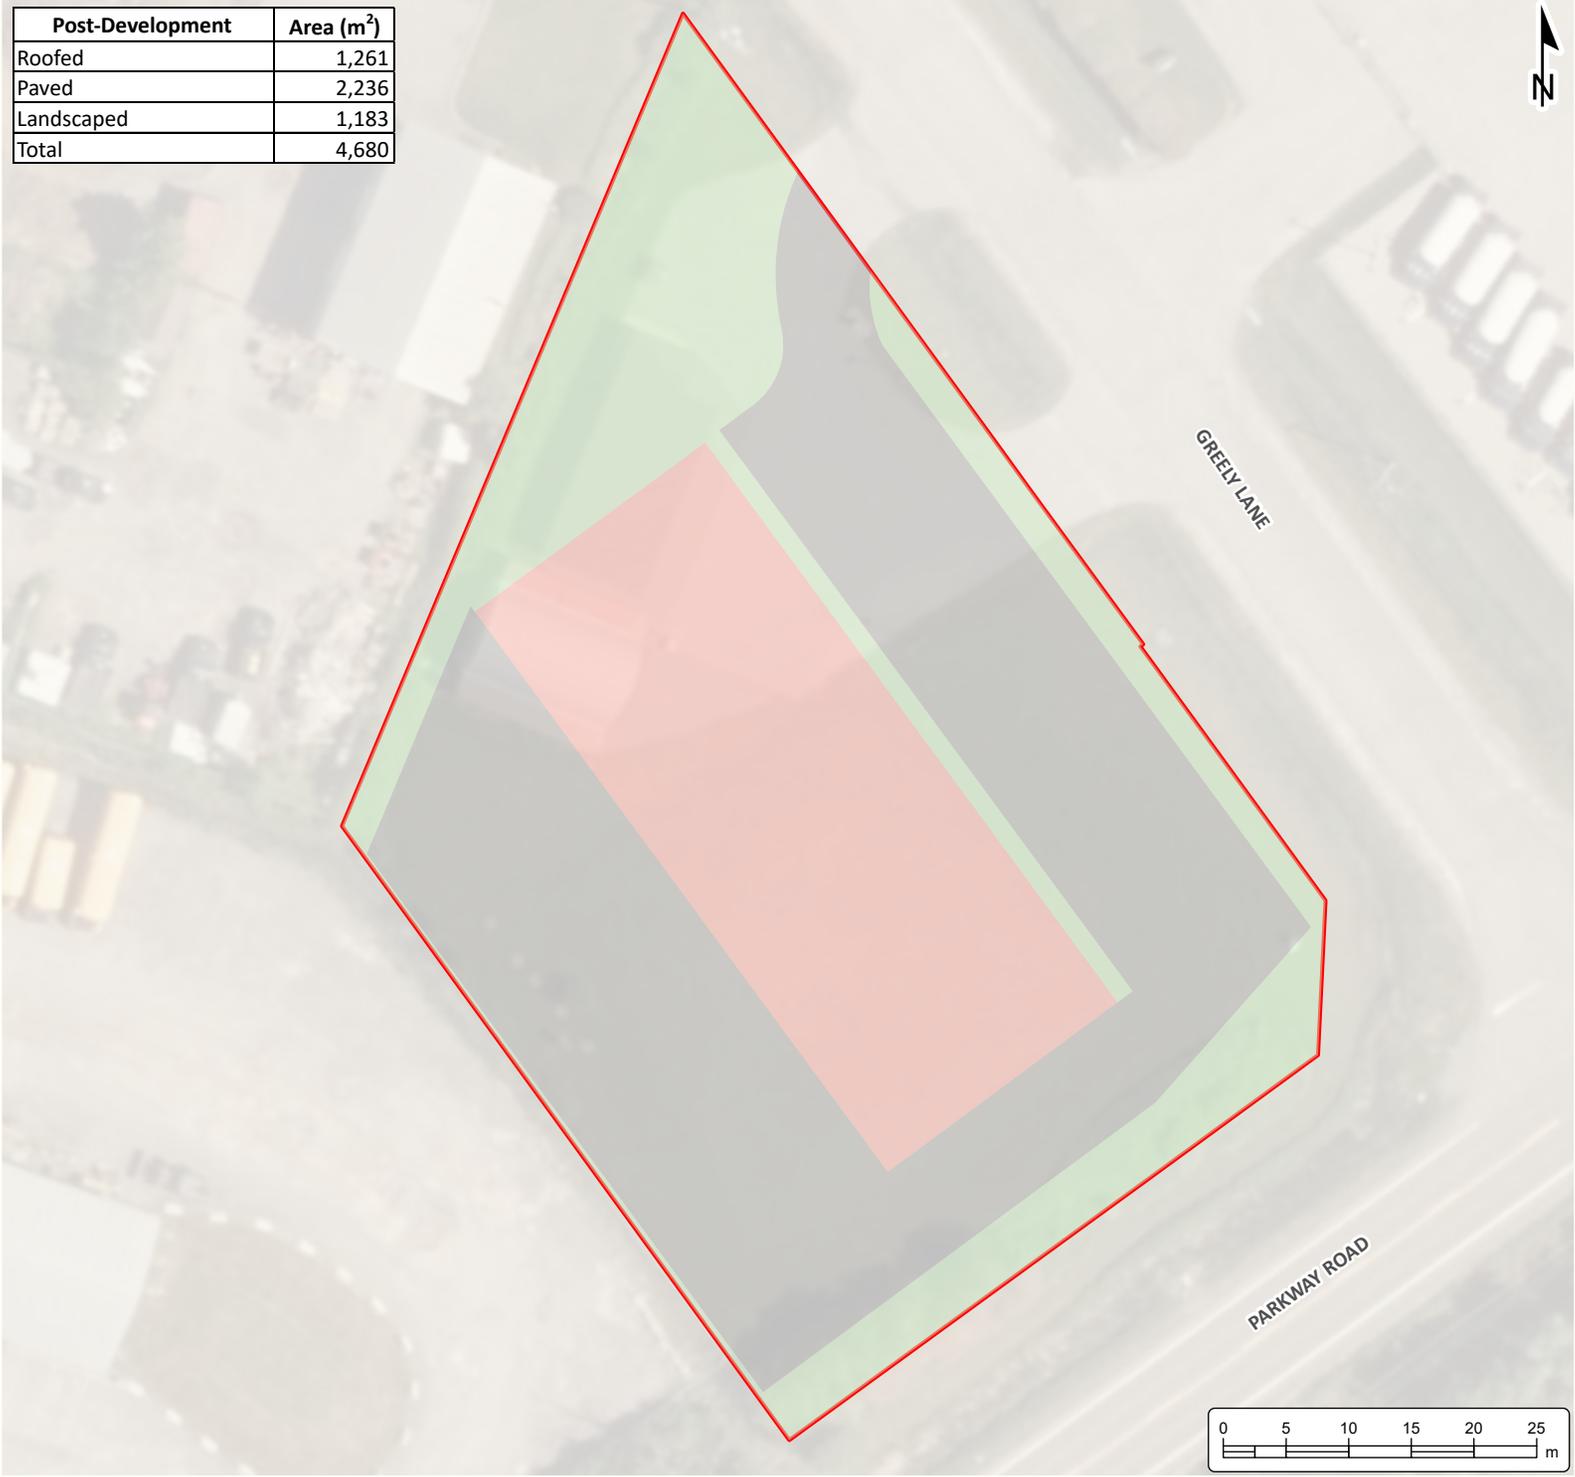
Project No.: 17281-002	Date: January 2026
Scale: 1:600	Rev.: Rev.:
Created by: NLB	Checked by: JT
Figure: 5	Projection: NAD 1983 UTM Zone 18N

The water balance for proposed conditions at the Site is summarized in Table 16. The post-development infiltration rate and runoff rate was calculated to be 211 m³/year and 3,229 m³/year, respectively.

Post-Development	Area (m ²)
Roofed	1,261
Paved	2,236
Landscaped	1,183
Total	4,680

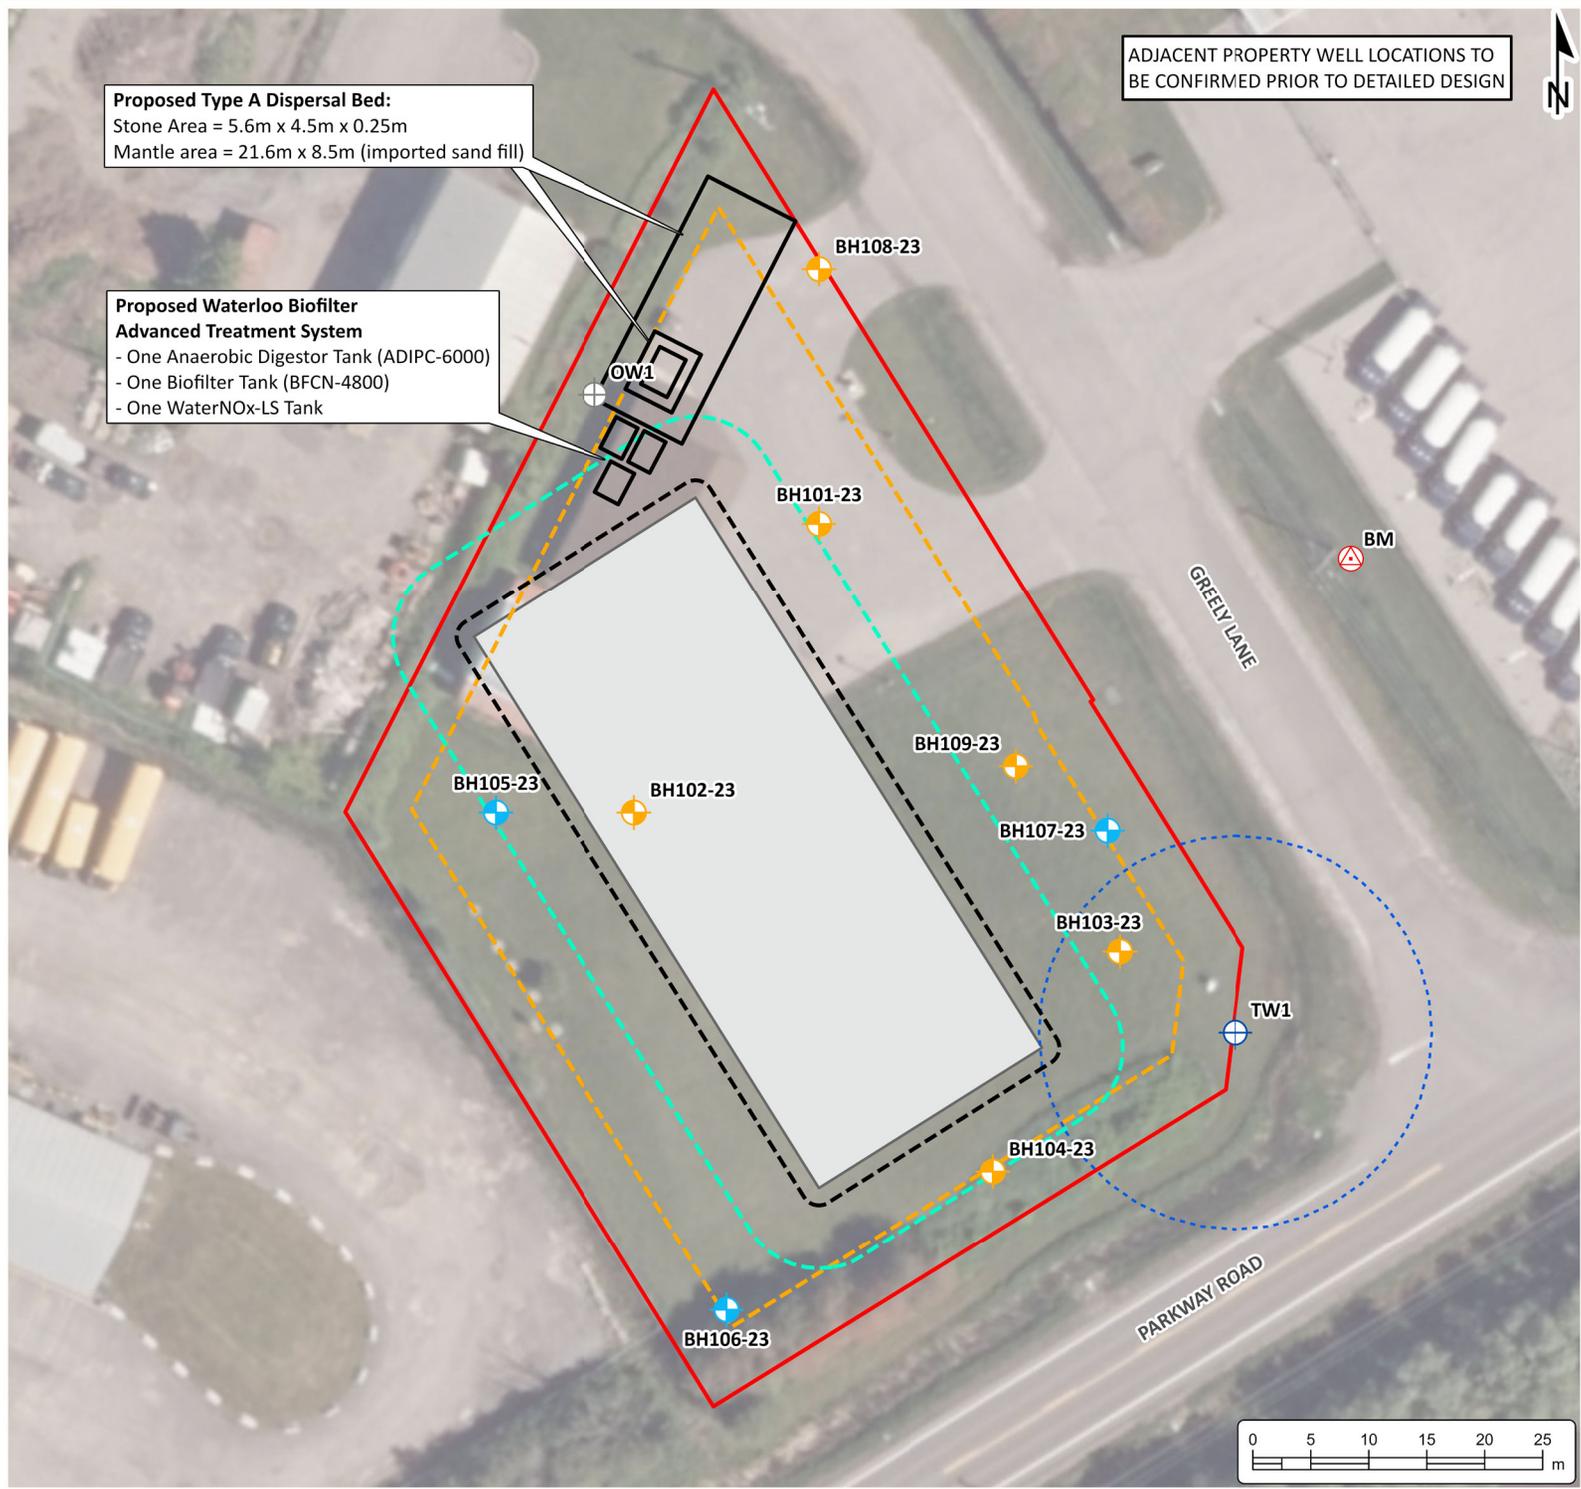
Project No.: 17281-002	Date: January 2026
Scale: 1:600	Rev.: NAD 1983 UTM Zone 17N
Created by: NLB	Checked by: JT
Figure: 6

Proposed Type A Dispersal Bed:
 Stone Area = 5.6m x 4.5m x 0.25m
 Mantle area = 21.6m x 8.5m (imported sand fill)

**Proposed Waterloo Biofilter
 Advanced Treatment System**
 - One Anaerobic Digester Tank (ADIPC-6000)
 - One Biofilter Tank (BFCN-4800)
 - One WaterNOx-LS Tank

The area of the Site appears to provide adequate space for the installation of an on-site sewage system and appears to meet the required setback distances outlined in OBC Tables 8.2.1.6.A and 8.2.1.6.B. However, this should be considered and evaluated during the detailed sewage system design stage. The Site conditions appear feasible to install an on-site sewage system.

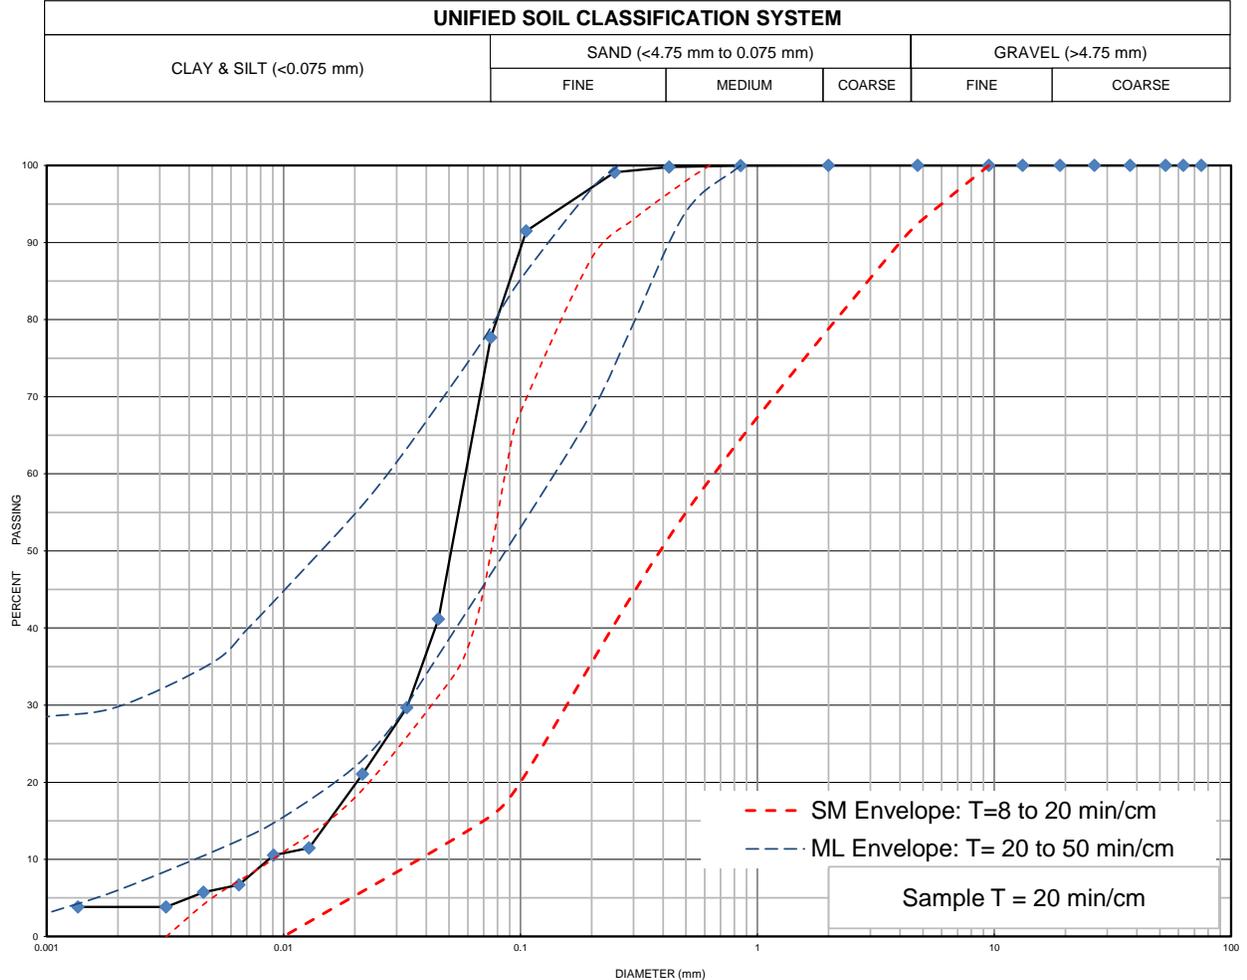
Grain Size Distribution Chart

Project Number: 17281-002 **Client:** Cassidy E.W. Construction Consultant Ltd.
Project Name: Hydrogeological Assessment - 1386 & 1394 Greely Lane, Ottawa
Sample Date: March 7-8, 2023 **Sampled By:** Farhan Imtiaz - Cambium Inc.
Location: BH 104-23 SS 6 **Depth:** 3.8 m to 4.4 m **Lab Sample No:** S-23-0478

Borehole No.	Sample No.	Depth	Gravel	Sand	Silt	Clay	Moisture
BH 104-23	SS 6	3.8 m to 4.4 m	0	22	74	4	14.3
Description		Classification	D ₆₀	D ₃₀	D ₁₀	C _u	C _c
Sandy Silt trace Clay		ML	0.0590	0.0340	0.0087	6.78	2.25

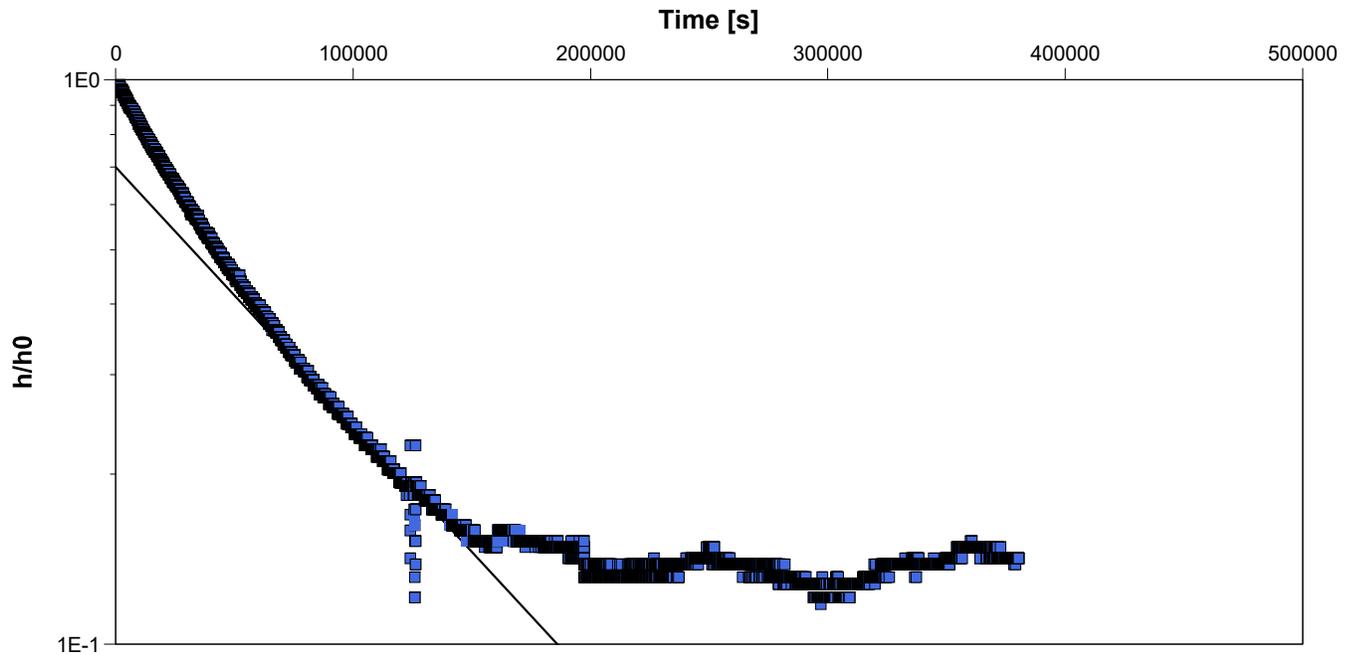
Calculation using Hvorslev

Observation Well	Hydraulic Conductivity [m/s]
BH105-23	6.35×10^{-9}

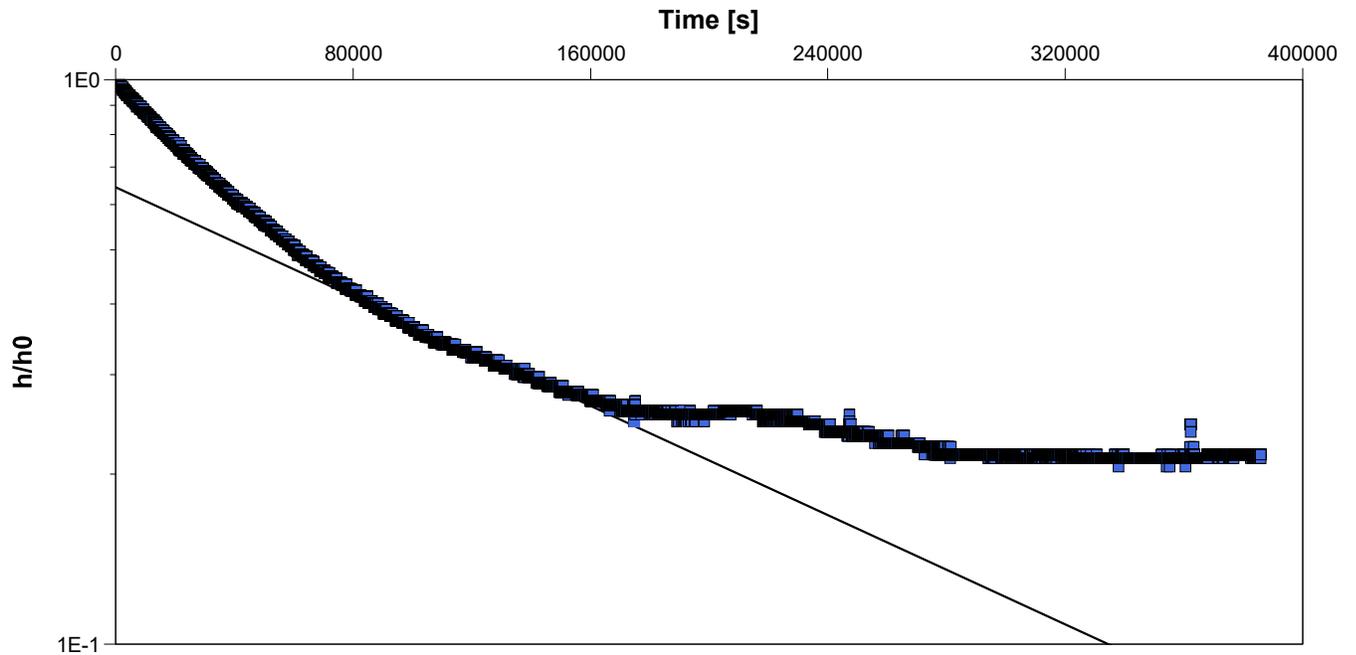
Calculation using Hvorslev

Observation Well	Hydraulic Conductivity [m/s]
BH105-23	3.38×10^{-9}

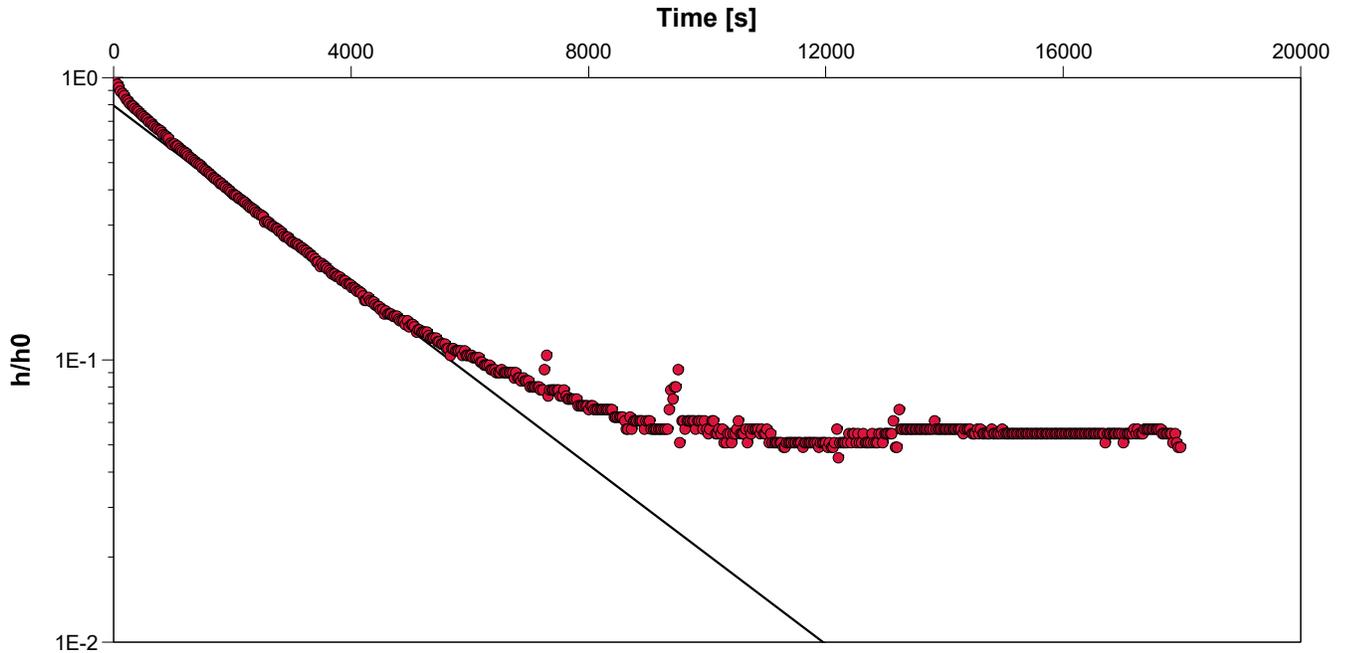
Calculation using Hvorslev

Observation Well	Hydraulic Conductivity [m/s]
BH106-23	2.22×10^{-7}

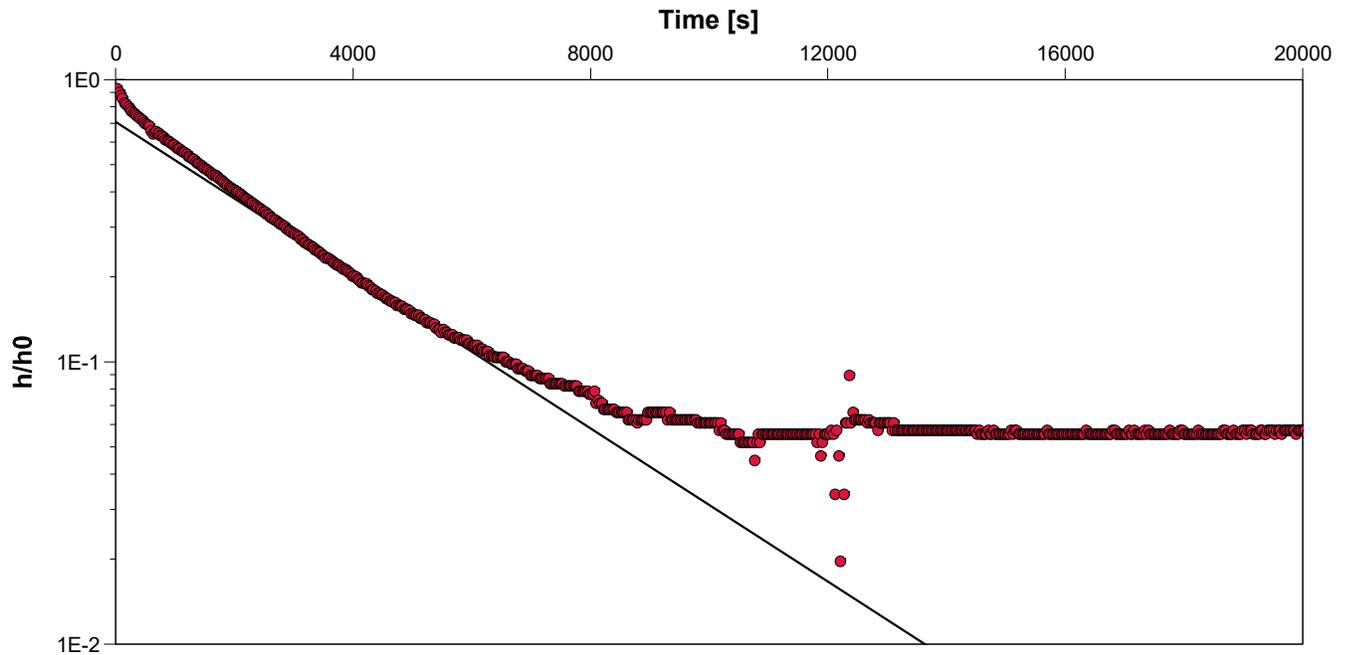
Calculation using Hvorslev

Observation Well	Hydraulic Conductivity [m/s]
BH106-23	1.90×10^{-7}

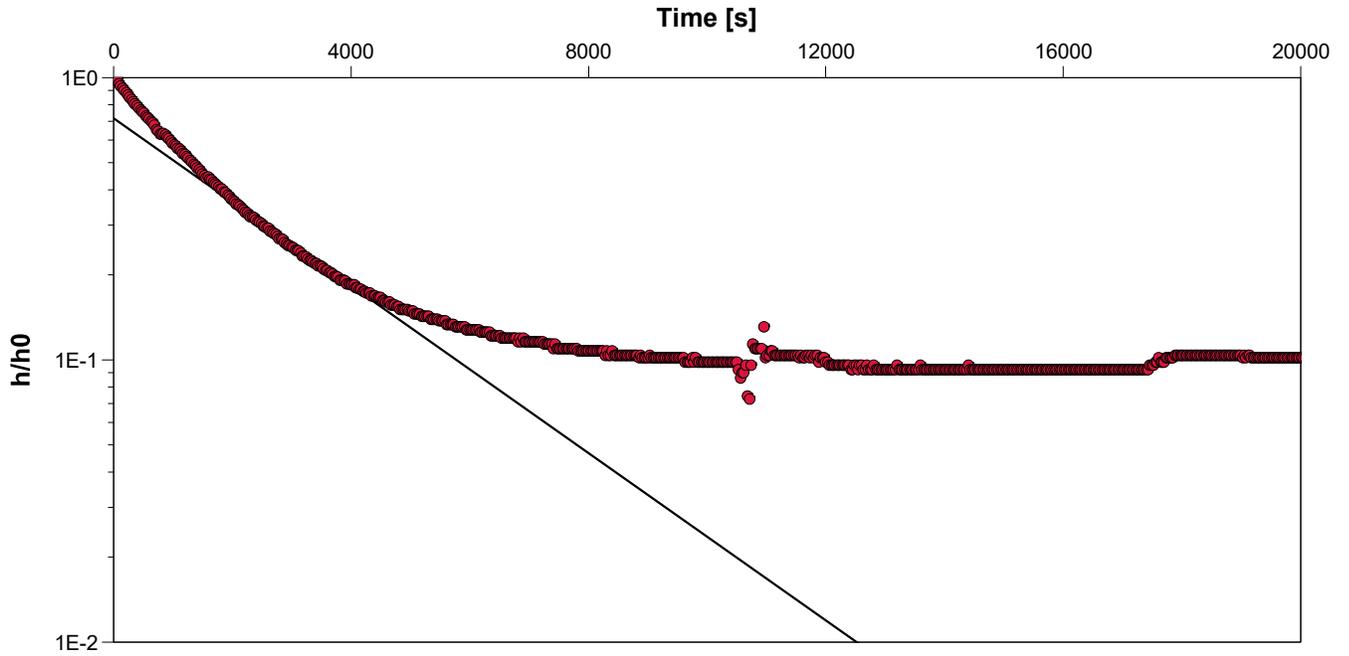
Calculation using Hvorslev

Observation Well	Hydraulic Conductivity [m/s]
BH106-23	2.07×10^{-7}

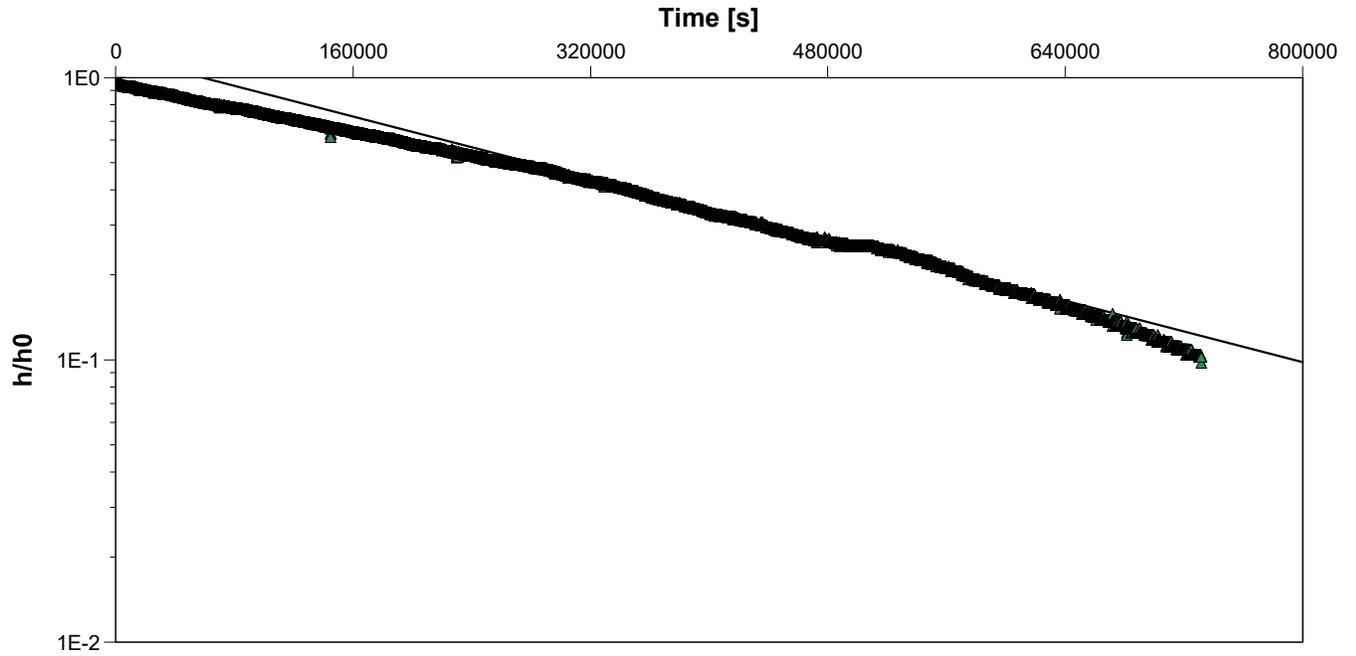
Calculation using Hvorslev

Observation Well	Hydraulic Conductivity [m/s]
BH107-23	1.90×10^{-9}

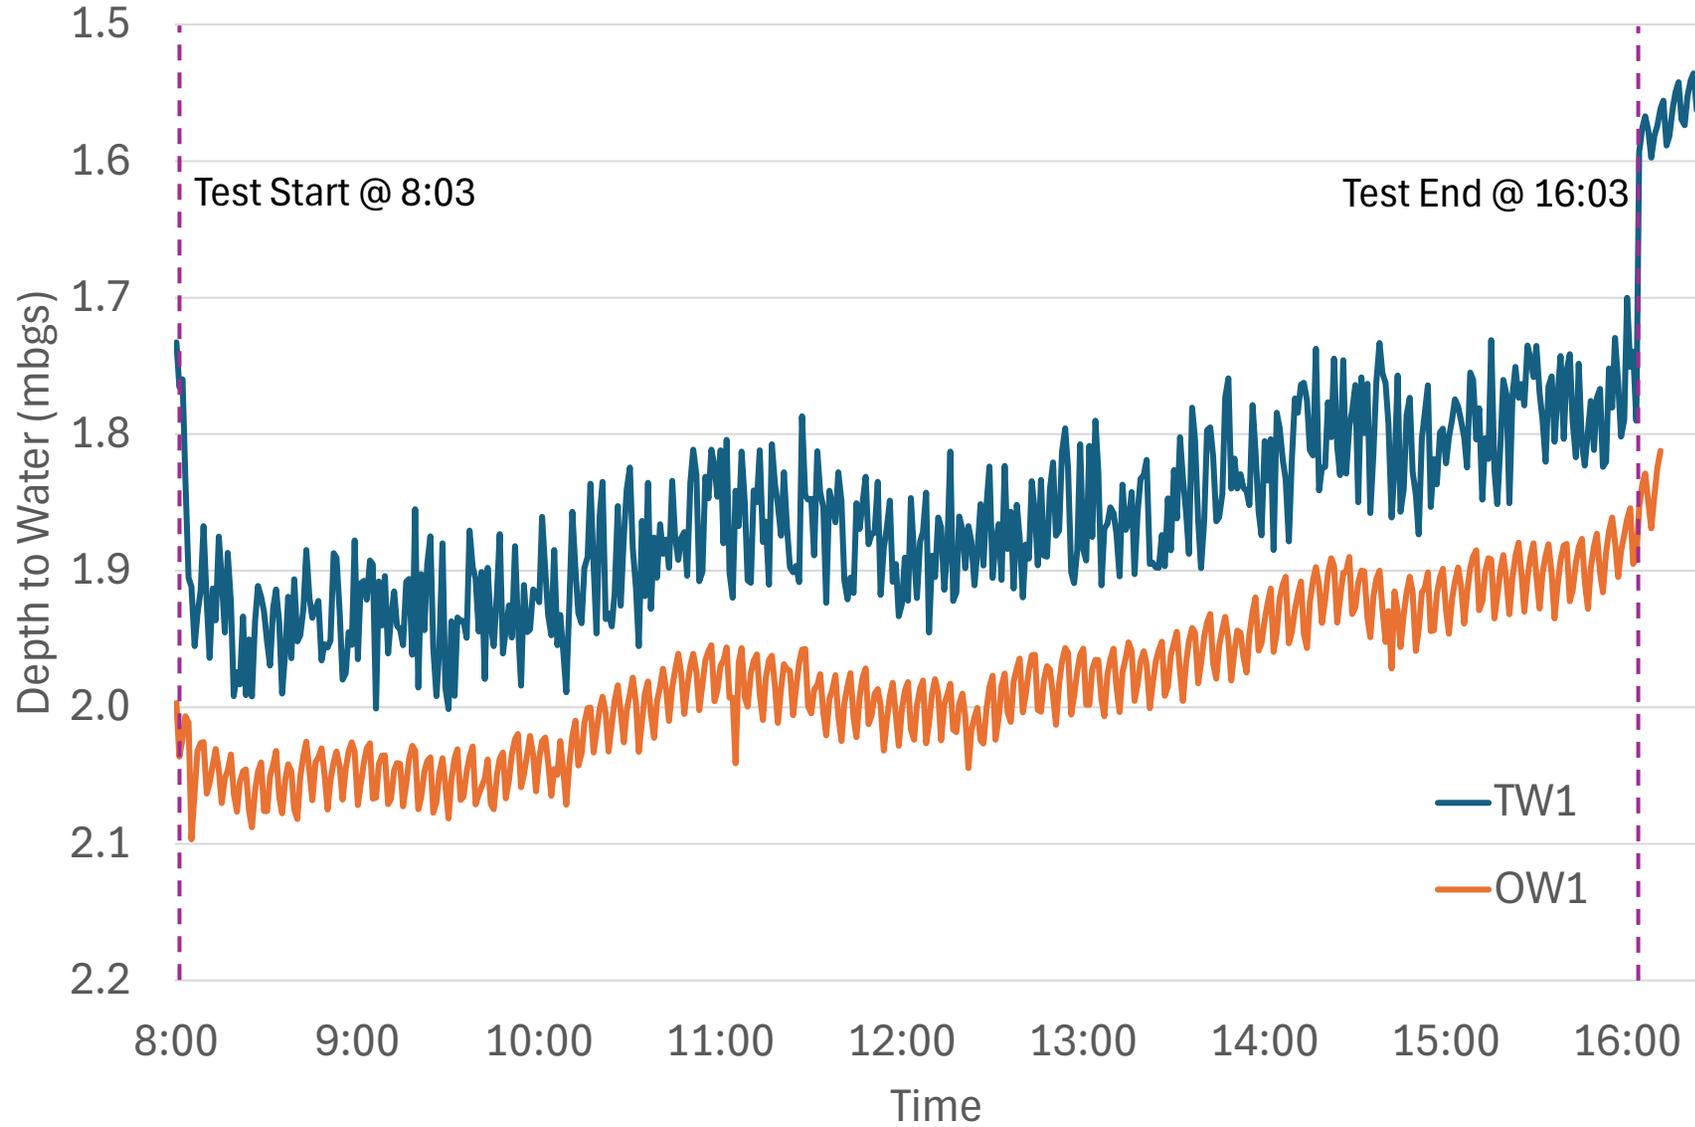
Measured Water Levels for TW1 Pumping Test

An 8-hour hydraulic pumping test was completed on TW1 by Cambium staff on May 29, 2025. Prior to the test, a Solinst Levellogger (logger) was installed in TW1 and OW1 (the pre-existing water supply well on the site) to monitor water levels before, during, and after the pumping test. Manual measurements were also recorded during the pumping tests to mitigate the possibility of equipment failure. Well water levels measured during pumping test activities are provided in Appendix H. OW1 was not used for at least 12 hours prior to the start of the pumping test, nor was it used during the test or subsequent recovery period.

Rainfall of 11.6 mm was recorded at the Ottawa Airport Climate Station (ID # 6106001) on the day of the pumping test (Appendix H). This is reflected in monitoring data collected in TW1 and OW1 during the pumping test. After an initial water level decrease up to 0.25 m within the first hour following the start of pumping, the water level in TW1 gradually increased for the duration of the test. A similar trend was observed in OW1, which experienced a maximum drawdown of approximately 0.1 m within the first hour before progressively increasing throughout the day. Water level fluctuations in TW1 and OW1 mirrored each other, both in terms of timing and magnitude (Appendix H).
