**Geotechnical Investigation  
Proposed Residential Development  
1600 James Naismith Drive  
Ottawa Ontario**

GEMTEC Project: 103752.002

December 12, 2025  
GEMTEC Project: 103752.002

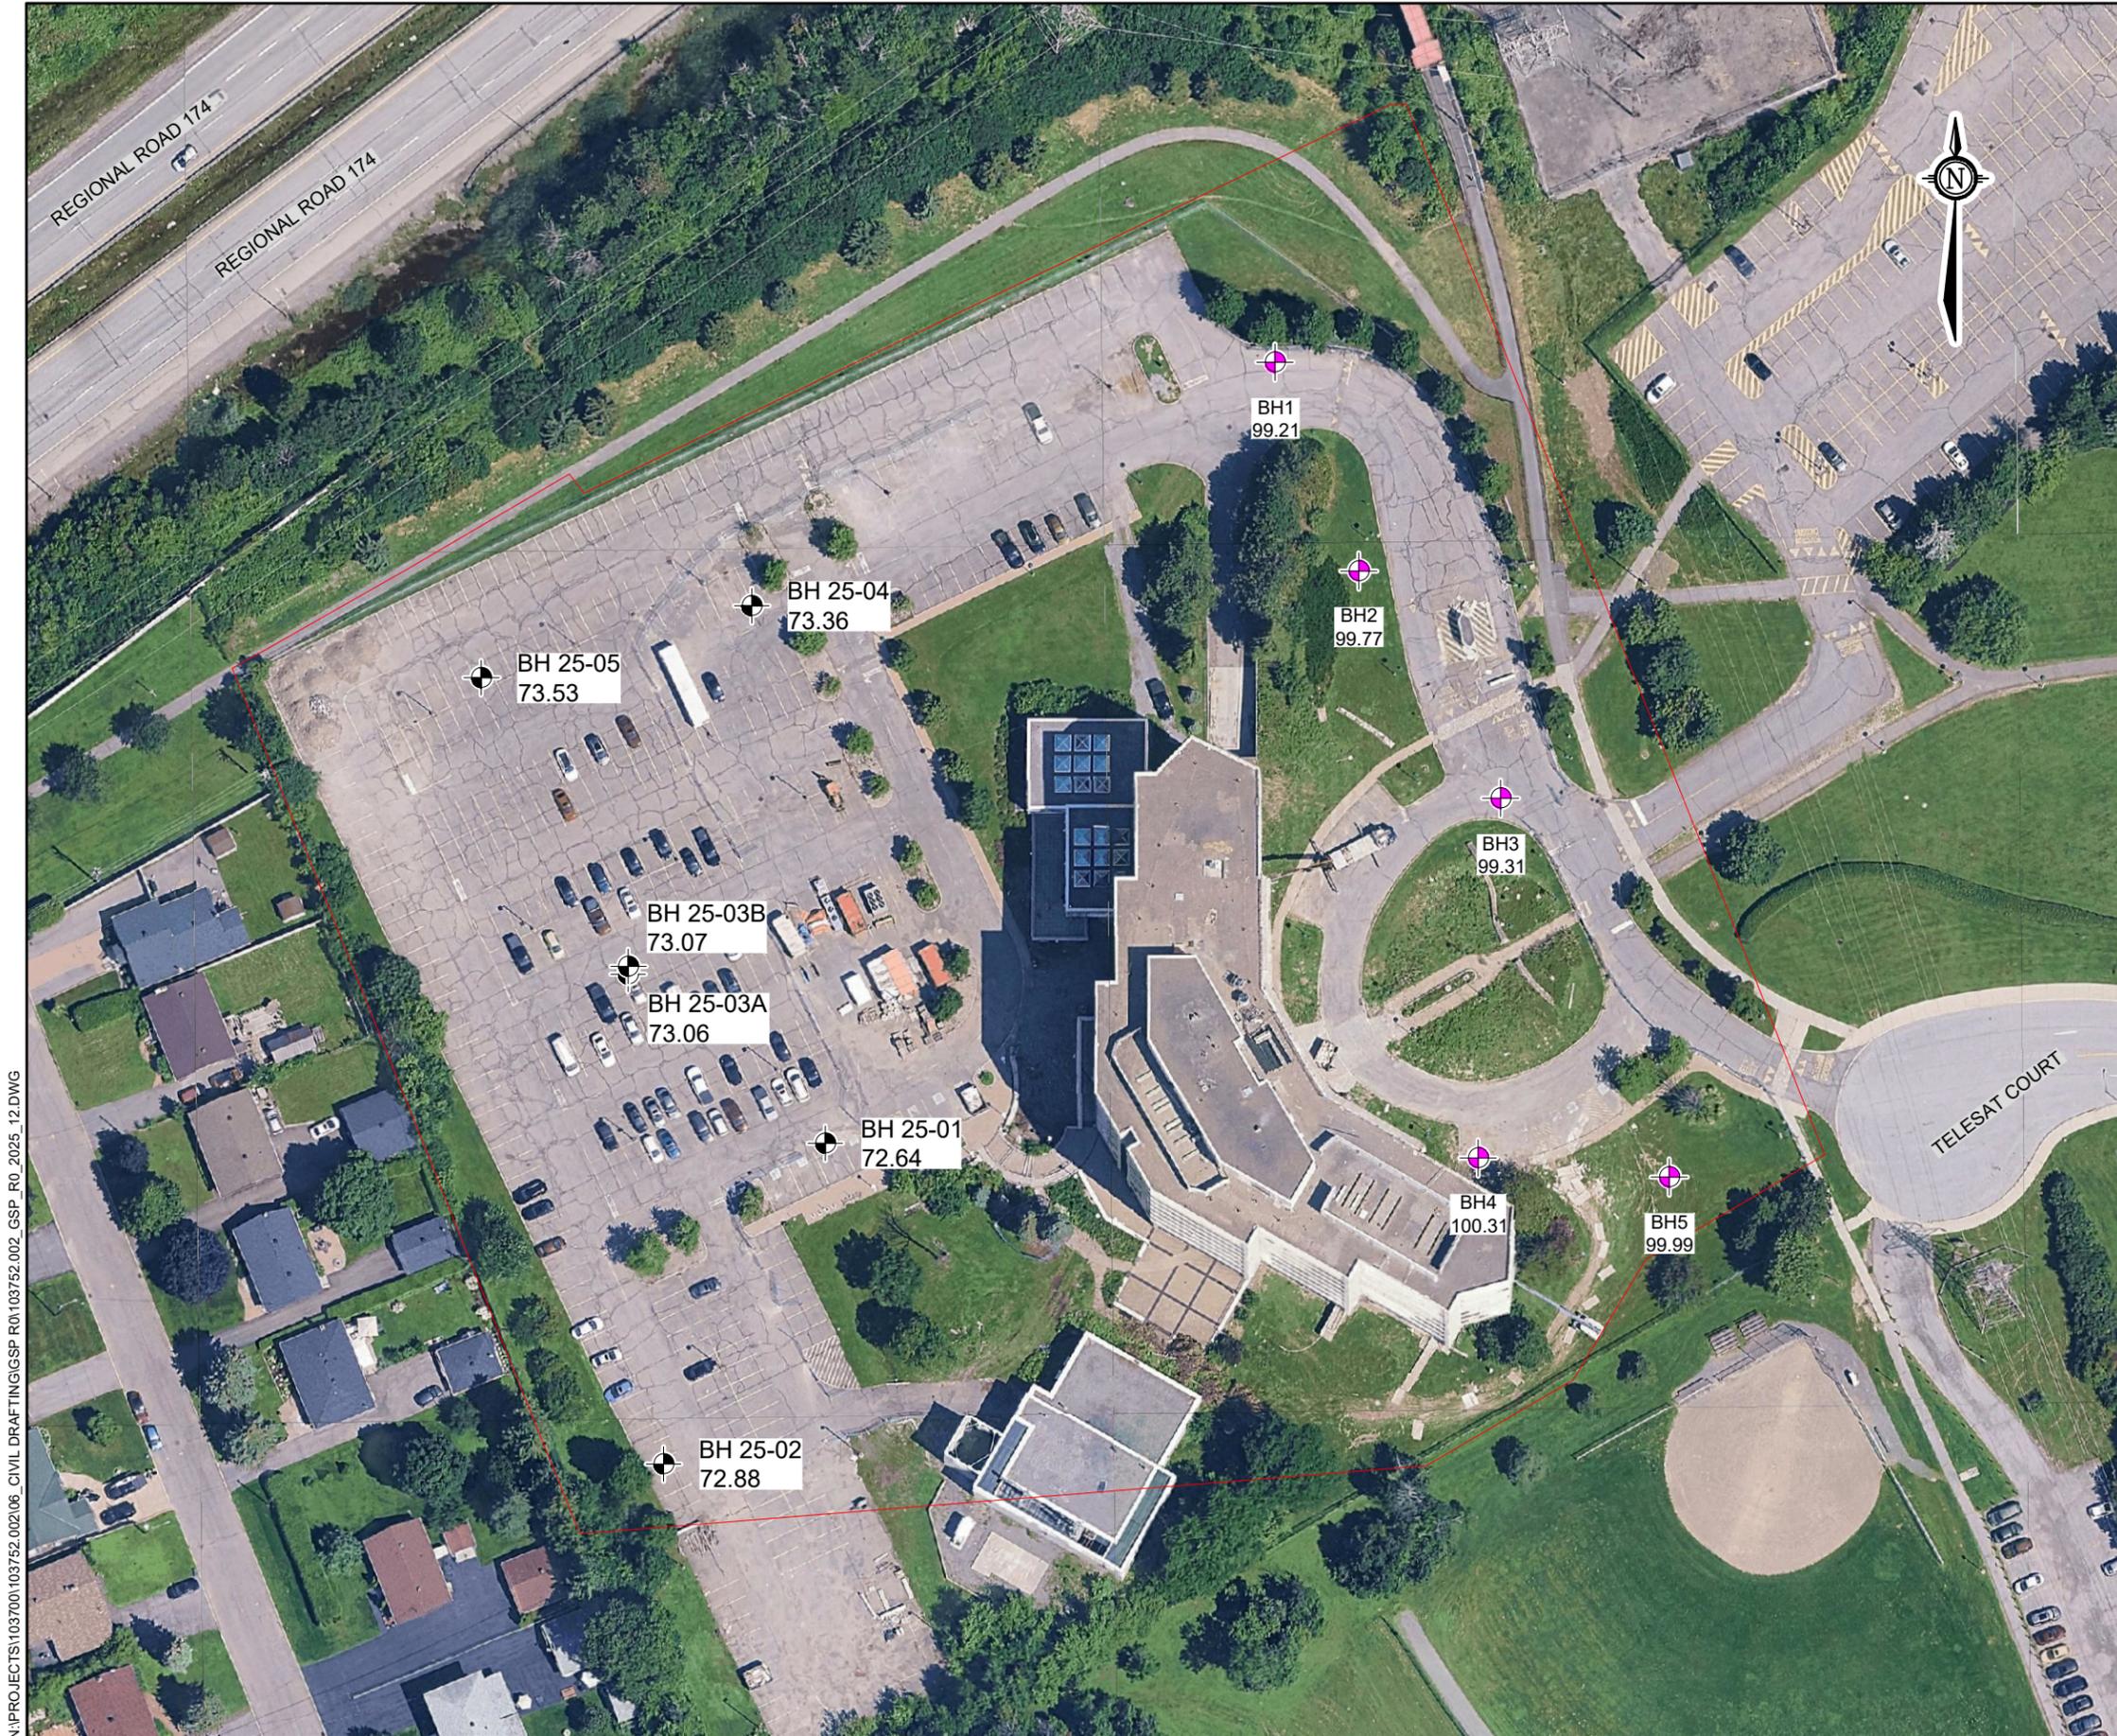
Figure 1 – Site Plan

<b>BH #</b>	← BOREHOLE ID
<b>XX.XX</b>	← GROUND SURFACE ELEVATION, IN METRES GEODEIC DATUM
	BOREHOLE LOCATION (current investigation by GEMTEC)
	BOREHOLE LOCATION (previous investigation by PINCHIN)
	APPROXIMATE SITE BOUNDARY

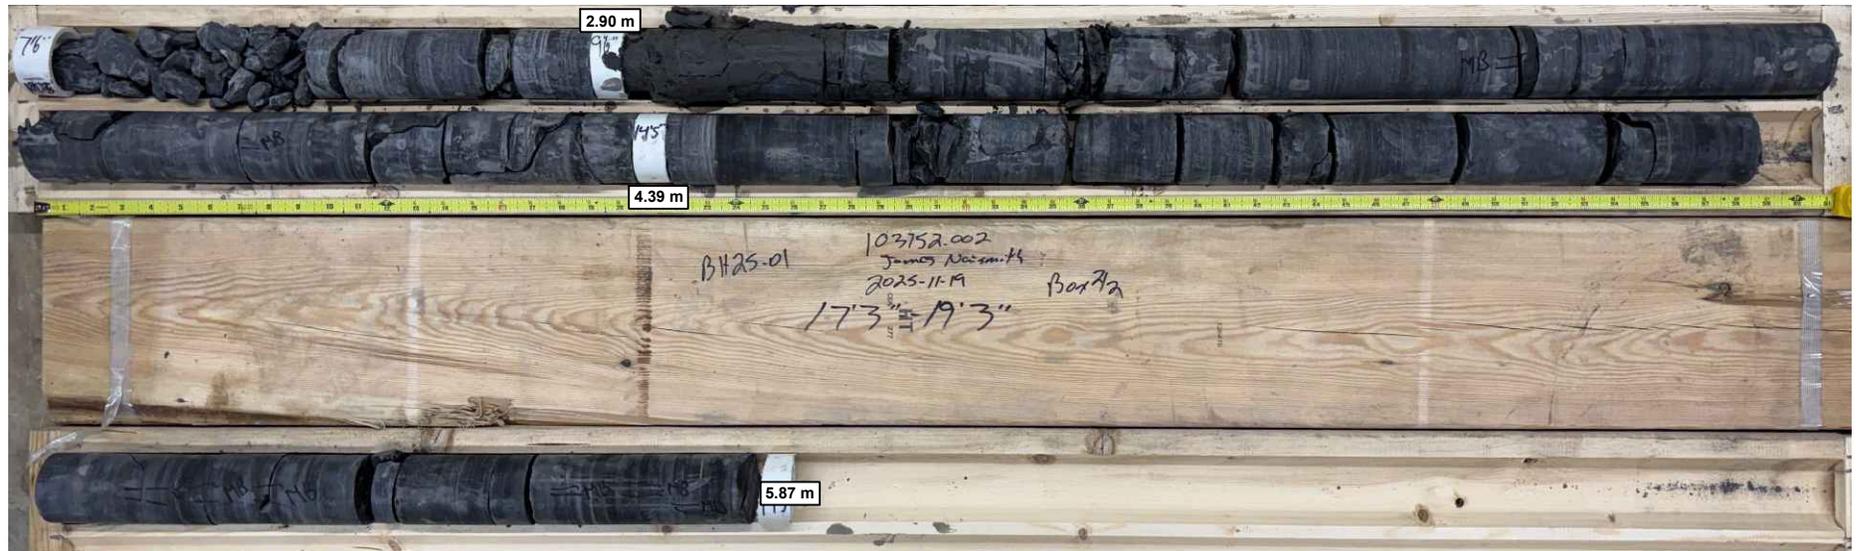
**BOREHOLE: BH25-01 (DRY)**  
**BORING DATE: NOVEMBER 19, 2025**  
**DEPTH: 2.29 TO 5.87 METRES BELOW GROUND SURFACE**

The bedrock was cored for 1.7 to 3.7 metres below the rock surface level using triple tube diamond drilling equipment. Within the bedrock core, the total core recovery (TCR) ranged from 12 to 100 percent, and the rock quality designation (RQD) ranged from 0 to 71 percent. According to the classification system in the Canadian Foundation Engineering Manual, 5<sup>th</sup> Edition, the bedrock at the borehole locations can be classified as very poor to fair quality. Photographs of the recovered core are provided in Appendix B with the associated borehole logs.

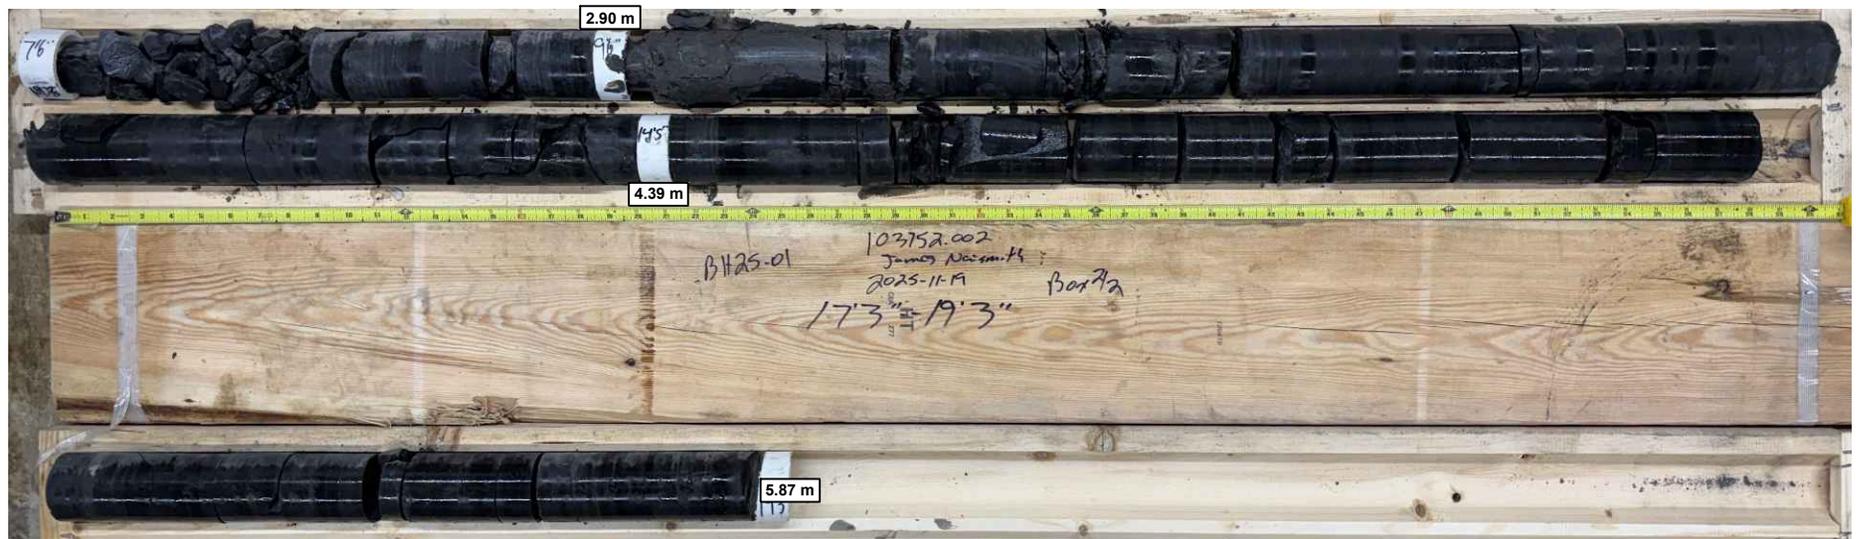
**BOREHOLE: BH25-01 (WET)  
BORING DATE: NOVEMBER 19, 2025  
DEPTH: 2.29 TO 5.87 METRES BELOW GROUND SURFACE**

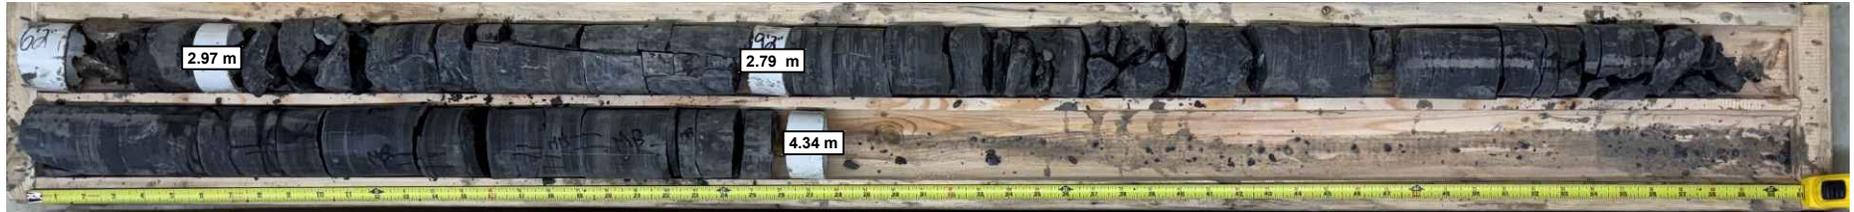
**BOREHOLE: BH25-02 (DRY)**  
**BORING DATE: NOVEMBER 19, 2025**  
**DEPTH: 1.88 TO 4.34 METRES BELOW GROUND SURFACE**

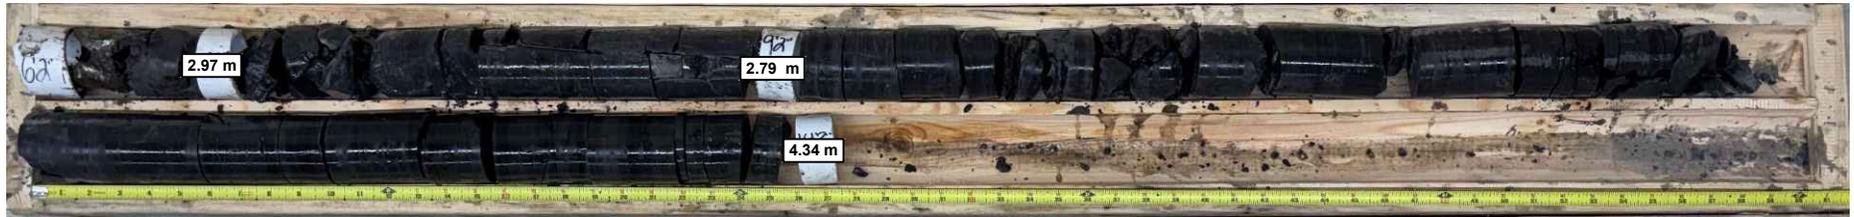
**BOREHOLE: BH25-02 (WET)**  
**BORING DATE: NOVEMBER 19, 2025**  
**DEPTH: 1.88 TO 4.34 METRES BELOW GROUND SURFACE**

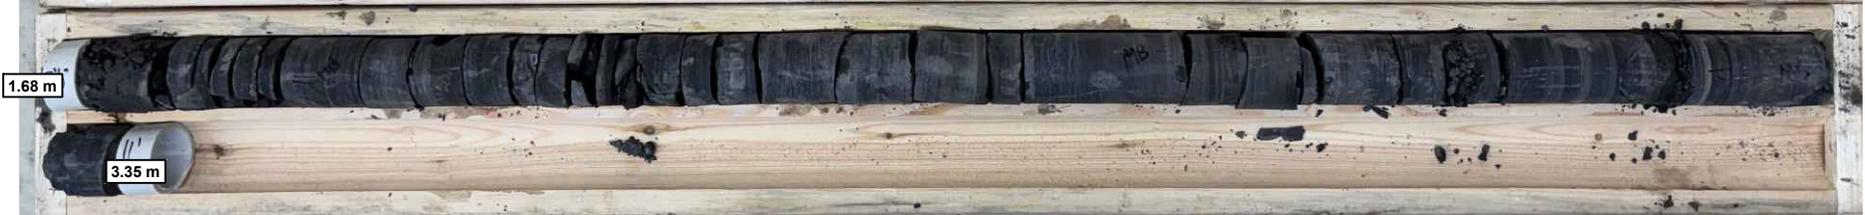
**BOREHOLE: BH25-03 (DRY)  
BORING DATE: NOVEMBER 20, 2025  
DEPTH: 1.68 TO 3.35 METRES BELOW GROUND SURFACE**

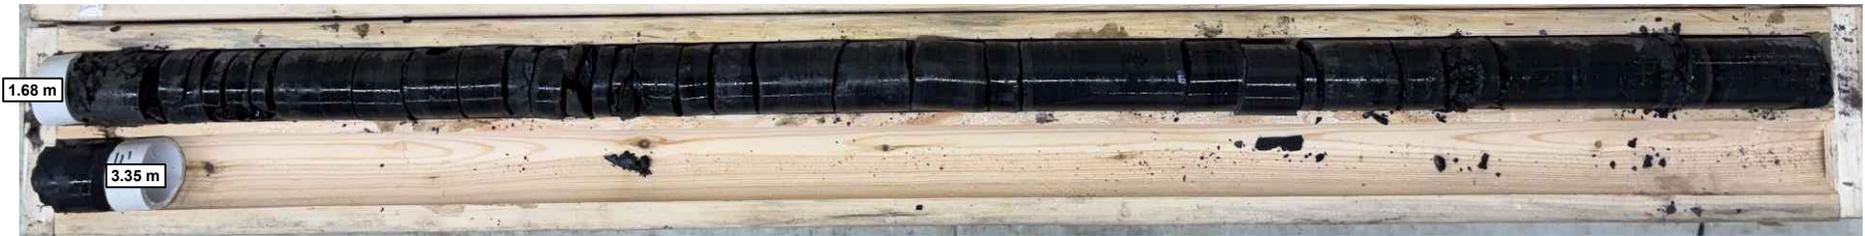
**BOREHOLE: BH25-03 (WET)**  
**BORING DATE: NOVEMBER 20, 2025**  
**DEPTH: 1.68 TO 3.35 METRES BELOW GROUND SURFACE**

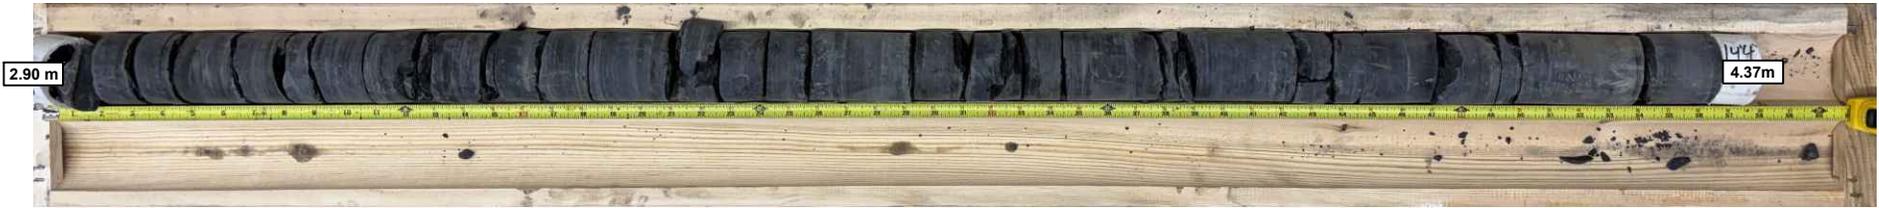
**BOREHOLE: BH25-04 (DRY)  
BORING DATE: NOVEMBER 19, 2025  
DEPTH: 2.90 TO 4.37 METRES BELOW GROUND SURFACE**

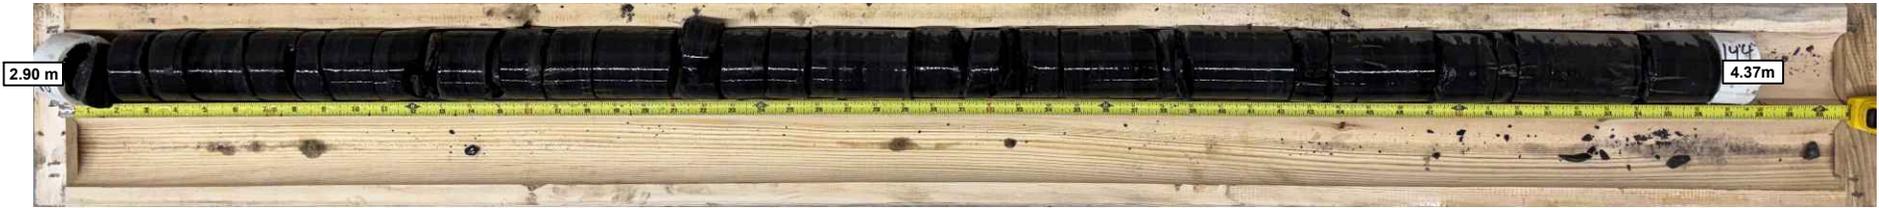
**BOREHOLE: BH25-04 (WET)**  
**BORING DATE: NOVEMBER 19, 2025**  
**DEPTH: 2.90 TO 4.37 METRES BELOW GROUND SURFACE**

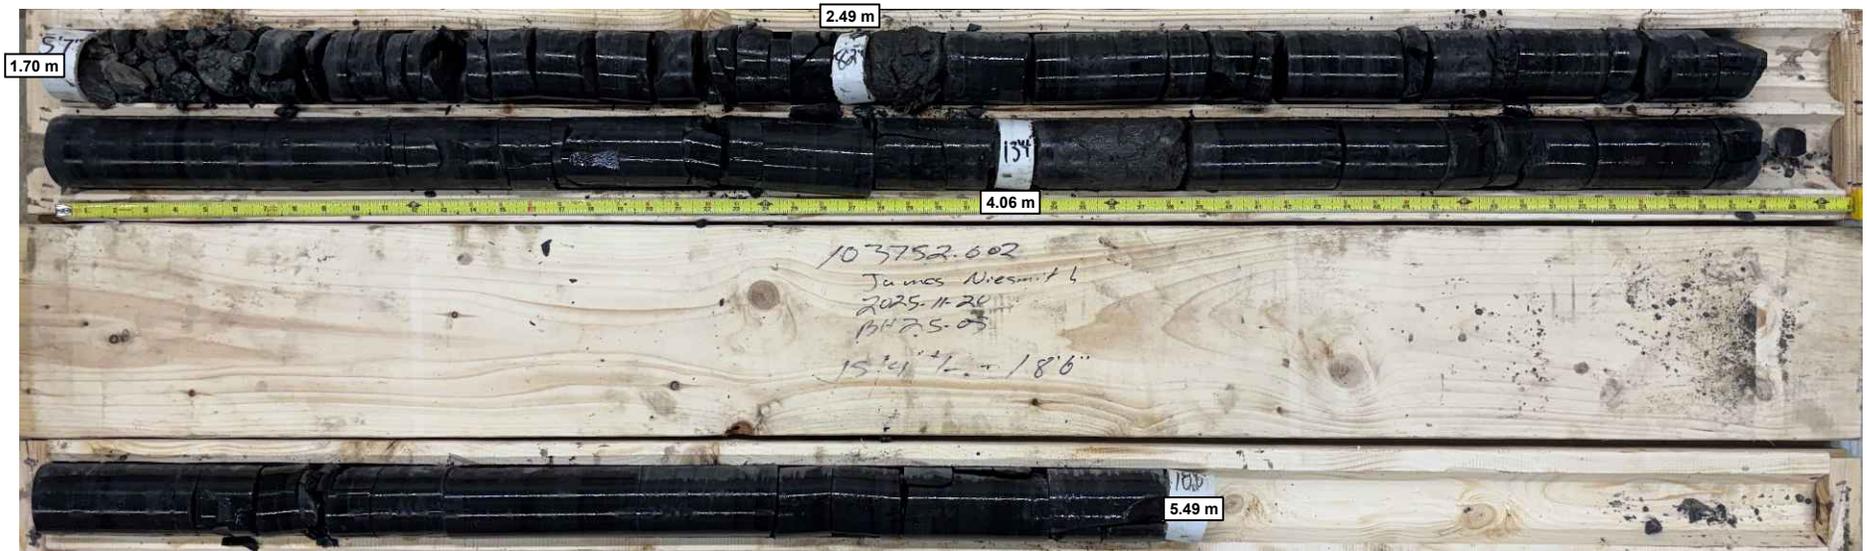
**BOREHOLE: BH25-05 (WET)  
BORING DATE: NOVEMBER 20, 2025  
DEPTH: 1.70 TO 5.49 METRES BELOW GROUND SURFACE**

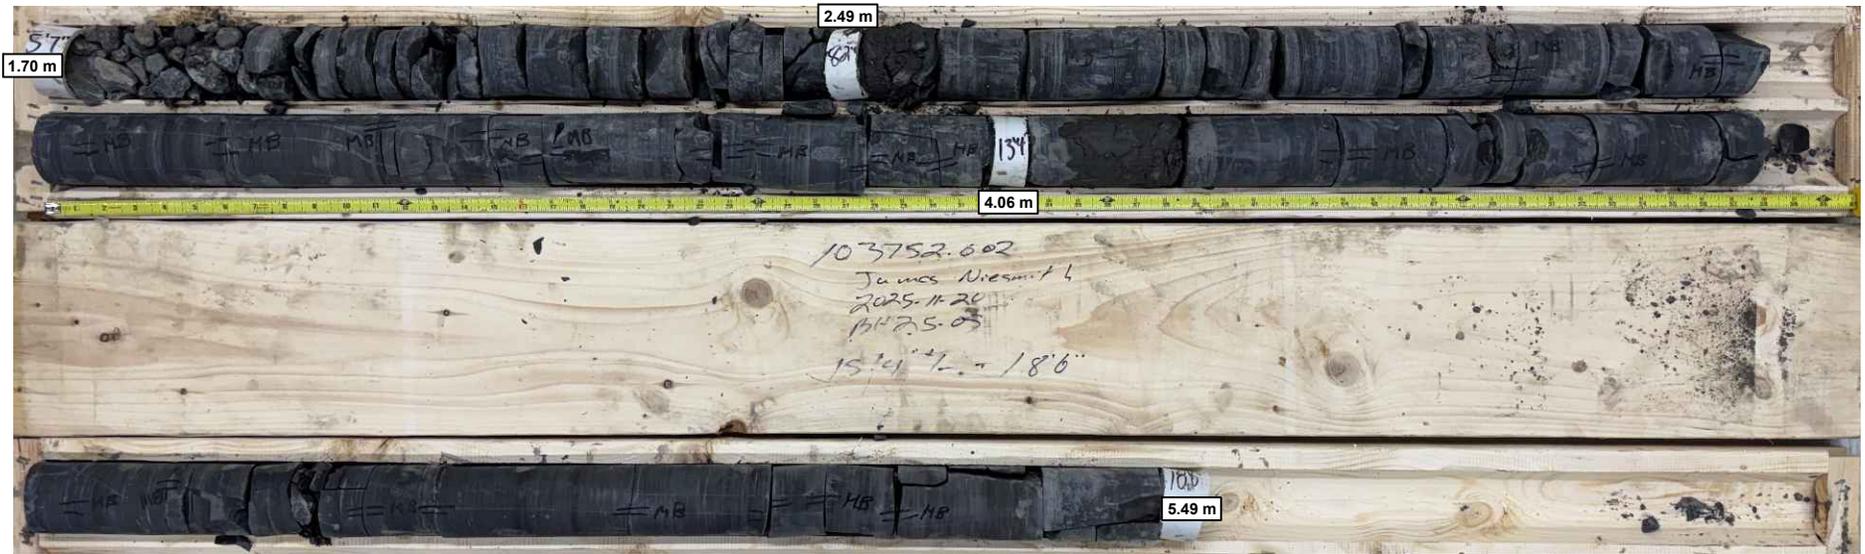
**FIGURE B10**

**BOREHOLE: BH25-05 (DRY)  
BORING DATE: NOVEMBER 20, 2025  
DEPTH: 1.70 TO 5.49 METRES BELOW GROUND SURFACE**

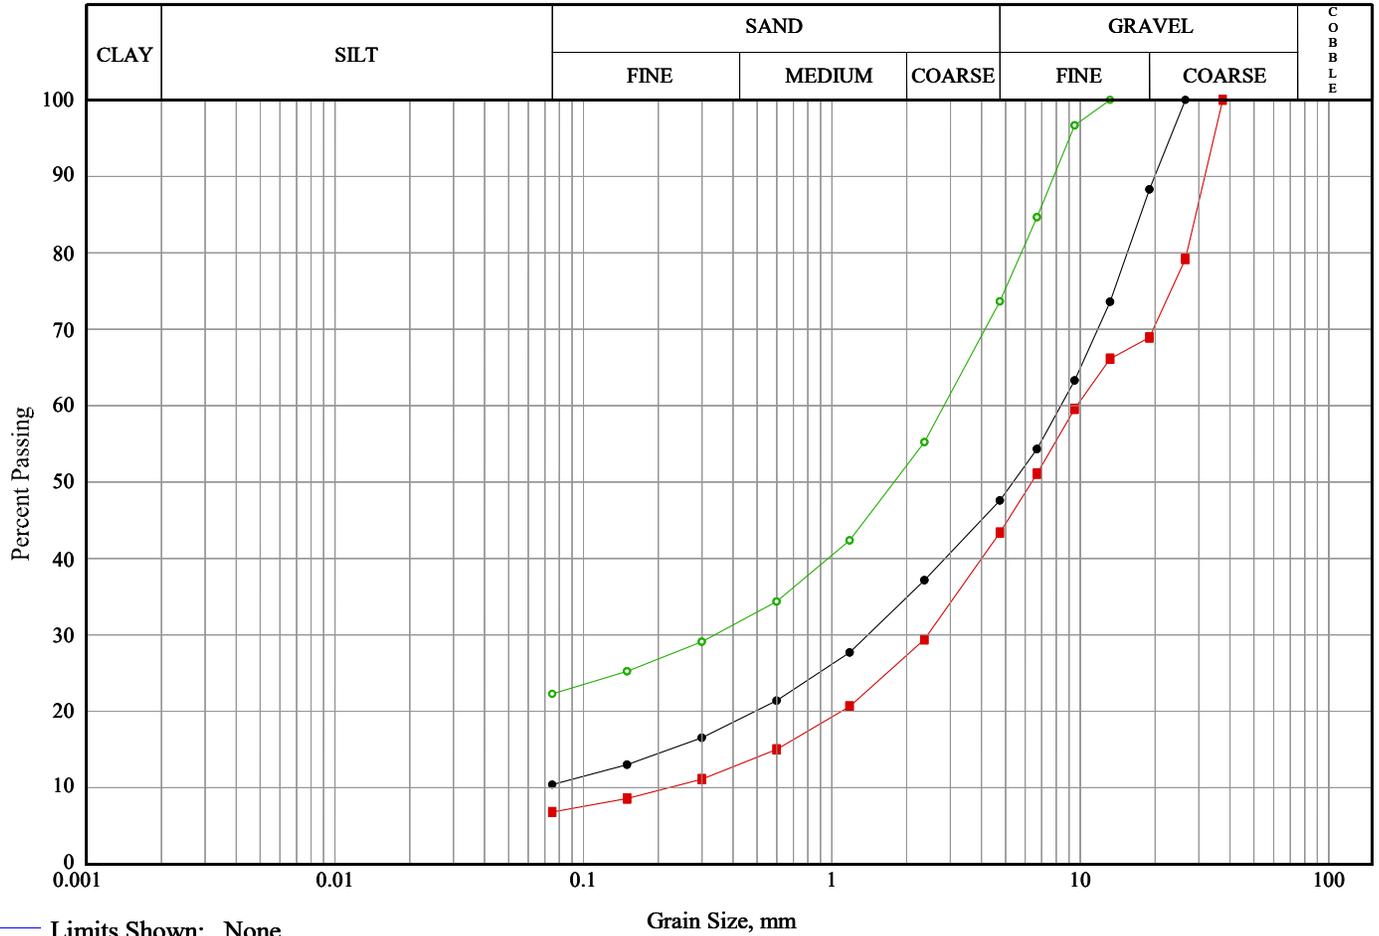
Line Symbol	Sample	Borehole/ Test Pit	Sample Number	Depth	% Cob.+ Gravel	% Sand	% Silt	% Clay
—●—		25-04	01		52.4	37.2	10.4	
—■—		25-04	02		56.6	36.6	6.8	
—○—		25-05	05		26.4	51.4	22.3

Line Symbol	USCS Classification	USCS Symbol	D <sub>10</sub>	D <sub>15</sub>	D <sub>30</sub>	D <sub>50</sub>	D <sub>60</sub>	D <sub>85</sub>	% 5-75µm
—●—		N/A	---	0.223	1.40	5.38	8.36	17.52	---
—■—		N/A	0.222	0.601	2.43	6.39	9.71	29.20	---
—○—		N/A	---	---	0.34	1.78	2.83	6.77	---
