Geotechnical Investigation

Proposed Residential Development

Phase 5 – Block 123

Report PG2855-3 Revision 1 dated February 9, 2026

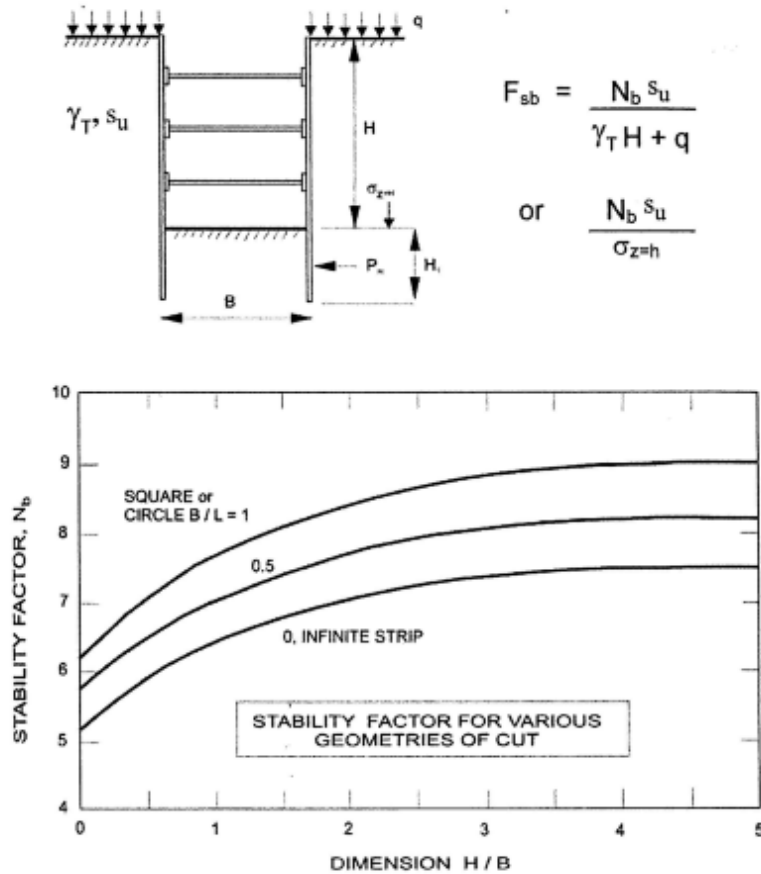
Figure 1 - Stability Factor for Various Geometries of Cut

- N_b - stability factor dependent upon the geometry of the excavation and given in Figure 1 on the following page.
- s_u - undrained shear strength of the soil below the base level.
- σ_z - total overburden and surcharge pressures at the bottom of the excavation.

In the case of soft to firm clays, a factor of safety of 2 is recommended for base stability.

Shear failure of excavation bases is typically rare in granular soils if adequate lateral support is provided. Inadequate dewatering can cause instability in excavations made through granular or layered soils. The potential for base heave in cohesive soils should be determined for the stability of flexible retaining systems.

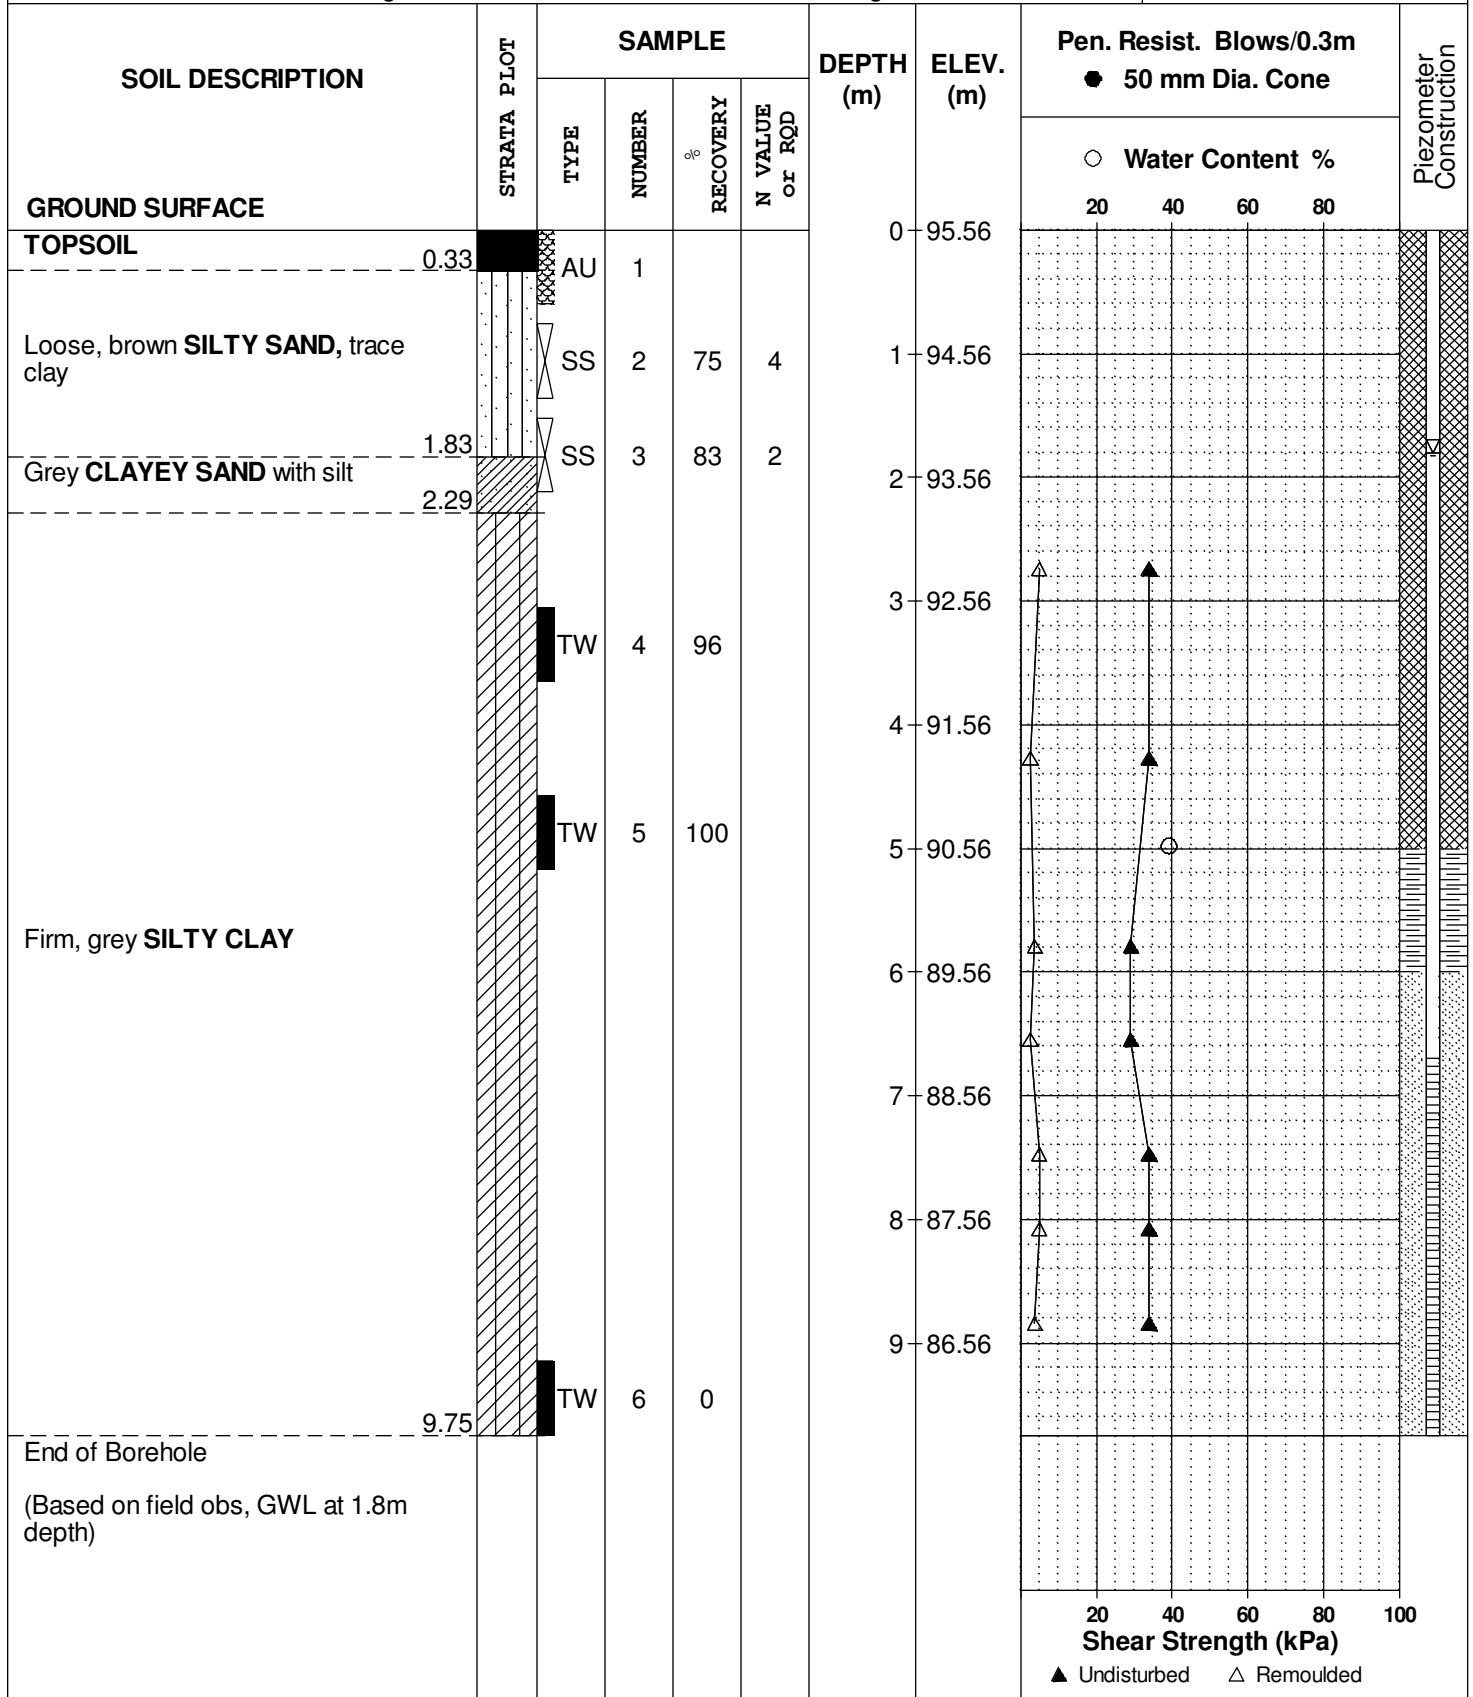
BORINGS BY CME 55 Power Auger

DATUM Ground surface elevations at test hole locations provided by Fairhall, Moffatt and Woodland Ltd.

Subsurface conditions observed in the test holes were recorded in detail in the field. Reference should be made to the Soil Profile and Test Data sheets presented in Appendix 1 for specific details of the soil profile encountered at the test hole locations.

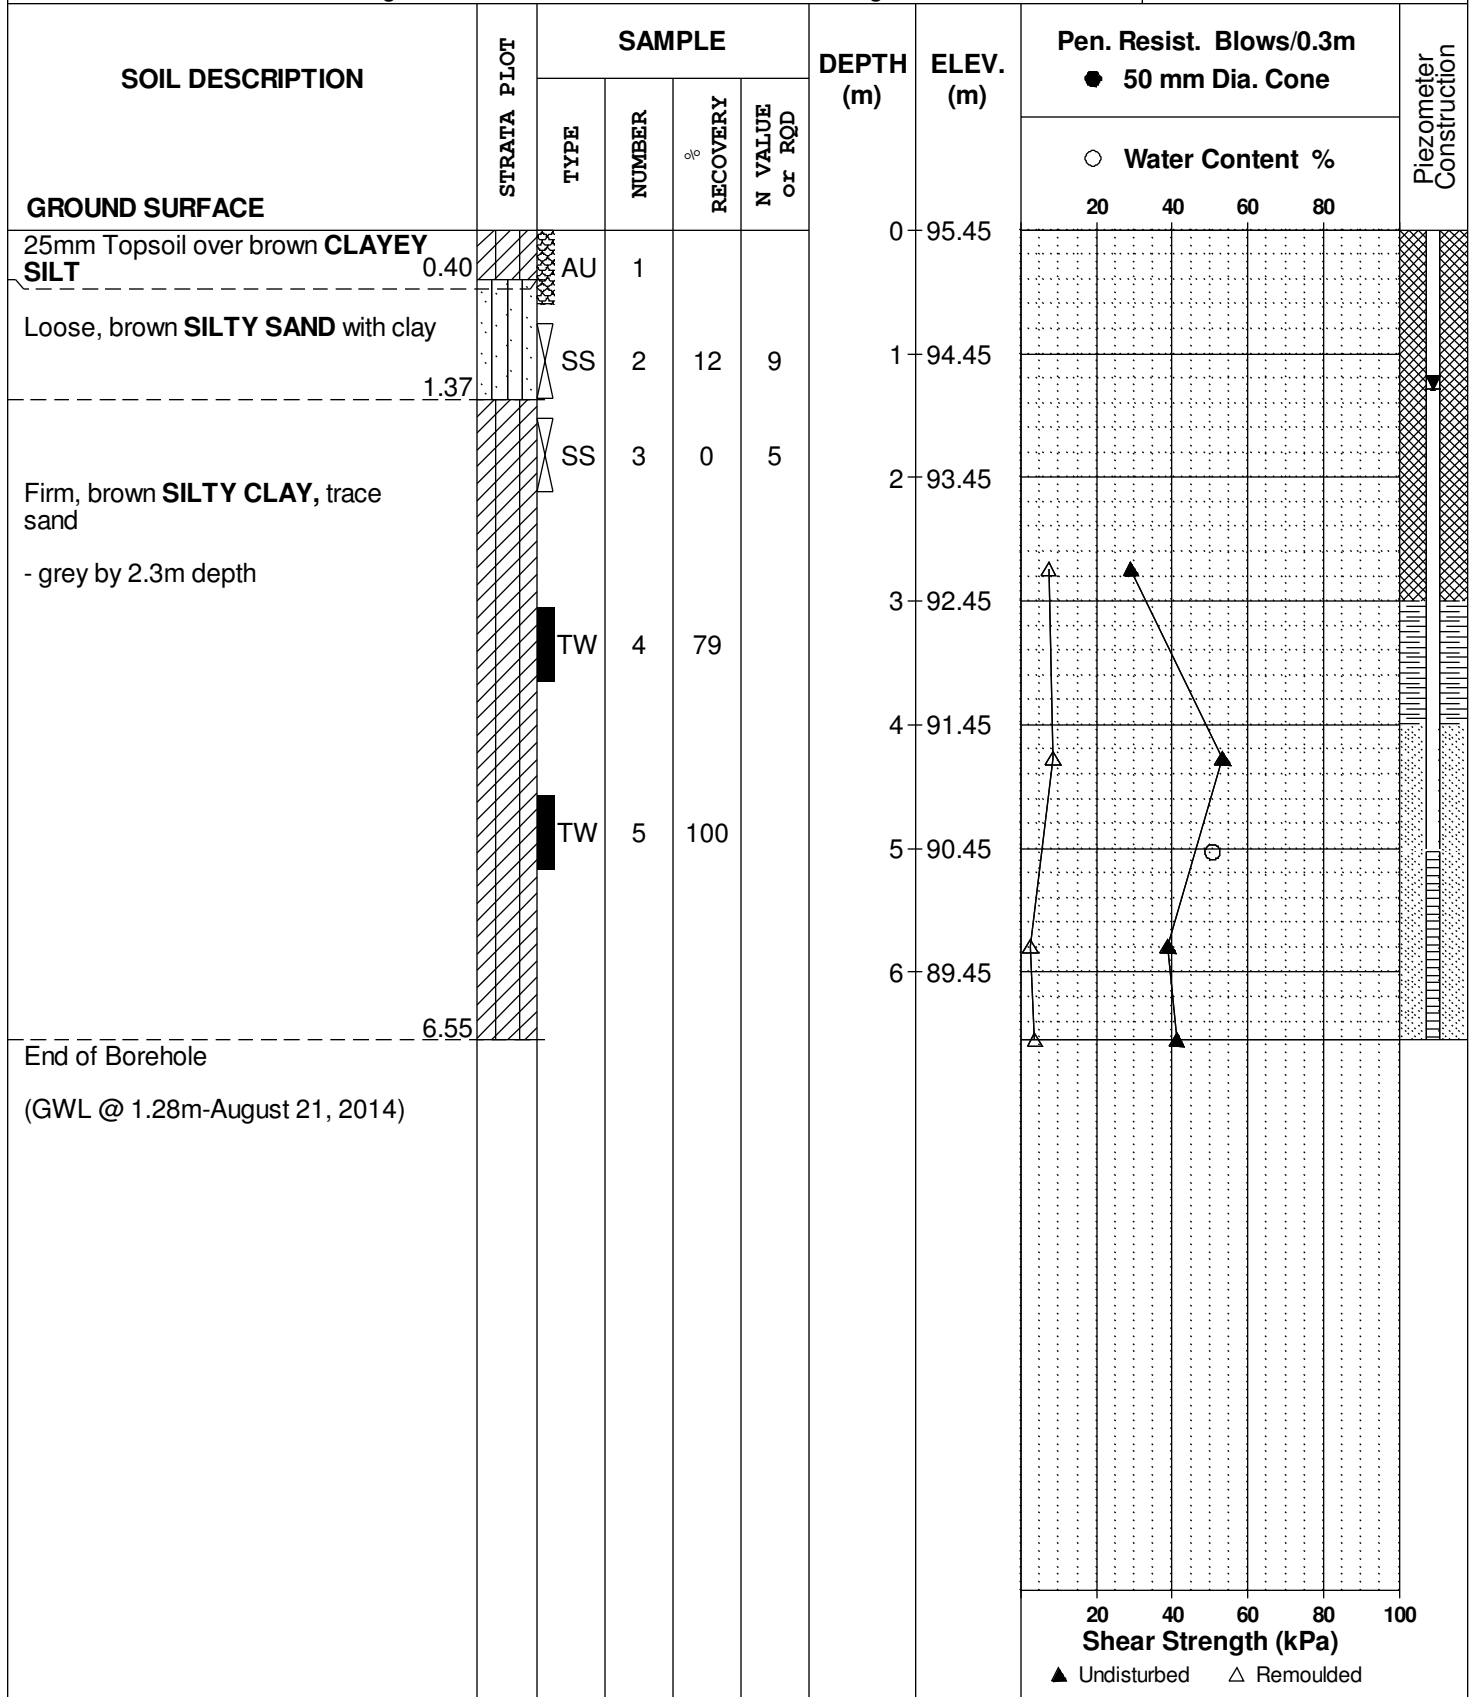
BORINGS BY CME 55 Power Auger

DATUM Ground surface elevations at test hole locations provided by Fairhall, Moffatt and Woodland Ltd.

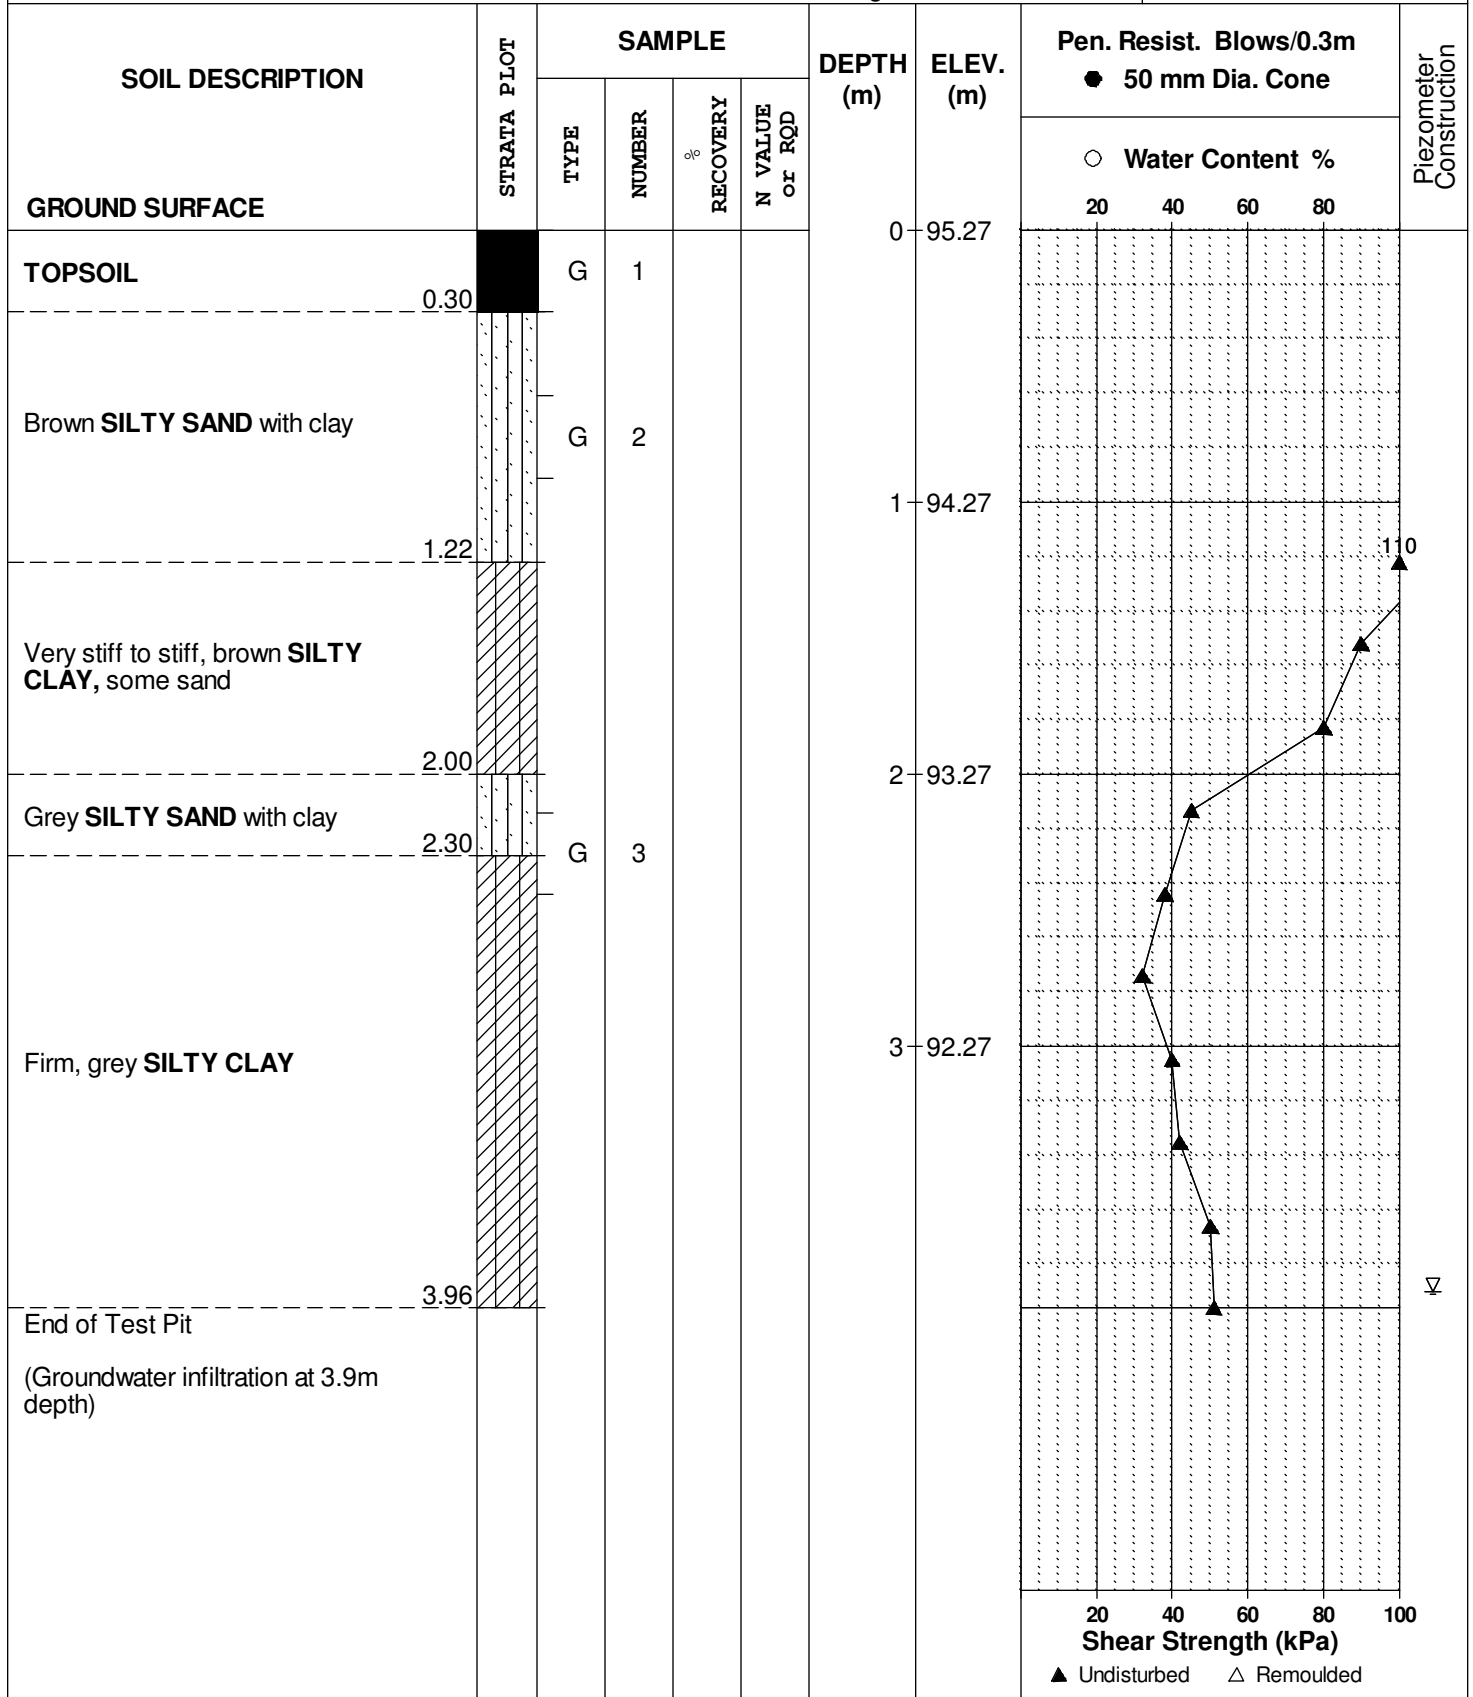
BORINGS BY Backhoe

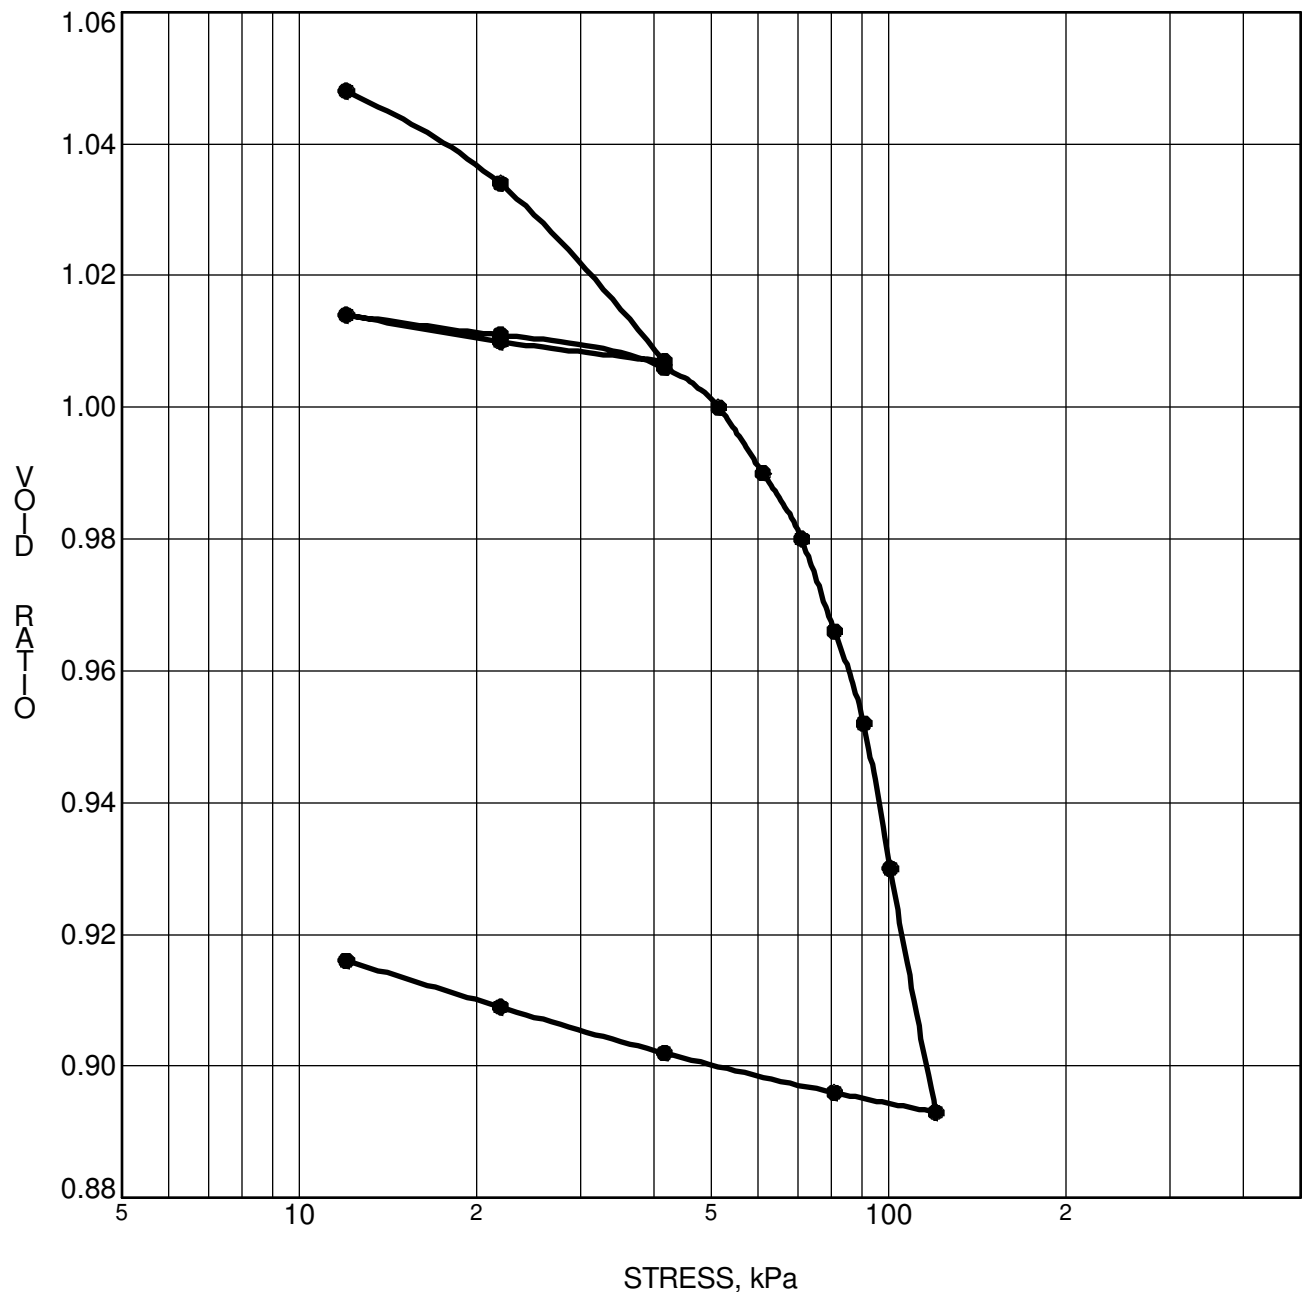
**CONSOLIDATION
TEST**

CONSOLIDATION TEST DATA SUMMARY					
Borehole No.	BH 7	p'_o	70.8 kPa	C_{cr}	0.015
Sample No.	TW 5	p'_c	75 kPa	C_c	0.471
Sample Depth	4.98 m	OC Ratio	1.1	W_o	39.1 %
Sample Elev.	90.58 m	Void Ratio	1.076	Unit Wt.	18.1 kN/m³

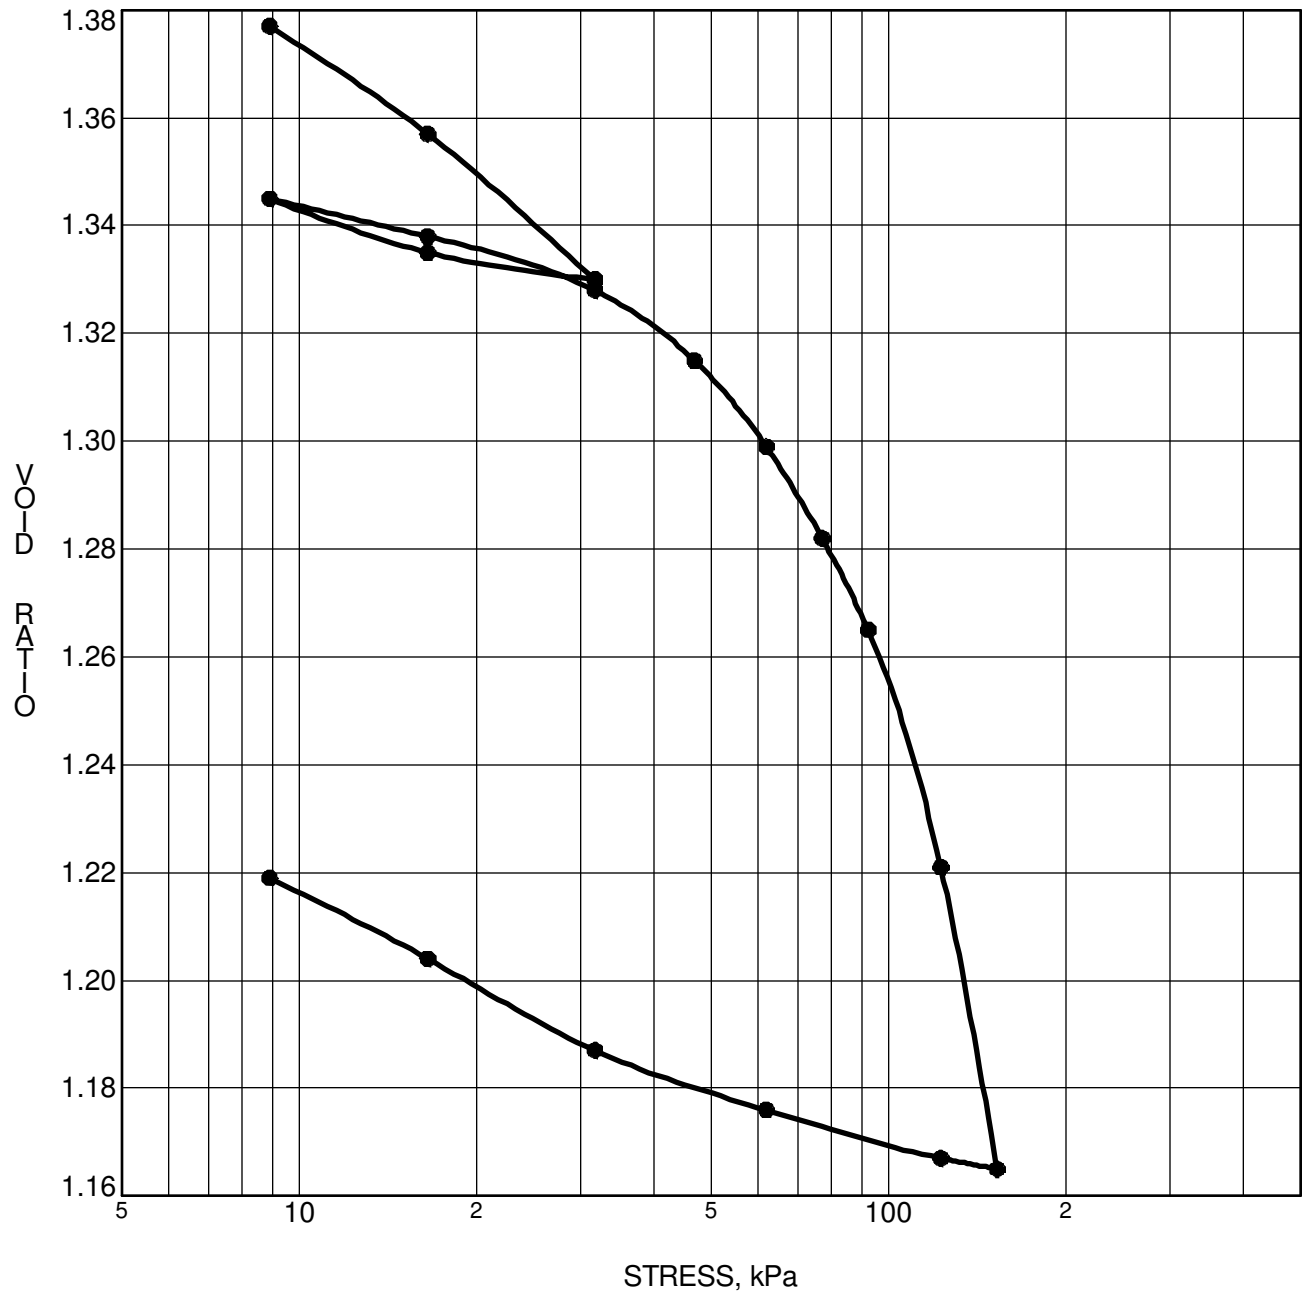
CONSOLIDATION TEST DATA SUMMARY					
Borehole No.	BH 8	p'_o	65 kPa	C_{cr}	0.030
Sample No.	TW 5	p'_c	92 kPa	C_c	0.589
Sample Depth	5.03 m	OC Ratio	1.4	W_o	50.6 %
Sample Elev.	90.42 m	Void Ratio	1.392	Unit Wt.	17.0 kN/m³

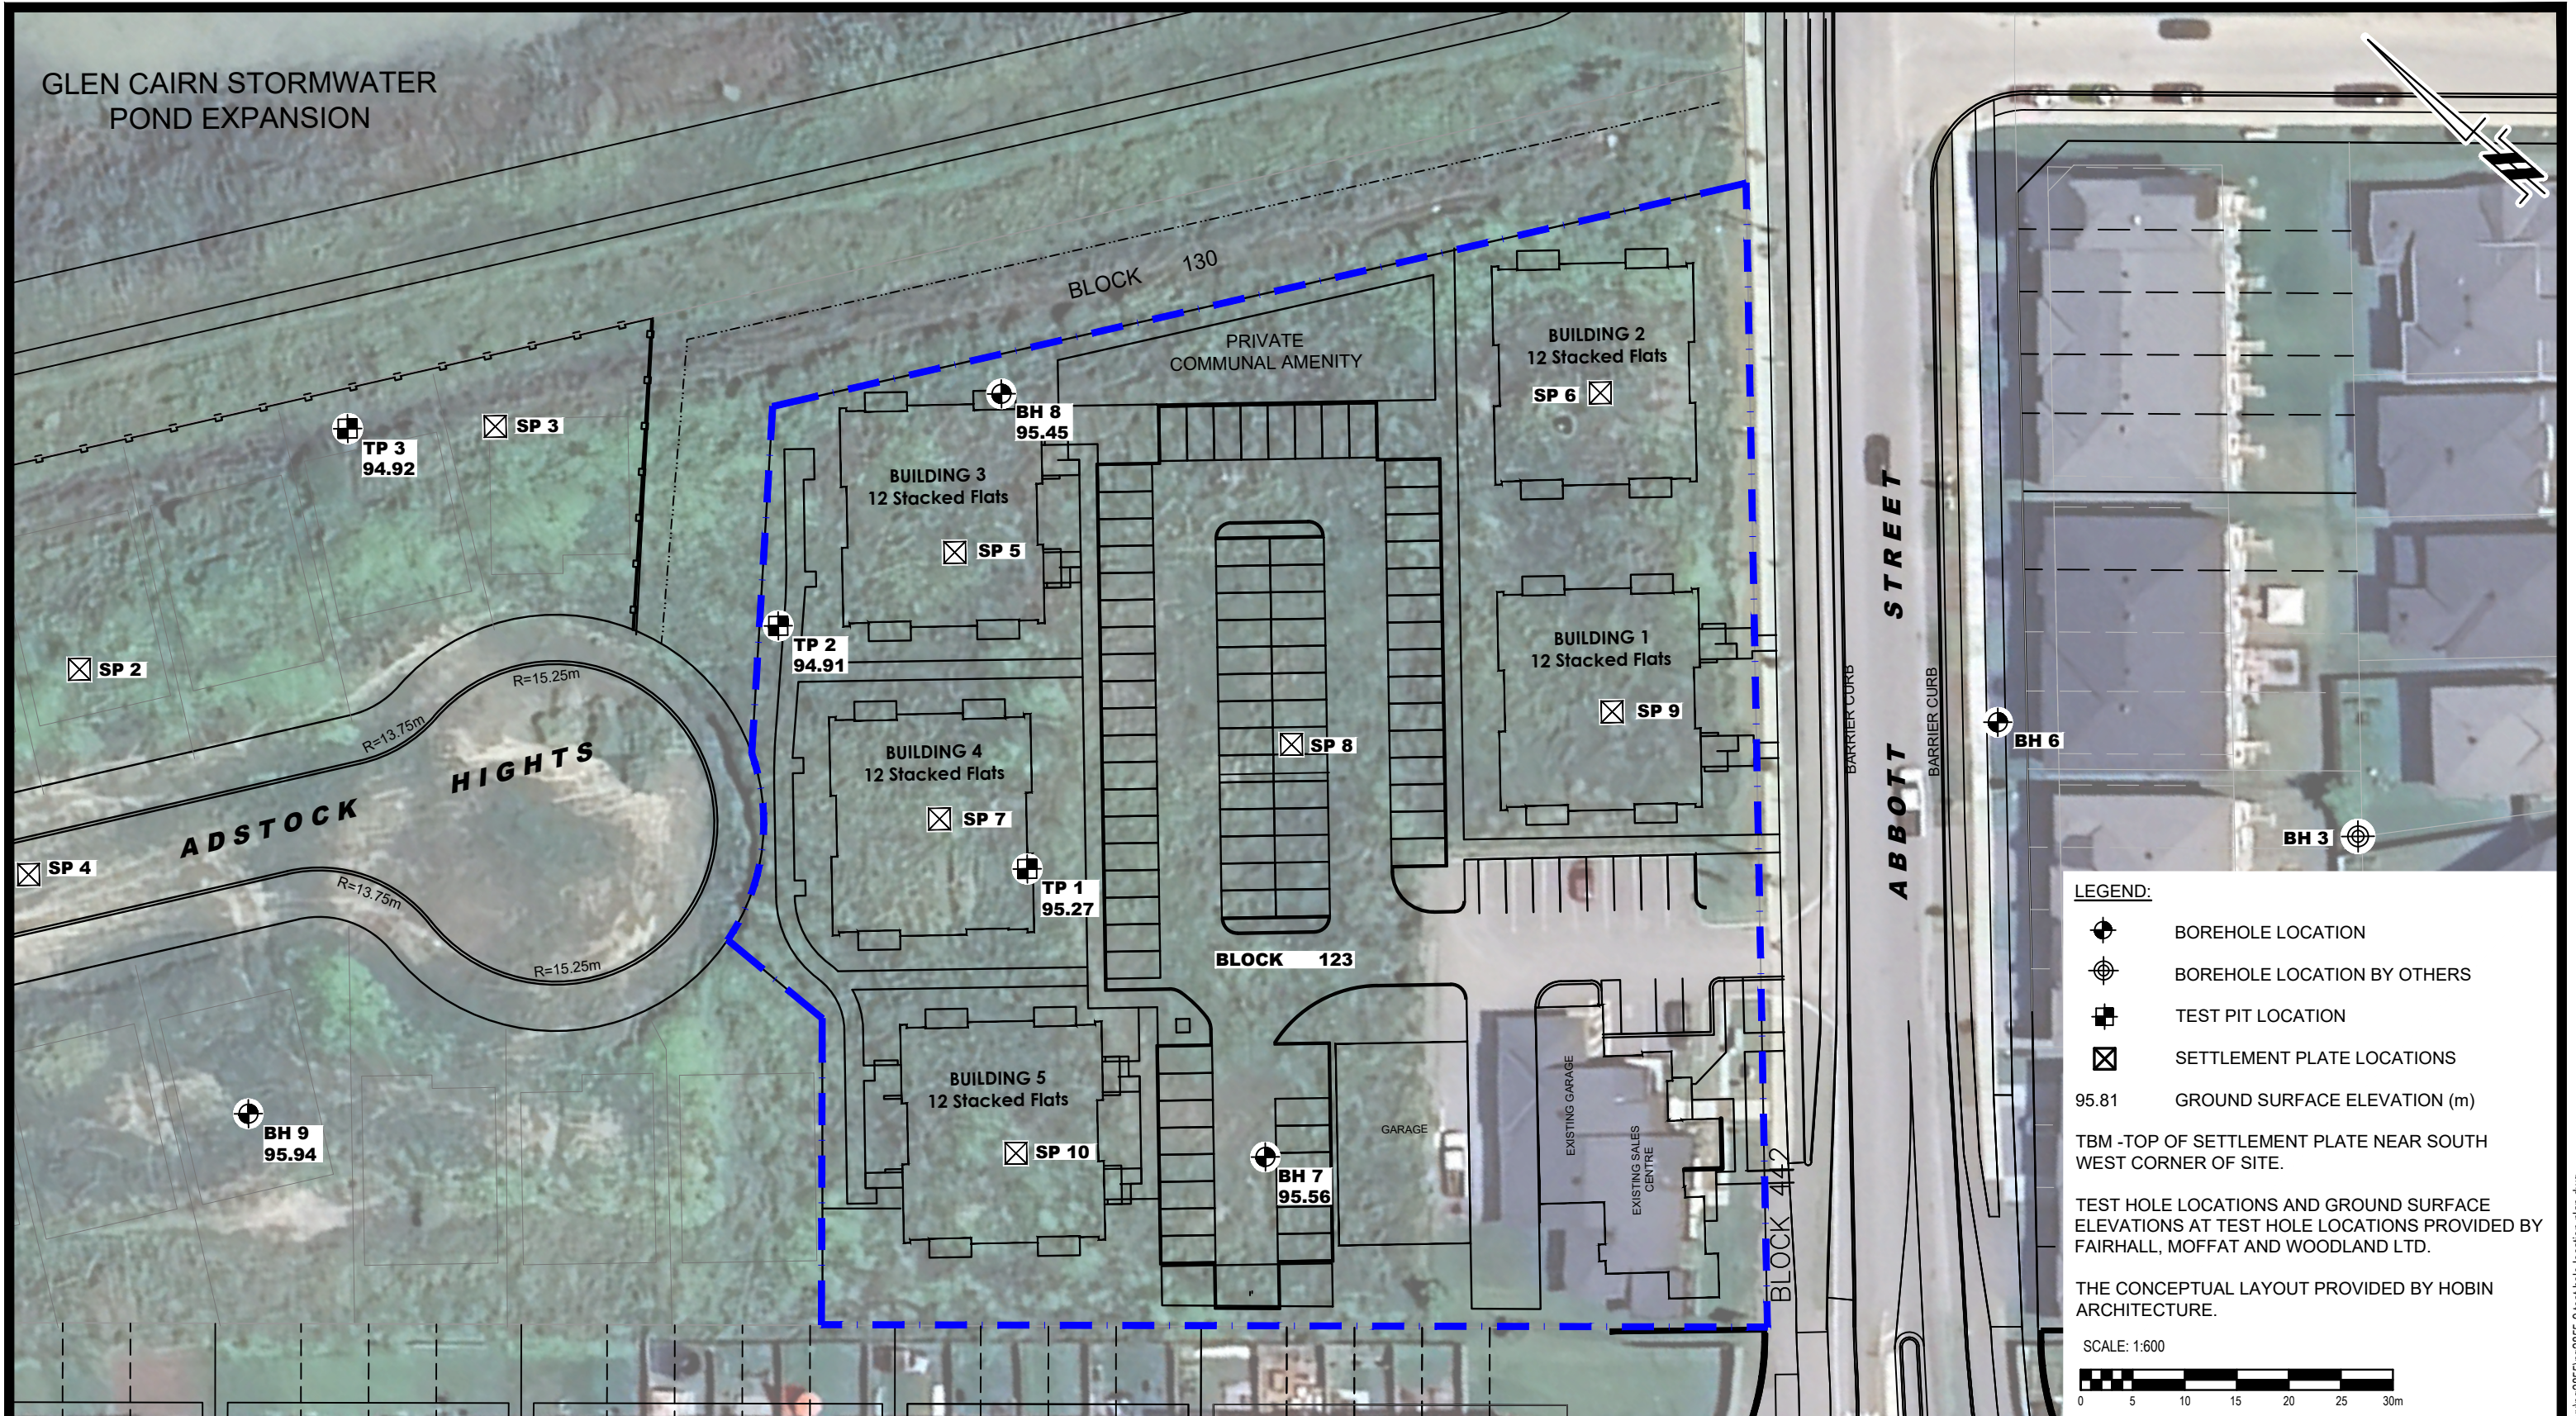
DRAWING PG2855-9 – TEST HOLE LOCATION PLAN

Existing borehole information within the subject site is presented in Appendix 1. The borehole locations are detailed in Drawing PG2855-9 – Test Hole Location Plan in Appendix 2. It should be noted that the low shear strength values noted at several sampling intervals were determined at the time of the original investigations to be caused by sampling disturbance and are not considered representative of the in-situ soil conditions.

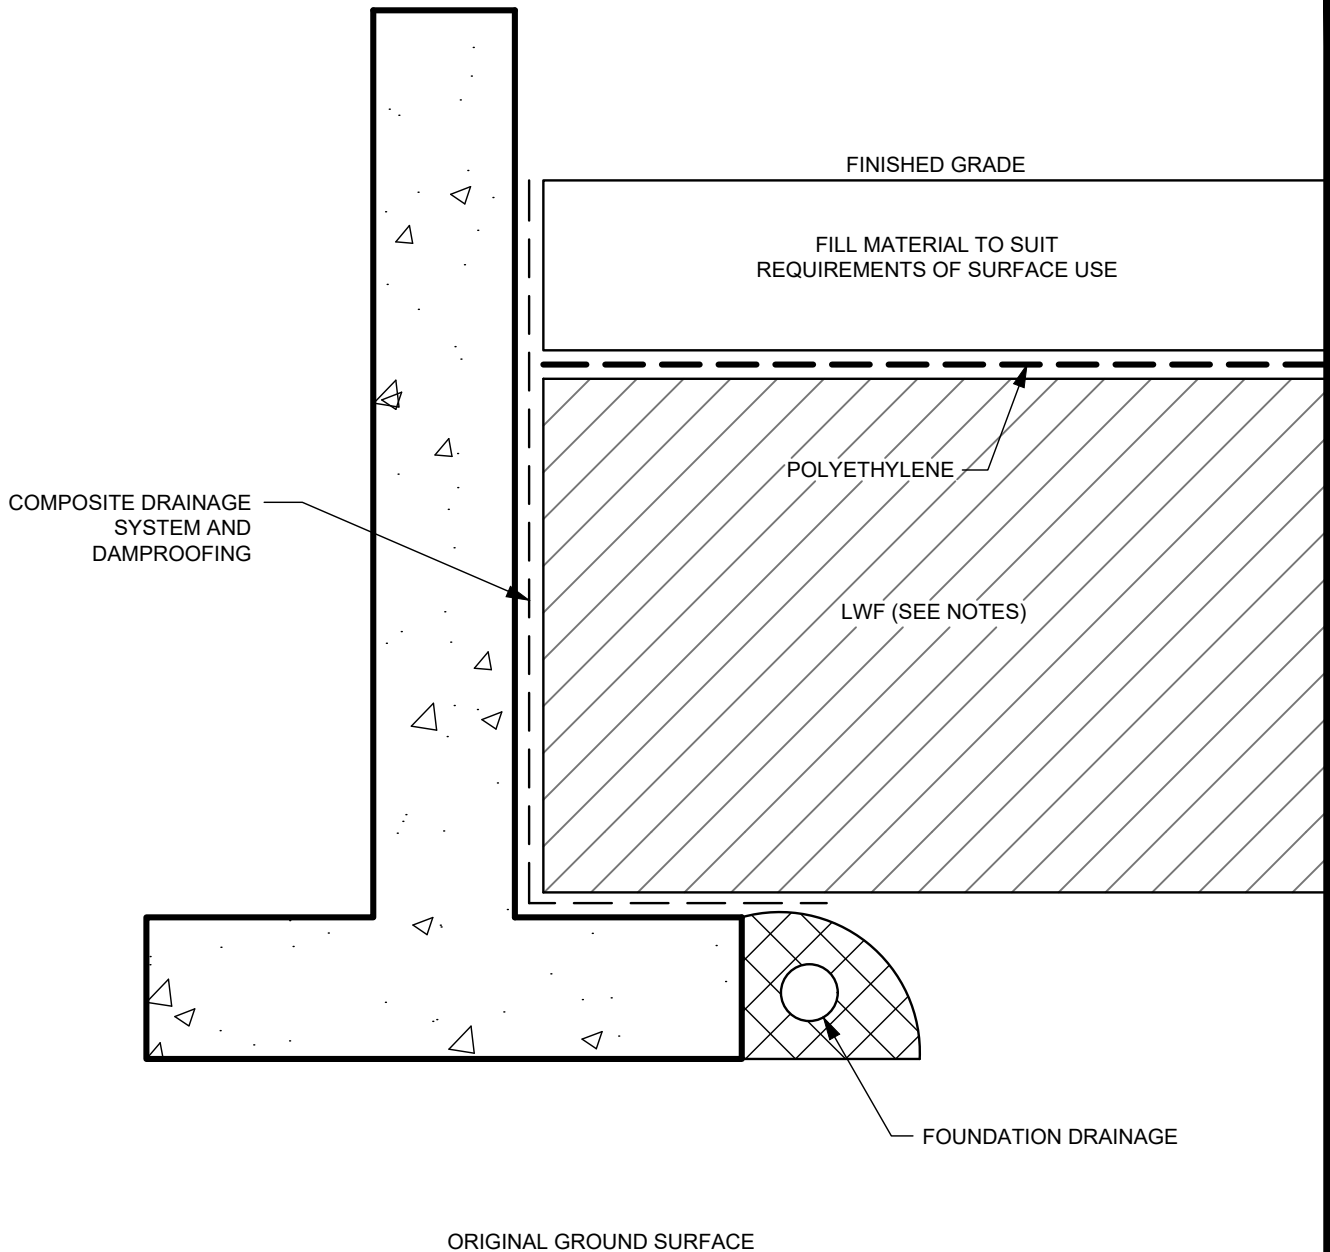
1. USE EPS12 BELOW FRONT PORCH
2. USE EPS15 BELOW GARAGE AND DRIVEWAY
USE EPS12 BELOW LANDSCAPED AREAS
3. MINIMUM GRANULAR THICKNESS OVER LWF SHOULD BE AS FOLLOWS:

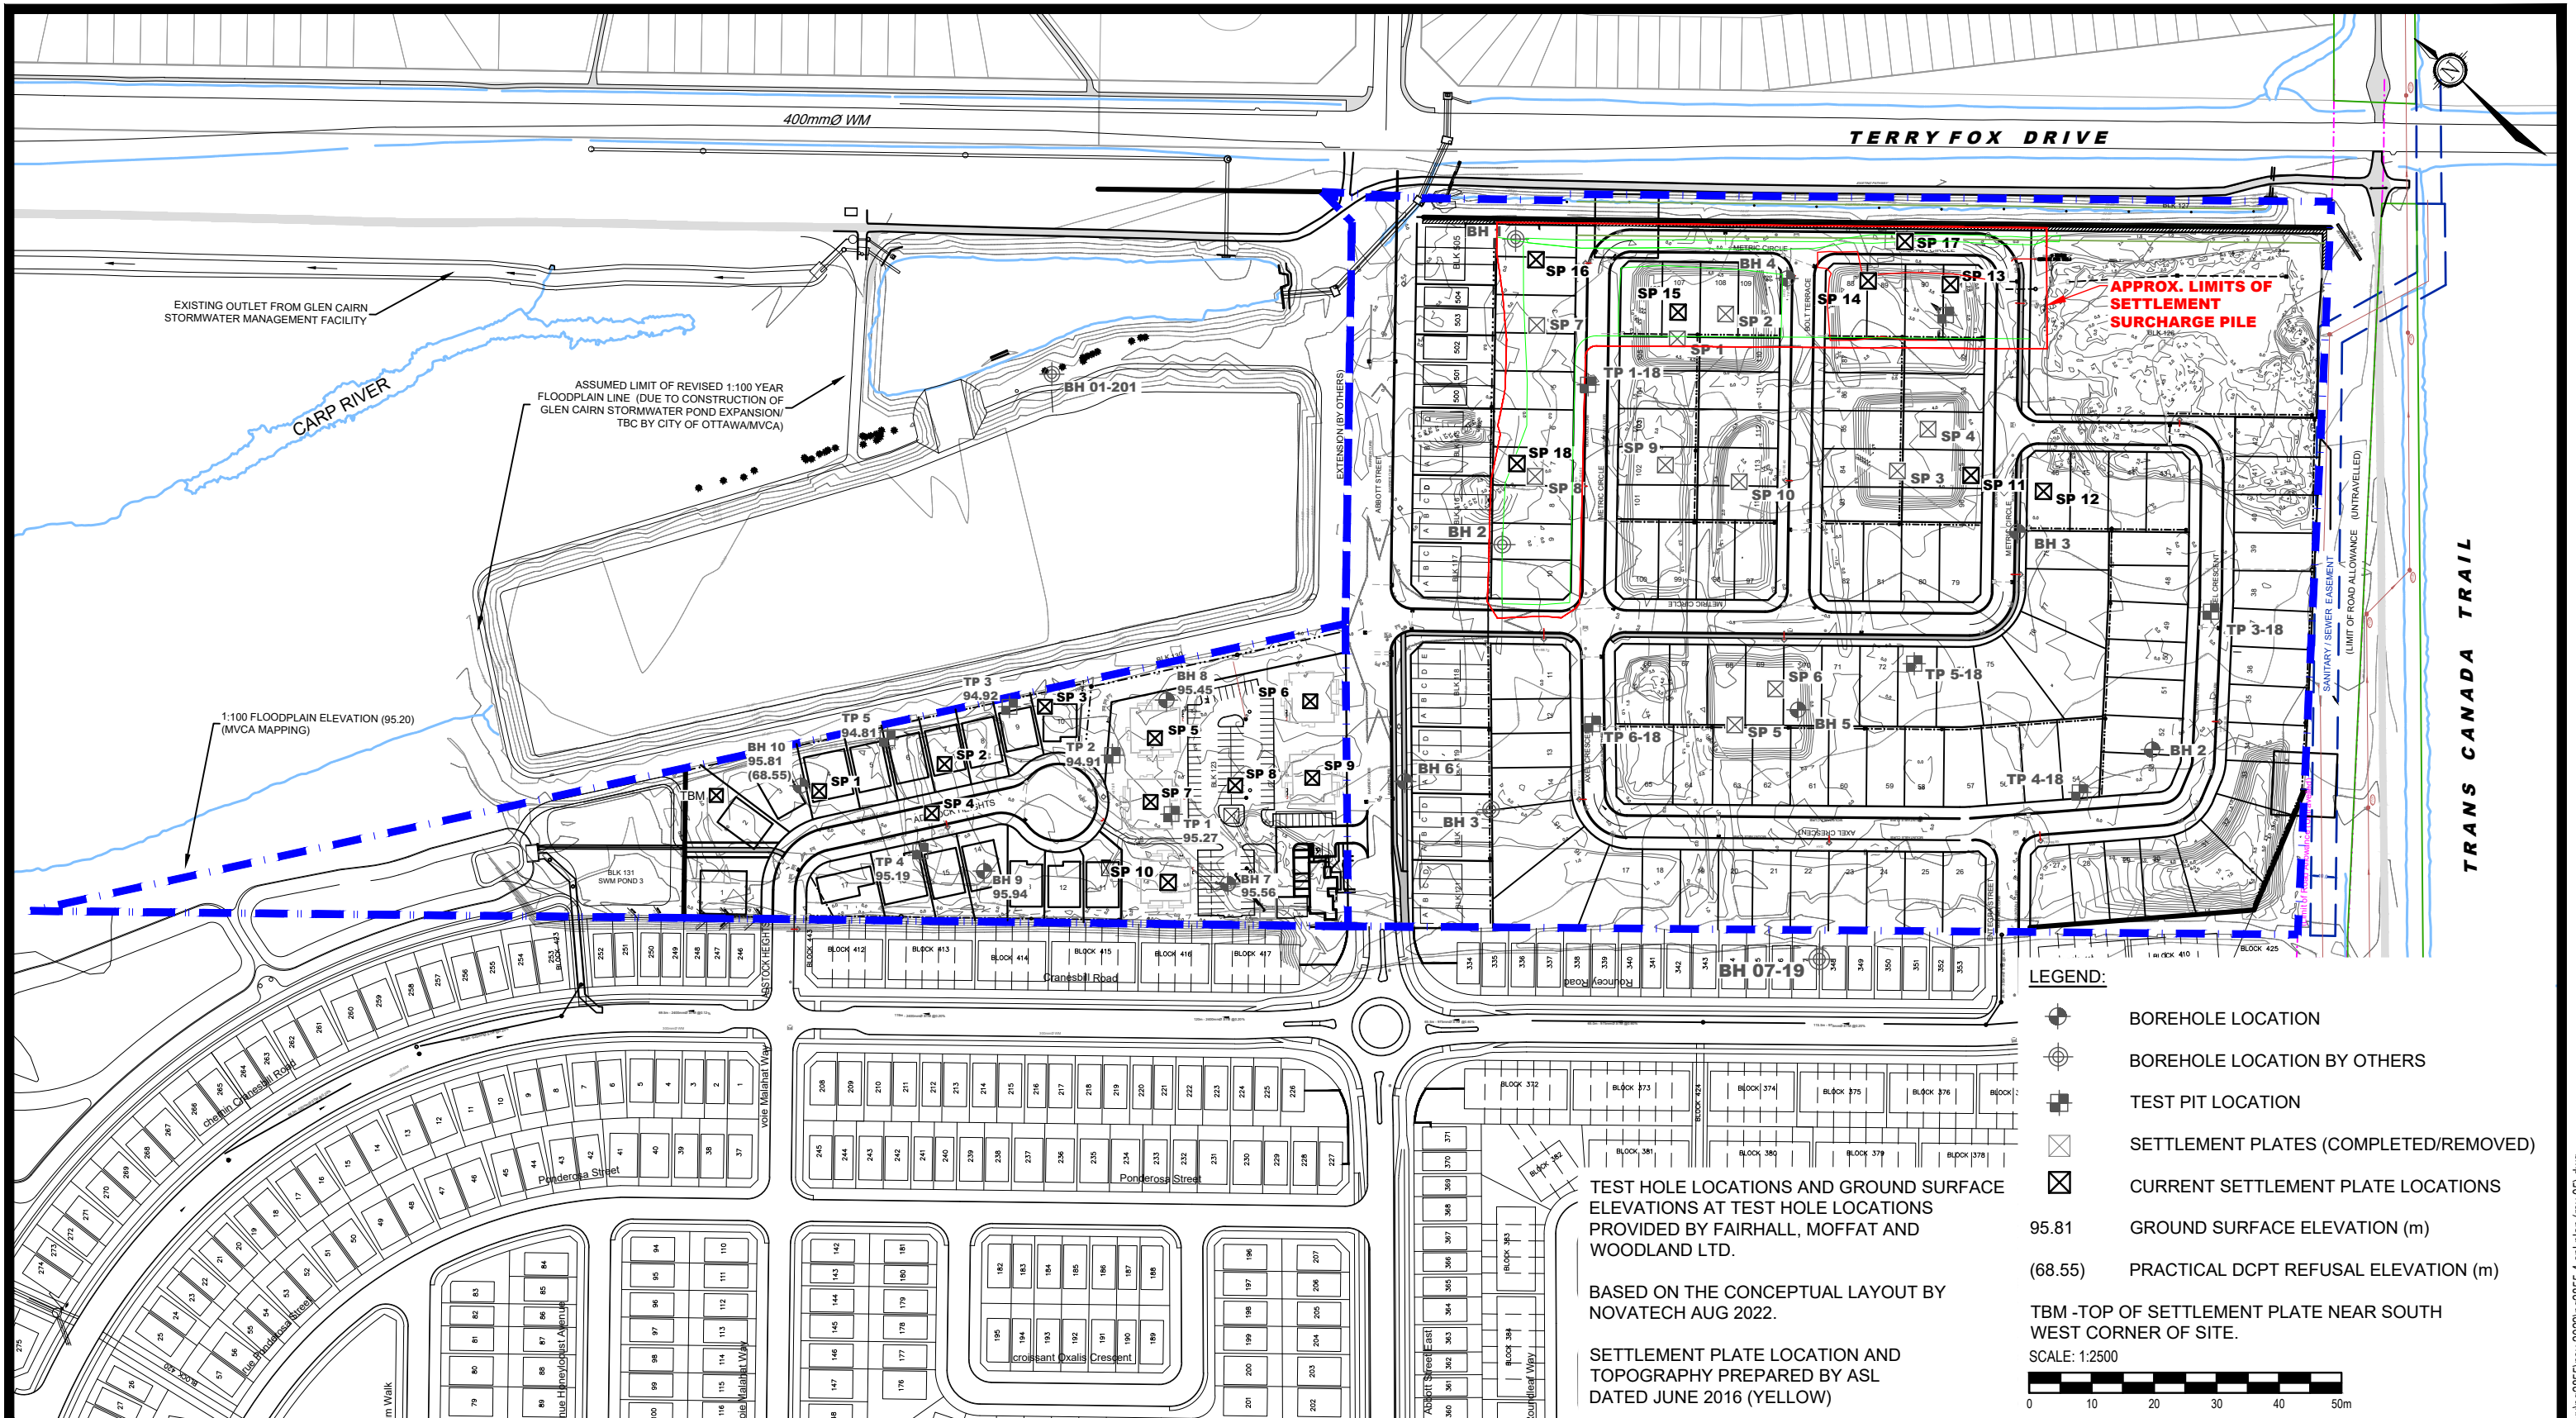
Title: **SETTLEMENT PLATE LOCATION PLAN**

- BOREHOLE LOCATION
- BOREHOLE LOCATION BY OTHERS
- TEST PIT LOCATION
- SETTLEMENT PLATES (COMPLETED/REMOVED)
- CURRENT SETTLEMENT PLATE LOCATIONS
- 95.81 GROUND SURFACE ELEVATION (m)
- (68.55) PRACTICAL DCPT REFUSAL ELEVATION (m)
- TBM - TOP OF SETTLEMENT PLATE NEAR SOUTH WEST CORNER OF SITE.
