Geotechnical Investigation

Proposed Residential Development

Phase 5 – Block 123

Report PG2855-3 Revision 1 dated February 9, 2026

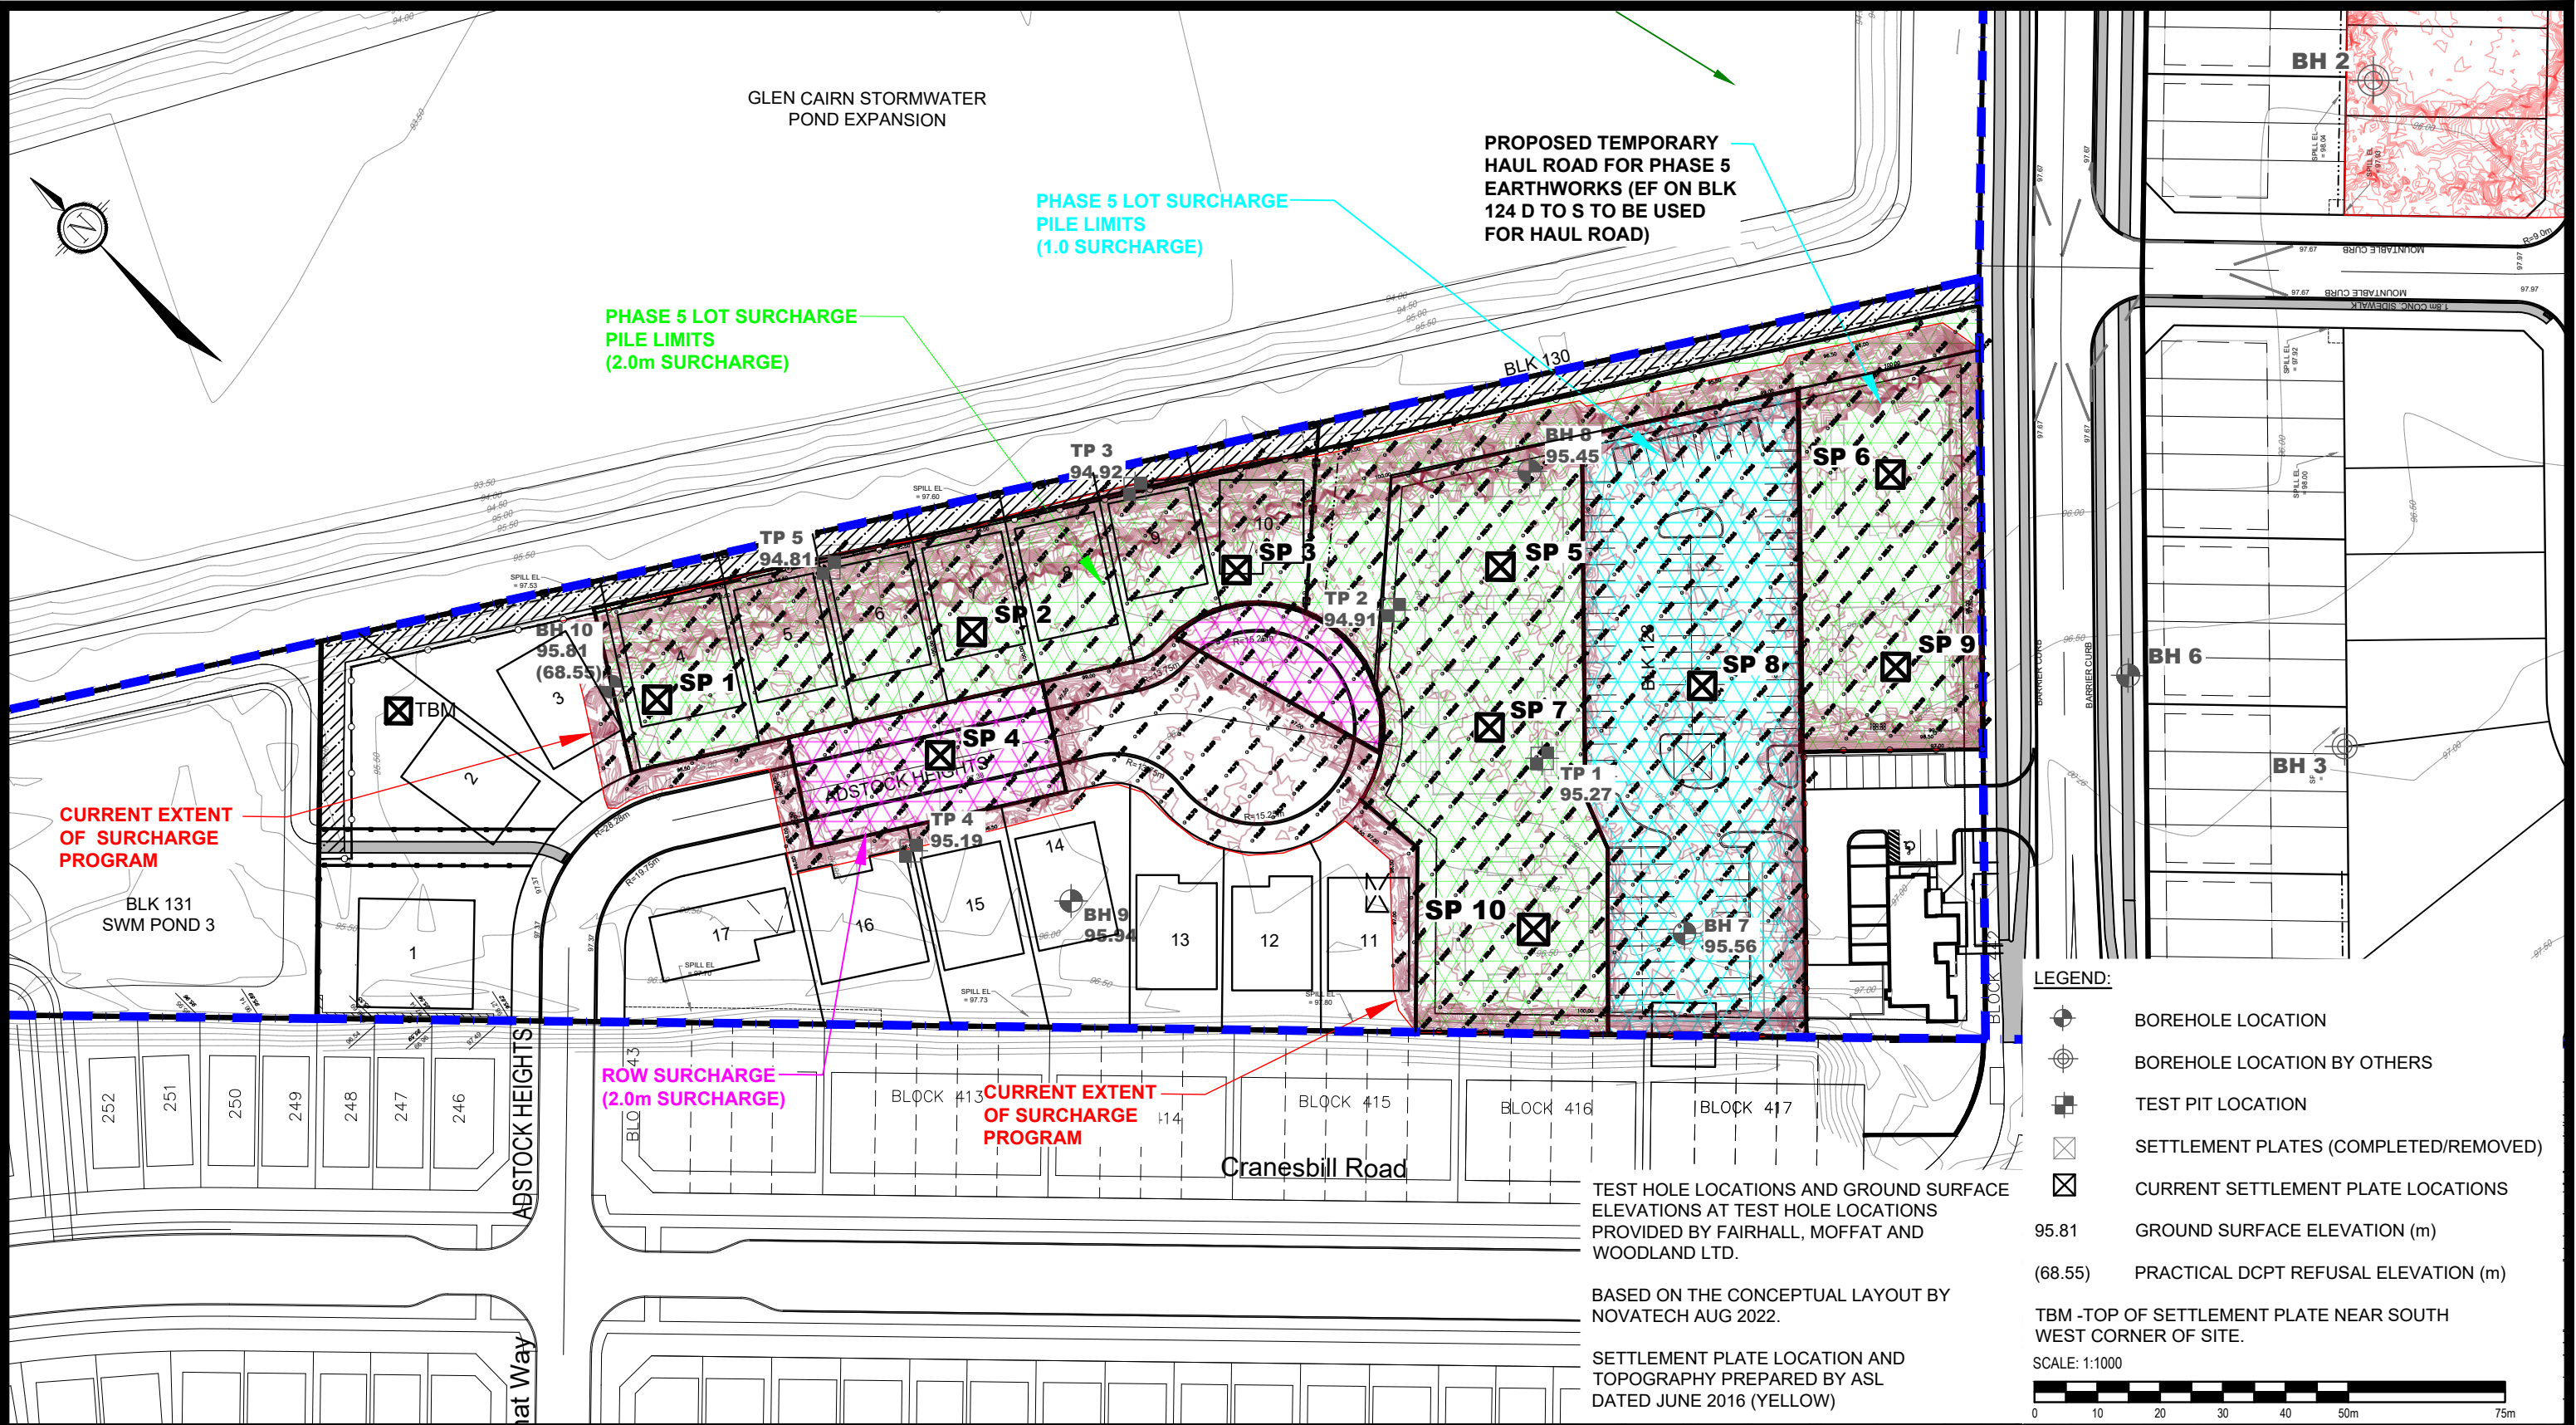
TEST HOLE LOCATIONS AND GROUND SURFACE ELEVATIONS AT TEST HOLE LOCATIONS PROVIDED BY FAIRHALL, MOFFAT AND WOODLAND LTD.

BASED ON THE CONCEPTUAL LAYOUT BY NOVATECH AUG 2022.

SETTLEMENT PLATE LOCATION AND TOPOGRAPHY PREPARED BY ASL DATED JUNE 2016 (YELLOW)
