Preliminary Geotechnical Investigation Report

Costco Gloucester Conversion to Business
Center – Fuel Station Addition
1900 Cyrville Road, Gloucester, Ontario

Project No. 121626297

March 2026

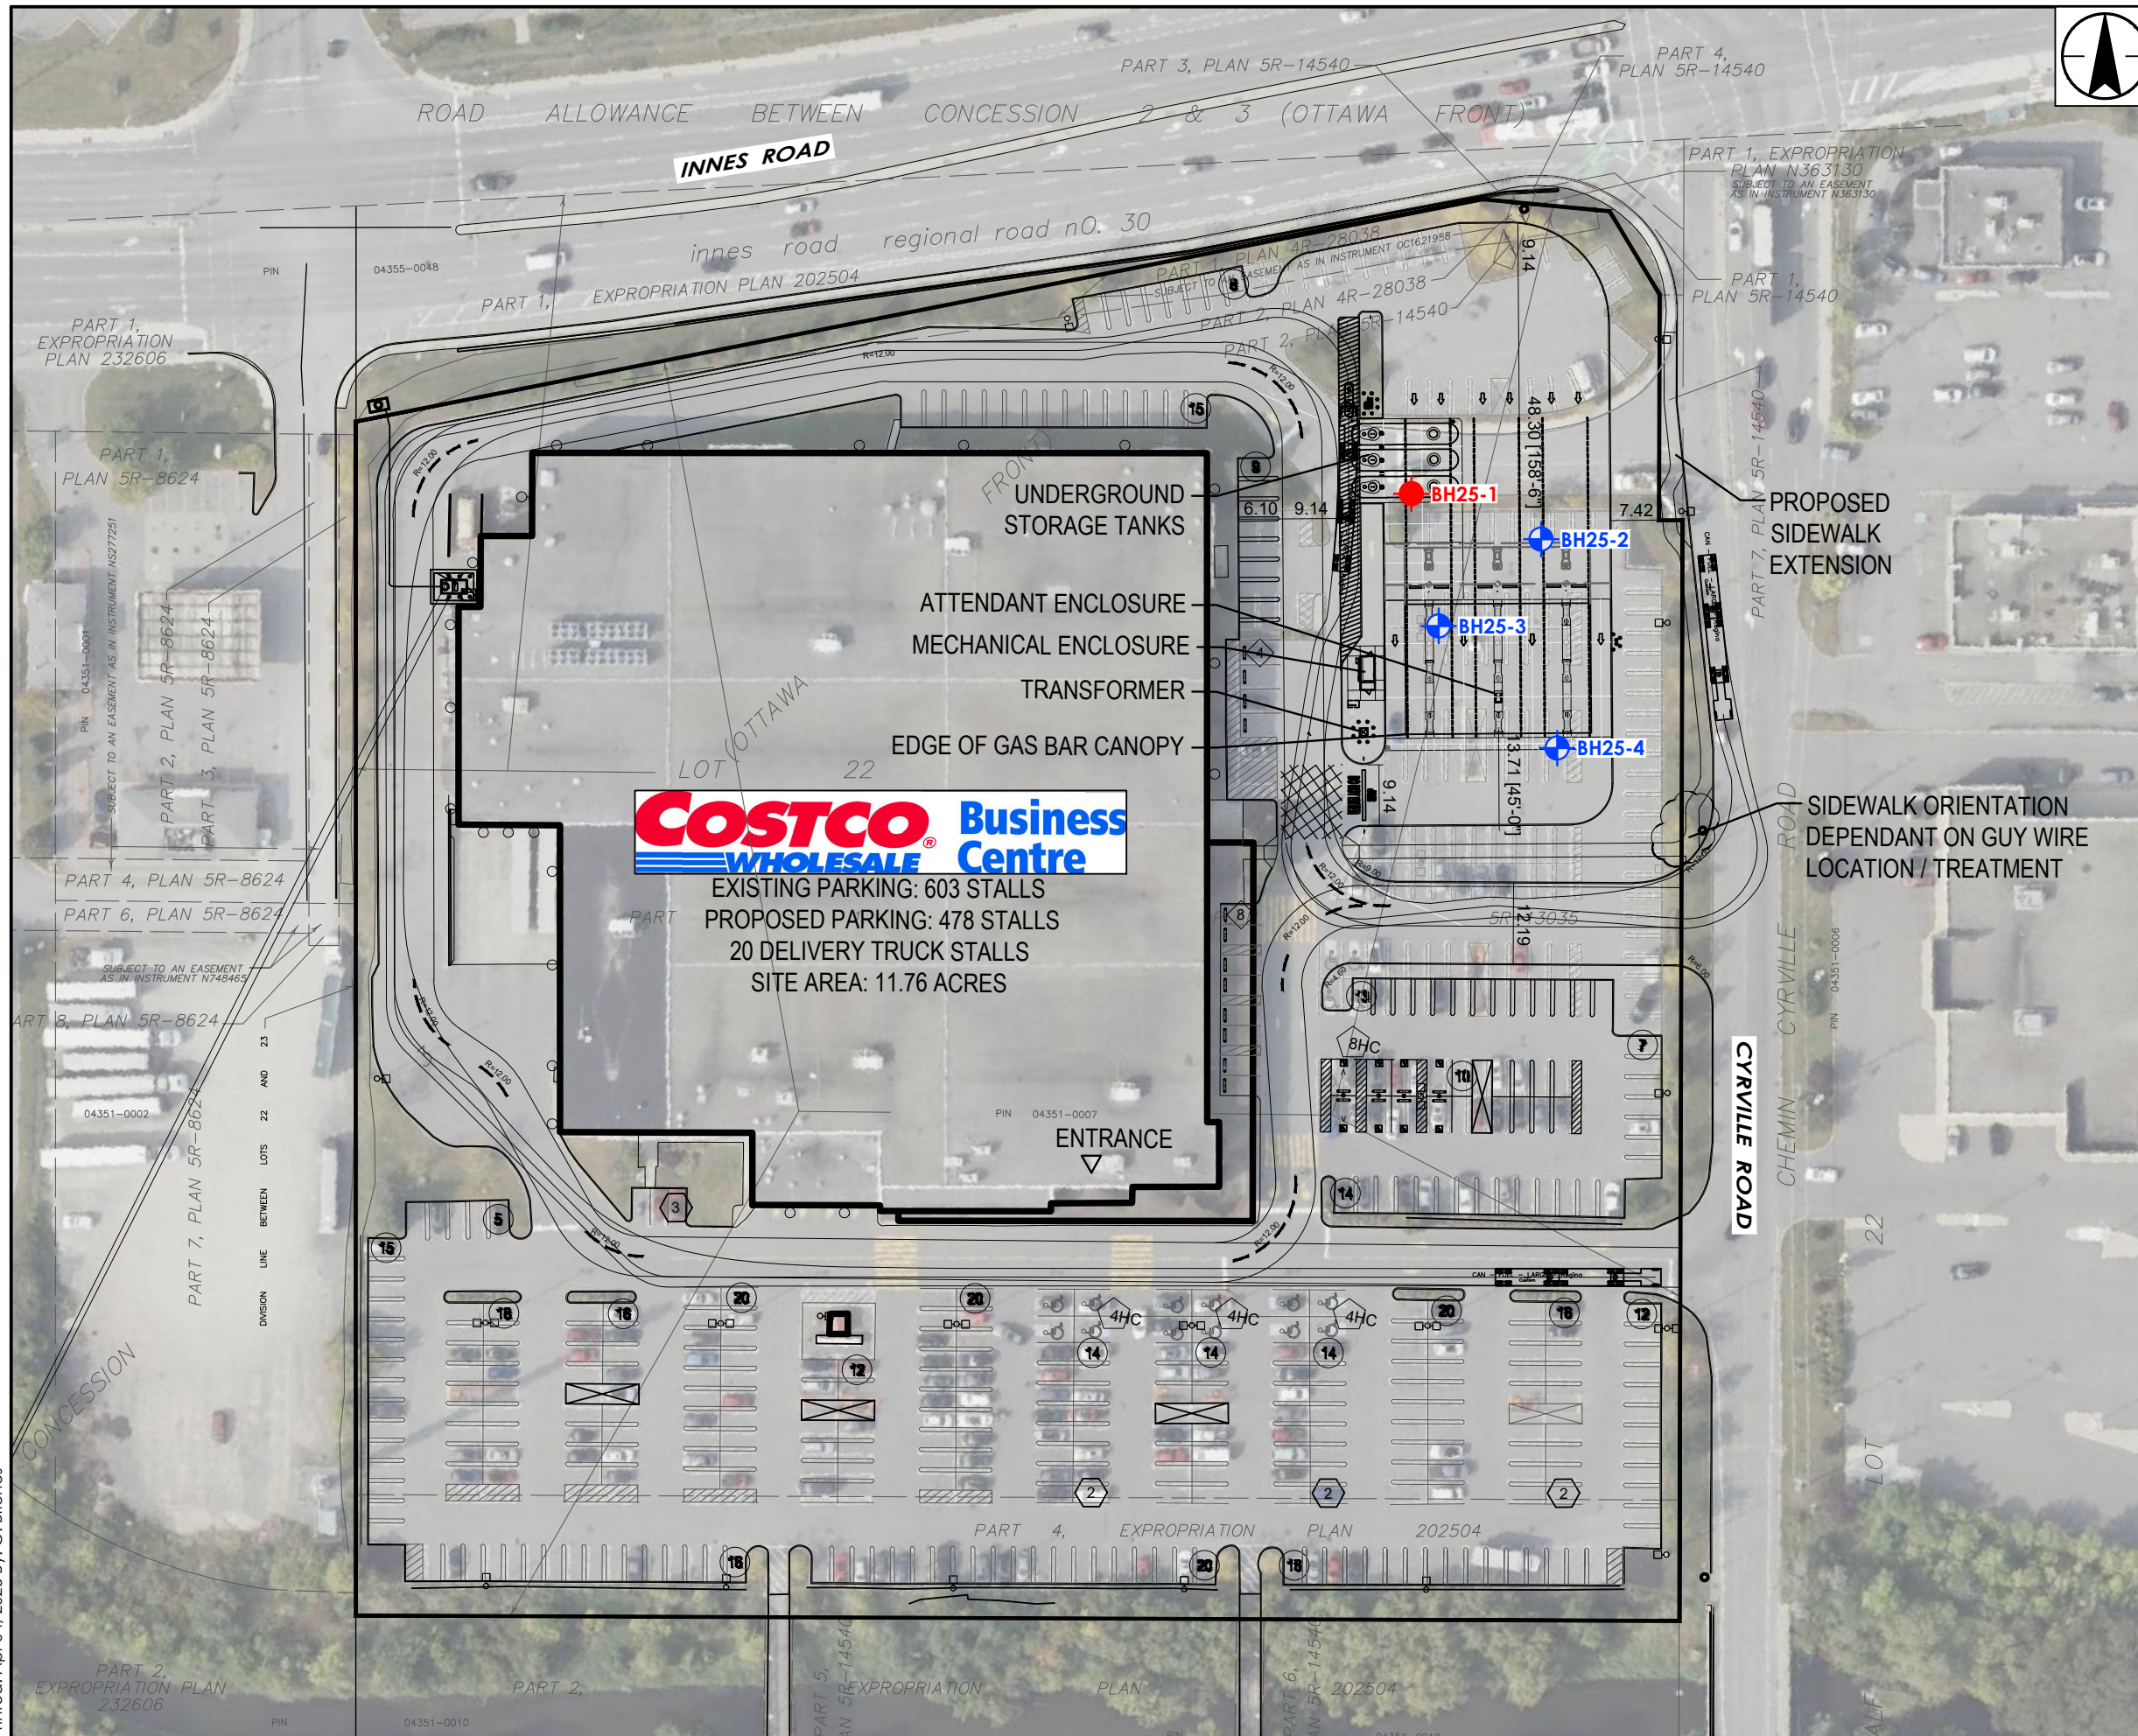
MONITORING WELL (STANTEC, 2025)

Boreholes BH25-01 was advanced at the location of the proposed underground storage tanks and boreholes BH25-02, BH25-03, and BH25-04 were advanced for the proposed pavement structures, pump foundations, and canopy foundations within the footprint of site plan SP-11.

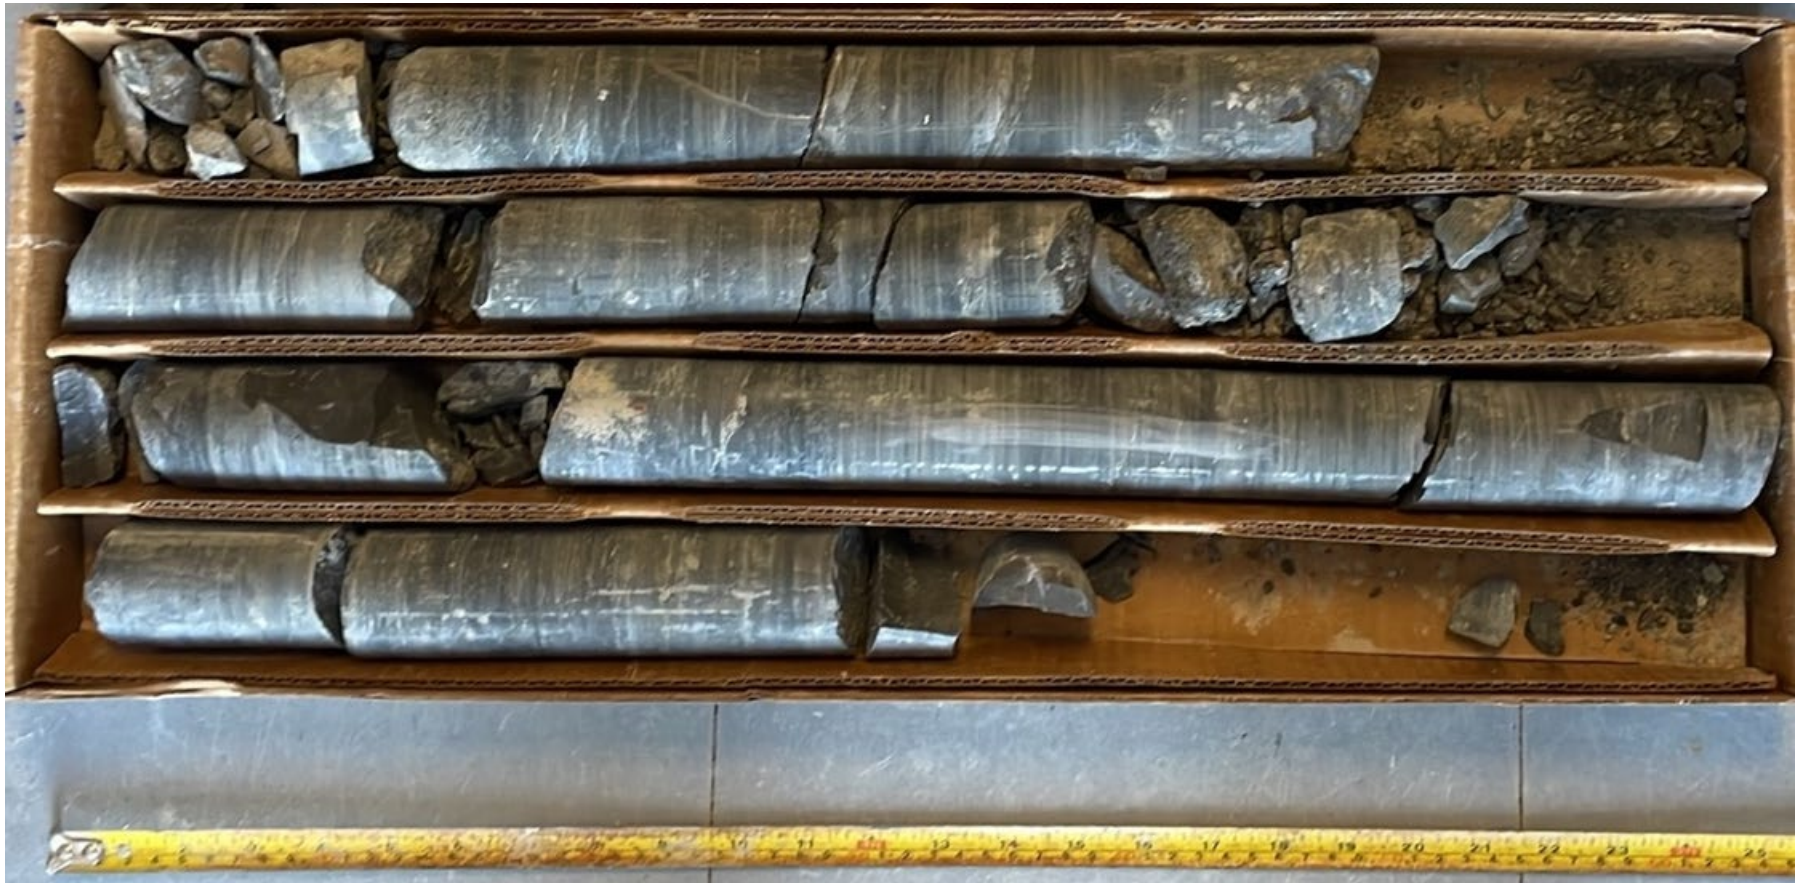
Rock Core Photo No.: 1

Rock Core Photograph

Borehole: BH25-01
