# **Geotechnical Investigation**

## **Proposed Commercial Development**

301 Somme Street  
Ottawa, Ontario

Report PG7567-1 dated November 14, 2025

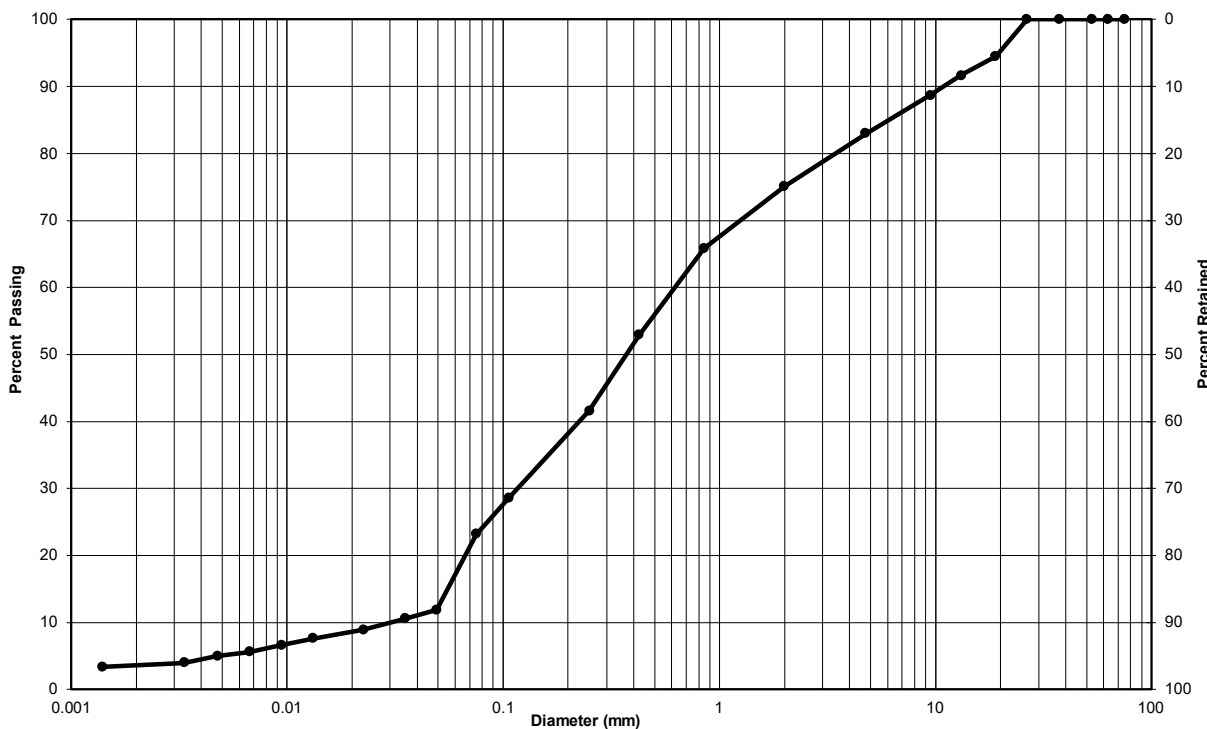
**Borehole no.:** BH1-21    **Sample no.:** SS2B  
**Depth:** 0.9 to 1.4m    **Enclosure:** -

Soil Description	Gravel (%)	Sand (%)	Clay & Silt (%)
Silty sand with gravel (SM)	17	60	23
<b>Silt-size particles (%):</b>	19		
<b>Clay-size particles (%) (&lt;0.002mm):</b>	4

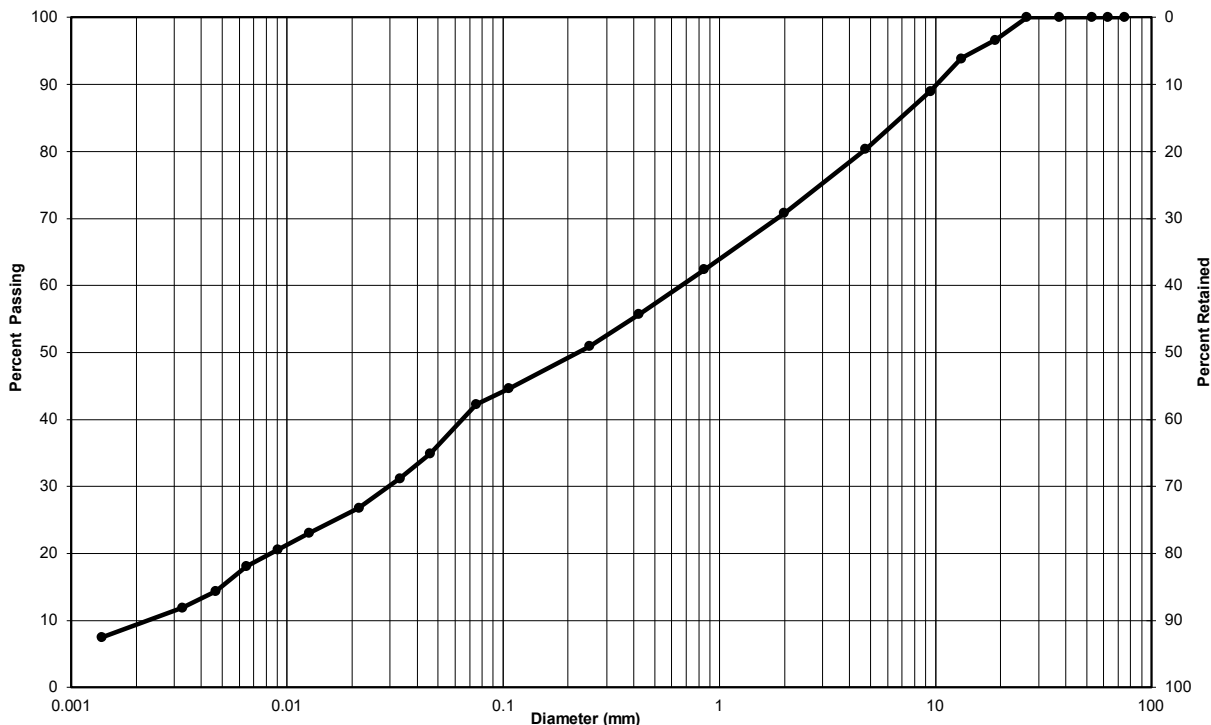
**Depth:** 8.4 to 9.0m **Enclosure:** -

Soil Description	Gravel (%)	Sand (%)	Clay & Silt (%)
Sandy lean clay with gravel (CL)	20	38	42
<b>Silt-size particles (%):</b>	33		
<b>Clay-size particles (%) (&lt;0.002mm):</b>	9

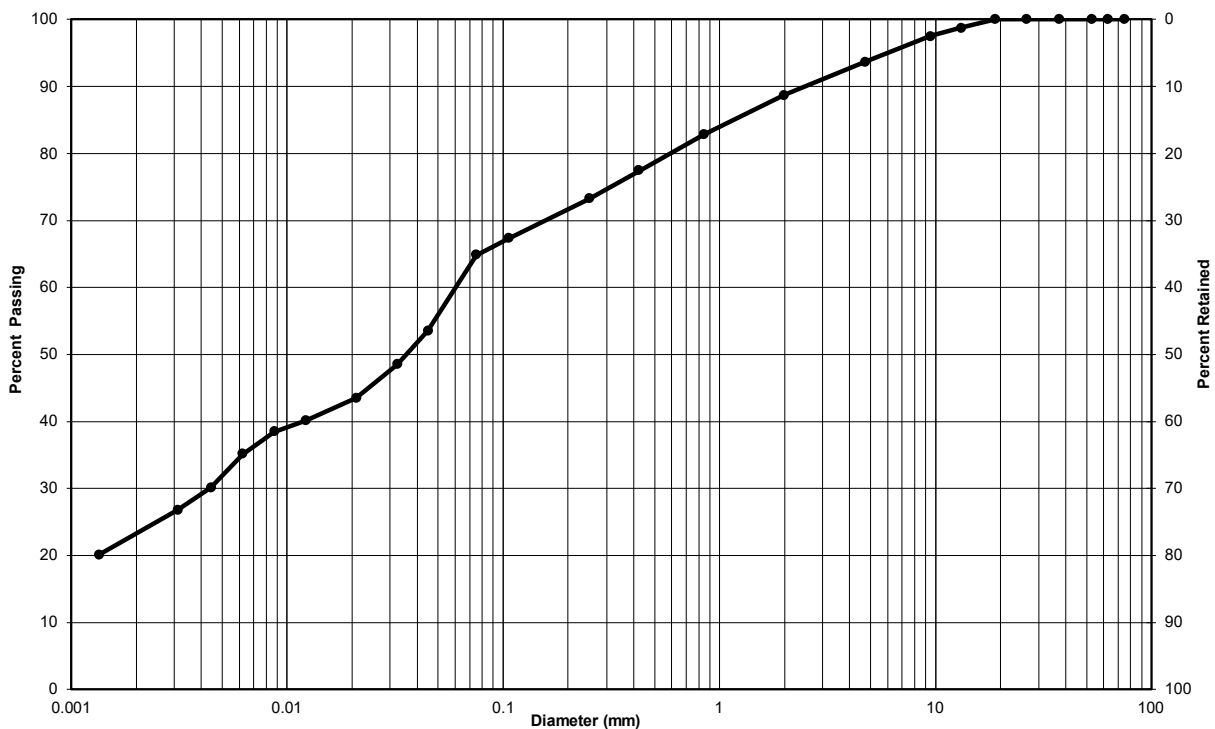
**Borehole no.:** BH2-21    **Sample no.:** SS18  
**Depth:** 13.0 to 13.6m    **Enclosure:** -

Soil Description	Gravel (%)	Sand (%)	Clay & Silt (%)
Sandy lean clay (CL)	6	29	65
<b>Silt-size particles (%):</b>	42		
<b>Clay-size particles (%) (&lt;0.002mm):</b>	23

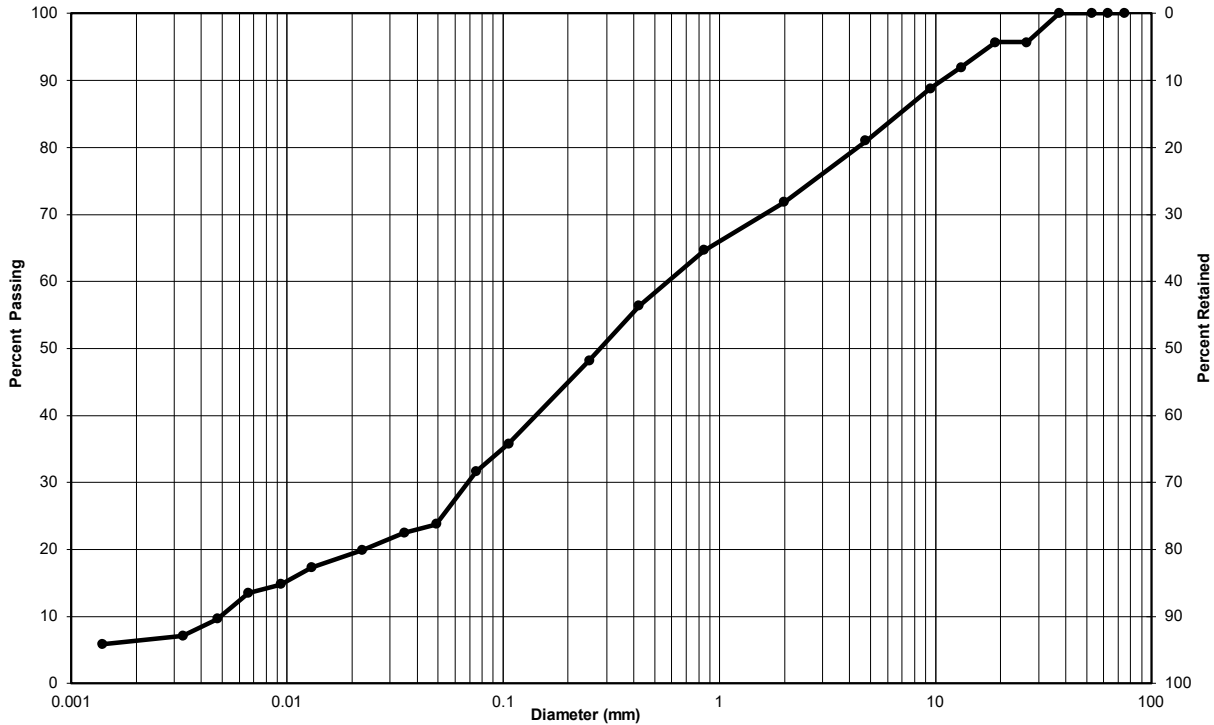
**Depth:** 5.3 to 5.9m **Enclosure:** -

Soil Description	Gravel (%)	Sand (%)	Clay & Silt (%)
Sandy silty clay with gravel (CL-ML)	19	49	32
<b>Silt-size particles (%):</b>	26		
<b>Clay-size particles (%) (&lt;0.002mm):</b>	6

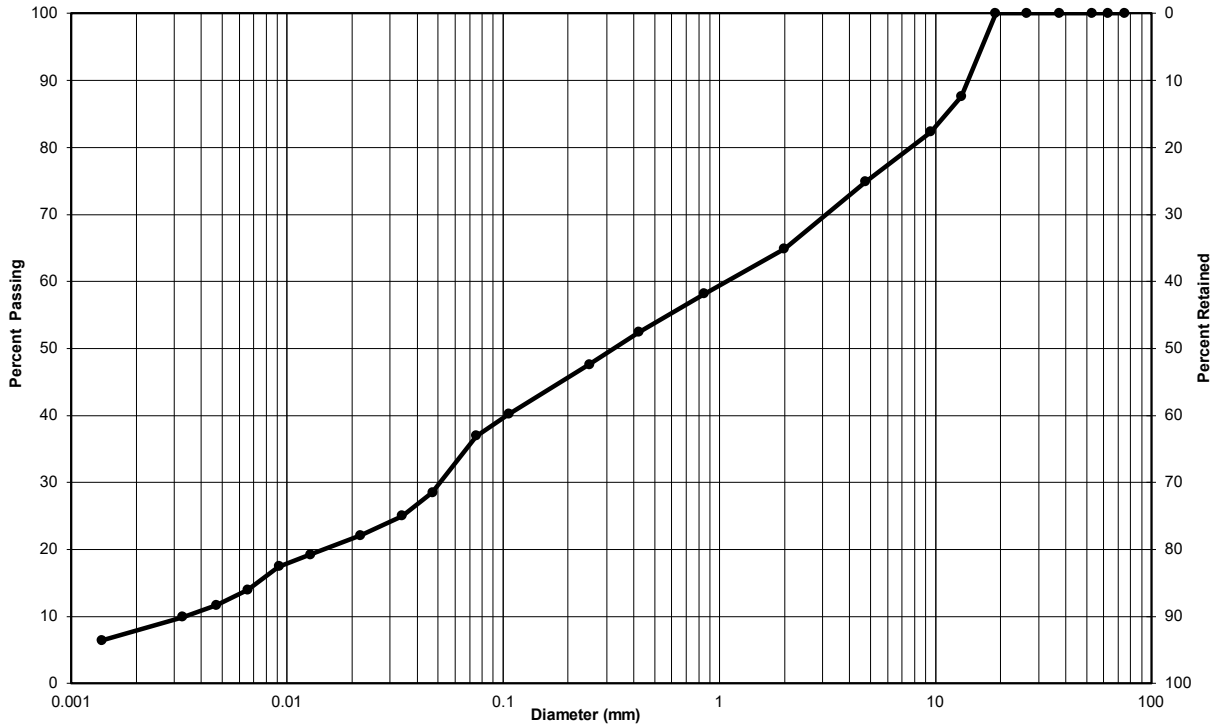
**Borehole no.:** BH5-21    **Sample no.:** SS3  
**Depth:** 1.5 to 2.1m    **Enclosure:** -

Soil Description	Gravel (%)	Sand (%)	Clay & Silt (%)
Silty sand with gravel (SM)	25	38	37
<b>Silt-size particles (%):</b>	29		
<b>Clay-size particles (%) (&lt;0.002mm):</b>	8

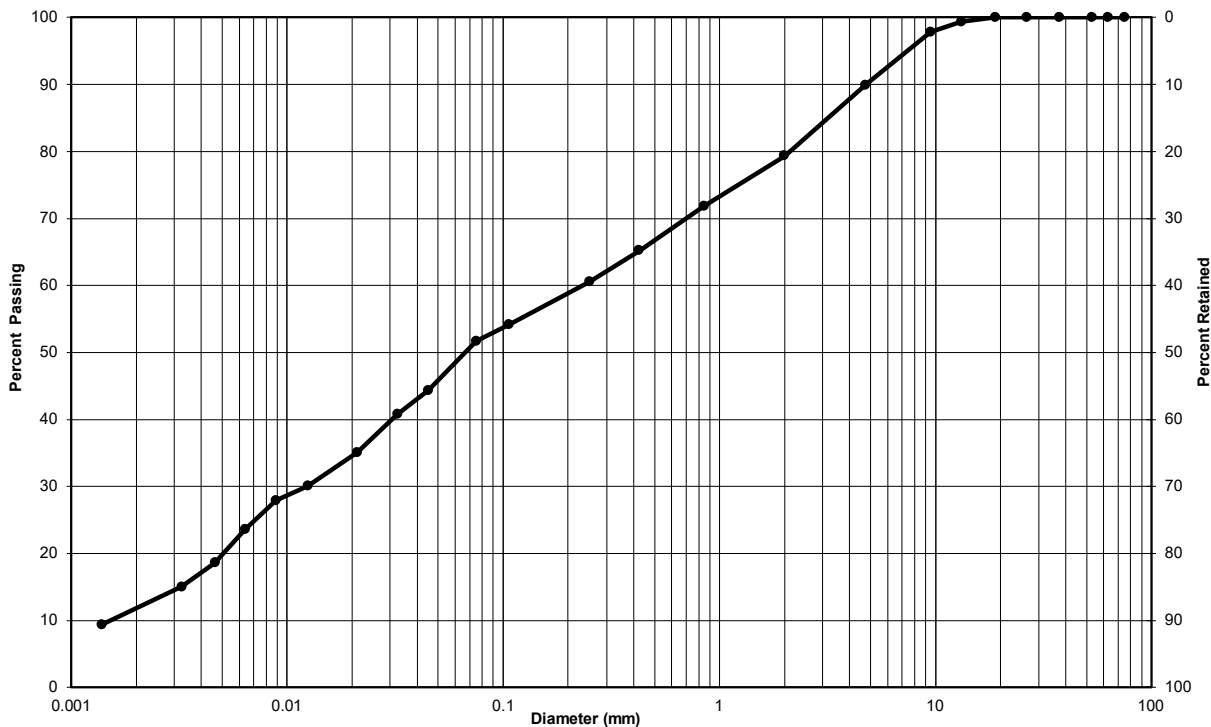
**Depth:** 4.6 to 5.2m **Enclosure:** -

Soil Description	Gravel (%)	Sand (%)	Clay & Silt (%)
Sandy silty clay with gravel (CL-ML)	10	38	52
<b>Silt-size particles (%):</b>	41		
<b>Clay-size particles (%) (&lt;0.002mm):</b>	11

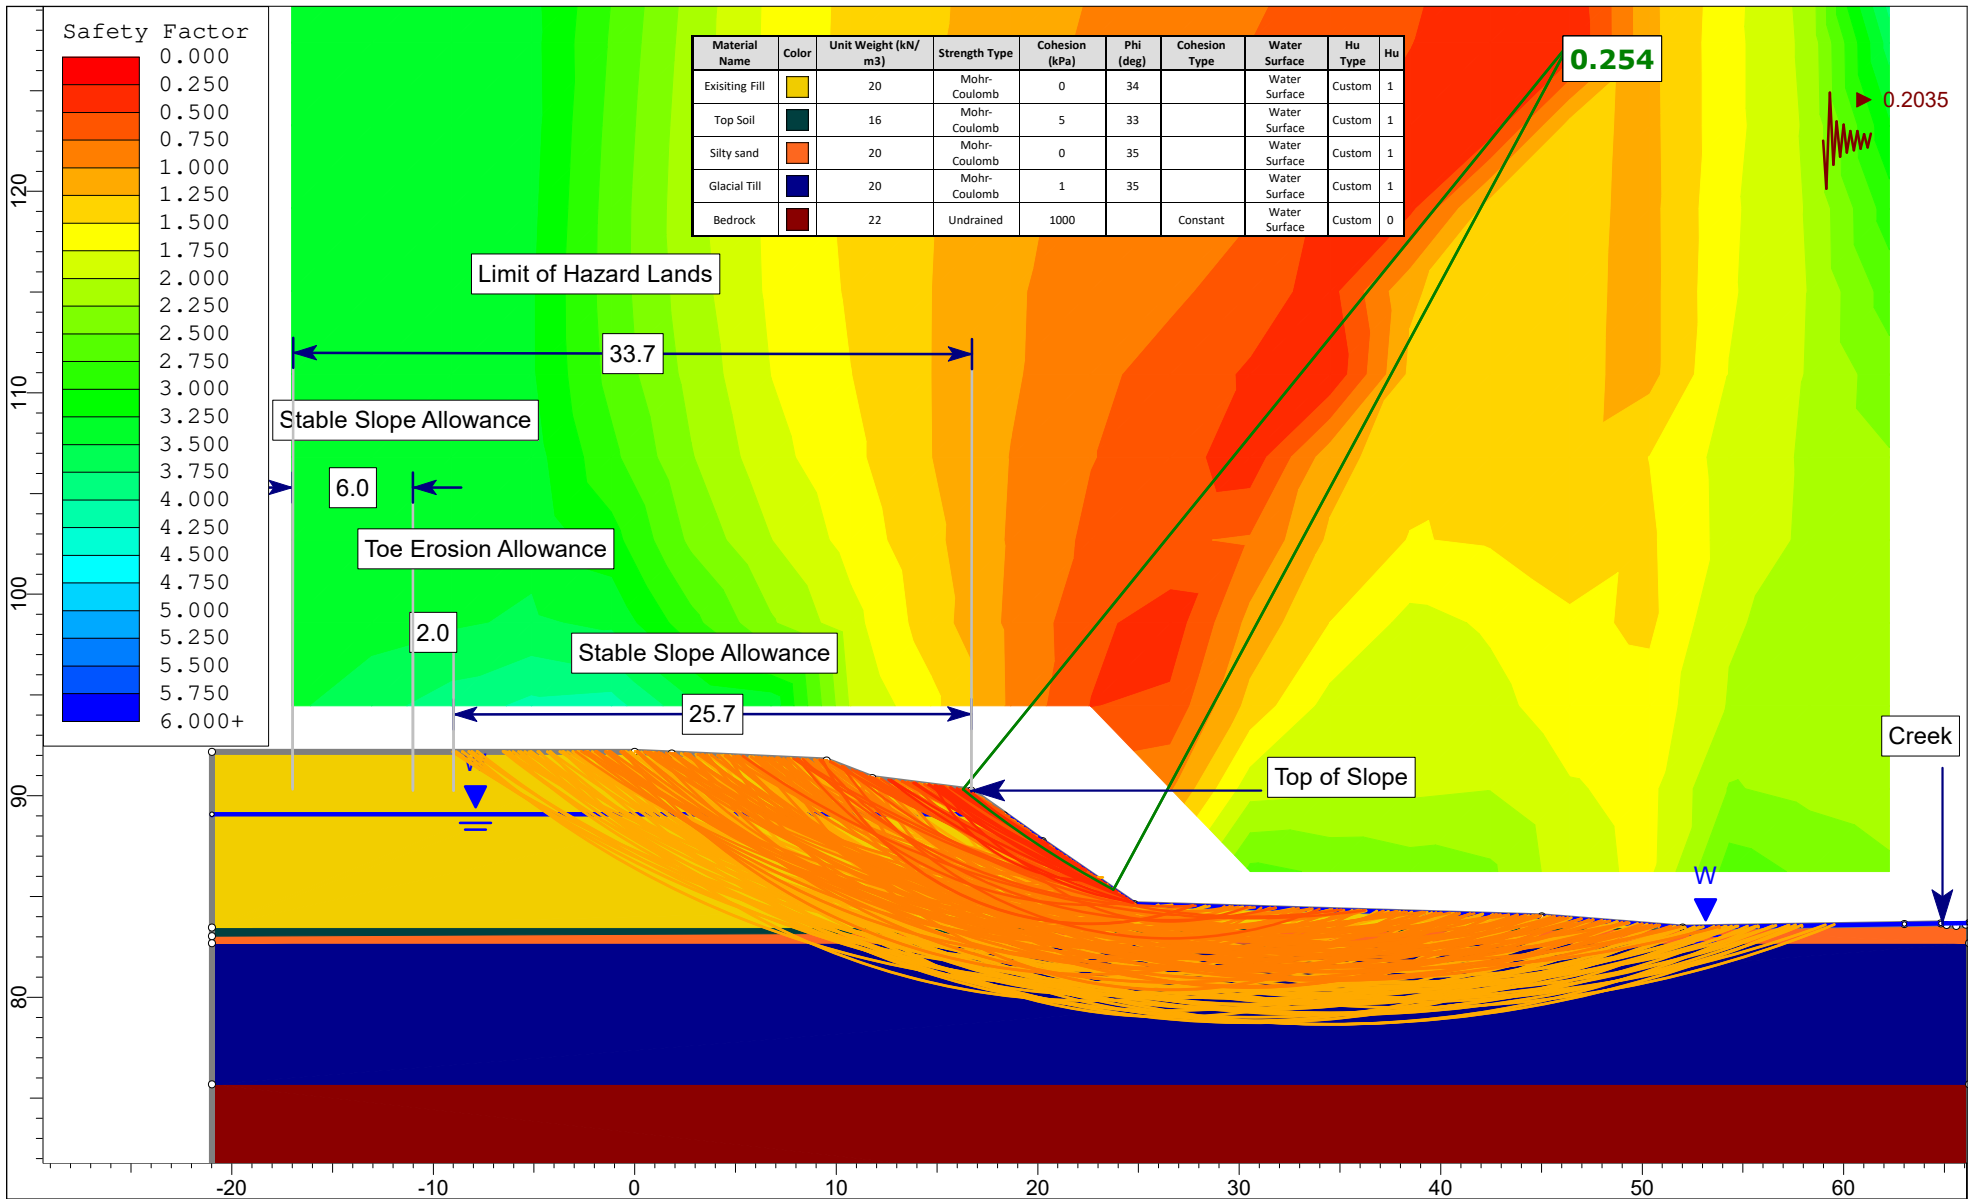
Project		PG7567 - 301 Somme Street		
	Slope Section		B	Scenario	Existing Seismic Condition
	Drawn By		DR	Company	W.O. Stinson & Son Ltd
	Date		2025-06-27	File Name	Figure 3B

Material Name	Color	Unit Weight (kN/m <sup>3</sup> )	Strength Type	Cohesion (kPa)	Phi (deg)	Cohesion Type	Water Surface	Hu Type	Hu
Existing Fill	Yellow	20	Mohr-Coulomb	0	34		Water Surface	Custom	1
Top Soil	Dark Green	16	Mohr-Coulomb	5	33		Water Surface	Custom	1
Silty sand	Orange	20	Mohr-Coulomb	0	35		Water Surface	Custom	1
Glacial Till	Dark Blue	20	Mohr-Coulomb	1	35		Water Surface	Custom	1
Bedrock	Dark Red	22	Undrained	1000		Constant	Water Surface	Custom	0

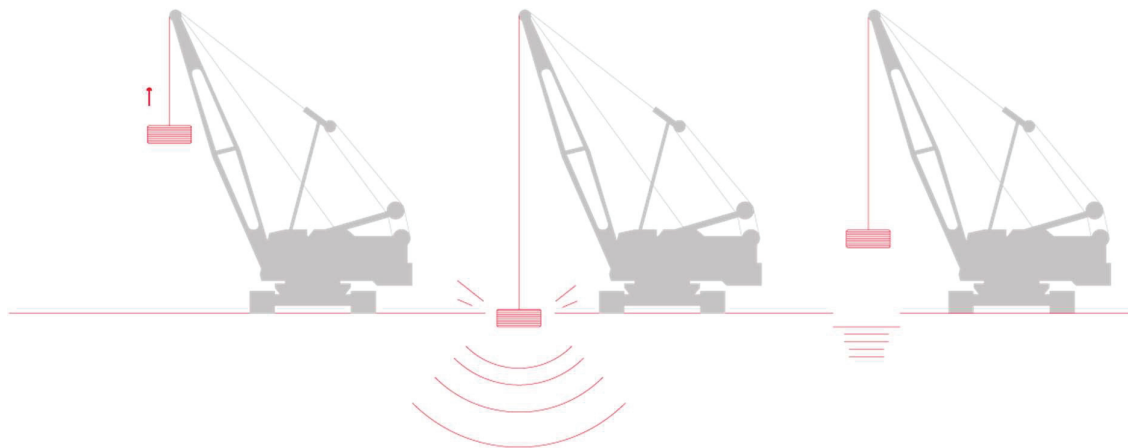
Figure 1 – Dynamic Compaction process

Dynamic Compaction (DC) is used to transmit high impacts to loose and soft soils that have an initial low bearing capacity, high compressibility and/or liquefaction potential in order to significantly improve their mechanical properties.

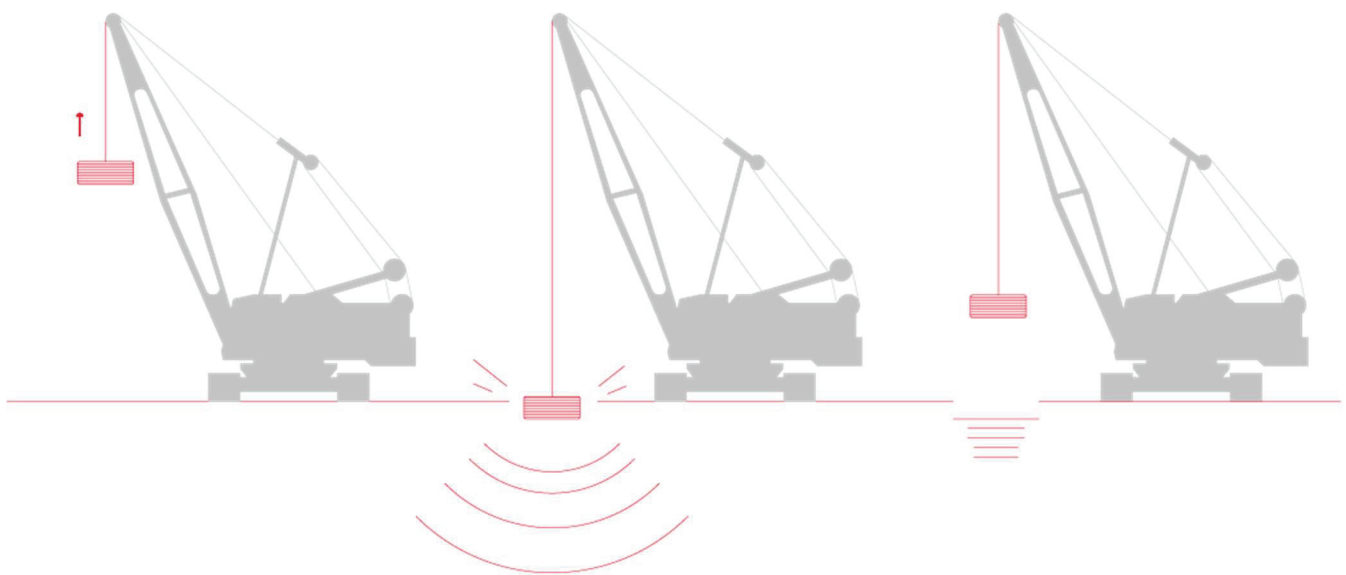
Figure 1 : Dynamic Compaction Densification Process

The arrangement of the impact points and the other parameters of the treatment (energy, phasing, rest periods) depend on the characteristics of the soil to be treated and on the results of the initial works. The depth of improvement is a function of the pounder weight and drop height, i.e. the amount of energy applied. Dynamic Compaction is used to increase the density and therefore bearing capacity and compressibility of in-situ soils. Using triggering criteria analysis outlined in Idriss and Boulanger (2014), CPT results or SPT results combined with grain size analysis of the targeted soils can be used to confirm that the FOS against liquefaction has increased following treatment with ground improvement.

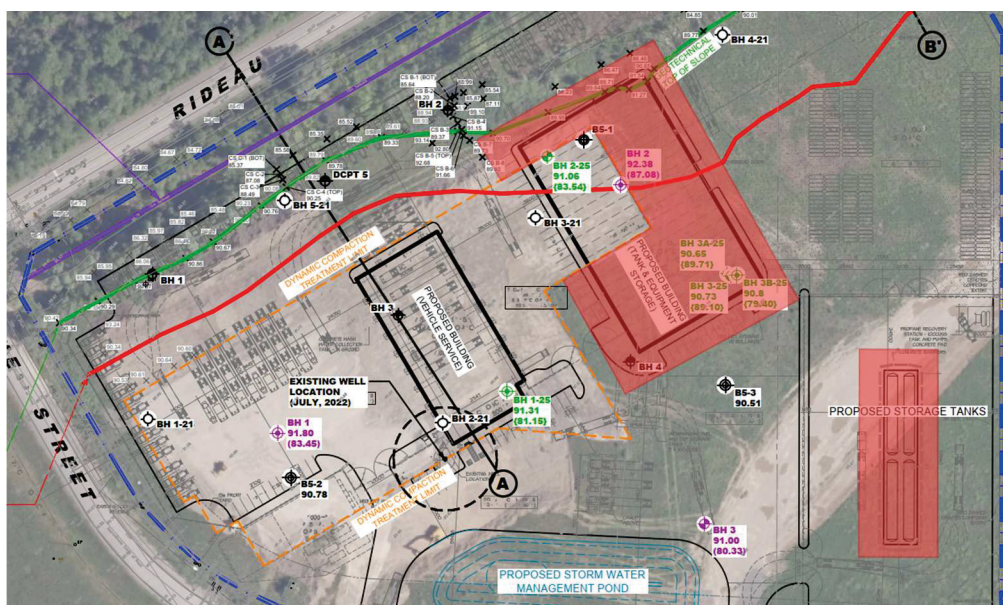
Figure 2 : Approximate Work Zone for Dynamic Compaction (photo: Paterson 2025)

Based on the Site Plan drawings and Paterson's Geotechnical Investigation, the location of the newly proposed buildings are outside of the previously completed ground improvement scope of work. Menard will implement the DC work within the footprint of the newly proposed buildings with a 4m buffer zone outside of the footprints as shown in **Figure 2**.

As noted above in Section 5.1, additional ground improvement will be required at the subject site in order to encompass the entirety of the currently proposed buildings. This is discussed in the letter in Appendix 4, which has been prepared by the ground improvement contractor.
