Geotechnical Investigation

Proposed Residential Development

3400 Woodroffe Avenue
Ottawa, Ontario

Report PG7287-1 Rev. 1 dated April 20, 2026

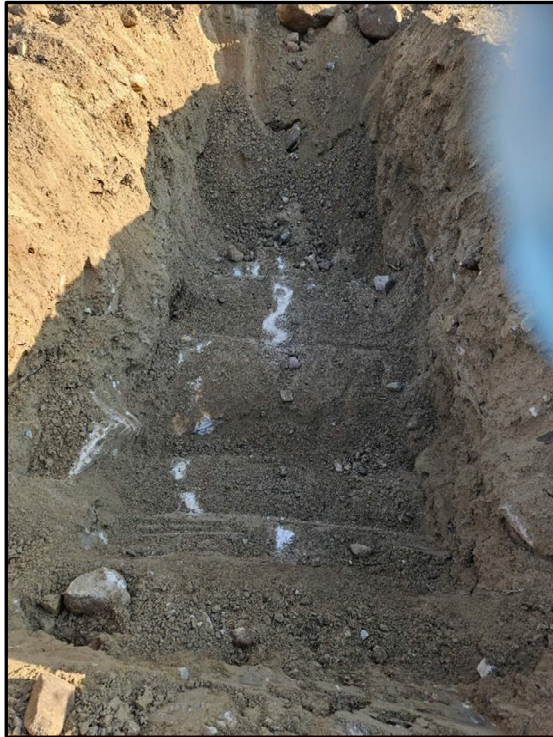
Photo 1: Photo of the test pit TP 1-24.

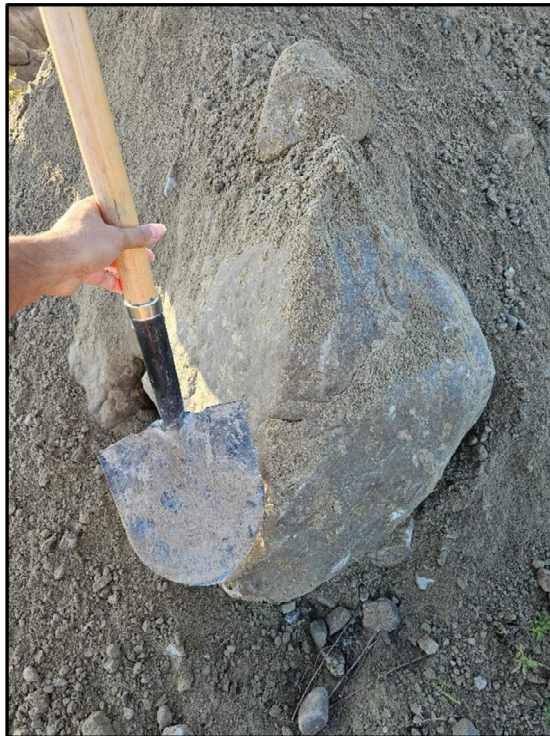
Photo 2: Photo illustrating the boulder excavated from the test pit TP 1-24.

The underlying glacial till was generally composed of compact to very dense, brown silty sand with gravel, cobbles and boulders. The amount of gravel, cobbles and boulders within the glacial till was noted to gradually increase with depth, varying approximately from 40 to 70 % of the total composition of the glacial till. The dimensions of the boulders observed within the test pits varied between about 300 to 1200 mm. Reference should be made to the test pit photos in Appendix 2 for a visual indication of the quantity and size of the gravel, cobbles, and boulders.

Significant cobbles and boulders should be expected during the servicing and building excavations at the subject site. A budget should be provided in the project tender for the removal of cobbles and boulders.

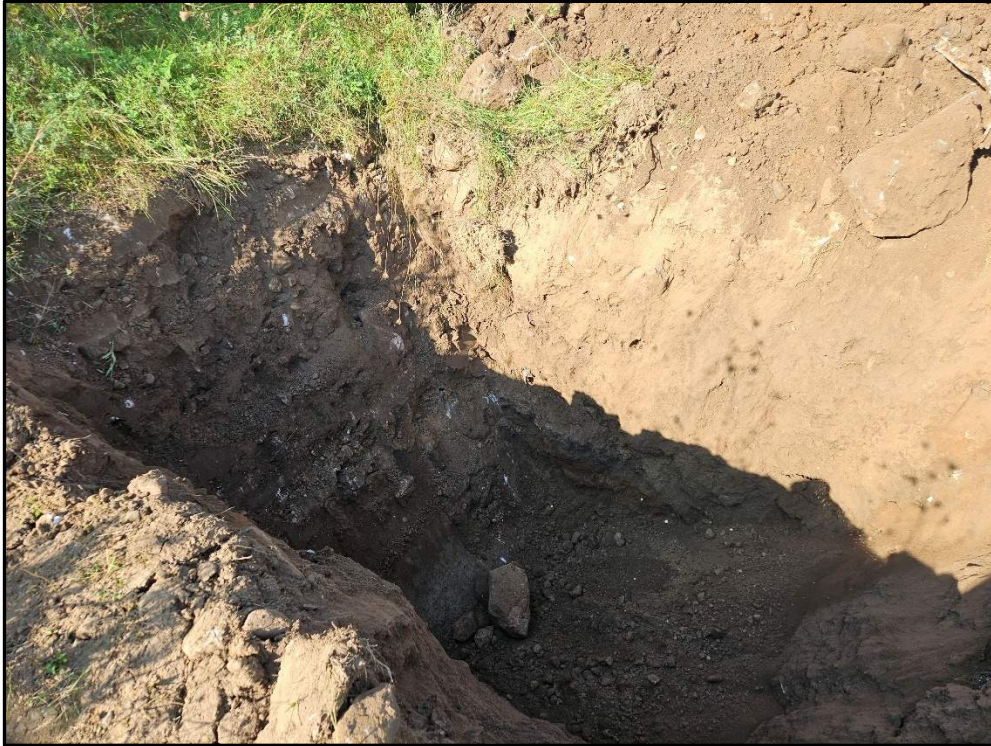
Photo 3: Photo of the test pit TP 2-24.

Generally, the subsurface profile at the test pit locations consists of a relatively thin layer of fill underlain by a glacial till deposit. The fill was generally observed to consist of silty sand with gravel and organics. Construction debris, such as crushed stone, bricks and concrete, were encountered within the upper approximate 0.3 and 2.4 m of the fill at test pits TP 2-24 and TP-3-24, respectively. It should also be noted that test pit TP 2-24 encountered refusal on a concrete slab at an approximate depth of 0.34m.

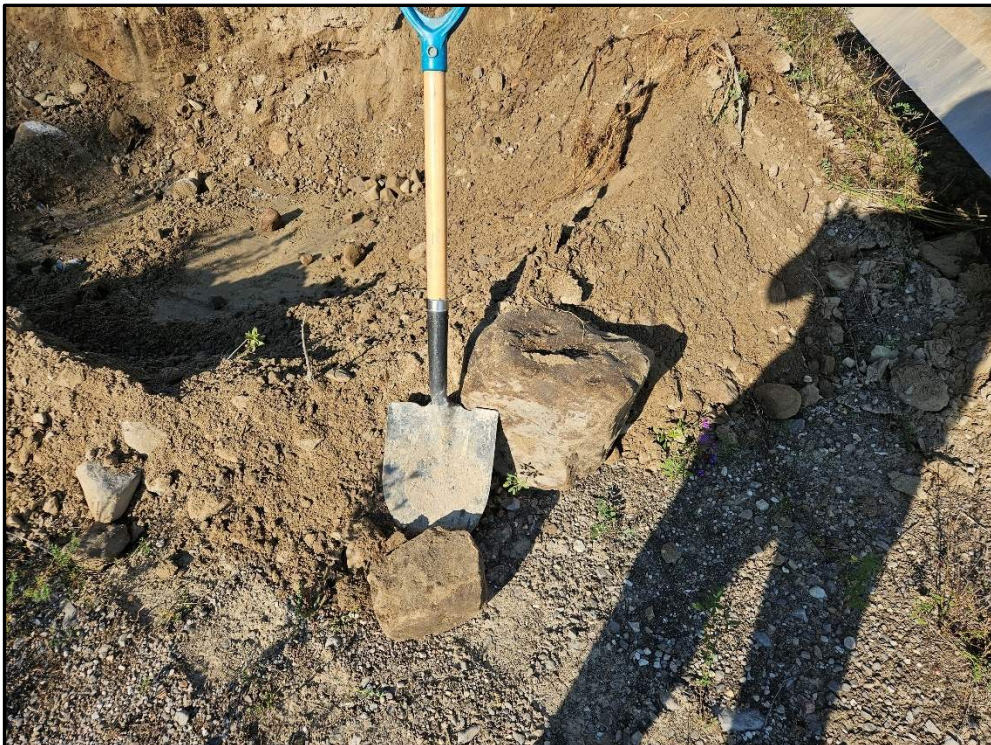
Photo 4: Photo illustrating the boulders from the test pit TP 2-24.

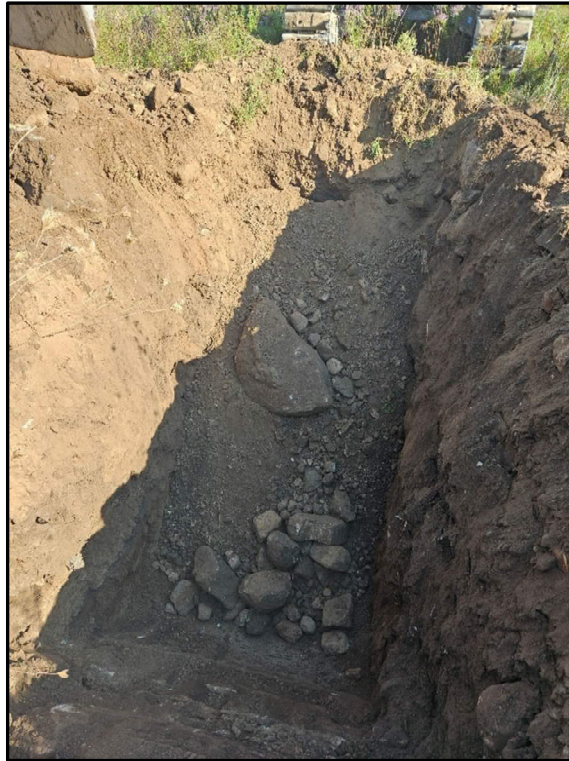
Photo 5: Photo of the test pit TP 3-24.

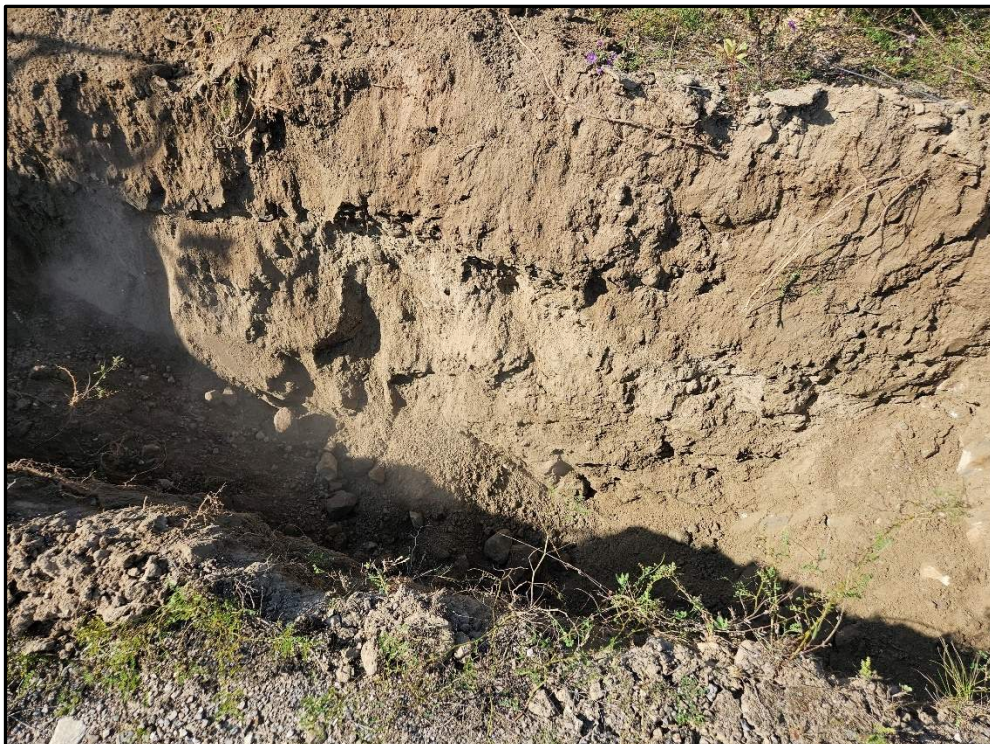
Photo 8: Photo of the test pit TP 4-24.

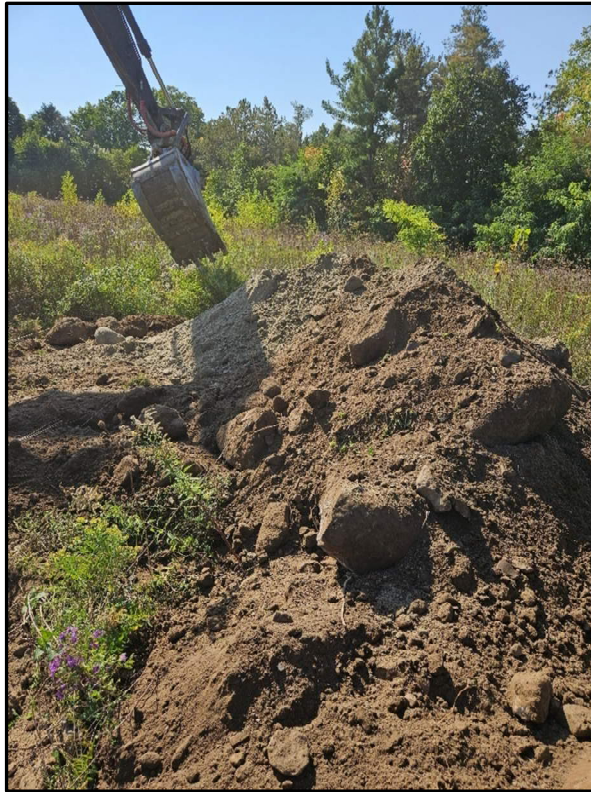
Photo 9: Photo illustrating the boulders excavated from the test pit TP 5-24.

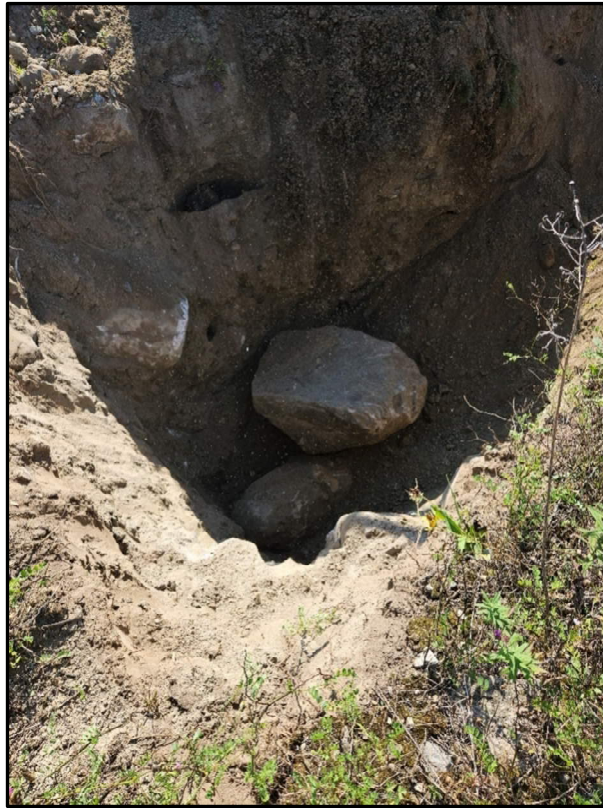
Photo 13: Photo of the test pit TP 8-24.

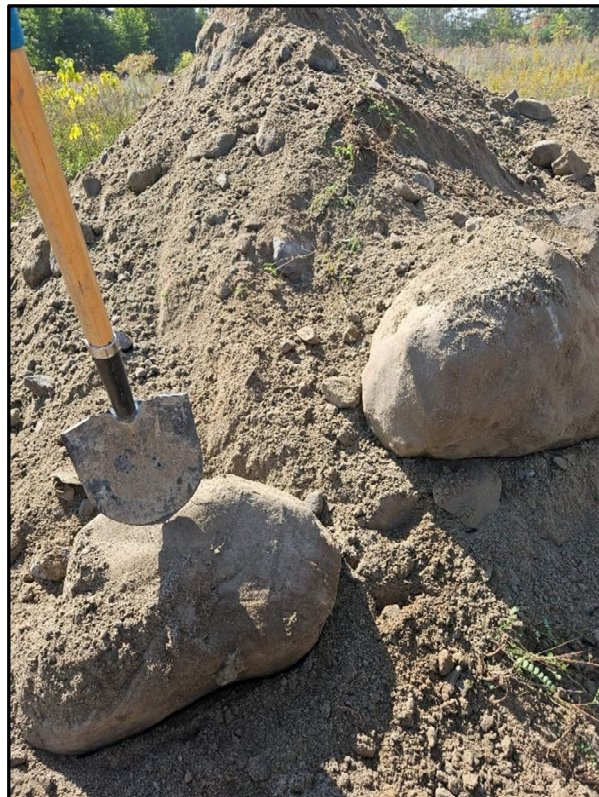
Photo 14: Photo illustrating the boulders excavated from the test pit TP 8-24.

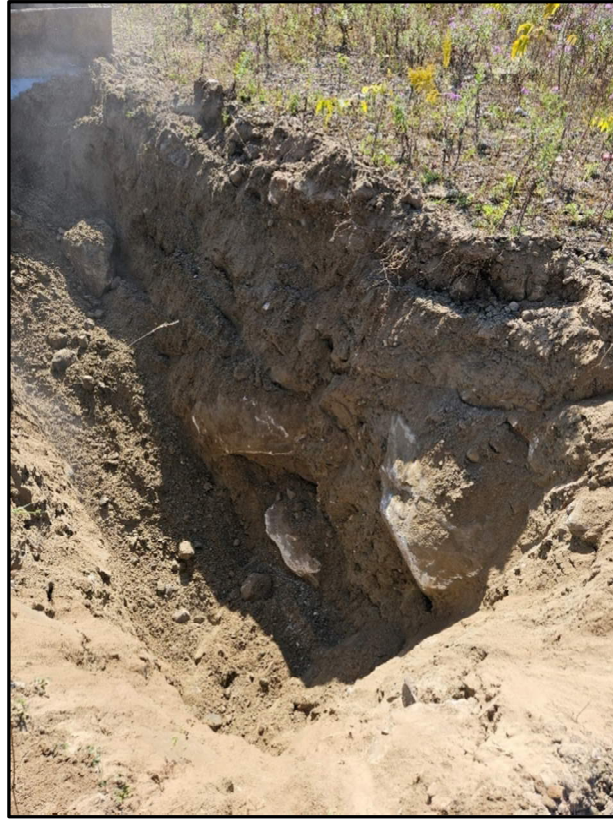
Photo 15: Photo of the test pit TP 9-24.
