# Phase Two Environmental Site Assessment

951 Gladstone Avenue and 145 Loretta Avenue North  
Ottawa, Ontario

Pinchin File: 285722.003

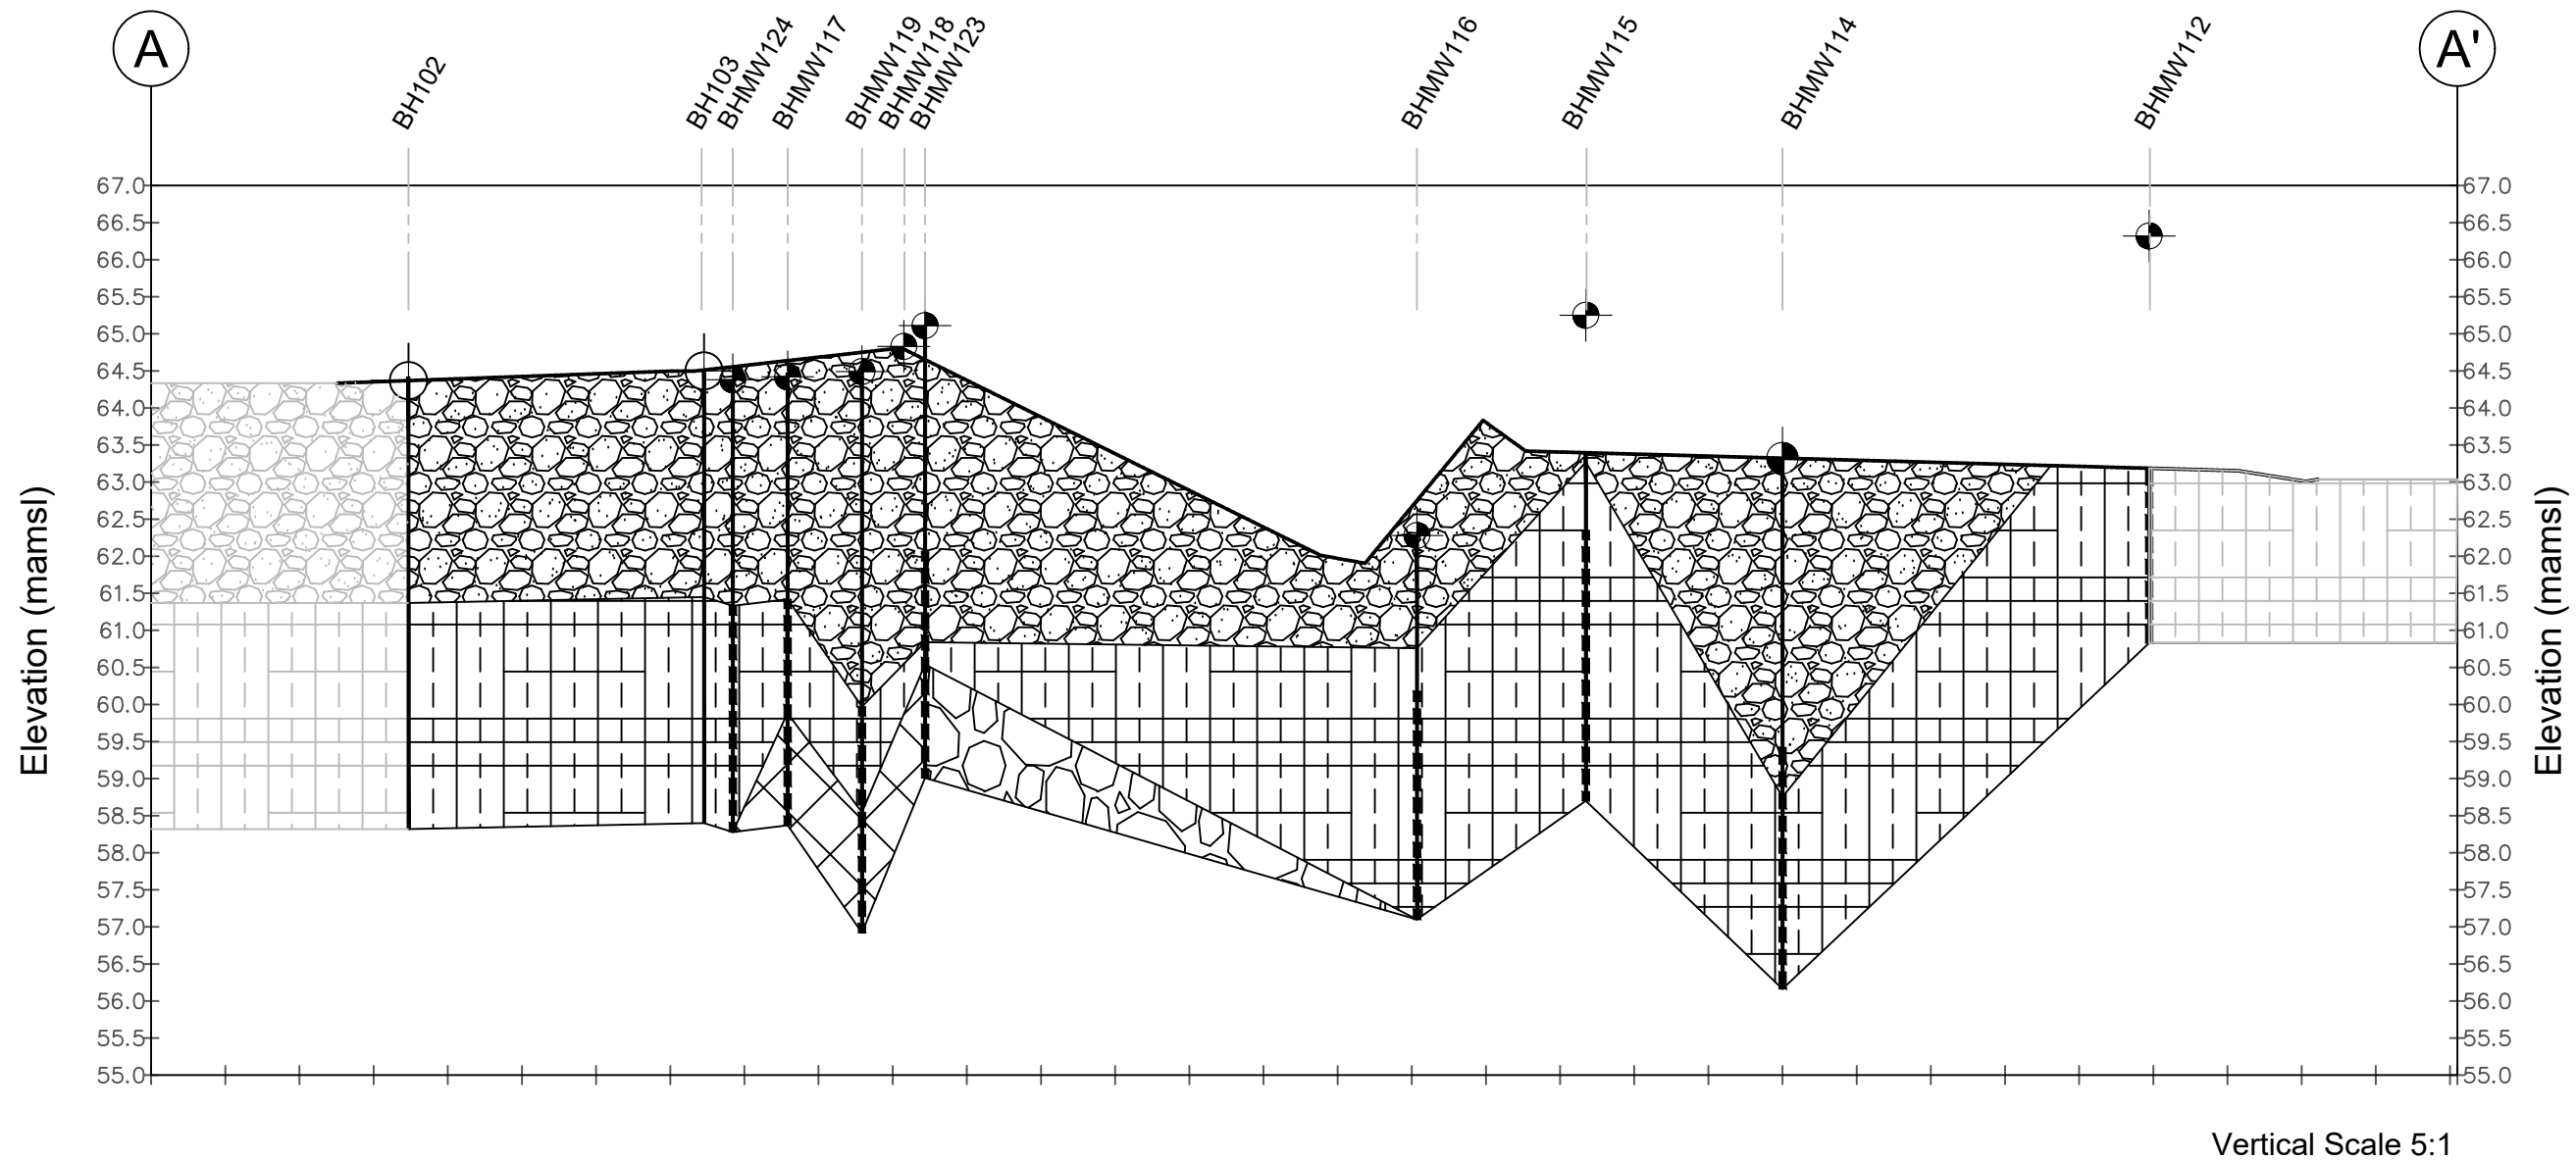
Cross Section  
A-A'

Vertical Scale 5:1

Cross-sections summarizing the subsurface geological conditions have been provided as Figures 8A to 8C.

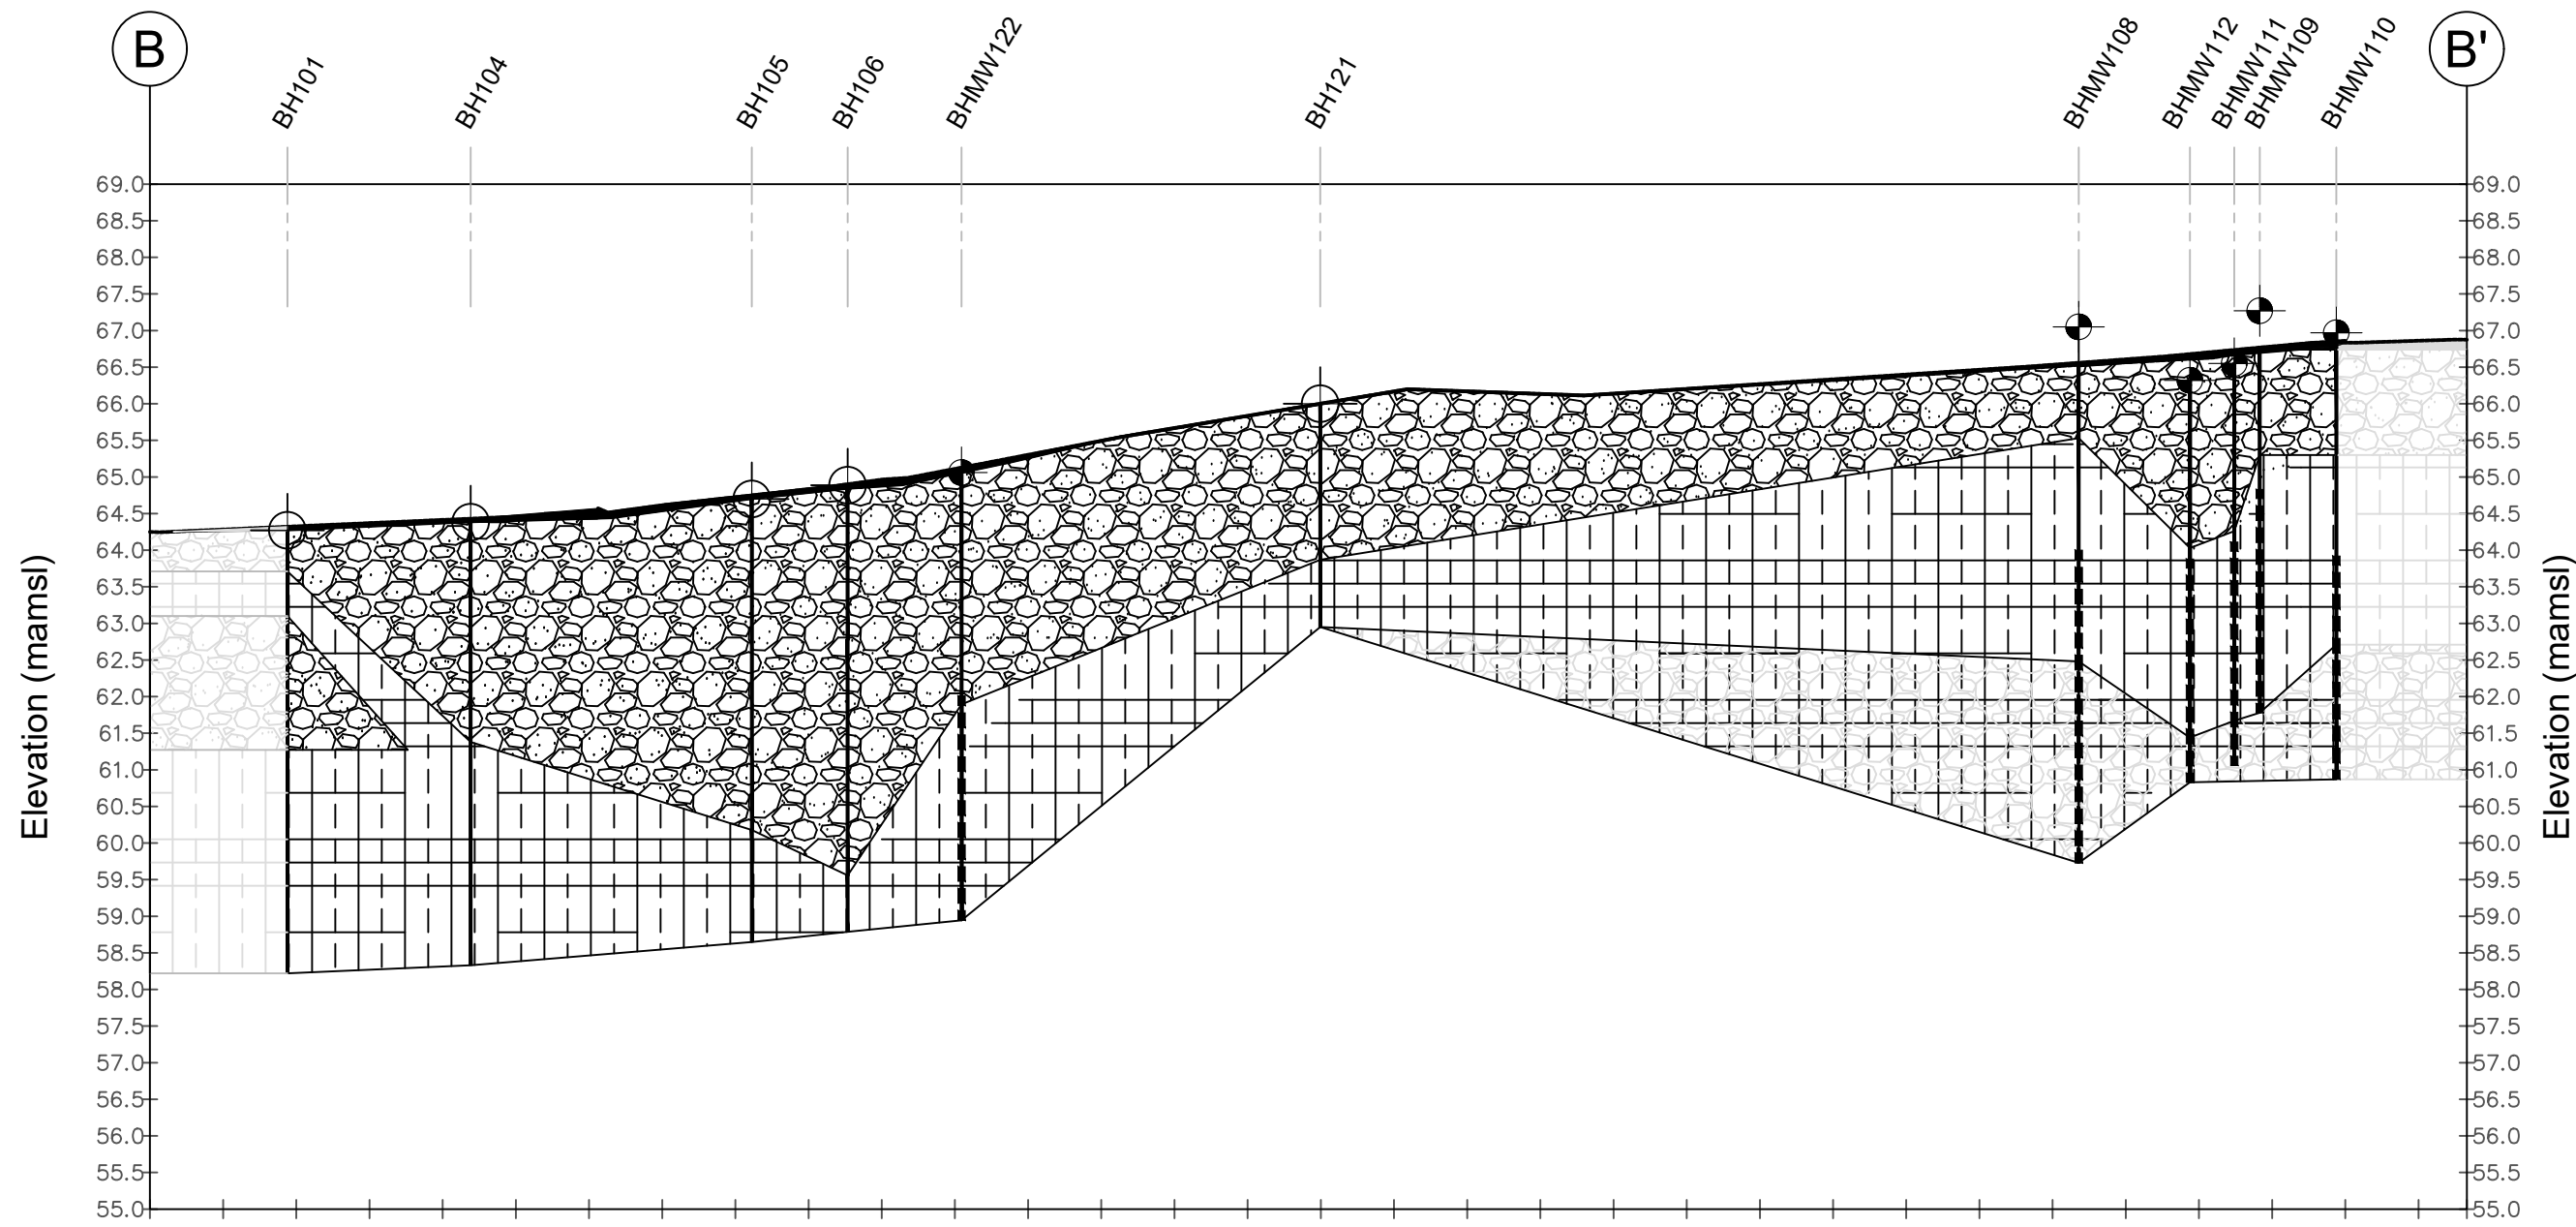
Cross Section  
B-B'

Vertical Scale 5:1
