**Re: Addendum 1 – Subfloor Drainage System Diagram and Additional  
Subsurface Information – Proposed Development – 100 Bareille Snow  
Street, Ottawa, Ontario**  
**Cambium Reference: 24896-001 Rev.1**

**GEOTECHNICAL  
INVESTIGATION**  
WATERIDGE LIFESTYLES LTD.  
Block 21 - Wateridge Village  
Ottawa, Ontario

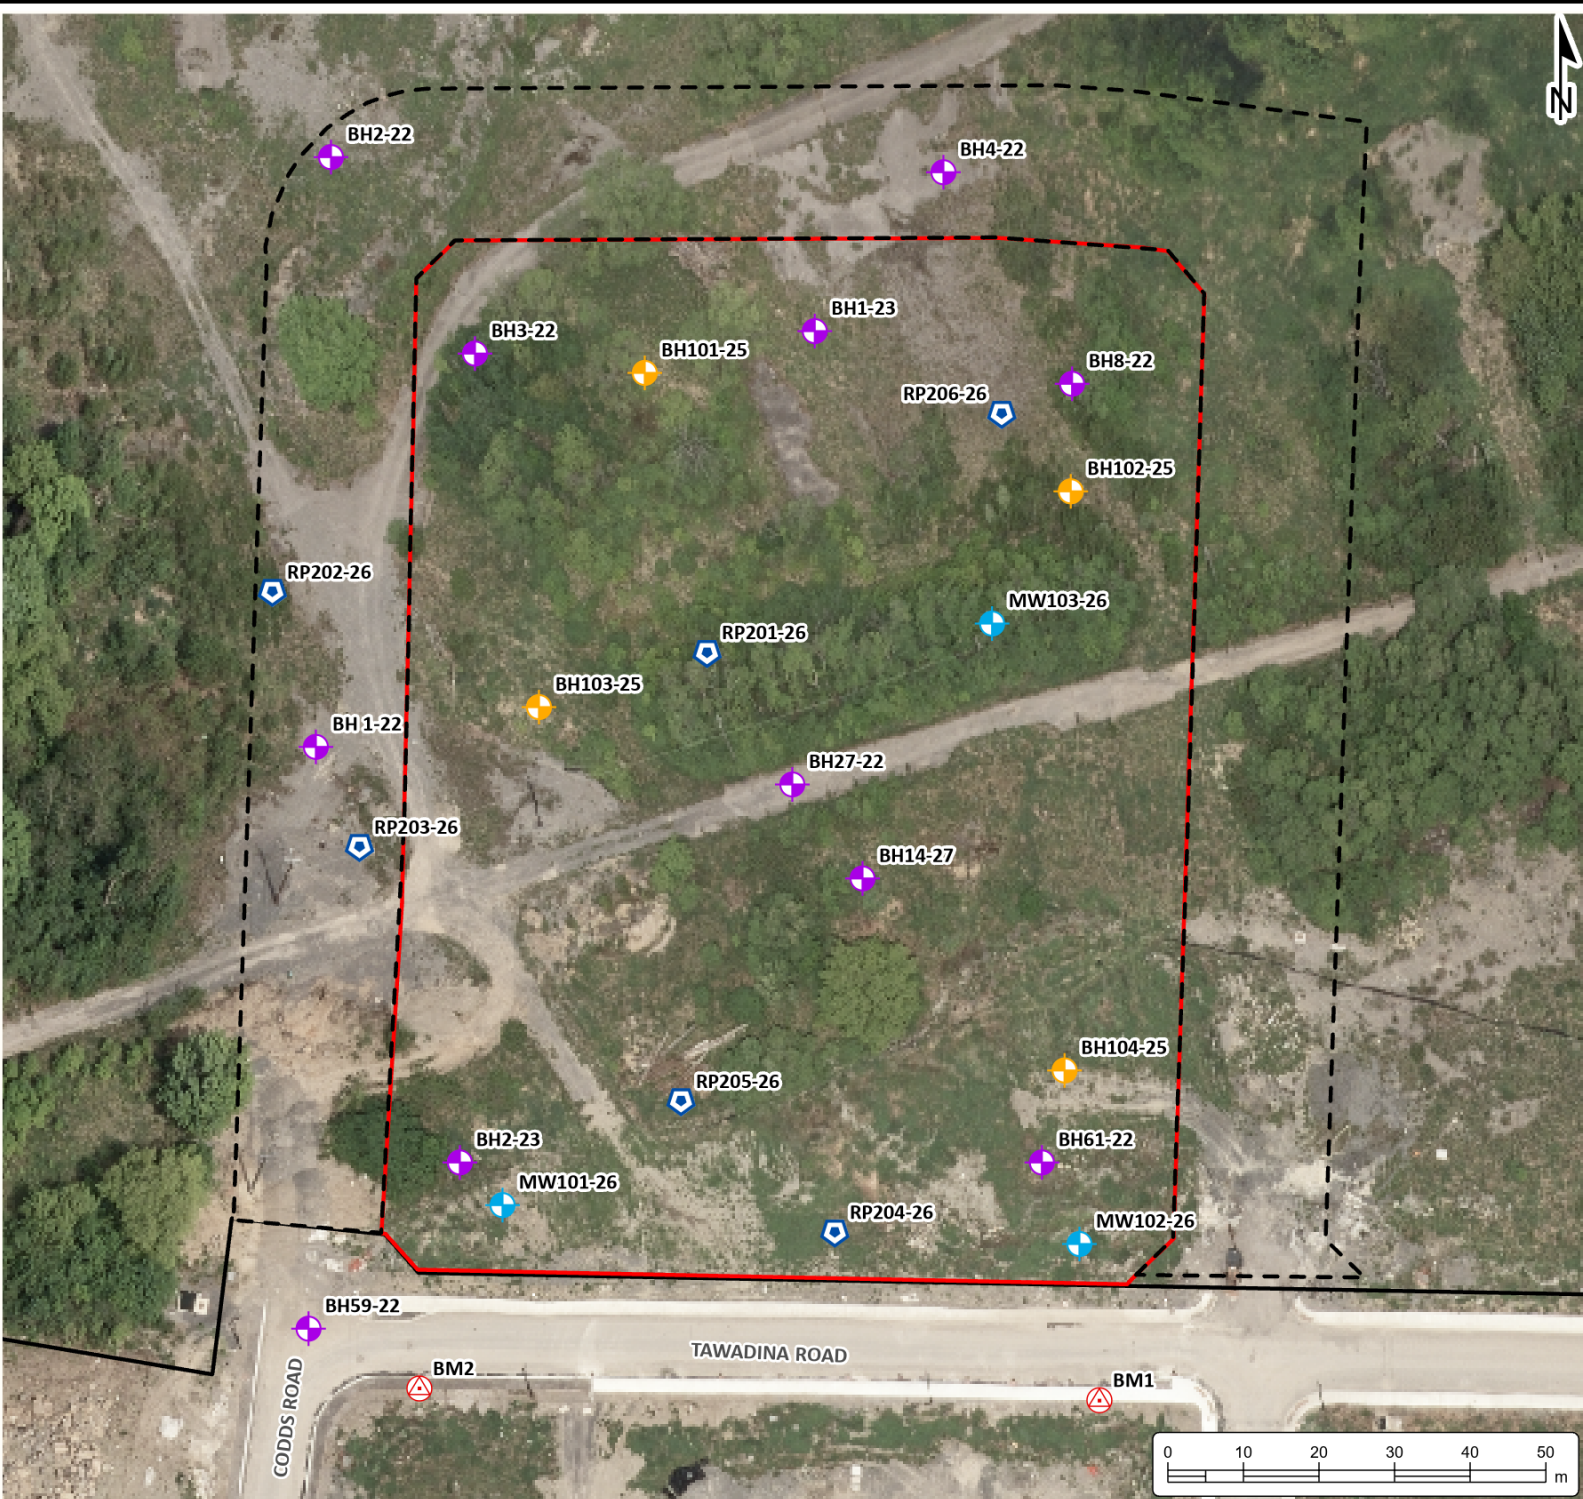
**TEST HOLE LOCATION PLAN**

Cambium installed a total of 3 groundwater monitoring wells, numbered MW101-26 through MW103-26, and advanced a total of 6 rock probes, numbered RP201-26 through RP206-26 on March 20, 2026. Groundwater monitoring wells were installed as part of the ongoing hydrogeological investigation and rock probes were advanced to obtain additional data at the site. Details of the locations and depths to bedrock at these test holes are provided in Table 1 below. In addition

to the table, an updated "Figure 2 – Test Hole Location Plan" is attached following the text of this letter.

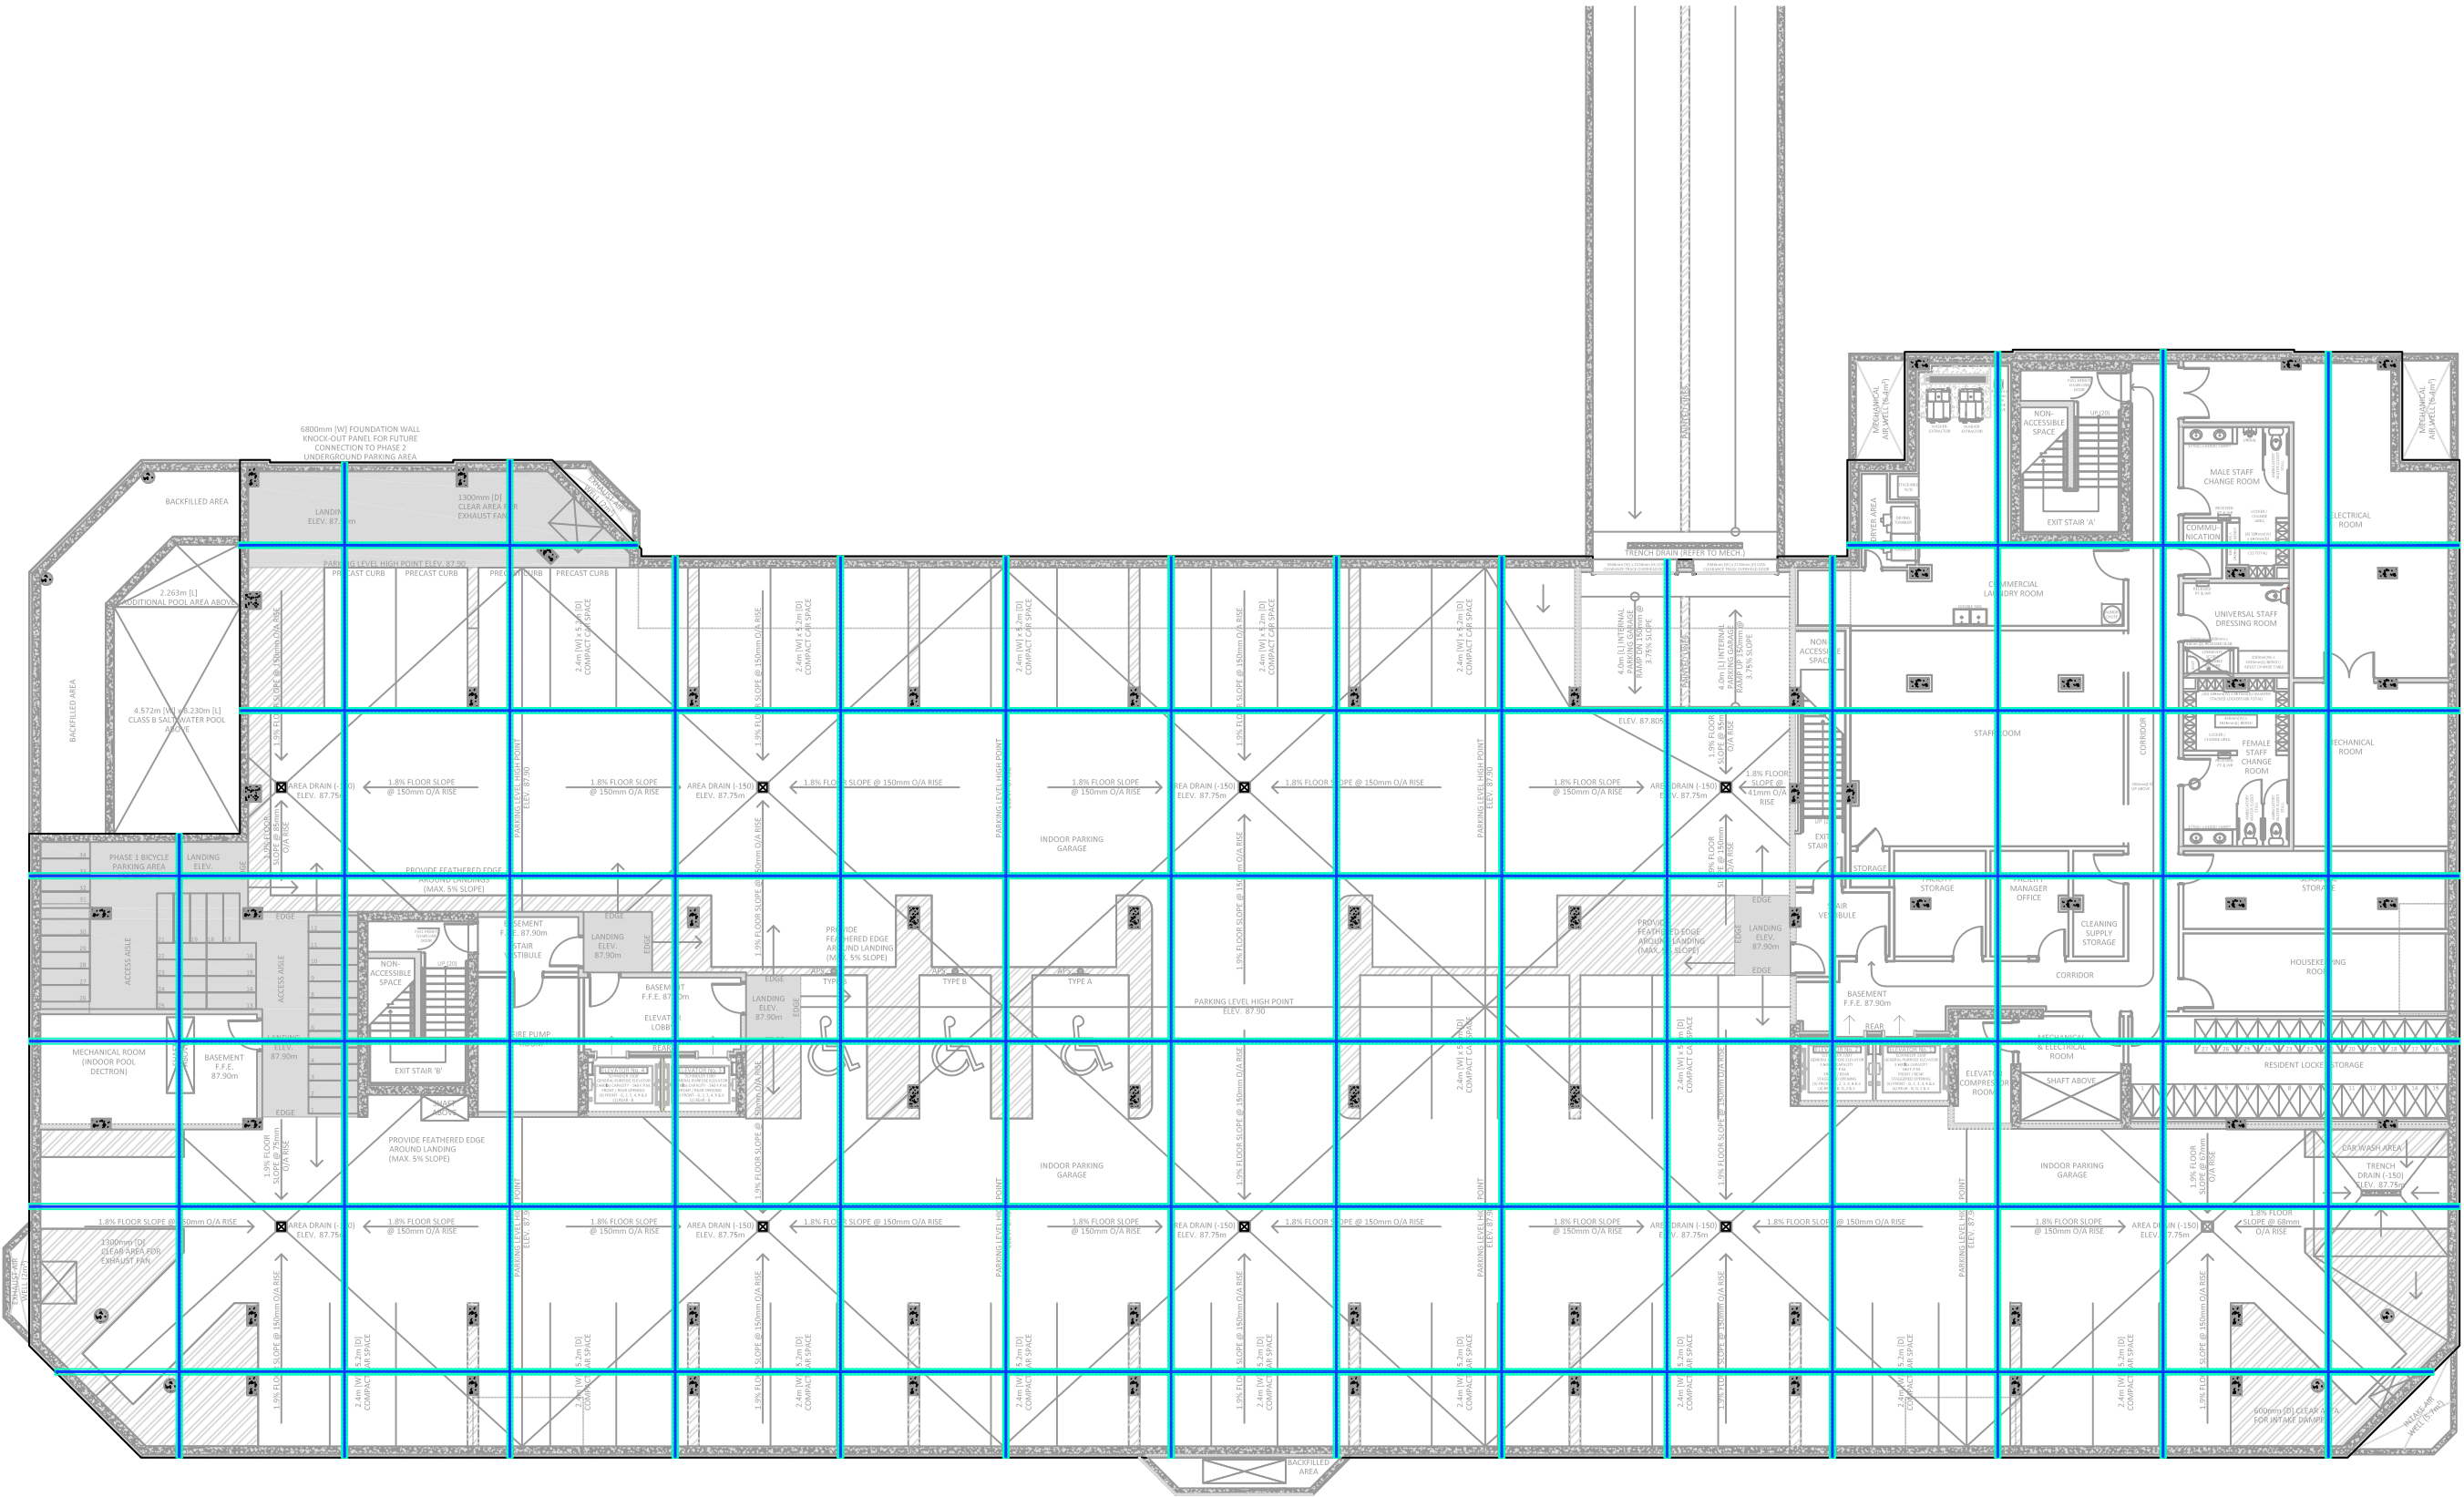
SUBFLOOR DRAINAGE  
LAYOUT

As indicated in Section 5.12 of the Geotechnical Report, the subfloor drainage system should consist of minimum 100 mm diameter perforated pipes spaced at a maximum of 6 m on center. The pipes must be surrounded on all sides by a minimum of 100 mm of 19 mm clear stone, and the pipe inverts should be a minimum 300 mm below the base of the slab. An example diagram of the subfloor drainage system is attached following the text of this letter titled Figure 3 – Subfloor Drainage Layout. The diagram is provided for guidance. The exact location of the subfloor drains may be altered based on design requirements.

- Notes:
- Pipes to be spaced at a maximum of 6m on center. Pipes must be surrounded on all sides by a minimum of 100 mm of 19 mm clear stone
  - Floor plan base data provided by Wateridge Lifestyles Ltd.
  - Cambium Inc. makes every effort to ensure this map is free from errors but cannot be held responsible for any damages due to error or omissions. This map should not be used for navigation or legal purposes. It is intended for general reference use only.
  - Distances on this plan are in millimeters unless otherwise noted.
