## **Phase I - Environmental Site Assessment**

3113 Carp Road  
Ottawa, Ontario

Megha Holdings Inc.

Report: PE5734-1R

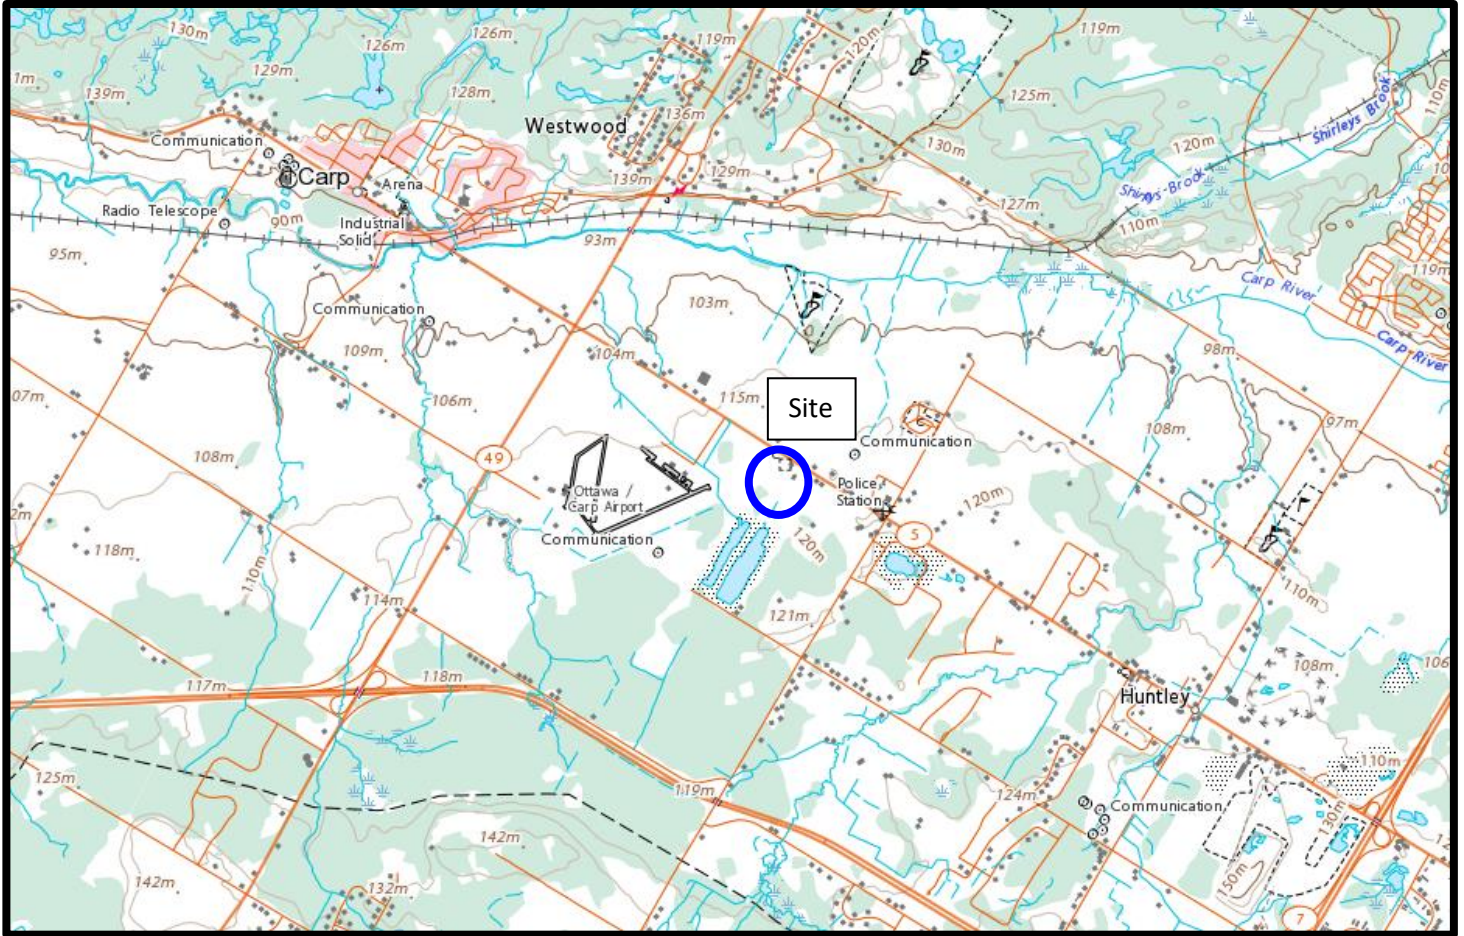
FIGURE 2  
TOPOGRAPHIC MAP

A topographic map was reviewed from the Natural Resources Canada – The Atlas of Canada website as part of this assessment. The regional topography in the general area of the subject site slopes down towards the northwest, in the direction of the Carp River. An illustration of the referenced topographic map is presented on Figure 2 – Topographic Map, appended to this report.

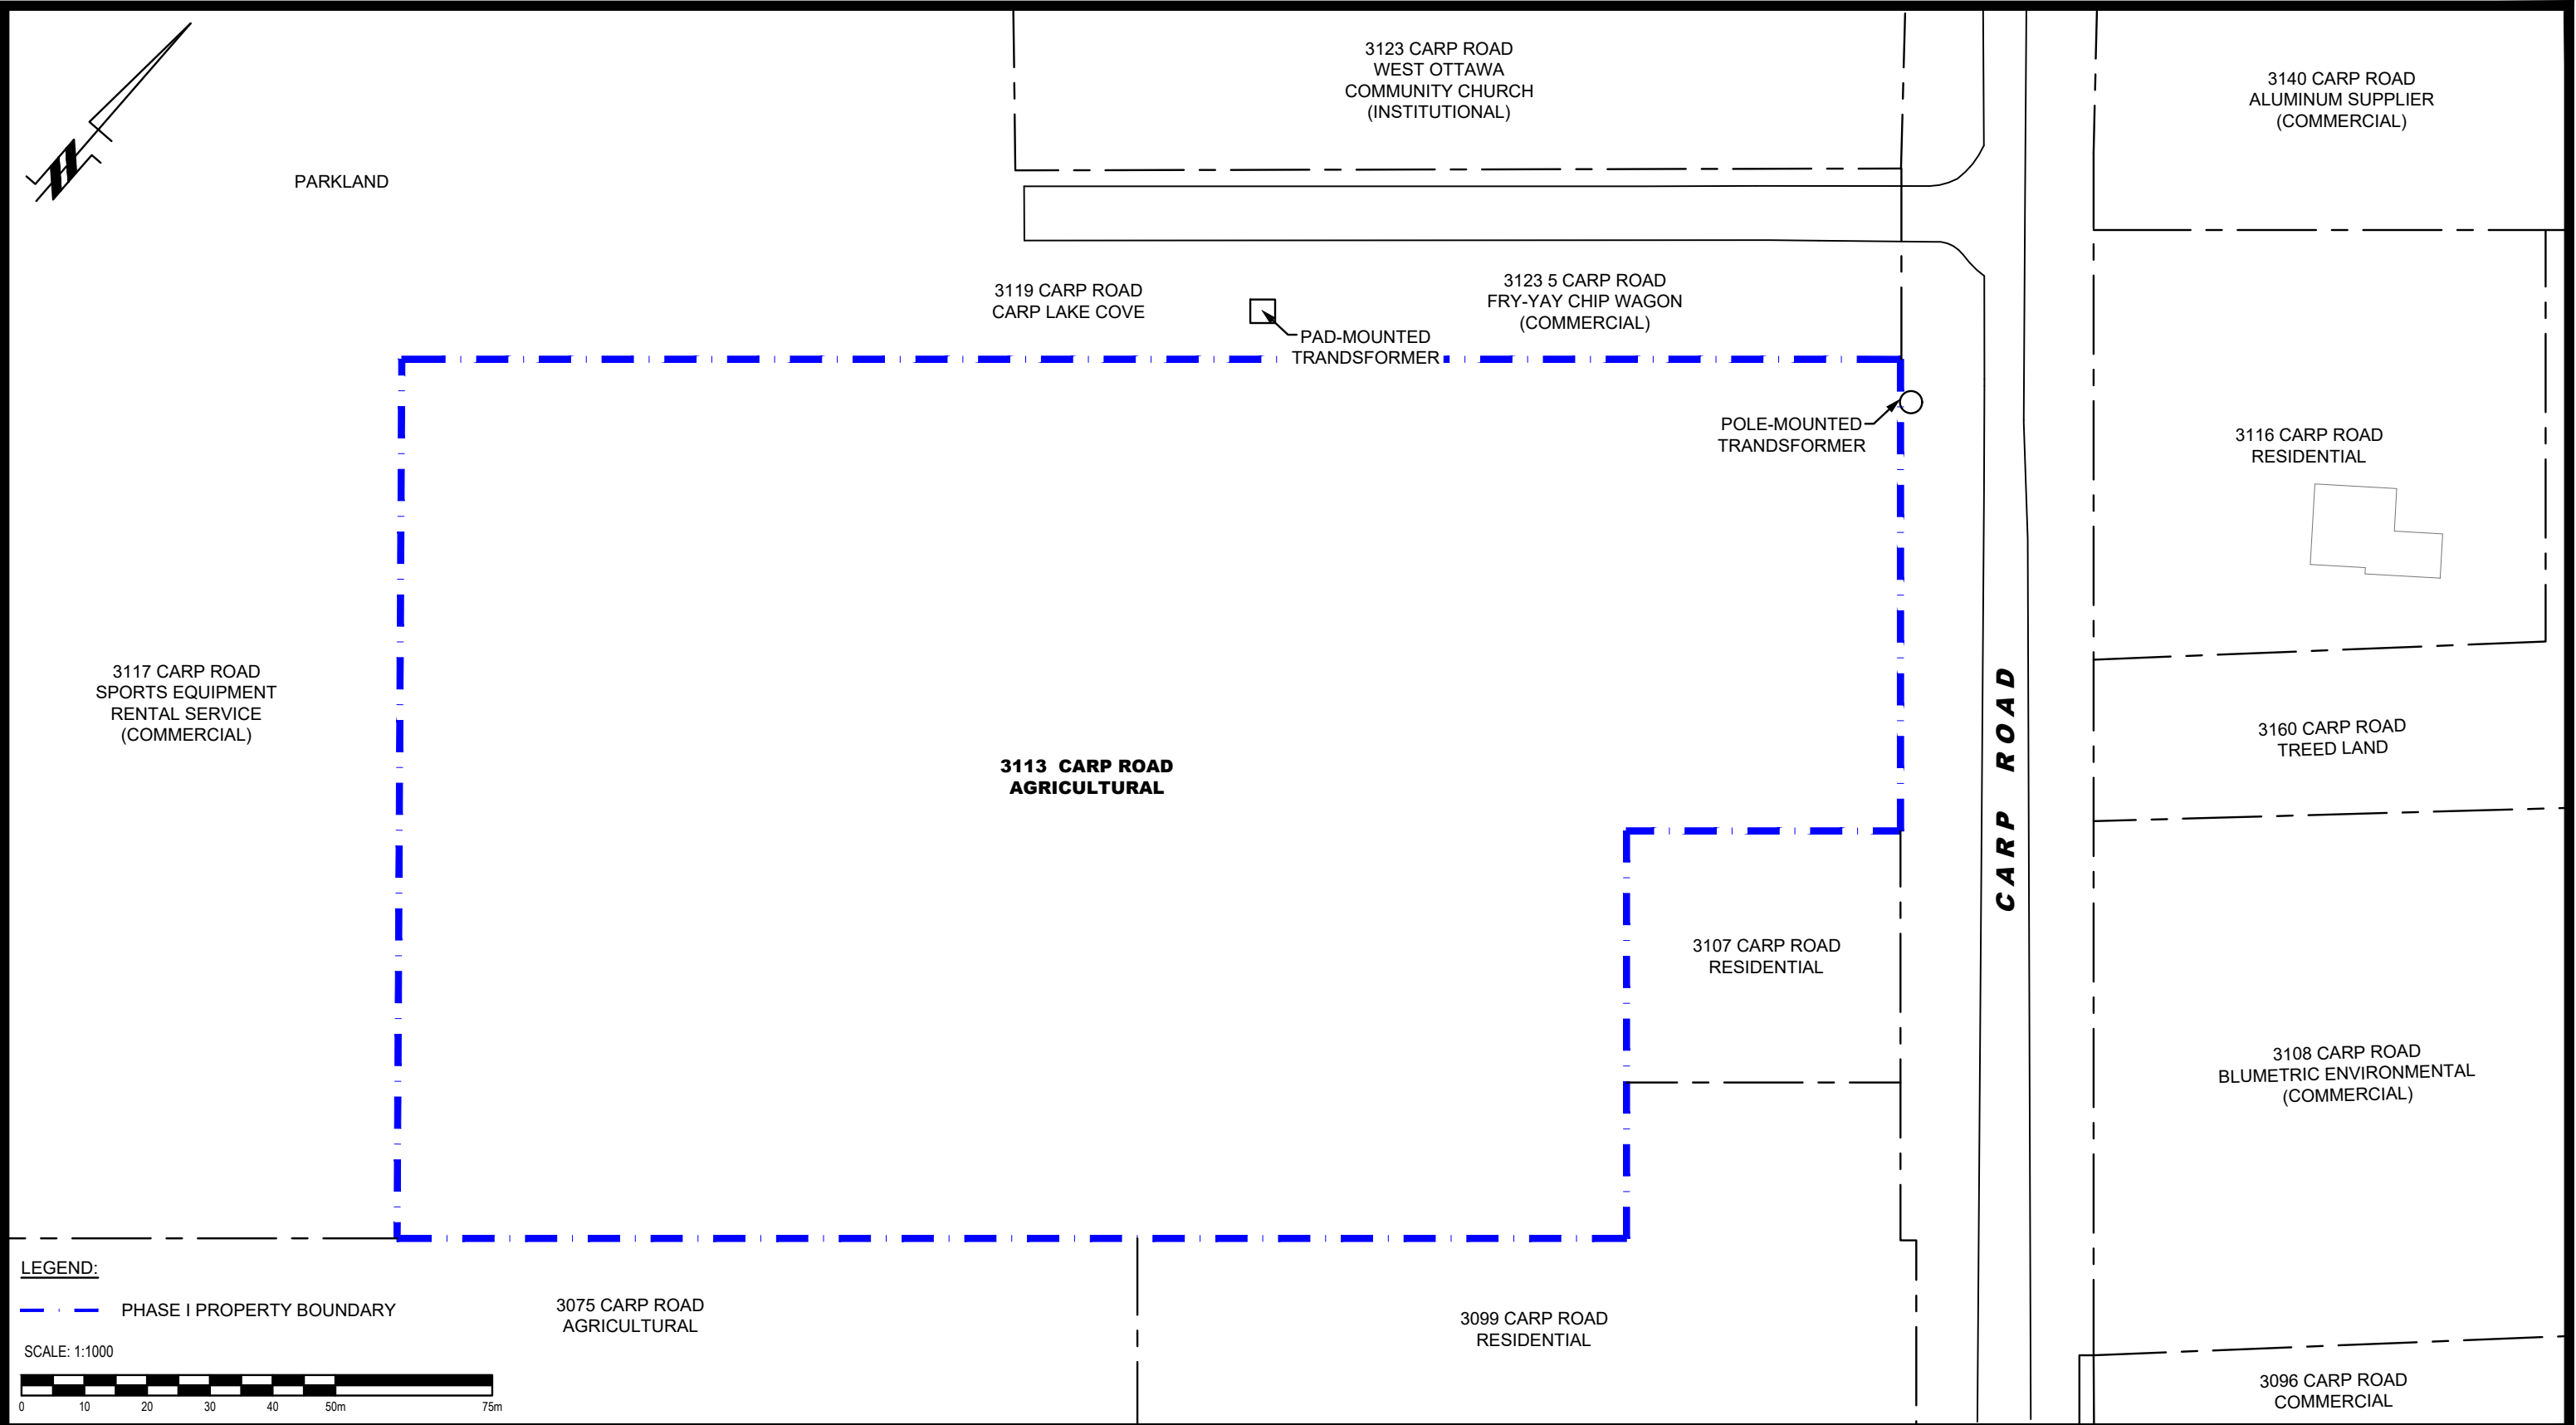
**DRAWING PE5734-1R – SITE PLAN**

An automotive repair shop is present at 3070 Carp Road (approximately 210 m northeast of the subject site). Due to its significant distance away, it does not pose a potential environmental risk to the subject site. Current land use adjacent to the subject site is illustrated on Drawing PE5734-2R – Surrounding Land Use Plan, appended to this report.

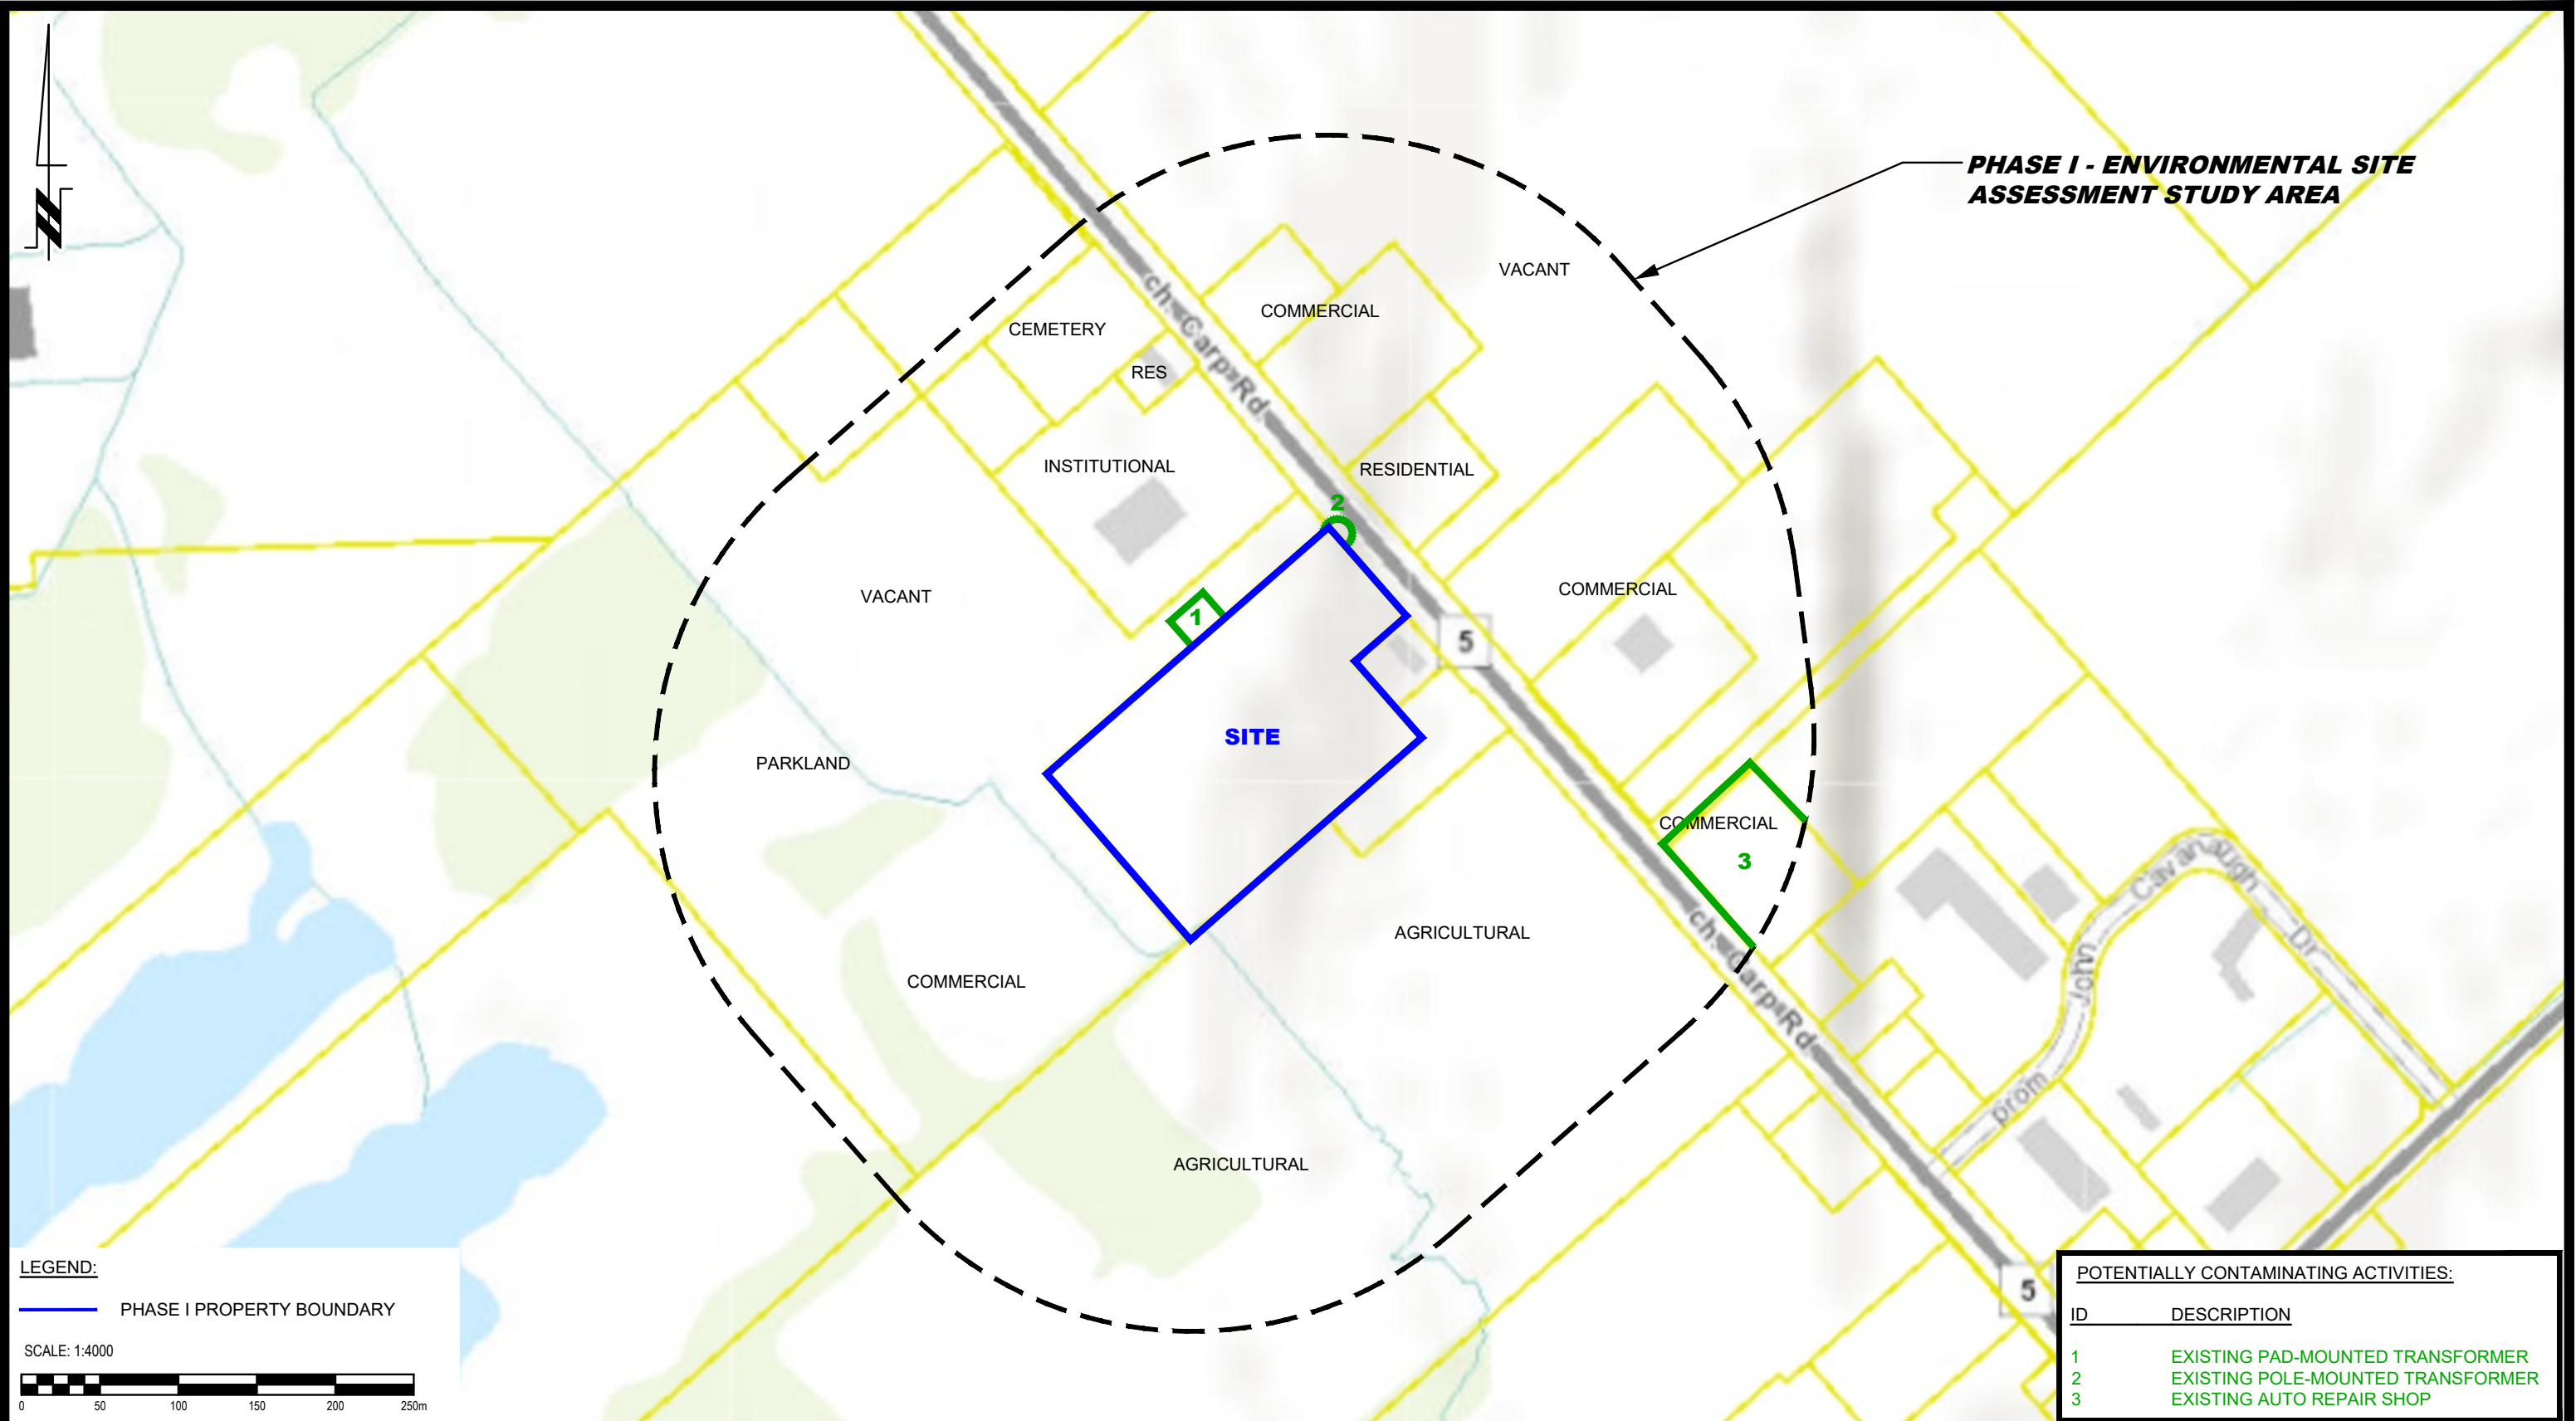
**DRAWING PE5734-2R – SURROUNDING LAND USE PLAN**

Three off-site PCAs were identified within the Phase I study area pertaining to an existing automotive repair shop, one pad mounted transformer and one pole mounted transformer along the western and northern boundaries of the subject site, respectively. They were deemed not to be of any environmental concern to the subject site due to the lack of leakage or staining from those units.

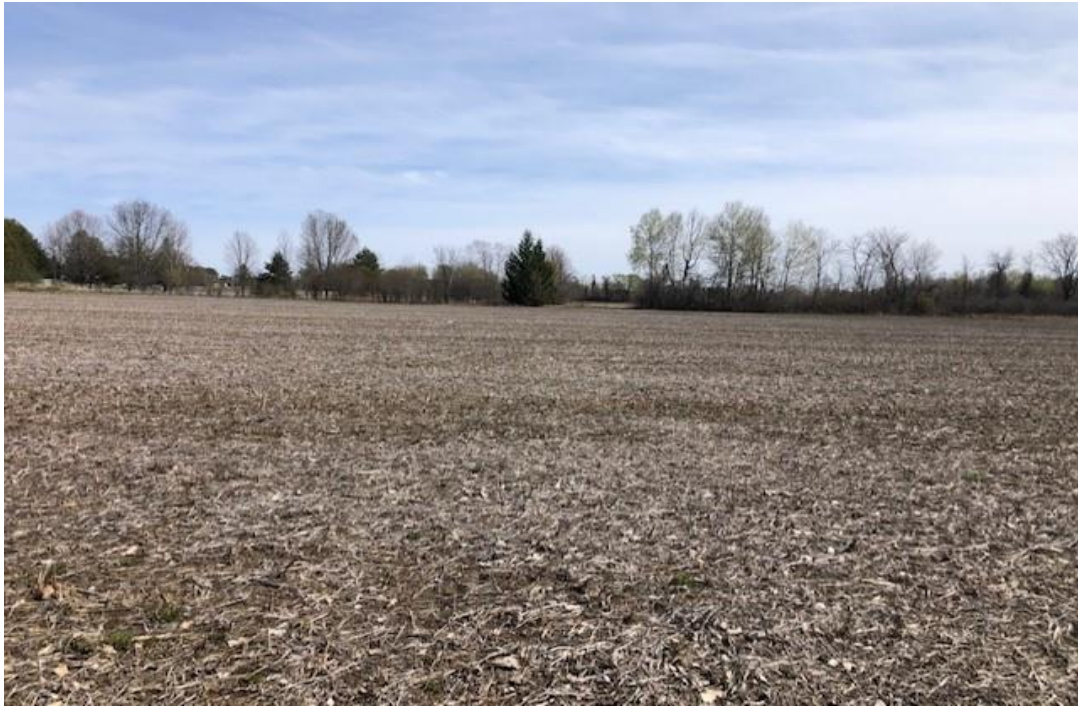
Photograph 1: View of the western portion of the subject site, facing east.

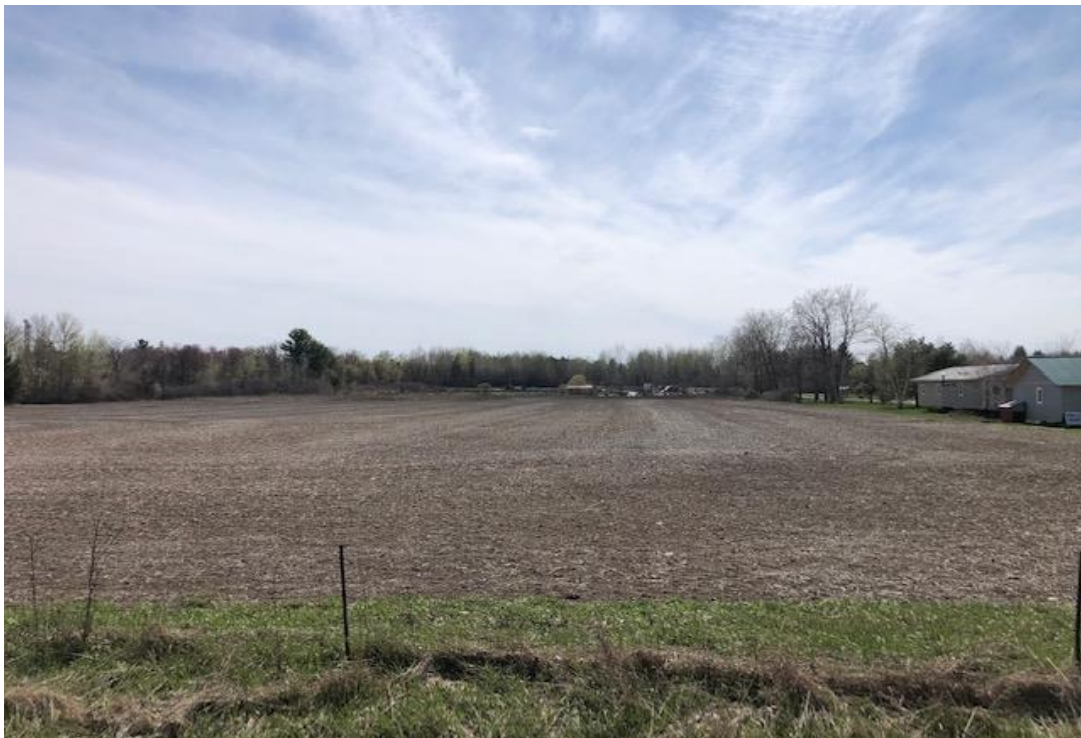
Photograph 2: View of the northern portion of the subject site, facing south.

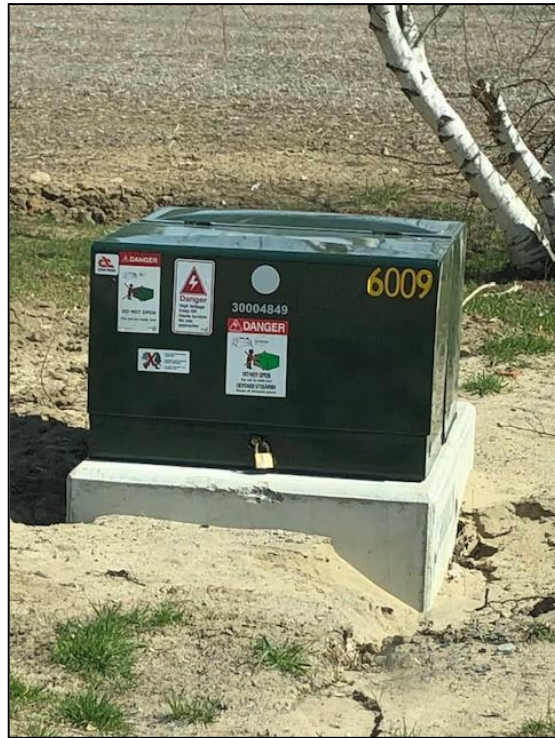
One pad mounted and one pole mounted transformer are present off-site, along the western and northern boundaries of the subject site, respectively. No leakage or staining were observed from these units. The transformers are considered to be potentially contaminating activities (PCAs) that do not result in areas of potential environmental concern (APEC).

Photograph 3: View of the pad mounted transformer along the western boundary of the subject site.
