# **Geotechnical Investigation**

## **Proposed Residential Development**

319 Huntmar Drive  
Ottawa, Ontario

Report PG7718-1 Revision 2 dated September 8, 2026

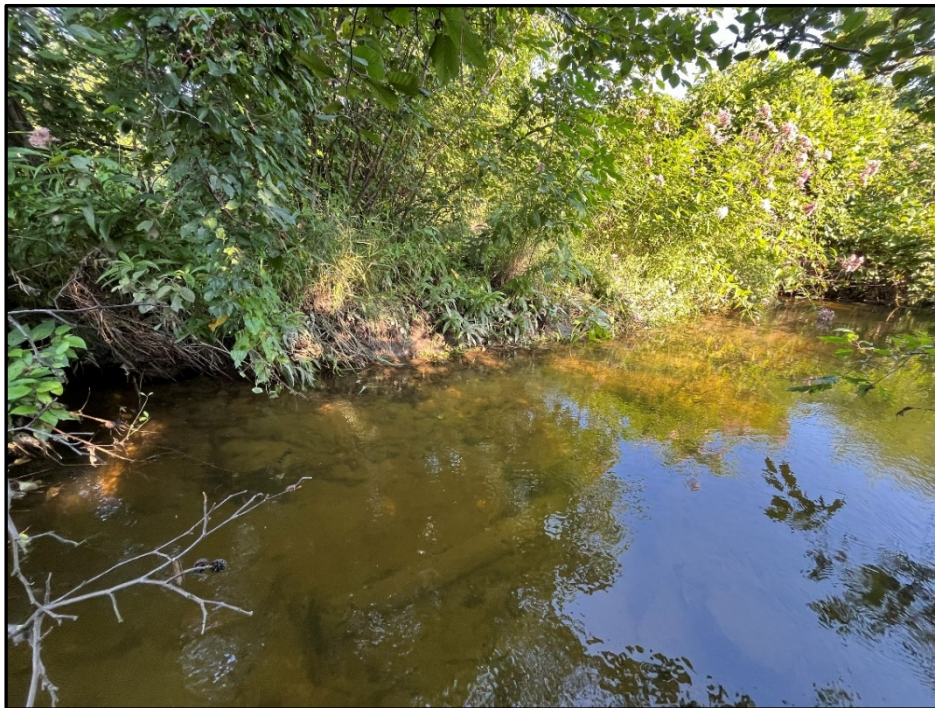
**Photo 1:** Photograph along the east portion of Feedmill Creek facing north and depicting the northern bank of the watercourse. The face slope along the north and south side of the watercourse were observed to be vegetated with brushes and some mature trees. Signs of erosion were not observed along this section.

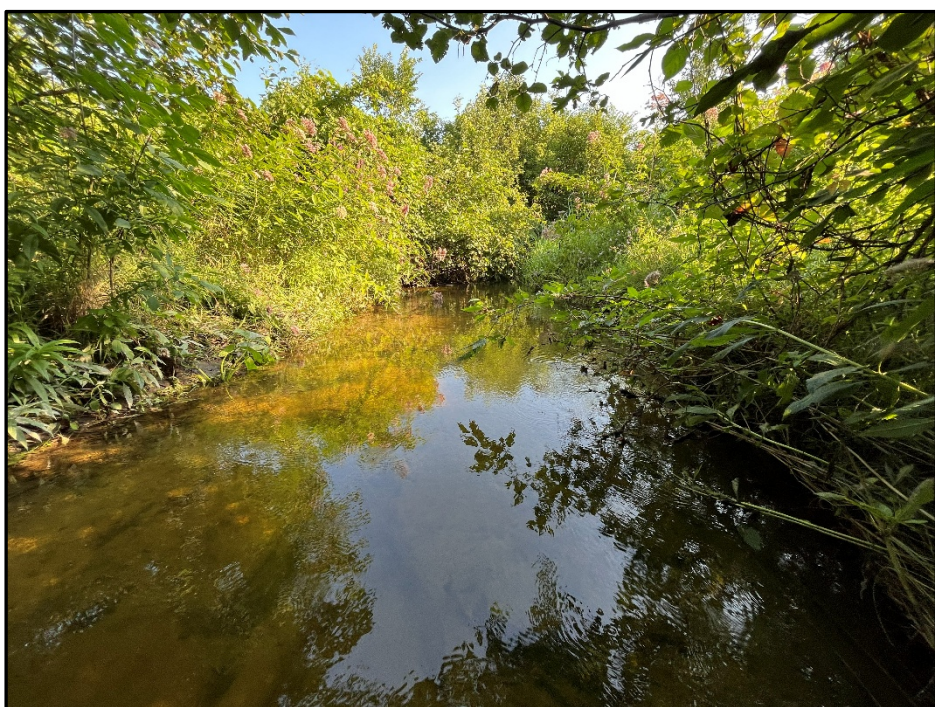
**Photo 2:** Photograph of the north and south slope face along the east portion of the watercourse. The slope was observed to be vegetated with dense brush and some mature trees. Major signs of erosion were not observed along this section of the watercourse.

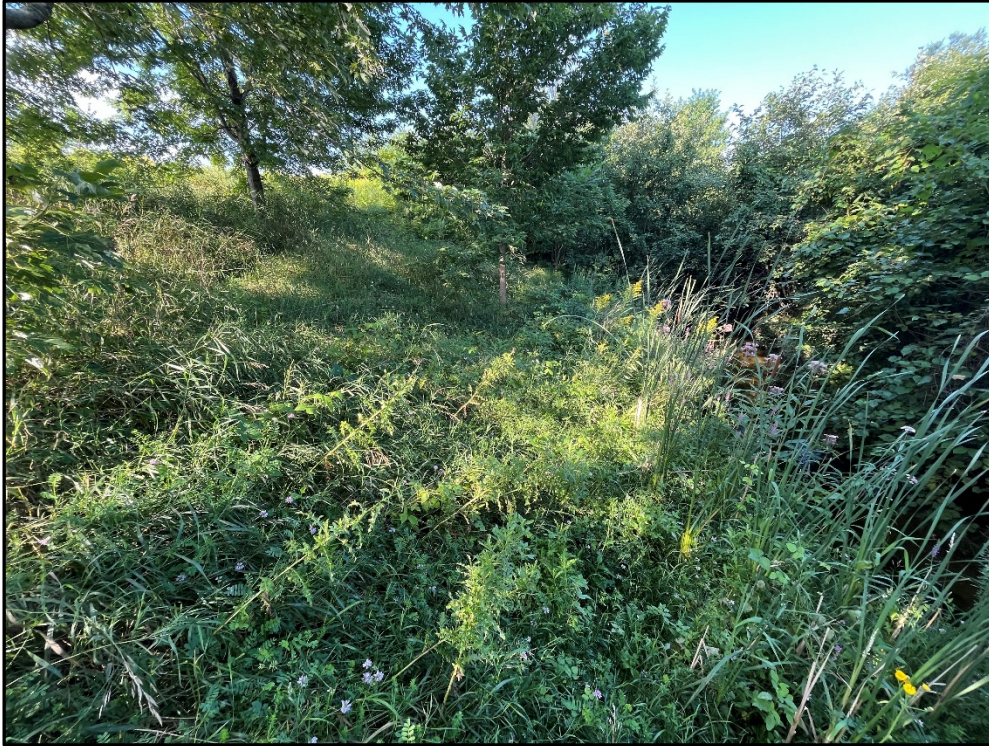
**Photo 3:** Photograph of south slope face along the central north boundary of the subject site. The bank at this location is observed to present a slight gradual slope. However, from a geotechnical perspective, the overall behavior of the watercourse is considered confined and in agreement with the remaining of the subject site.

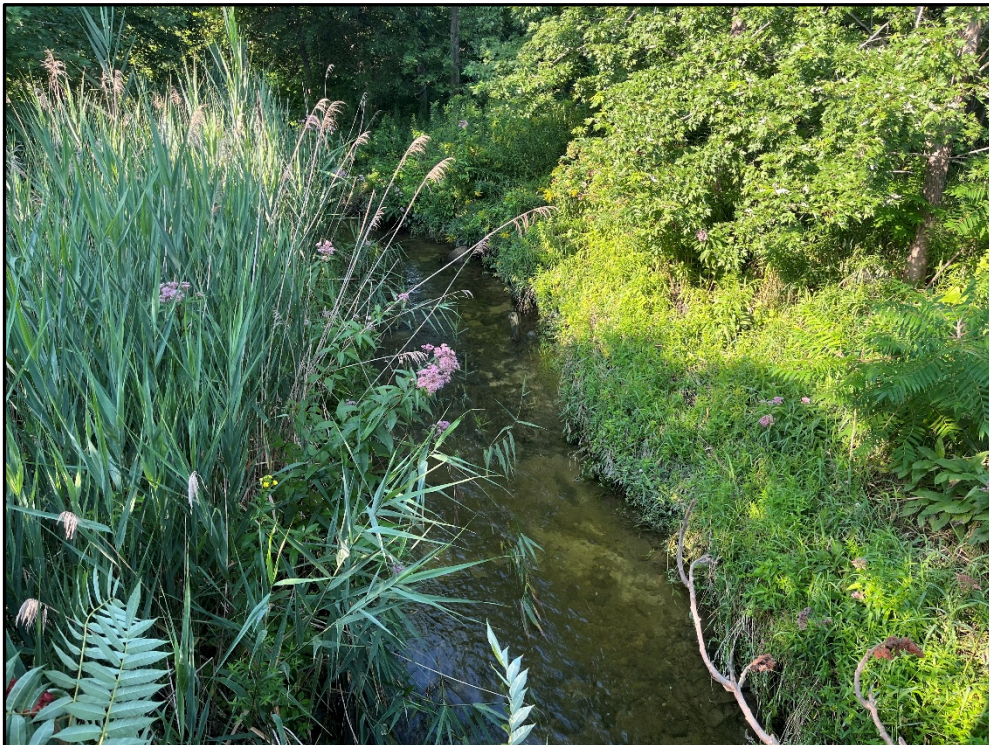
**Photo 4:** Photograph of the area of slope section E facing west. The slope face was observed to be vegetated with dense brush and some mature trees. Signs of erosion were not observed at the time of the site visit.

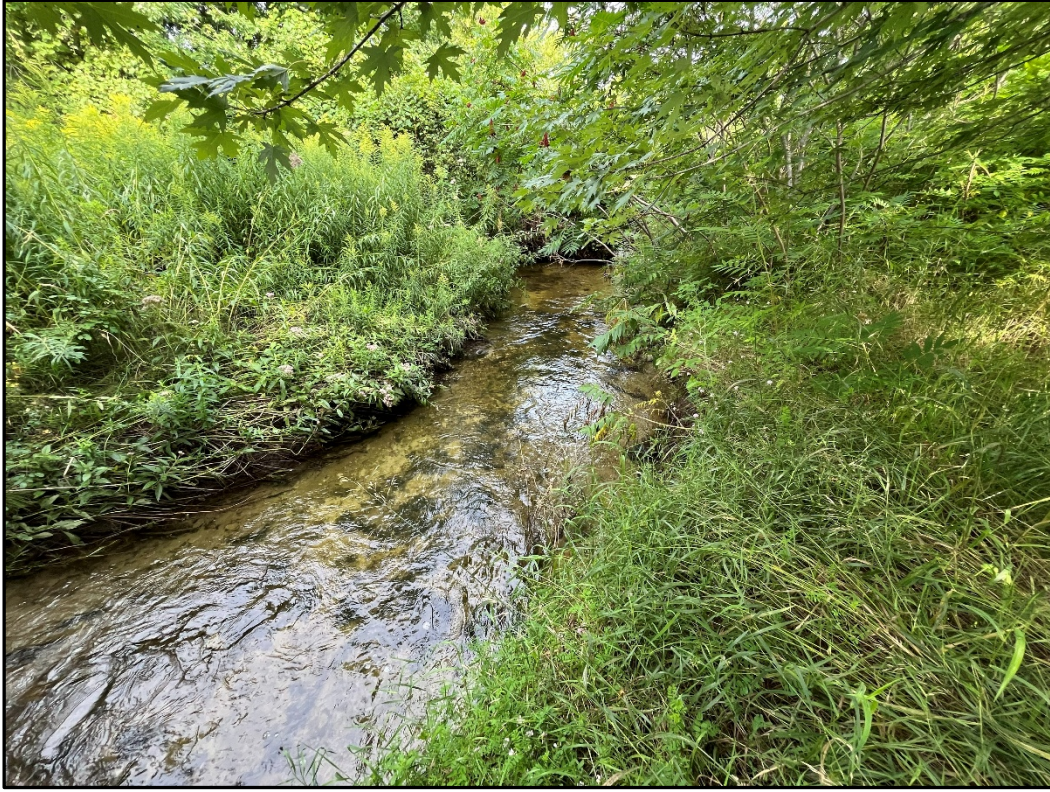
**Photo 5:** Photograph of the area of slope section F facing northeast. The slope face was observed to be vegetated with dense brush and some mature trees.

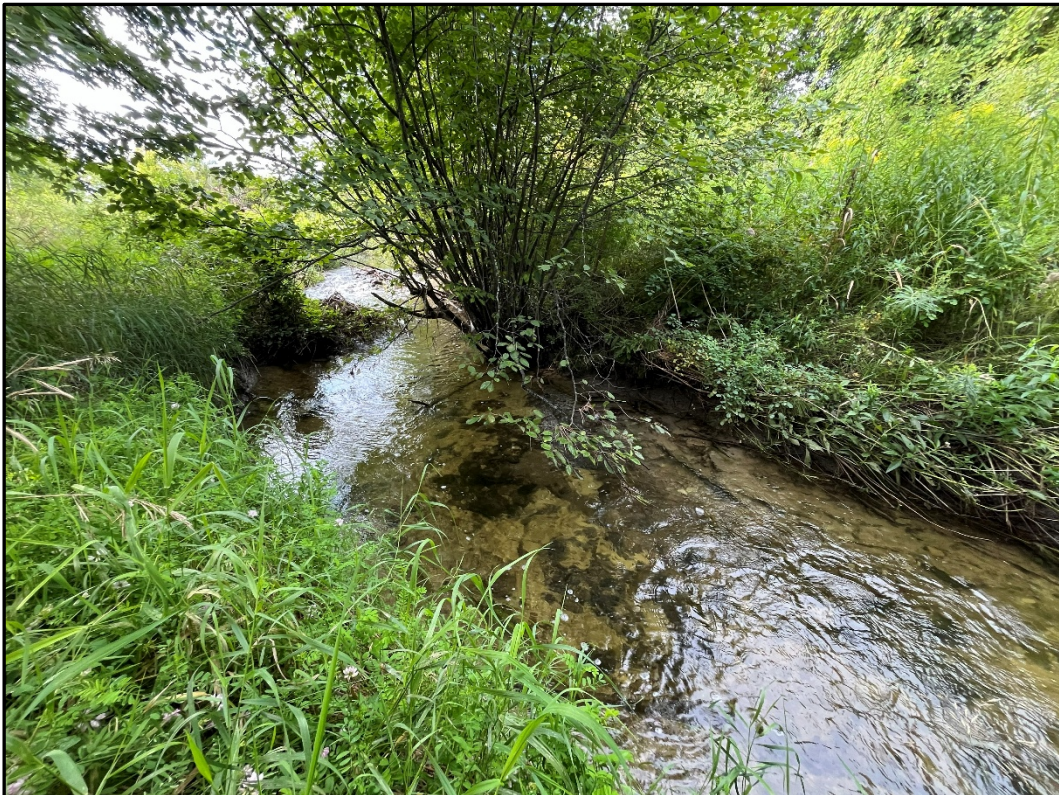
**Photo 6:** Photograph of the area of slope section F facing south. The slope face was observed to be vegetated with dense brush and mature trees. Signs of erosion were not observed.
