## Geotechnical Investigation

Proposed Indoor Aquatic and Recreation Facility  
2775, 2785 Palladium Drive; and  
Block 244 Plan 4M 1687  
Ottawa, Ontario  
*Revision 2*

LRL File No.: 240720

May 2025; Revised: October 2026

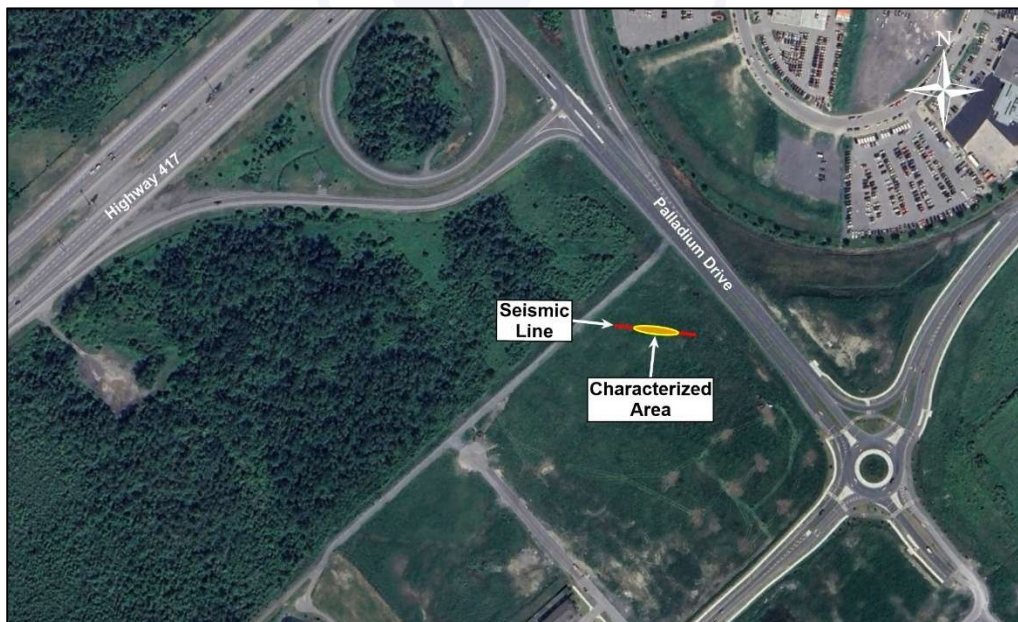
**Figure 2: Location of the seismic spreads**  
(source: Google Earth™)
