Geotechnical Investigation

Proposed Commercial Development
Earl Armstrong Road at Limebank Road
Ottawa, Ontario

January 28, 2013

Report: PG2744-1

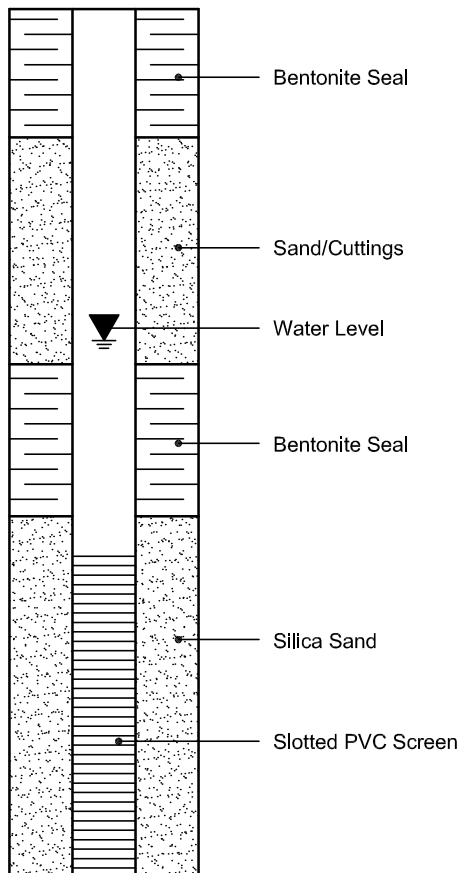
MONITORING WELL CONSTRUCTION

Flexible PVC standpipes were installed in all boreholes to permit monitoring of the groundwater levels subsequent to the completion of the sampling program.

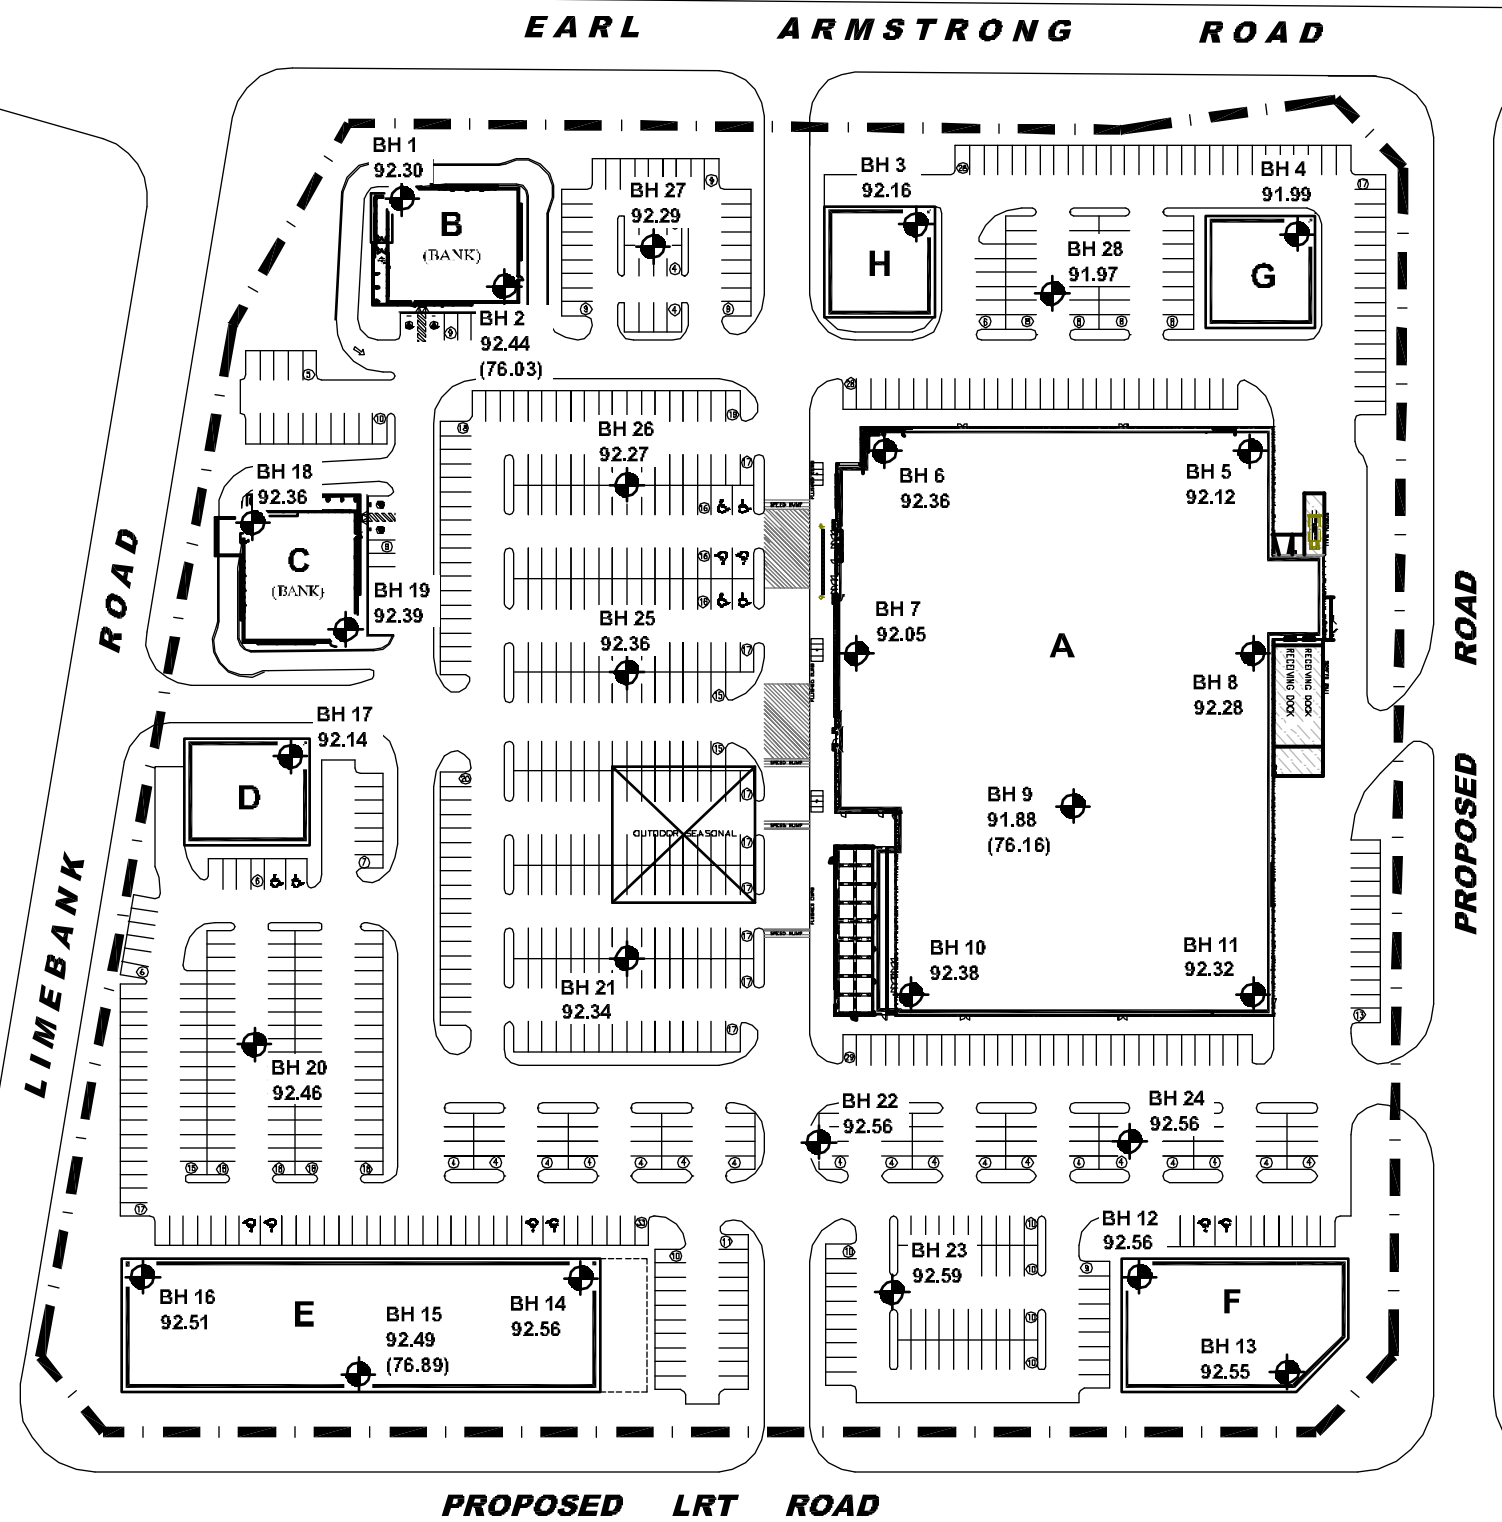
DRAWING PG2744-1 - TEST HOLE LOCATION PLAN

The field program for the investigation was conducted on December 13, 14, 17, 18 and 19, 2012. At that time, twenty-eight (28) boreholes were completed by Paterson to provide general coverage of the subject site. The locations of the test holes are shown on Drawing PG2744-1 - Test Hole Location Plan included in Appendix 2.

The test hole locations were selected by Paterson and surveyed by Annis, O'Sullivan, Vollebekk. The ground surface elevations at the test hole locations are referenced to a geodetic datum. The locations and ground surface elevations of the test holes are presented on Drawing PG2744-1 - Test Hole Location Plan in Appendix 2.
