Geotechnical Investigation

Proposed Commercial Development
Campeau Drive
Ottawa, Ontario

February 11, 2013

Report: PG2767-1

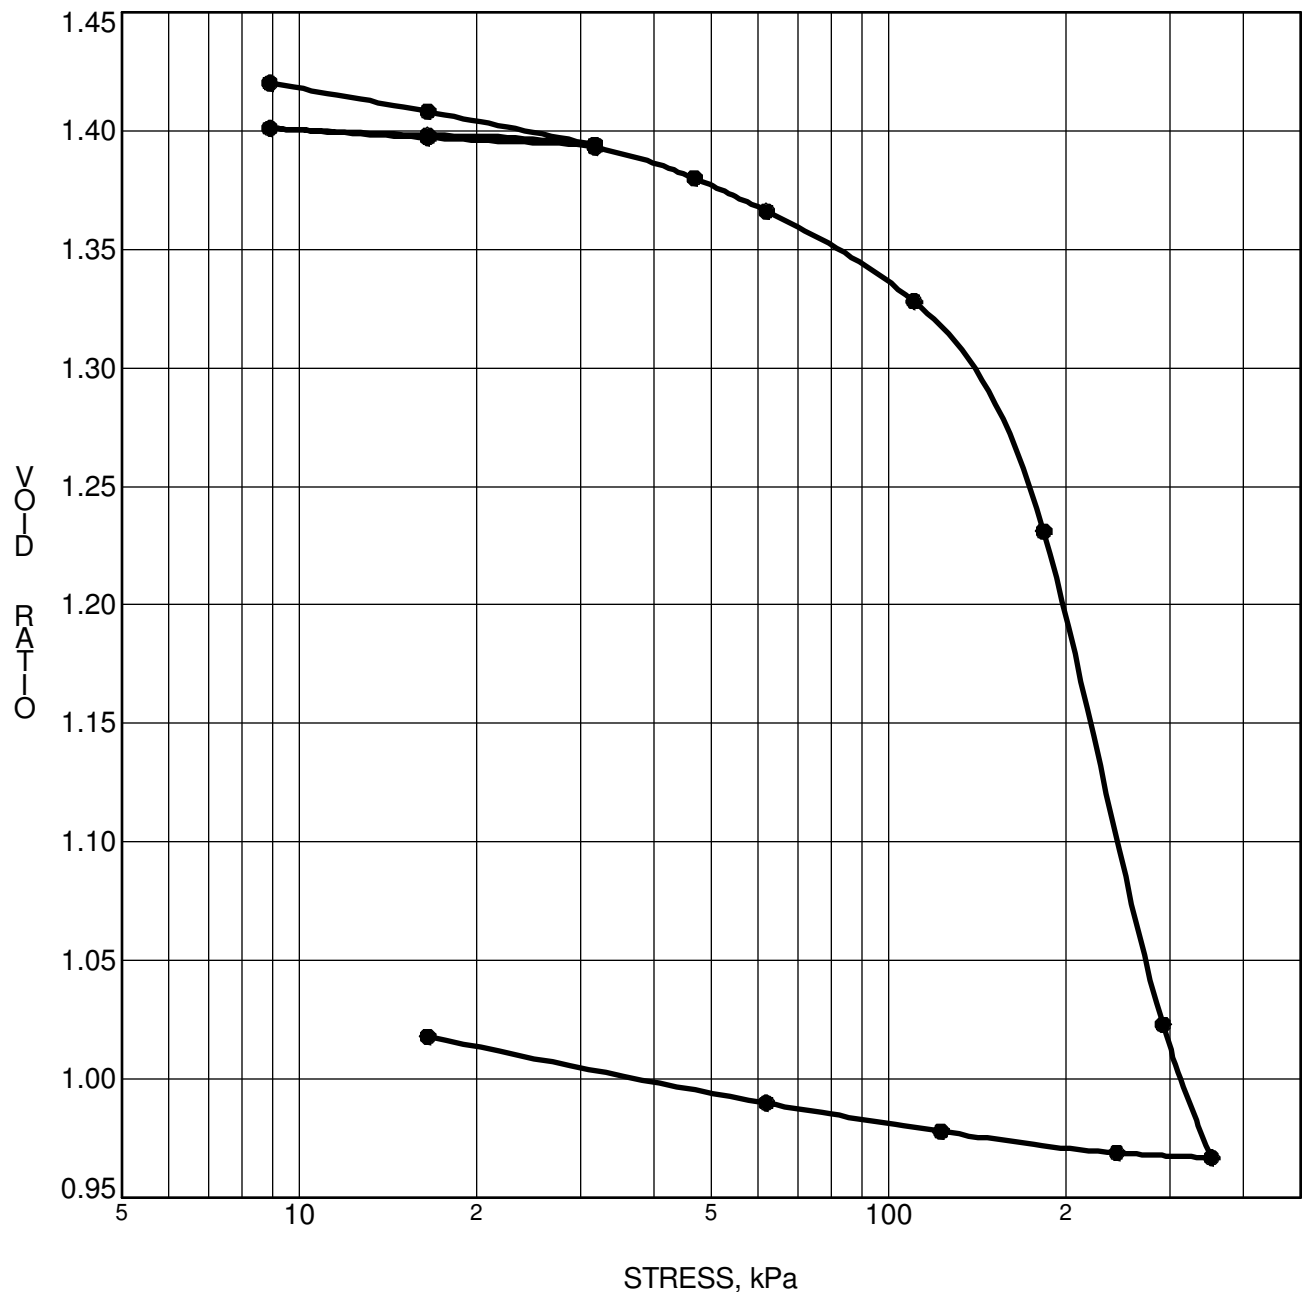
CONSOLIDATION TEST DATA SUMMARY					
Borehole No.	BH 5	p'_o	77 kPa	C_{cr}	0.013
Sample No.	TW 4	p'_c	150 kPa	C_c	0.959
Sample Depth	5.80 m	OC Ratio	1.9	W_o	52.1 %
Sample Elev.	95.58 m	Void Ratio	1.433	Unit Wt.	17.2 kN/m³

It should be noted that the values of $p'_{c'}$, $p'_{o'}$, C_{cr} and C_c are determined using standard engineering practices and are estimates only. In addition, natural variations within the soil deposit would also affect the results. Furthermore, the $p'_{o'}$ parameter is directly influenced by the groundwater level. While the groundwater levels were measured at the time of the fieldwork, the levels vary with time and this has an impact on the available preconsolidation. Lowering the groundwater level increases the $p'_{o'}$ and therefore reduces the available preconsolidation. Unacceptable settlements could be induced by a significant lowering of the groundwater level. The $p'_{o'}$ values for the consolidation tests carried out for the present investigation are based on the long term groundwater level being 0.5 m above the bottom of the silty clay crust. The level of the groundwater level is based on the colour and undrained shear strength profile of the silty clay.

Based on the test results, silty clay layer depth and stiffness of the deposit, the following permissible grade raises are recommended for the proposed development:

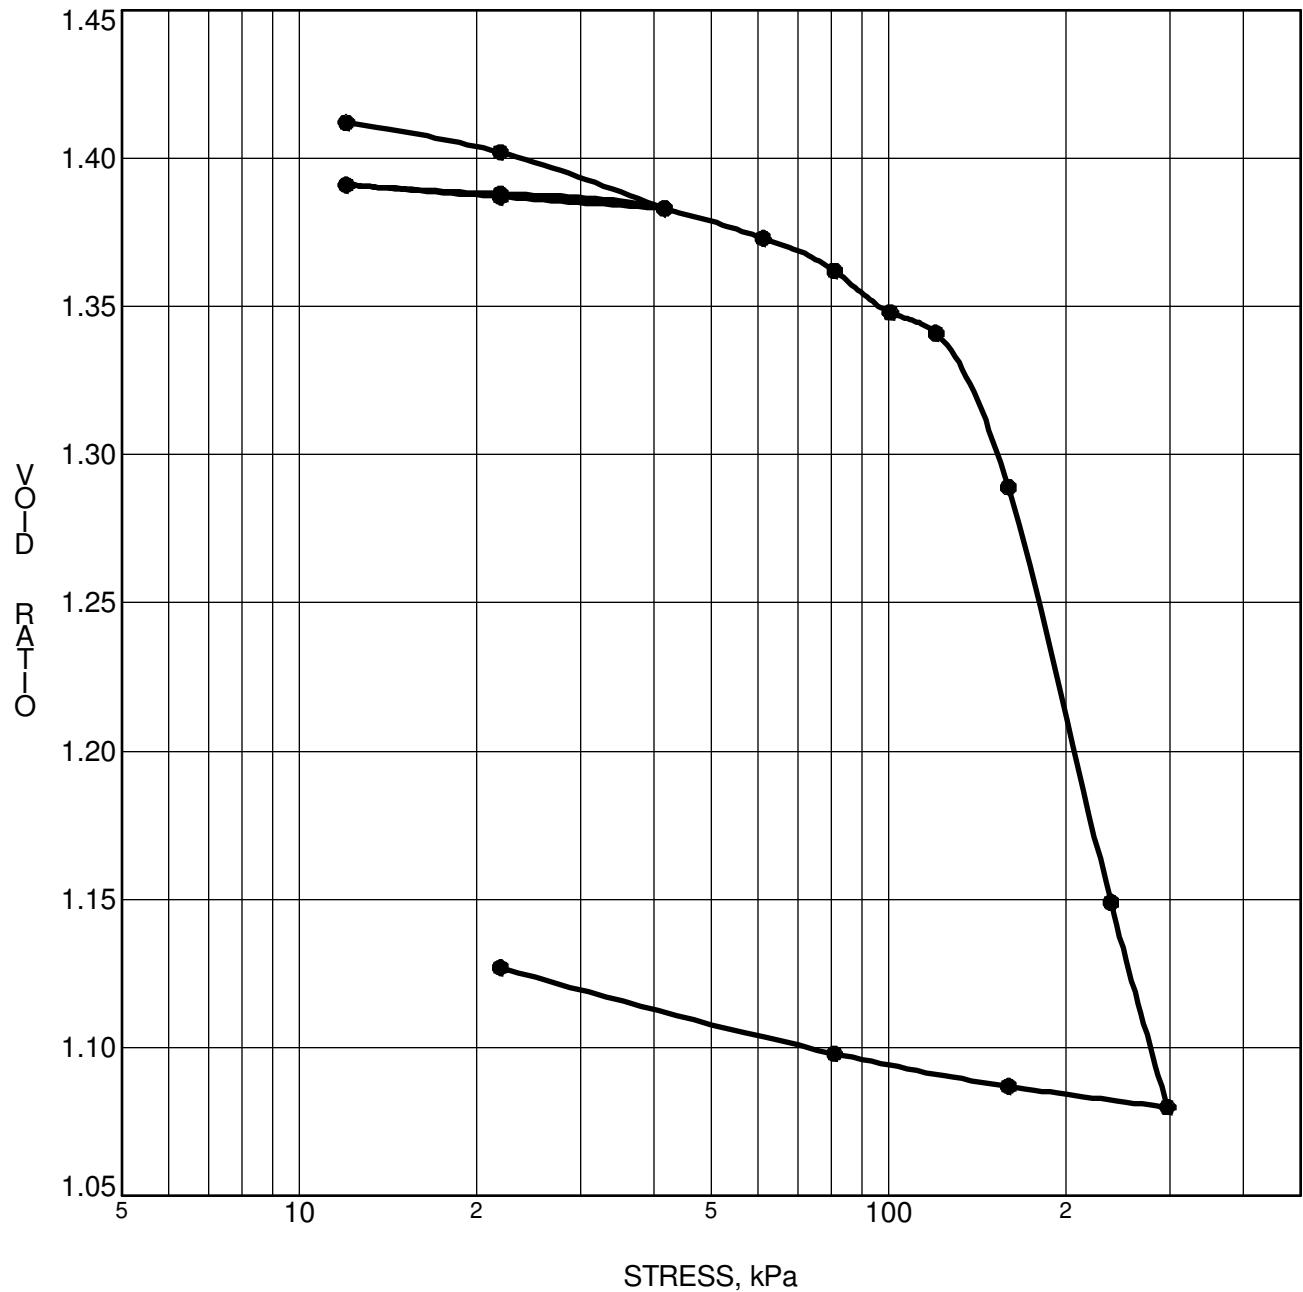
CONSOLIDATION TEST DATA SUMMARY					
Borehole No.	BH 6	p'_o	69 kPa	C_{cr}	0.014
Sample No.	TW 4	p'_c	144 kPa	C_c	0.814
Sample Depth	4.96 m	OC Ratio	2.1	W_o	51.8 %
Sample Elev.	96.43 m	Void Ratio	1.424	Unit Wt.	17.2 kN/m³

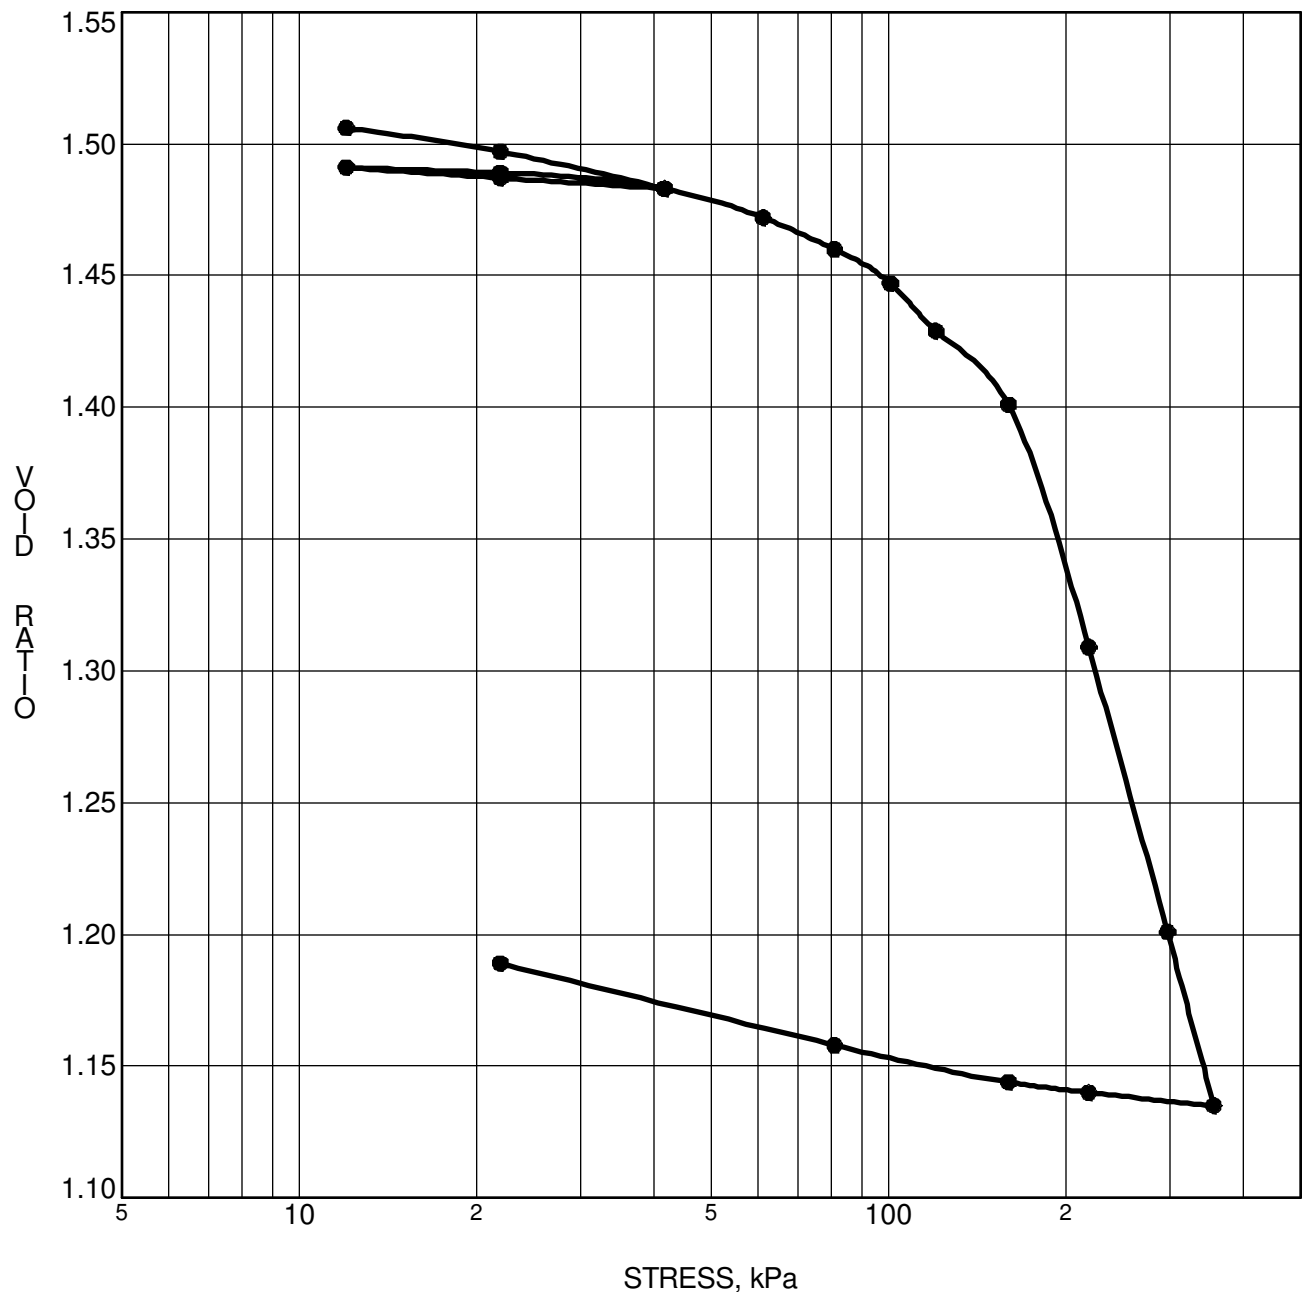
CONSOLIDATION TEST DATA SUMMARY					
Borehole No.	BH11	p'_o	57 kPa	C_{cr}	0.014
Sample No.	TW 4	p'_c	161 kPa	C_c	0.814
Sample Depth	4.36 m	OC Ratio	2.8	W_o	55.1 %
Sample Elev.	95.57 m	Void Ratio	1.515	Unit Wt.	17.0 kN/m³

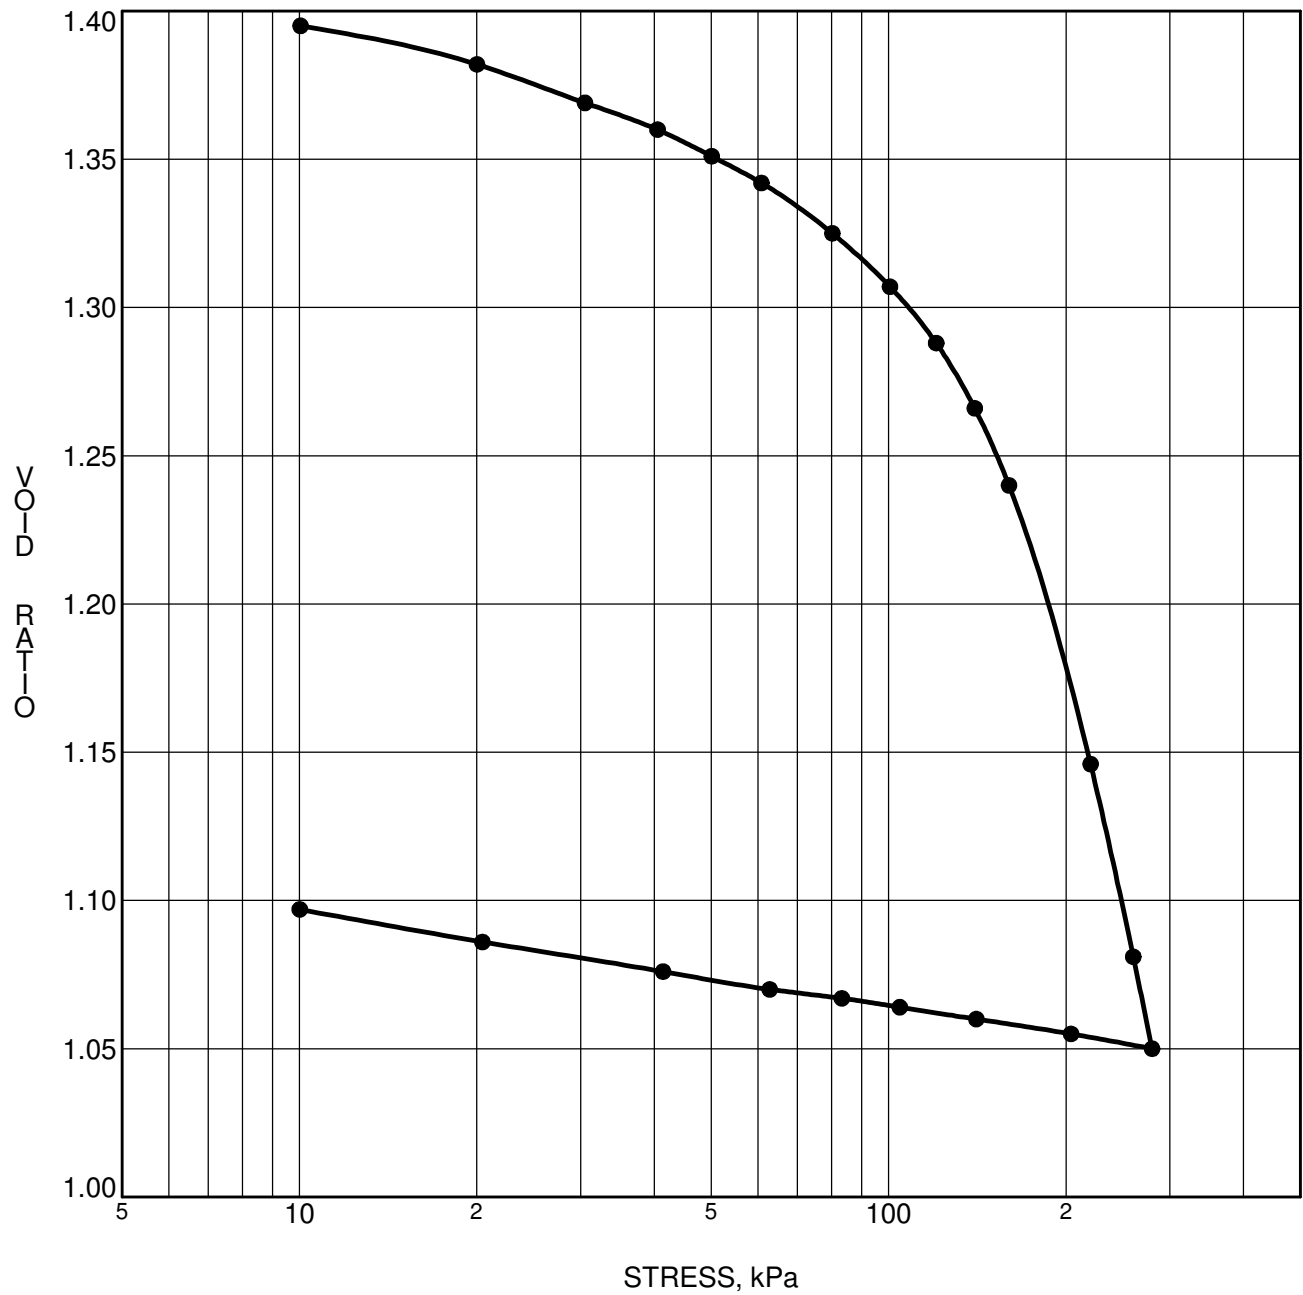
CONSOLIDATION TEST DATA SUMMARY					
Borehole No.	BH10-10	p'_o	96 kPa	C_{cr}	0.022
Sample No.	TW 9	p'_c	152 kPa	C_c	0.788
Sample Depth	8.01 m	OC Ratio	1.6	W_o	51.3 %
Sample Elev.	92.61 m	Void Ratio	1.412	Unit Wt.	17.2 kN/m³

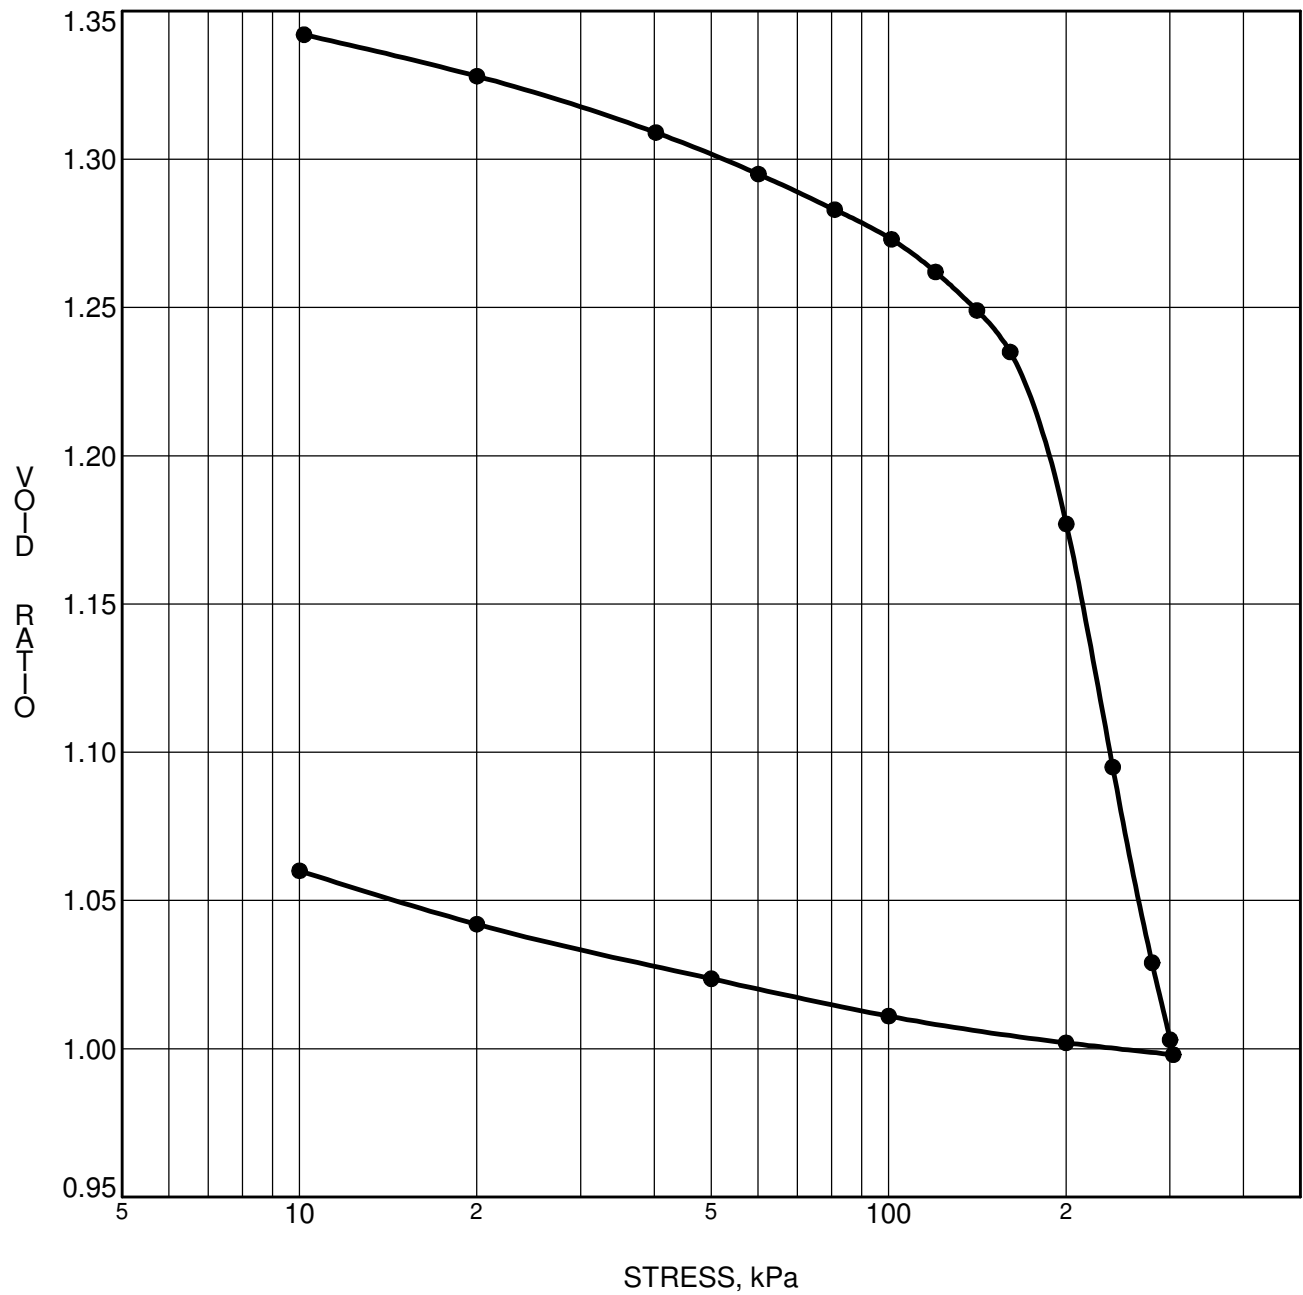
CONSOLIDATION TEST DATA SUMMARY					
Borehole No.	BH 8-10	p'_o	78 kPa	C_{cr}	0.042
Sample No.	TW 4	p'_c	175 kPa	C_c	1.003
Sample Depth	5.84 m	OC Ratio	2.2	W_o	49.4 %
Sample Elev.	94.90 m	Void Ratio	1.359	Unit Wt.	17.4 kN/m³

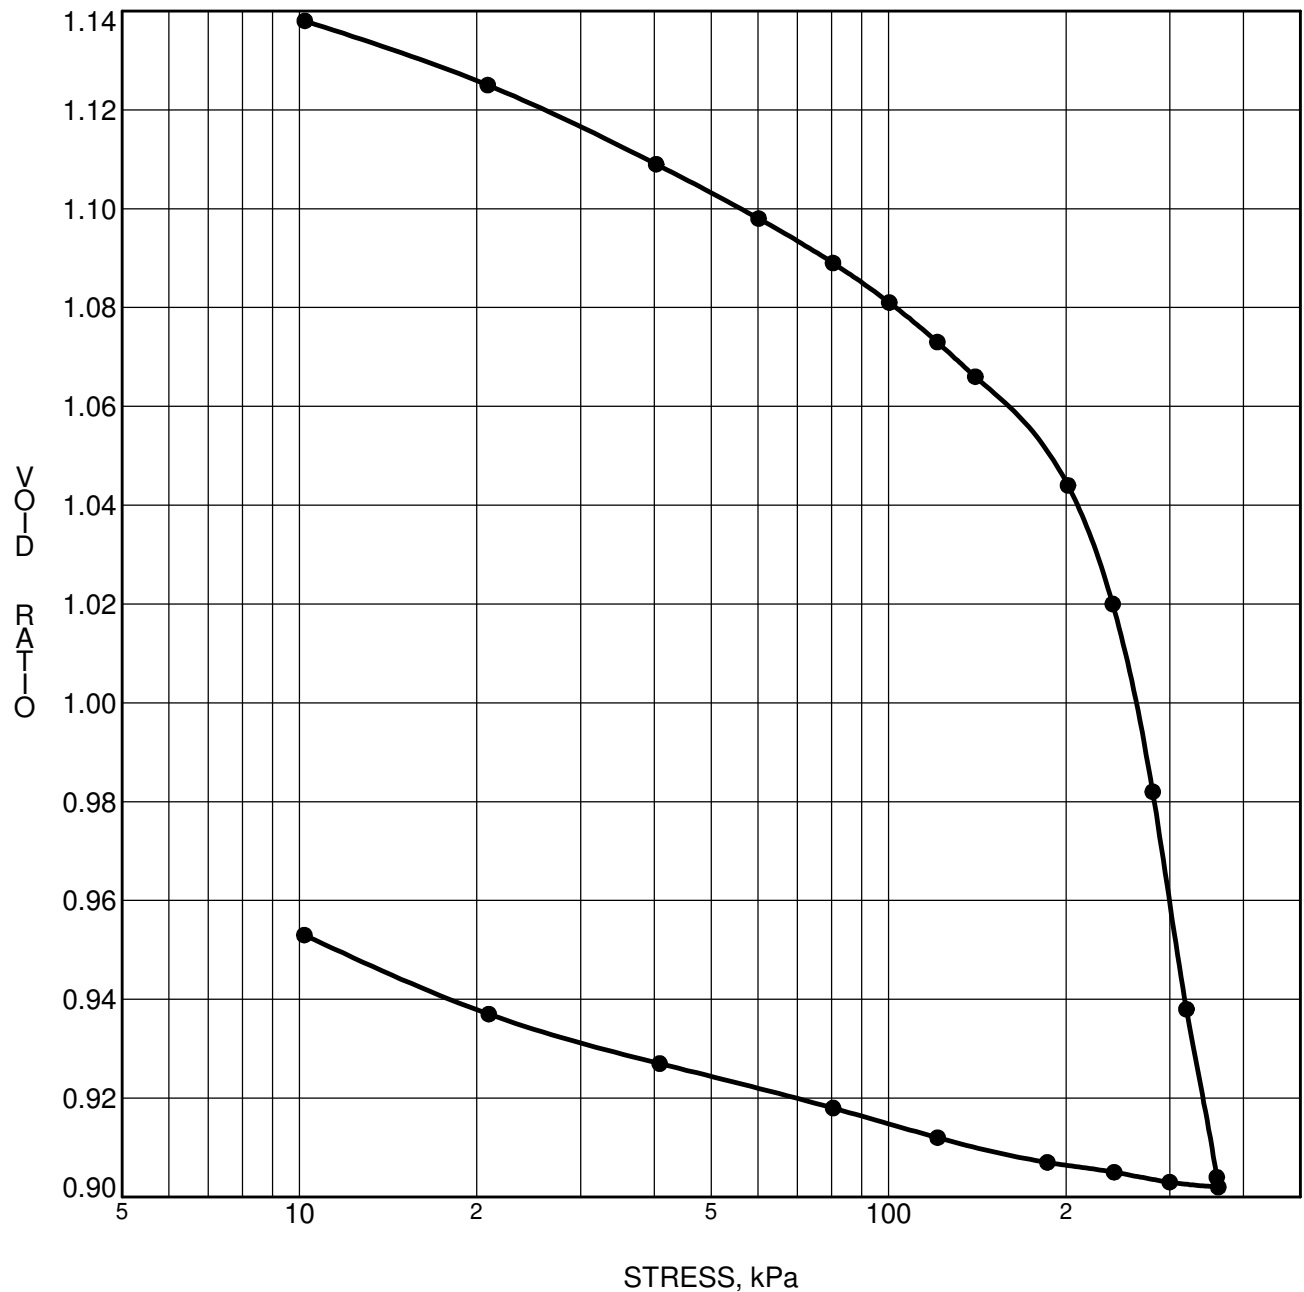
CONSOLIDATION TEST DATA SUMMARY					
Borehole No.	BH 9-10	p'_o	93 kPa	C_{cr}	0.028
Sample No.	TW 4	p'_c	235 kPa	C_c	0.663
Sample Depth	6.58 m	OC Ratio	2.5	W_o	41.9 %
Sample Elev.	93.29 m	Void Ratio	1.151	Unit Wt.	18.1 kN/m³
