**Geotechnical Investigation  
Fernbank Crossing Residential  
Subdivision  
Phase 5  
Ottawa, Ontario**

November 30, 2018  
Project: 64153.97

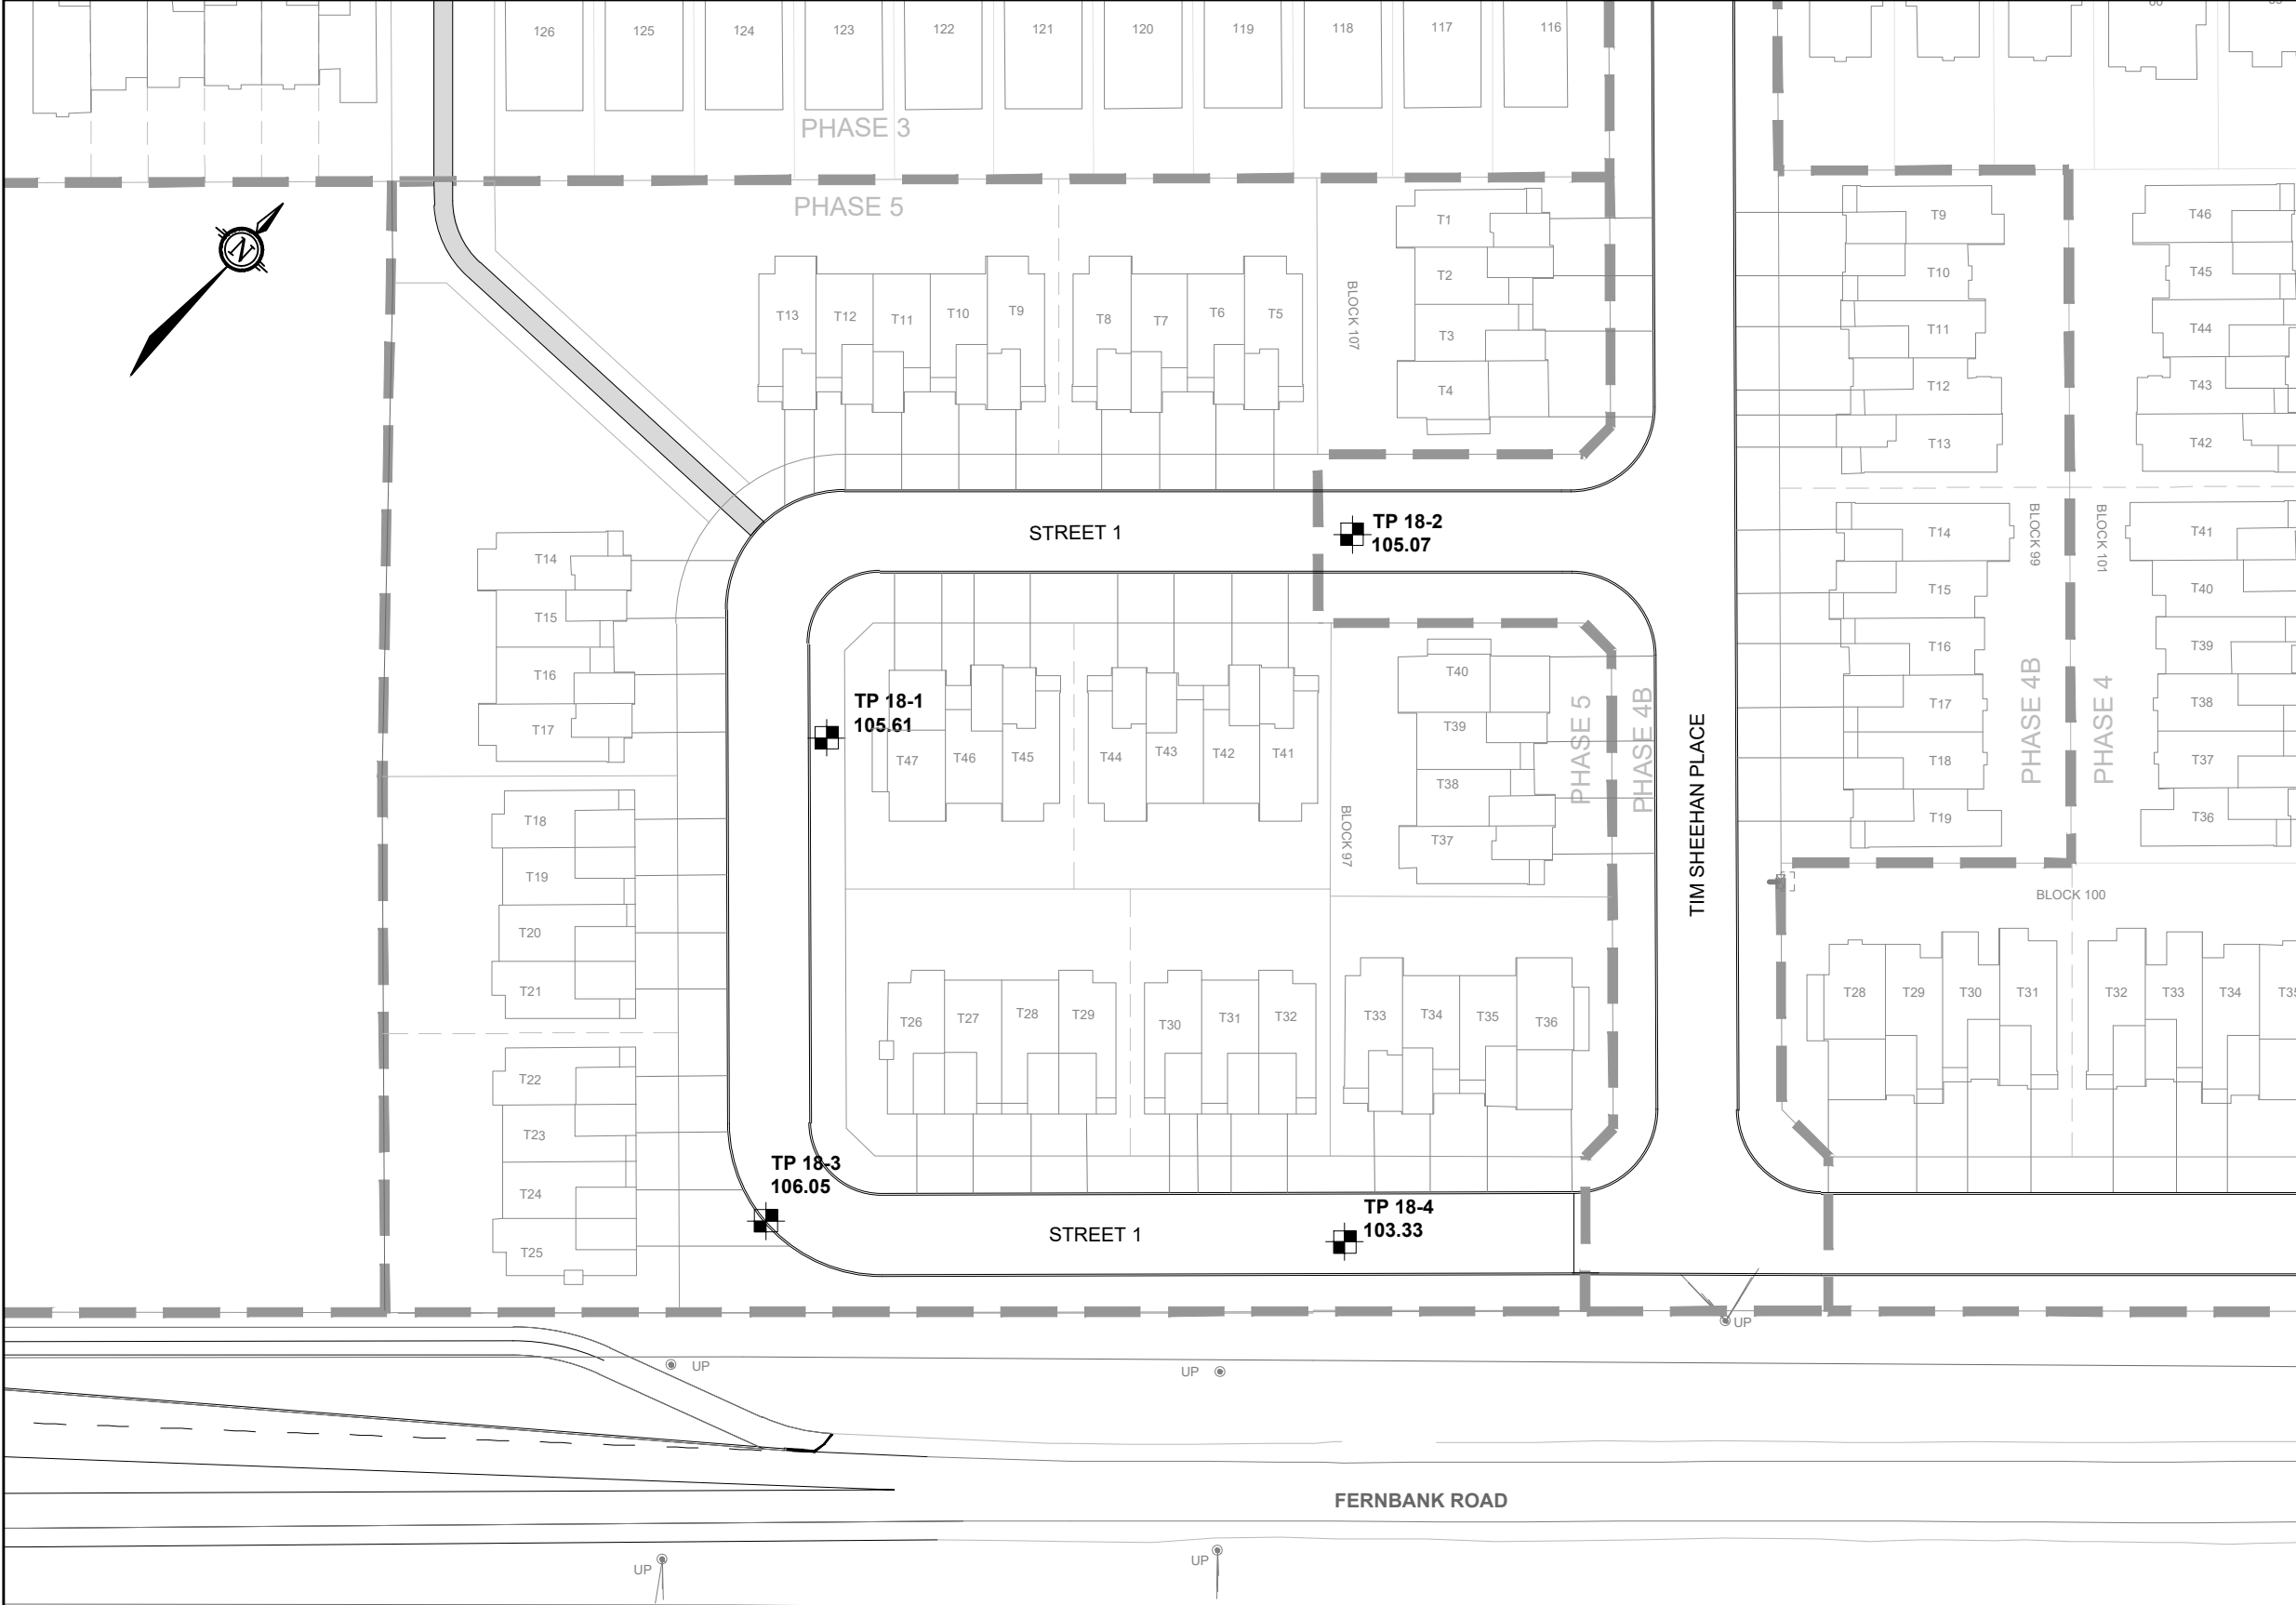
TEST PIT LOCATION IN PLAN  
(current investigation by GEMTEC)

The field work for this investigation was carried out on August 14, 2018. At that time, four (4) test pits, numbered 18-1 to 18-4, inclusive, were advanced at the site to refusal (depths ranging from about 2.5 to 3.9 metres below surface grade) using a 470 Hitachi shovel supplied and operated by Thomas Cavanagh Construction Limited of Ashton, Ontario.

The approximate locations of the test pits are shown on the Test Pit Location Plan, Figure 2. Descriptions of the subsurface conditions logged in the test pits are provided on the Record of Test Pit sheets in Appendix A. The results of the laboratory classification testing are provided on the Record of Test Pit sheets and in Appendix B. The results of the chemical analysis relating to corrosion of buried steel and concrete on the soil sample collected are provided in Appendix C.

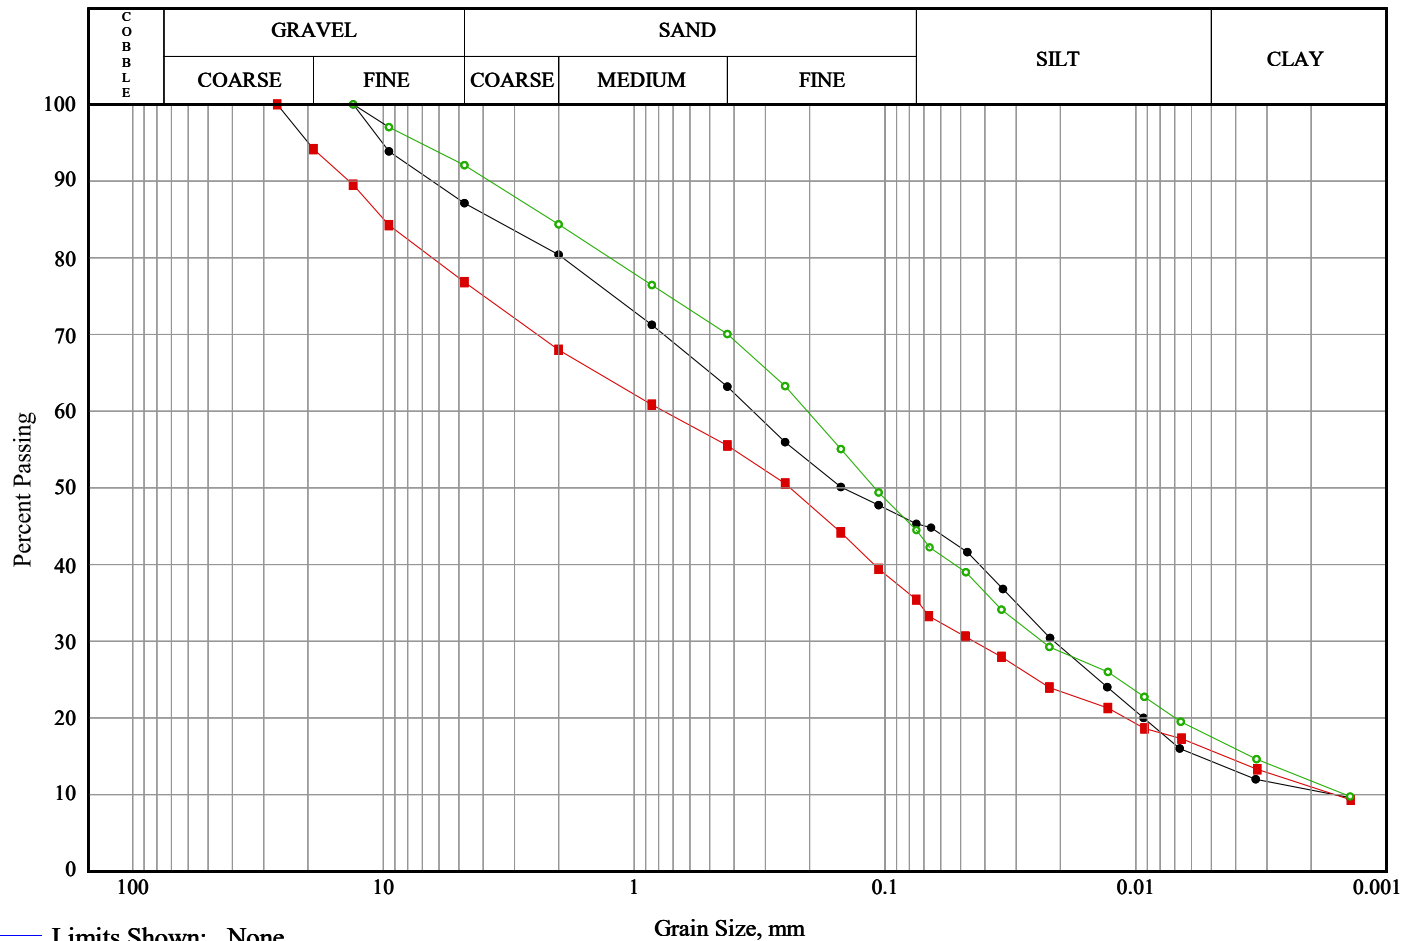
<b>GEMTEC</b> CONSULTING ENGINEERS AND SCIENTISTS	Client: Novatech	<b>Soils Grading Chart</b>
	Project: Fernbank Crossing Subdivision	
	Project #: 6415397

Line Symbol	Sample	Borehole/ Test Pit	Sample Number	Depth	% Cob.+ Gravel	% Sand	% Silt	% Clay
—●—		18-1	4	0.7-0.8	12.9	41.8	31.0	14.3
—■—		18-2	2	0.3-0.6	23.2	41.4	19.7	15.7
—○—		18-3	4	0.8-2.1	7.9	47.6	26.9	17.5

Line Symbol	CanFEM Classification	USCS Symbol	D <sub>10</sub>	D <sub>15</sub>	D <sub>30</sub>	D <sub>50</sub>	D <sub>60</sub>	D <sub>85</sub>	% 5-75µm
—●—	Silty sand , some gravel, some clay		0.00	0.01	0.02	0.15	0.34	3.61	31.0
—■—	Gravelly sand , some silt, some clay		0.00	0.00	0.04	0.24	0.76	9.96	19.7
—○—	Silty sand , some clay , trace gravel		0.00	0.00	0.02	0.11	0.20	2.15	26.9

Two (2) grain size distribution tests were undertaken on selected samples of sandy silt/silty sand from test pits 18-1 and 18-2. The results are provided in Appendix B and are summarized in Table 4.1.

Location	Sample Number	Sample Depth (metres)	Gravel (%)	Sand (%)	Silt (%)	Clay (%)
18-1	4	0.7 – 0.8	13	42	34	11
18-2	2	0.3 – 0.6	23	41	25	11
