## **Geotechnical Investigation**

Proposed Residential Development  
Eagleson Road at Terry Fox Drive  
Ottawa, Ontario

Claridge Homes

Report PG3411-2 Revision 1

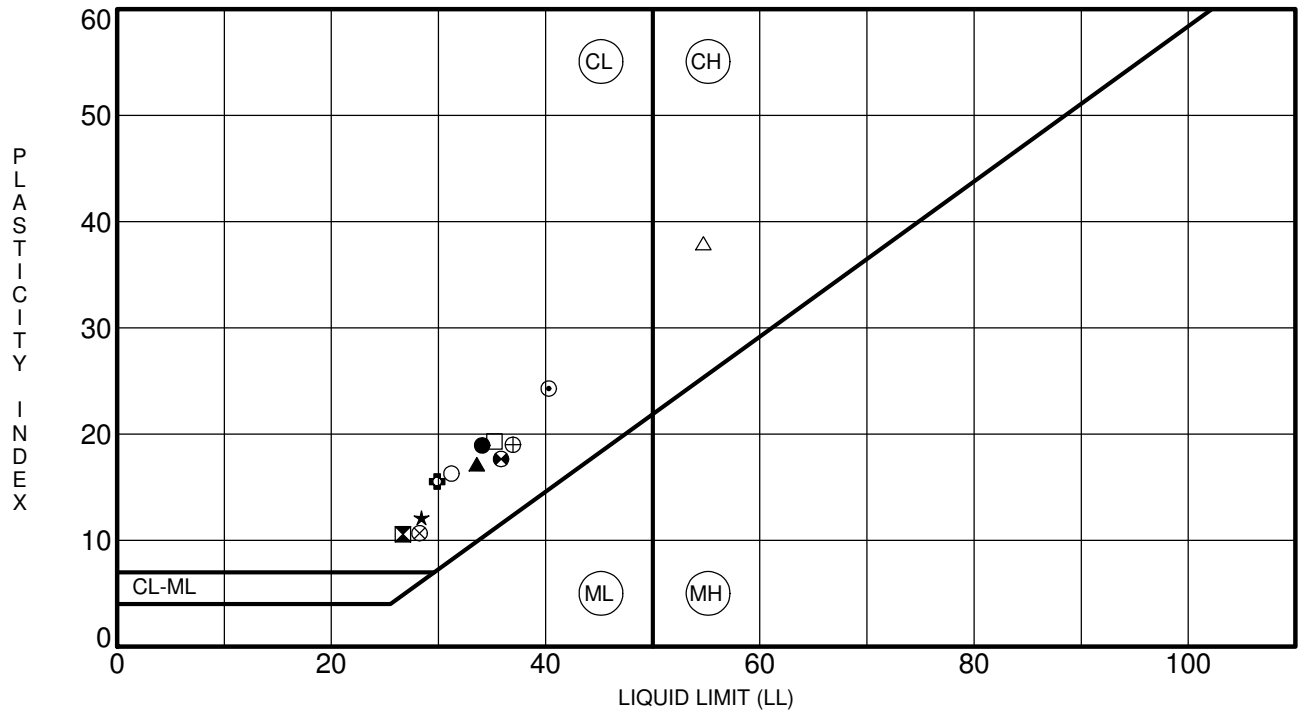
**ATTERBERG LIMITS'  
RESULTS**

Specimen Identification	LL	PL	PI	Fines	Classification
● BH 1-18 SS 4	34	15	19		CL - Inorganic clays of low plasticity
⊠ BH 2-18 SS 4	27	16	11		CL - Inorganic clays of low plasticity
▲ BH 3-18 SS 3	34	16	17		CL - Inorganic clays of low plasticity
★ TP 1-18 G 4	28	16	12		CL - Inorganic clays of low plasticity
⊙ TP 2-18 G 3	40	16	24		CL - Inorganic clays of low plasticity
⊕ TP 3-18 G 4	30	14	16		CL - Inorganic clays of low plasticity
○ TP 4-18 G 3	31	15	16		CL - Inorganic clays of low plasticity
△ TP 5-18 G 4	55	17	38		CH - Inorganics clays of high plasticity
⊗ TP 7-18 G 3	28	18	11		CL - Inorganic clays of low plasticity
⊕ TP 8-18 G 2	37	18	19		CL - Inorganic clays of low plasticity
□ TP 9-18 G 3	35	16	19		CL - Inorganic clays of low plasticity
⊕ TP10-18 G 2	36	18	18		CL - Inorganic clays of low plasticity

<b>Table 1 - Summary of Atterberg Limits Tests</b>					
<b>Samples</b>	<b>De pth (m)</b>	<b>Initial Moisture Content %</b>	<b>Liquid Limit %</b>	<b>Plastic Limit %</b>	<b>Plasticity Index %</b>
BH1-18	2.3-2.9	35.0	34	15	19
BH2-18	3 - 3.7	31.0	27	16	11
BH3-18	1.5 - 2.2	34.0	34	16	17
TP1-18	2.3 - 2.5	28.0	28	16	12
TP2-18	1.5 - 1.7	45.0	40	16	24
TP3-18	2.3 - 2.5	32.0	30	14	16
TP4-18	1.5 - 1.7	26.0	31	15	16
TP5-18	2.3 - 2.5	53.0	55	17	38

<b>Table 1 - Summary of Atterberg Limits Tests (Cont'd)</b>					
<b>Samples</b>	<b>Depth (m)</b>	<b>Initial Moisture Content %</b>	<b>Liquid Limit %</b>	<b>Plastic Limit %</b>	<b>Plasticity Index %</b>
TP7-18	1.5 - 1.7	27.0	28	18	11
TP8-18	1.0 - 1.1	28.0	37	18	19
TP9-18	1.5 - 1.6	24.0	35	16	19
TP10-18	1.0 - 1.1	27.0	36	18	18

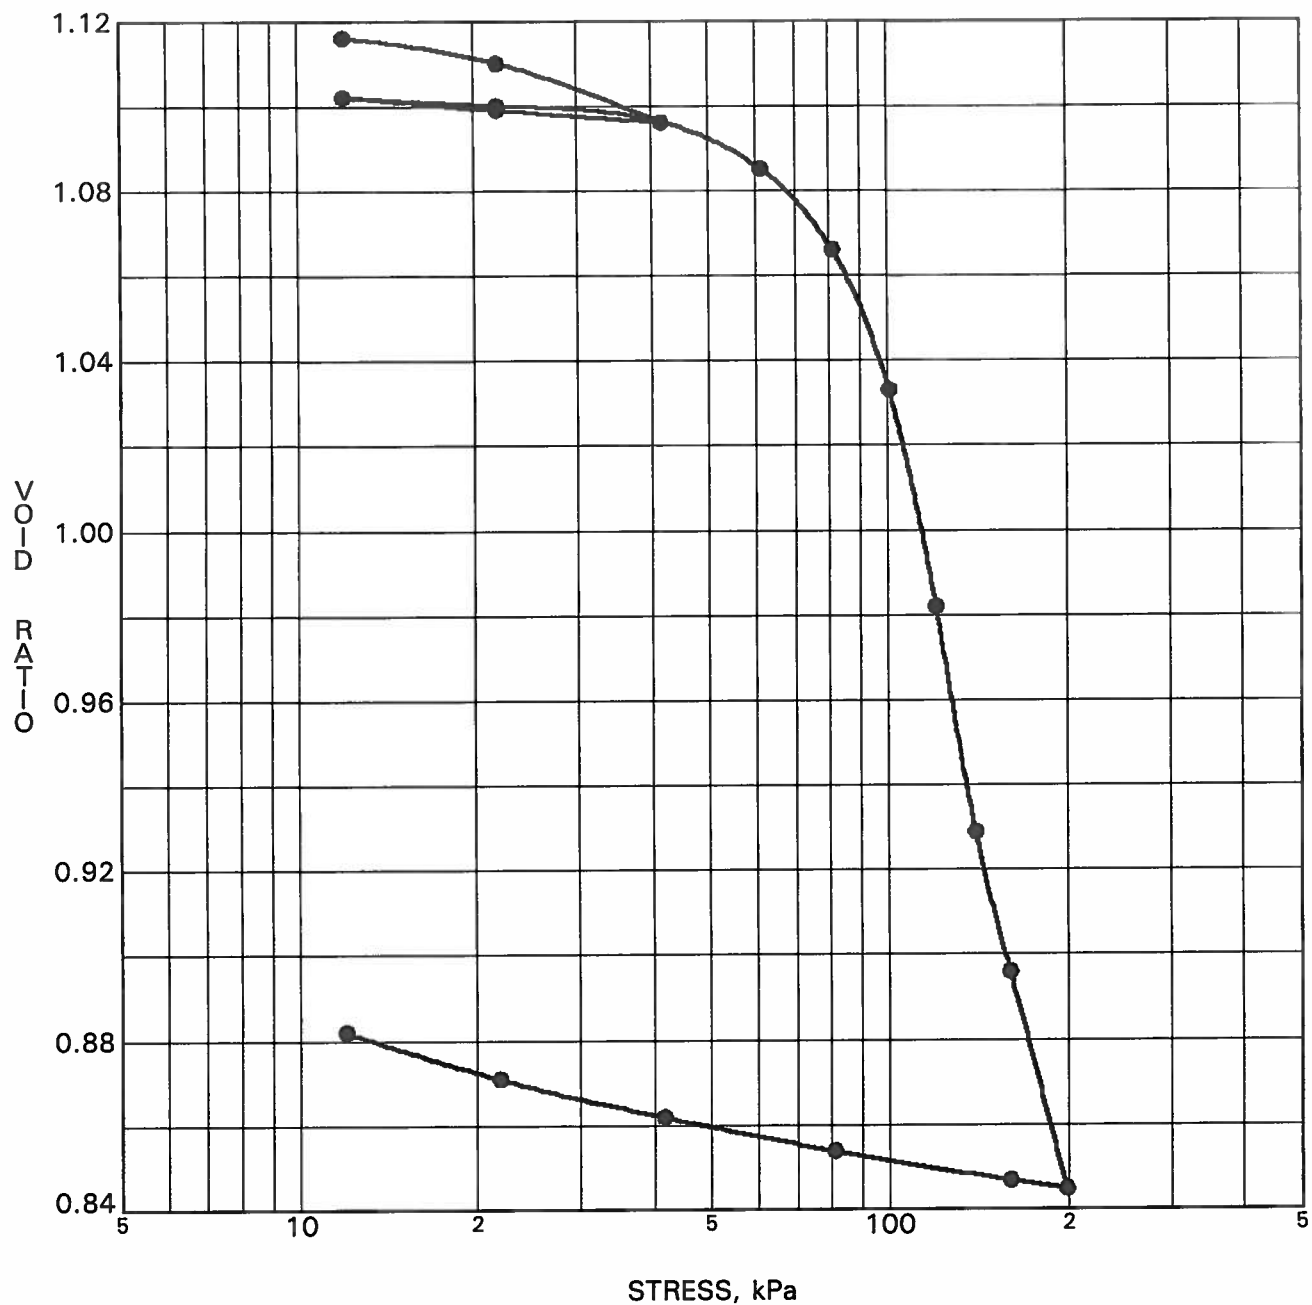
**CONSOLIDATION  
TEST**

CONSOLIDATION TEST DATA SUMMARY					
Borehole No.	BH 5	$p'_o$	61 kPa	$C_{cr}$	0.012
Sample No.	TW 4	$p'_c$	87 kPa	$C_c$	0.706
Sample Depth	4.28 m	OC Ratio	1.4	$W_o$	40.9 %
Sample Elev.	92.01 m	Void Ratio	1.125	Unit Wt.	17.9 kN/m <sup>3</sup>
