Supplemental Geotechnical Investigation
Proposed Residential Development
Riverside South - Phase 12
708 & 720 River Road
Ottawa, Ontario

Report PG3320-2 Revision 1

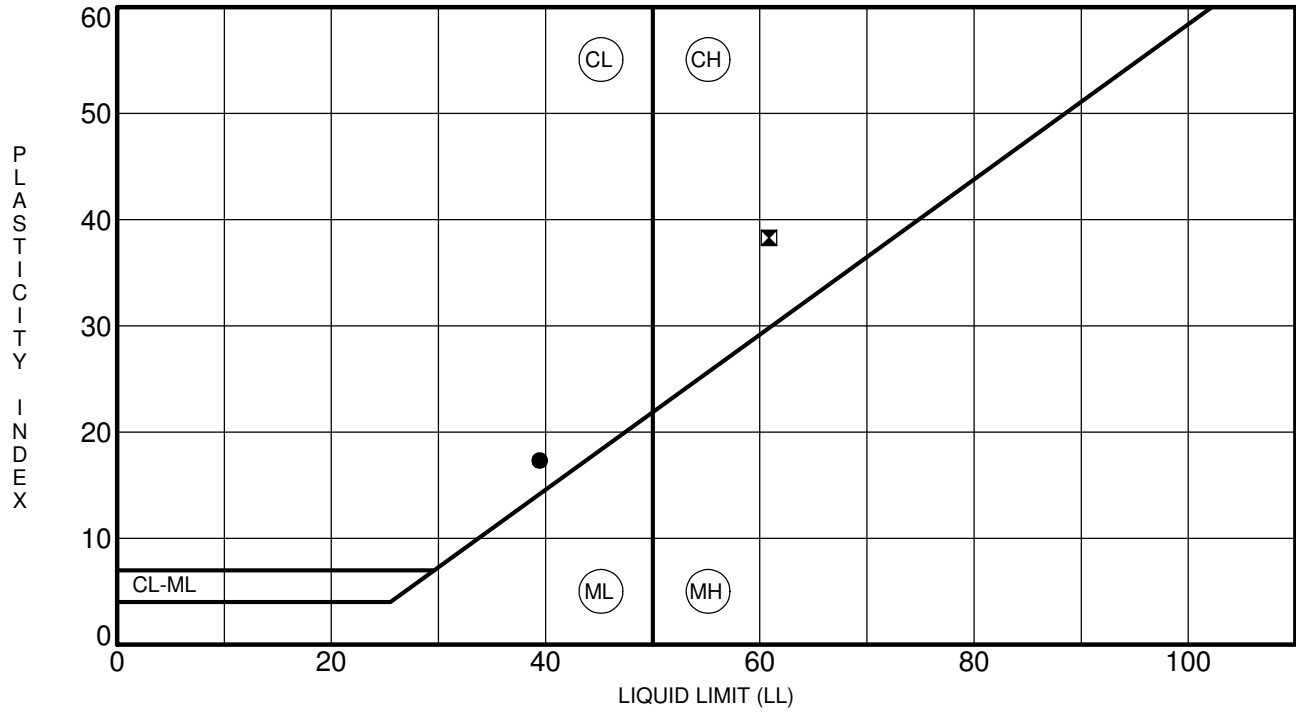
Specimen Identification	LL	PL	PI	Fines	Classification
● TP 5-20 G 2	39	22	17		CL - Inorganic clays of low plasticity
✕ TP 6-20 G 2	61	23	38		CH - Inorganic clays of high plasticity

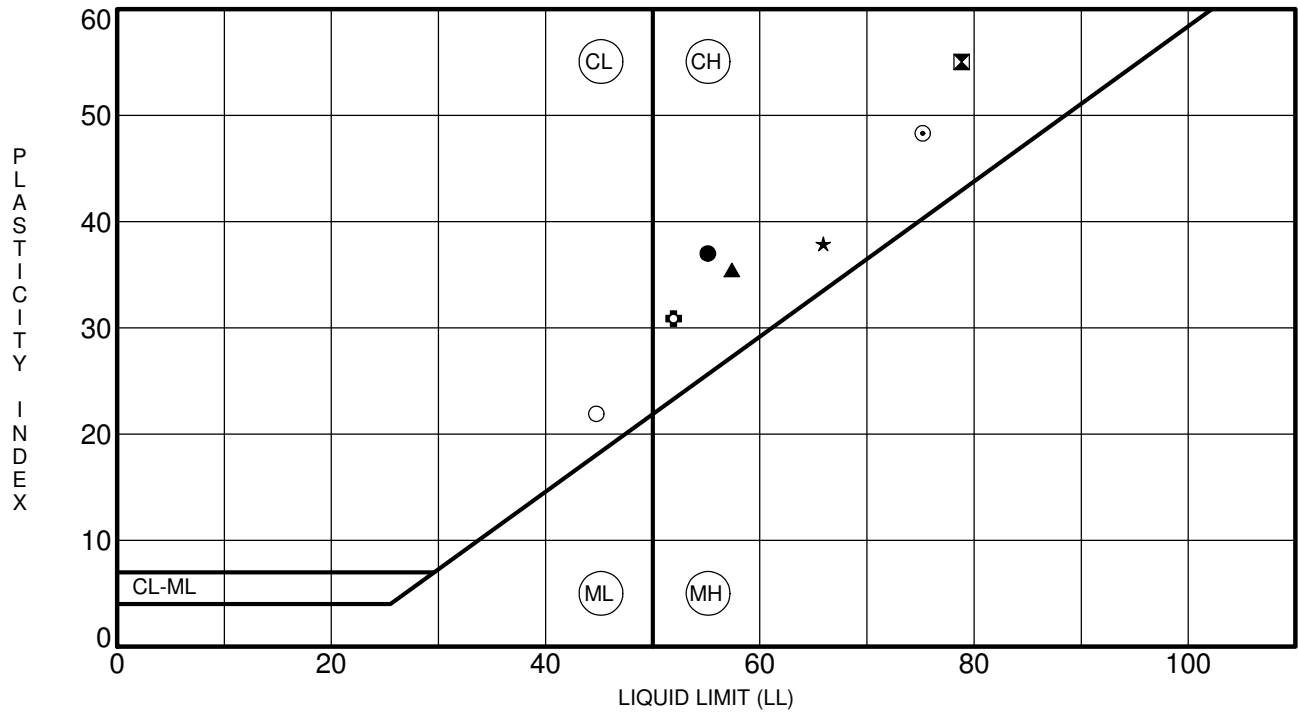
The soil samples recovered from the subject site were visually examined in our laboratory to review the results of the field logging. Gradation and Atterberg limits testing, as well as associated moisture content testing, was completed on the recovered silty clay samples at selected locations throughout the subject site. The results of the Atterberg limits tests are presented on the Atterberg Limits Results sheet in Appendix 1. The tested silty clay samples classify as inorganic clays of low plasticity (CL) and inorganic clays of high plasticity (CH) in accordance with the Unified Soil Classification System.

Specimen Identification	LL	PL	PI	Fines	Classification
● BH 1-19 SS3	55	18	37		CH - Inorganic clays of high plasticity
⊠ BH 2-19 SS3	79	24	55		CH - Inorganic clays of high plasticity
▲ BH 4-19 SS3	57	22	35		CH - Inorganic clays of high plasticity
★ BH 5-19 SS2	66	28	38		CH - Inorganic clays of high plasticity
⊙ BH 6-19 SS2	75	27	48		CH - Inorganic clays of high plasticity
⊕ BH 7-19 SS2	52	21	31		CH - Inorganic clays of high plasticity
○ BH 8-19 SS3	45	23	22		CL - Inorganic clays of low plasticity

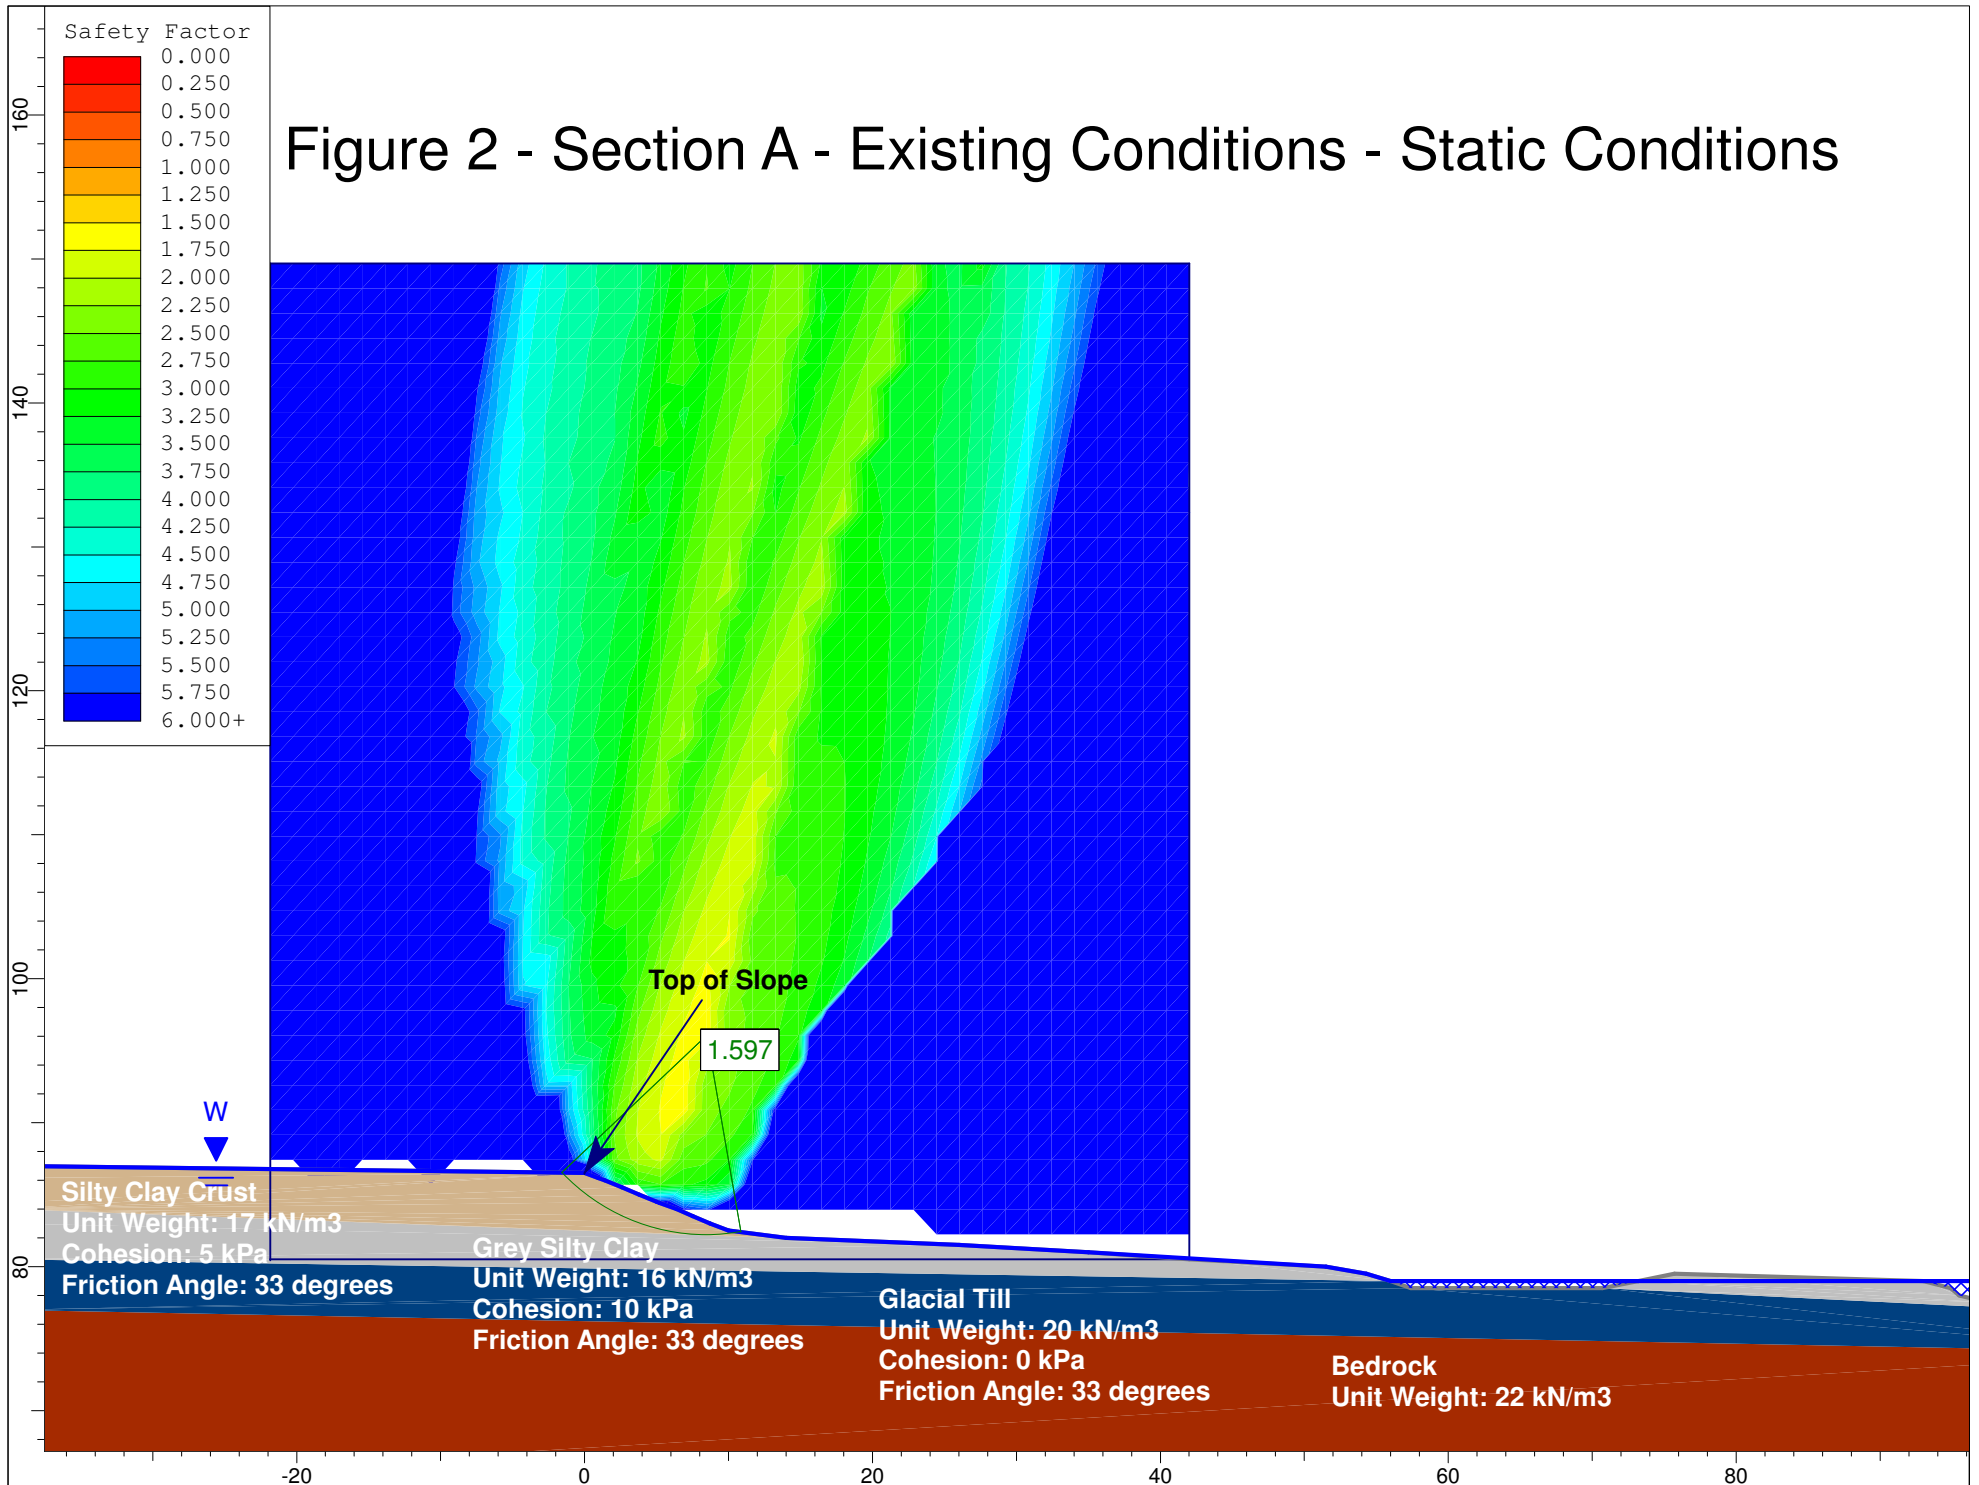
Figure 2 - Section A - Existing Conditions - Static Conditions

The results for the existing slope conditions under static loading at Sections A, B, C, D and E are shown in Figures 2, 4, 6, 8 and 10 respectively, presented in Appendix 2. The factor of safety was found to be greater than 1.5 at all sections.

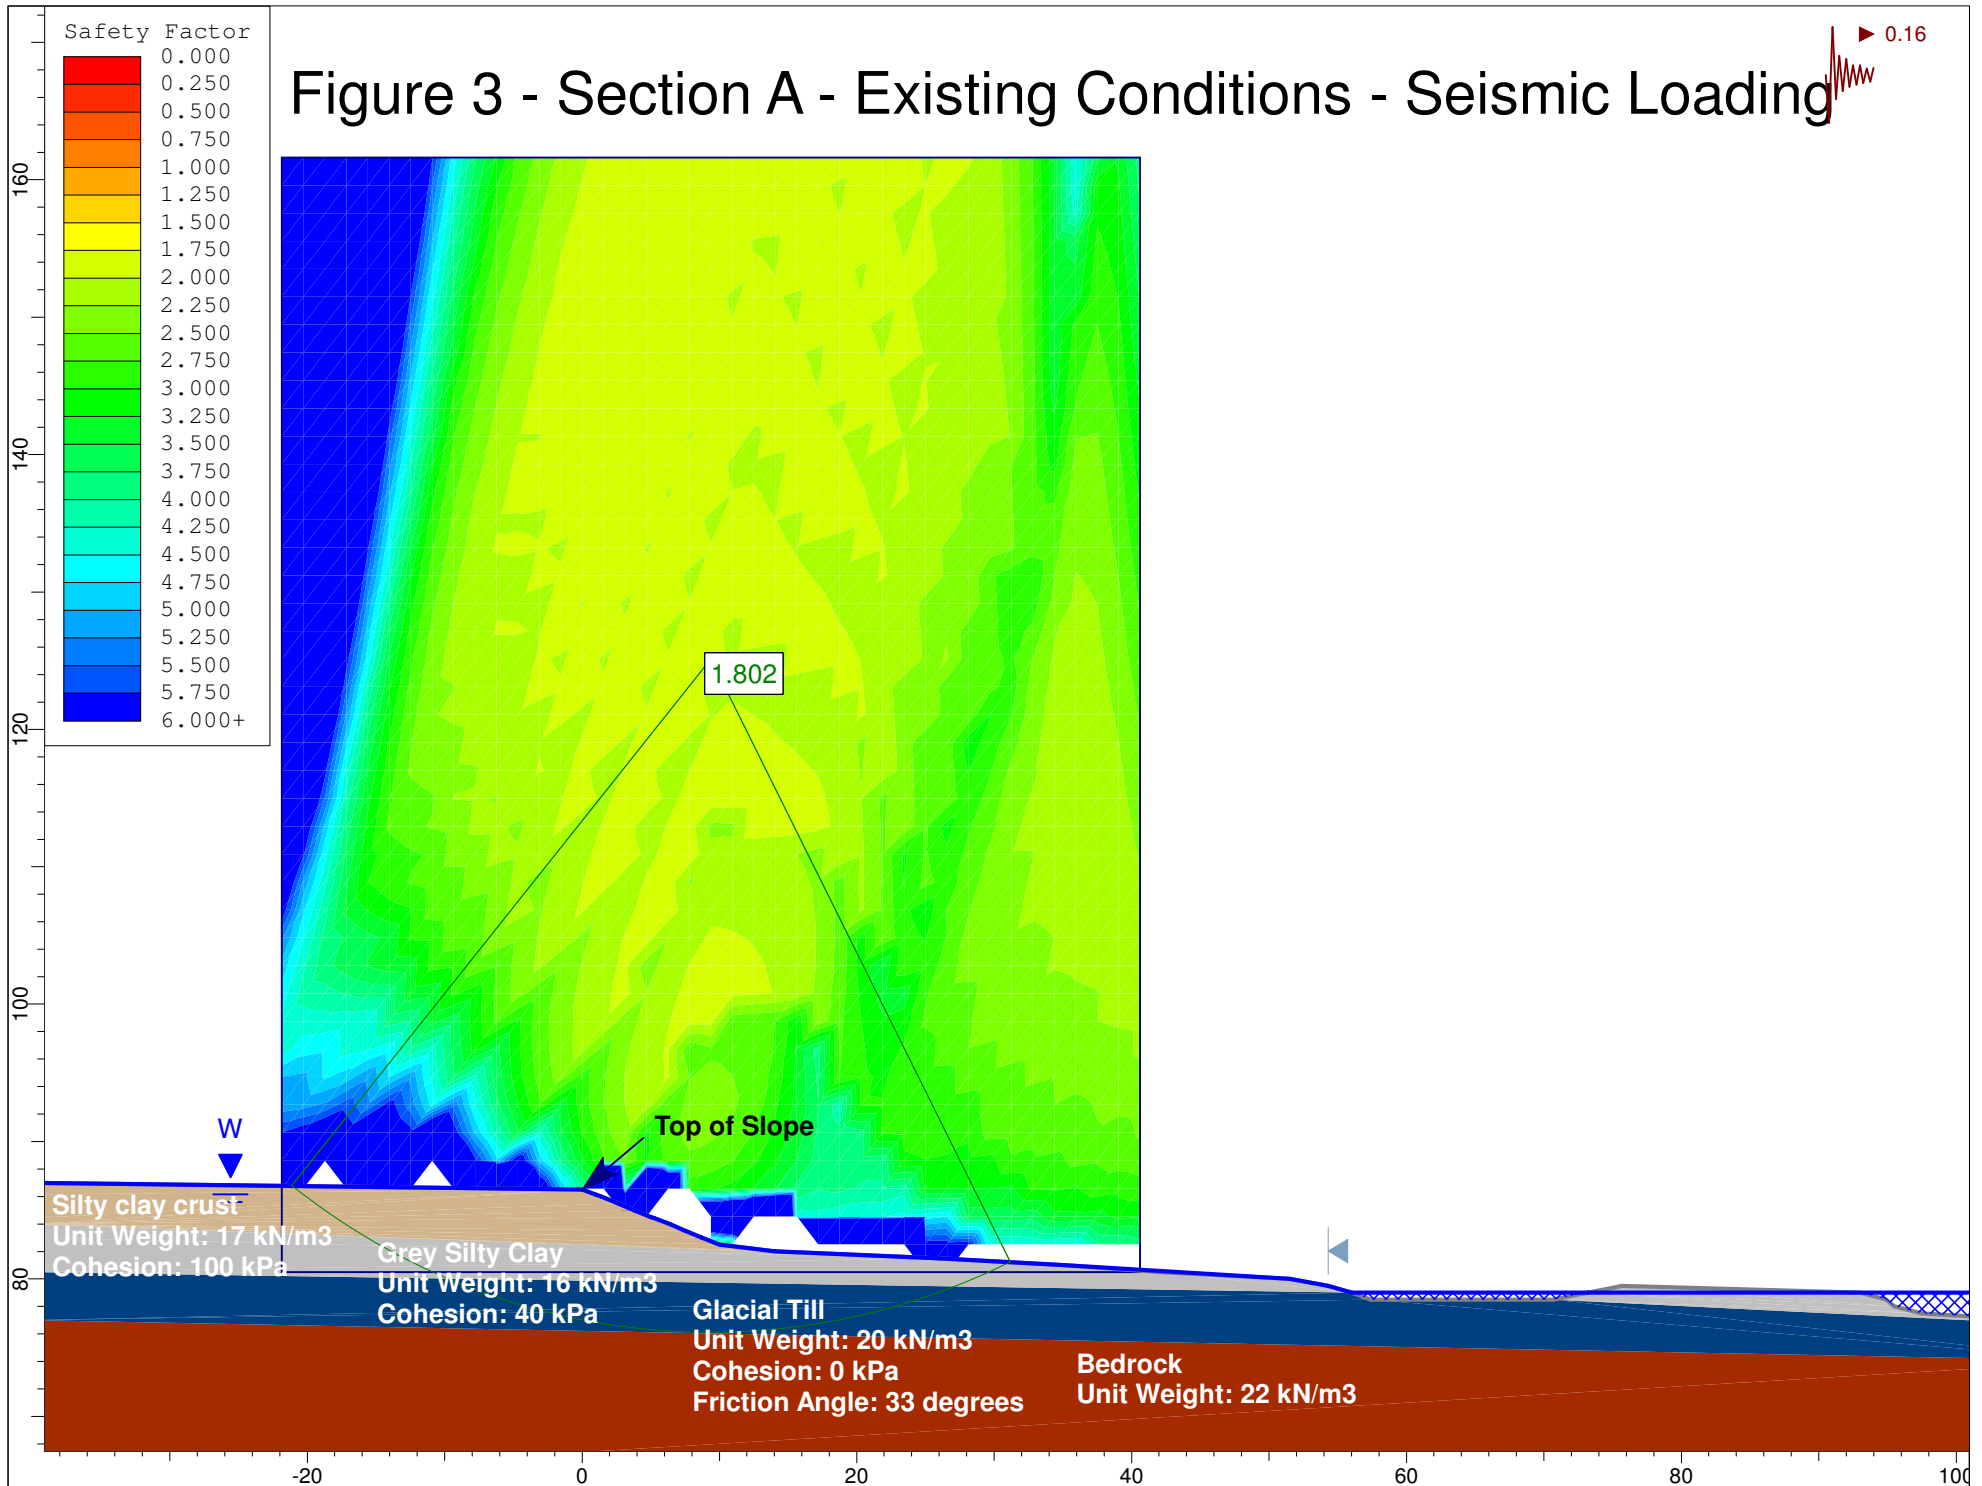
Figure 3 - Section A - Existing Conditions - Seismic Loading

The results of the analyses including seismic loading are shown in Figures 3, 5, 7, 9 and 11 for the slope sections. The results indicate that the factors of safety are greater than 1.1 under seismic conditions. Based on these results, the slopes are considered to be stable under seismic loading. Therefore, when considering seismic loading, no geotechnical setback from the top of the slope is required to achieve a factor of safety of 1.1 for the limit of hazard lands.

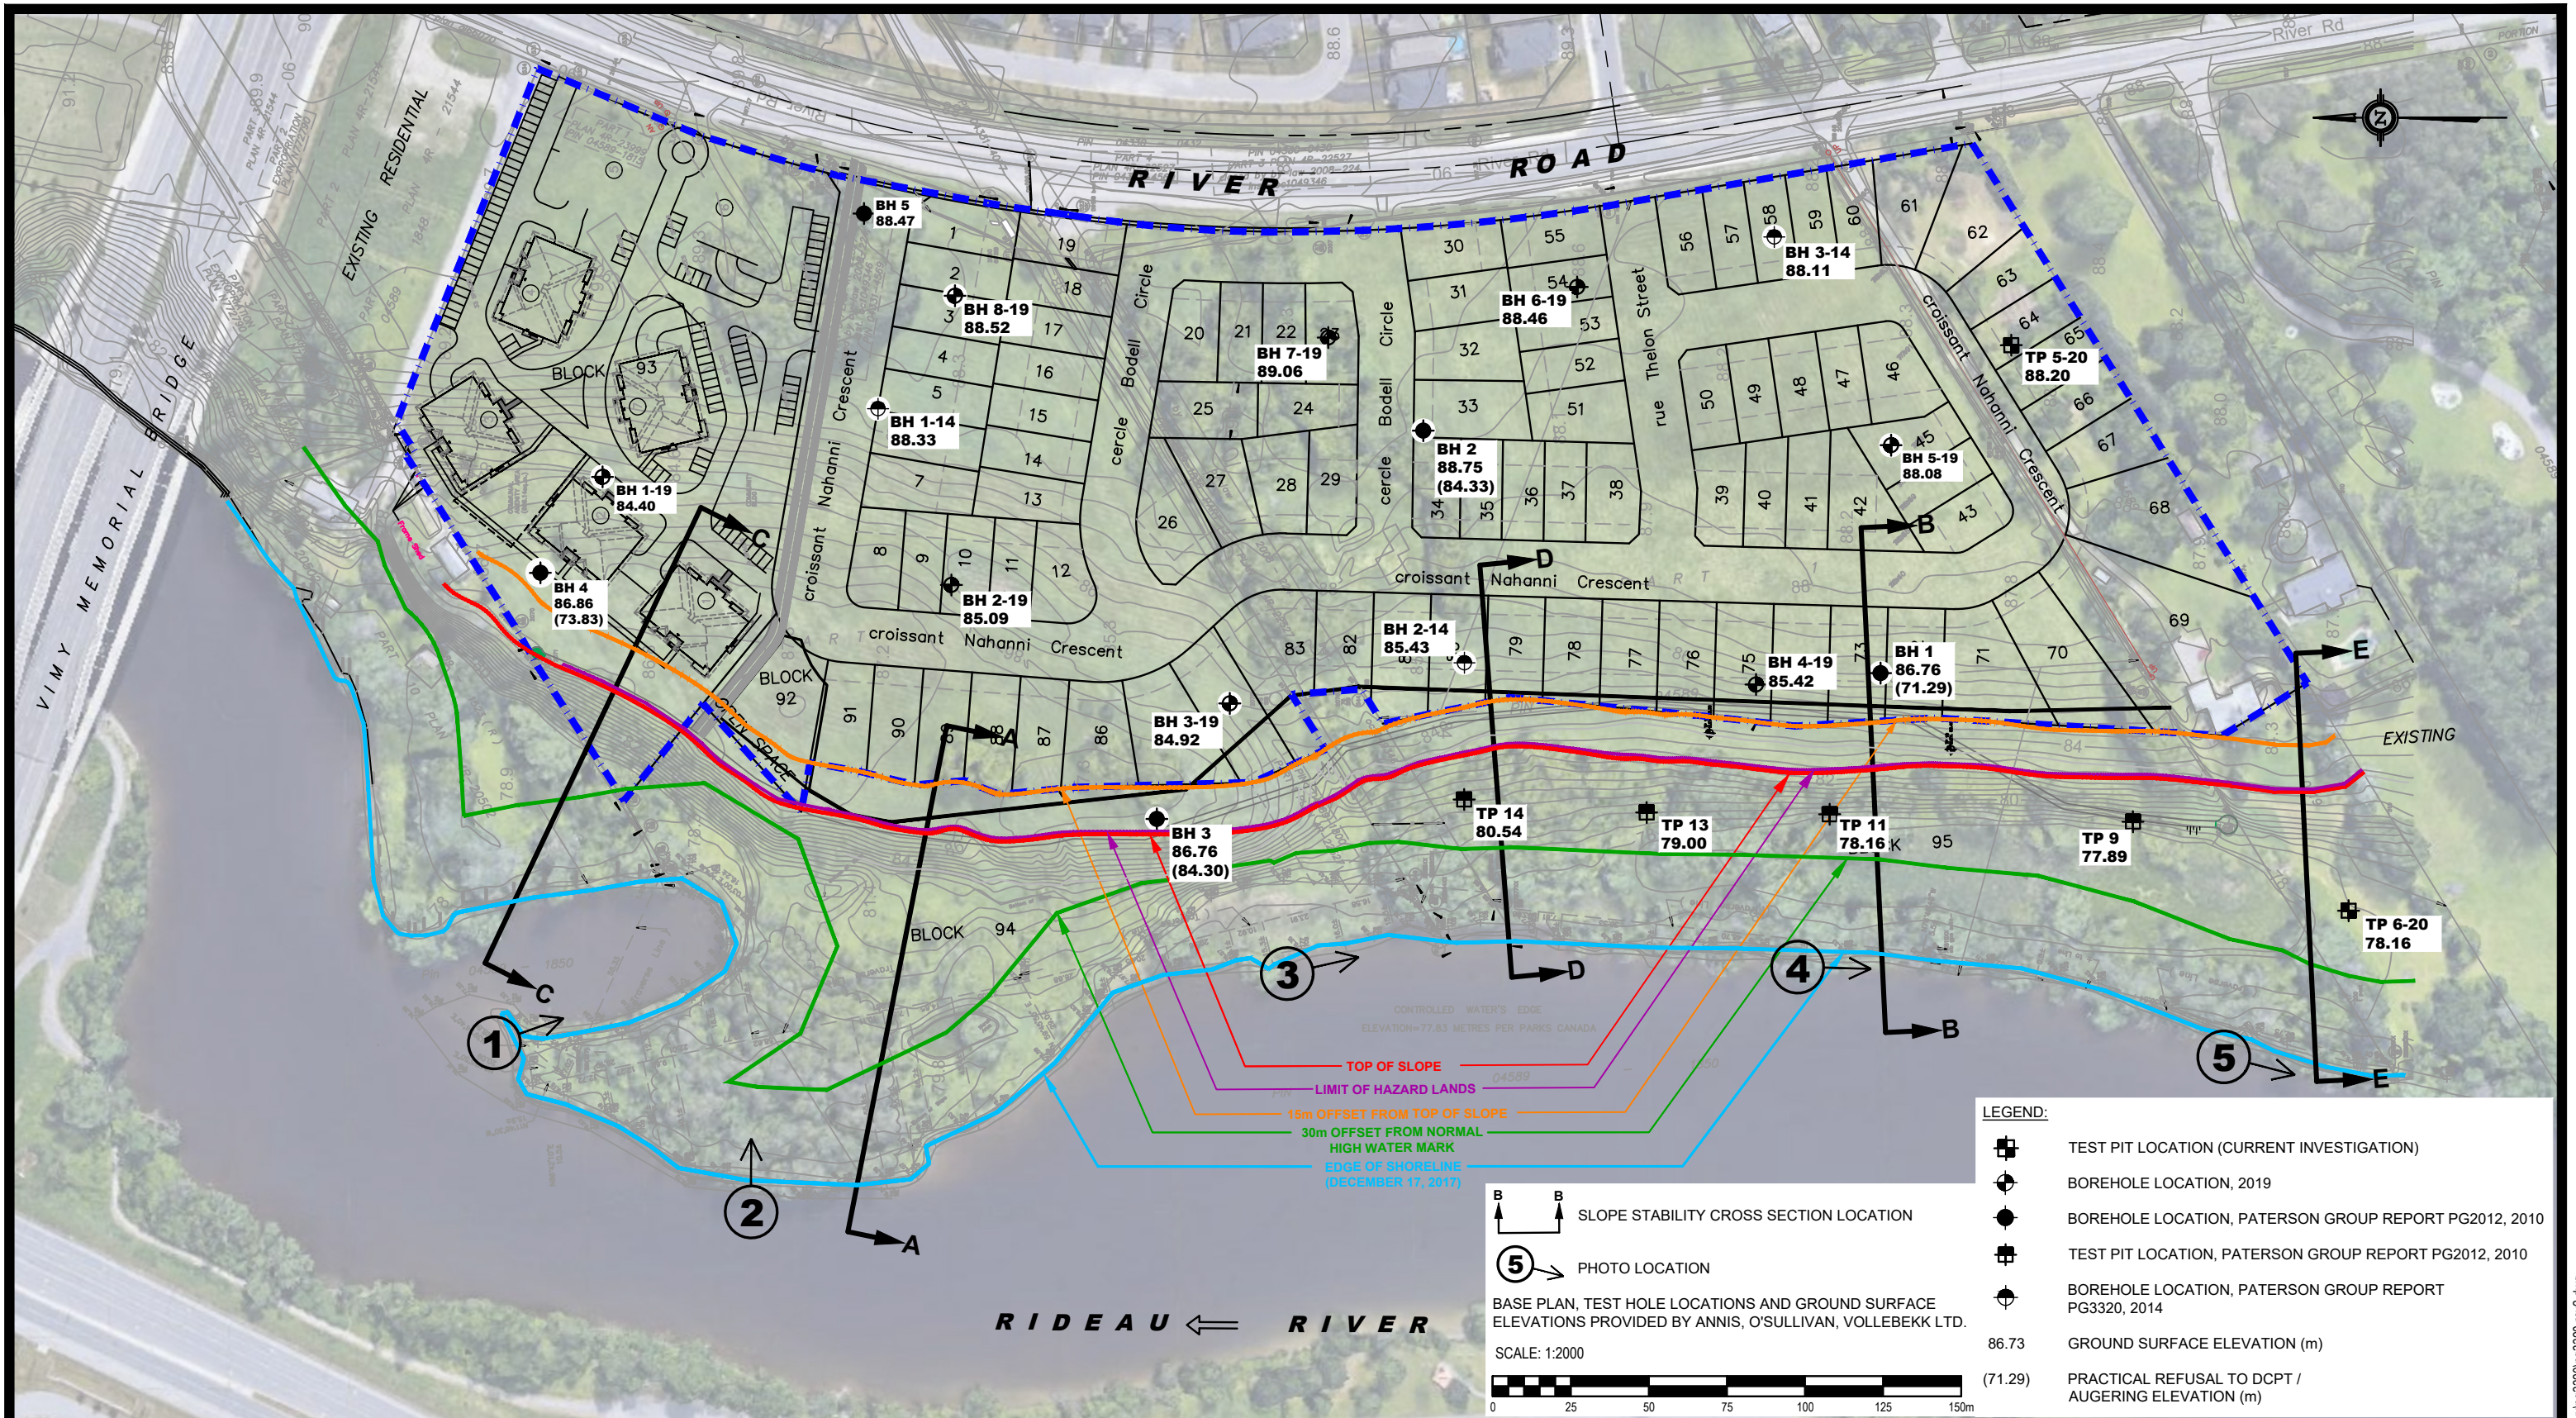
Scale:	1:2000	Date:	03/2020
Drawn by:	RCG	Report No.:	PG3320-2
Checked by:	KP	Dwg. No.:	PG3320-2
Approved by:	DJG	Revision No.:	2

The geotechnical limit of hazard lands taken from top of slope for the subject site is indicated on Drawing PG3320-2 - Test Hole Location Plan in Appendix 2. The limit of hazard lands designation line runs parallel to the top of stable slope for the subject. Our slope stability analysis results indicate that the subject slope is stable and a stable slope allowance is not required for the limit of hazard lands line. Based on available topographic data and our site visit observations, the toe of slope is located greater than 15 m from the edge of the watercourse. Therefore, a toe erosion allowance and 6 m erosion access allowance are not required as part of the limit of hazard lands setback from top of stable slope. No signs of active erosion were noted along the slope face.

The proposed development is bordered to the west by the east valley corridor wall of the Rideau River. A geotechnical limit of hazard lands line was established for the subject slope and a slope stability assessment was completed. The limit of hazard lands line and slope stability sections reviewed as part of our slope stability assessment are presented in Drawing PG3320-2 - Test Hole Location Plan presented in Appendix 2.

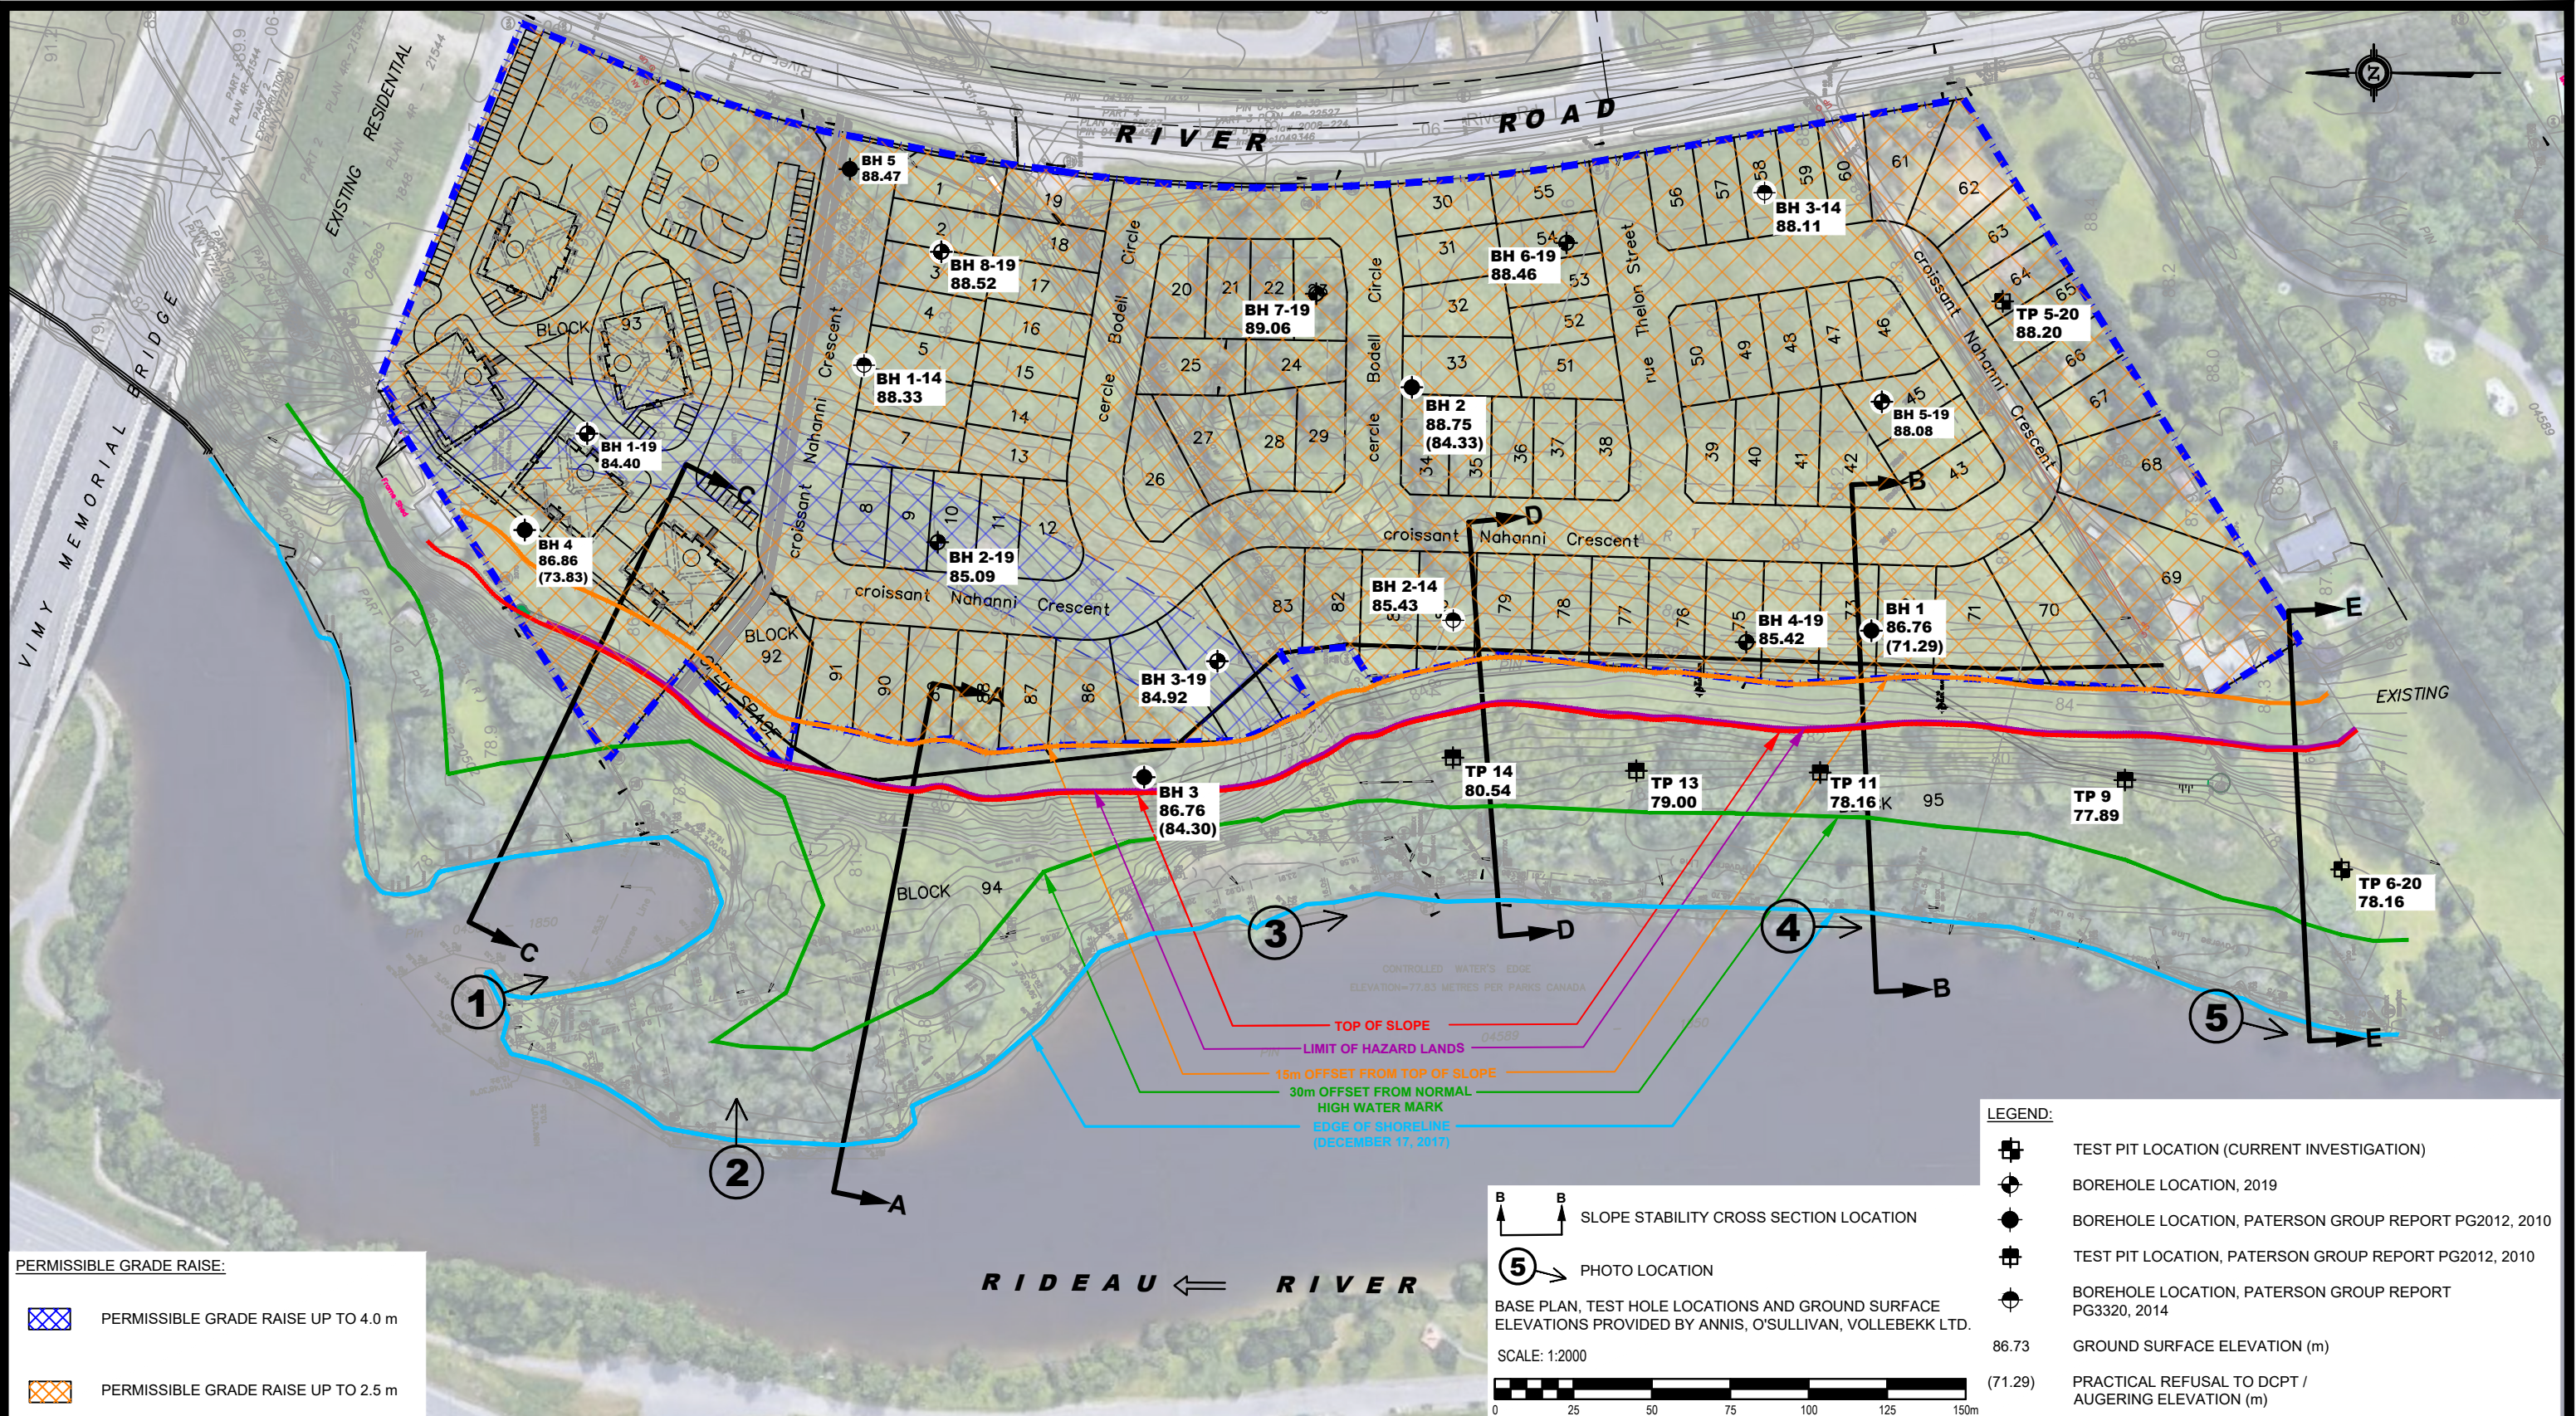
Scale:	1:2000	Date:	06/2019
Drawn by:	MPG	Report No.:	PG3320-2
Checked by:	KP	Dwg. No.:	PG3320-4
Approved by:	DJG	Revision No.:	1

Due to the presence of a silty clay deposit, the subject site will be subjected to permissible grade raises. As previously noted in Section 4.1, a small natural ditch was observed in the north portion of the site. Soil removal by a natural erosion process, such as in this scenario, has unloaded the underlying silty clay soil. Therefore, placement of fill material up to the top of bank elevation within this area will not overload the underlying soils. A permissible grade raise of 4 m, measured from the bottom of the ditch is recommended for this area. In other areas of the site where cohesive soils are encountered below footing level, a permissible grade raise of 2.5 m is recommended for the proposed development. Refer to the attached Drawing PG3320-4 - Permissible Grade Raise Plan in Appendix 2.

PERMISSIBLE GRADE RAISE UP TO 4.0 m
	PERMISSIBLE GRADE RAISE UP TO 2.5 m
