# Geotechnical Investigation and Slope Stability Analysis Proposed Residential Development 37 Wildpine Court Ottawa, Ontario

OTT-00263154-A0

August 24, .2021

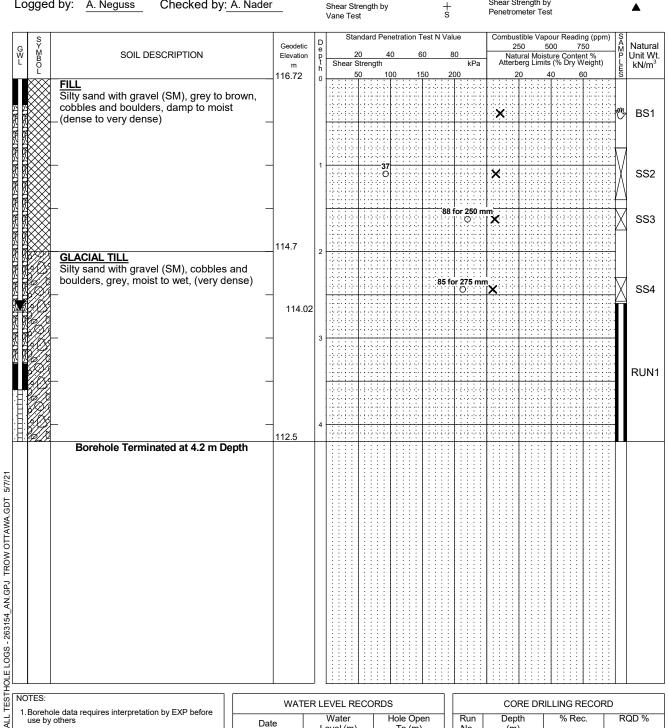
### Log of Borehole BH-4

Log of Bo	rehole BH-	4	eyn
Project No:	OTT-00263154-A0		Figure No. 5	
Project:	Proposed Residential Development			. '
Location:	37 Wildpine Court, Ottawa, Ontario		Page. <u>1</u> of <u>1</u>	<u> </u>
Date Drilled:	December 11, 2020	Split Spoon Sample	Combustible Vapour Reading	
Orill Type:	Track Mounted Drill Rig	Auger Sample SPT (N) Value O	Natural Moisture Content Atterberg Limits	<b>×</b> ⊷
Datum:	Geodetic Elevation	Dynamic Cone Test Shelby Tube	Undrained Triaxial at % Strain at Failure	$\oplus$
_ogged by:	A. Neguss Checked by: A. Nader	Shear Strength by + Vane Test S	Shear Strength by Penetrometer Test	<b>A</b>

A detailed description of the geotechnical conditions encountered in the testholes is given on the testhole logs, Figures 3 to 15, 4A, 5A, 10A, 12A, and 15A. The testhole logs and related information depict subsurface conditions only at the specific locations and times indicated. Subsurface conditions and water levels at other locations may differ from conditions at the locations where sampling was conducted. The passage of time may also result in changes in the conditions interpreted to exist at the locations where sampling was conducted.

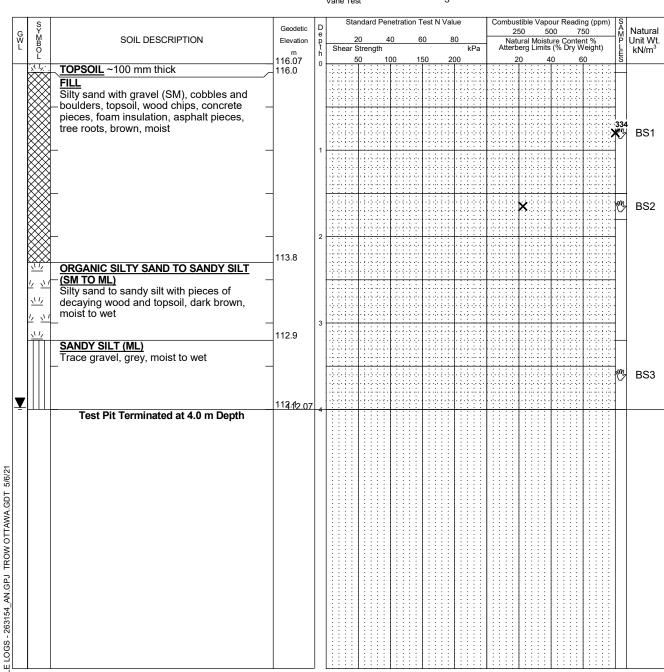
Log o	of To	est Pit TP-1	· · ·	ZVI
Project No:	OTT-00263154-A0			5: O	~^\
Project:	Proposed Residential Development	Figure No. 9	ı		
Location:	37 Wildpine Court, Ottawa, Ontario			Page. <u>1</u> of <u>1</u>	
Date Drilled:	'December 18, 2020		Split Spoon Sample	Combustible Vapour Reading	
Drill Type:	'Excavator		Auger Sample SPT (N) Value	Natural Moisture Content  Atterberg Limits	<b>×</b> —⊖
Datum:	Geodetic Elevation		Dynamic Cone Test Shelby Tube	Undrained Triaxial at % Strain at Failure	Φ
Logged by:	A. Neguss Checked by: A. Nader		Shear Strength by + Vane Test S	Shear Strength by Penetrometer Test	<b>A</b>
S Y M B O L	SOIL DESCRIPTION E	Elevation	Standard Penetration Test N Value	Combustible Vapour Reading (ppm)   250   500   750	S A M Natura P Unit W L kN/m <sup>3</sup>
TOPS		16.0	·

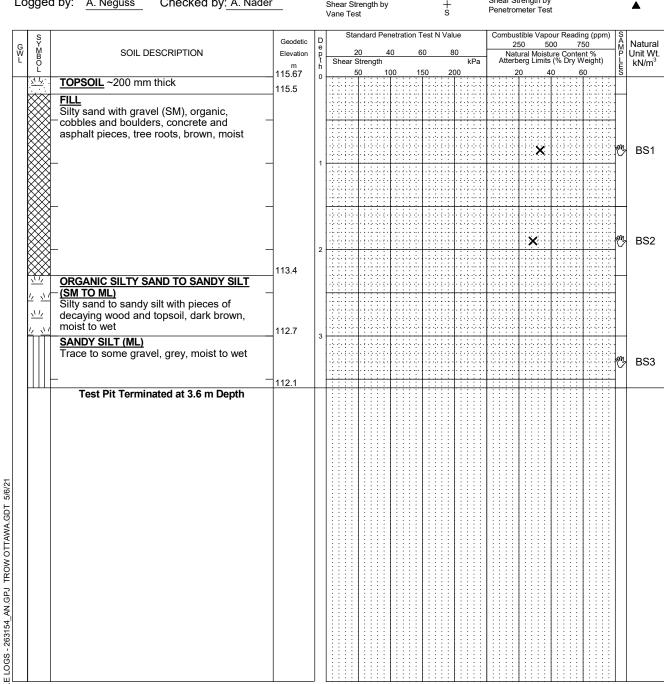
### Log of Tost Dit TD-2

LUg	OI IE	<b>531 F IL I</b>	<b>-</b> -	•	• (	λ
Project No:	OTT-00263154-A0				Fig., 10		//\
Project:	Proposed Residential Development				Figure No. 10	_	
Location:	37 Wildpine Court, Ottawa, Ontario				Page. <u>1</u> of <u>1</u>	_	
Date Drilled:	'December 18, 2020		Split Spoon Sample		Combustible Vapour Reading		
Drill Type:	'Excavator		Auger Sample SPT (N) Value		Natural Moisture Content Atterberg Limits	<u> </u>	<b>X</b> —⊖
Datum:	Geodetic Elevation		Dynamic Cone Test Shelby Tube	_	Undrained Triaxial at % Strain at Failure	_	$\oplus$
Logged by:	A. Neguss Checked by: A. Nader		Shear Strength by Vane Test	+ s	Shear Strength by Penetrometer Test		<b>A</b>
S		Geodetic D	Standard Penetration T	est N Value	Combustible Vapour Reading (p	pm) S	Natur

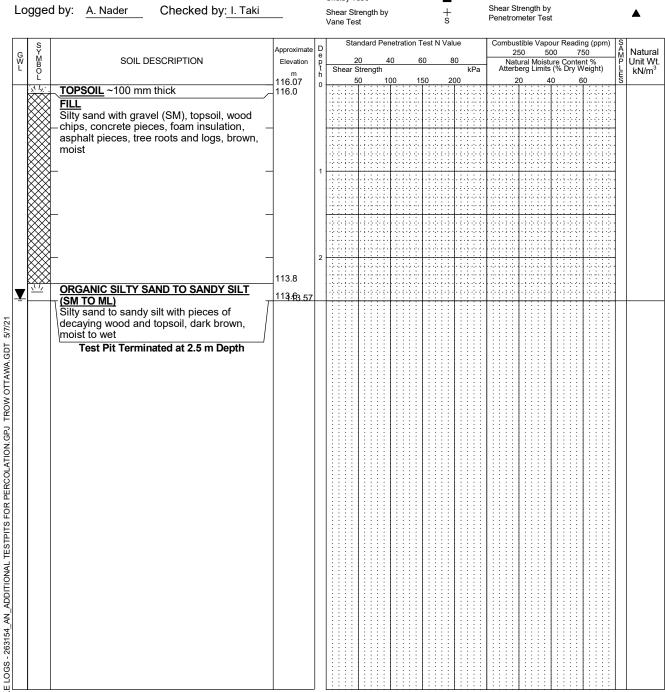
#### Log of Tost Dit TD-1A

Log of To	est Pit TF	P-1A		eyn
Project No:	OTT-00263154-A0			E: N 4A	
Project: Location:	Proposed Residential Development  37 Wildpine Court, Ottawa, Ontario			Figure No. 4A  Page. 1 of 1	- <b>I</b> -
Date Drilled: Drill Type:		_ Split Spoon Sample Auger Sample		Combustible Vapour Reading Natural Moisture Content	□ <b>X</b>
Datum: Logged by:	Approximate Elevation  A. Nader Checked by: I. Taki	- SPT (N) Value  Dynamic Cone Test  Shelby Tube  Shear Strength by  Vane Test		Atterberg Limits Undrained Triaxial at % Strain at Failure Shear Strength by Penetrometer Test	⊕ <b>A</b>

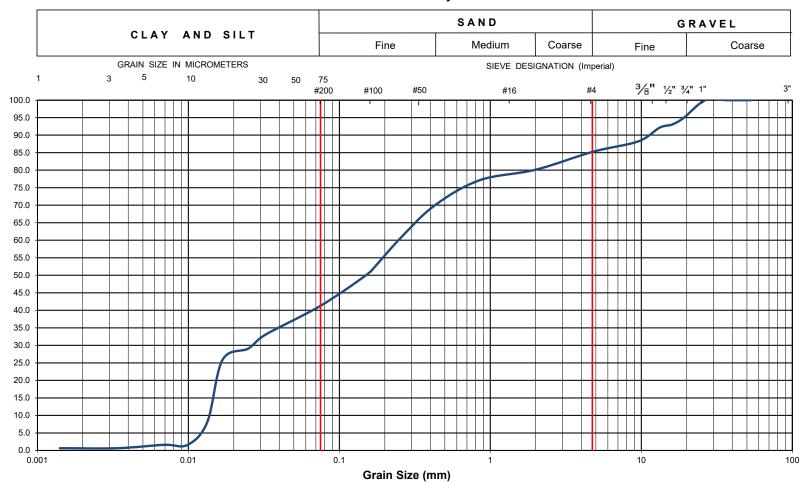
# Grain-Size Distribution Curve Method of Test For Particle Size Analysis of Soil ASTM C-136/ASTM D422

EXP Project No.:	OTT-00263154-A0	Project Name :		Proposed Resid	ential D	evelopment				
Client :	Wildpine Trails Inc.	Project Location	:							
Date Sampled :	December 11, 2020	Borehole No:		BH-2	San	ple No.:	S	S2	Depth (m) :	0.8-1.4
Sample Description :		% Silt and Clay	42	% Sand	43	% Gravel		15	Figure :	16
Sample Description :		FILL: Silty SA	ND with	h Gravel (SM)					rigure .	10

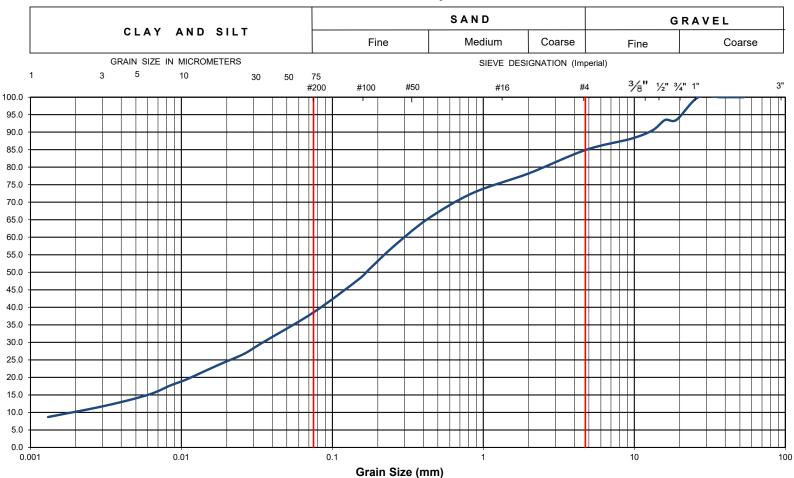
# Grain-Size Distribution Curve Method of Test For Particle Size Analysis of Soil ASTM C-136/ASTM D422

EXP Project No.:	OTT-00263154-A0	Project Name :		Proposed Resid	lential D	evelopment					
Client :	Wildpine Trails Inc.	Project Location	Project Location: 37 Wildpine Court, Ottawa, Ontario								
Date Sampled :	December 11, 2020	Borehole No:		BH-7	San	nple No.:	SS	2	Depth (m) :	0.8-1.4	
Sample Description :		% Silt and Clay	39	% Sand	46	% Gravel		15	Figure :	47	
Sample Description :		FILL: Silty Sand with Gravel (SM)

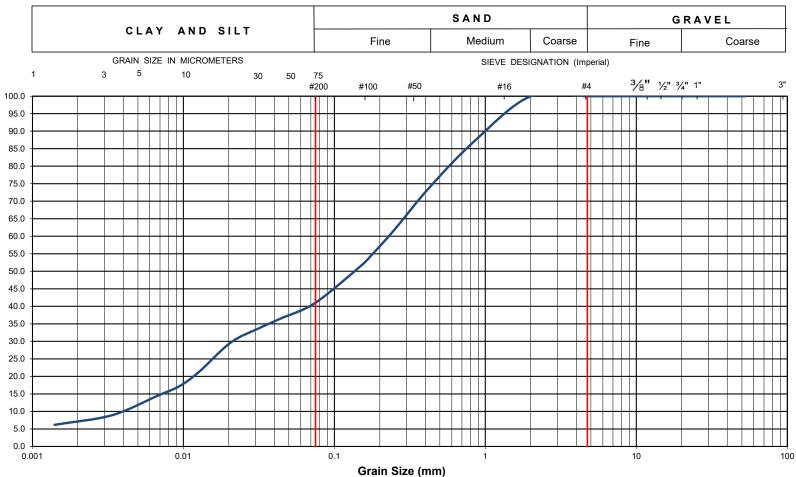
# Grain-Size Distribution Curve Method of Test For Particle Size Analysis of Soil ASTM C-136/ASTM D422

EXP Project No.:	OTT-00263154-A0	Project Name :		Proposed Resid	ential D	evelopment				
Client :	Wildpine Trails Inc.	Project Location	:							
Date Sampled :	December 11, 2020	Borehole No:		BH-2	San	ple No.:	S	S4	Depth (m) :	2.3-2.9
Sample Description :		% Silt and Clay	41	% Sand	59	% Gravel		0	Figure :	18
Sample Description :		Organic	Silty SA	ND (SM)					rigule .	10

Table II: Summary of Grain-size Analysis and Organic Content Results – Organic Silty Sand to Sandy Silt Samples								
Borehole No.	Moisture		Organic	Grain-size Analysis (%)				Soil Classification
– Sample No.	Depth (m)	Content (%)	Content (%)	Gravel	Sand	Silt	Clay	(USCS)
BH-2 – SS4	2.3 – 2.9	89.4	14.4	0	59	34	7	Organic Silty SAND (SM)
BH-3 – SS5	3.0 – 3.6	174.1	27.7	0	36	58	6	Organic Sandy SILT (ML)

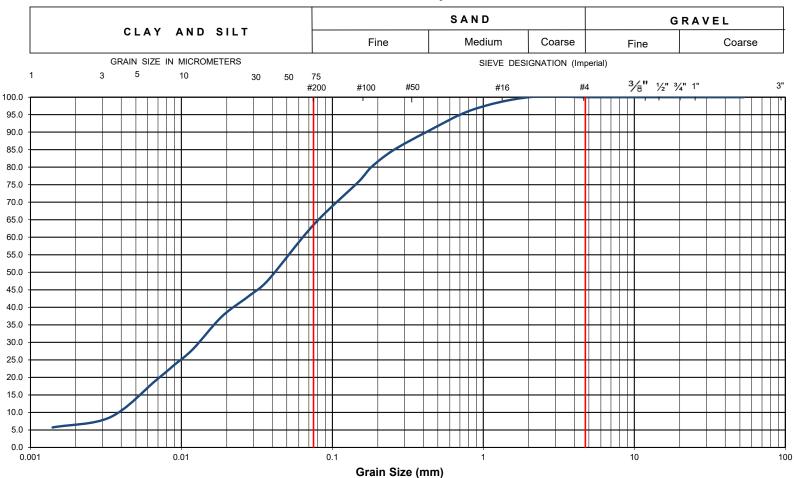
# Grain-Size Distribution Curve Method of Test For Particle Size Analysis of Soil ASTM C-136/ASTM D422

EXP Project No.:	OTT-00263154-A0	Project Name :		Proposed Resid	ential D	evelopment				
Client :	Wildpine Trails Inc.	Project Location	:							
Date Sampled :	December 11, 2020	Borehole No:		BH-3	Sam	ple No.:	s	S5	Depth (m) :	3.0-3.7
Sample Description :		% Silt and Clay	64	% Sand	36	% Gravel		0	Figure :	19
Sample Description :		Organic	Sandy S	SILT (ML)					rigule .	19

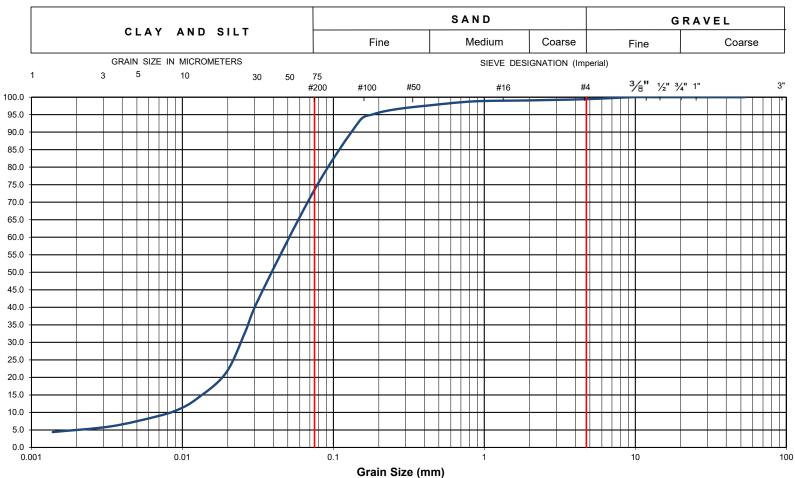
# Grain-Size Distribution Curve Method of Test For Particle Size Analysis of Soil ASTM C-136/ASTM D422

EXP Project No.:	OTT-00263154-A0	Project Name :		Proposed Resid	ential D	evelopment				
Client :	Wildpine Trails Inc.	Project Location	:							
Date Sampled :	December 11, 2020	Borehole No:		BH-3	Sam	ple No.:	S	S7	Depth (m):	4.6-5.2
Sample Description :		% Silt and Clay	73	% Sand	26	% Gravel		1	-Figure :	20
Sample Description :		Sand	dy SILT	(ML)					Tigule .	20

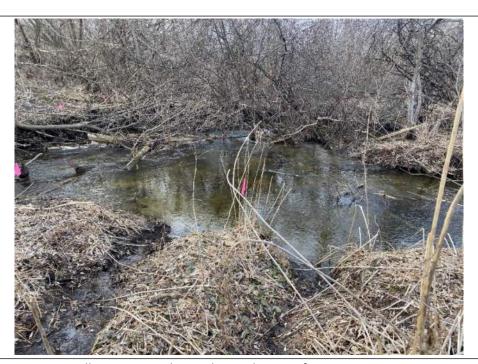
Gully erosion at the Poole Creek west of cross-section A

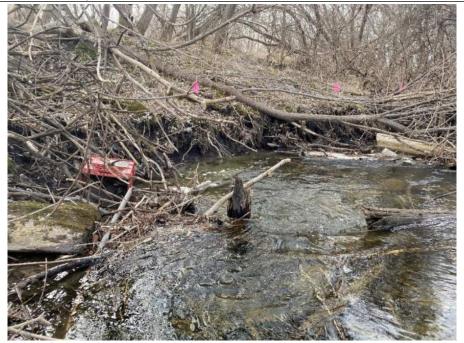
Toe erosion at the Poole Creek west of cross-section A

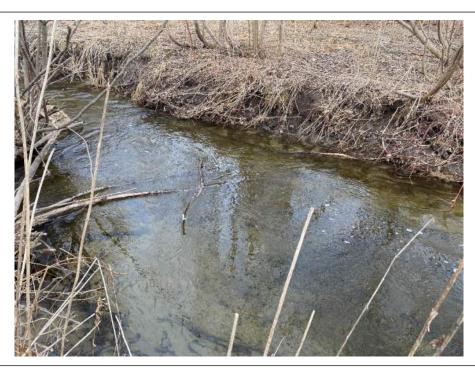
Toe erosion at the Poole Creek west of cross-section A

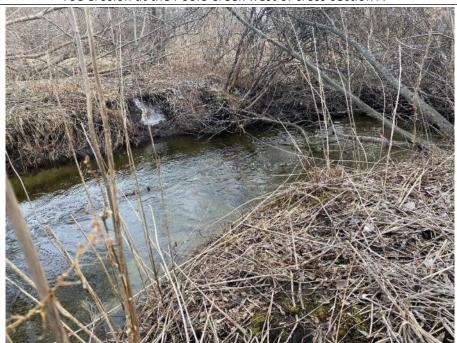
Toe erosion at the Poole Creek west of cross-section A

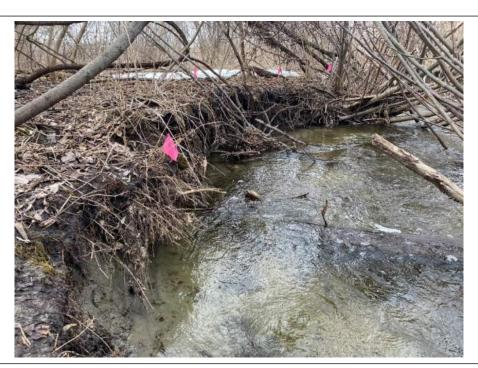
Toe erosion at the Poole Creek between cross-sections A and B

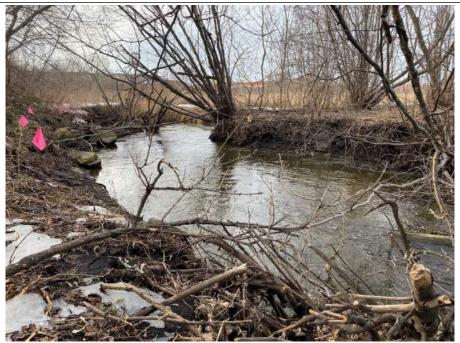
Toe erosion at the Poole Creek between cross-sections A and B

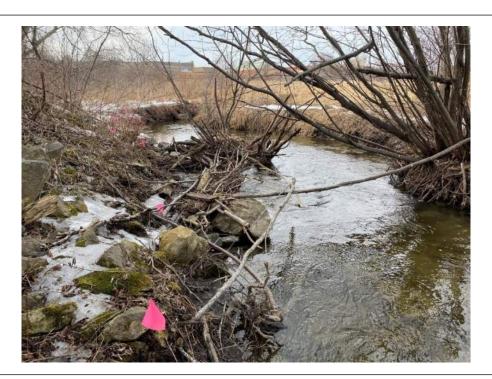
Toe erosion at the Poole Creek between cross-sections A and B

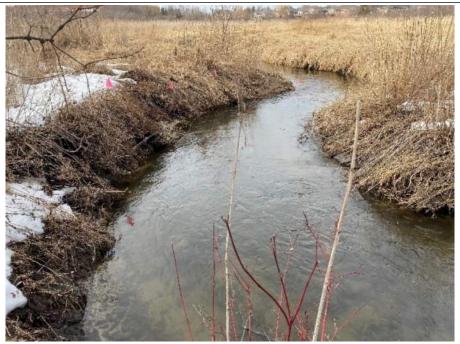
Toe erosion at the Poole Creek between cross-sections A and B

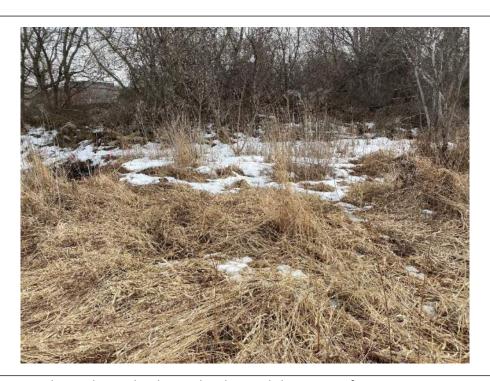
The Poole Creek tributary borders and slope west of cross-section B

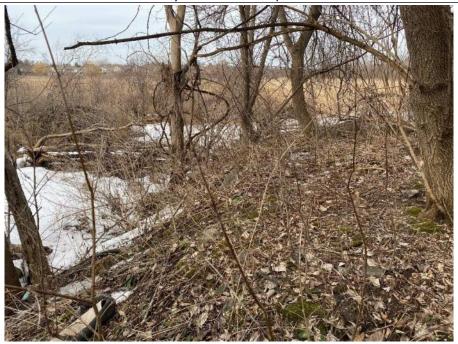
The Poole Creek tributary borders and slope near cross-section B

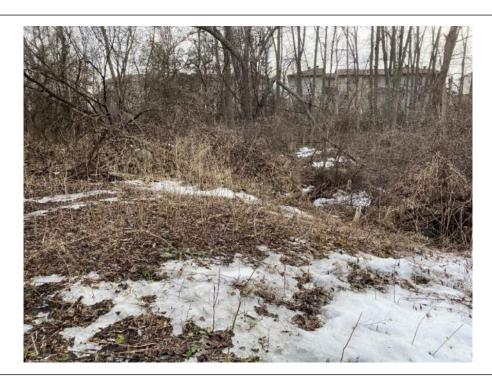
The Poole Creek tributary borders and slope between cross-sections B and C

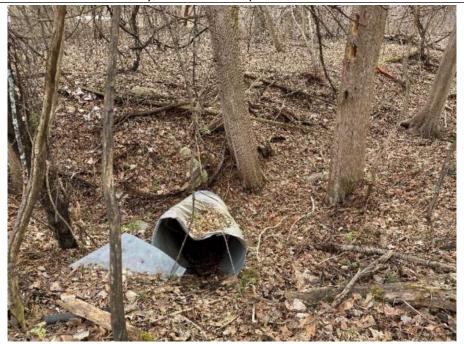
The Poole Creek tributary borders and slope near cross-sections D
