# Geotechnical Investigation Proposed Commercial Development

1015 March Road Ottawa, Ontario

Prepared for Kanata United

Report PG5014-1 Revision 1 dated June 28, 2022

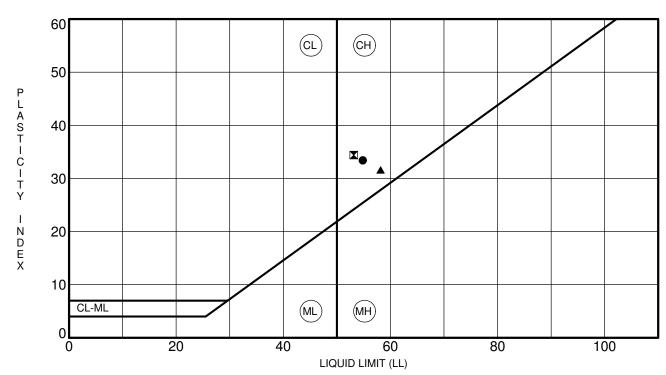
**ATTERBERG LIMITS' RESULTS**

-	Specimen Ide	ntification	LL	PL	PI	Fines	Classification
•	BH 3	SS 2	55	21	33		CH - Inorganic clay of high plasticity
X	BH 8	SS 3	53	19	34		CH - Inorganic clay of high plasticity
<b>A</b>	BH10	SS 2	58	27	32		CH - Inorganic clay of high plasticity

Table 1 - Summary of Atterberg Limits Results							
Sample	Moisture Content %	Liquid Limit %	Plastic Limit %	Plasticity Index %	Classification		
BH 3 - SS 2	26.9	55	21	33	СН		
BH 8 - SS 3	27.3	53	19	34	СН		
BH 10 - SS 2	29.8	58	27	32	СН		
BH 1-22 – SS 2	33.2	65	21	44	СН		
BH 7-22 – SS 2	38.4	54	21	33	СН

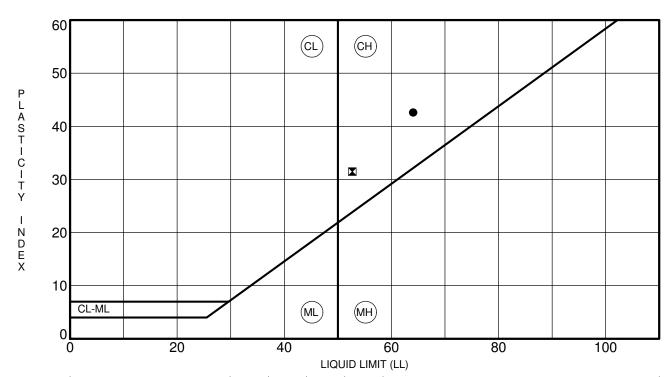
ATTERBERG LIMITS'
RESULTS

5	Specimen Identific	ation	LL	PL	PI	Fines	Classification
•	BH 1-22	SS2	64	21	43		CH - Inorganic clays of high plasticity
	BH 7-22	SS2	53	21	31		CH - Inorganic clays of high plasticity
П							
П
