**Richmond Village Development Corporation –
Green Lands
Integrated Environmental Review**

Updated Report

August 31, 2022

KILGOUR & ASSOCIATES LTD.
www.kilgourassociates.com
Project Number: CAIV 1230

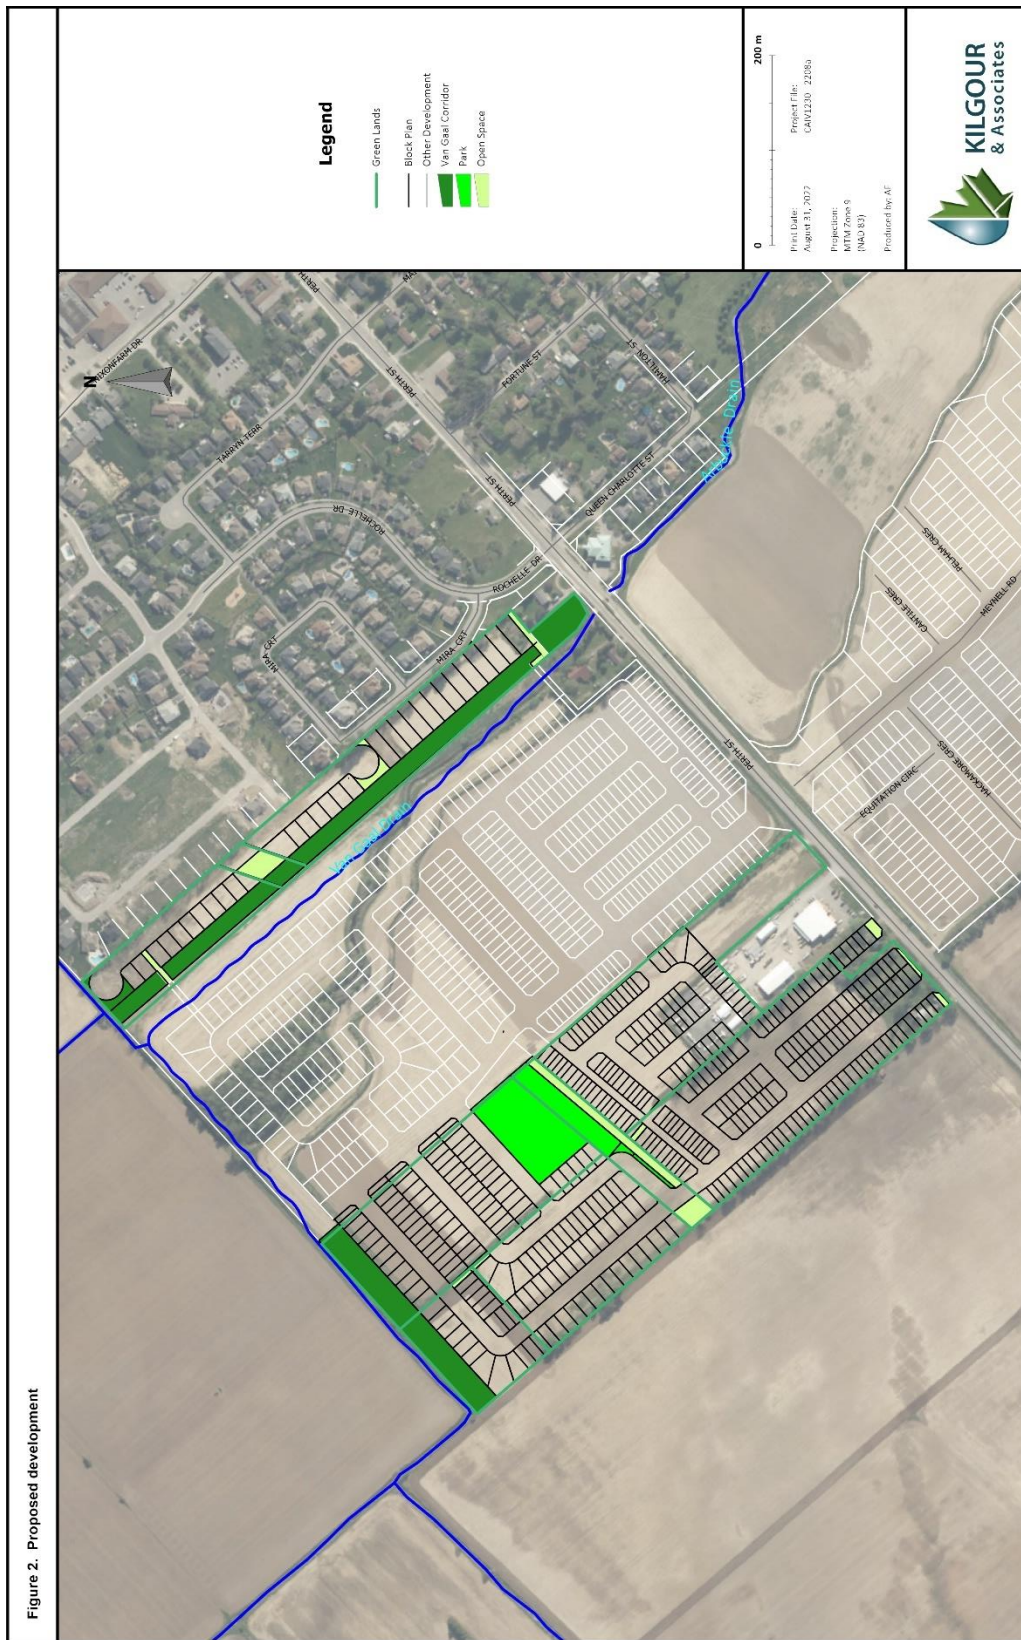
Figure 2. Proposed development

Figure 2. Proposed site development

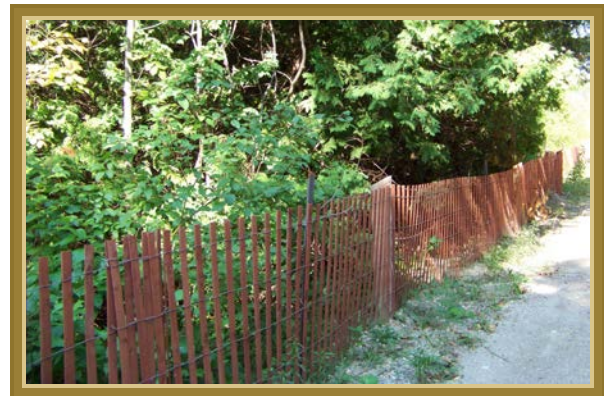
Plate 5. Example of a wood lath snow fencing used to exclude turtles (photo credit: Karine Beriault).

- The fencing should be attached to heavy plastic or metal stakes using heavy-duty wire staples or tie-wire.
- The stakes are recommended to be placed at 2 to 3 m intervals and securely driven into the ground 30 cm or more.
- Wood lath snow fencing across streams, ditches or waterways should have case-specific modifications.
- Wood lath snow fencing lends itself well to being combined with other types of material to ensure complete exclusion.
- See general best practices section below for additional details.

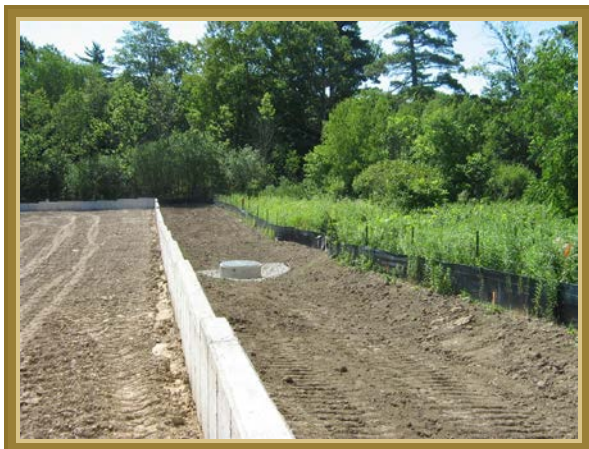
Plate 6. Stand-alone continuous concrete wall used to exclude salamander species installed as pre-cast forms (photo credit: Steven Roorda).

Concrete, metal or vinyl walls can stand alone or be combined with woven wire or chain link fences. They are durable, require minimal maintenance and are effective in excluding target species from high risk areas and guiding them to crossing structures or other desired locations (Plates 6 and 7). This fence type is comprised of a continuous vertical face of concrete, metal or vinyl sheeting with no gaps. Concrete walls can be installed as either pre-cast sections or pour directly in place.

The wall height depends upon the target species, but they are usually between 45 and 60 cm tall and buried 25 cm. Concrete, metal or vinyl exclusion fencing is most appropriate for salamanders, skinks, small snakes, and small turtles. For large turtle species, a chain link fence can be installed directly on top of the concrete wall for complete exclusion.

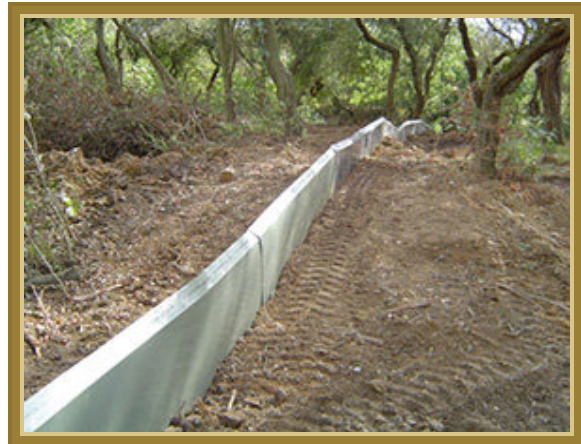
Plate 7. Pre-formed vinyl sheeting fence intended to exclude salamanders for a construction site (photo credit: Herpetosure Ltd.)

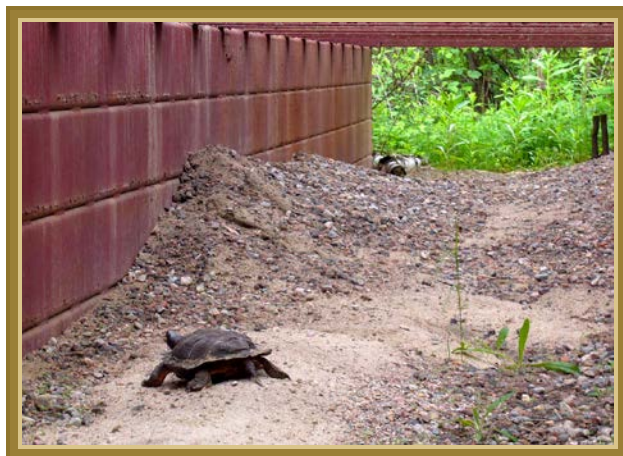
Plate 7. A wood turtle travelling through a dry eco-passage. Ecopassages such as this help to ensure the long-term connectivity of seasonal habitat for this and other reptile and amphibian species (photo credit: Amy Mui).

During the installation of fencing with an eco-passage, it is important that the fencing sits flush with the passage to ensure that

there are no gaps where animals can squeeze through.
