Geotechnical Investigation

Proposed Commercial Plaza

Riverside South Residential Development
1515 Earl Armstrong Road - Ottawa

Report PG5304-1 Revision 4 dated February 22, 2023

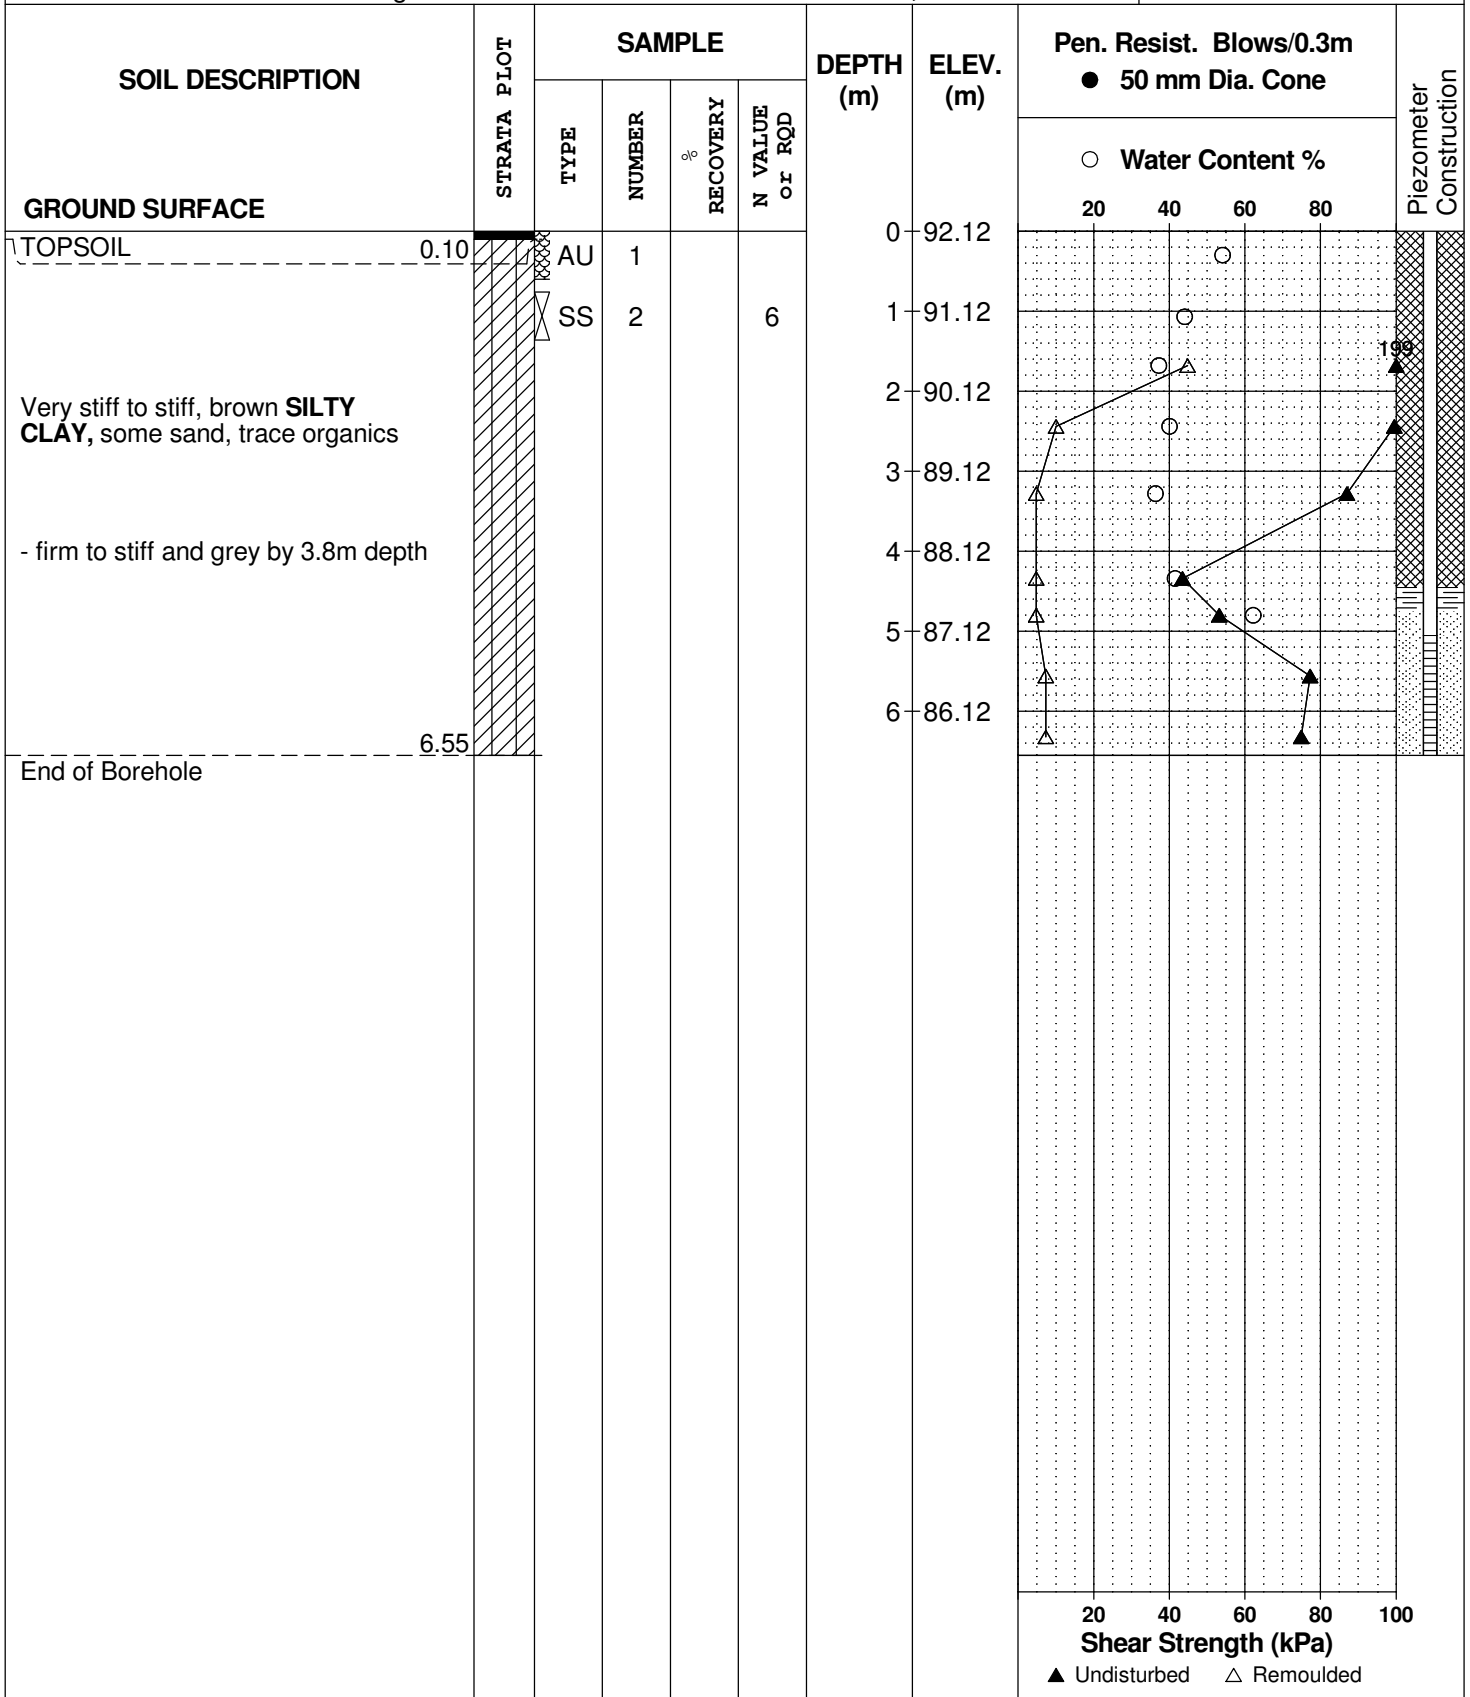
HOLE NO. BH 2-20

BORINGS BY CME 55 Power Auger

DATE March 25, 2020

The subsurface conditions observed in the test holes were recorded in detail in the field. The soil profiles are presented on the Soil Profile and Test Data sheets in Appendix 1 of this report.

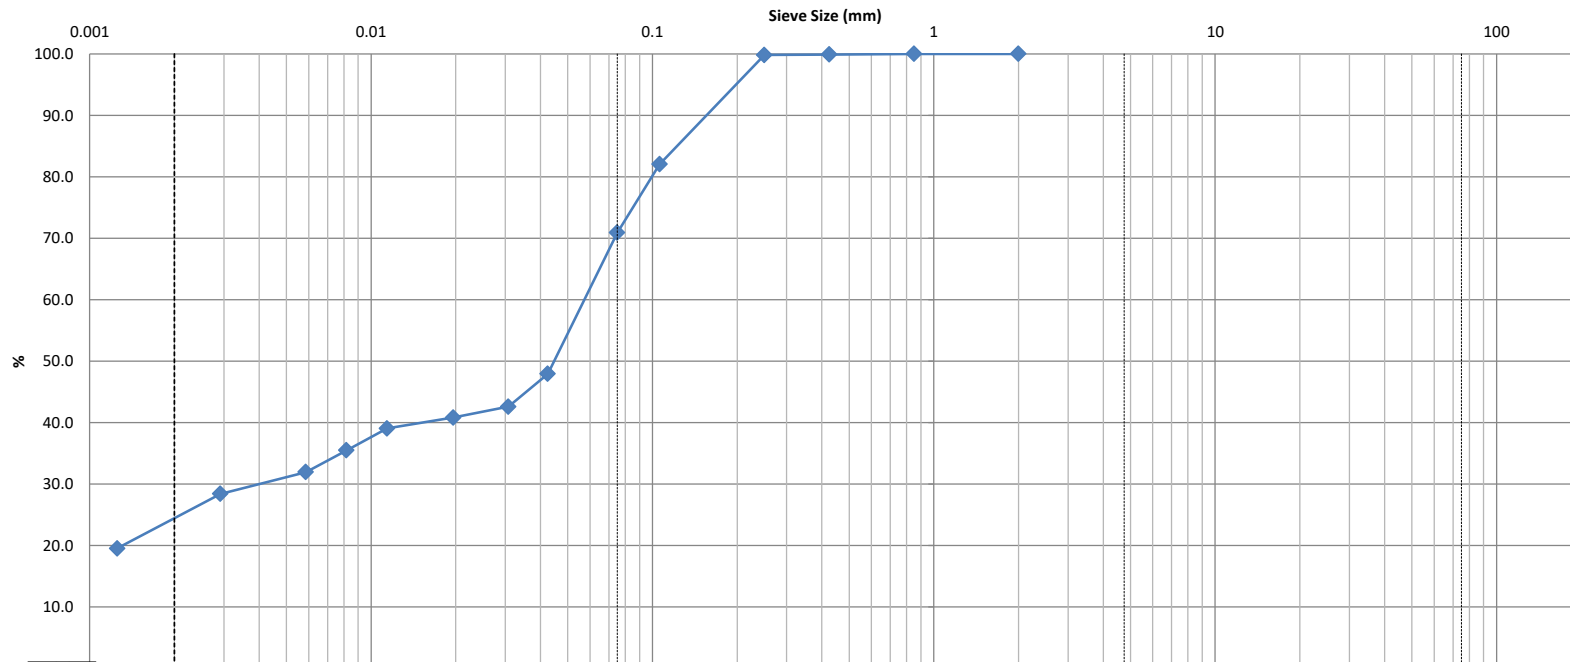
CLIENT:	Urbandale	DEPTH:	1.6 - 1.7m	FILE NO:	PG5307
CONTRACT NO.:		BH OR TP No.:	TP5-22 G2	LAB NO:	32048
PROJECT:	1515 Earl Armstrong			DATE RECEIVED:	17-Mar-22
				DATE TESTED:	28-Mar-22
DATE SAMPLED:	17-Mar-22			DATE REPORTED:	30-Mar-22
SAMPLED BY:	G.P.			TESTED BY:	CS

Identification	Soil Classification					MC(%)	LL	PL	PI	Cc	Cu
	D100	D60	D30	D10	Gravel (%)	33.0					
					0.0	29.1		45.9		25.0

Atterberg limits testing, as well as associated moisture content testing, was completed on the recovered silty clay samples where encountered. The results of the Atterberg limits tests are presented in Table 1 and on the Atterberg Limits Results sheet in Appendix 1. The tested silty clay samples classify as inorganic silts of high plasticity (CH) or inorganic clay of low plasticity (CL) in accordance with the Unified Soil Classification System.

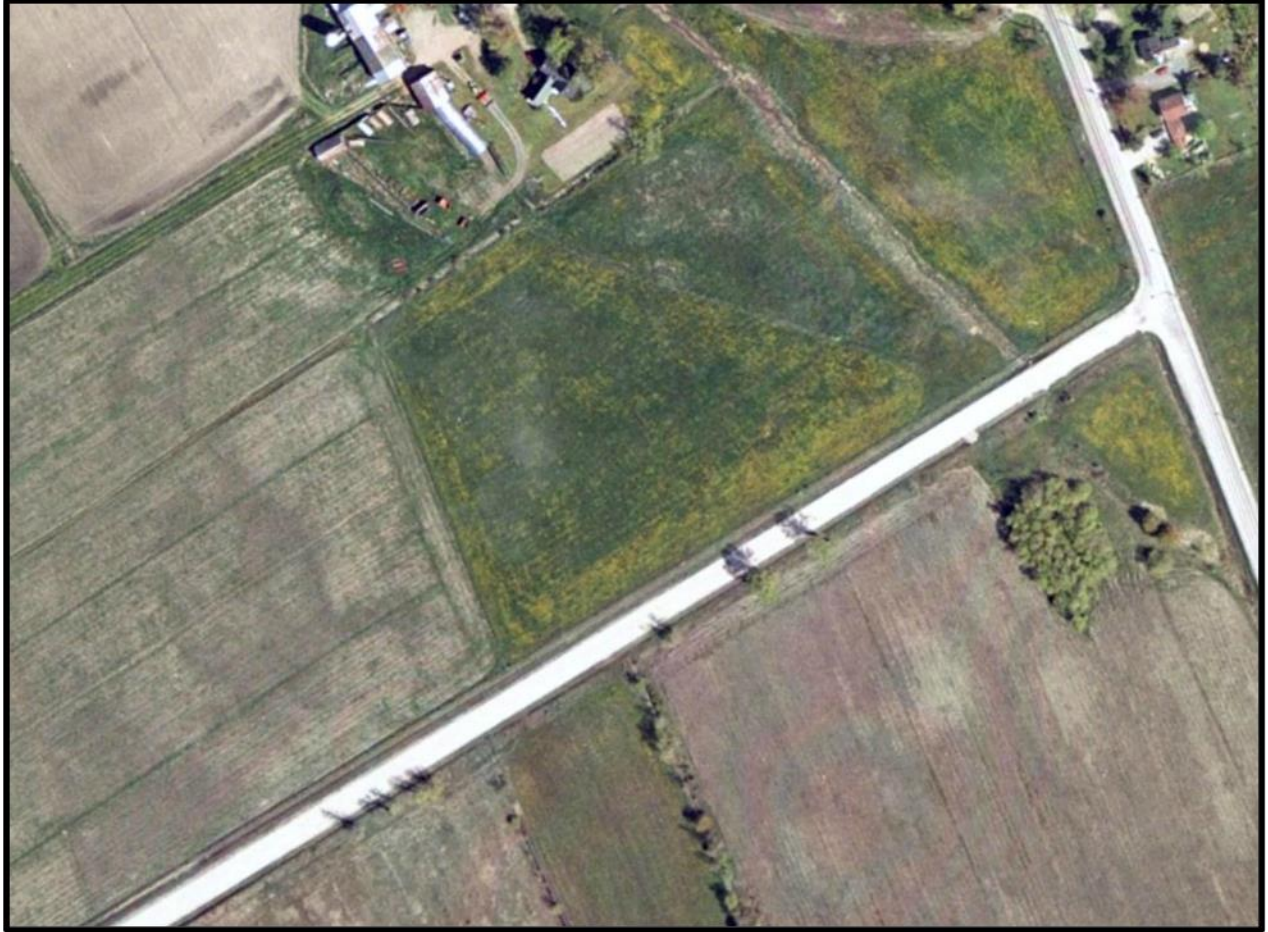
FIGURE 2

Aerial Photograph - 2002

However, based on available aerial photos, the subject site was used to stockpile soil and store construction material as recently as 2007. Additionally, an asphalt paved municipal road, which ran east-west through the center of the site, was in use as recently as 2002 and was no longer maintained in 2005. Reference should be made to the aerial photographs in Figure 2 - Aerial Photograph - 2002, Figure 3 - Aerial Photograph - 2007 and Figure 4 - Aerial Photograph - 2017 which illustrate the former and present site conditions, respectively.

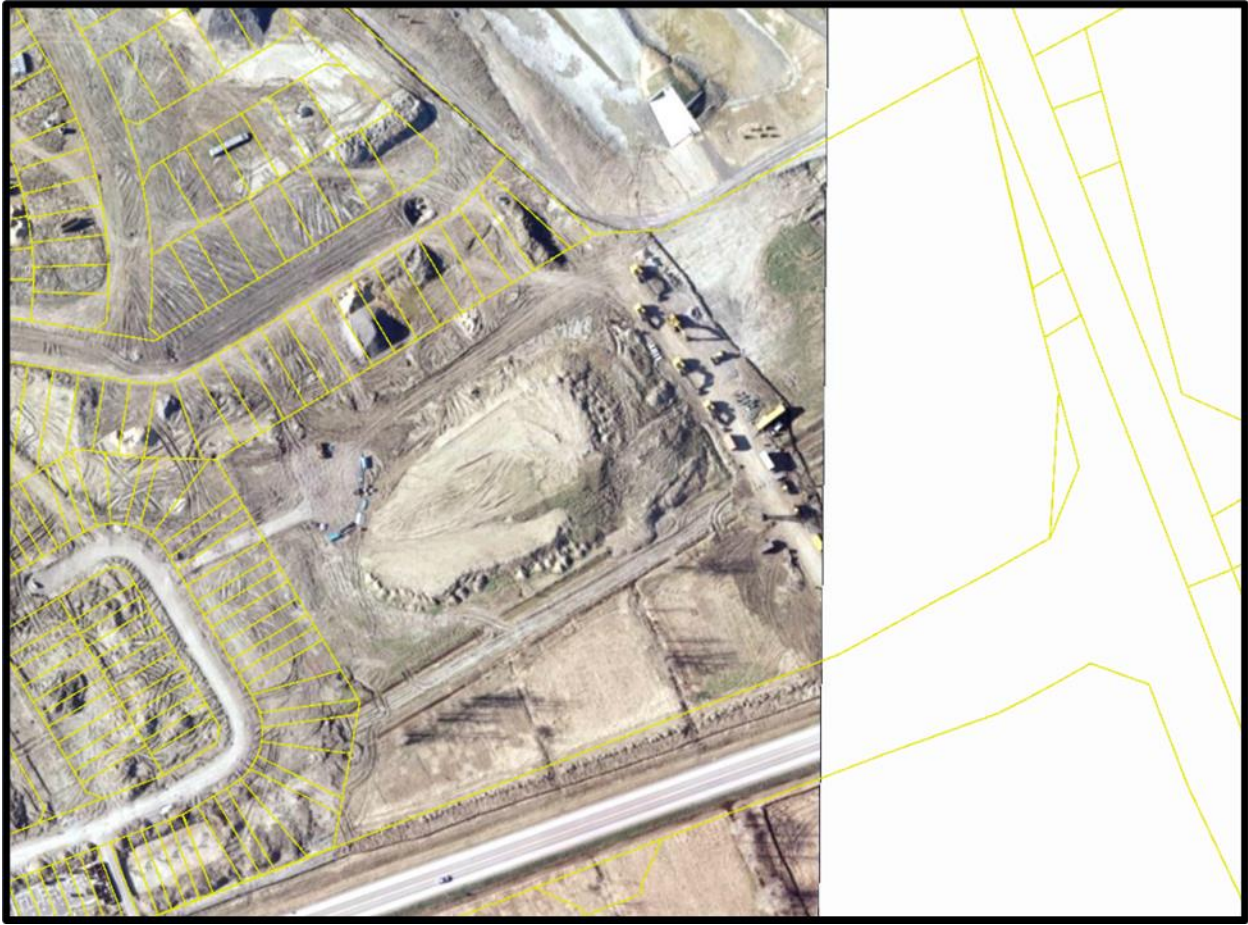
FIGURE 3

Aerial Photograph - 2007

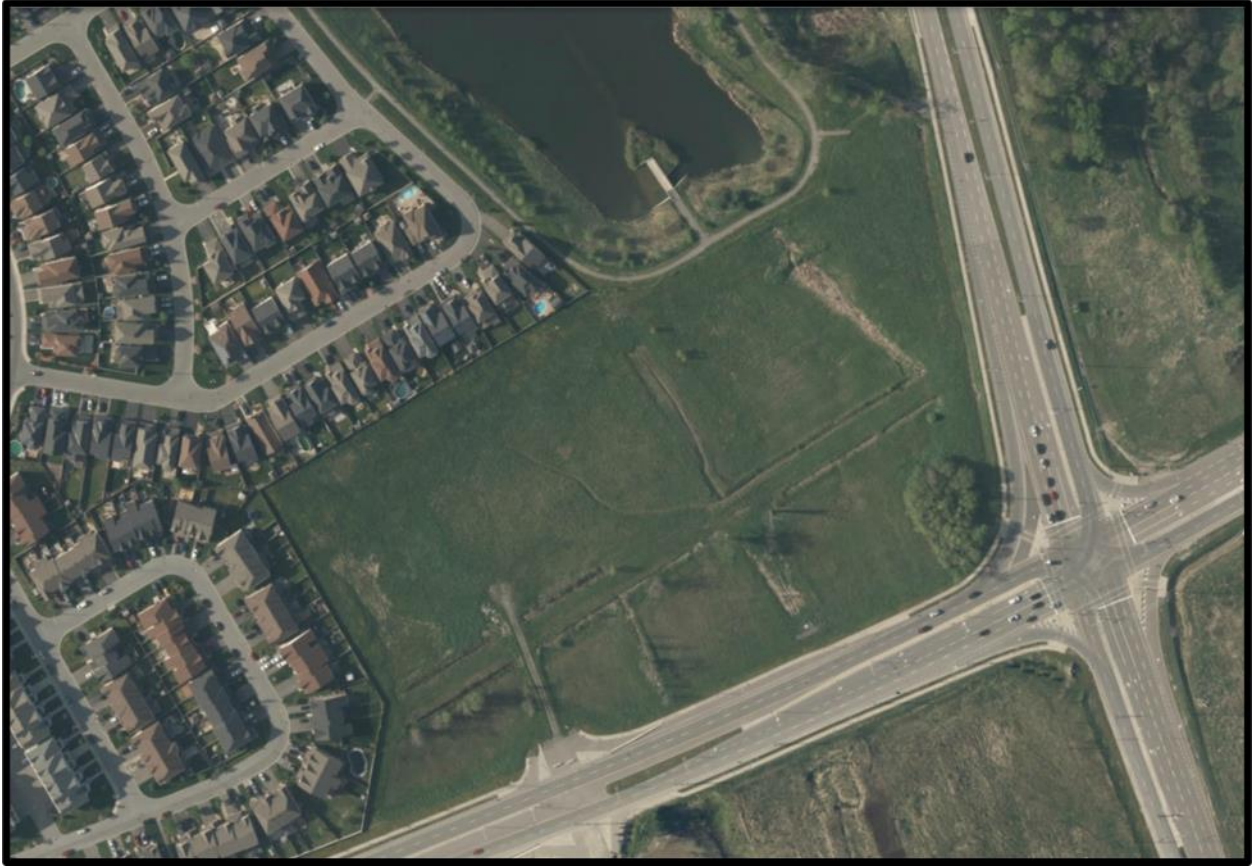
FIGURE 4

Aerial Photograph - 2017

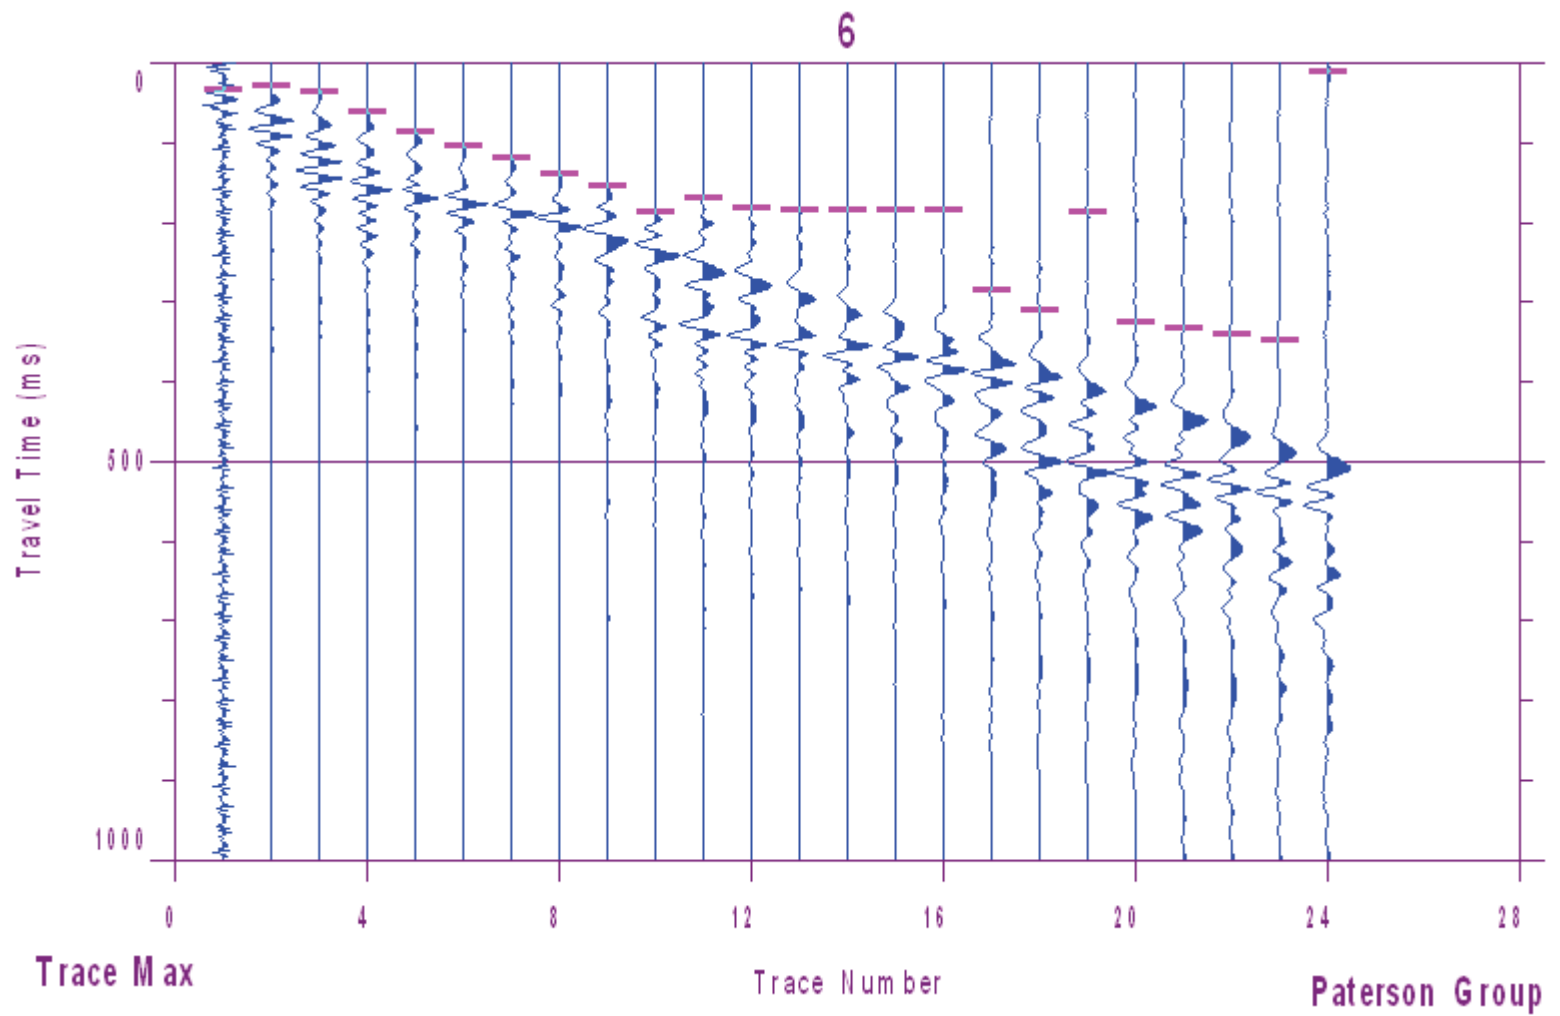
FIGURE 5 - Shear Wave Velocity Profile at Shot Location -3 m

Interpretation for the shear wave velocity results were completed by Paterson personnel. Shear wave velocity measurement was completed by reflection/refraction methods. The interpretation is performed by recovering arrival times from direct and refracted waves. The interpretation is repeated at each shot location to provide an average shear wave velocity, V_{s30} , of the upper 30 m below the structures foundation. The layer intercept times, velocities from different layers and critical distances are interpreted from the shear wave records to compute the bedrock depth at each location. The bedrock velocity was interpreted by the main refractor wave velocity, which is considered a conservative estimate of the bedrock velocity due to the increasing quality of the bedrock with depth. As bedrock quality increases, the bedrock shear wave velocity also increases.

Based on the seismic test results, the average shear wave velocity, Vs30, for shallow foundations at the subject site is 374 m/s. Therefore, a Site Class C is applicable for design of the proposed buildings, as per Table 4.1.8.4.A of the OBC 2012. The soils underlying the subject site are not considered to be susceptible to liquefaction.

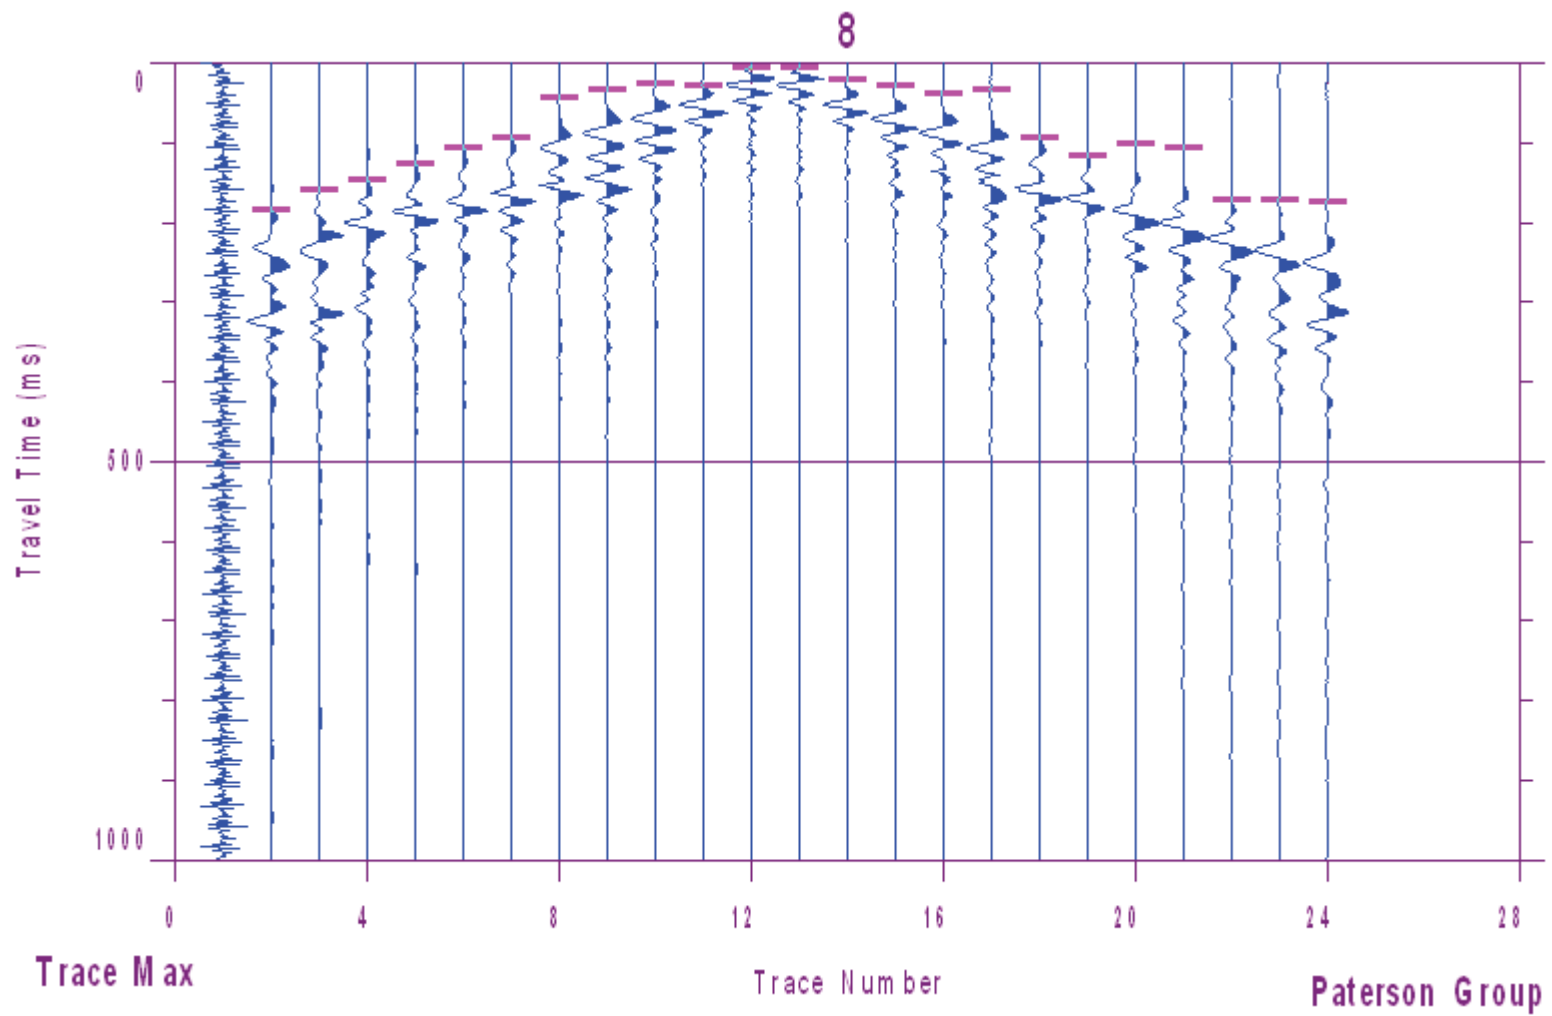
FIGURE 6 - Shear Wave Velocity Profile at Shot Location 34.5 m

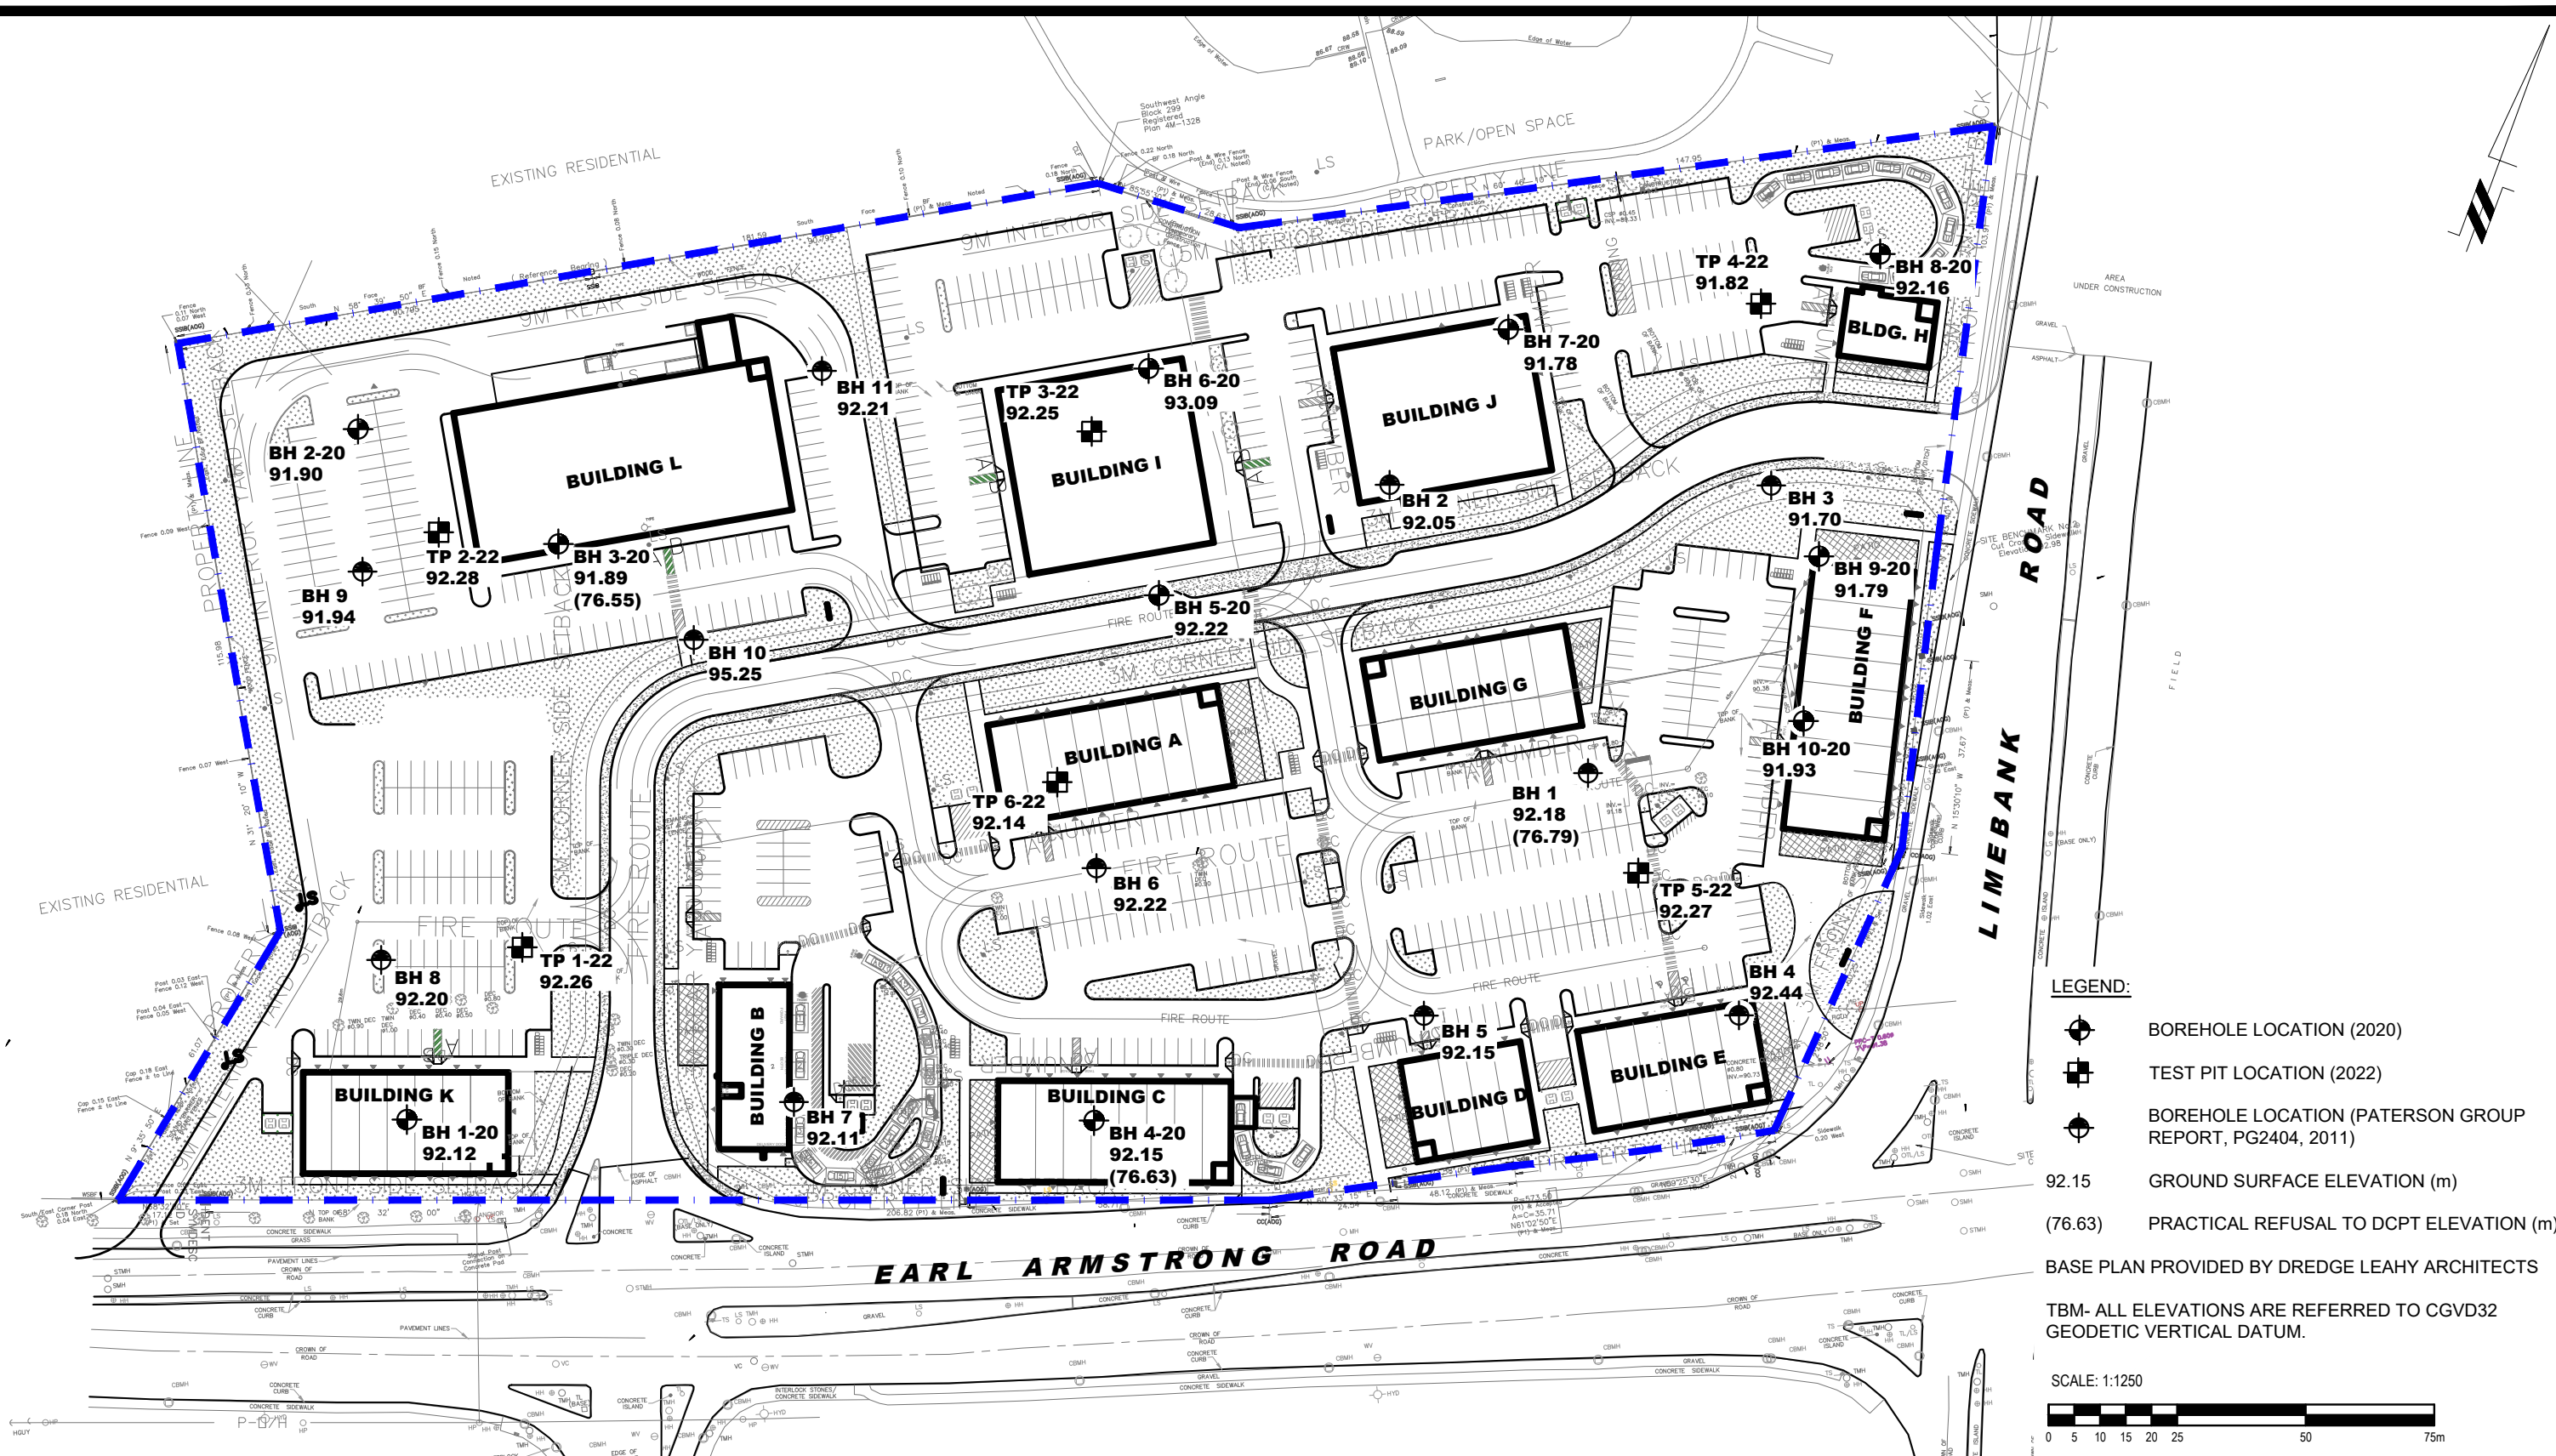
DRAWING PG5304-1 – TEST HOLE LOCATION PLAN

- BOREHOLE LOCATION (2020)
- TEST PIT LOCATION (2022)
- BOREHOLE LOCATION (PATERSON GROUP REPORT, PG2404, 2011)
- 92.15 GROUND SURFACE ELEVATION (m)
- (76.63) PRACTICAL REFUSAL TO DCPT ELEVATION (m)
