Updated Geotechnical Investigation and Slope Stability Analysis. Proposed Residential Development 37 Wildpine Court Ottawa, Ontario

OTT-00263154-A0

June 15, 2023 (supersede August 24, 2021 report)

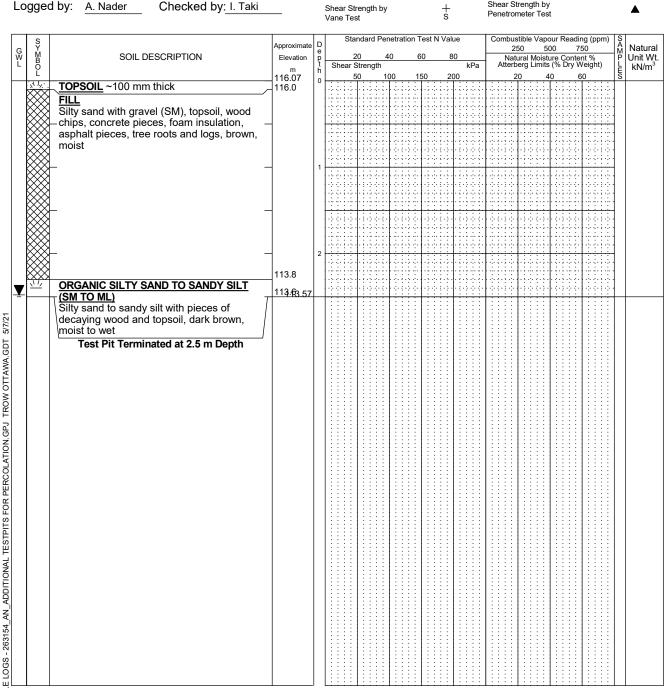
Proiect No:	OTT-00263154-A0	<u></u>	• • •	•	CV
roject No.	011-00203134-A0			Figure No. 5	
Project:	Proposed Residential Development				
_ocation:	37 Wildpine Court, Ottawa, Ontario			Page. <u>1</u> of <u>1</u>	_
Date Drilled:	'December 11, 2020	Split Spoon Sample	\boxtimes	Combustible Vapour Reading	
Orill Type:	'Track Mounted Drill Rig	Auger Sample		Natural Moisture Content	×
om Type.	Track Mounted Drill Rig	SPT (N) Value	0	Atterberg Limits	\longrightarrow
Datum:	Geodetic Elevation	Dynamic Cone Test —	_	Undrained Triaxial at	\oplus
		Shelby Tube		% Strain at Failure	
ogged by:	A. Neguss Checked by: A. Nader	Shear Strength by	+	Shear Strength by

A detailed description of the geotechnical conditions encountered in the testholes is given on the testhole logs, Figures 3 to 15, 4A, 5A, 10A, 12A, and 15A. The testhole logs and related information depict subsurface conditions only at the specific locations and times indicated. Subsurface conditions and water levels at other locations may differ from conditions at the locations where sampling was conducted. The passage of time may also result in changes in the conditions interpreted to exist at the locations where sampling was conducted.

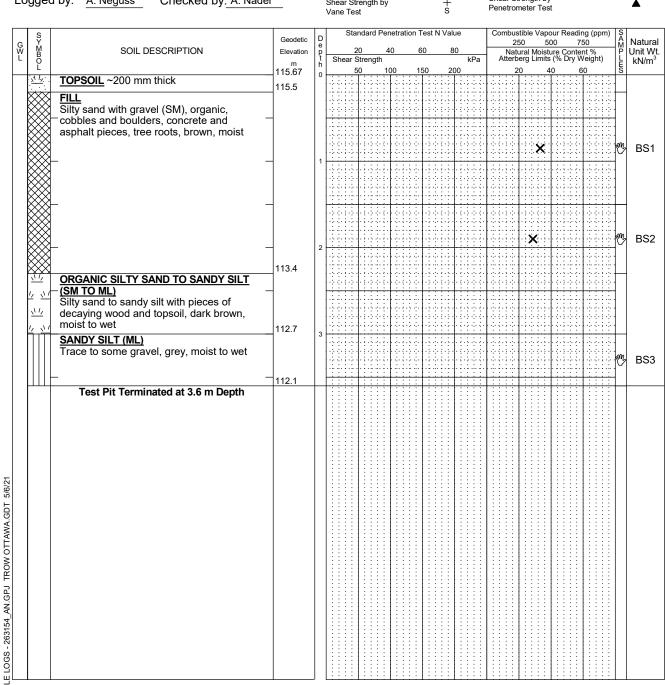
Log of T	est Pit TP-2	% c	אכ
Project No:	OTT-00263154-A0		-	<i>-</i> /\\\\\
Project:	Proposed Residential Development		Figure No <u>10</u> Page. 1 of 1	- 1
Location:	37 Wildpine Court, Ottawa, Ontario		- Fage 011	
Date Drilled:	'December 18, 2020	Split Spoon Sample	Combustible Vapour Reading	
Drill Type:	'Excavator	Auger Sample SPT (N) Value O	Natural Moisture Content Atterberg Limits	× —⊖
Datum:	Geodetic Elevation	Dynamic Cone Test Shelby Tube	Undrained Triaxial at % Strain at Failure	\oplus
Logged by:	A. Neguss Checked by: A. Nader	Shear Strength by + Vane Test S	Shear Strength by Penetrometer Test	A

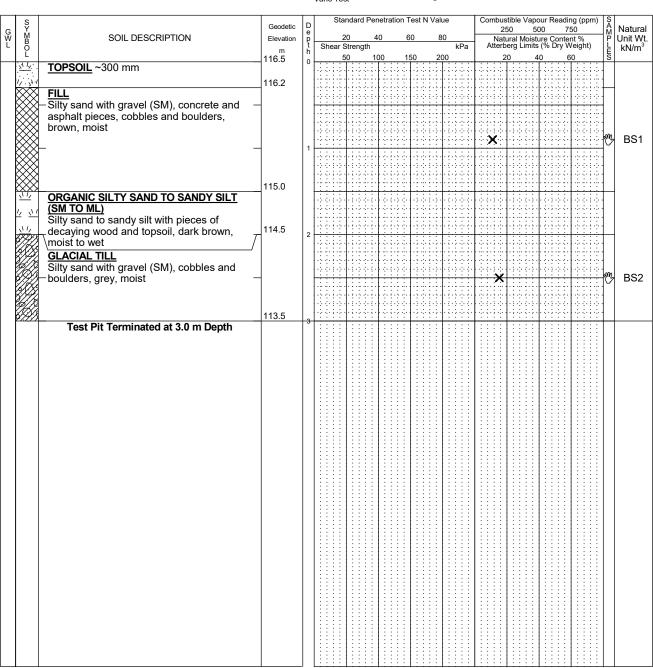
Log	of T	E	est Pit <u>T</u>	ГР - 4			* (2	X
Proje	ect No:	OTT-00263154-A0					Cianona Na	12	`	<u>ر</u>	/\
Proje	ect:	Proposed Residential Development					Figure No	12			
Loca	tion:	37 Wildpine Court, Ottawa, Ontario					Page. ₋	_1_ of _	1_		
Date	Drilled:	'December 18, 2020			Split Spoon Sample		Combustible Va	pour Readin	g		
Drill ⁻	Гуре:	Excavator			Auger Sample SPT (N) Value		Natural Moisture Atterberg Limits		L		X
Datu	m:	Geodetic Elevation			Dynamic Cone Test Shelby Tube		Undrained Triax % Strain at Fail	tial at	•		Φ
Logg	ed by:	A. Neguss Checked by: A. Nader	·		Shear Strength by Vane Test	+ s	Shear Strength Penetrometer T				A
G M W B		SOIL DESCRIPTION	Geodetic Elevation	D e p	Standard Penetration 20 40	60 80	Combustible Va 250 Natural Mo	500 75	0 t %		Natu Unit V

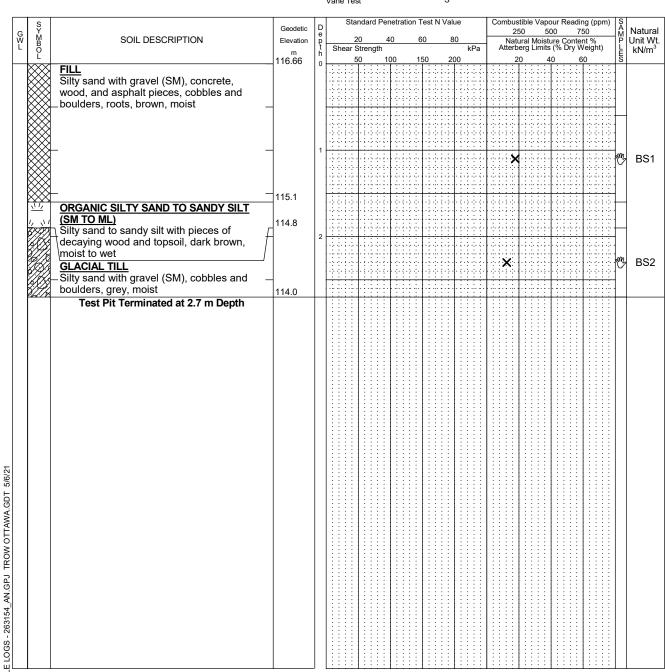
Draiget No.				
Project No:	OTT-00263154-A0		Figure No. 15	
Project:	Proposed Residential Development			_
Location:	37 Wildpine Court, Ottawa, Ontario		Page. <u>1</u> of <u>1</u>	_
Date Drilled:	December 18, 2020	Split Spoon Sample	Combustible Vapour Reading	
Orill Type:	Excavator	Auger Sample SPT (N) Value	Natural Moisture Content Atterberg Limits	× ⊢—⊙
Datum:	Geodetic Elevation	Dynamic Cone Test Shelby Tube	Undrained Triaxial at % Strain at Failure	\oplus
_ogged by:	A. Neguss Checked by: A. Nader	Shear Strength by +	Shear Strength by Penetrometer Test	•

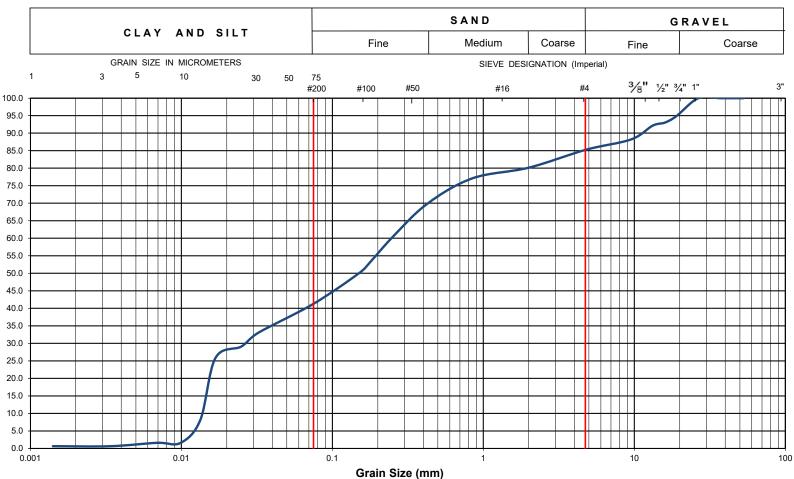
Grain-Size Distribution Curve Method of Test For Particle Size Analysis of Soil ASTM C-136/ASTM D422

EXP Project No.:	OTT-00263154-A0	Project Name :	roject Name : Proposed Residential Development							
Client :	Wildpine Trails Inc.	Project Location	oject Location : 37 Wildpine Court, Ottawa, Ontario							
Date Sampled :	December 11, 2020	Borehole No:		BH-2	Sample No.:		SS2		Depth (m):	0.8-1.4
Sample Description :		% Silt and Clay	42	% Sand	43	% Gravel		15	Figure :	16
Sample Description : FILL: Silty SAND with Gravel (SM)									rigure .	10

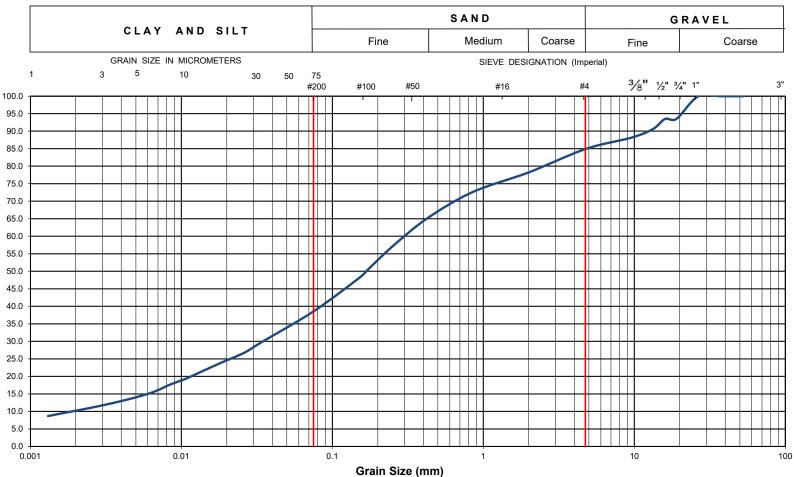
Grain-Size Distribution Curve Method of Test For Particle Size Analysis of Soil ASTM C-136/ASTM D422

EXP Project No.:	OTT-00263154-A0	Project Name :	roject Name : Proposed Residential Development							
Client :	Wildpine Trails Inc.	Project Location	oject Location : 37 Wildpine Court, Ottawa, Ontario							
Date Sampled :	December 11, 2020	Borehole No:		BH-7	Sample No.:			ple No.: SS2		0.8-1.4
Sample Description :		% Silt and Clay	39	% Sand	46	% Gravel		15	Figure :	17
Sample Description :										17

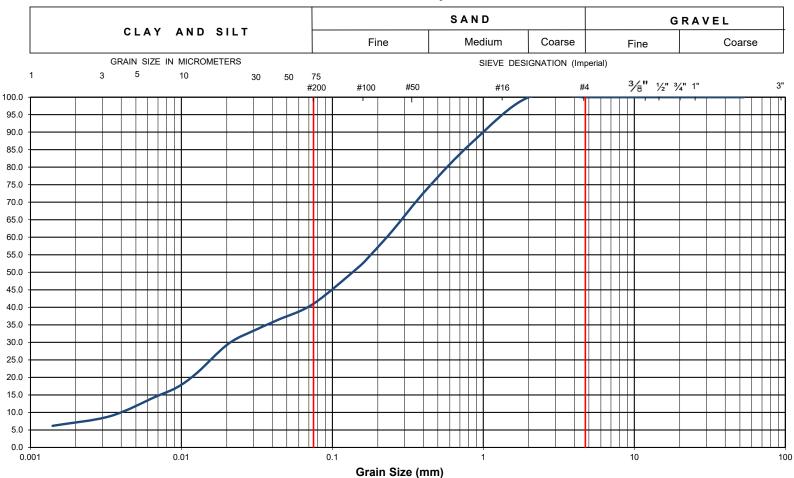
Grain-Size Distribution Curve Method of Test For Particle Size Analysis of Soil ASTM C-136/ASTM D422

EXP Project No.:	OTT-00263154-A0	154-A0 Project Name : Proposed Residential Development									
Client :	Wildpine Trails Inc.	Project Location	Project Location : 37 Wildpine Court, Ottawa, Ontario								
Date Sampled :	December 11, 2020	Borehole No:	Borehole No: BH-2				SS4		Depth (m) :	2.3-2.9	
Sample Description :		% Silt and Clay	41	% Sand	59	% Gravel		0	Figure :	18	
Sample Description : Organic Silty SAND (SM)									inguie .	10

Table II: Summary of Grain-size Analysis and Organic Content Results – Organic Silty Sand to Sandy Silt Samples								
Borehole No.	Depth (m)	Moisture Content	Organic Content	Grair	n-size An	alysis (%	6)	Soil Classification
– Sample No.	Depth (m)	(%)	(%)	Gravel	Sand	Silt	Clay	(USCS)
BH-2 – SS4	2.3 – 2.9	89.4	14.4	0	59	34	7	Organic Silty SAND (SM)
BH-3 – SS5	3.0 – 3.6	174.1	27.7	0	36	58	6	Organic Sandy SILT (ML)

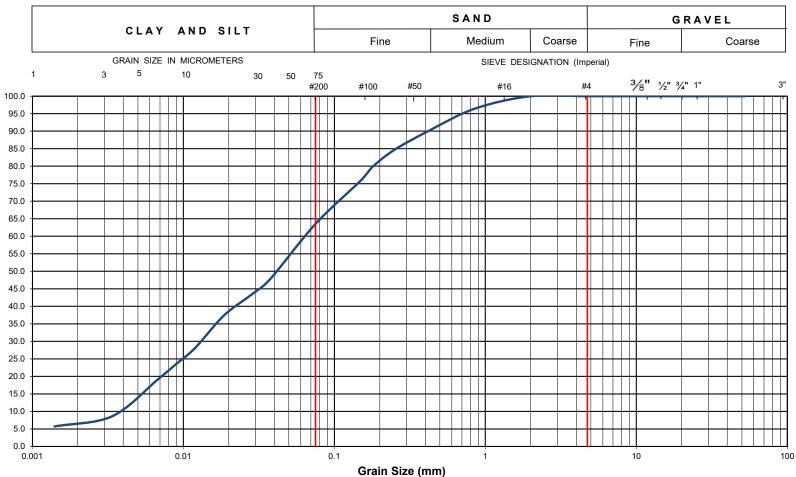
Grain-Size Distribution Curve Method of Test For Particle Size Analysis of Soil ASTM C-136/ASTM D422

EXP Project No.:	OTT-00263154-A0	Project Name : Proposed Residential Development										
Client :	Wildpine Trails Inc.	Project Location : 37 Wildpine Court, Ottawa, Ontario										
Date Sampled :	December 11, 2020	Borehole No:		BH-3 Sample No.:				S5	Depth (m) :	3.0-3.7		
Sample Description :		% Silt and Clay	64	% Sand	36	% Gravel		0	Figure: 19			
Sample Description : Organic Sandy SILT (ML)									rigure .	19

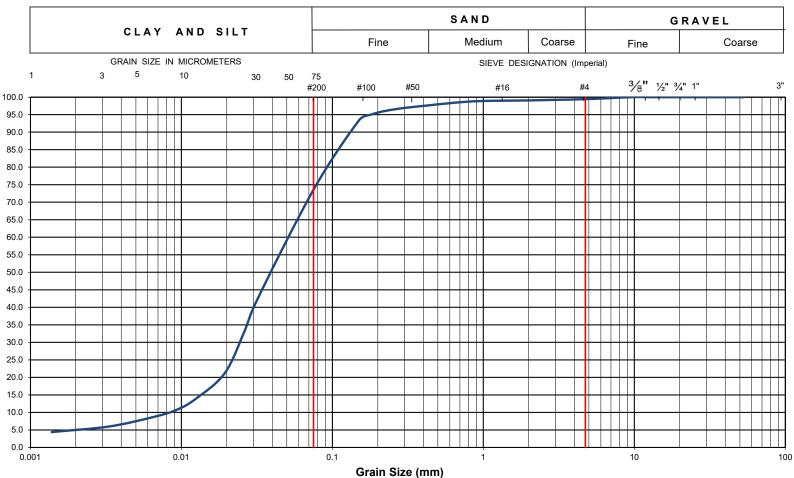
Grain-Size Distribution Curve Method of Test For Particle Size Analysis of Soil ASTM C-136/ASTM D422

EXP Project No.:	OTT-00263154-A0	Project Name : Proposed Residential Development									
Client :	Wildpine Trails Inc.	Project Location : 37 Wildpine Court, Ottawa, Ontario									
Date Sampled :	December 11, 2020	Borehole No:		BH-3 Sample No.:				S 7	Depth (m) :	4.6-5.2	
Sample Description :		% Silt and Clay	73	% Sand	26	% Gravel		1	Figure: 20		
Sample Description : Sandy SILT (ML)									rigule .	20

and 6. It is in a compact state as indicated by the SPT N-values of 12 to 25 and has a natural moisture content ranging from 11.5 to 41.0 percent. Grain size analysis was conducted on two (2) sample of the sandy silt and the grain size distribution curves are shown in Figure 20 and Figure 21 and the test results are summarized in Table III.

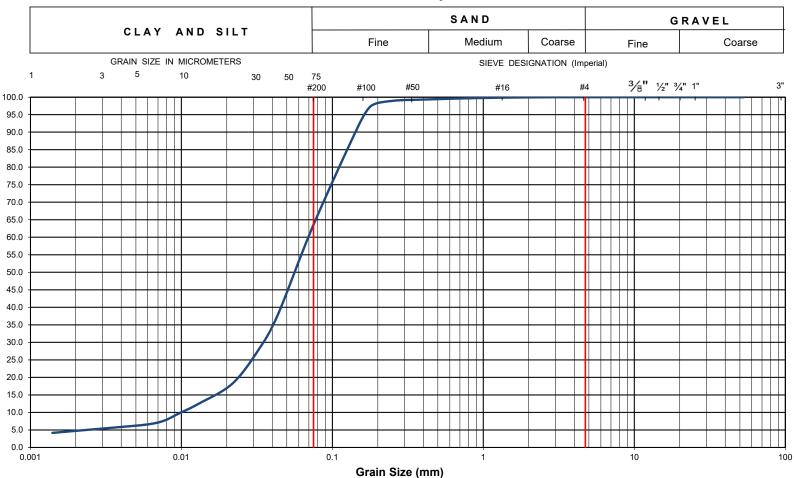
Grain-Size Distribution Curve Method of Test For Particle Size Analysis of Soil ASTM C-136/ASTM D422

EXP Project No.:	OTT-00263154-A0 Project Name : Proposed Residential Development										
Client :	Wildpine Trails Inc.	Project Location	Project Location : 37 Wildpine Court, Ottawa, Ontario								
Date Sampled :	December 11, 2020	Borehole No:		BH-8 Sample No.:				36	Depth (m):	3.8-4.4	
Sample Description :		% Silt and Clay	64	% Sand	36	% Gravel		0	Figure: 21		
Sample Description : Sandy Silt (ML)									riguie .	۷1

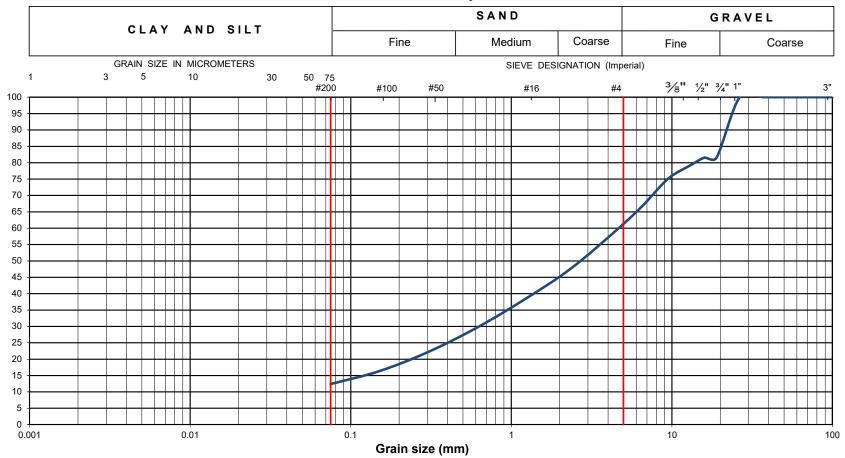
Grain-Size Distribution Curve Method of Test For Sieve Analysis of Aggregate ASTM C-136

EXP Project No.:	OTT-00263154-A0	Project Name : Proposed Residential Development									
Client :	Wildpine Trails Inc.	Project Location	Project Location : 37 Wildpine Court, Ottawa, Ontario								
Date Sampled :	December 11, 2020	Borehole No:	Borehole No: BH-4 Sample: SS3 I						1.5-2.1		
Sample Composition :		Gravel (%)	39	Sand (%)	48	Silt & Clay (%)	13	Figure :	22		
Sample Description : GLACIAL TILL: Silty Sand with Gravel (SM)									22

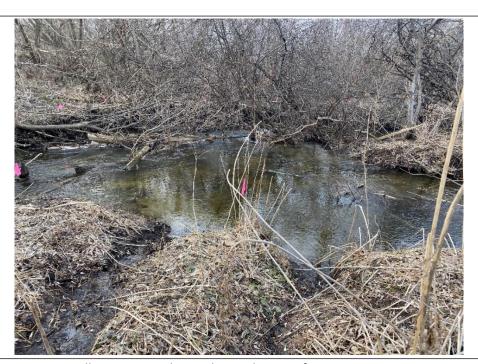
Gully erosion at the Poole Creek west of cross-section A

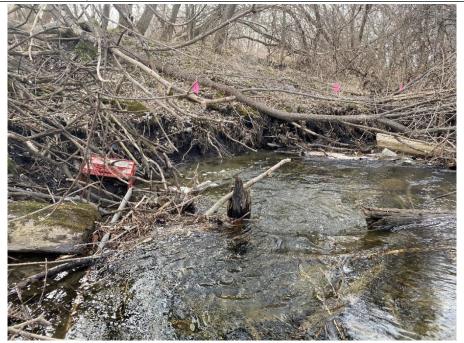
Toe erosion at the Poole Creek west of cross-section A

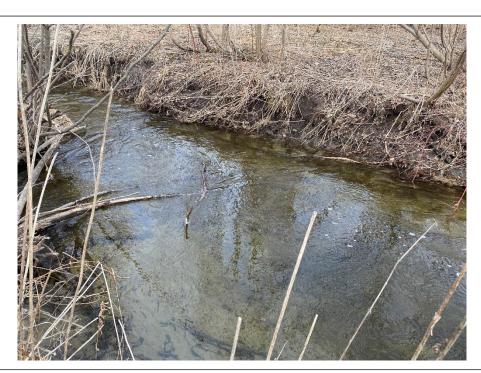
Toe erosion at the Poole Creek west of cross-section A

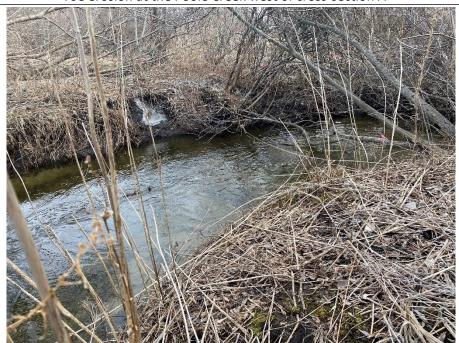
Toe erosion at the Poole Creek west of cross-section A

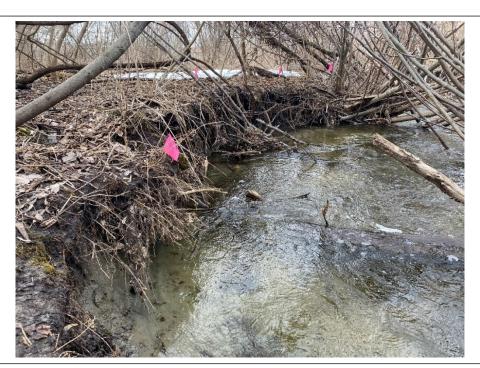
Toe erosion at the Poole Creek between cross-sections A and B

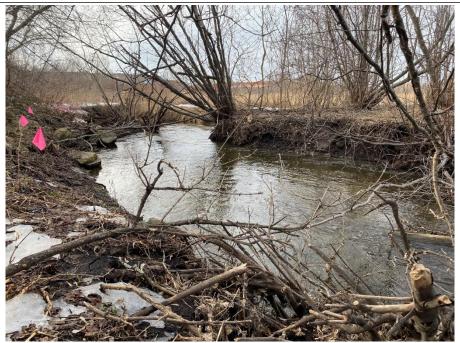
Toe erosion at the Poole Creek between cross-sections A and B

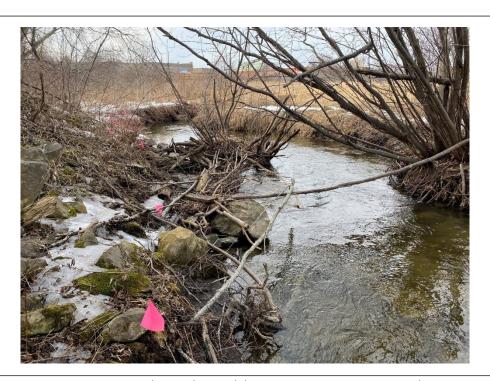
Toe erosion at the Poole Creek between cross-sections A and B

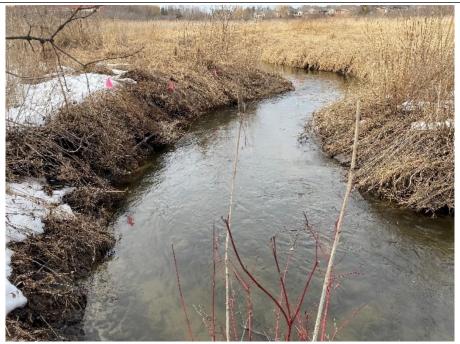
Toe erosion at the Poole Creek between cross-sections A and B

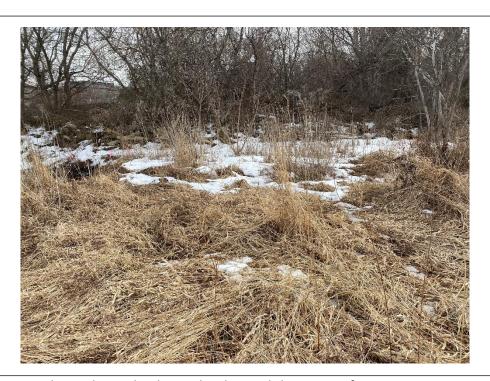
The Poole Creek tributary borders and slope west of cross-section B

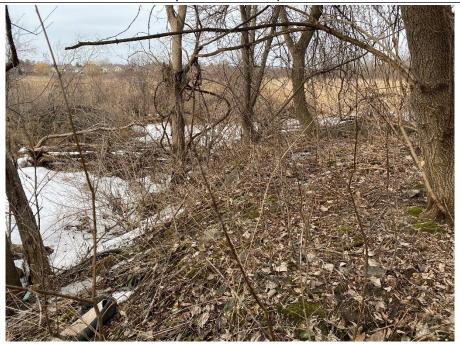
The Poole Creek tributary borders and slope near cross-section B

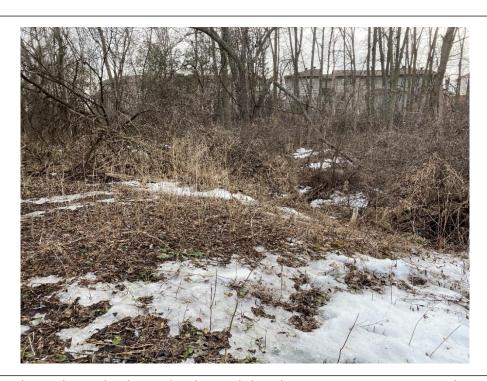
The Poole Creek tributary borders and slope between cross-sections B and C

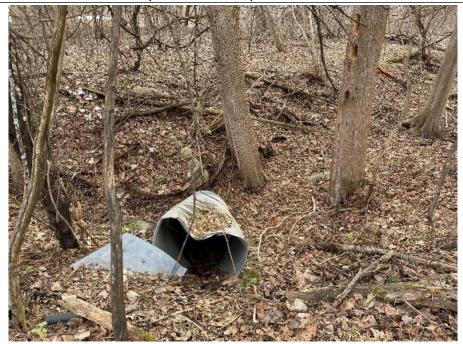
The Poole Creek tributary borders and slope near cross-sections D
