Hydrogeological Study and Water Budget Assessment

Proposed Residential Development

5993 & 6115 Flewellyn Road & 6030 & 6070 Fernbank Road
Ottawa, Ontario

Report PH4681-REP.01.R2
dated August 7, 2024

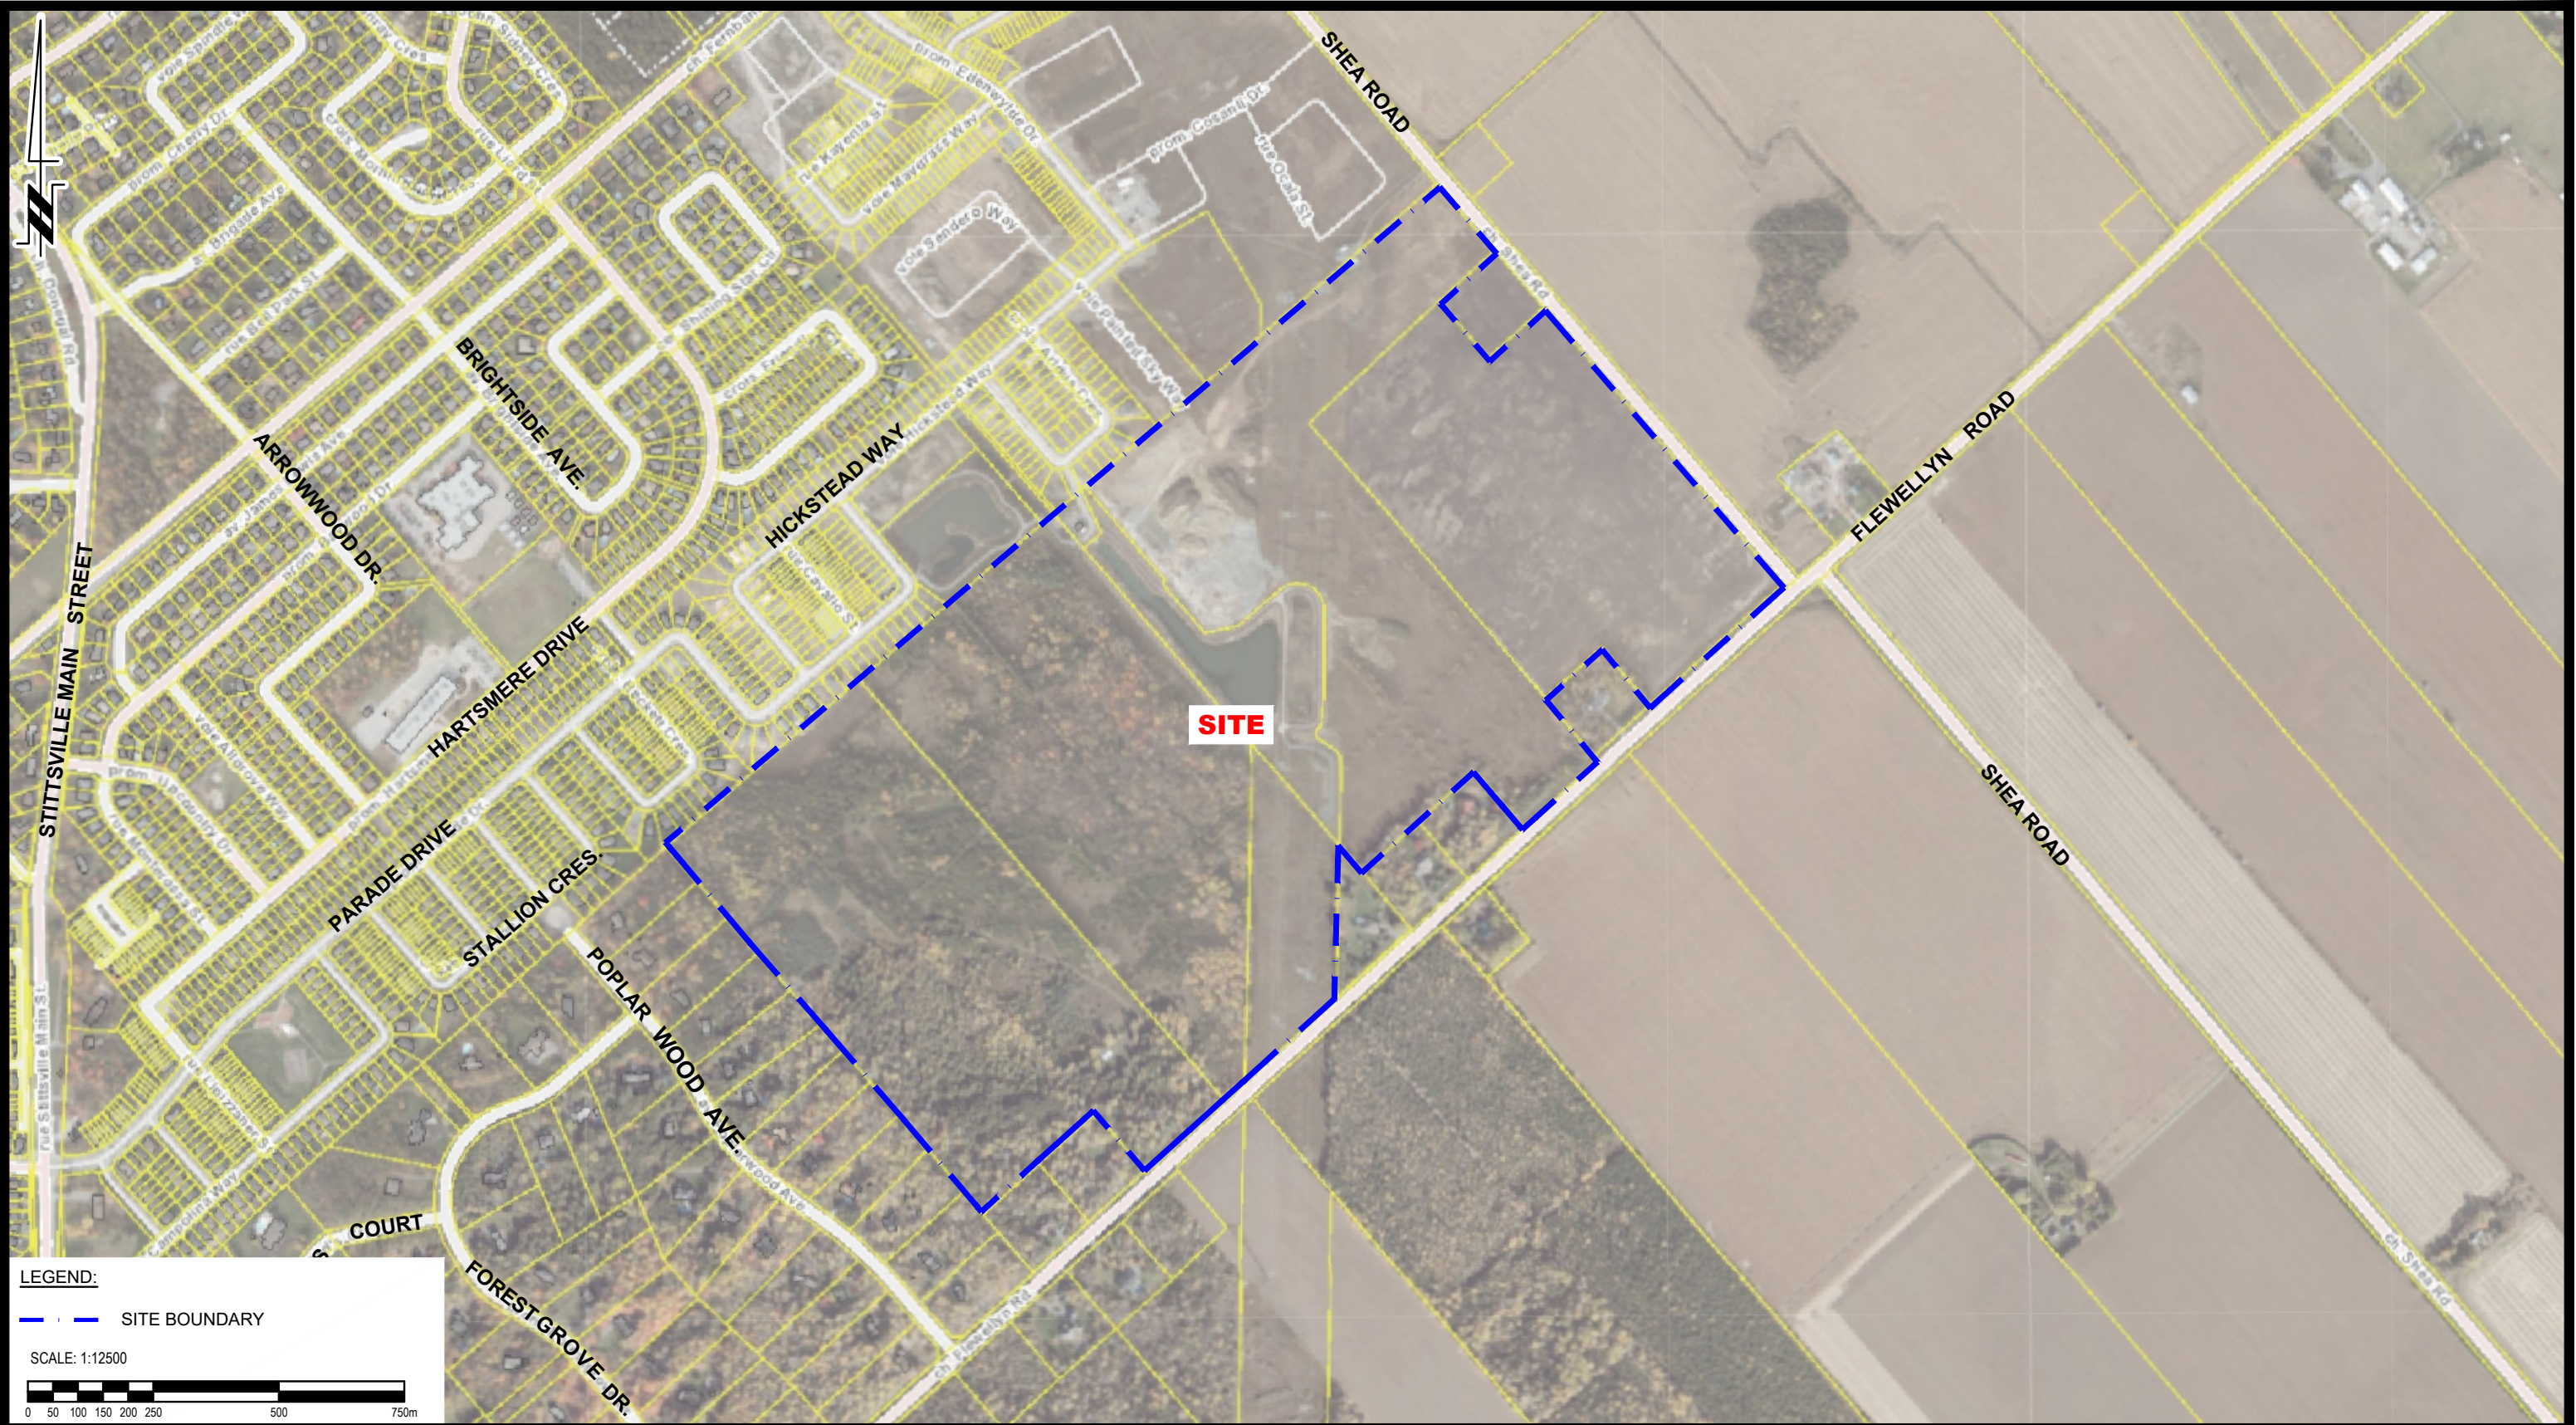
SITE PLAN

The subject site consists of a mixture of agricultural lands, meadows, and forested areas. The location of the subject site is shown on PH4681-1 - Site Plan appended to this report.

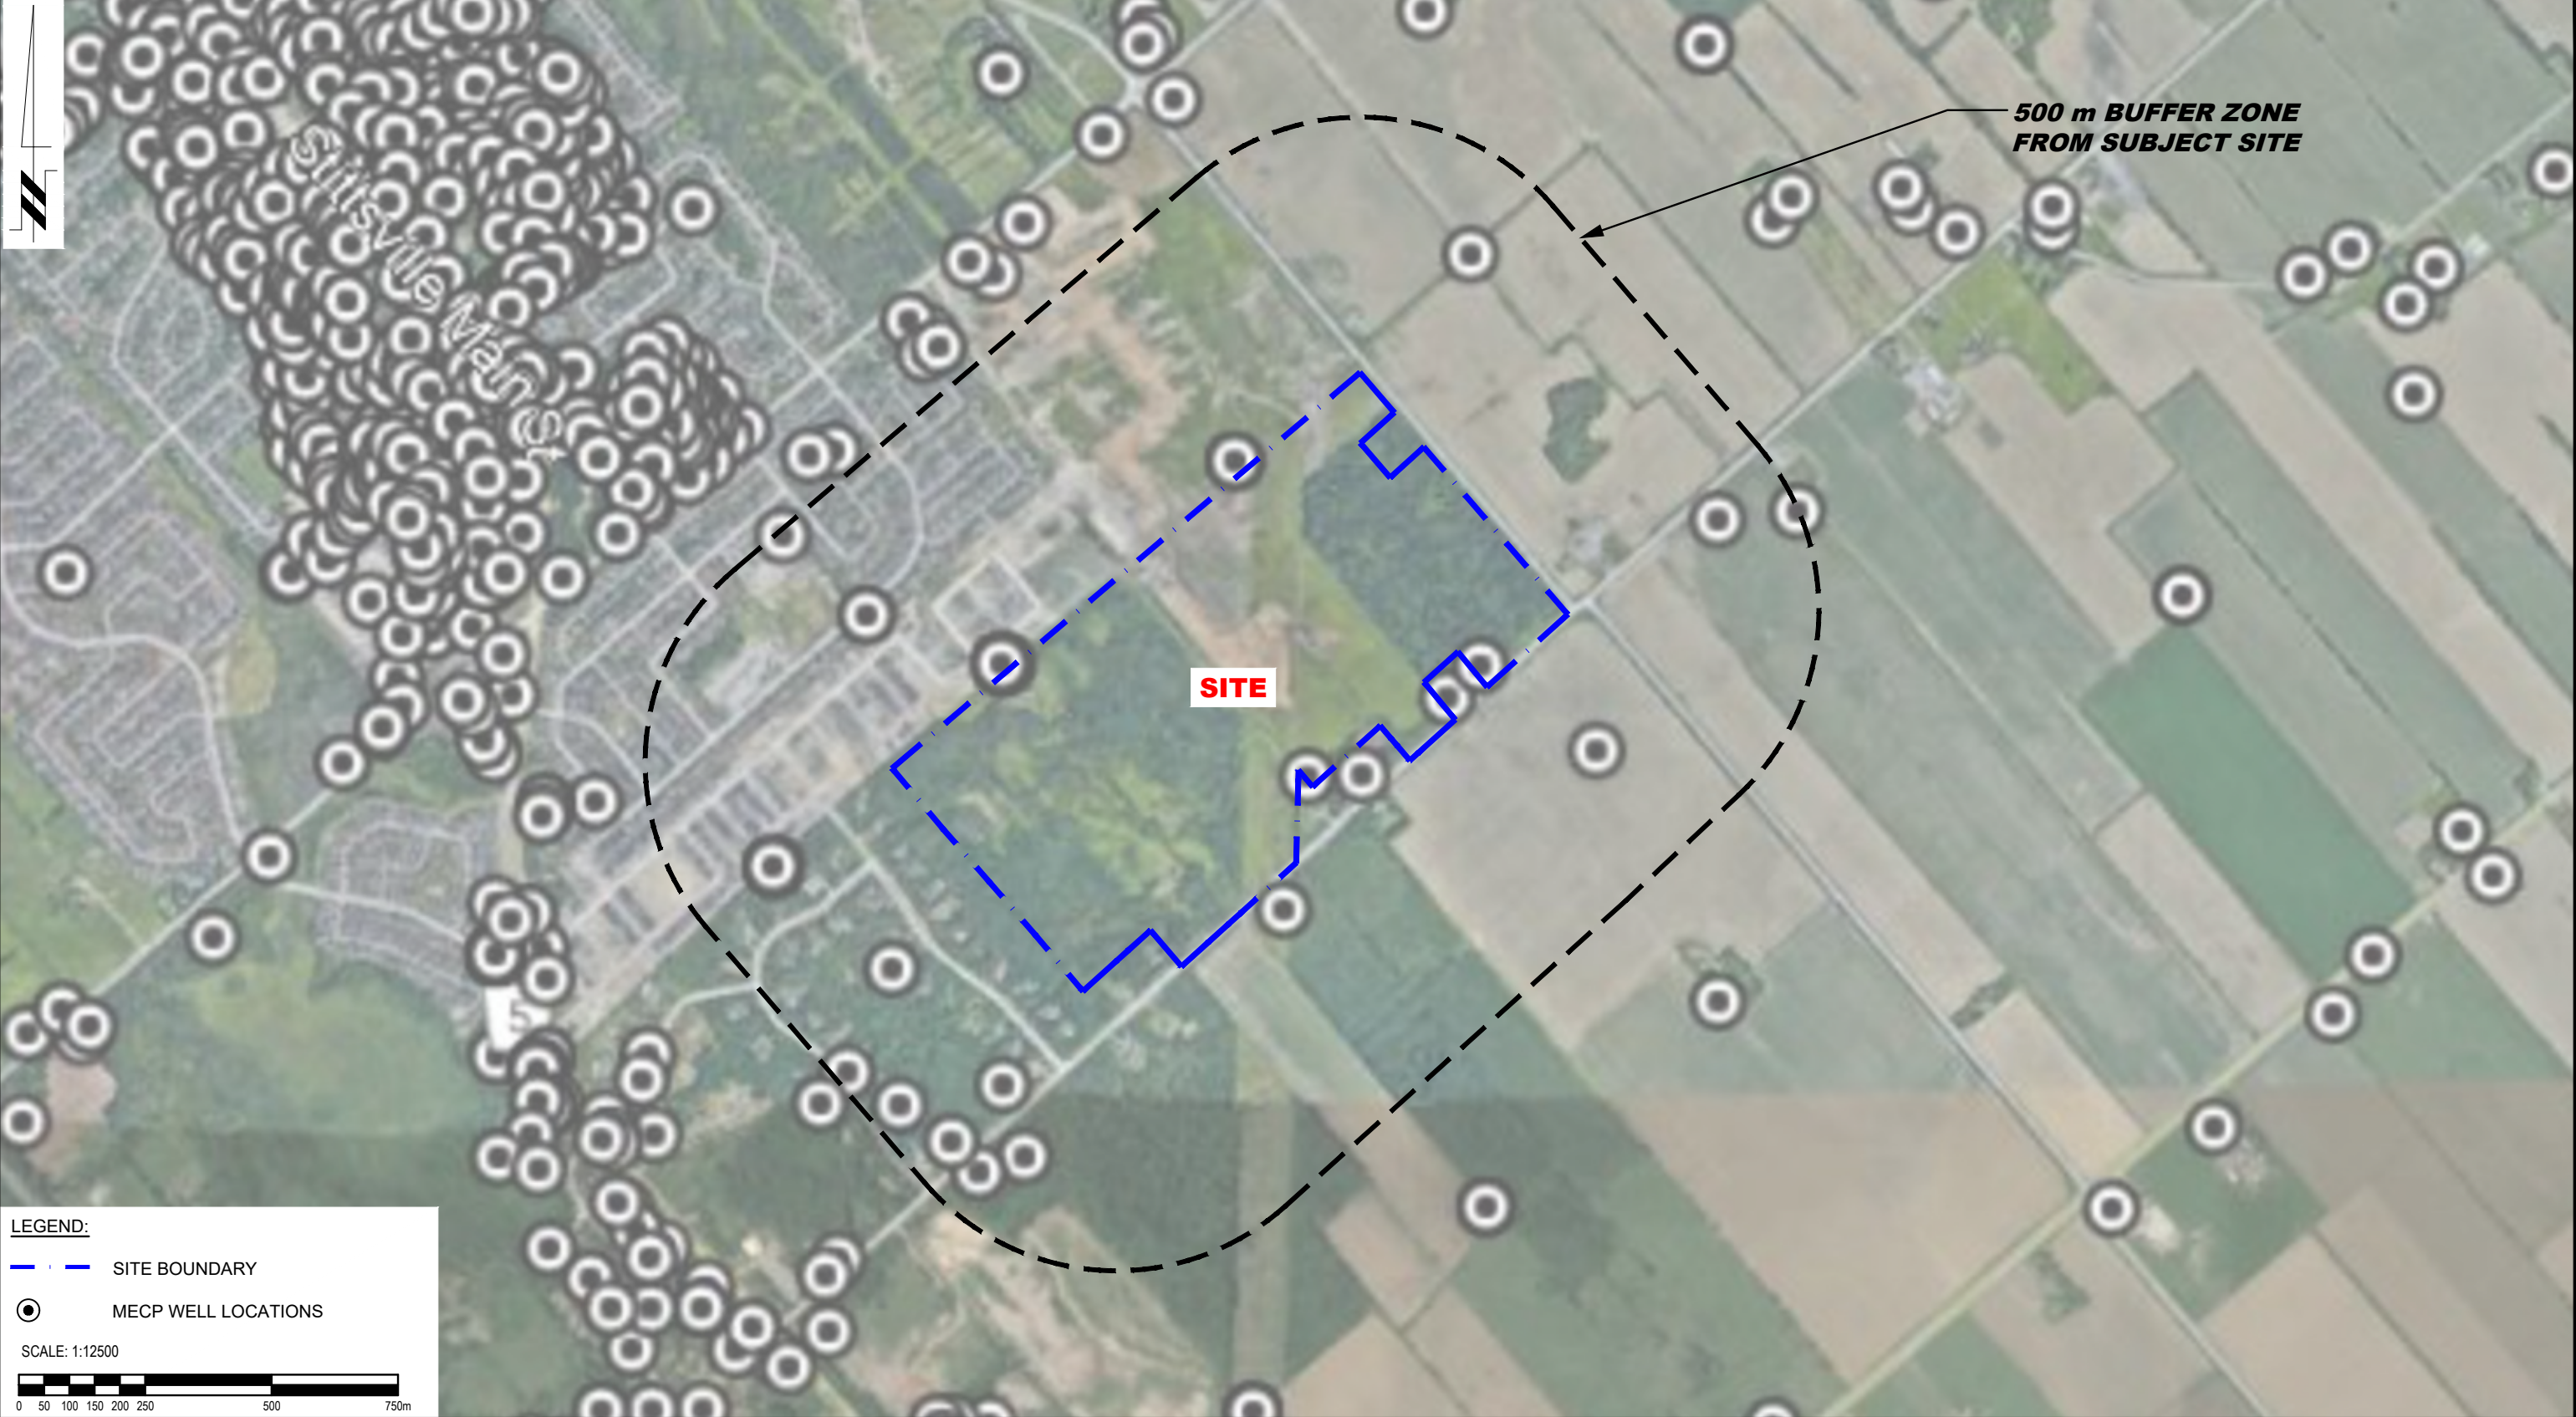
Title: **MECP WATER WELL LOCATION PLAN**

There are several water wells within 500 m of the site as depicted on drawing PH4681-2 - MECP Water Well Location Plan appended to this report. However, after reviewing the water well records of the surrounding water supply wells, it was noted that the majority of the wells are screened within the bedrock aquifer at depths below the proposed servicing depths at the subject site, providing sufficient vertical separation between the wells and potential development activities.

A search of the Ontario Water Well Records database indicates there are several water wells within 500 m of the site as depicted on drawing PH4681-2 - MECP Water Well Location Plan appended to this report. However, after reviewing the water well records of the surrounding water supply wells, it was noted that the majority of the wells are screened within the bedrock aquifer at depths below the proposed servicing depths at the subject site, providing sufficient vertical separation between the wells and potential development activities.

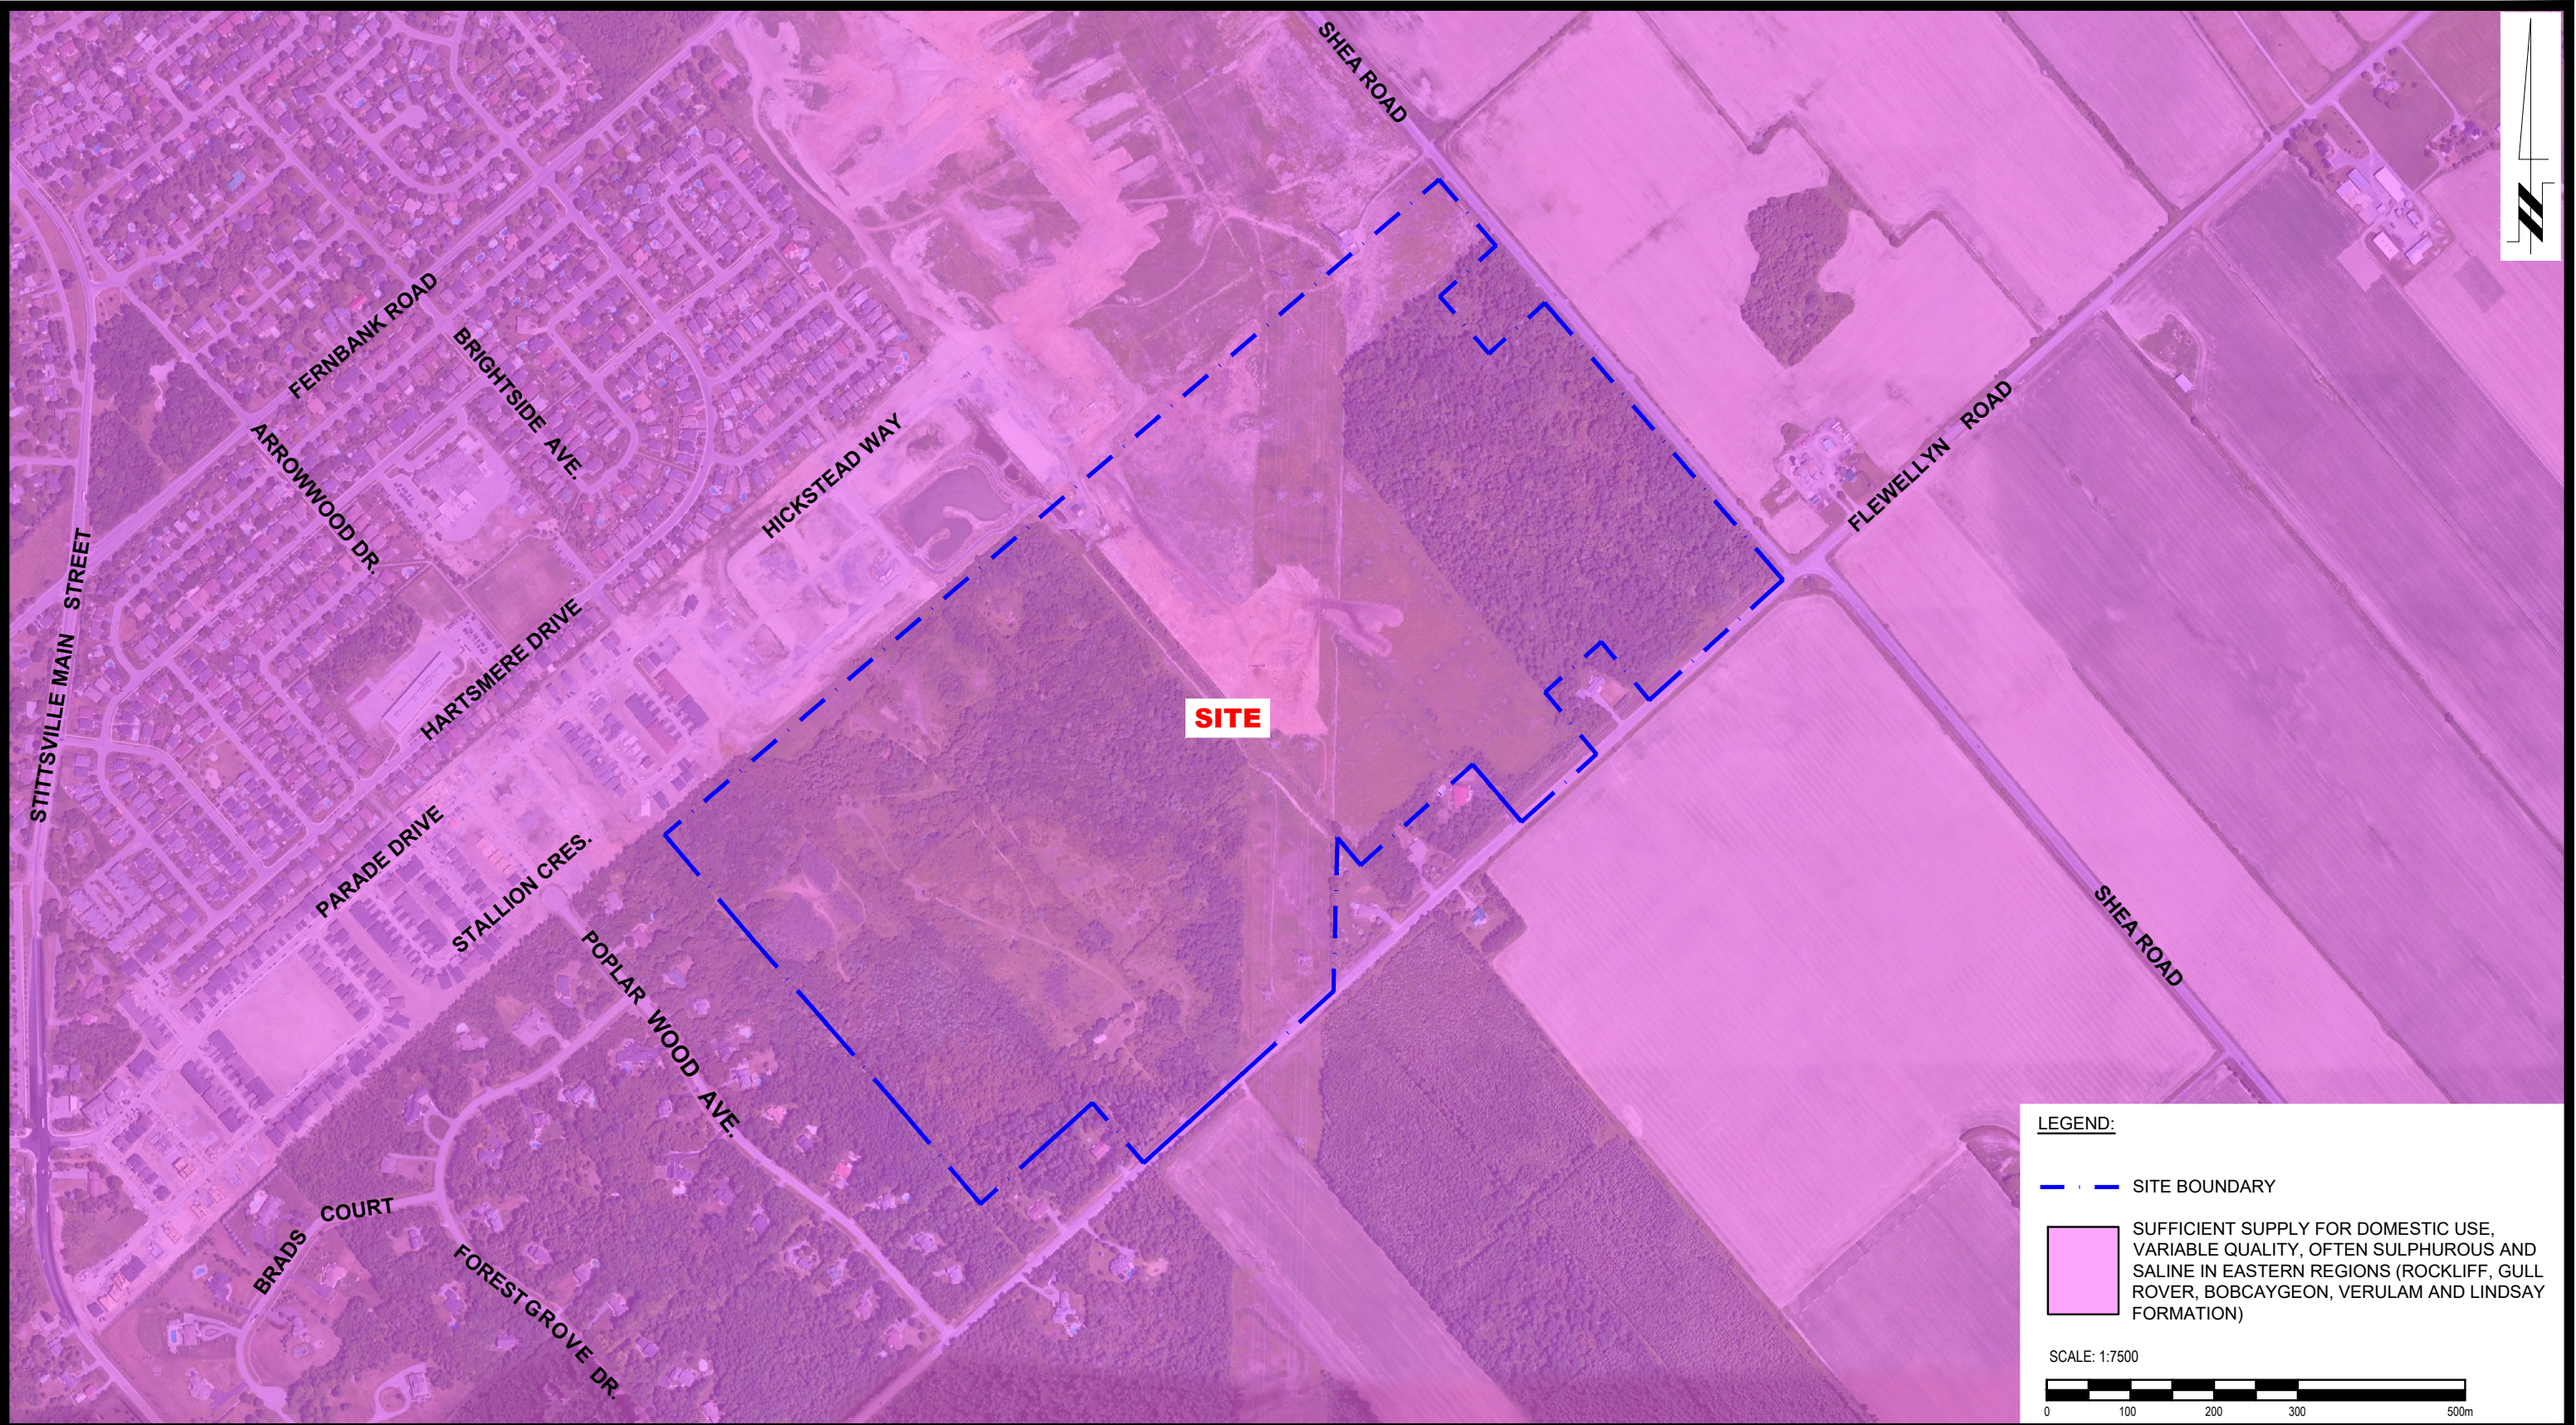
DRAWING PH4681-5 - BEDROCK AQUIFER PLAN

gradients. In general, aquifer systems may be present in overburden soils or bedrock. Although groundwater has been observed within overburden soils at the subject site, the typical overburden materials found at the site do not allow for the development of significant water supply wells. Water supply wells in the vicinity are instead likely found in bedrock aquifers.

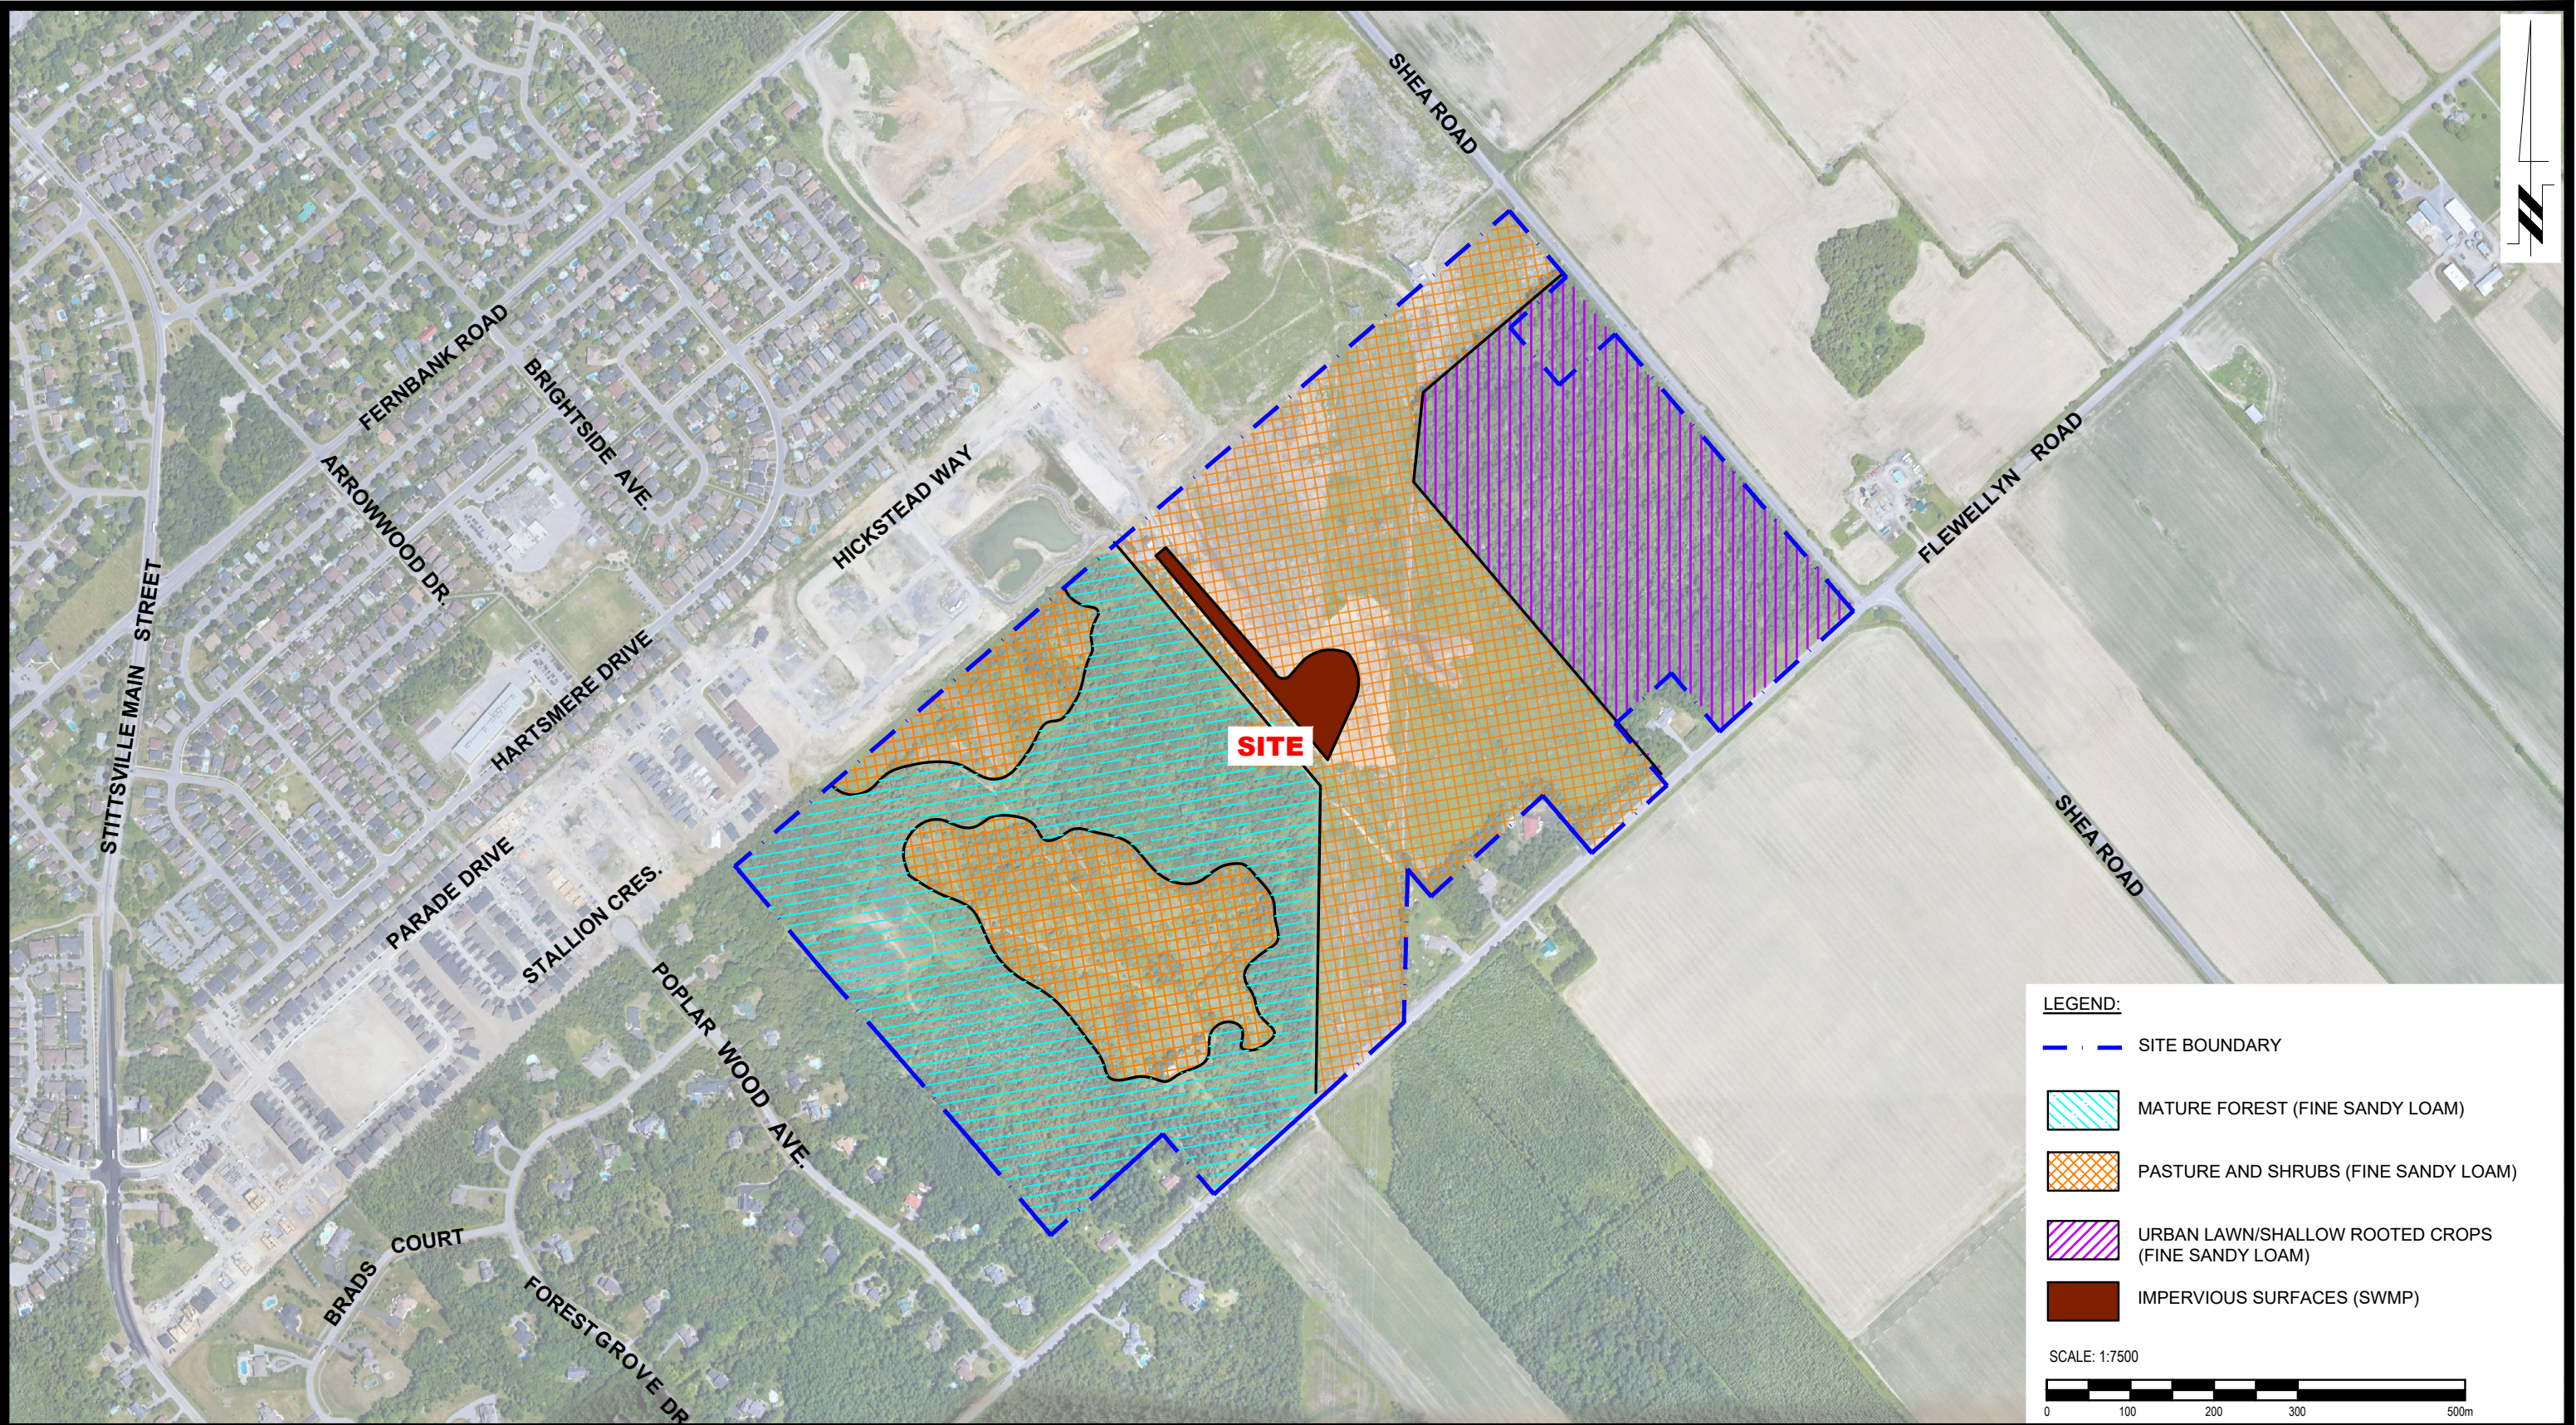
DRAWING PH4681-6 - PRE-DEVELOPMENT TERRAIN COMPOSITION PLAN

The site-specific water budget assessment (SSWB) was conducted to determine the hydrogeological function of the subject site, to identify infiltration potential and to identify opportunities for Low Impact Development (LID) measures. The study area currently consists of a mixture of agricultural lands, meadows, and forested areas. The pre-development terrain compositions are illustrated on Drawings PH4681-6 - Pre-Development Terrain Composition Plan appended to this report.

- SITE BOUNDARY
- MATURE FOREST (FINE SANDY LOAM)
- PASTURE AND SHRUBS (FINE SANDY LOAM)
- URBAN LAWN/SHALLOW ROOTED CROPS (FINE SANDY LOAM)
- IMPERVIOUS SURFACES (SWMP)

The subject site generally consists of agricultural lands and meadows with select areas with mature forests to the western portion of the site. A pre-development vegetation infiltration factor of 0.1 was therefore used for the majority of the site with the exception of the tree covered area which was given a vegetation infiltration factor of 0.2.

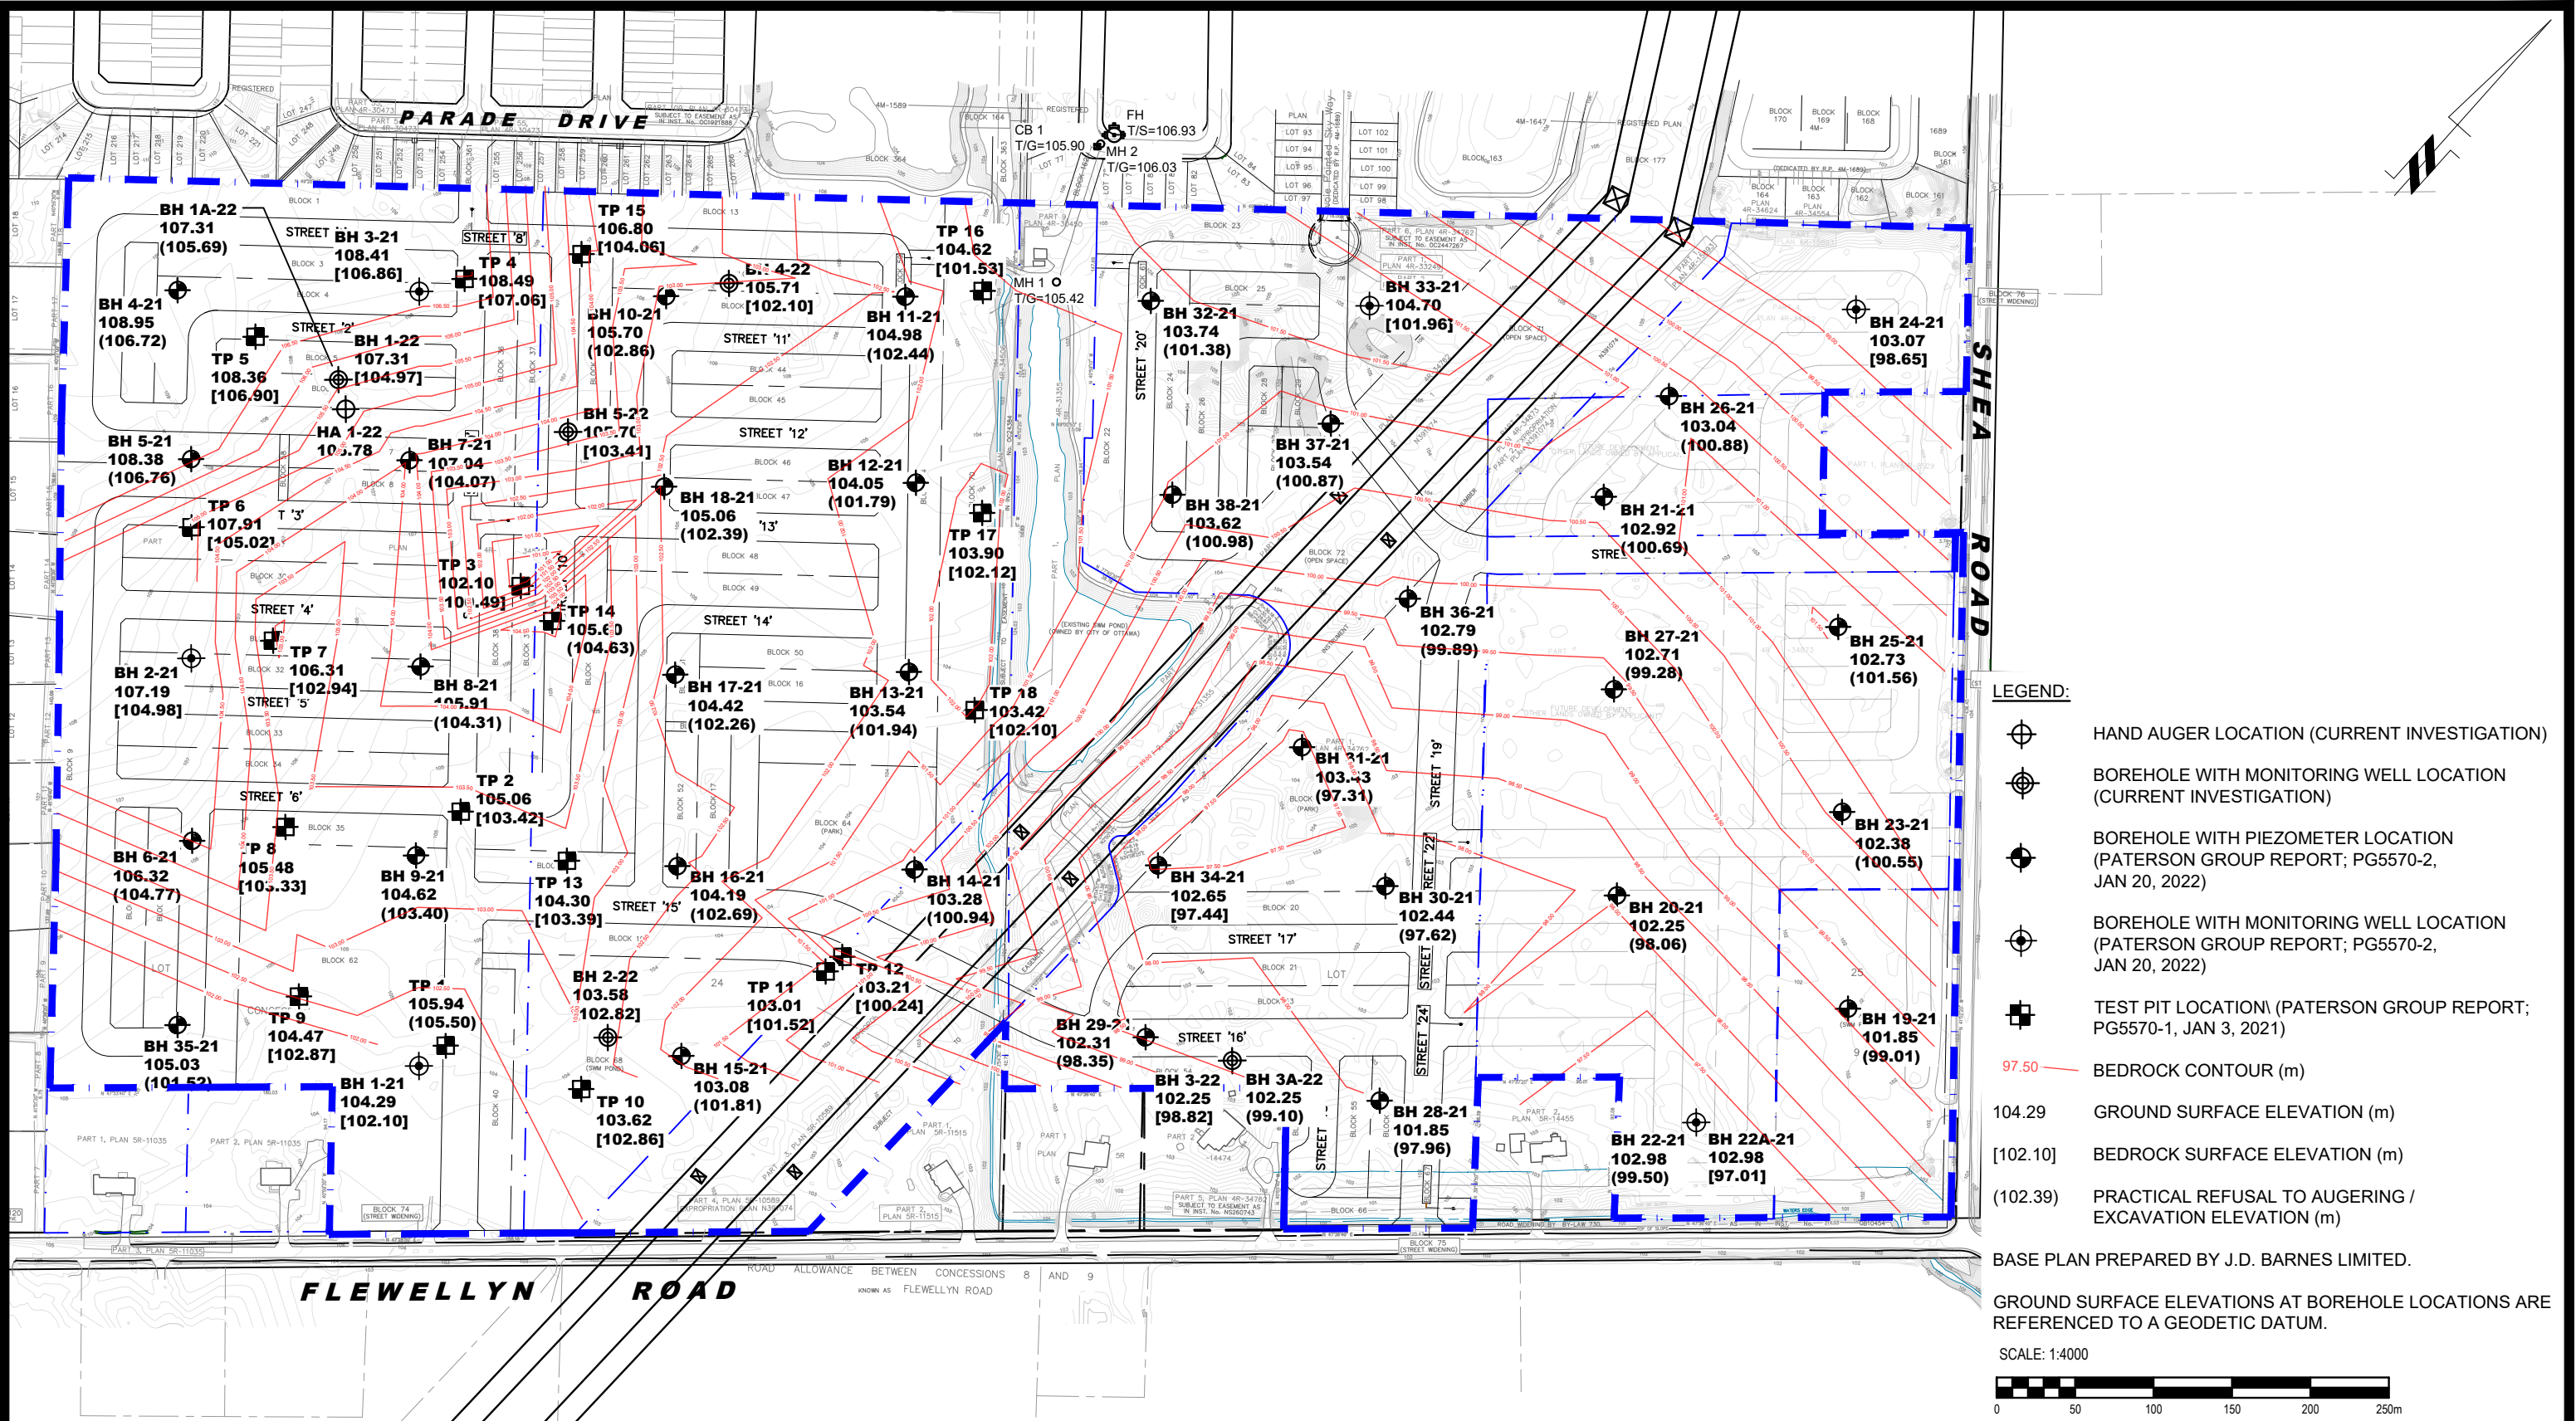
Bedrock was encountered between 0.8 and 6.0 m bgs and cored to maximum depth of 10.2 m bgs at select borehole locations. Bedrock depths are shown on Drawing PG5570-2 - Bedrock Contour Plan. The bedrock was observed to consist of limestone interbedded with dolostone, generally being excellent in quality.

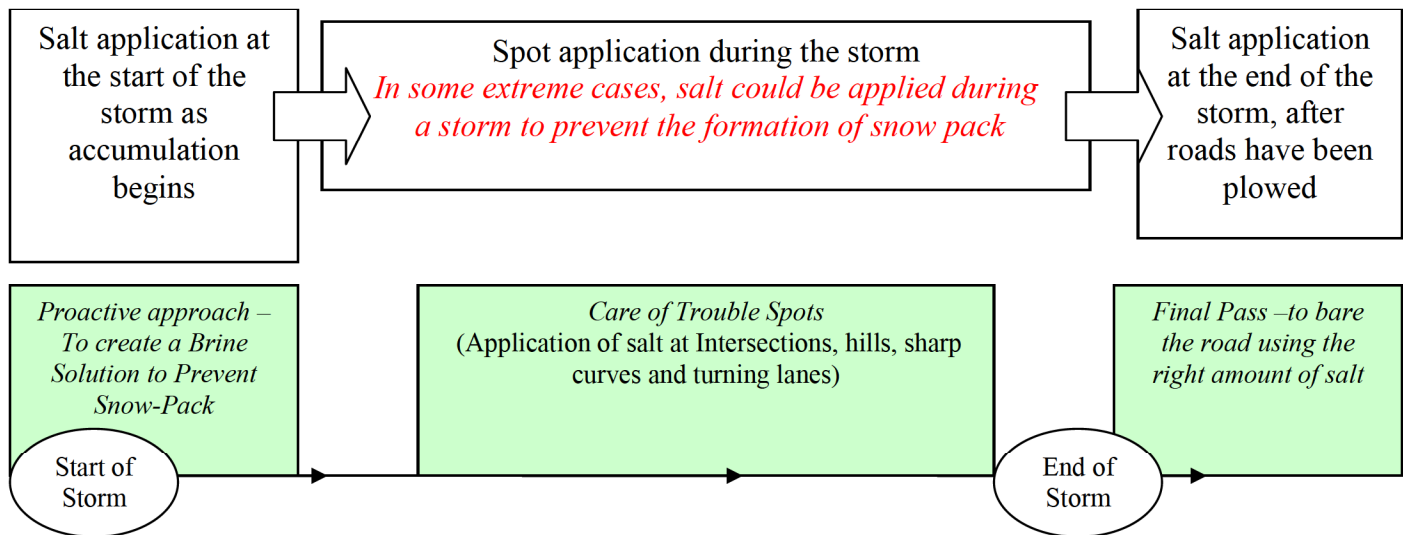
Timing of Application – BARE PAVEMENT ROADS

Salt shall be spread just at the beginning of the icy precipitation.

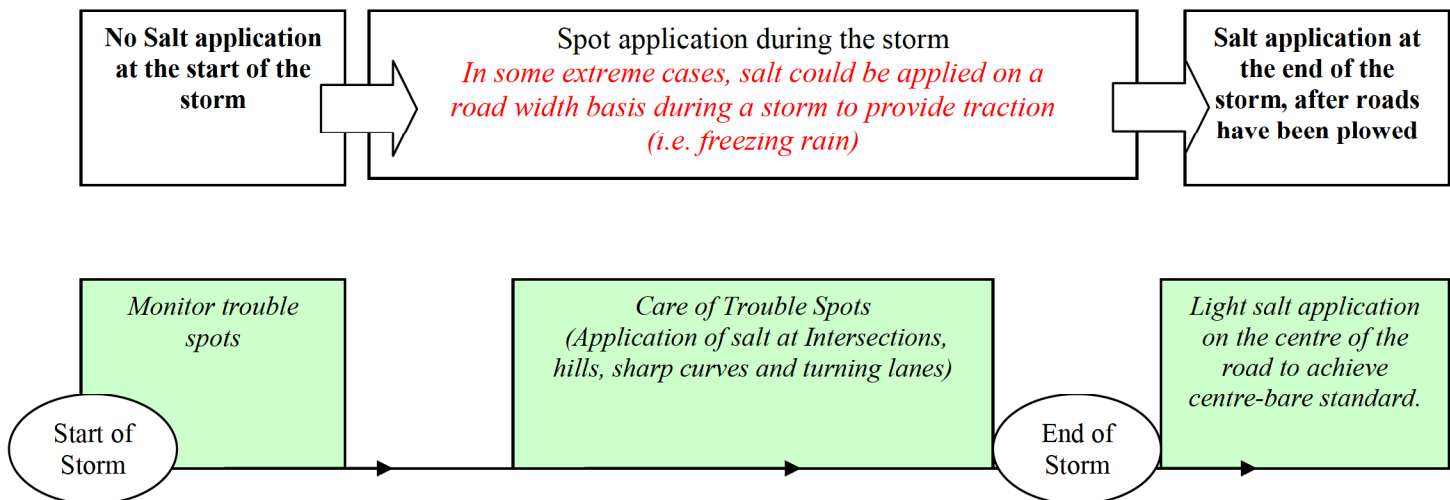
Timing of Application – CENTRE-BARE PAVEMENT ROADS

No Salt application at the start of the storm. Monitor trouble spots.
