**Geotechnical Investigation
Proposed Industrial Development
3112 Carp Road
Ottawa, Ontario**

T & L Carroll Holdings Inc.
1380 Howie Road
Carp, Ontario
K0A 1L0

March 23, 2026
GEMTEC Project: 102151.001

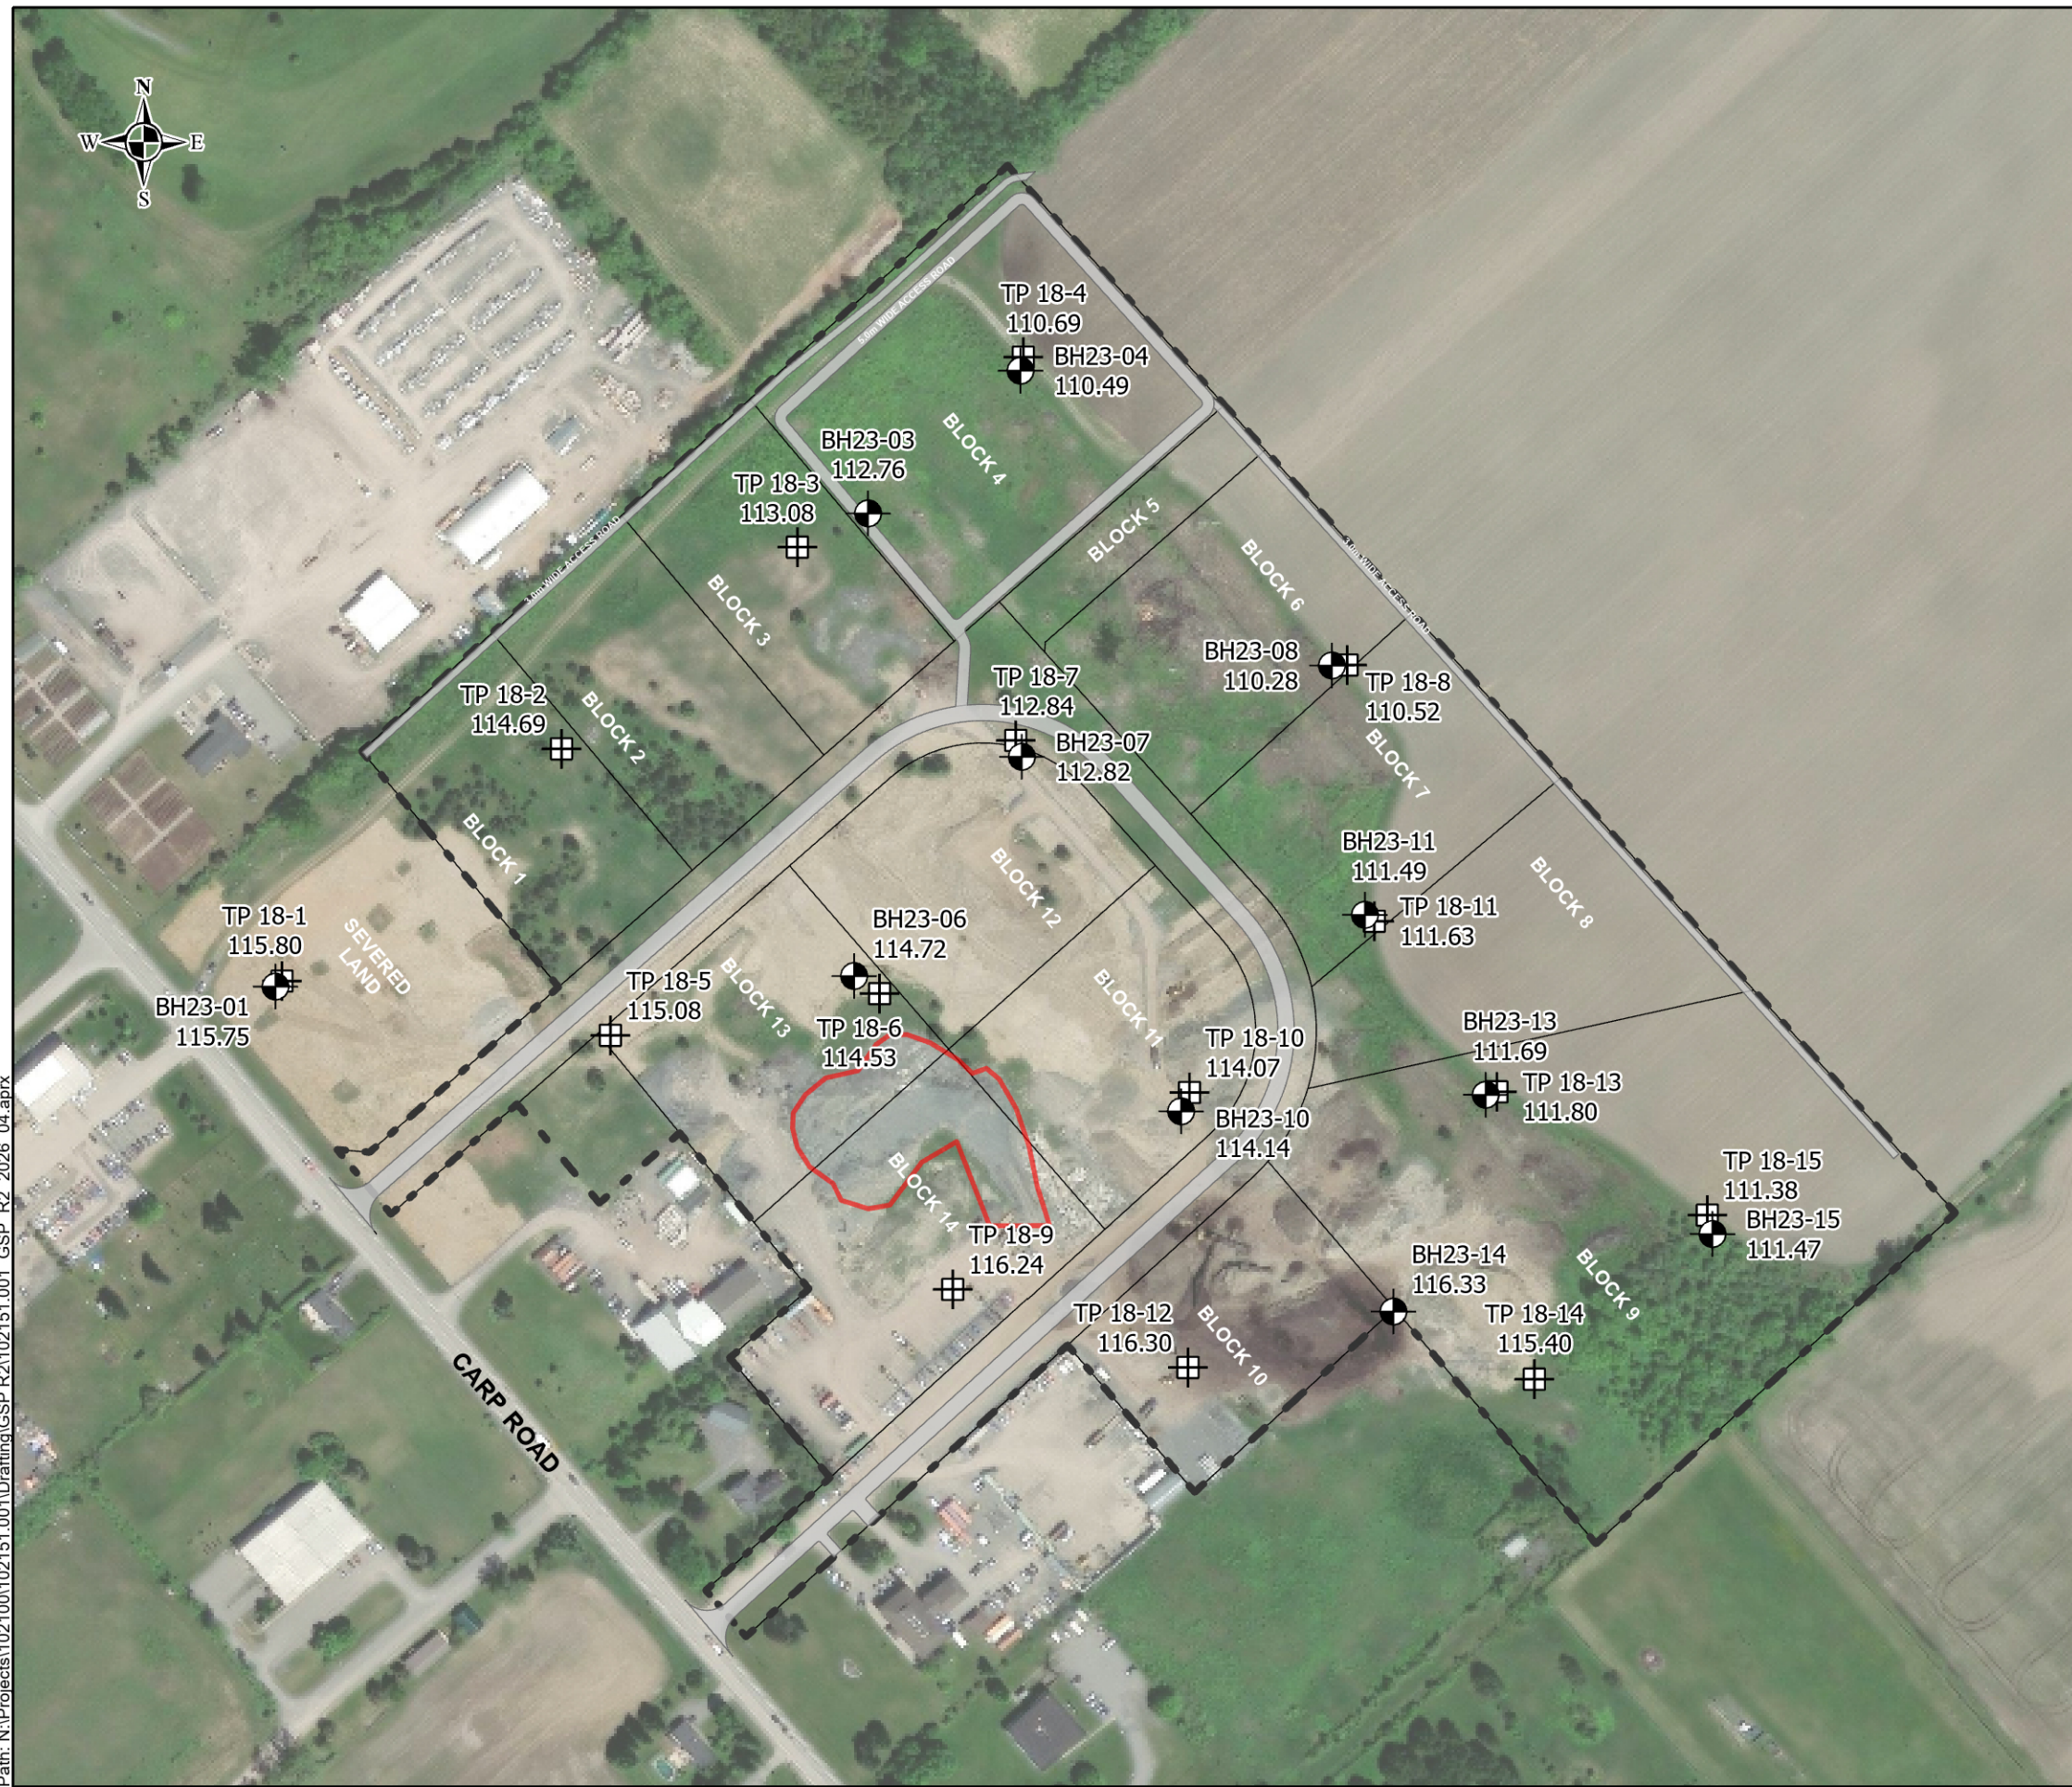
Figure 1 – Site Plan

At the time of the investigation, a stockpile of fill material was observed at the site, as shown in Figure 1, with an approximate height of about 5 metres, based on the as surveyed top of stockpile at about elevation 119 metres and the base of the stockpile at about elevation 114 metres.
