# **Hydrogeological Study and Water Budget Assessment**

## **Proposed Residential Development**

East Parcel - 5971 Flewellyn Road and 1770 and 1820 Shea  
Road  
Ottawa, Ontario

Report PH4681-REP.02  
dated April 24, 2026

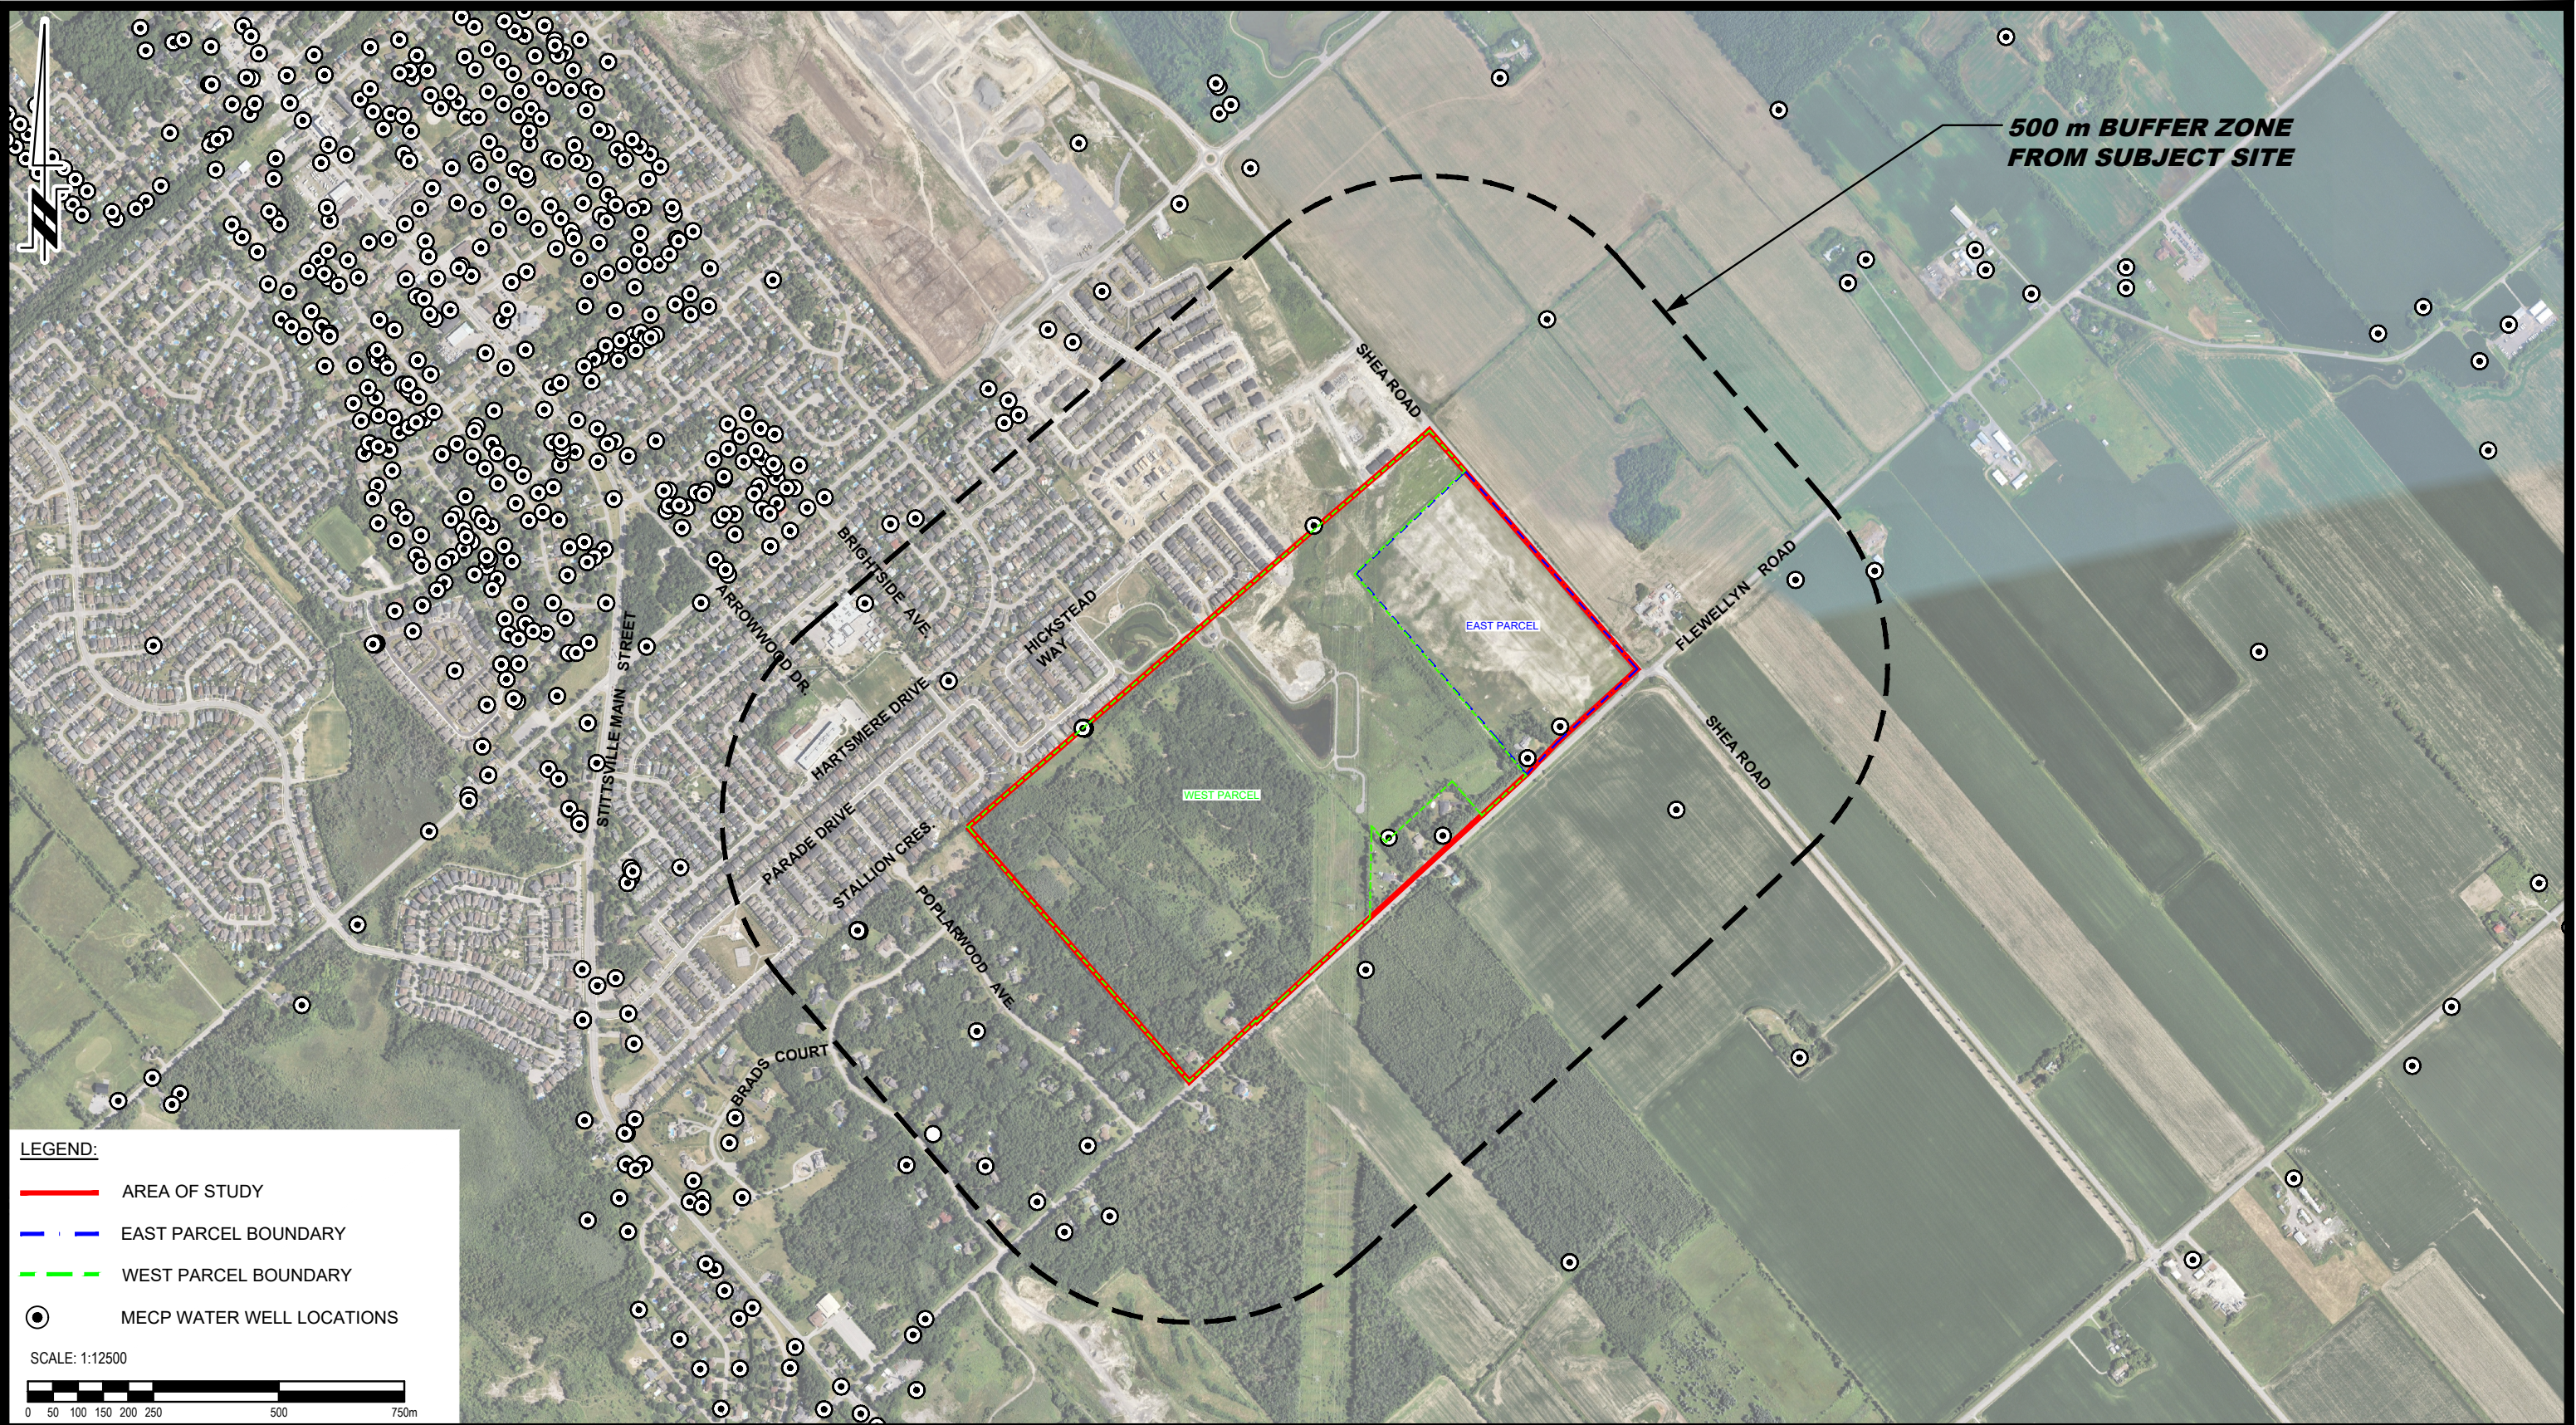
| Checked by: | OB | Dwg. No.: | <b>PH4681-2</b> |

- AREA OF STUDY
- - - EAST PARCEL BOUNDARY
- - - WEST PARCEL BOUNDARY
- ⊙ MECP WATER WELL LOCATIONS

A search of the Ontario Water Well Records database indicates there are several water wells within 500 m of the site as depicted on Drawing PH4681-2 - MECF Water Well Location Plan appended to this report. It should be noted that other construction activities such as blasting and hoe-ramming can have an impact on adjacent well users depending on the location and duration of such activities, in addition to dewatering activities. However, after reviewing the water well records of the surrounding water supply wells, it was noted that the majority of the wells are screened within the bedrock aquifer at depths below the proposed servicing depths at the subject site, providing sufficient vertical separation between the wells and potential development activities which may include dewatering and/or blasting.

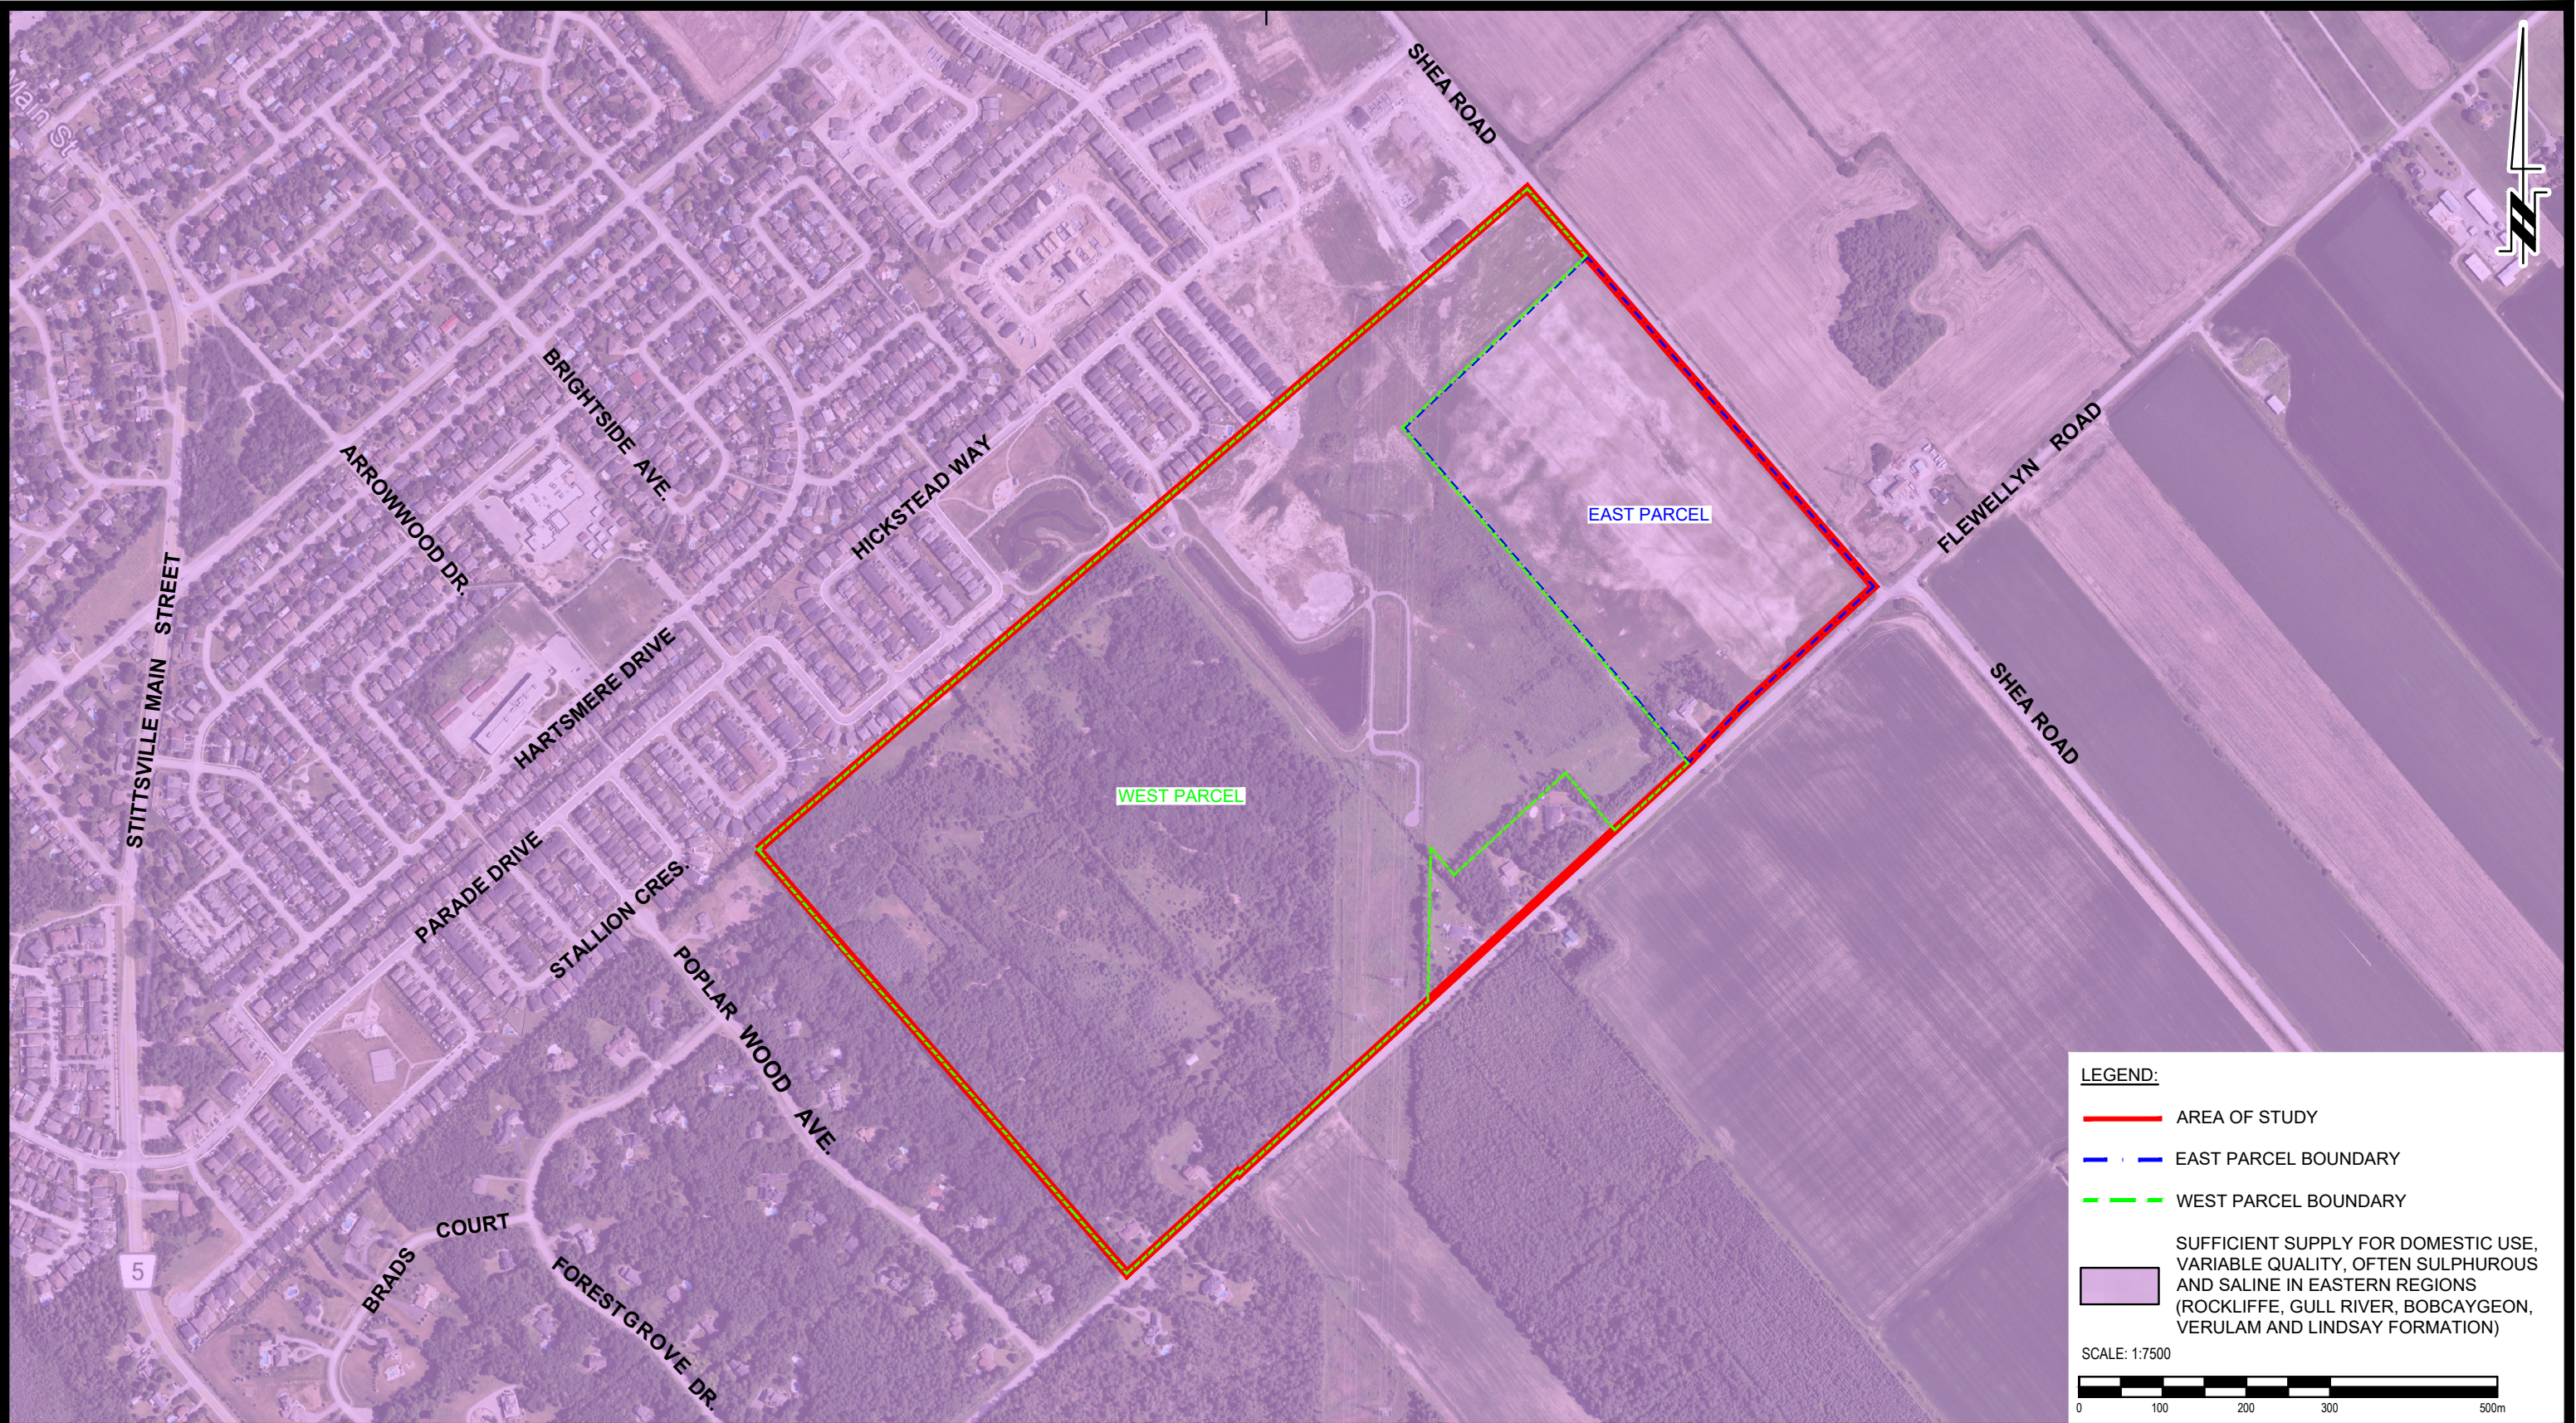
| | | | | 4 | UPDATED CONCEPT PLAN AND SITE BOUNDARIES | 10/04/2026 | OB | | | OTTAWA,<br>Title: BEDROCK AQUIFER PLAN | | Drawn by: JM | | Report No.: PH4681-REP.01<br>PH4681-REP.02 | |

Aquifer systems may be defined as geological media, either overburden soils or fractured bedrock, which permit the movement of groundwater under hydraulic gradients. In general, aquifer systems may be present in overburden soils or bedrock. Although groundwater has been observed within overburden soils at the subject site, the typical overburden materials found at the site do not allow for the development of significant water supply wells. Water supply wells in the vicinity are instead likely found in bedrock aquifers.

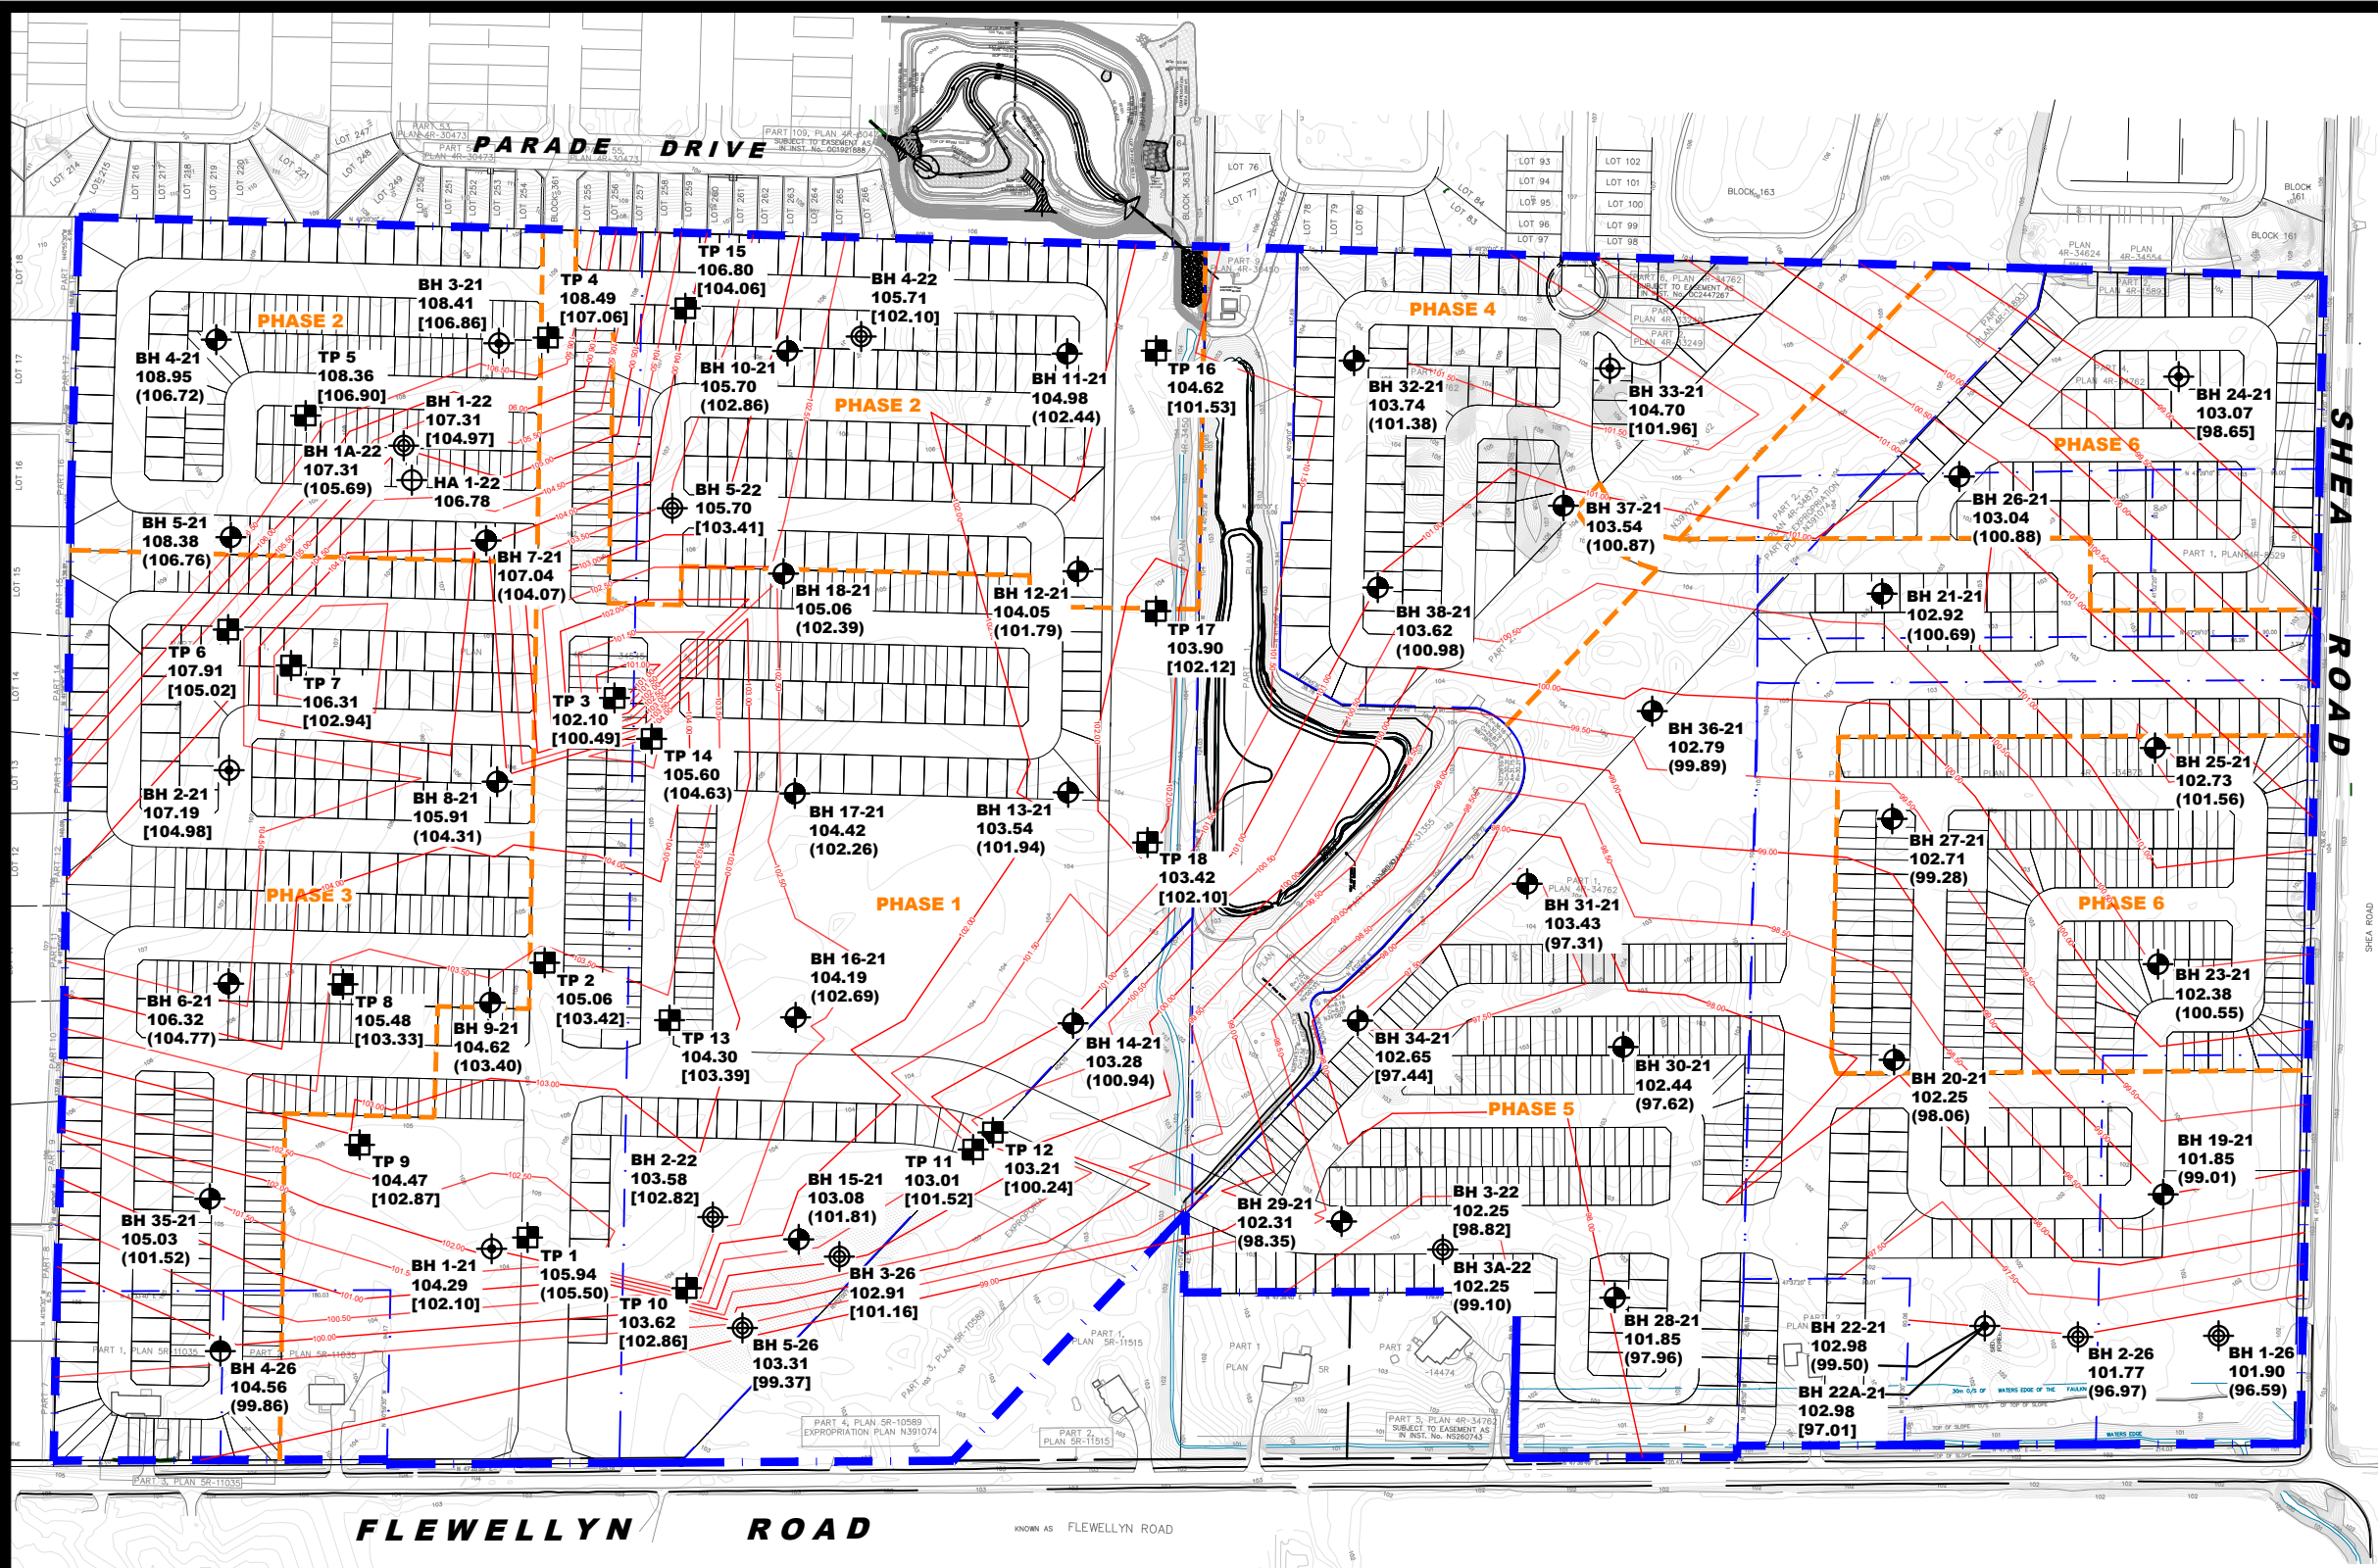
- LEGEND:**
- HAND AUGER LOCATION (CURRENT INVESTIGATION)
  - BOREHOLE WITH MONITORING WELL LOCATION (CURRENT INVESTIGATION)
  - BOREHOLE WITH PIEZOMETER LOCATION (CURRENT INVESTIGATION)
  - BOREHOLE WITH PIEZOMETER LOCATION (PATERSON GROUP REPORT; PG5570-2, JAN 20, 2022)
  - BOREHOLE WITH MONITORING WELL LOCATION (PATERSON GROUP REPORT; PG5570-2, JAN 20, 2022)
  - TEST PIT LOCATION (PATERSON GROUP REPORT; PG5570-1, JAN 3, 2021)
  - 97.50 BEDROCK CONTOURS (m)
  - 104.29 GROUND SURFACE ELEVATION (m)
  - [102.10] BEDROCK SURFACE ELEVATION (m)
  - (102.39) PRACTICAL REFUSAL TO AUGERING / EXCAVATION ELEVATION (m)

GROUND SURFACE ELEVATIONS AT BOREHOLE LOCATIONS ARE REFERENCED TO A GEODETIC DATUM.

Bedrock was encountered between 0.8 and 6.0 m bgs and cored to maximum depth of 10.2 m bgs at select borehole locations. Bedrock depths are shown on Drawing PG5570-2 - Bedrock Contour Plan. The bedrock was observed to consist of limestone interbedded with dolostone, generally being excellent in quality.
