## Geotechnical Investigation

Proposed Residential Development  
Summerside West - Phases 4, 5 and 6  
Tenth Line Road - Ottawa

May 14, 2018

Report: PG4049-2

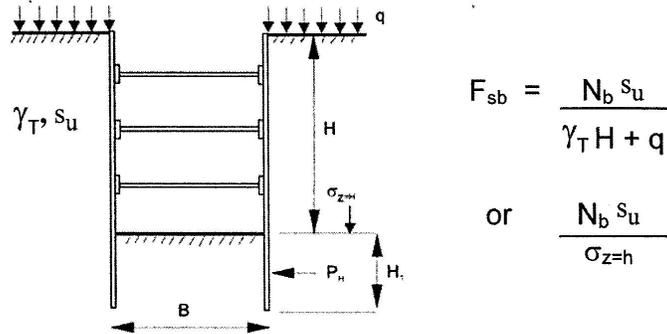
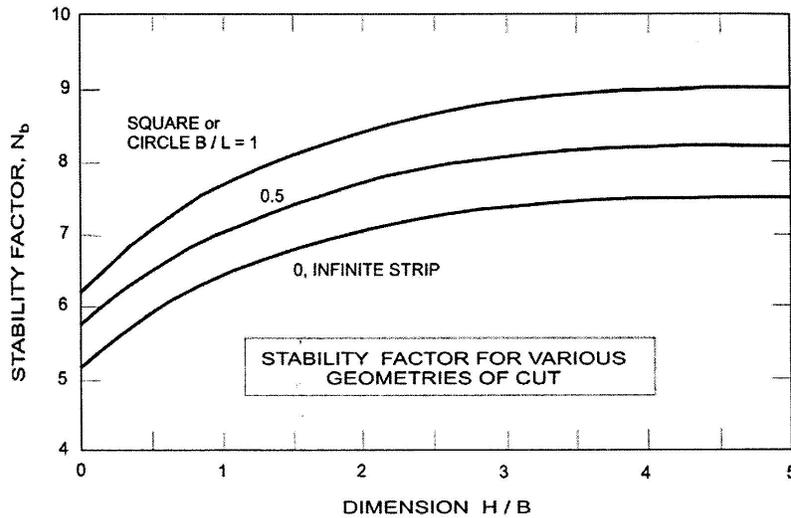
Figure 1 - Stability Factor for Various Geometries of Cut

$s_u$  - undrained shear strength of the soil below the base level

$\sigma_z$  - total overburden and surcharge pressures at the bottom of the excavation

In the case of soft to firm clays, a factor of safety of 2 is recommended for base stability.

Shear failure of excavation bases is typically rare in granular soils if adequate lateral support is provided. Inadequate dewatering can cause instability in excavations made through granular or layered soils. The potential for base heave in cohesive soils should be determined for stability of flexible retaining systems.

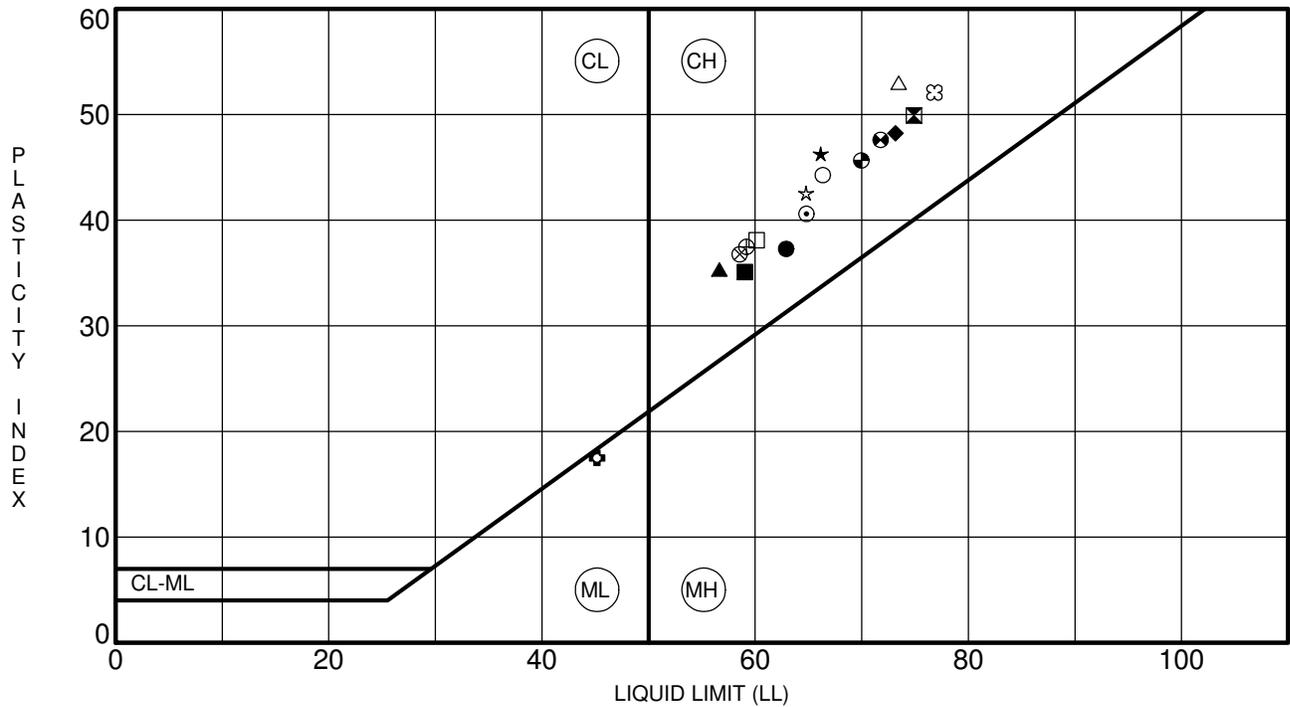
Specimen Identification	LL	PL	PI	Fines	Classification
● BH 1-18 SS 3	63	26	37		CH - Inorganic clays of high plasticity
⊠ BH 2-18 SS 2	75	25	50		CH - Inorganic clays of high plasticity
▲ BH 3-18 SS 3	57	21	35		CH - Inorganic clays of high plasticity
★ BH 4-18 SS 2	66	20	46		CH - Inorganic clays of high plasticity
⊙ BH 5-18 SS 2	65	24	41		CH - Inorganic clays of high plasticity
⊕ BH 6-18 SS 3	45	28	17		ML - Inorganic silt of low plasticity
○ BH 7-18 SS 2	66	22	44		CH - Inorganic clays of high plasticity
△ BH 8-18 SS 2	73	20	53		CH - Inorganic clays of high plasticity
⊗ BH 9-18 SS 3	59	22	37		CH - Inorganic clays of high plasticity
⊕ BH10-18 SS 2	59	22	37		CH - Inorganic clays of high plasticity
□ BH11-18 SS 3	60	22	38		CH - Inorganic clays of high plasticity
⊕ BH12-18 SS 2	72	24	48		CH - Inorganic clays of high plasticity
⊕ BH12-18 SS 3	70	24	46		CH - Inorganic clays of high plasticity
☆ BH13-18 SS 3	65	22	43		CH - Inorganic clays of high plasticity

⊗ BH14-18 SS 2	77	25	52		CH - Inorganic clays of high plasticity
■ BH15-18 SS 3	59	24	35		CH - Inorganic clays of high plasticity
◆ BH16-18 SS 2	73	25	48		CH - Inorganic clays of high plasticity

<b>Table 1 - Summary of Atterberg Limits Tests</b>					
<b>Sample</b>	<b>Moisture Content %</b>	<b>Liquid Limit %</b>	<b>Plastic Limit %</b>	<b>Plasticity Index %</b>	<b>Classification</b>
BH 1-18 SS 3	n/a	63	26	37	CH
BH 2-18 SS 2	38.0	75	25	50	CH
BH 3-18 SS 3	n/a	57	21	35	CH
BH 4-18 SS 2	49.5	66	20	46	CH
BH 5-18 SS 2	38.0	65	24	41	CH
BH 6-18 SS 3	n/a	45	28	17	ML
BH 7-18 SS 2	37.6	66	22	44	CH
BH 8-18 SS 2	35.2	73	20	53	CH
BH 9-18 SS 3	41.2	59	22	37	CH
BH 10-18 SS 2	42.0	59	22	37	CH
BH 11-18 SS 3	65.2	60	22	38	CH
BH 12-18 SS 2	40.1	72	24	48	CH
BH 12-18 SS 3	n/a	70	24	46	CH
BH 13-18 SS 3	38.7	65	22	43	CH
BH 14-18 SS 2	47.2	77	25	52	CH
BH 15-18 SS 3	n/a	59	24	35	CH
BH 16-18 SS 2	47.2	73	25	48	CH

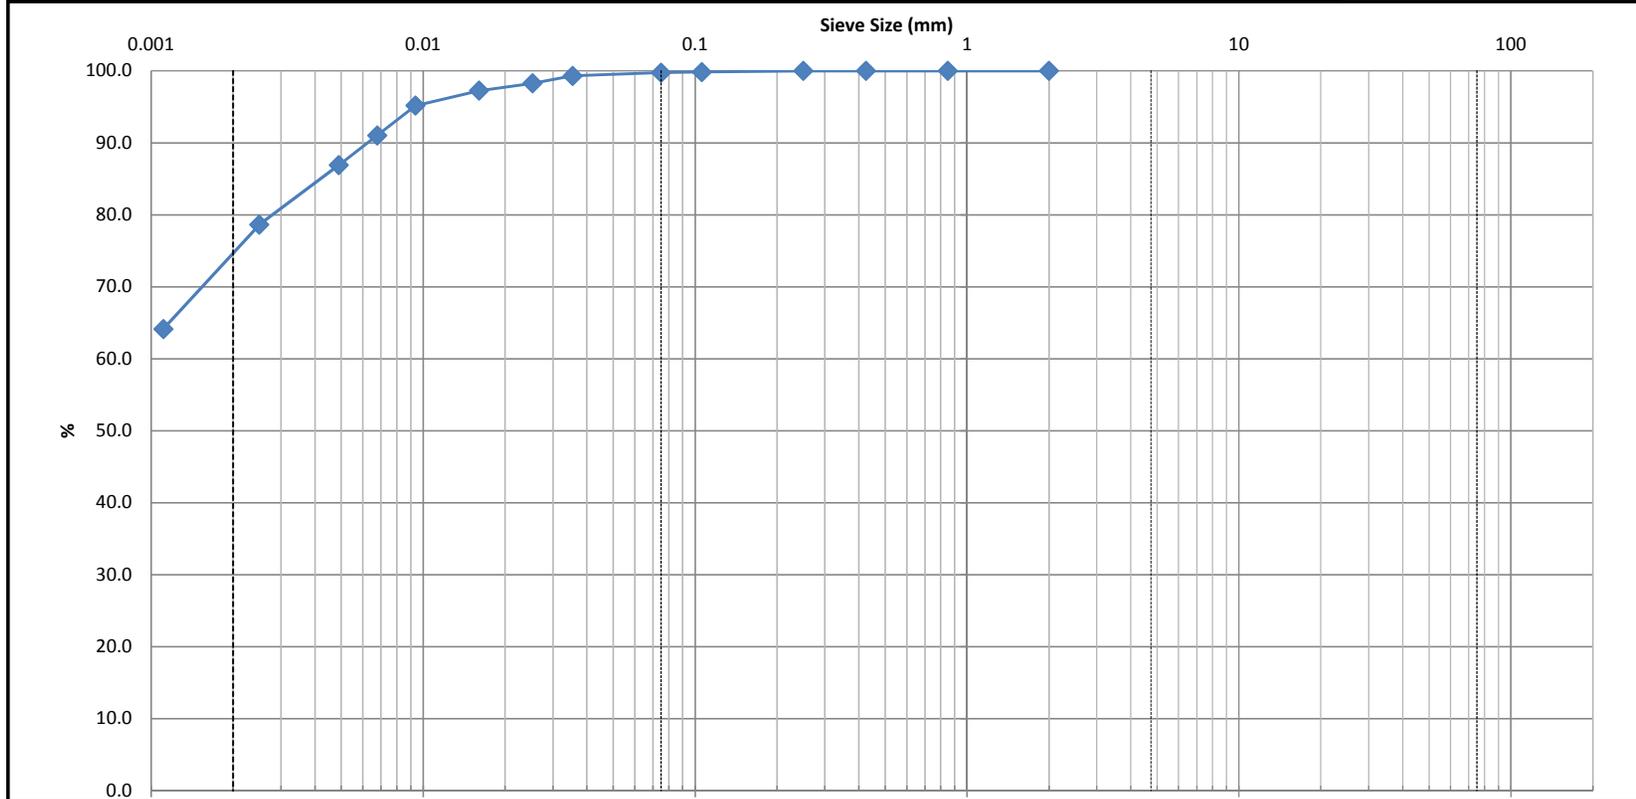
Identification	Soil Classification					MC(%)	LL	PL	PI	Cc	Cu
						28.2					
	D100	D60	D30	D10	Gravel (%)	Sand (%)	Silt (%)	Clay (%)			
				0.0	0.3	25.2	74.5

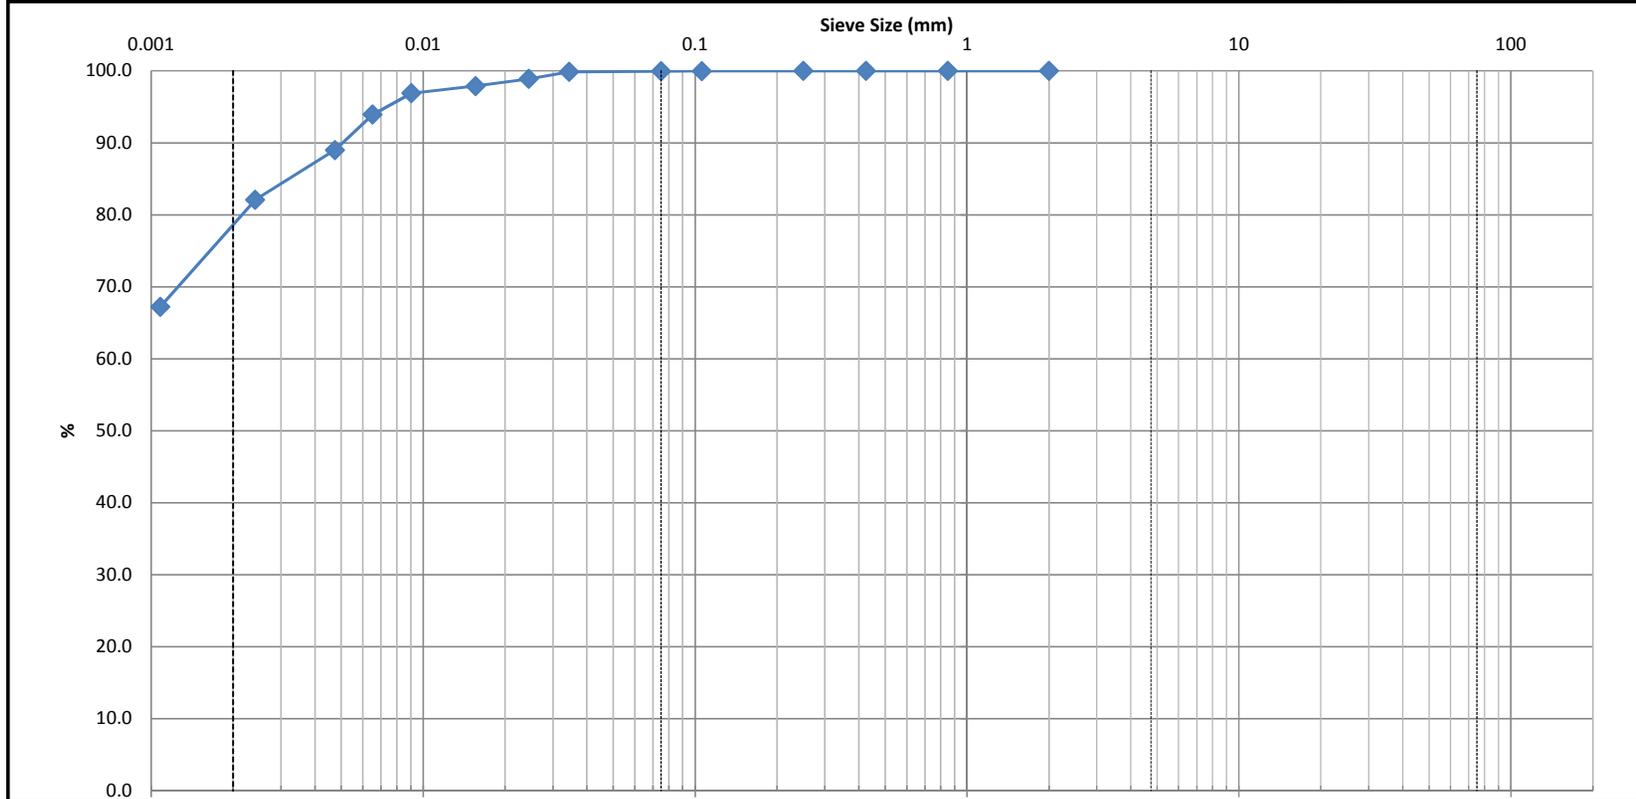
Identification	Soil Classification					MC(%)	LL	PL	PI	Cc	Cu
						45.4					
	D100	D60	D30	D10	Gravel (%)	Sand (%)	Silt (%)	Clay (%)			
				0.0	0.1	20.9	79.0

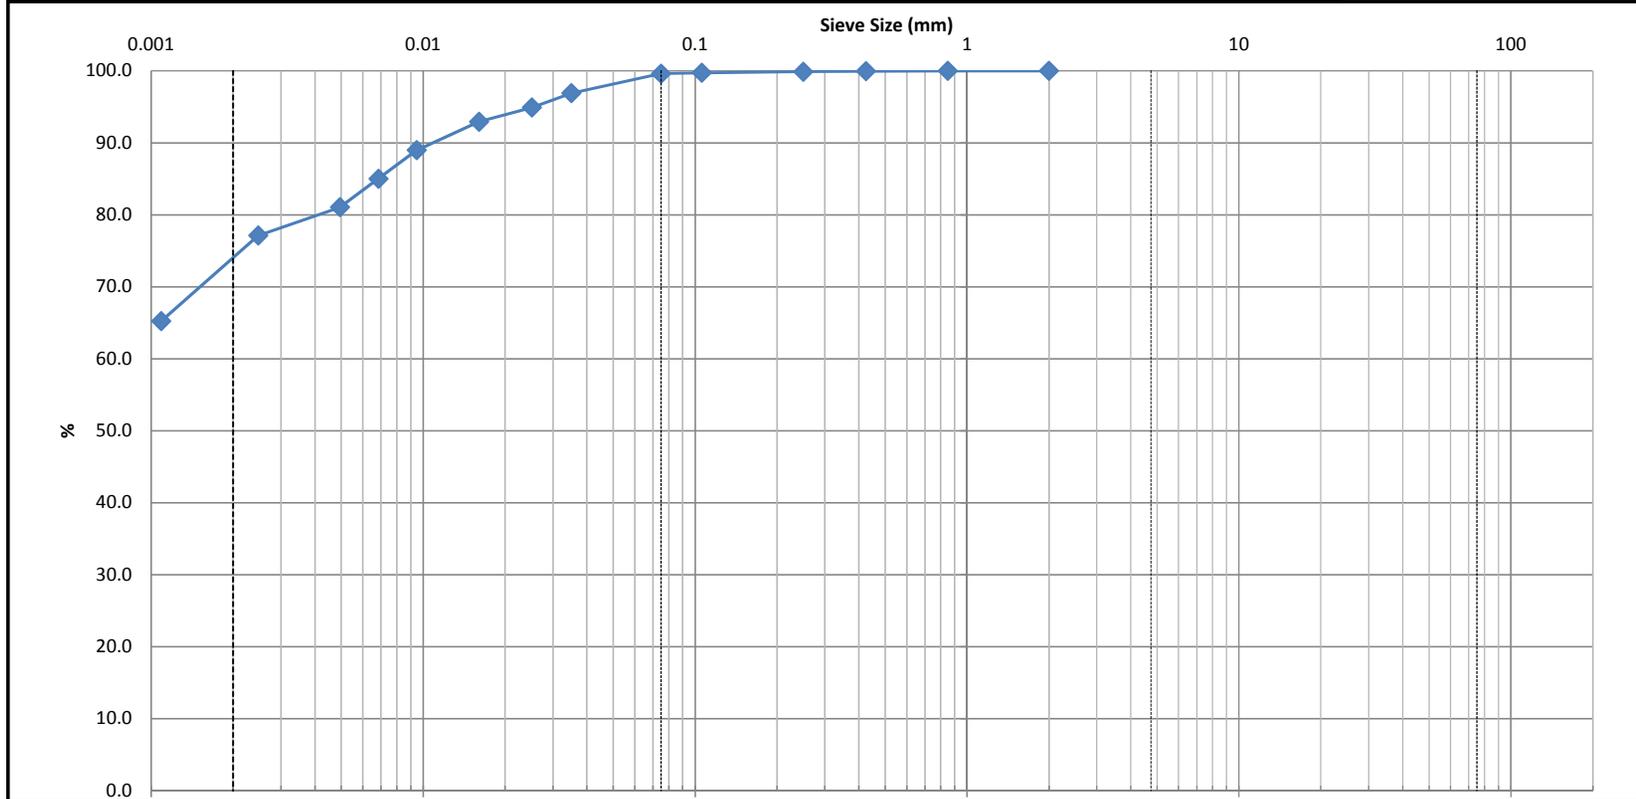
Identification	Soil Classification					MC(%)	LL	PL	PI	Cc	Cu
						27.1					
	D100	D60	D30	D10	Gravel (%)	Sand (%)	Silt (%)	Clay (%)			
				0.0	0.4	25.1	74.5

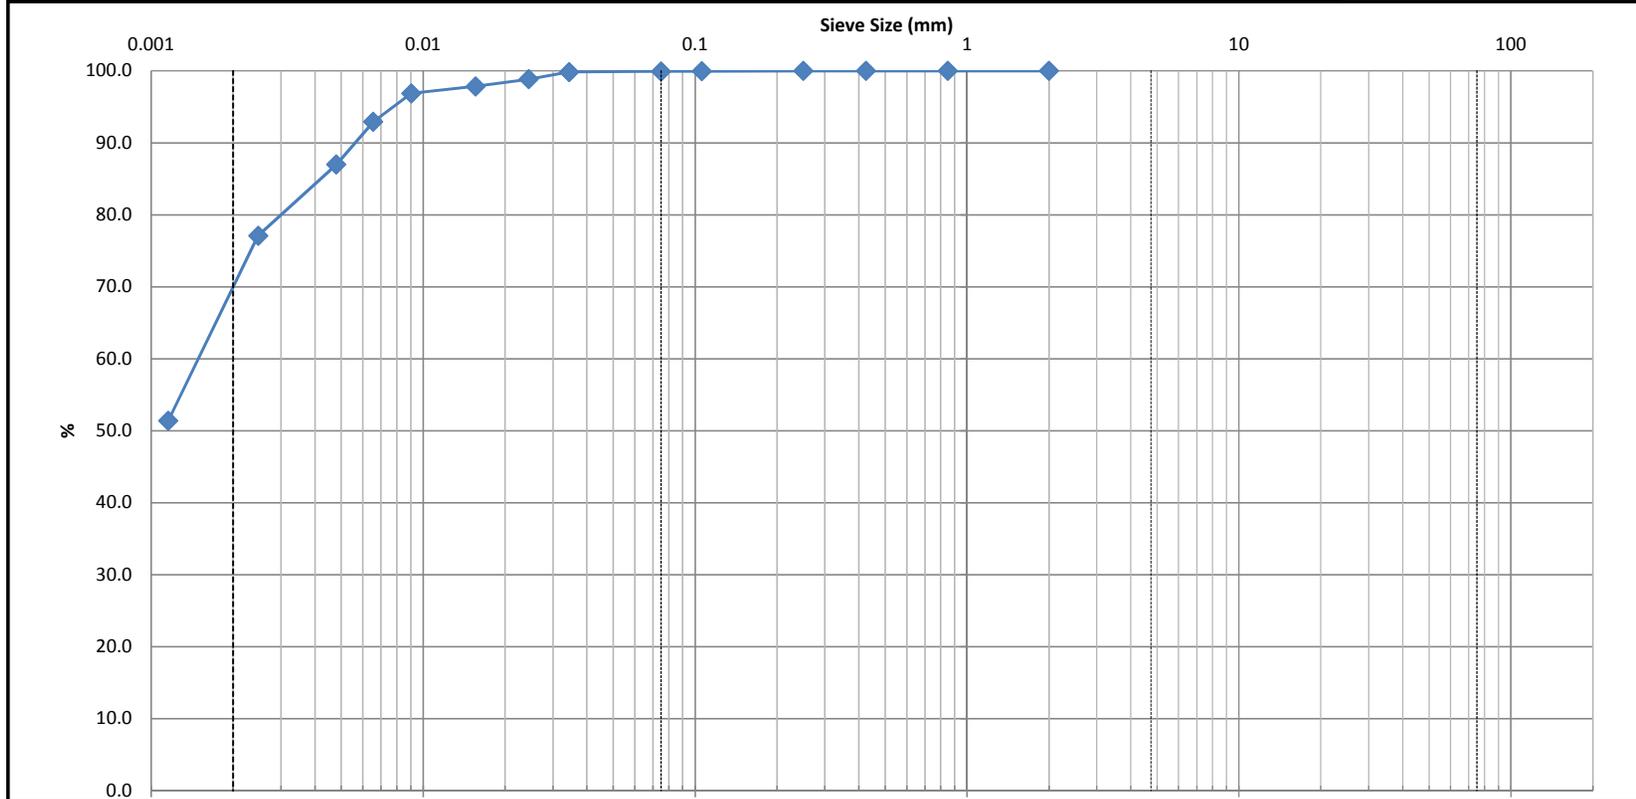
Identification	Soil Classification					MC(%)	LL	PL	PI	Cc	Cu
						27.1					
	D100	D60	D30	D10	Gravel (%)	Sand (%)	Silt (%)	Clay (%)			
				0.0	0.1	30.4	69.5

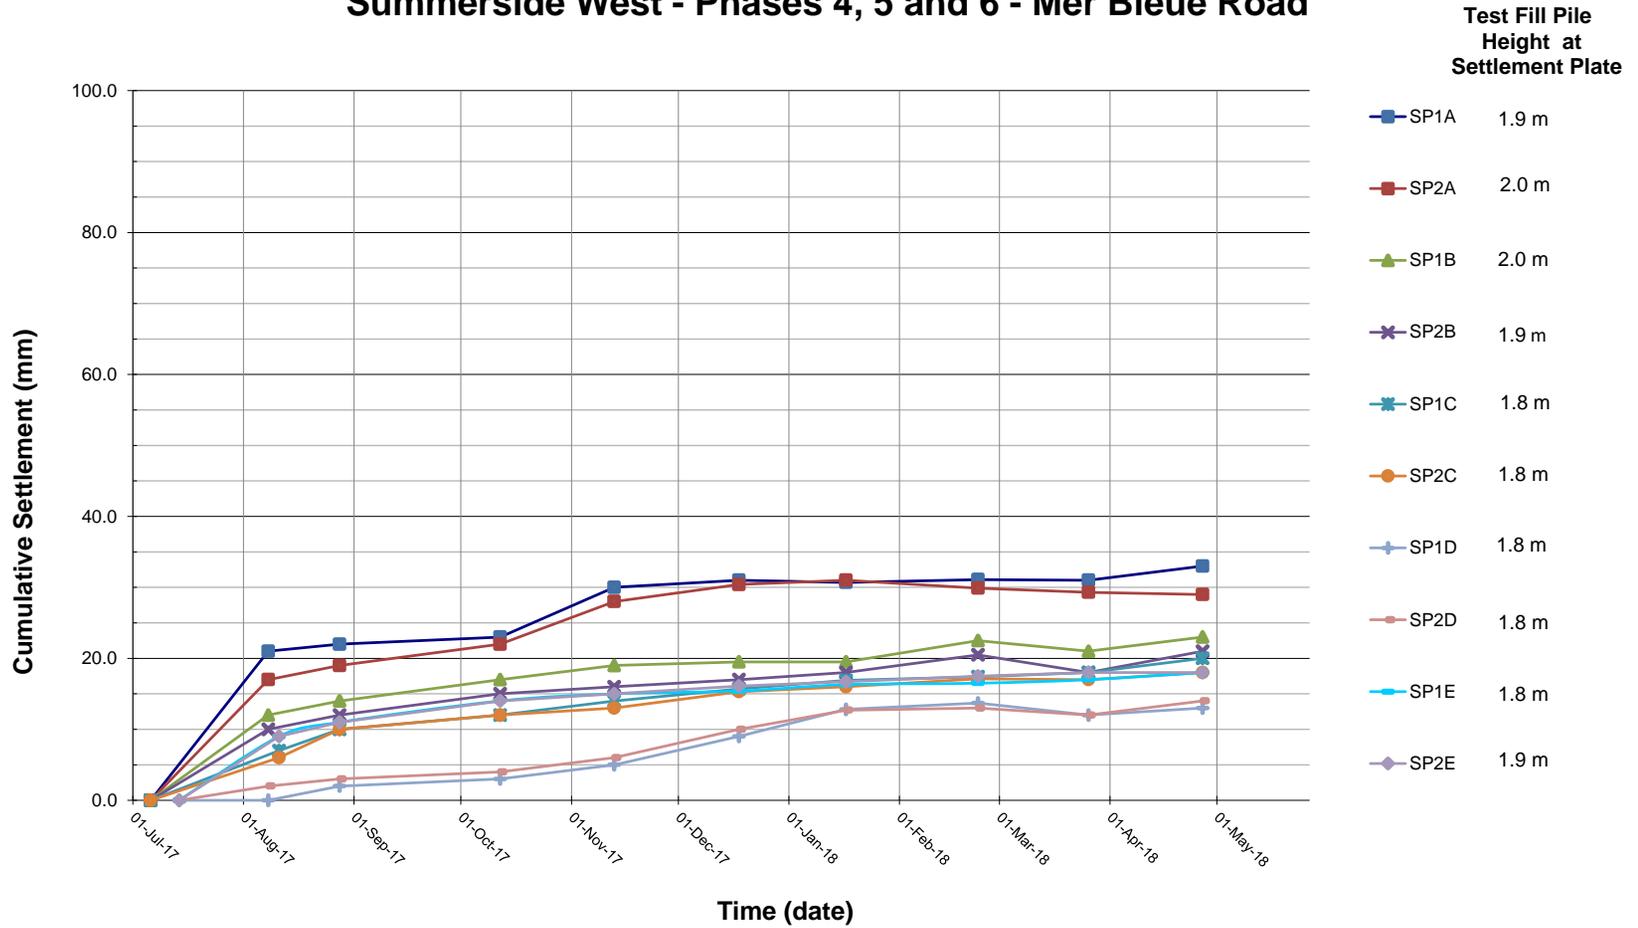
**Figure 2 - Test Fill Pile Settlement Monitoring Program  
Summerside West - Phases 4, 5 and 6 - Mer Bleue Road**

The results of our survey are presented in Figure 2 - Test Fill Settlement Monitoring Program in Appendix 2. Total settlement of less than 25 mm was observed at all of the test fill piles, except Test Fill Pile A where total settlement of less than 35 mm was recorded up to May 2018. Less than 5 mm of settlement was observed at all settlement monitoring plates over the last 6 months. Therefore, it is expected that majority of the primary settlement has occurred to date.

Based on the settlement data recorded, a permissible grade raise has been updated for the subject site. Our permissible grade raise recommendations for the subject site are presented in Subsection 5.3.

Generally, the potential long term settlement is evaluated based on the compressibility characteristics of the silty clay. A test fill settlement monitoring program was recently completed for the subject site to accurately model the site permissible grade raise recommendations. Based on the test fill monitoring program results, a permissible grade raise restriction of **1.3 m** above original ground surface is recommended for grading within 4 m of the proposed buildings and a permissible grade raise of **1.5 m** is recommended for roadways. It should be noted that the abovenoted permissible grade raise value is based on the results of our test fill settlement monitoring program. Figure 2 - Test Fill Pile Settlement Monitoring Program in Appendix 2 presents the results of our test fill settlement monitoring program to date.

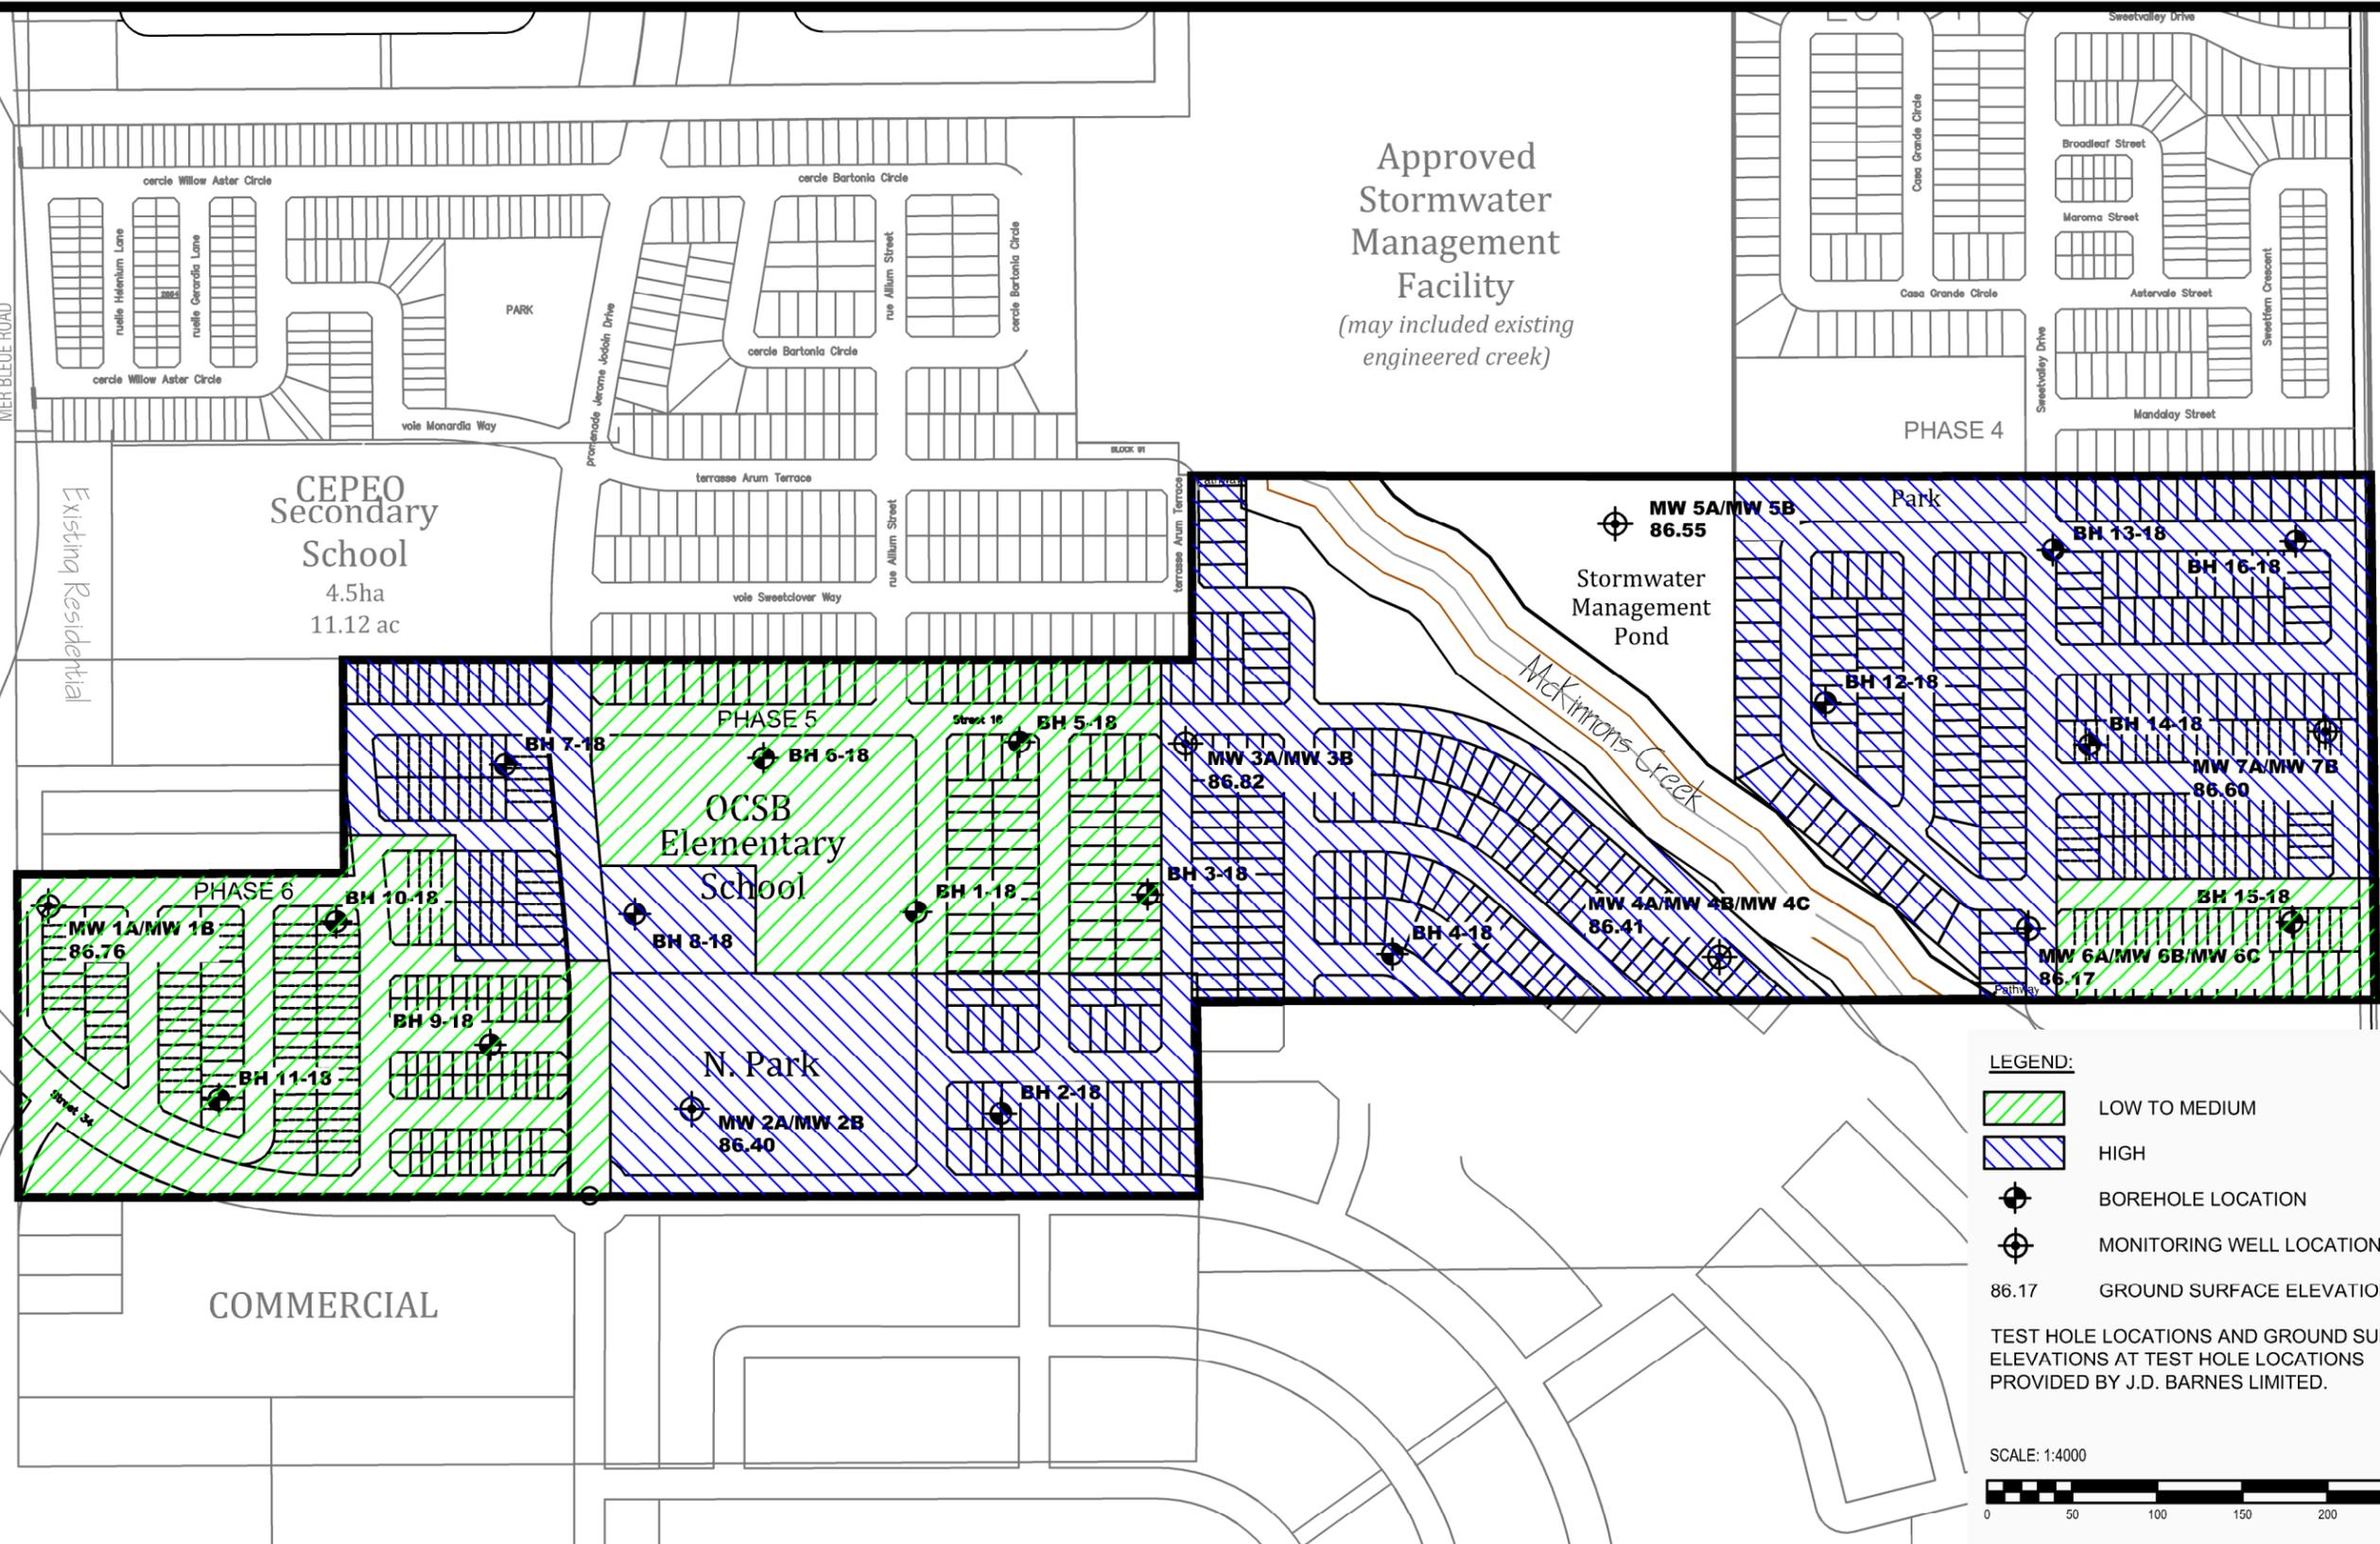
- LEGEND:**
- LOW TO MEDIUM
  - HIGH
  - BOREHOLE LOCATION
  - MONITORING WELL LOCATION
  - 86.17 GROUND SURFACE ELEVATION (m)

TEST HOLE LOCATIONS AND GROUND SURFACE ELEVATIONS AT TEST HOLE LOCATIONS PROVIDED BY J.D. BARNES LIMITED.
