REPORT ON

GEOTECHNICAL INVESTIGATION
PROPOSED COMMERCIAL BUILDING
3443 INNES ROAD
INNES WARD
CITY OF OTTAWA, ONTARIO

June 2017

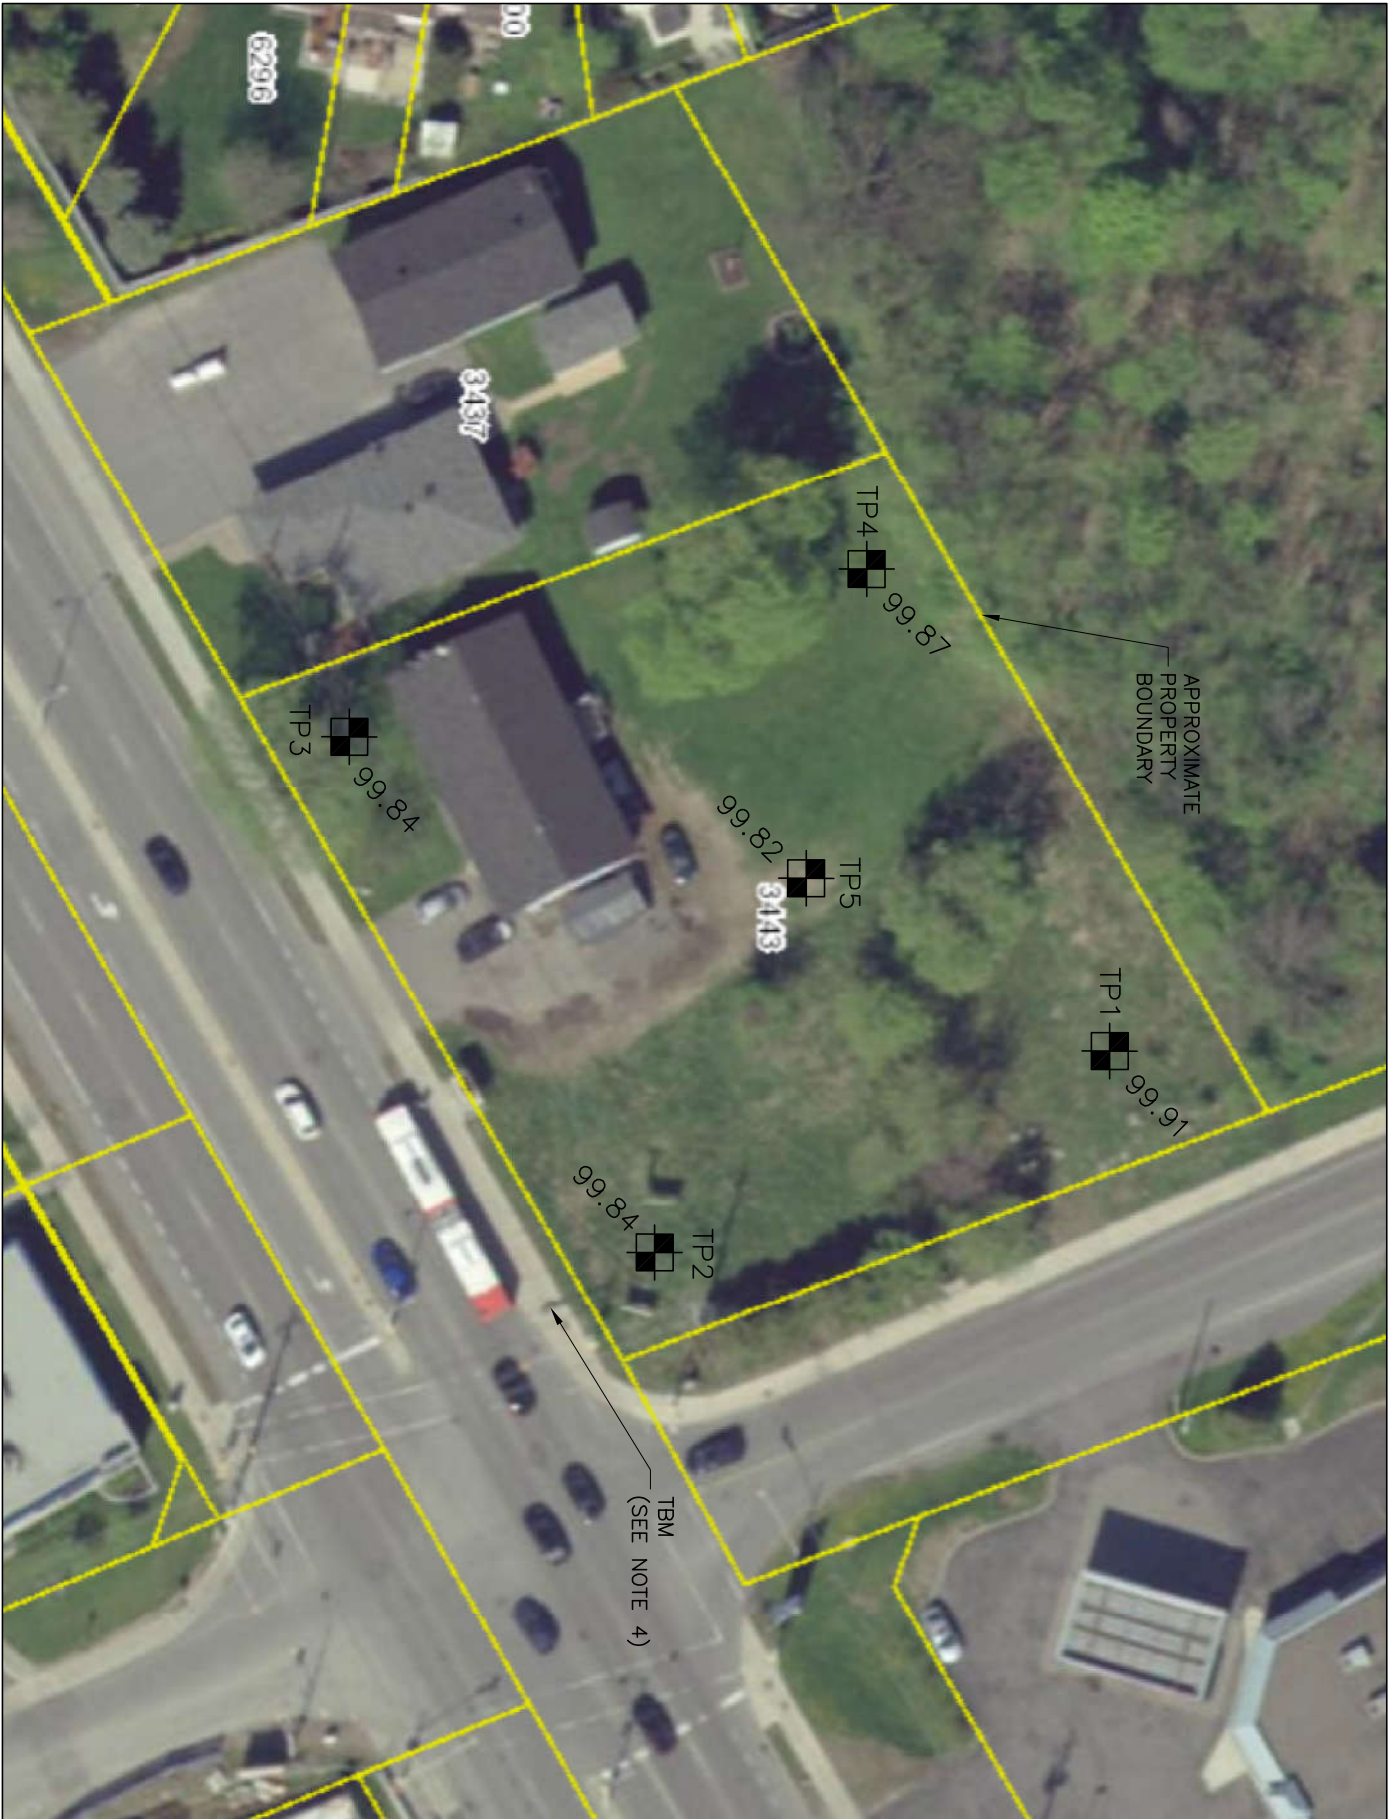
FIGURE 3 – SITE SKETCH PLAN

completion. A description of the subsurface conditions encountered at each of the test pits is given in the attached Record of Test Pits sheets. The approximate locations of the test pits are shown on the attached Site Sketch Plan, Figure 3.

The ground surface elevations at the test pits were measured by members of our engineering staff relative to a temporary benchmark with an assigned elevation of 100.00 metres local datum (see Site Sketch Plan, Figure 3).

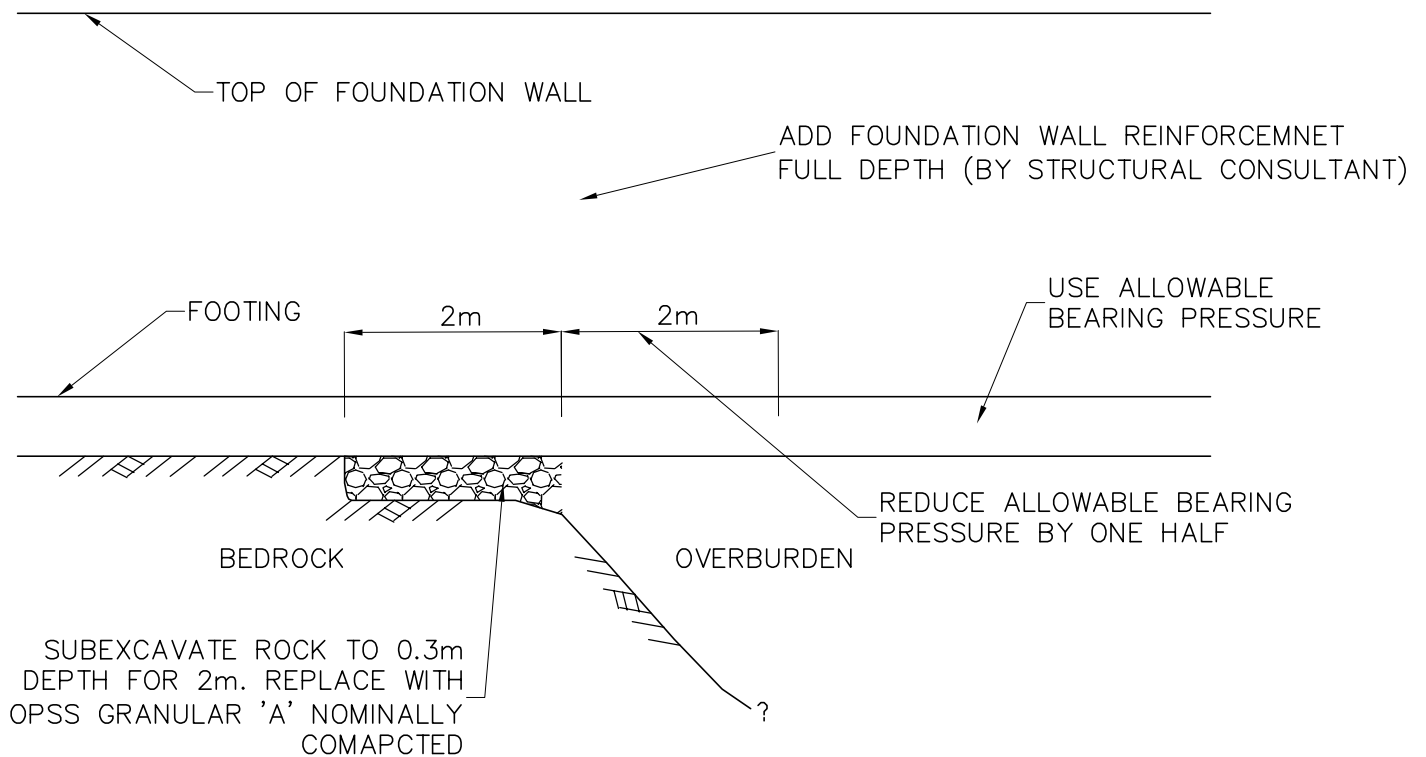
FIGURE 4

TYPICAL BEDROCK/OVERBURDEN FOOTING TRANSITION DETAIL

In view of the presence of the silty sand, silty clay and glacial till at the site, it is strongly suggested that footings for the proposed building should be founded all on the silty sand and/or silty clay and/or glacial till and/or engineered fill or all on the bedrock subgrade to minimize the potential for foundation wall cracks in overburden to bedrock subgrade transition areas. Where footings are founded on both the silty sand and/or silty clay and/or glacial till and/or engineered fill and the bedrock a suitable footing subgrade transition treatment, such as shown in Figure 4, should be used in conjunction with an engineered structural design to resist potential distress for up to 25 millimetres of differential settlement across the transition.
