Client: Ottawa Community Housing

Project:  
**811 GLADSTONE AFFORDABLE HOUSING**

Drawing:  
**TREE CONSERVATION REPORT**

| Project Number:<br>2008-01 | Sheet Number:<br>TCR 1 |

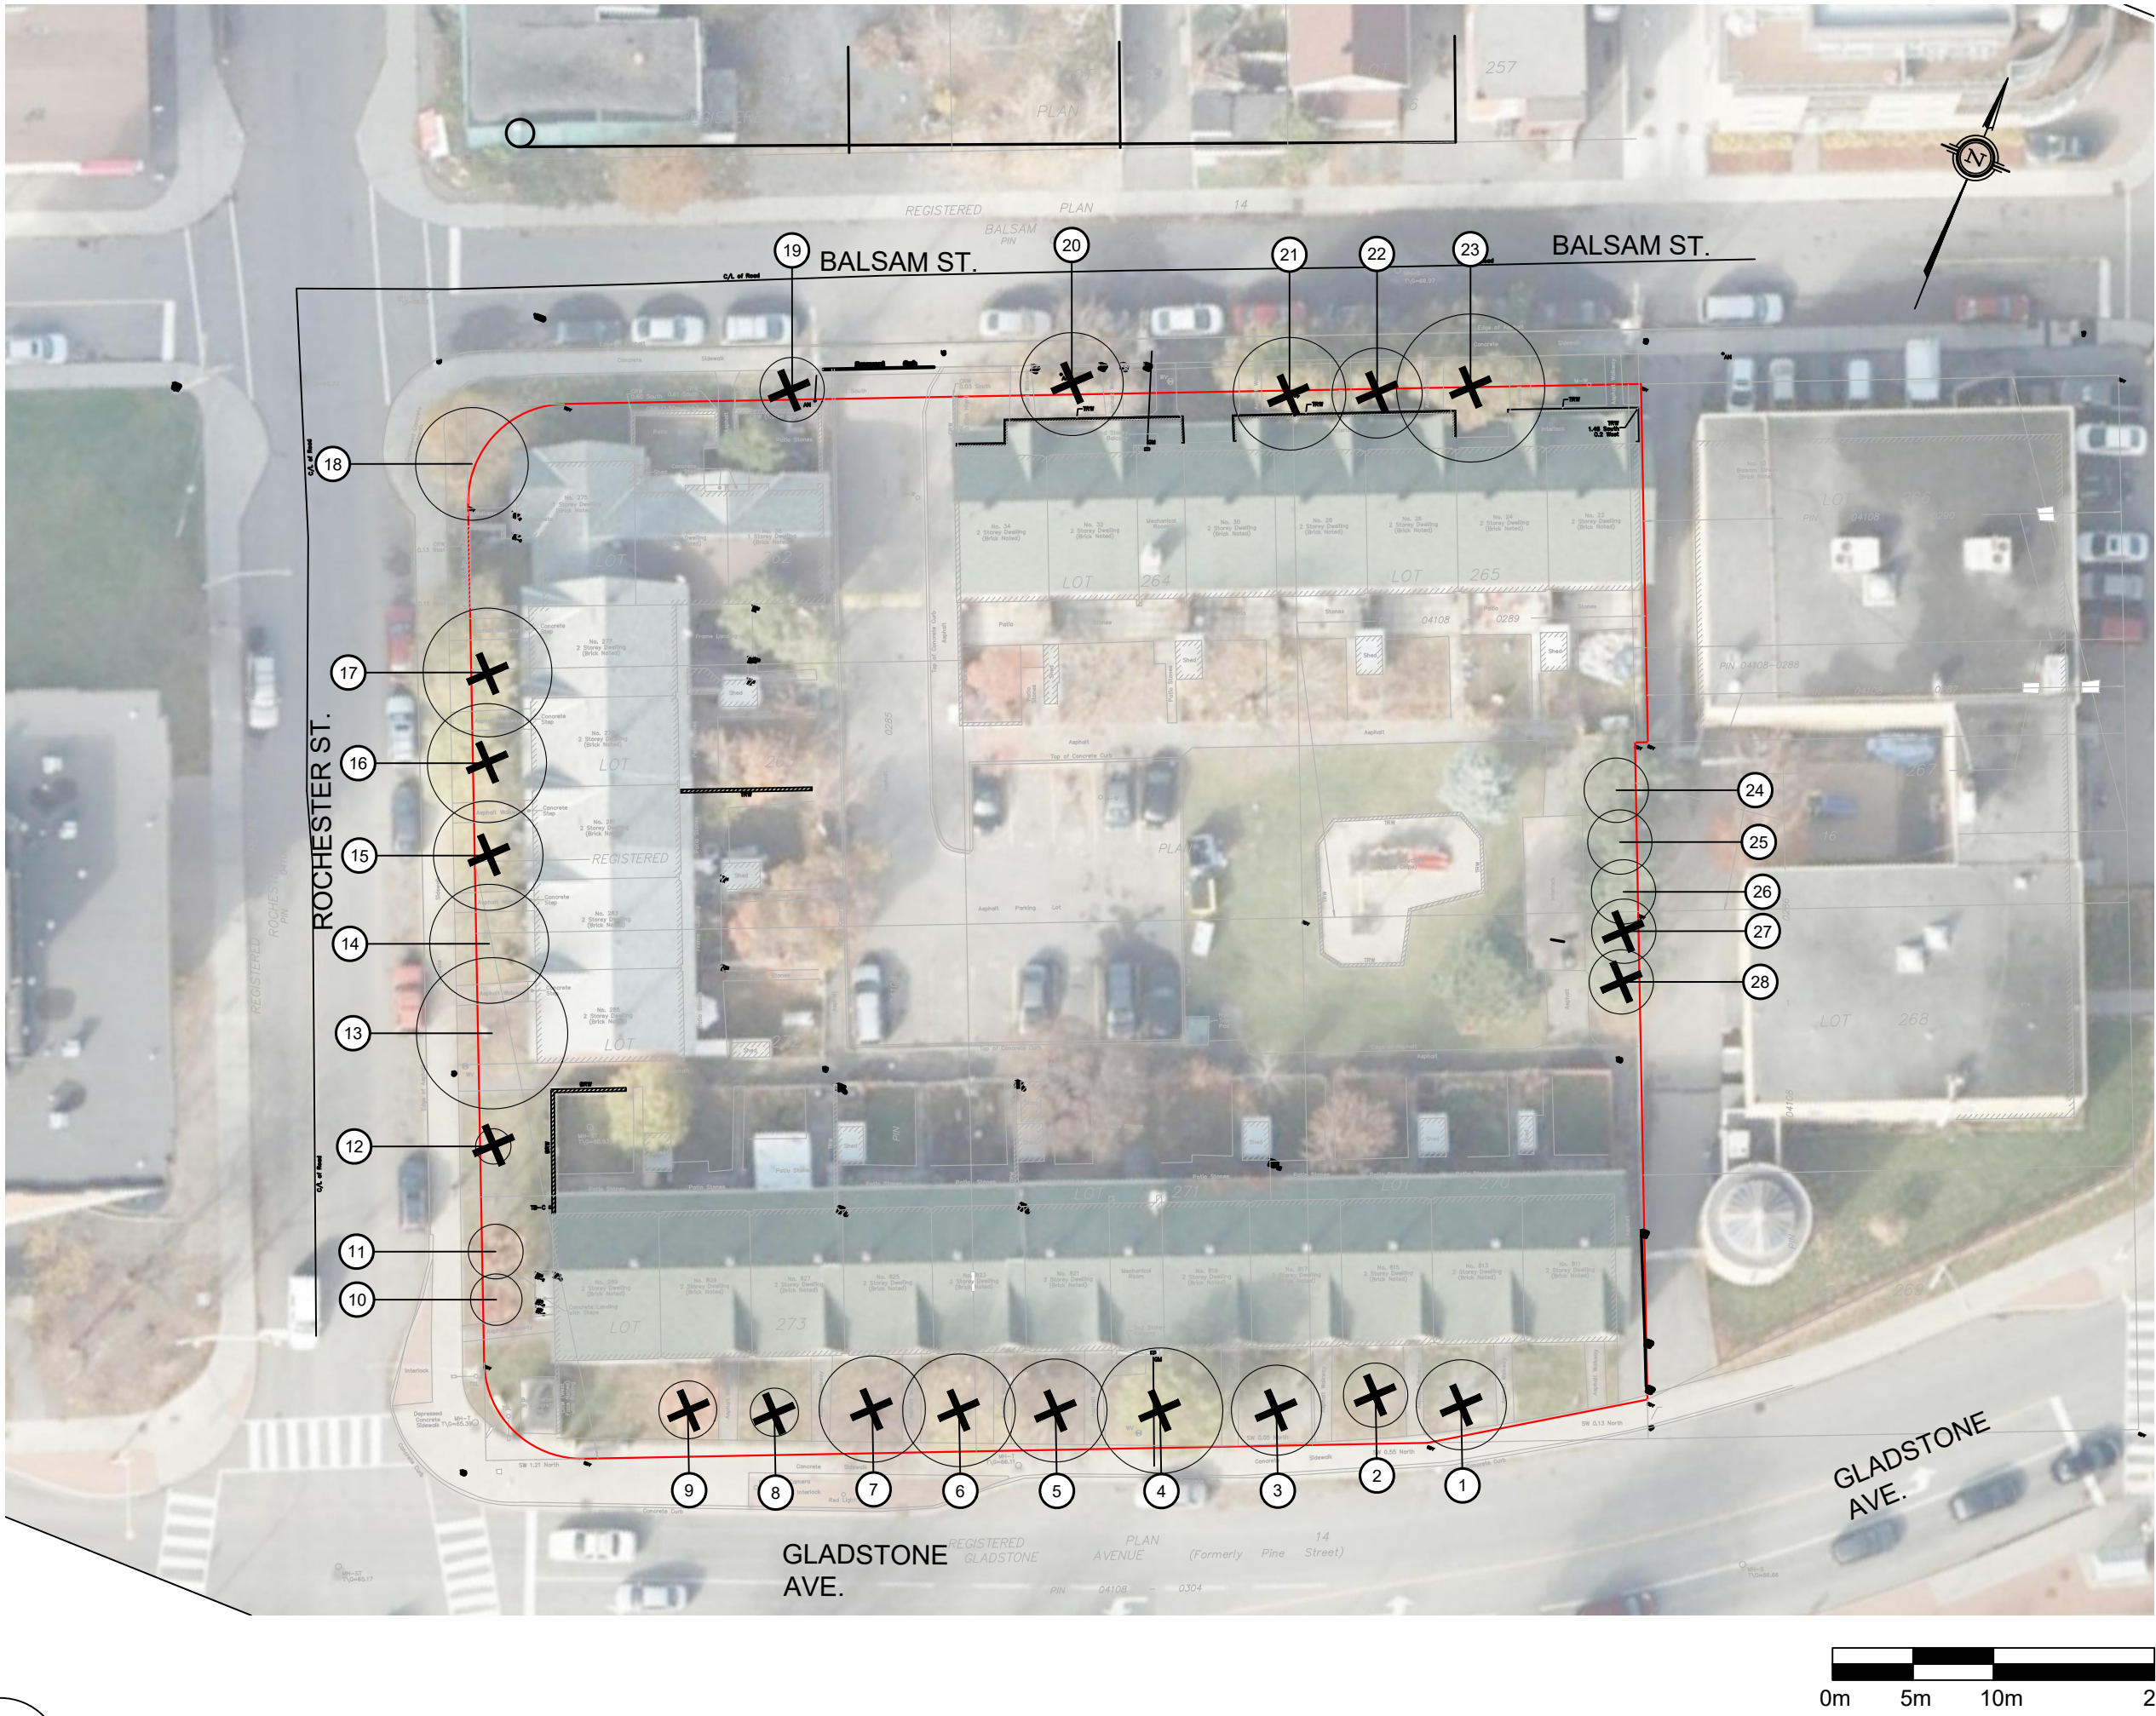
1

## CURRENT VEGETATION

Scale: 1:400
