Muncaster
Environmental
Planning Inc.

August 20, 2019

**RE: Environmental Impact Statement and Tree Conservation Report Update
Cardinal Creek Village - Phases 5 and 6**

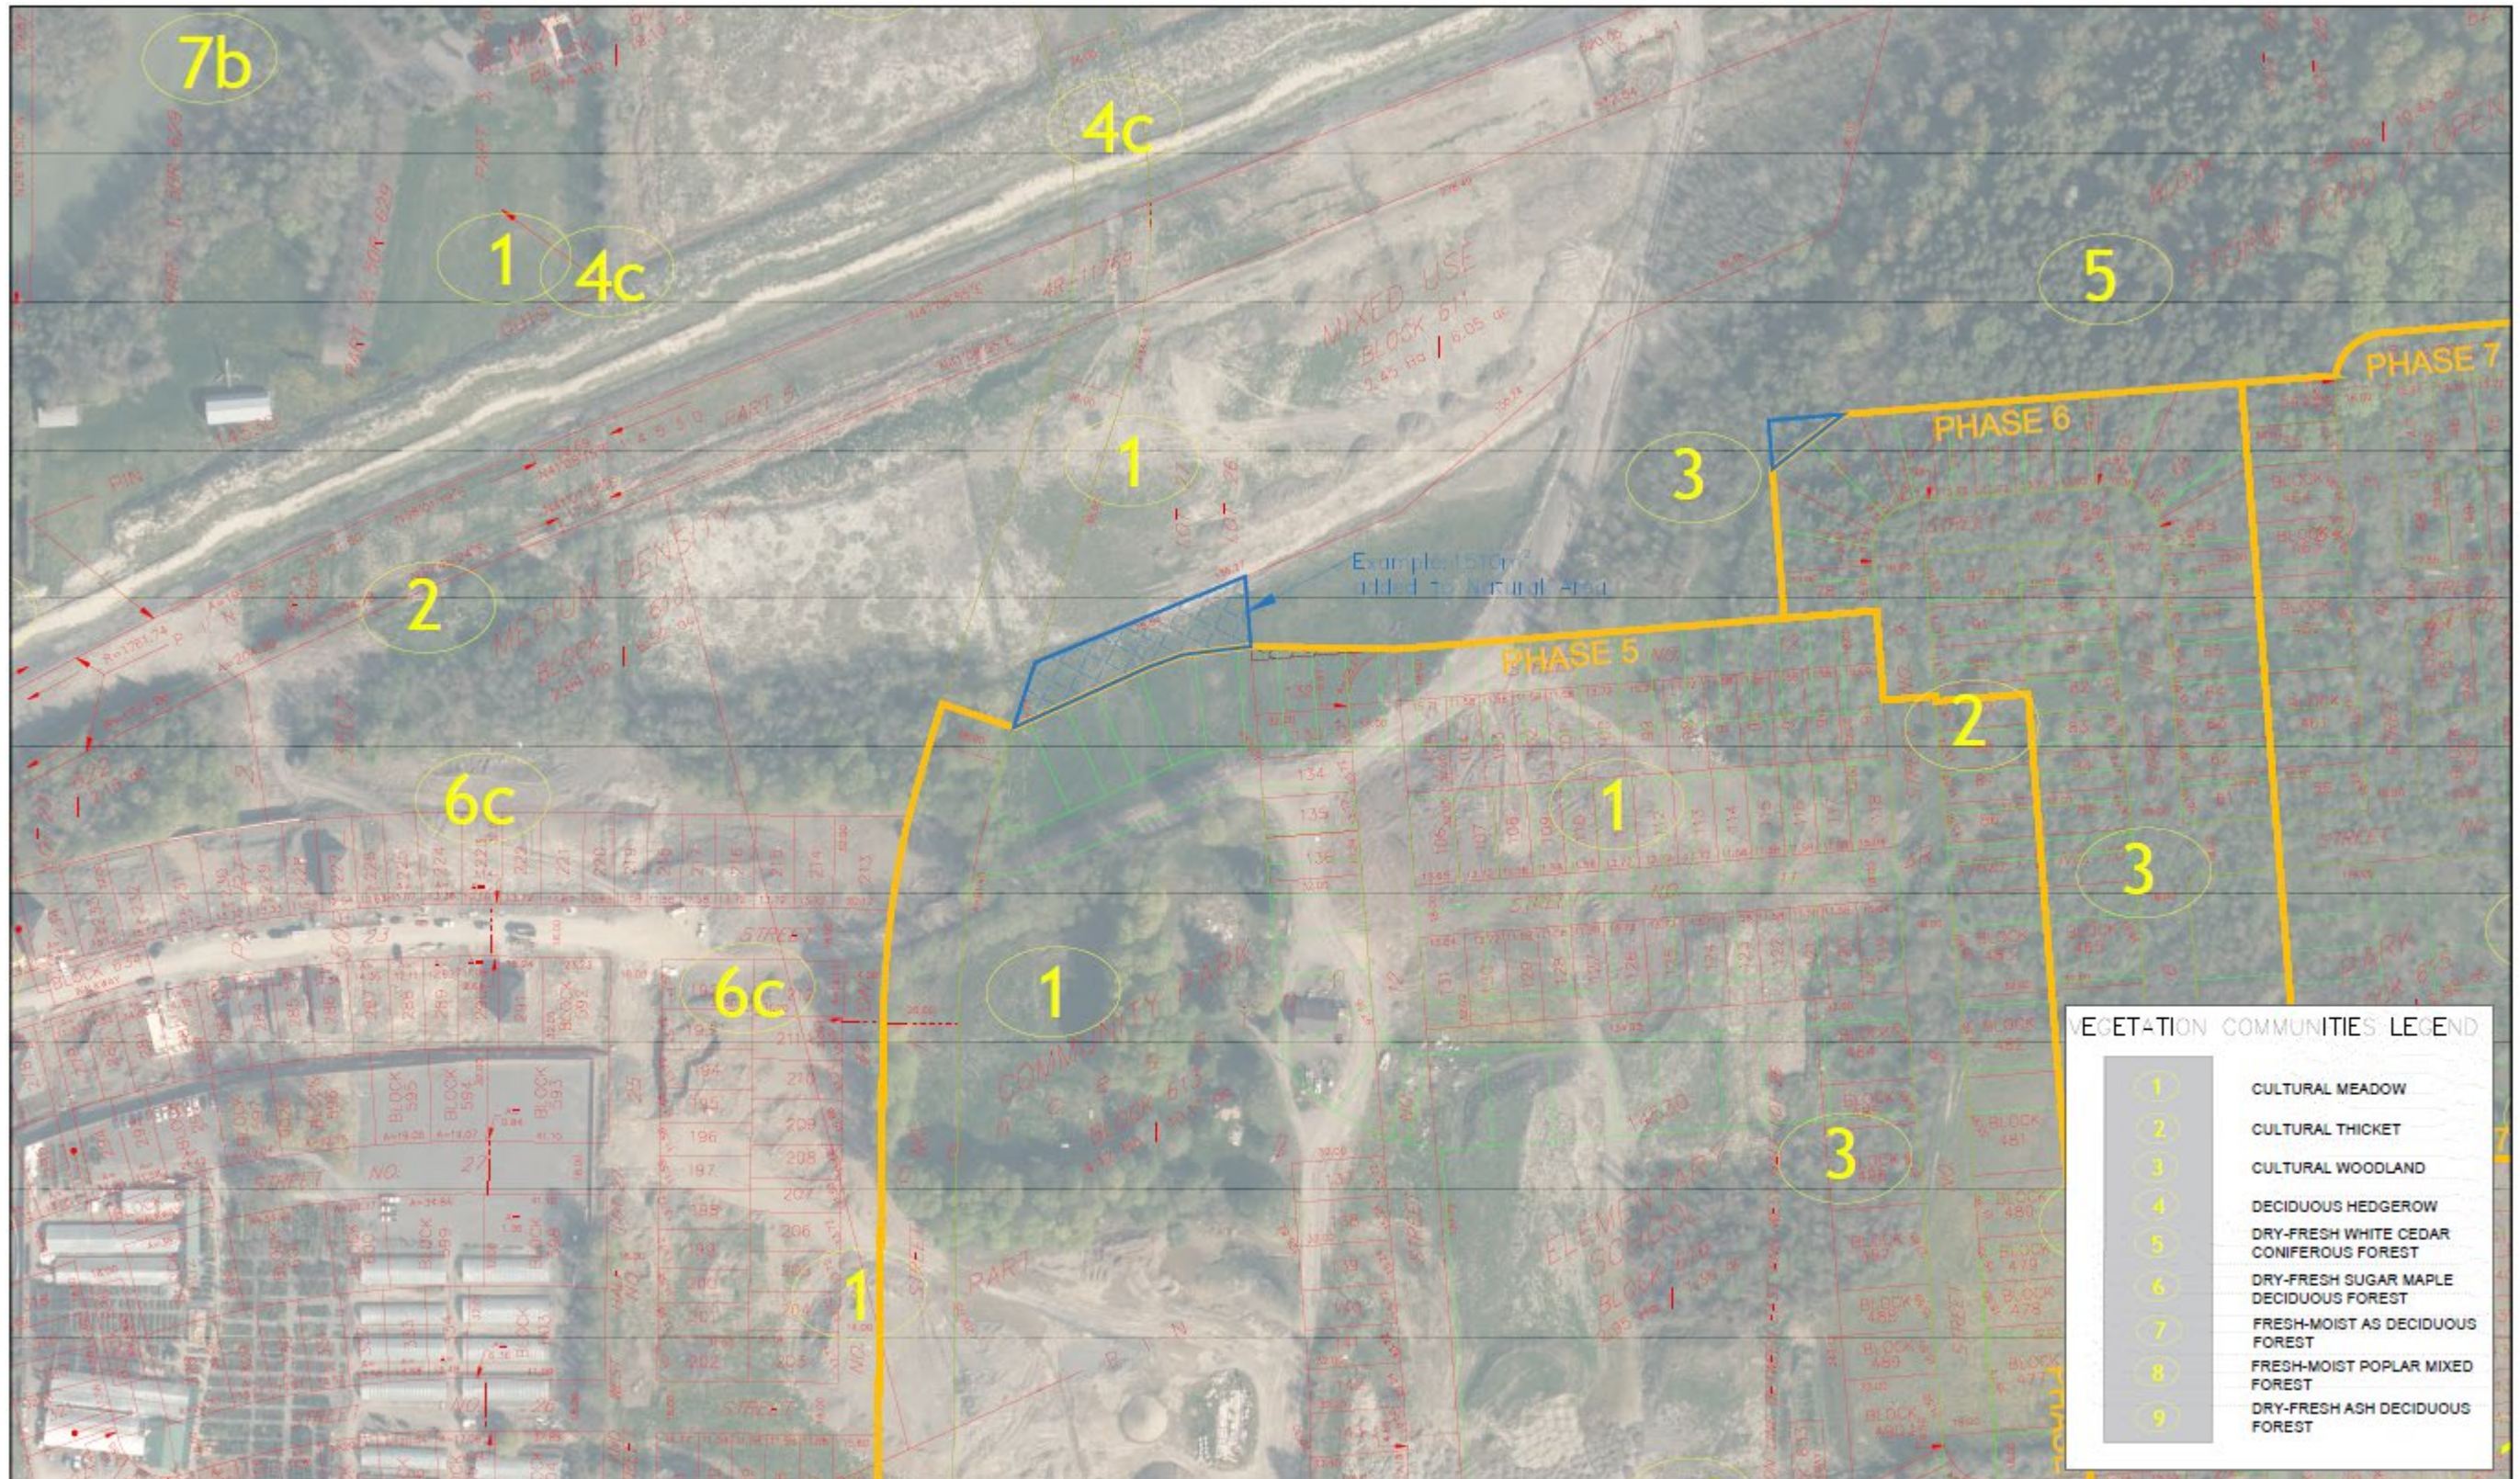
FIGURE 1 – PHASES 5 and 6 – NORTH PORTION

**CURRENT CARDINAL CREEK VILLAGE PHASES 5/6/7
 & ORIGINAL DEC 2013 DRAFT PLAN OVERLAY**

The Phase 5 and 6 lands are dominated by agricultural fields, with deciduous hedgerows between the agricultural fields, and cultural meadows, thickets, and woodlands present in the north portion. The deciduous hedgerows (vegetation community '4f' on Figure 2) are dominated by white ash up to 55cm diameter at breast height (dbh), with green ash and white elm up to 38cm dbh well represented. Many of the ash and elm have reduced leaf-out and vine coverage is common.

The cultural woodland (vegetation community '3' on Figures 1 and 2) includes regenerating trembling aspen, apple, sugar maple, white ash, white elm, and green ash up to 25cm dbh. Many of the trees have fungal growth, while vine coverage is common on others. Ash regeneration is extensive in the meadow and thicket habitats north of Old Montreal Road, with Manitoba maple and poplar regeneration also present. Many of these trees also have fungal growth while vine coverage is common on others. Common buckthorn, glossy buckthorn, red-osier dogwood, red raspberry, staghorn sumac, slender willow, Bebb's willow, apple, highbush cranberry and hawthorn shrubs are well represented in the cultural habitats (vegetation communities '1', '2',

and ‘3’ on Figures 1 and 2), with the hawthorn and apple shrubs particularly dense in many areas.

As shown on Figures 1 and 2 below, some minor changes are proposed to the lands to be included as part of the undisturbed natural areas:

- 1) in the northwest portion of the Phase 5 lands, within a former agricultural field, 1,510 m² are proposed to be added the lands not be disturbed and zoned *Environmental Protection* (see blue hatching on Figure 1). This addition will be contiguous with the *Environmental Protection* lands to the east however the addition is over 80 metres west of the current west edge of the cultural woodland and upland cedar forest. Note that a six metre servicing corridor will be required in this area in the future. This is the same corridor that will be required in the *Environmental Protection* lands to the east.

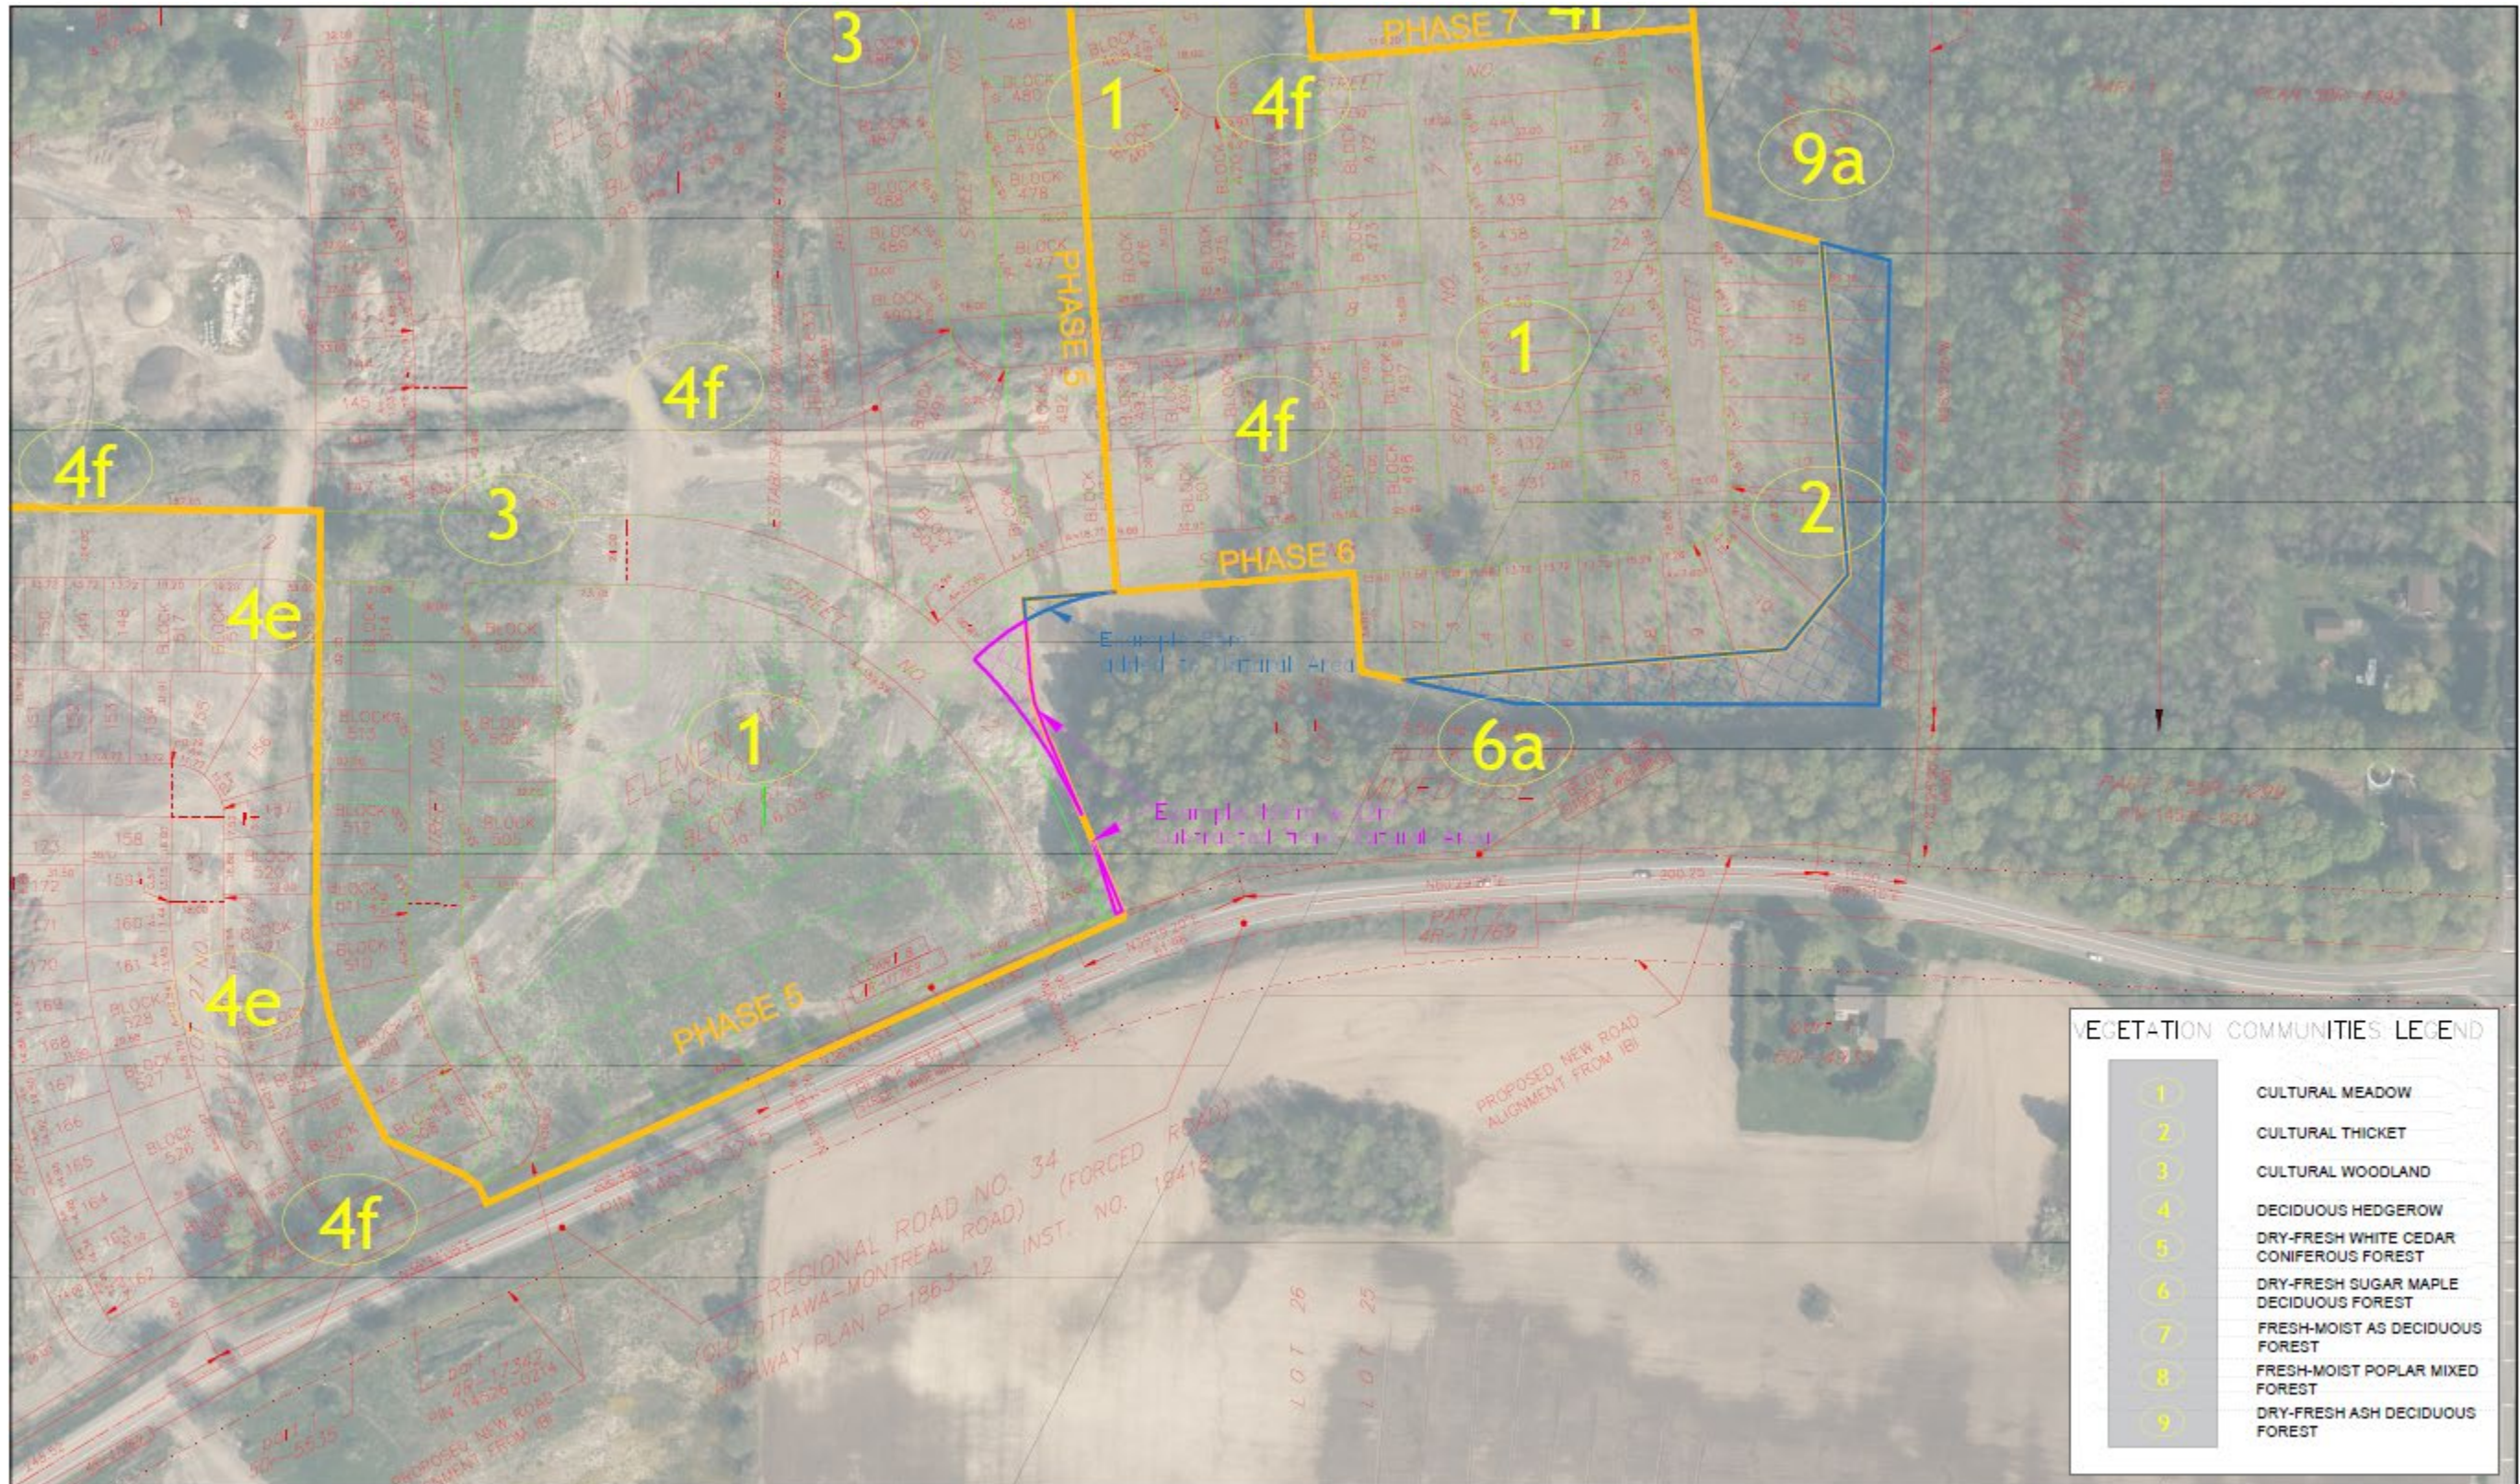
FIGURE 2 – PHASES 5 and 6 – SOUTH PORTION

CURRENT CARDINAL CREEK VILLAGE PHASES 5/6/7 & ORIGINAL DEC 2013 DRAFT PLAN OVERLAY

2) South of Old Montreal Road where the edge of *Environmental Protection* lands was formerly associated with the edge of the Famille Laporte right-of-way where it curved around to meet Old Montreal Road. Under the updated road network and development concept, the boundary has been adjusted to add 85m² to the area not to be disturbed (see blue hatching on Figure 2), with 422m² and 32m² proposed for removal from the *Environmental Protection* zoning (see pink hatching on Figure 2). Both the addition and subtraction are in a former agricultural field to the northwest of the upland maple forest along the escarpment north of Old Montreal Road. At the closest point the subtraction will be over seven metres west of the maple forest and thus the critical root zones of the adjacent trees are not anticipated to be impacted.
