29 SELKIRK STREET  
DEVELOPMENT

29 SELKIRK STREET  
OTTAWA, ONTARIO

TREE CONSERVATION  
REPORT

TCR 01

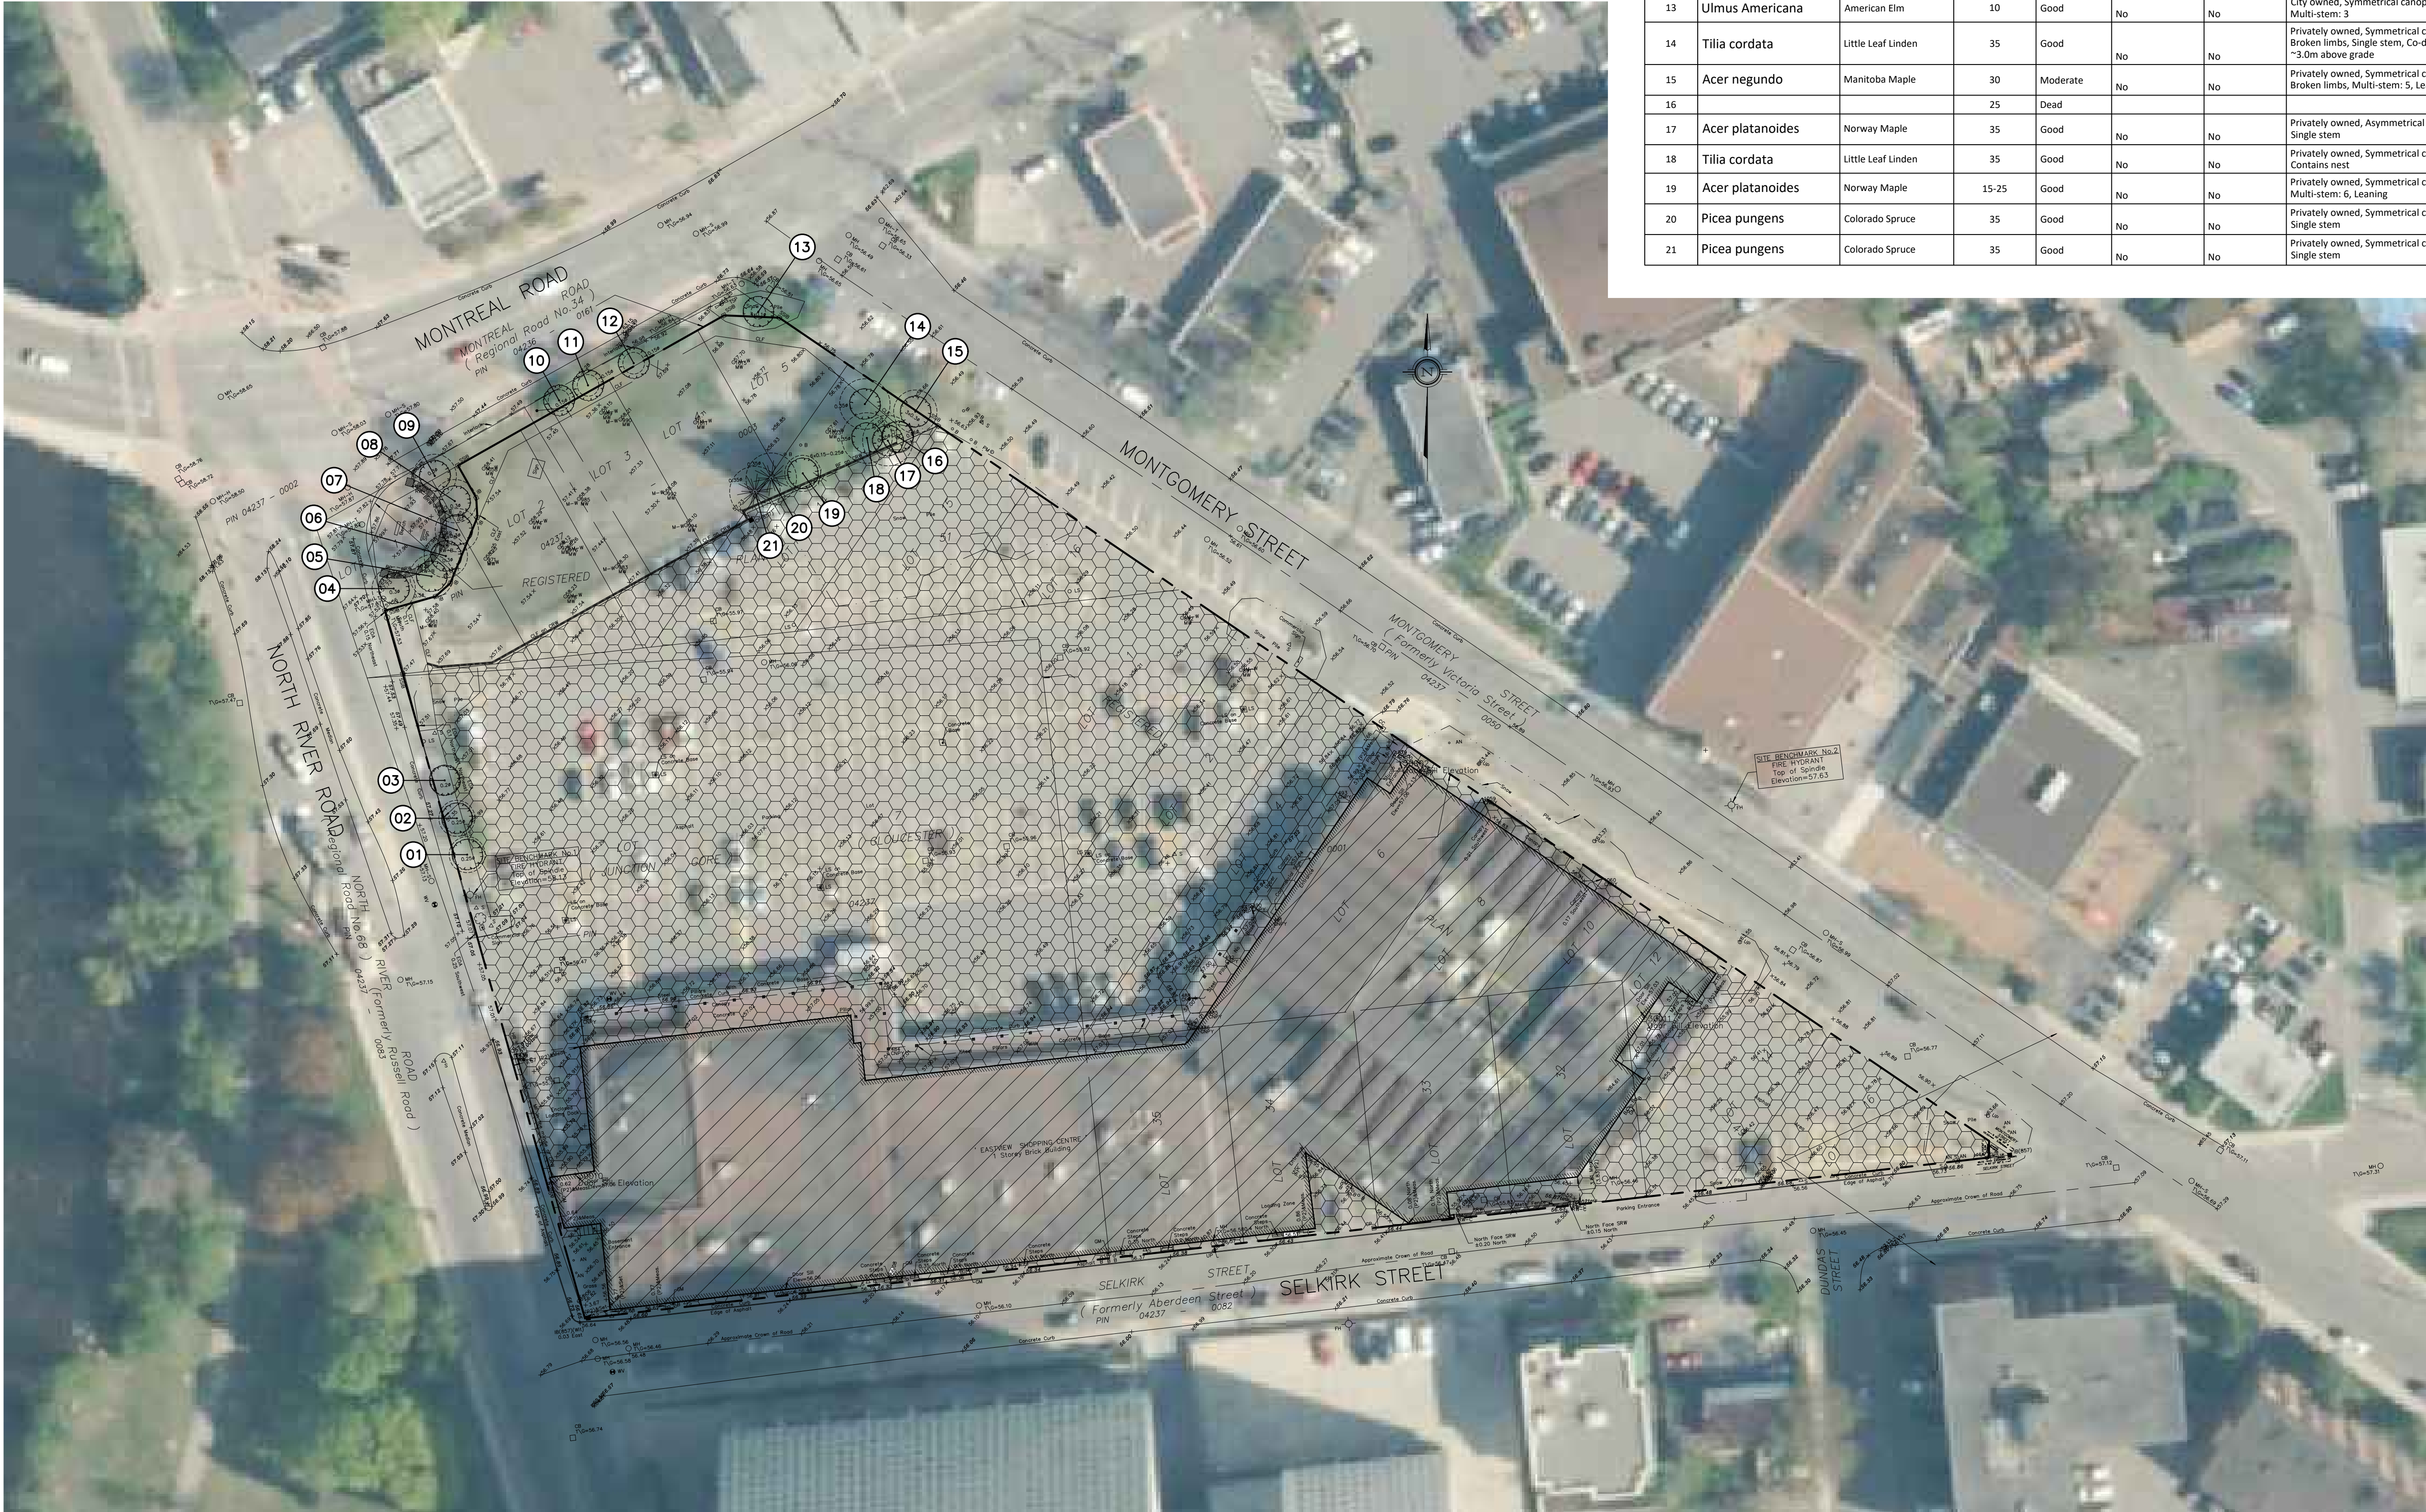
1 EXISTING VEGETATION

- THE EXISTING SITE CONTAINS MULTIPLE PARCELS OF LAND. THE LARGEST LAND PARCEL INCLUDES A SINGLE STORY COMMERCIAL/RETAIL BUILDING AND IS LARGELY OCCUPIED BY PARKING LOT. THE PROPERTY IS FAIRLY FLAT AND VOID OF TREES WITH THE EXCEPTION OF A FEW ALONG THE WESTERN EDGE BETWEEN THE PARKING AND SIDEWALK ADJACENT NORTH RIVER ROAD. THE SECOND SMALLER PARCEL TO THE NORTH IS COMPRISED OF TURF AND ASPHALT CONSISTENT WITH A DECOMMISSIONED LOT. THE PARCEL IS SEPARATED FROM THE PARKING LOT BY A LOW RETAINING WALL AND FENCING CHAIN LINK AND WOOD BOARD FENCING. A NUMBER OF TREE ARE ESTABLISHED NORTH OF THE RETAINING WALL.

- THE SITE IS 16930m<sup>2</sup> (1.693Ha).
  - APPROXIMATELY 9553m<sup>2</sup> IS OCCUPIED BY HARD SURFACES.
  - APPROXIMATELY 5577m<sup>2</sup> IS OCCUPIED BY BUILDING.

- GENERALLY, THE TREES ON THE PROPERTY ARE IN GOOD CONDITION. TREES OUTSIDE THE PROPERTY (CITY TREES) ARE GENERALLY IN GOOD CONDITION WITH THE EXCEPTION OF A COUPLE THAT ARE EITHER DEAD/POOR CONDITION.

- 21 TREES WERE INVENTORIED IN THE PROXIMITY OF THE PROJECT PROPERTY.
  - 10 TREES ARE ON CITY PROPERTY, WHILE 11 TREES ARE ON PRIVATE PROPERTY.
  - THE CITY TREES AT THE NORTHWEST CORNER OF THE PROPERTY ARE PART OF A PARKETTE/SEATING SPACE PER THE INTERSECTION OF NORTH RIVER ROAD AND MONTREAL ROAD. THESE LARGE TREES, WHICH ARE IN GOOD CONDITION, PROVIDE SHADE FOR THE SEATING AREA AND HAVE A HIGH VALUE FUNCTION. A COUPLE OF THE TREE'S CRITICAL ROOT ZONES CROSS THE PROPERTY LINE AND DO SO IN A MINOR CAPACITY.
