Phase One Environmental Site Assessment

1164 & 1166 Highcroft Drive,
Ottawa (Manotick), Ontario

EXECUTIVE SUMMARY

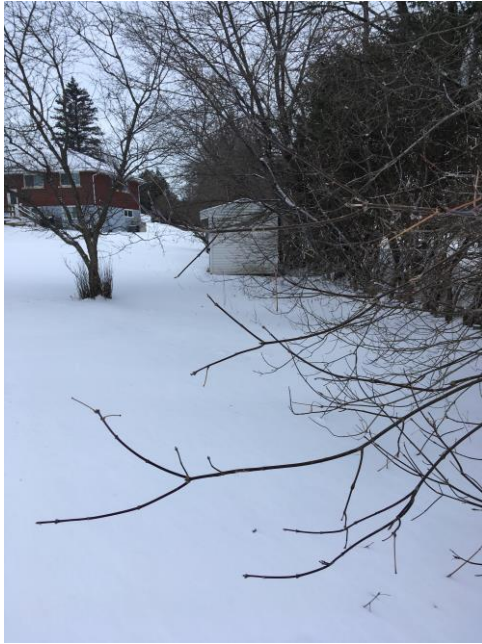
Photograph No. 3

Date: 10/1/2019	
Description Facing north, view of east property line and shed located at 1164 Highcroft Drive.

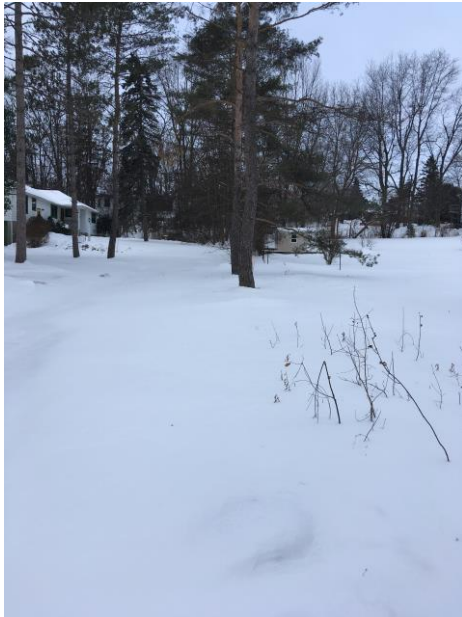
Photograph No. 4

Date: 10/1/2019	
Description Facing west, view of south property line and shed located at 1166 Highcroft drive in background.

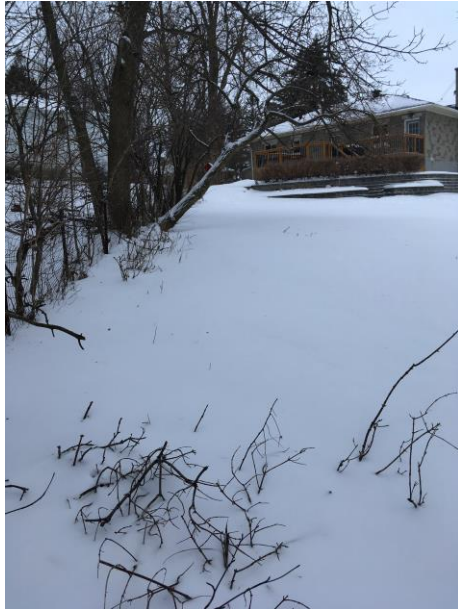
Photograph No. 5

Date: 10/1/2019	
Description Facing north, view of west property line.

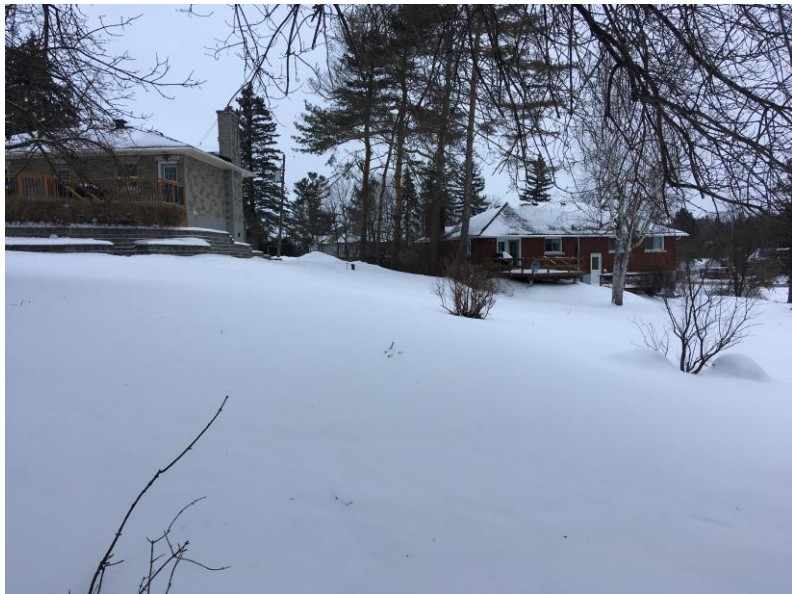
Photograph No. 6

Date: 10/1/2019	
Description Facing north, general site conditions including topography of site (sloping east).

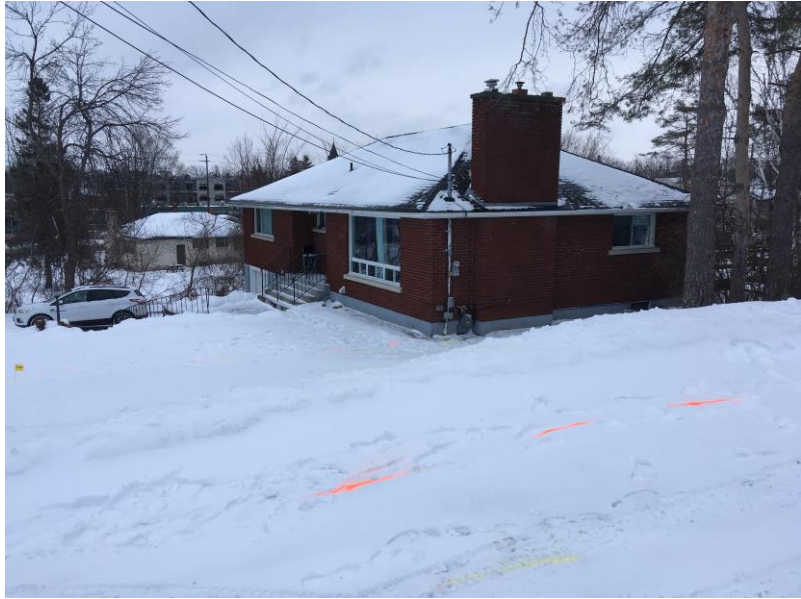
Photograph No. 7

Date: 10/1/2019	
Description Facing east, view of 1164 Highcroft Drive.

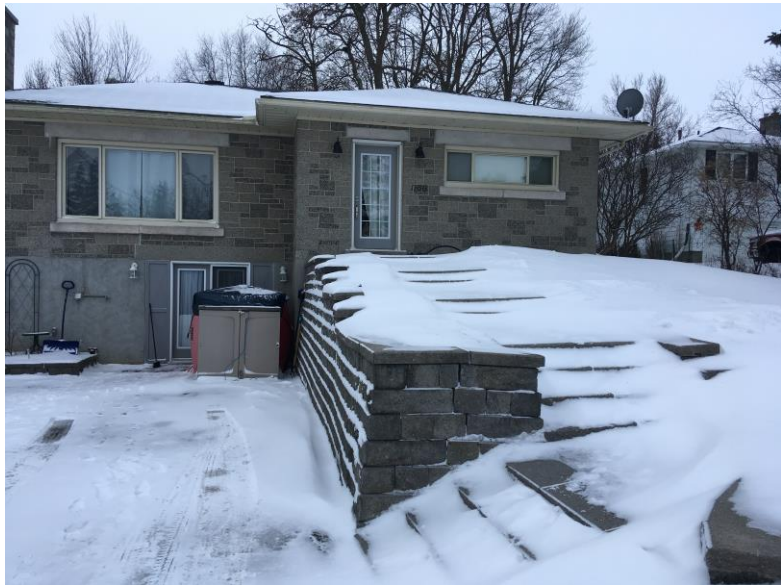
Photograph No. 8

Date: 10/1/2019	
Description Facing south, view of 1166 Highcroft Drive.

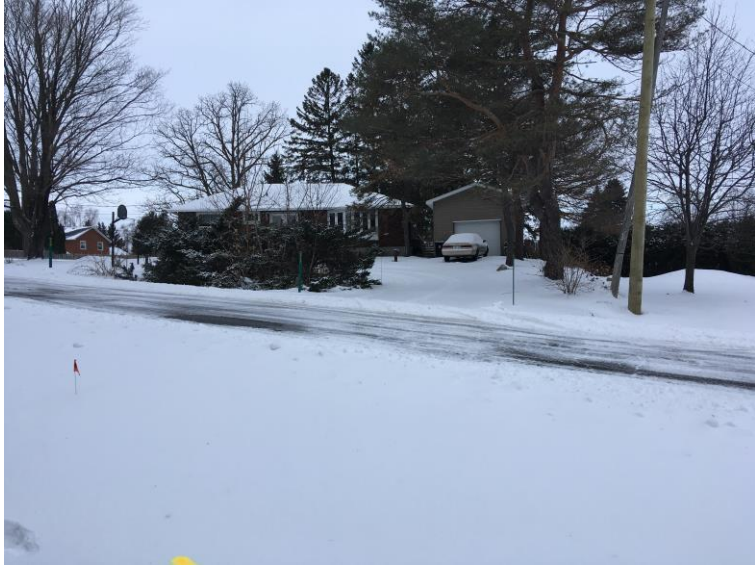
Photograph No. 9

Date: 10/1/2019	
Description Facing north, view of adjacent (residential) land to the north of the site.

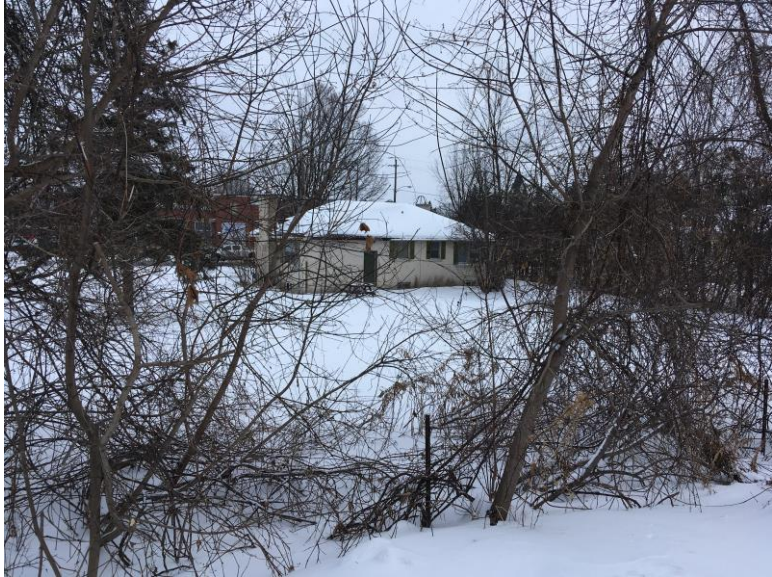
Photograph No. 11

Date: 10/1/2019	
Description Facing east view of adjacent (residential) land to the east of the site.

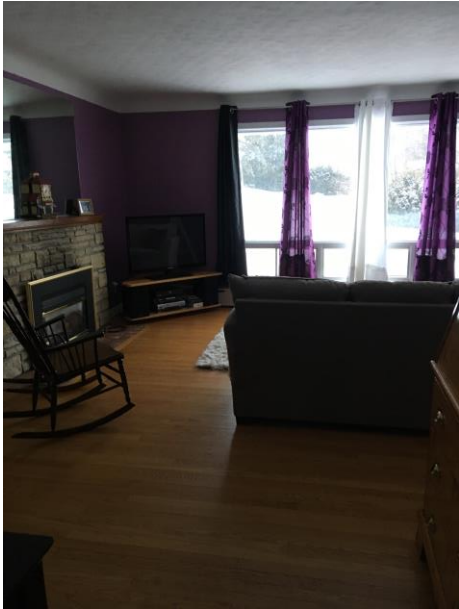
Photograph No. 13

Date: 10/1/2019	
Description View of general interior conditions of 1164 Highcroft Drive.

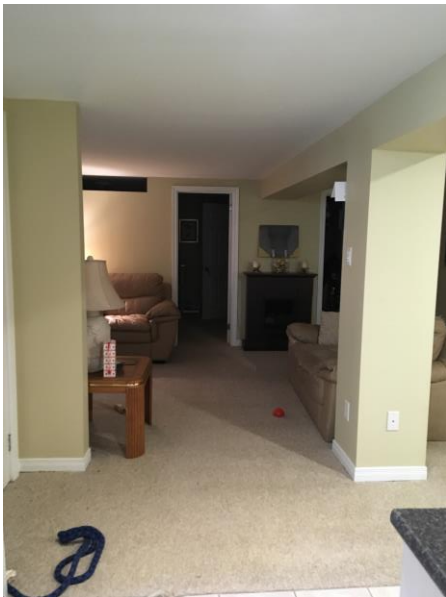
Photograph No. 14

Date: 10/1/2019	
Description View of general interior (basement) conditions of 1164 Highcroft Drive.

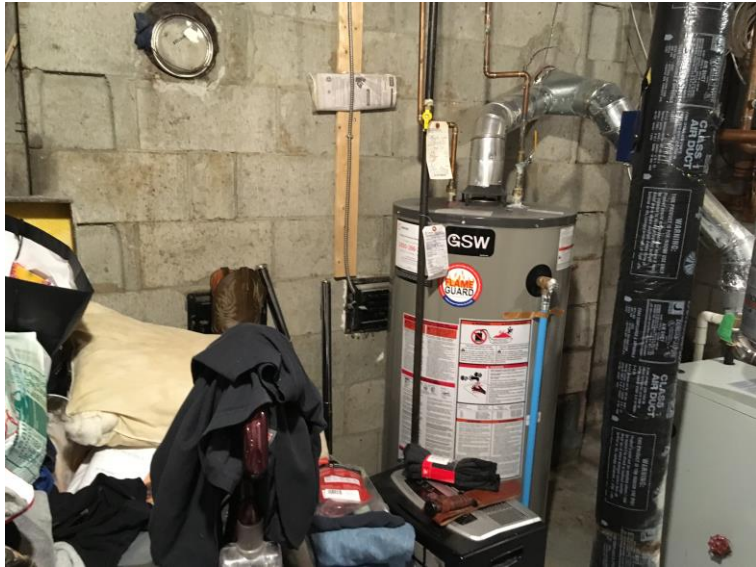
Photograph No. 15

Paint booth:	Not applicable.
Staining or corrosion (other than water):	Not applicable.
Mechanical equipment:	Mechanical equipment associated with the residence (furnace, hot water heater, pressure tank, etc.) are present in the basements.
Interior finishing	General interior finishing for both 1164 & 1166 Highcroft consisted of carpet and ceramic flooring with some concrete flooring, and acoustic ceiling tiles in the basement, drywall walls with some textured finished ceilings and wood floor in the main level.
Other:	Not applicable.

Date: 10/1/2019	
Description View of mechanical room, water heater and furnace in basement of 1164 Highcroft Drive.

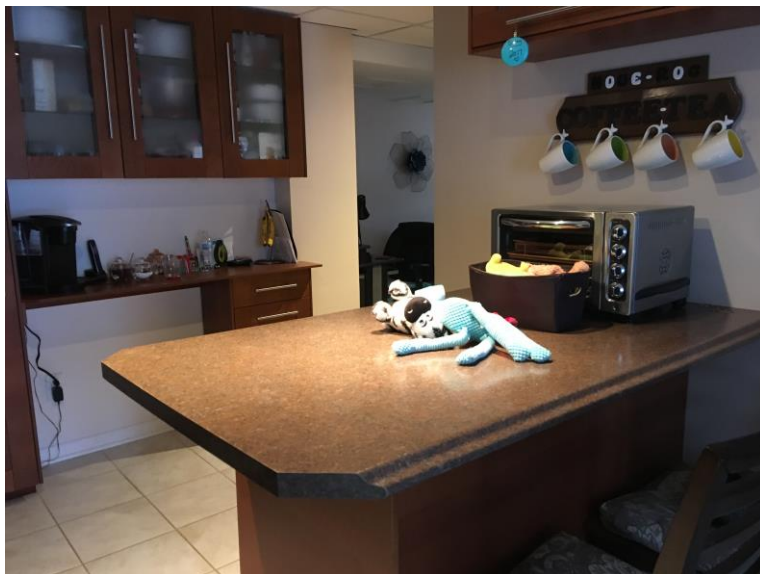
Photograph No. 16

Date: 10/1/2019	
Description View of general interior (basement) conditions of 1166 Highcroft Drive.

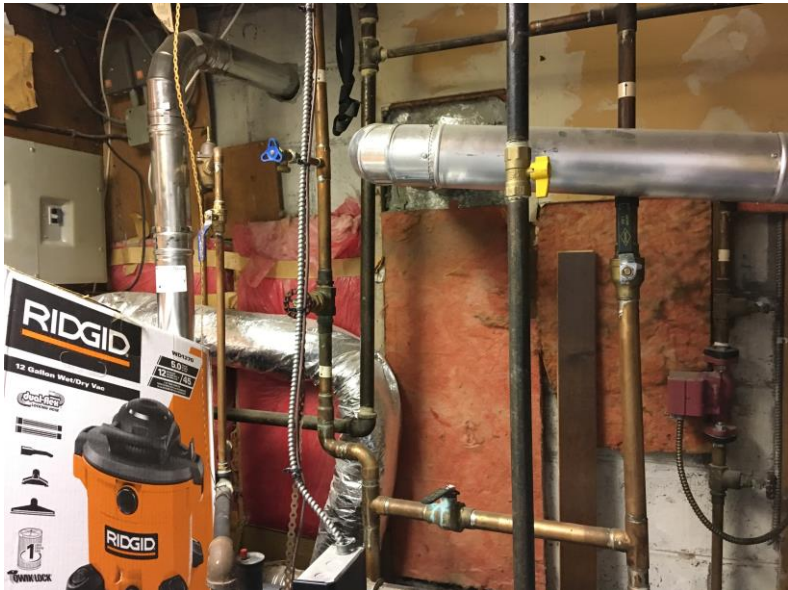
Photograph No. 17

Date: 10/1/2019	
Description View of mechanical room in basement of 1166 Highcroft Drive.

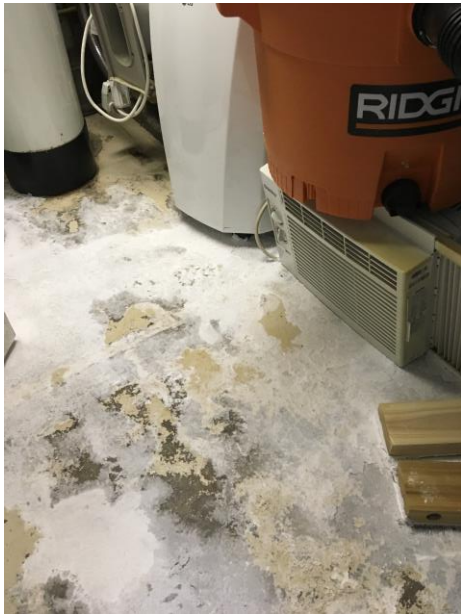
Photograph No. 18

Date: 10/1/2019	
Description View of salt brine spill from water softener on floor in mechanical room of 1166 Highcroft Drive.

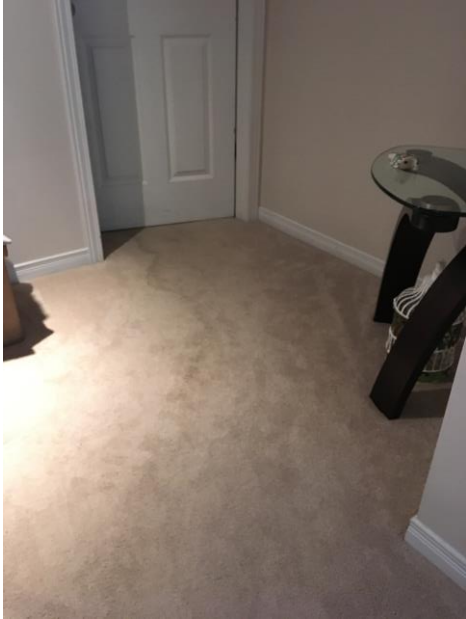
Photograph No. 19

Obvious evidence of water damage was observed in the basement of 1166 Highcroft Drive. Water staining was seen on the carpeted floor, and in select areas of the dry wall and acoustic ceiling tiles. Potential for mould is possible.

Areas of possible sources of mould (i.e. water damage, poor housekeeping, poor ventilation) were identified. Obvious evidence of water damage was in the basement of 1166 Highcroft Drive. Water staining was seen on the carpeted floor, and in select areas of the dry wall and acoustic ceiling tiles. Further inquiry during the Site visit determined that the areas have been previously damaged due to seasonal flooding, i.e., cracks in foundation.

Date: 10/1/2019	
Description View of water damage from flooding on floor in basement of 1166 Highcroft Drive. e.

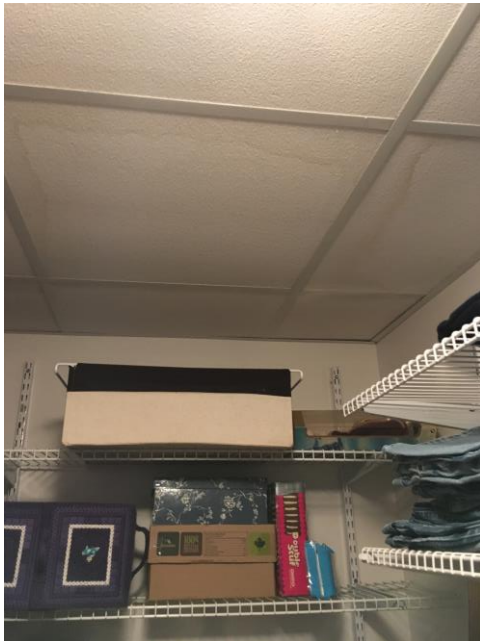
Photograph No. 20

Date: 10/1/2019	
Description View of water damage from flooding in basement closet of 1166 Highcroft Drive.
