CULTURAL HERITAGE IMPACT STATEMENT FOR
65 STEWART STREET, OTTAWA

APRIL 1, 2021

JUXTA PROJECT NO. 2105

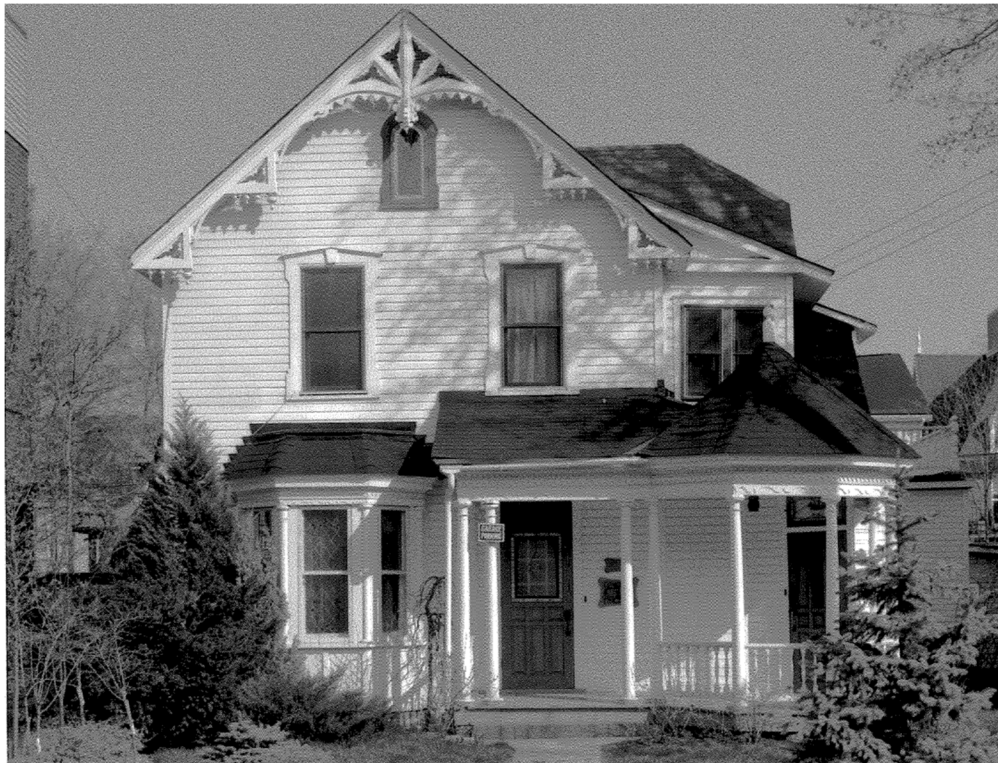
Figure 2: Street façade (1992, courtesy City of Ottawa)

The site also includes a mature blue spruce in the front yard (the same tree in sapling form can be observed in Figure 2), and an adolescent deciduous tree. Both trees are among the larger trees on the street and contribute positively to the street condition. In addition, the trees serve to reinforce the sense of privacy of the building, as noted above.

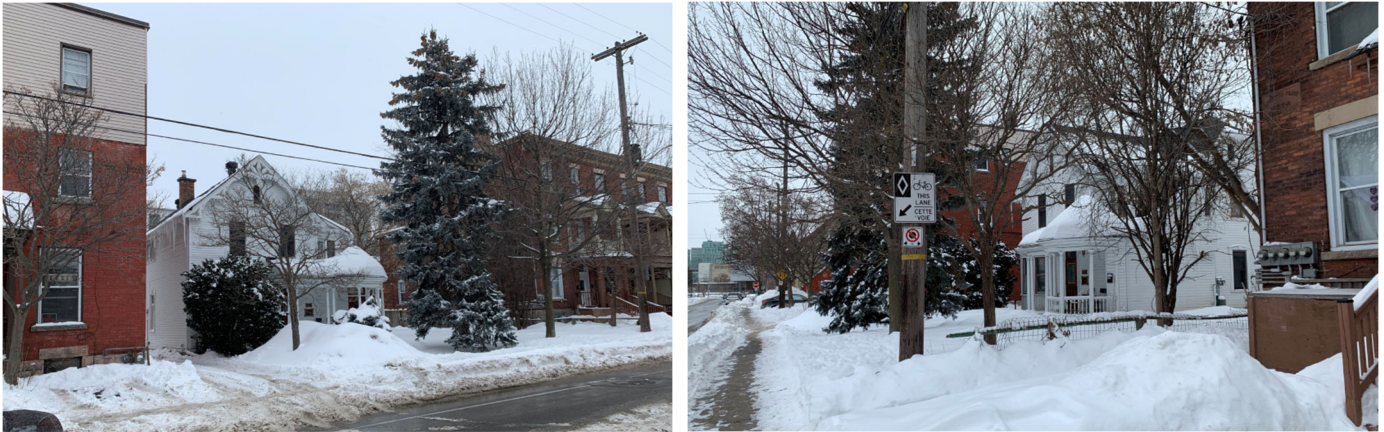
Figures 3 & 4: Oblique views of the building from both directions on the street.

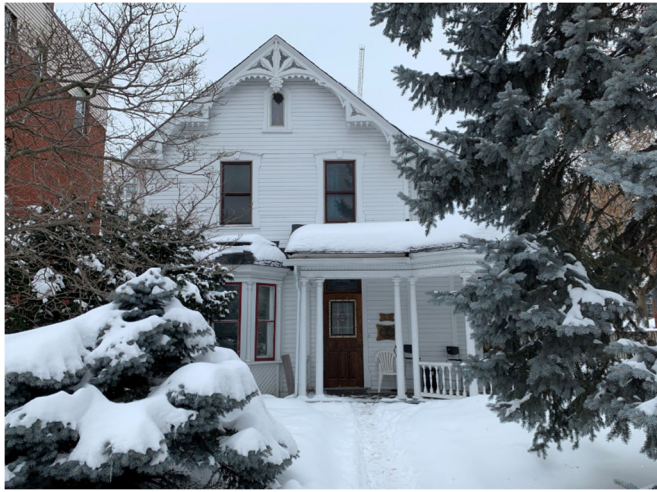
Figures 5 & 6: LEFT: A front view of the façade now. RIGHT: a view of the street and neighbouring conditions (courtesy Google)

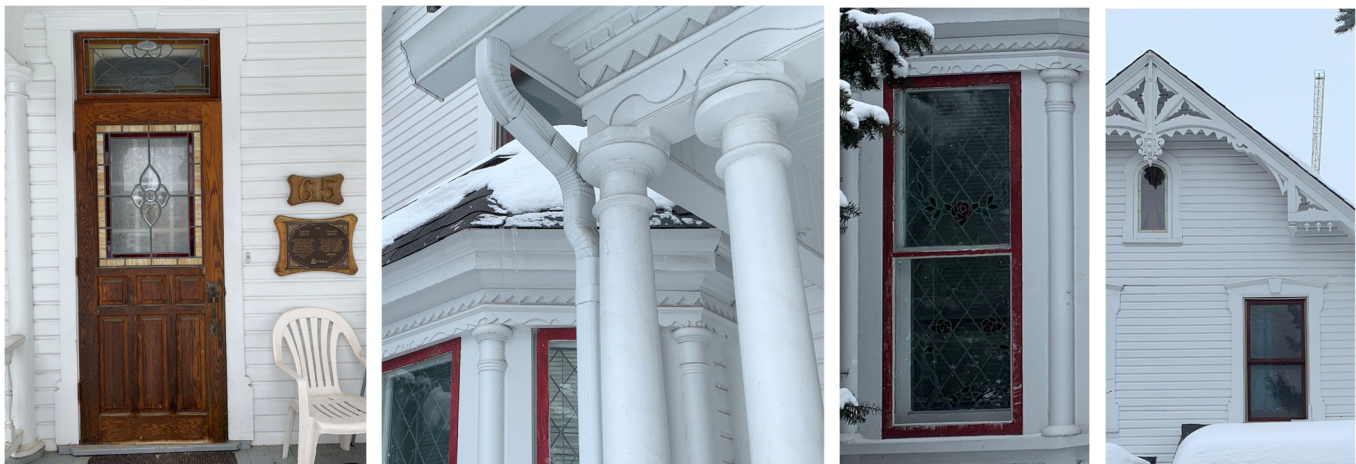
- The front-gabled design, which is unique in the immediate area,
- The horizontal wood cladding including the profile with shadow-line,
- Decorative elements, including:
 - Intricate front bargeboard,
 - Arched gable window,
 - Front porch cornice, columns and rails,
 - Bay window cornice and pilasters matching the porch,
 - Shouldered window trim with “keystone” detailing,
 - Paneled front doors, with stained glass inserts and transoms,
 - Original single-hung front windows (ground floor) with diamond patterned glazing and stained glass detailing, and
- The picturesque massing, particularly the relationship between the front gable and the octagonal porch bay.

Figure 7: Various exterior notable design features

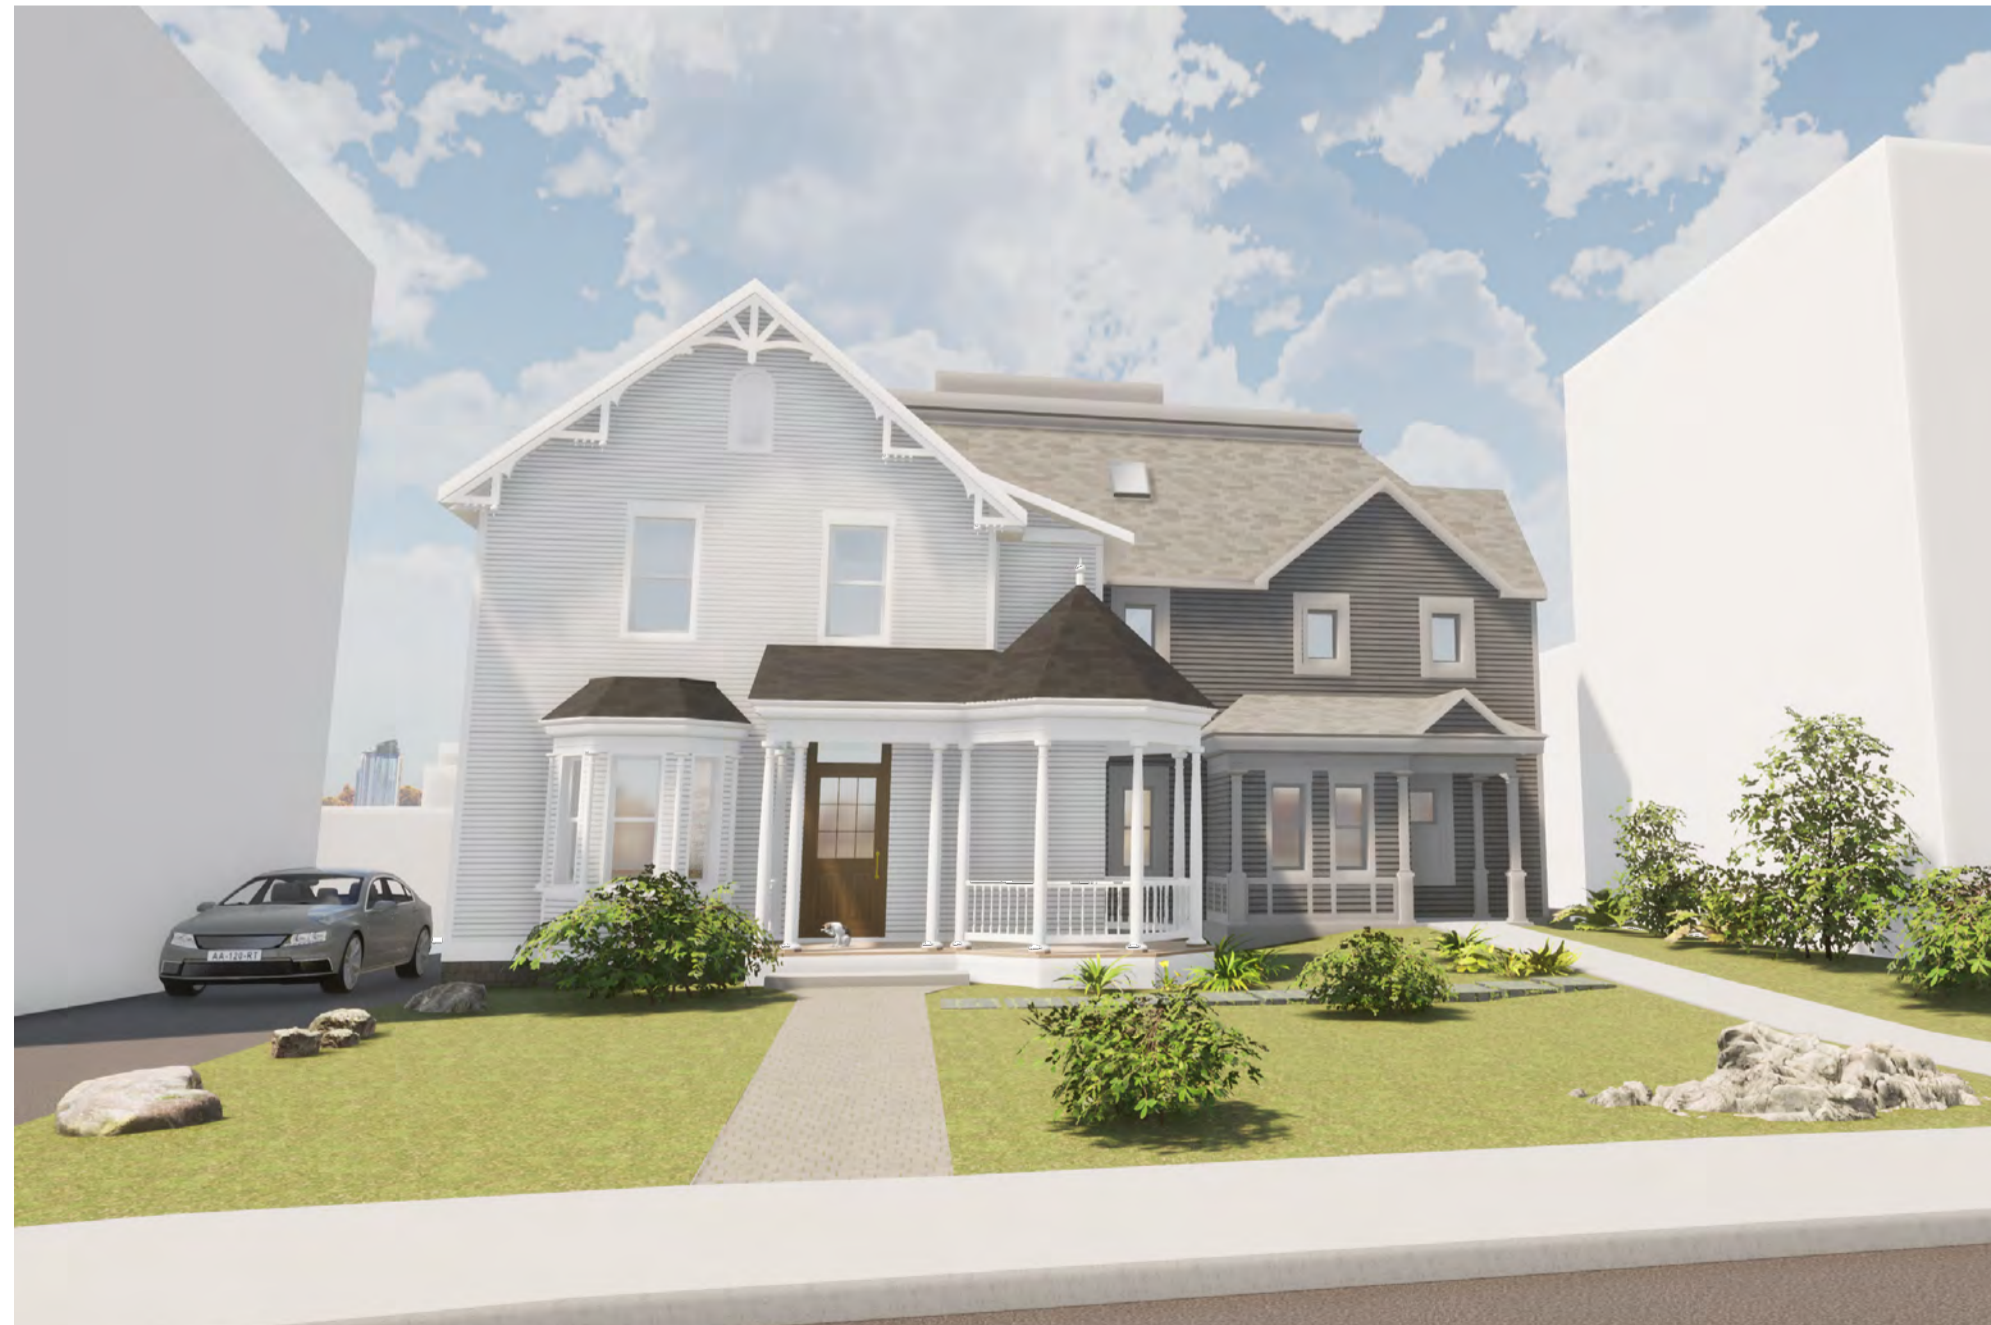
2
SPC-4 PROPOSED STREET VIEW w/o EXISTING TREES
NOT TO SCALE NOTE: EXISTING TREES TO STAY NO SHOWN FOR CLARITY

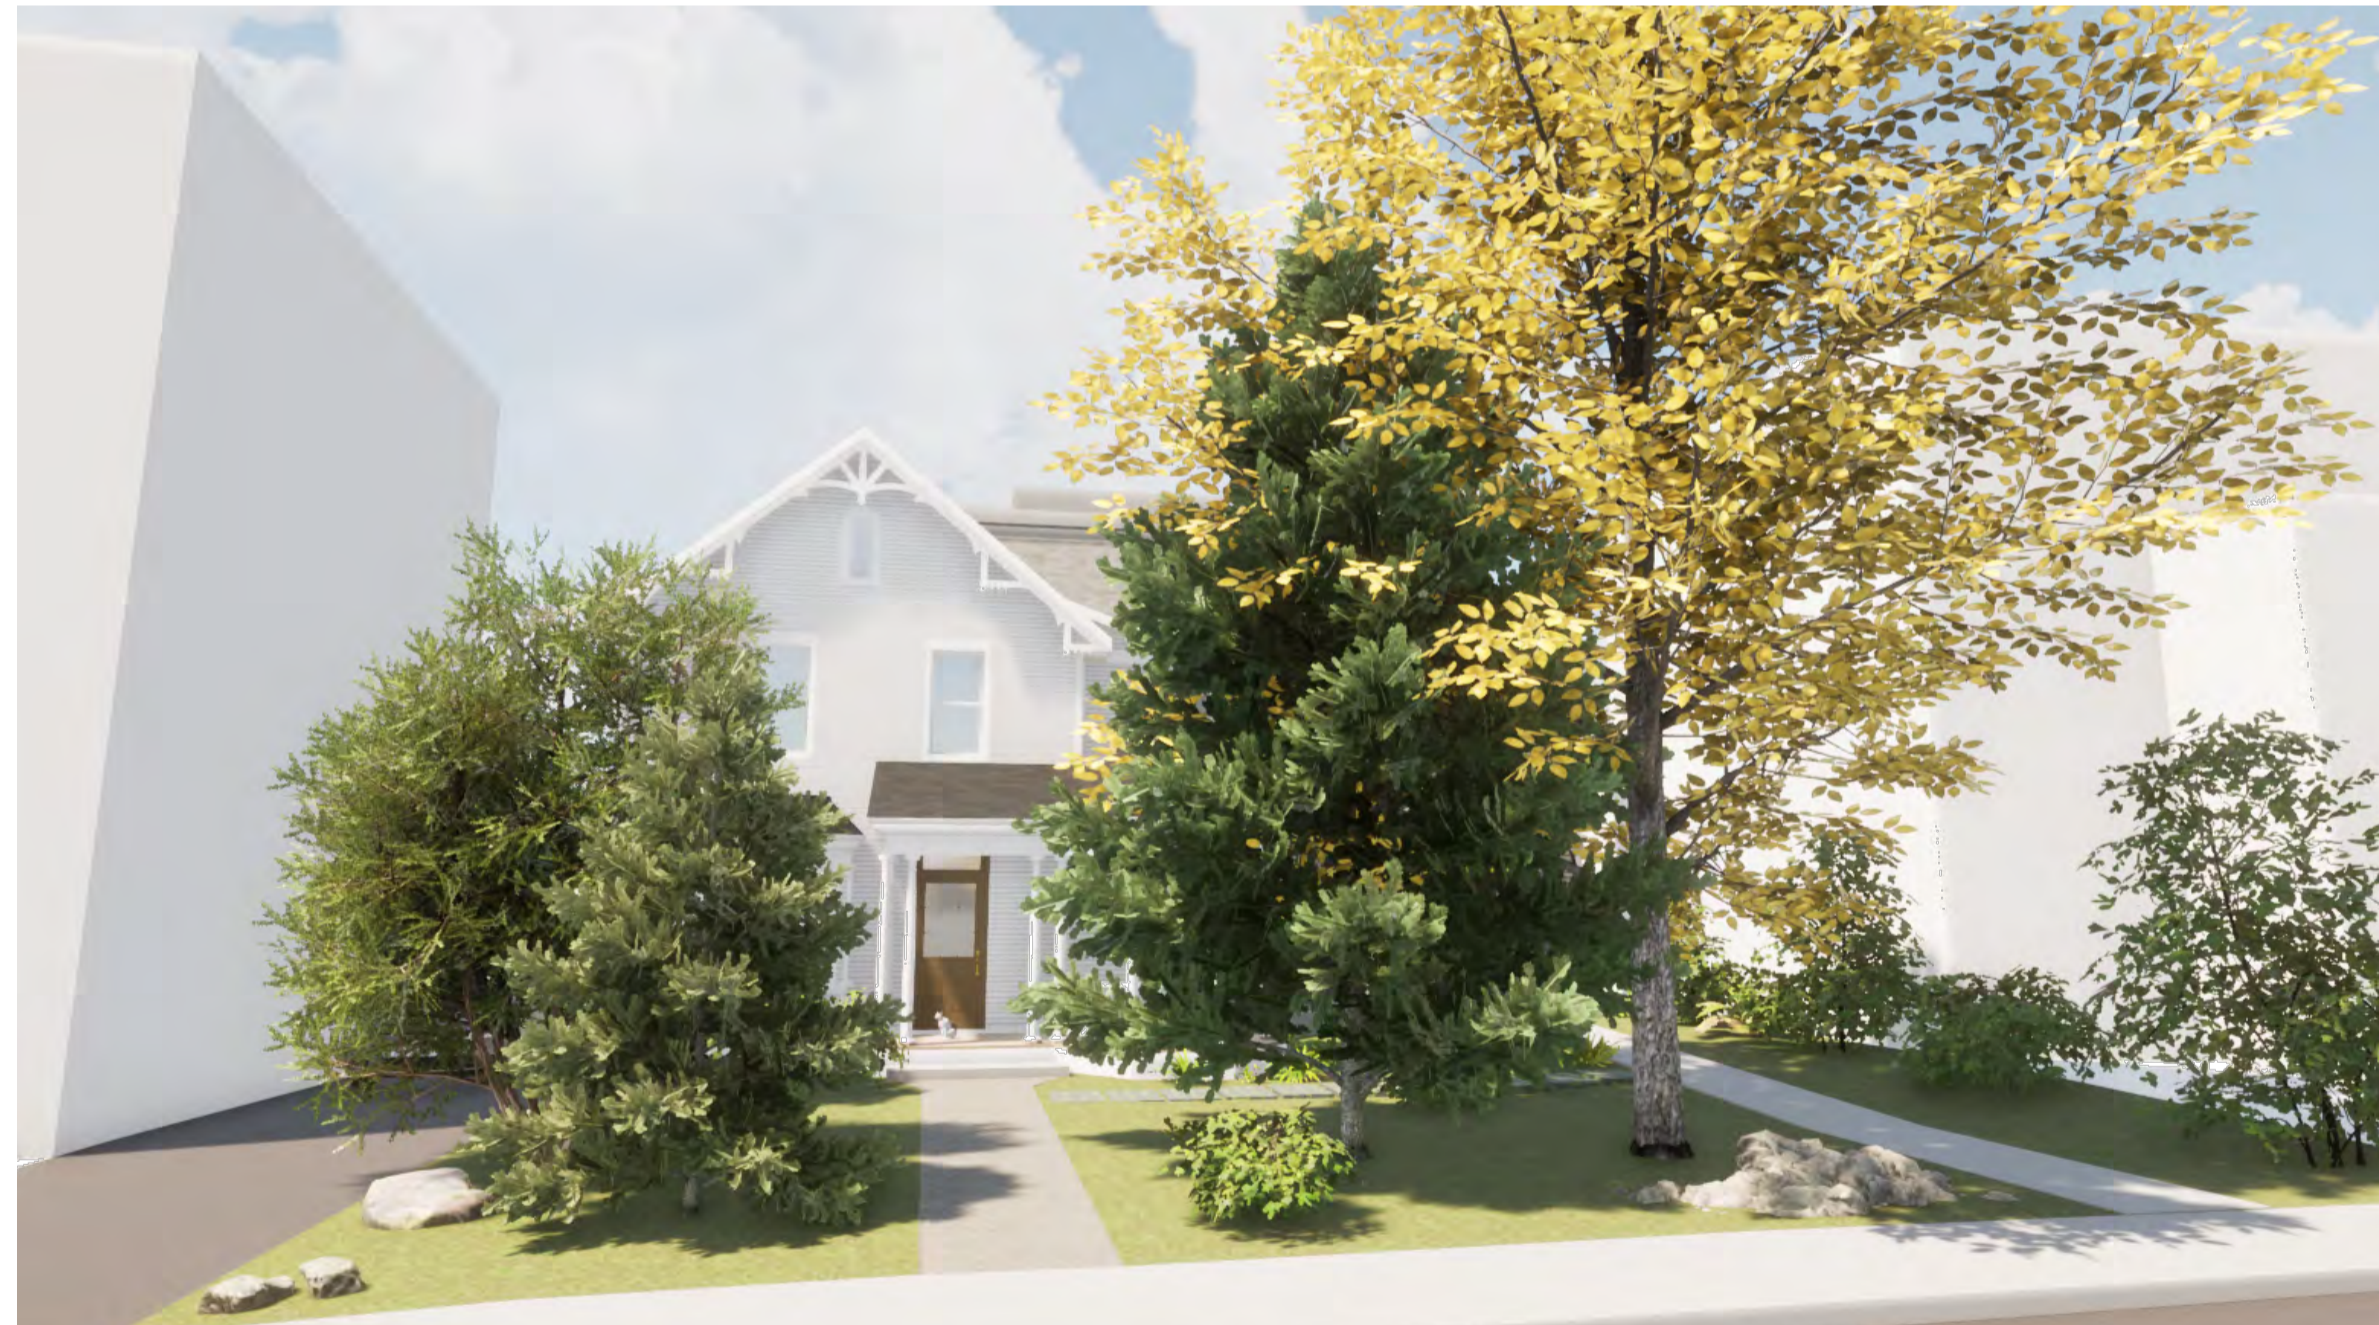
1
SPC-4 PROPOSED STREET VIEW w/ EXISTING TREES
NOT TO SCALE
