**Servicing and Stormwater  
Management Report – 2829  
Dumaurier Avenue**

Stantec Project No. 160401596

February 18, 2021

Stantec Consulting Ltd.

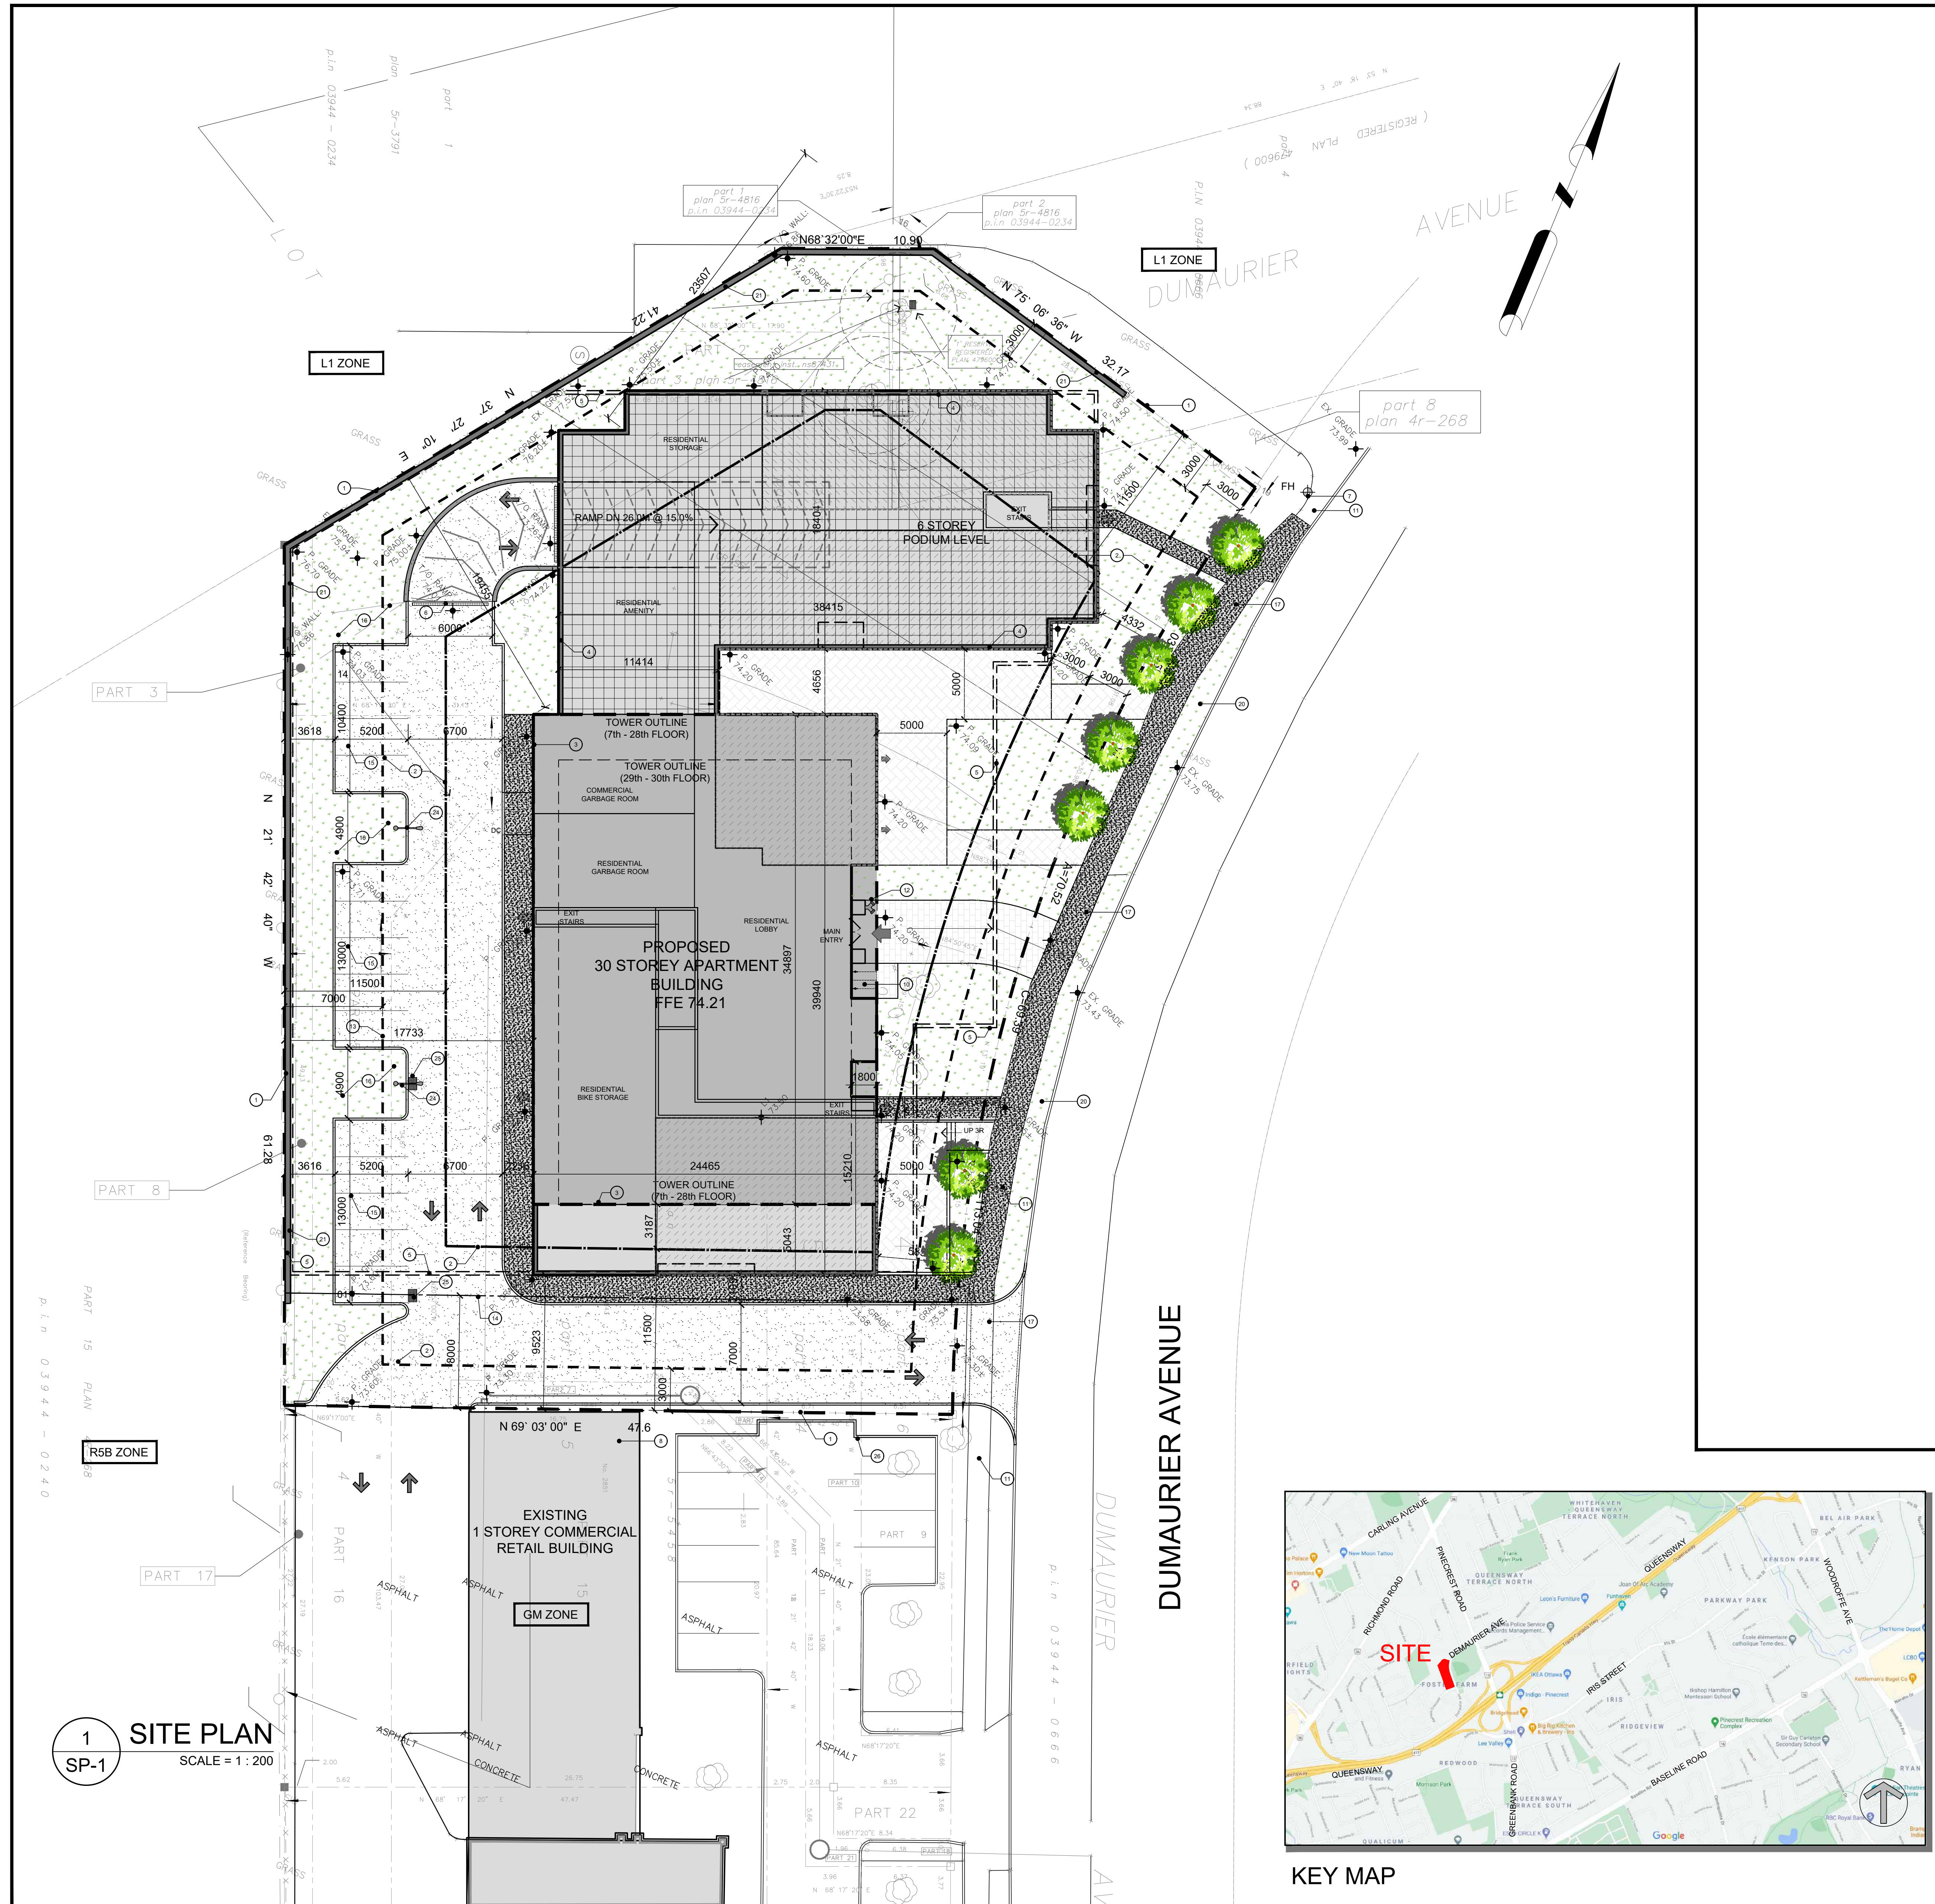
- DRAWING NOTES:**
- ① PROPERTY LINE
  - ② BUILDING / HEIGHT SETBACK LINE
  - ③ OUTLINE OF TOWER
  - ④ LINE OF PODIUM LEVEL
  - ⑤ LINE OF PARKING GARAGE BELOW

- ⑥ RAMP TO U/G GARAGE WITH TRENCH DRAIN
  - ⑦ EXISTING FIRE HYDRANT
  - ⑧ EXISTING COMMERCIAL BUILDING
  - ⑨ 2.0m WIDE CONCRETE SIDEWALK C/W DEPRESSED CURBS AT DRIVEWAY ENTRANCE
