## Phase I - Environmental Site Assessment

359 Kent Street  
436 and 444 MacLaren Street  
Ottawa, Ontario

Taggart Realty Management

Report: PE5204-1

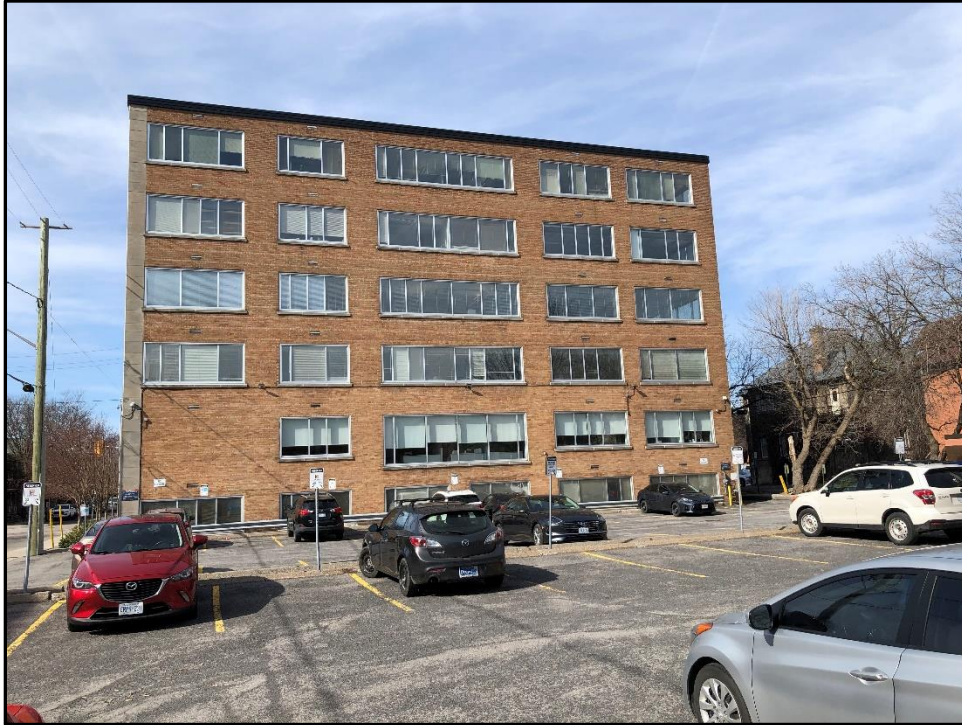
The property addressed 359 Kent Street is occupied by a six-storey brick and stone block clad commercial office building. Based on the historical information, the building was constructed in approximately 1955. The building has a flat membrane roof and a concrete foundation. The building is heated with natural gas fired boilers located in the basement and cooled with rooftop air conditioning units, as well as supplemental air conditioning units located on the ground floor.

Photo 1: At the 359 Kent Street parking lot, facing west towards the 359 Kent Street commercial building.

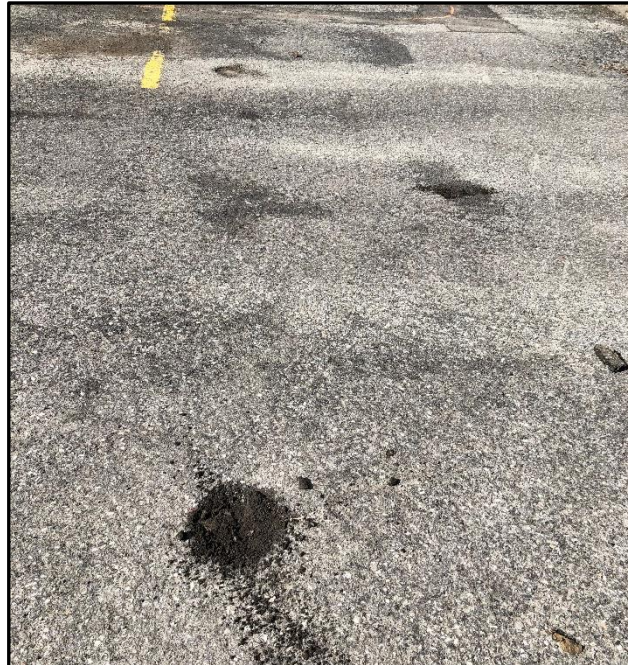
Based on previous environmental reports conducted by Jacques Whitford, a 19,000L underground storage tank (UST) containing heating oil was formerly located near the northeast corner of the 359 Kent Street building. Sealed boreholes and monitoring wells were observed in the asphalt in the vicinity of the former UST from the 2005 Phase II investigation. As previously mentioned, impacted soil was identified during the 2005 investigation directly below the former UST location. The presence of the former heating oil UST represents an APEC on the subject site.

Photo 3: Evidence of boreholes present from the 2005 Phase II investigation at the location of the former heating oil UST location (359 Kent Street).

As part of this investigation, it was recommended that groundwater in the vicinity of the former UST be resampled, however, the seven (7) monitoring wells were decommissioned. As such, the former presence of the UST represents an APEC on the Phase I property.

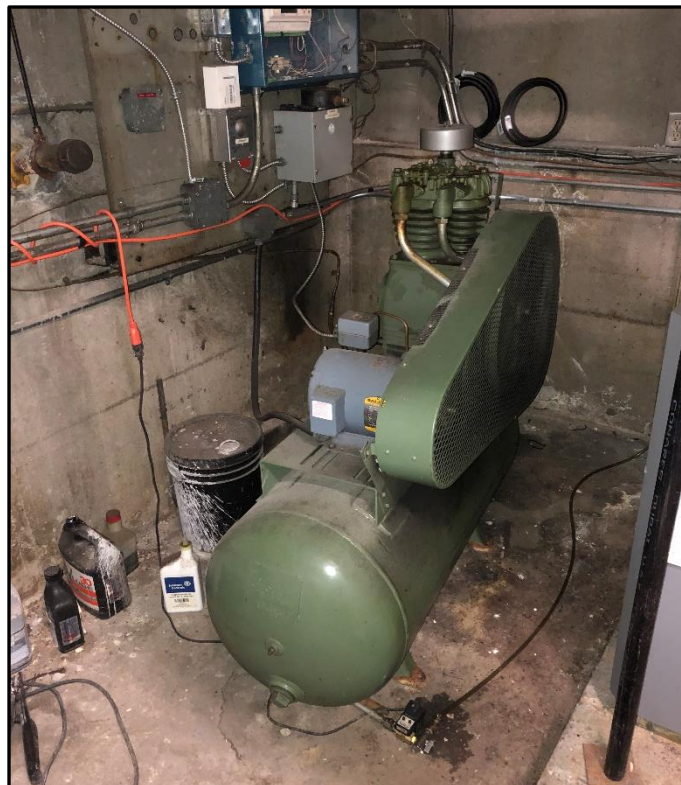
gas, however, a capped vent pipe from a former AST and associated former oil furnace was identified in the boiler room. No significant concerns were noted with respect to the former AST and oil furnace.

Photo 4: Basement boiler room in 359 Kent Street – former AST and oil furnace location, with capped vent pipe present on exterior wall.

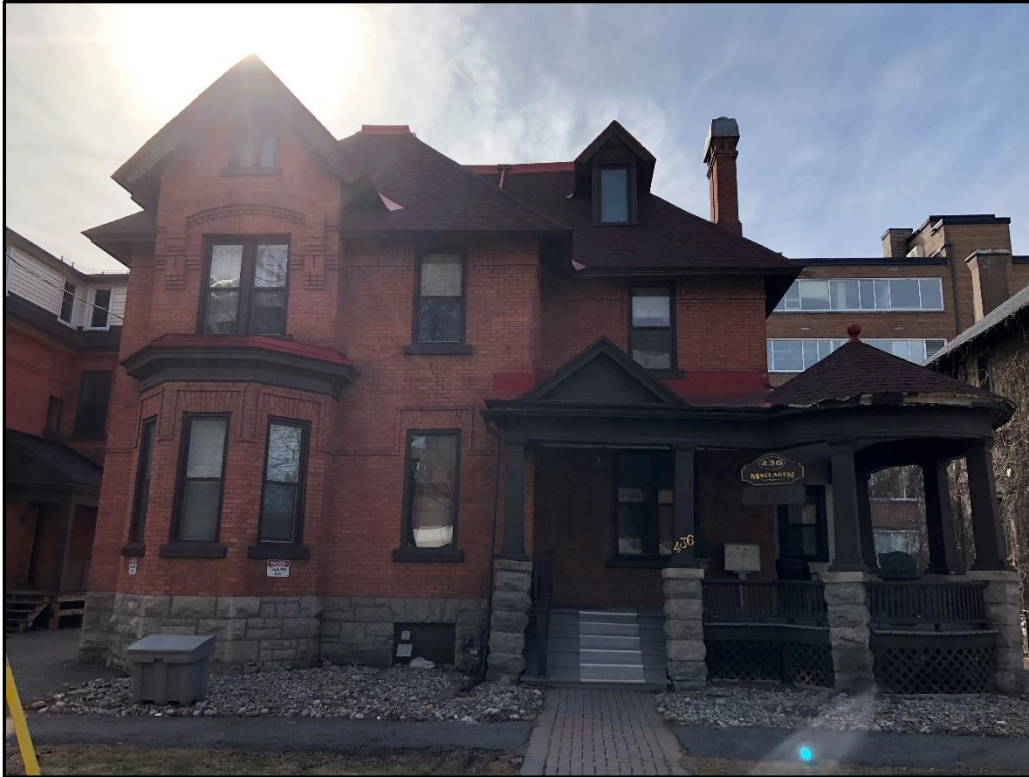
The property addressed 436 MacLaren Street is occupied by a three-storey brick and block exterior office building. The building features a stone foundation, and a primarily sloped and shingled roof, with a small flat bitumen style portion. Based on the previous property owner (2017), the building was built in 1896 for residential

Photo 5: North of 436 MacLaren Street, facing the front of 436 MacLaren Street commercial office building.

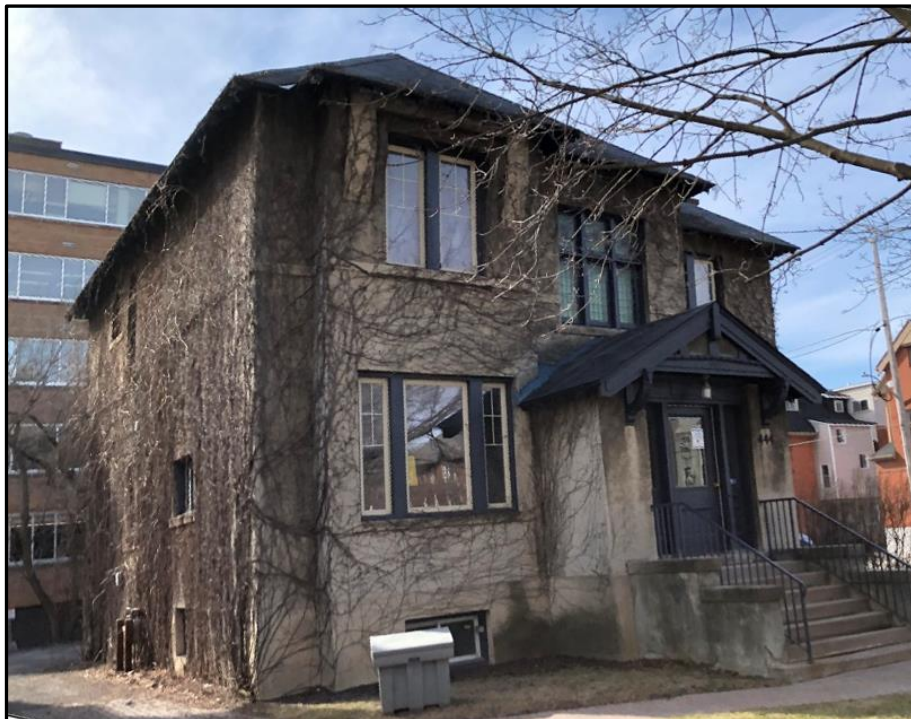
The property addressed 444 MacLaren Street is occupied by a two-storey cement parking clad office building. The building features a stone foundation, and a sloped and shingled roof. Based on the historical data, the building was built in the mid 1890s for residential purposes, and has since been repurposed for commercial office use. The building is heated with a natural gas fired boiler.

Photo 6: North of 444 MacLaren Street, facing south towards the 444 MacLaren Street commercial office building.

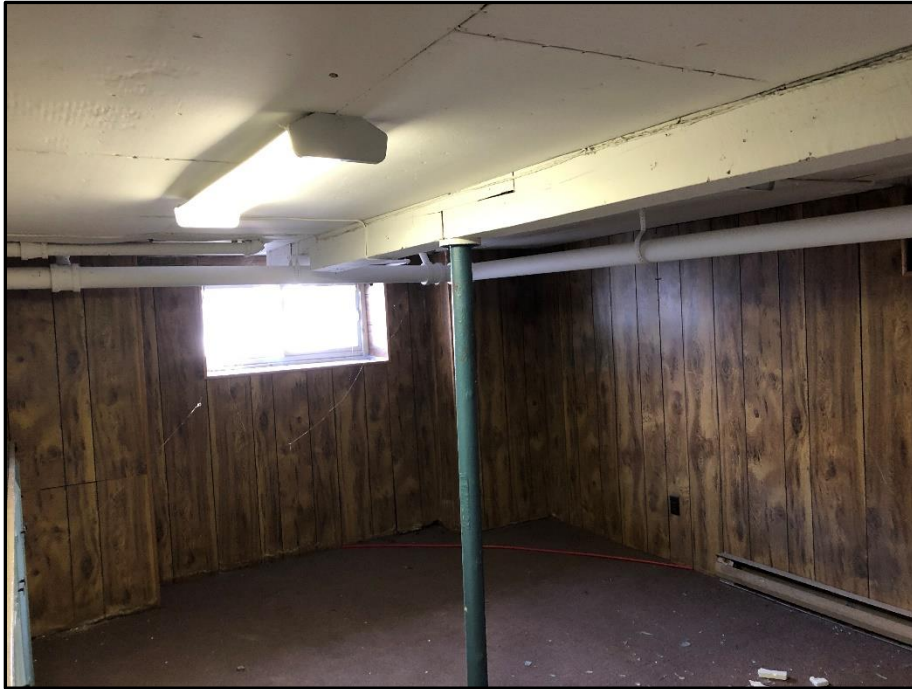
Photo 7: In the basement of the 444 MacLaren Street commercial office building, with finished walls and floors.
